**STATE OF WASHINGTON
DEPARTMENT OF ECOLOGY**

AGREED ORDER for

**Focused Feasibility Study and Draft
Cleanup Action Plan – ExxonMobil ADC
Site**

No. DE **6184**

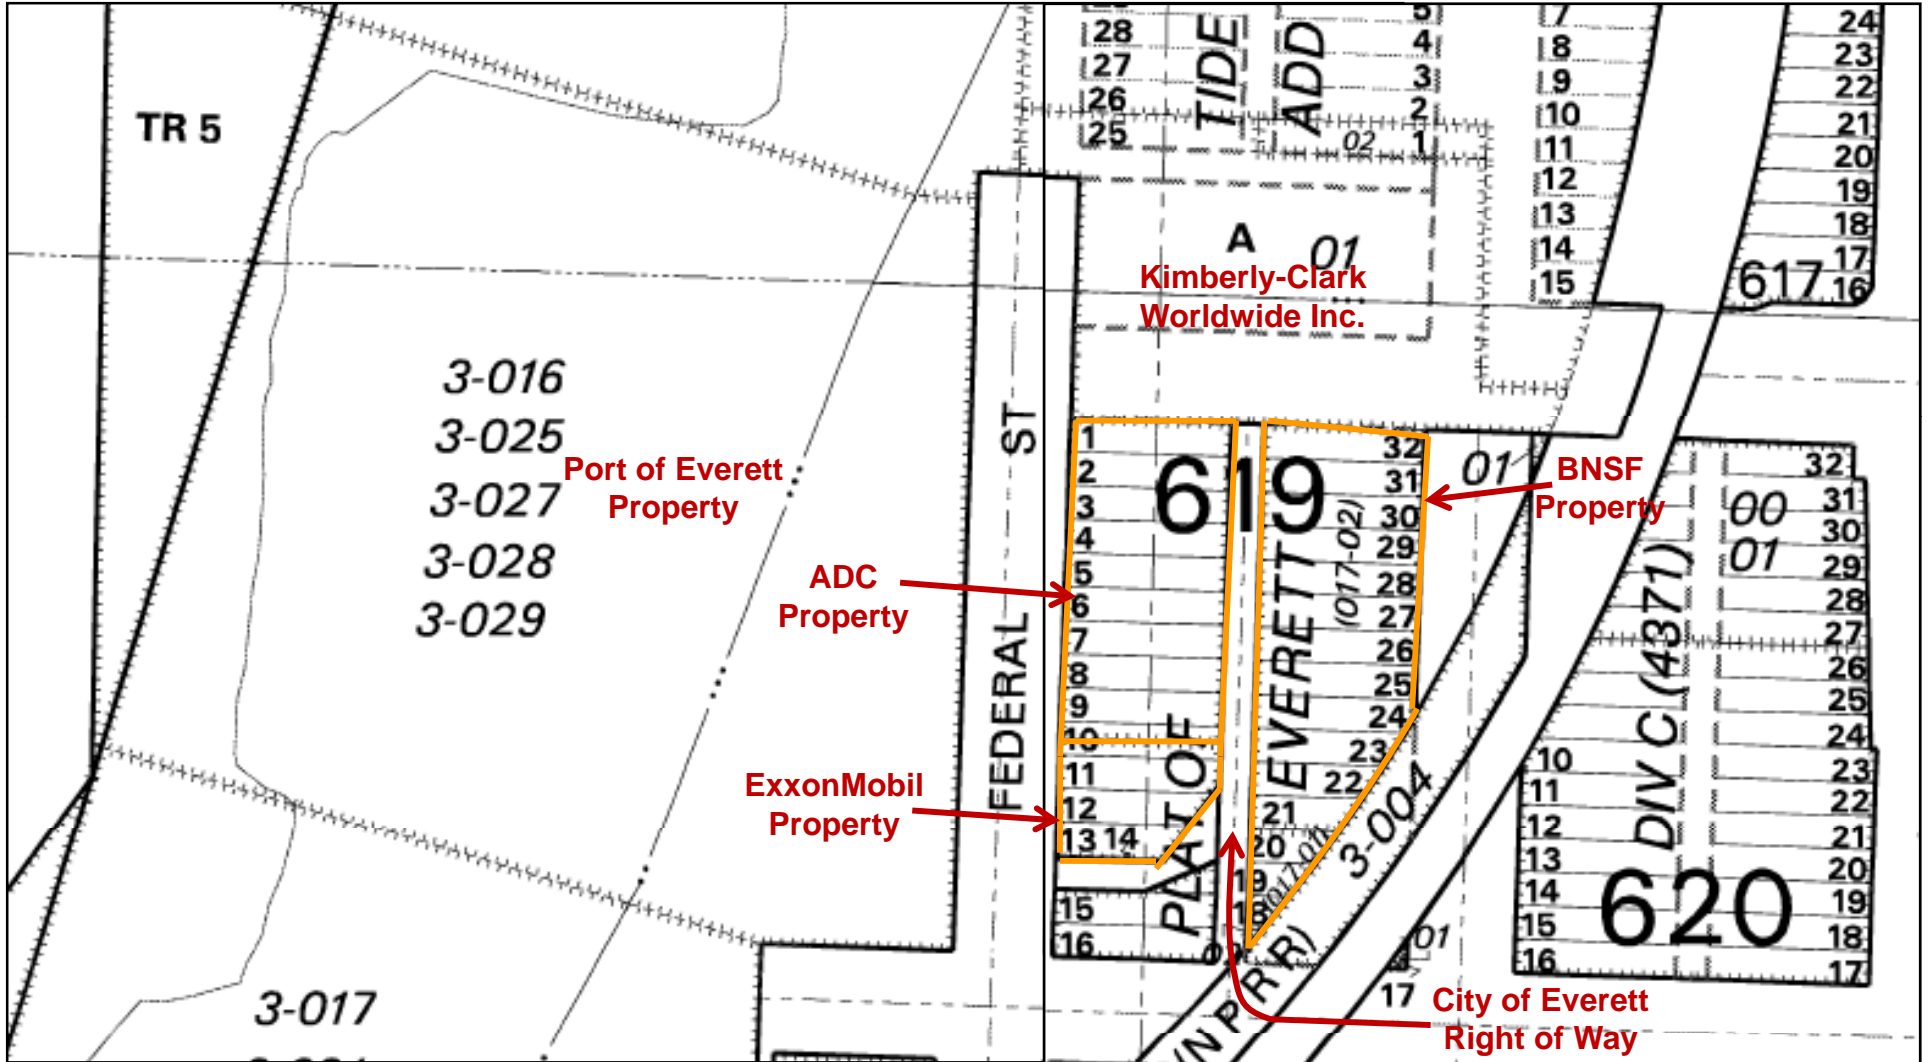
**Exhibit A – Figure 3
 Snohomish County Assessor's Office Tax Parcel Map**

THIS IS NOT A SURVEY. IT IS A TAX PARCEL MAP USED FOR THE LOCATION OF PROPERTY ONLY. SNOHOMISH COUNTY DISCLAIMS ANY WARRANTY OF MERCHANTABILITY OR WARRANTY OF FITNESS OF THIS MAP FOR ANY PARTICULAR PURPOSE, EITHER EXPRESS OR IMPLIED. NO REPRESENTATION OR WARRANTY IS MADE CONCERNING THE ACCURACY, CURRENCY, COMPLETENESS OR QUALITY OF DATA DEPICTED ON THIS MAP. ANY USER OF THIS MAP ASSUMES ALL RESPONSIBILITY FOR USE THEREOF, AND FURTHER AGREES TO HOLD SNOHOMISH COUNTY HARMLESS FROM AND AGAINST ANY DAMAGE, LOSS OR LIABILITY ARISING FROM ANY USE OF THIS MAP. PERSONS SEEKING THE MOST CURRENT TAX PARCEL DATA SHOULD CONSULT THE OFFICIAL DATABASE ON FILE WITH THE SNOHOMISH COUNTY ASSESSOR.

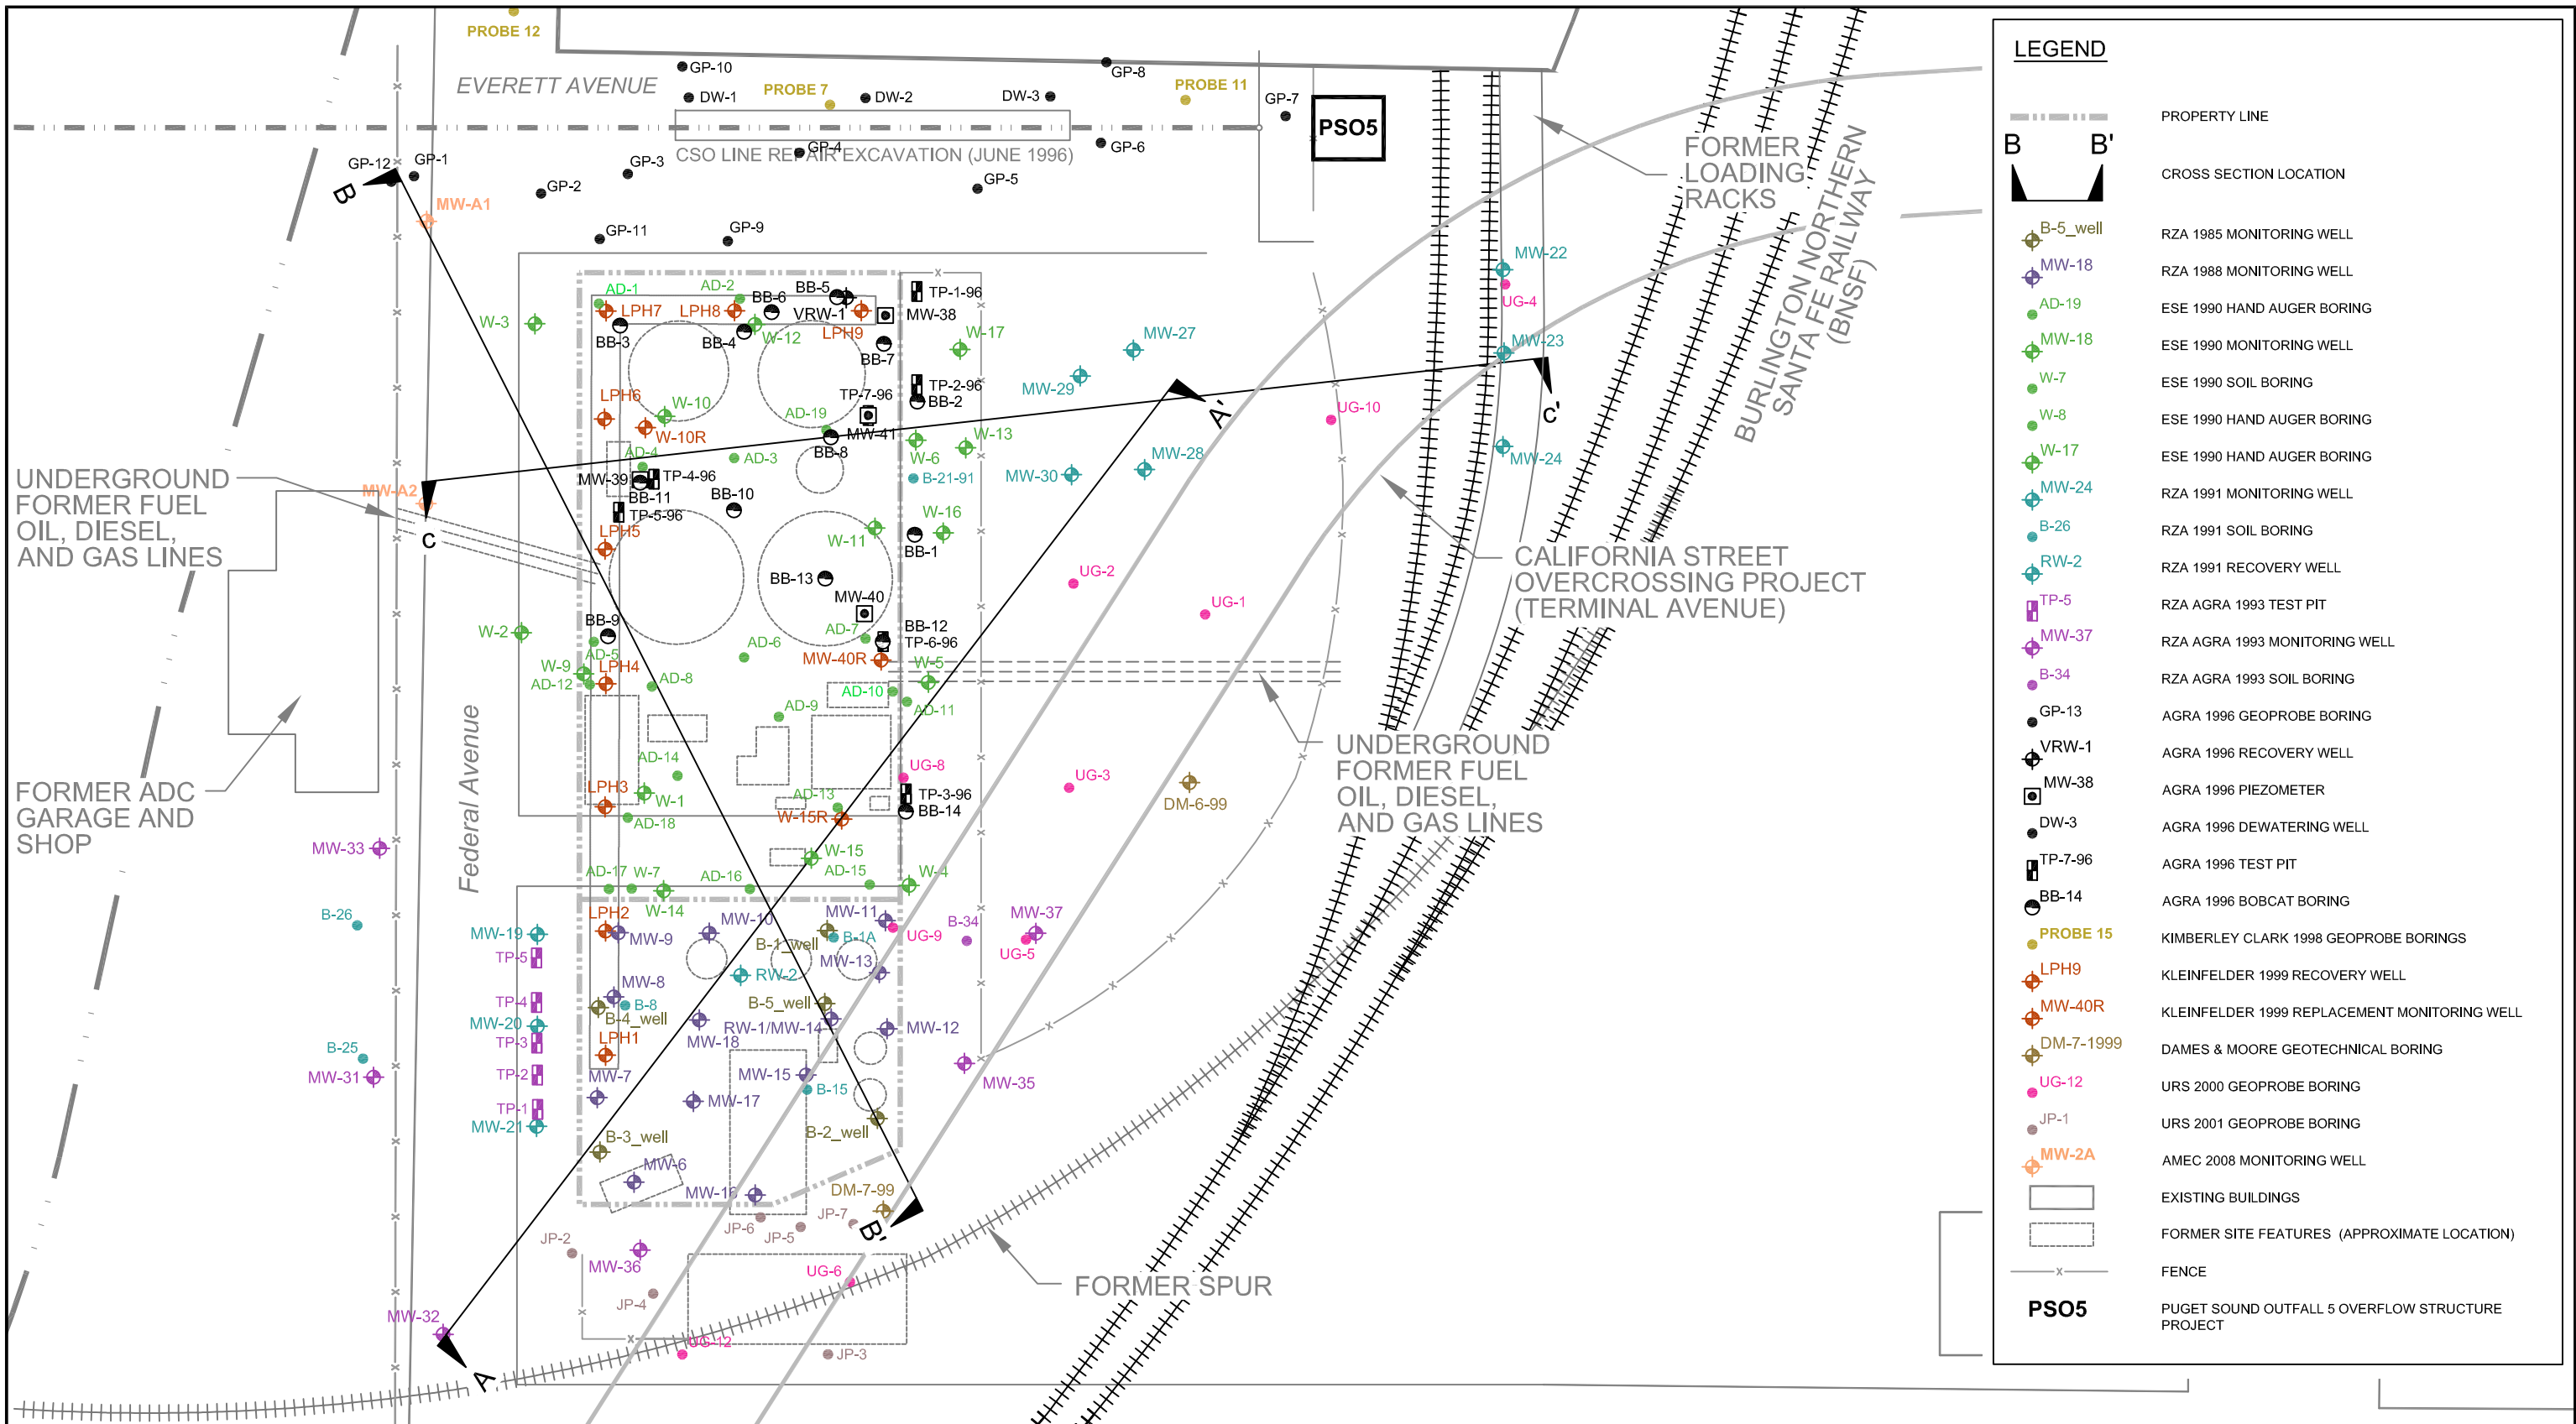
CLIENT: EXXONMOBIL AND AMERICAN DISTRIBUTING CO.	
PROJECT: EXXONMOBIL/ADC PROPERTY ECOLOGY SITE ID 2728		DWN BY: BRJ	DATUM: NAD83	DATE: AUGUST 2009	
TITLE: FEATURES SEEN IN 1993 AERIAL OVER 2003 AERIAL		CHKD BY: AIS/MS	REV. NO.: 1	PROJECT NO.: 9-915-15716C	
		PROJECTION: WA SP North	SCALE: 1 inch = 200 feet	FIGURE No.: FIGURE 14

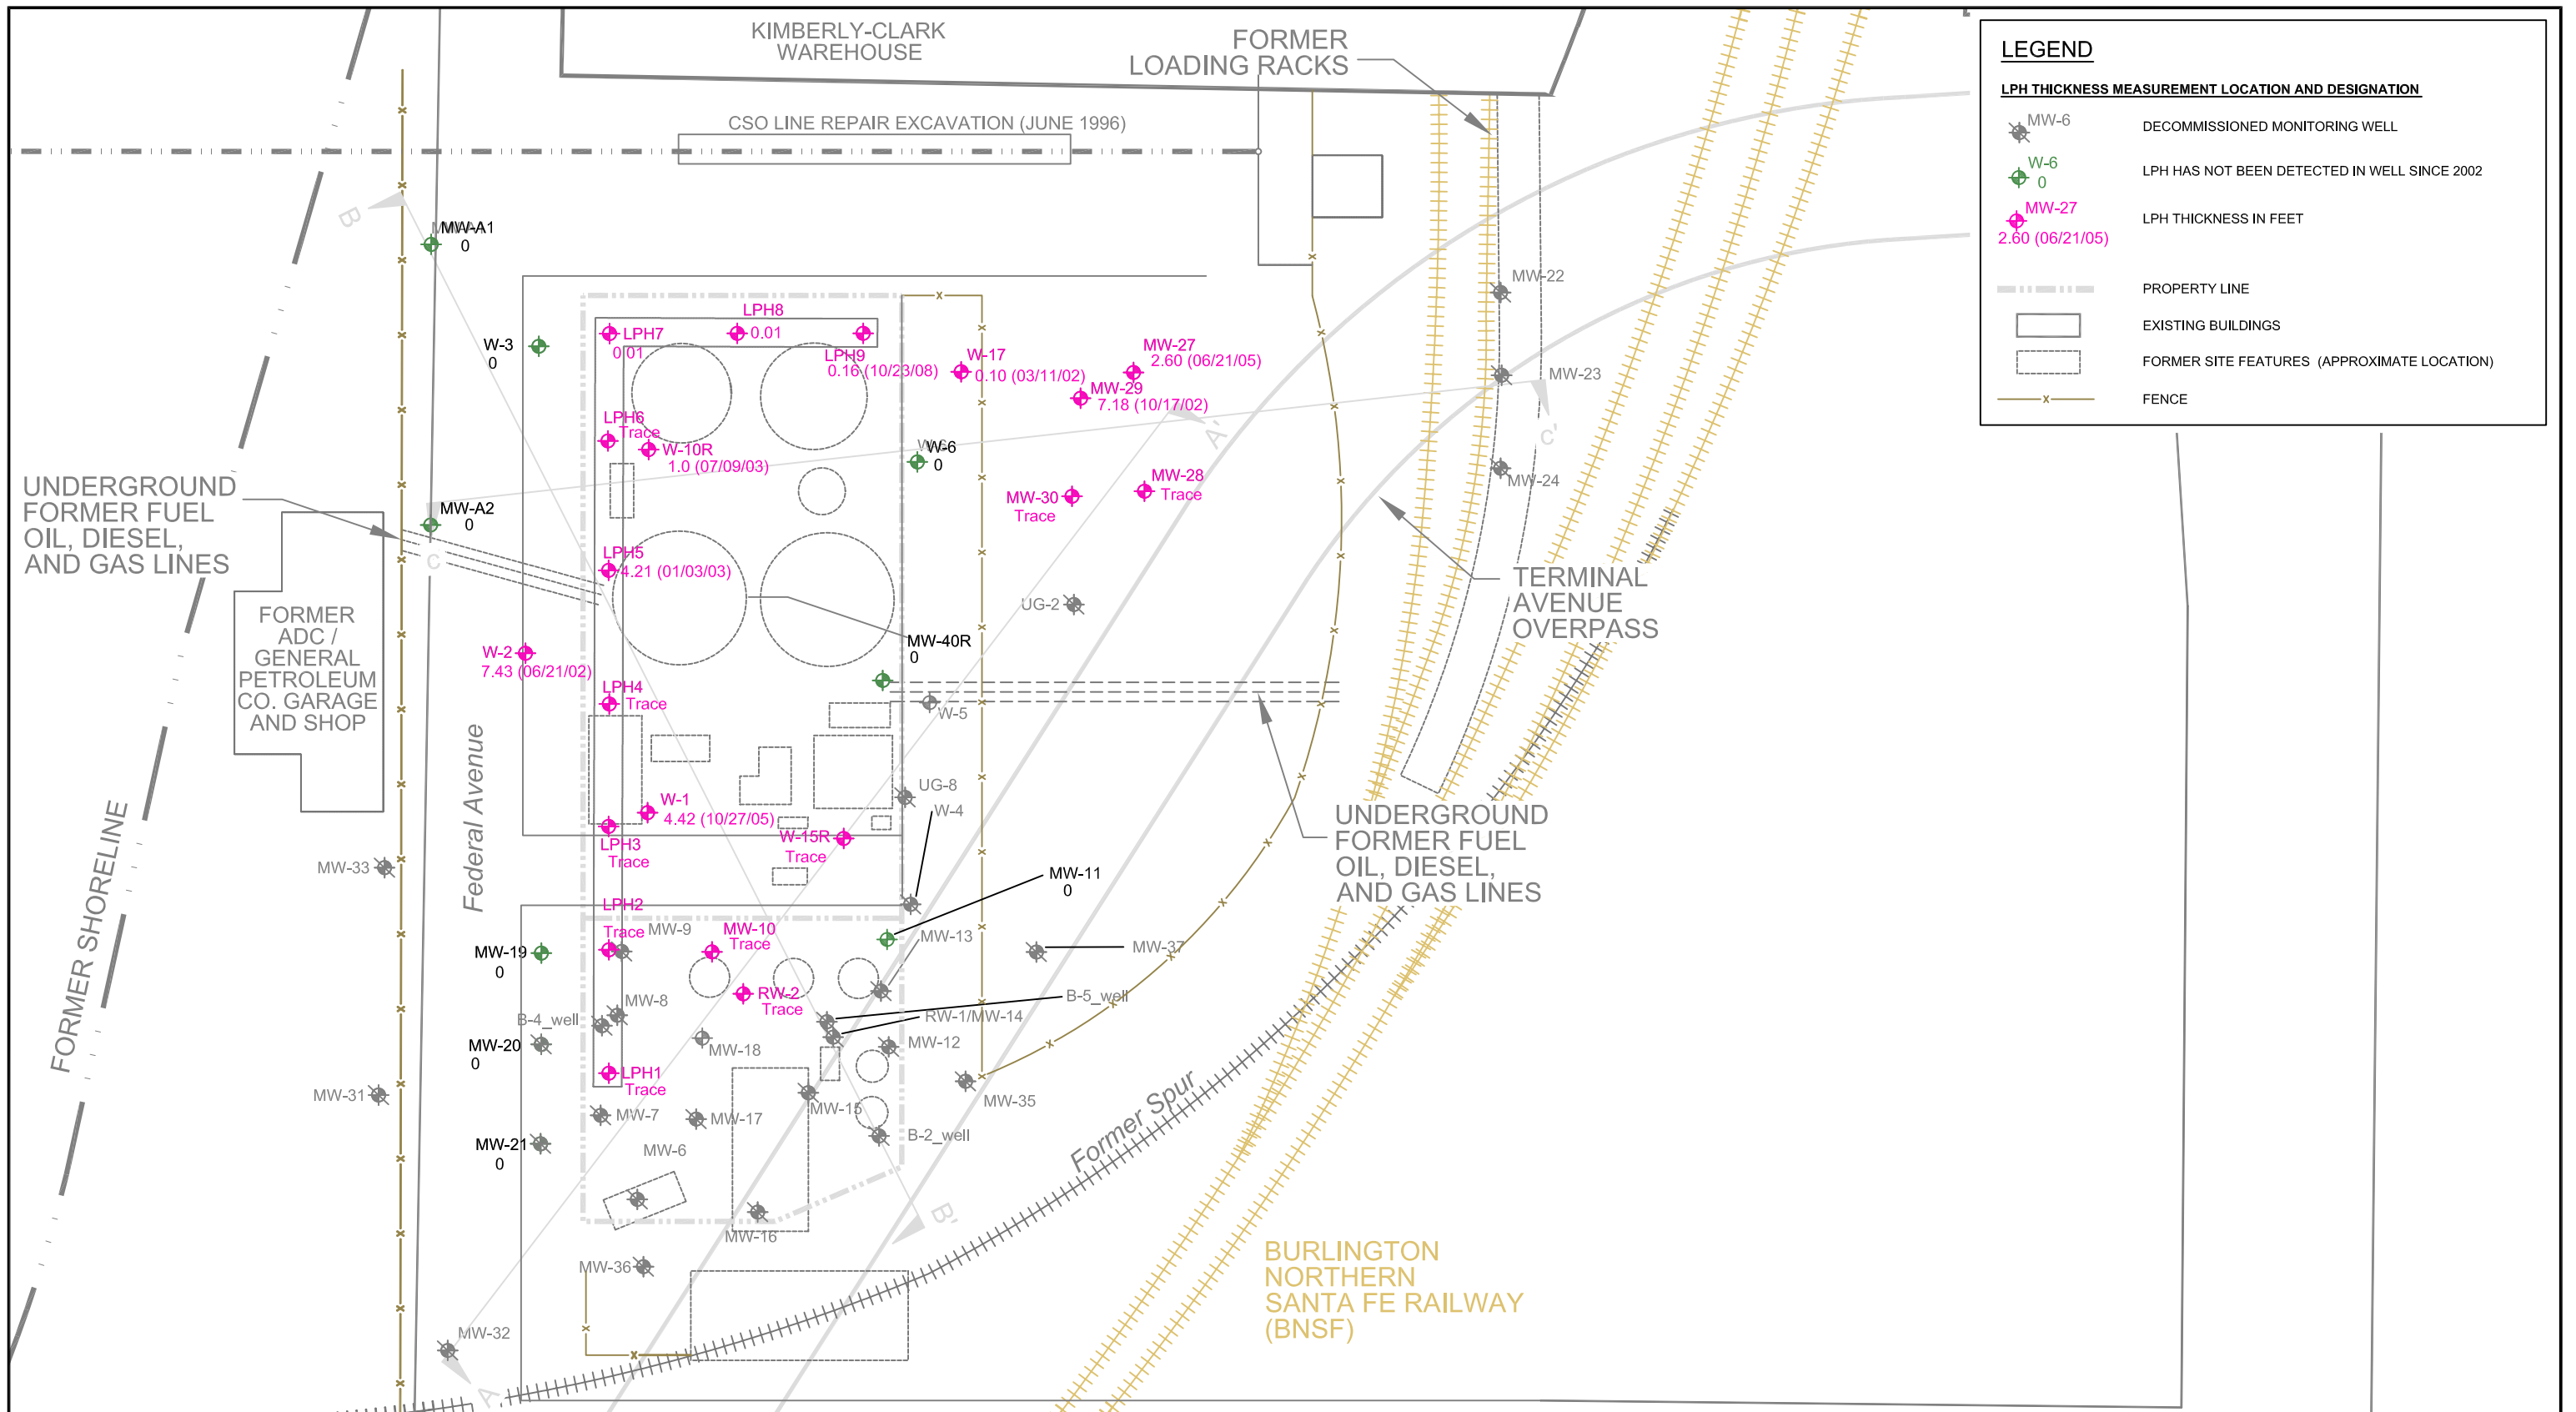
LEGEND	
LPH THICKNESS MEASUREMENT LOCATION AND DESIGNATION	
	DECOMMISSIONED MONITORING WELL
	LPH HAS NOT BEEN DETECTED IN WELL SINCE 2002
	LPH THICKNESS IN FEET
	PROPERTY LINE
	EXISTING BUILDINGS
	FORMER SITE FEATURES (APPROXIMATE LOCATION)
	FENCE

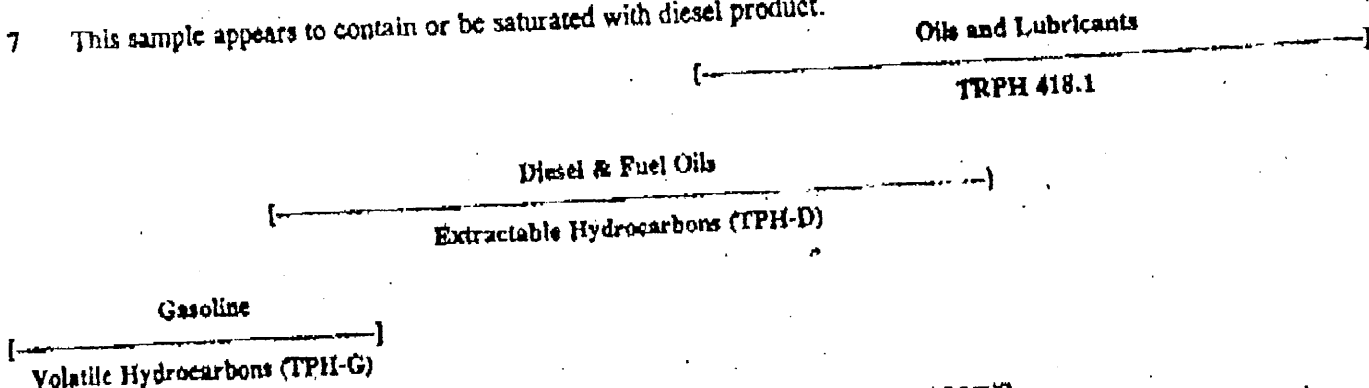
HYDROCARBON BOILING POINT RANGE

- D 1 This sample appears to contain volatile gasoline range organics.
- D 2 The hydrocarbons present in this sample resemble heavy, non-resolvable oil range organics. Quantitation by TPH-Diesel Extended or TPH 418.1 is recommended.
- D 3 The hydrocarbon concentration result in this sample is partially due to an individual peak(s) eluting in the diesel / motor oil carbon range.
- D 4 The hydrocarbons present in this sample are a complex mixture of diesel range and heavy oil range organics.
- D 5 The hydrocarbon result shown is an estimated (greater than) value due to the high concentration. Reanalysis is being performed to yield a quantitative result. An amended report will follow.
- D 6 The sample chromatographic pattern does not resemble the fuel standard used for quantitation. A fuel fingerprint is advised.
- D 7 This sample appears to contain or be saturated with diesel product.

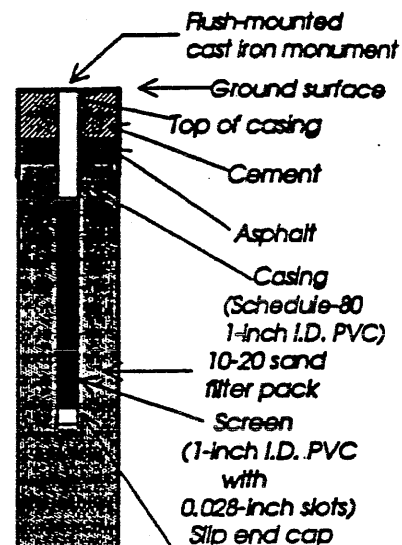
DEPTH (feet)	SOIL DESCRIPTION	SAMPLE TYPE	SAMPLE NUMBER	BLOW COUNTS	OVIM READING	GROUND WATER	TESTING
0	Asphalt and base course over moist, gray/black, fine SAND and broken gravel						
	Moist to wet, brown, fine SAND with some silt, trace petroleum odor		GP-5/ 3.0'			ATD	
	Moist to wet, gray, fine SAND, strong petroleum odor, LPH below 3.7 feet		GP-5/ 4.0'			3/22/96	WPH-D
5	Grades to moist, fine sandy SILT		GP-5/ 6.5'				
	Fine grained wood debris with LPH						
	Saturated, gray, fine SAND with LPH		GP-5/ 8.0'				WPH-D
10	Bottom of boring at 9.5 feet, due to refusal.						
15							
20							
25							
30

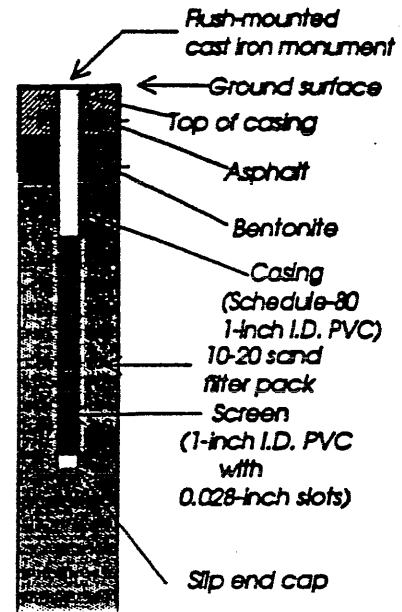
DEPTH (feet)	SOIL DESCRIPTION	SAMPLE TYPE	SAMPLE NUMBER	BLOW COUNTS	QVM READING	GROUND WATER
0	Asphalt and base course					
	Minor recovery, moist, dark gray SAND, slight petroleum odor		GP-8/ 3.0'			▼ 3/22/96
5	Moist, black to gray/green, fine sandy SILT with wood debris, 1" thick zone of LPH					
	Fine grained wood debris saturated with LPH over gray/green SILT		GP-8/ 9.0'		11	
10	Minor recovery - silty, fine SAND over fine grained wood debris, petroleum odor					
	Bottom of boring at 11 feet.					
15						
20						
25						
30

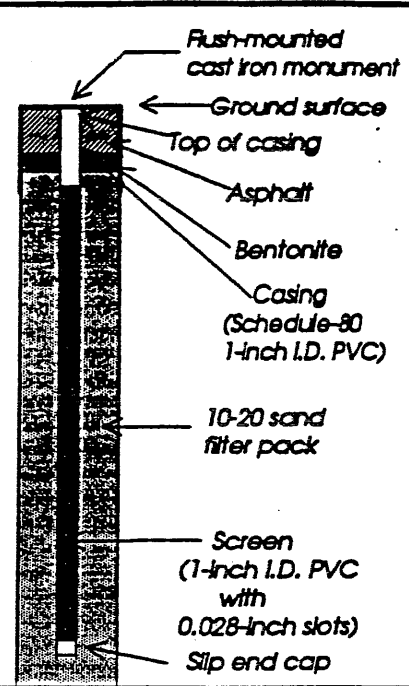
DEPTH (feet)	SOIL DESCRIPTION	SAMPLE TYPE	SAMPLE NUMBER	BLOW COUNTS	OVM READING	GROUND WATER
0	Asphalt and base course					
-	Trace recovery; minor gravel and wood fragments					
5	Minor recovery; moist, gray, fine SAND over minor wood debris and sandy SILT with gravel, strong petroleum odor					3/22/96
10	No recovery		GP-9/ 8.0		3.0	
12	Bottom of boring at 12 feet.					
15						
20						
25						
30

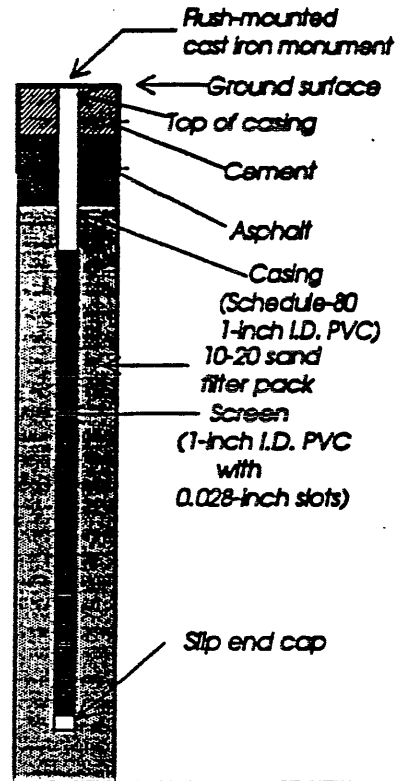
DEPTH (feet)	SOIL DESCRIPTION	SAMPLE TYPE	SAMPLE NUMBER	BLOW COUNTS	QVM READING	GROUND WATER	TESTING
0	Asphalt and base course over moist, black, gravelly SAND, slight petroleum odor						
5	Moist, gray/brown, fine to coarse SAND grading to brown, fine SAND with some gravel, non-odorous		GP-12/ 8.0'				
10	Wet, gray stained globules black, fine SAND with gravel, strong petroleum odor and minor LPH globules		GP-12/ 10.0'			3/22/96 ATD	
	Saturated, gray, fine SAND with some gravel, strong petroleum odor, minor globules of LPH		GP-12/ 11.0'				WITH-D
			GP-12/ 12.5'		3.2		WITH-D
15	Bottom of boring at 14 feet.						
20							
25							
30

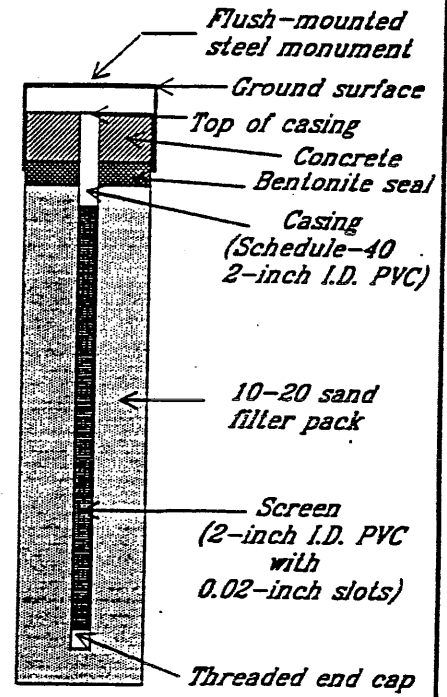
DEPTH (feet)	SOIL DESCRIPTION	SAMPLE TYPE	SAMPLE NUMBER	BLOW COUNTS	QVM READING	GROUND WATER
0	2" Asphalt.					
0 - 5	Medium dense, moist, gray, silty fine SAND with hydrocarbon odor		S-1	15		ATD
5 - 10	Loose, wet, brown, PEAT with oily sheen and hydrocarbon odor		S-2	2		
10 - 13.5	Loose, moist, gray, medium SAND hydrocarbon odor and sheen		S-3	4		
13.5 - 15	Boring terminated at 13.5 feet.					
15 - 20						
20 - 25						
25 - 30

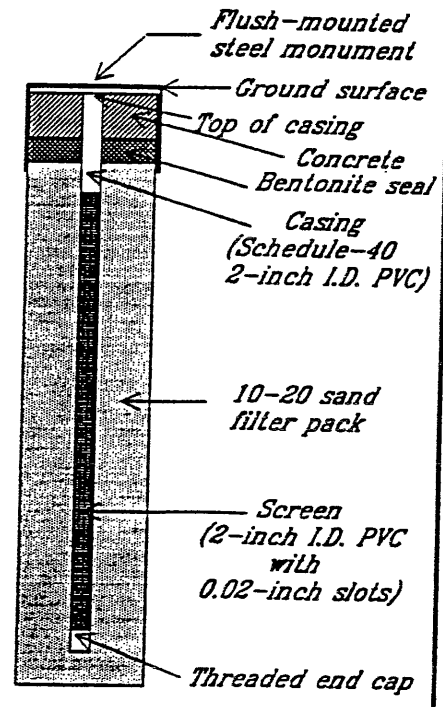
DEPTH (feet)	SOIL DESCRIPTION	SAMPLE TYPE	SAMPLE NUMBER	BLOW COUNTS	OVM READING	GROUND WATER
0	2" Asphalt.					
	3 inches brown/gray sandy GRAVEL					
5	Loose, moist, gray silty fine SAND	S-1	2			ATD
10	Loose, moist, brown, PEAT layer, strong hydrocarbon odor	S-2	2			
	Loose, moist to wet, brown, silty medium SAND with organics (peat); moderate hydrocarbon odor	S-3	2			
15	Boring terminated at 13.5 feet.					
20						
25						
30

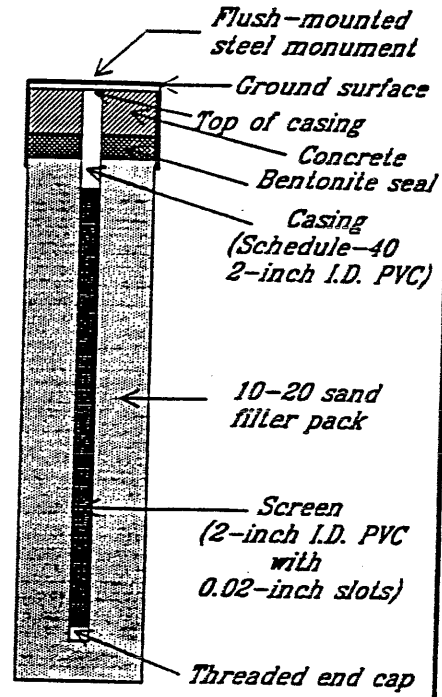
DEPT (feet)	SOIL DESCRIPTION	SAMPLE TYPE	SAMPLE NUMBER	BLOW COUNTS	QVM READING	GROUND WATER
0	2" to 3" Asphalt. Loose, moist, gray, sandy, gravel					
5	Loose, moist, gray fine sandy SILT grading into silty fine sand		S-1	3		ATD
10	Loose, wet, black oil-saturated PEAT with wood		S-2	5		
			S-3	50/3"

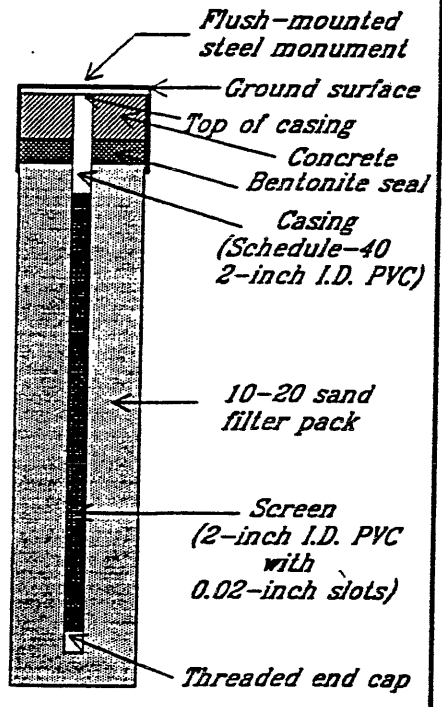
DEPTH (feet)	SOIL DESCRIPTION	SAMPLE TYPE	SAMPLE NUMBER	BLOW COUNTS	QVM READING	GROUND WATER
0	2" Asphalt.					
	Loose, moist, gray, silty SAND					
	Loose, moist, gray, silty fine SAND	⊗	S-1	5		▼ ATD
5	Loose, black, oily wood and PEAT					
	Very loose, wet, oily, gray medium SAND with organics (wood and peat)		S-2	2		
10	Loose, wet (oily), black/brown PEAT and wood		S-3	8		
15	Boring terminated at 13.5 feet.					
20						
25						
30

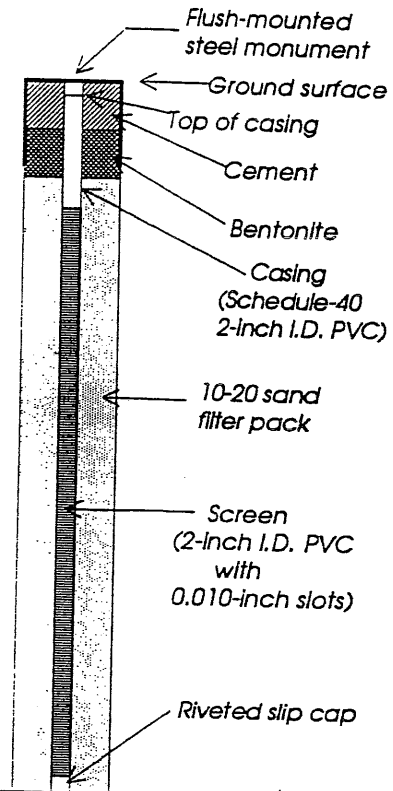
DEPTH (feet)	SOIL DESCRIPTION	SAMPLE TYPE	SAMPLE NUMBER	BLOW COUNTS	OVM READING	GROUND WATER
0	Asphaltic Concrete					
0 - 5	Medium dense, wet, brownish-gray, fine SAND with gravel (Fill). Slight petroleum-like odor observed		S-1	25	5	
5 - 10	Loose, wet to saturated, dark greenish-gray, SAND with some gravel and wood debris (Fill)		S-2	6	5	
10 - 15	Medium dense, saturated, dark gray, medium SAND with wood debris		S-3	22	5	
15	Bottom of boring at 15 feet.					
20						
25						
30

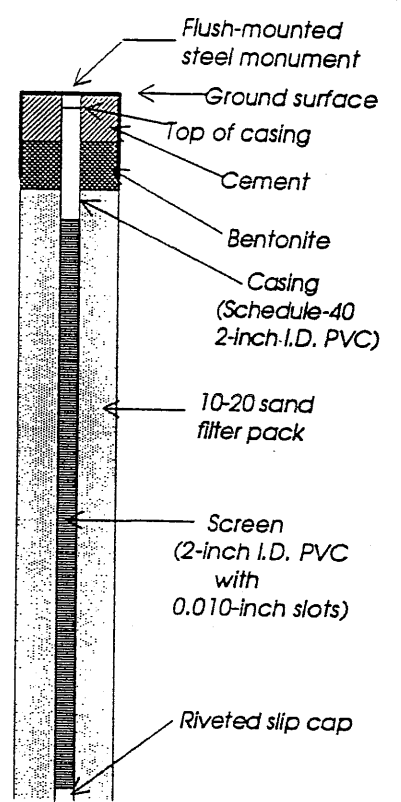
DEPTH (feet)	SOIL DESCRIPTION	SAMPLE TYPE	SAMPLE NUMBER	BLOW COUNTS	OVM READING	GROUND WATER
0	Gravel surface					
5	Medium dense, wet to saturated, greenish-gray, gravelly, medium SAND (Fill)		S-1	13	5	▼ 12/8/93
10	Medium dense, saturated, grayish-dark brown, medium SAND with gravel, some silt and wood fragments		S-2	17	5	
15	Medium dense, saturated, grayish-dark brown, silty, fine to medium SAND with some gravel and wood fragments		S-3	17	5	
15	Bottom of boring at 15 feet. No unusual staining or petroleum-like odors observed.					
20						
25						
30

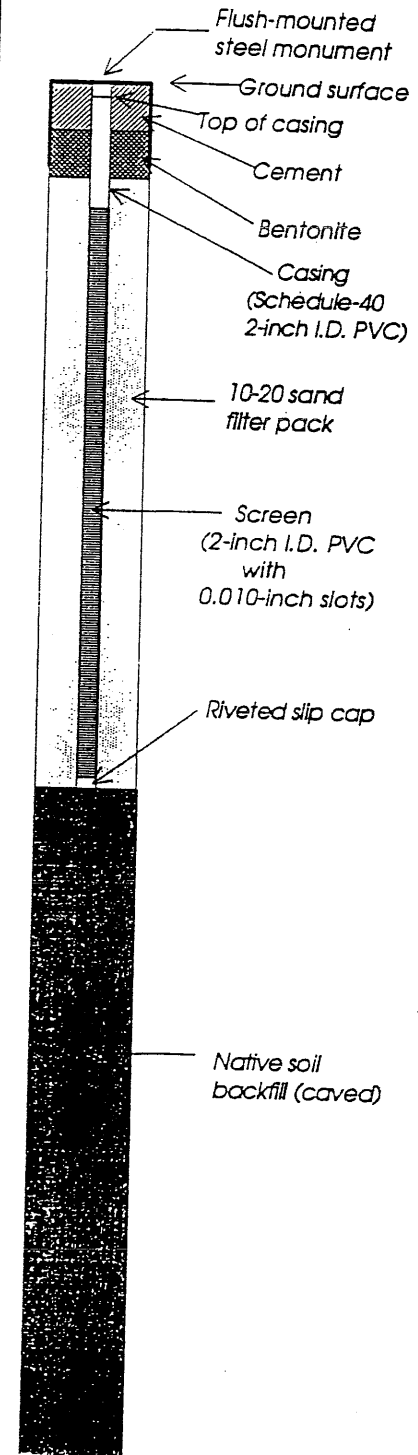
DEPTH (feet)	SOIL DESCRIPTION	SAMPLE TYPE	SAMPLE NUMBER	BLOW COUNTS	OMV READING	GROUND WATER
0	Asphaltic Concrete					
0 - 5	Medium dense, wet to saturated, gray, medium to coarse SAND with some gravel (Fill)		S-1	21	5	▼ 12/8/93
5 - 7	Medium dense, saturated, greenish-gray, silty, fine to medium SAND (Fill)		S-2	11	5	
7 - 9	Loose, saturated, brown, silty PEAT		S-3	5	5	
9 - 11	Loose to medium dense, saturated, gray to brownish-gray, SAND with trace to some silt, gravel and wood fragments		S-4	8	5	
11 - 13	(Chunk of wood stuck in sample tube; S-5 blow count probably not representative)		S-5	50/5	5	
13 - 15			S-6	11	5	
15 - 17			S-7	6	5	
17 - 19			S-8	10	5	
19 - 21			S-9	17	5	
21 - 23			S-10	14	5	
23 - 25	Very stiff, saturated, brown, clayey SILT with organics (PEAT-Like)		S-11	17	5	
25 - 29	Bottom of boring at 29 feet.

No unusual staining or petroleum-like odors observed.

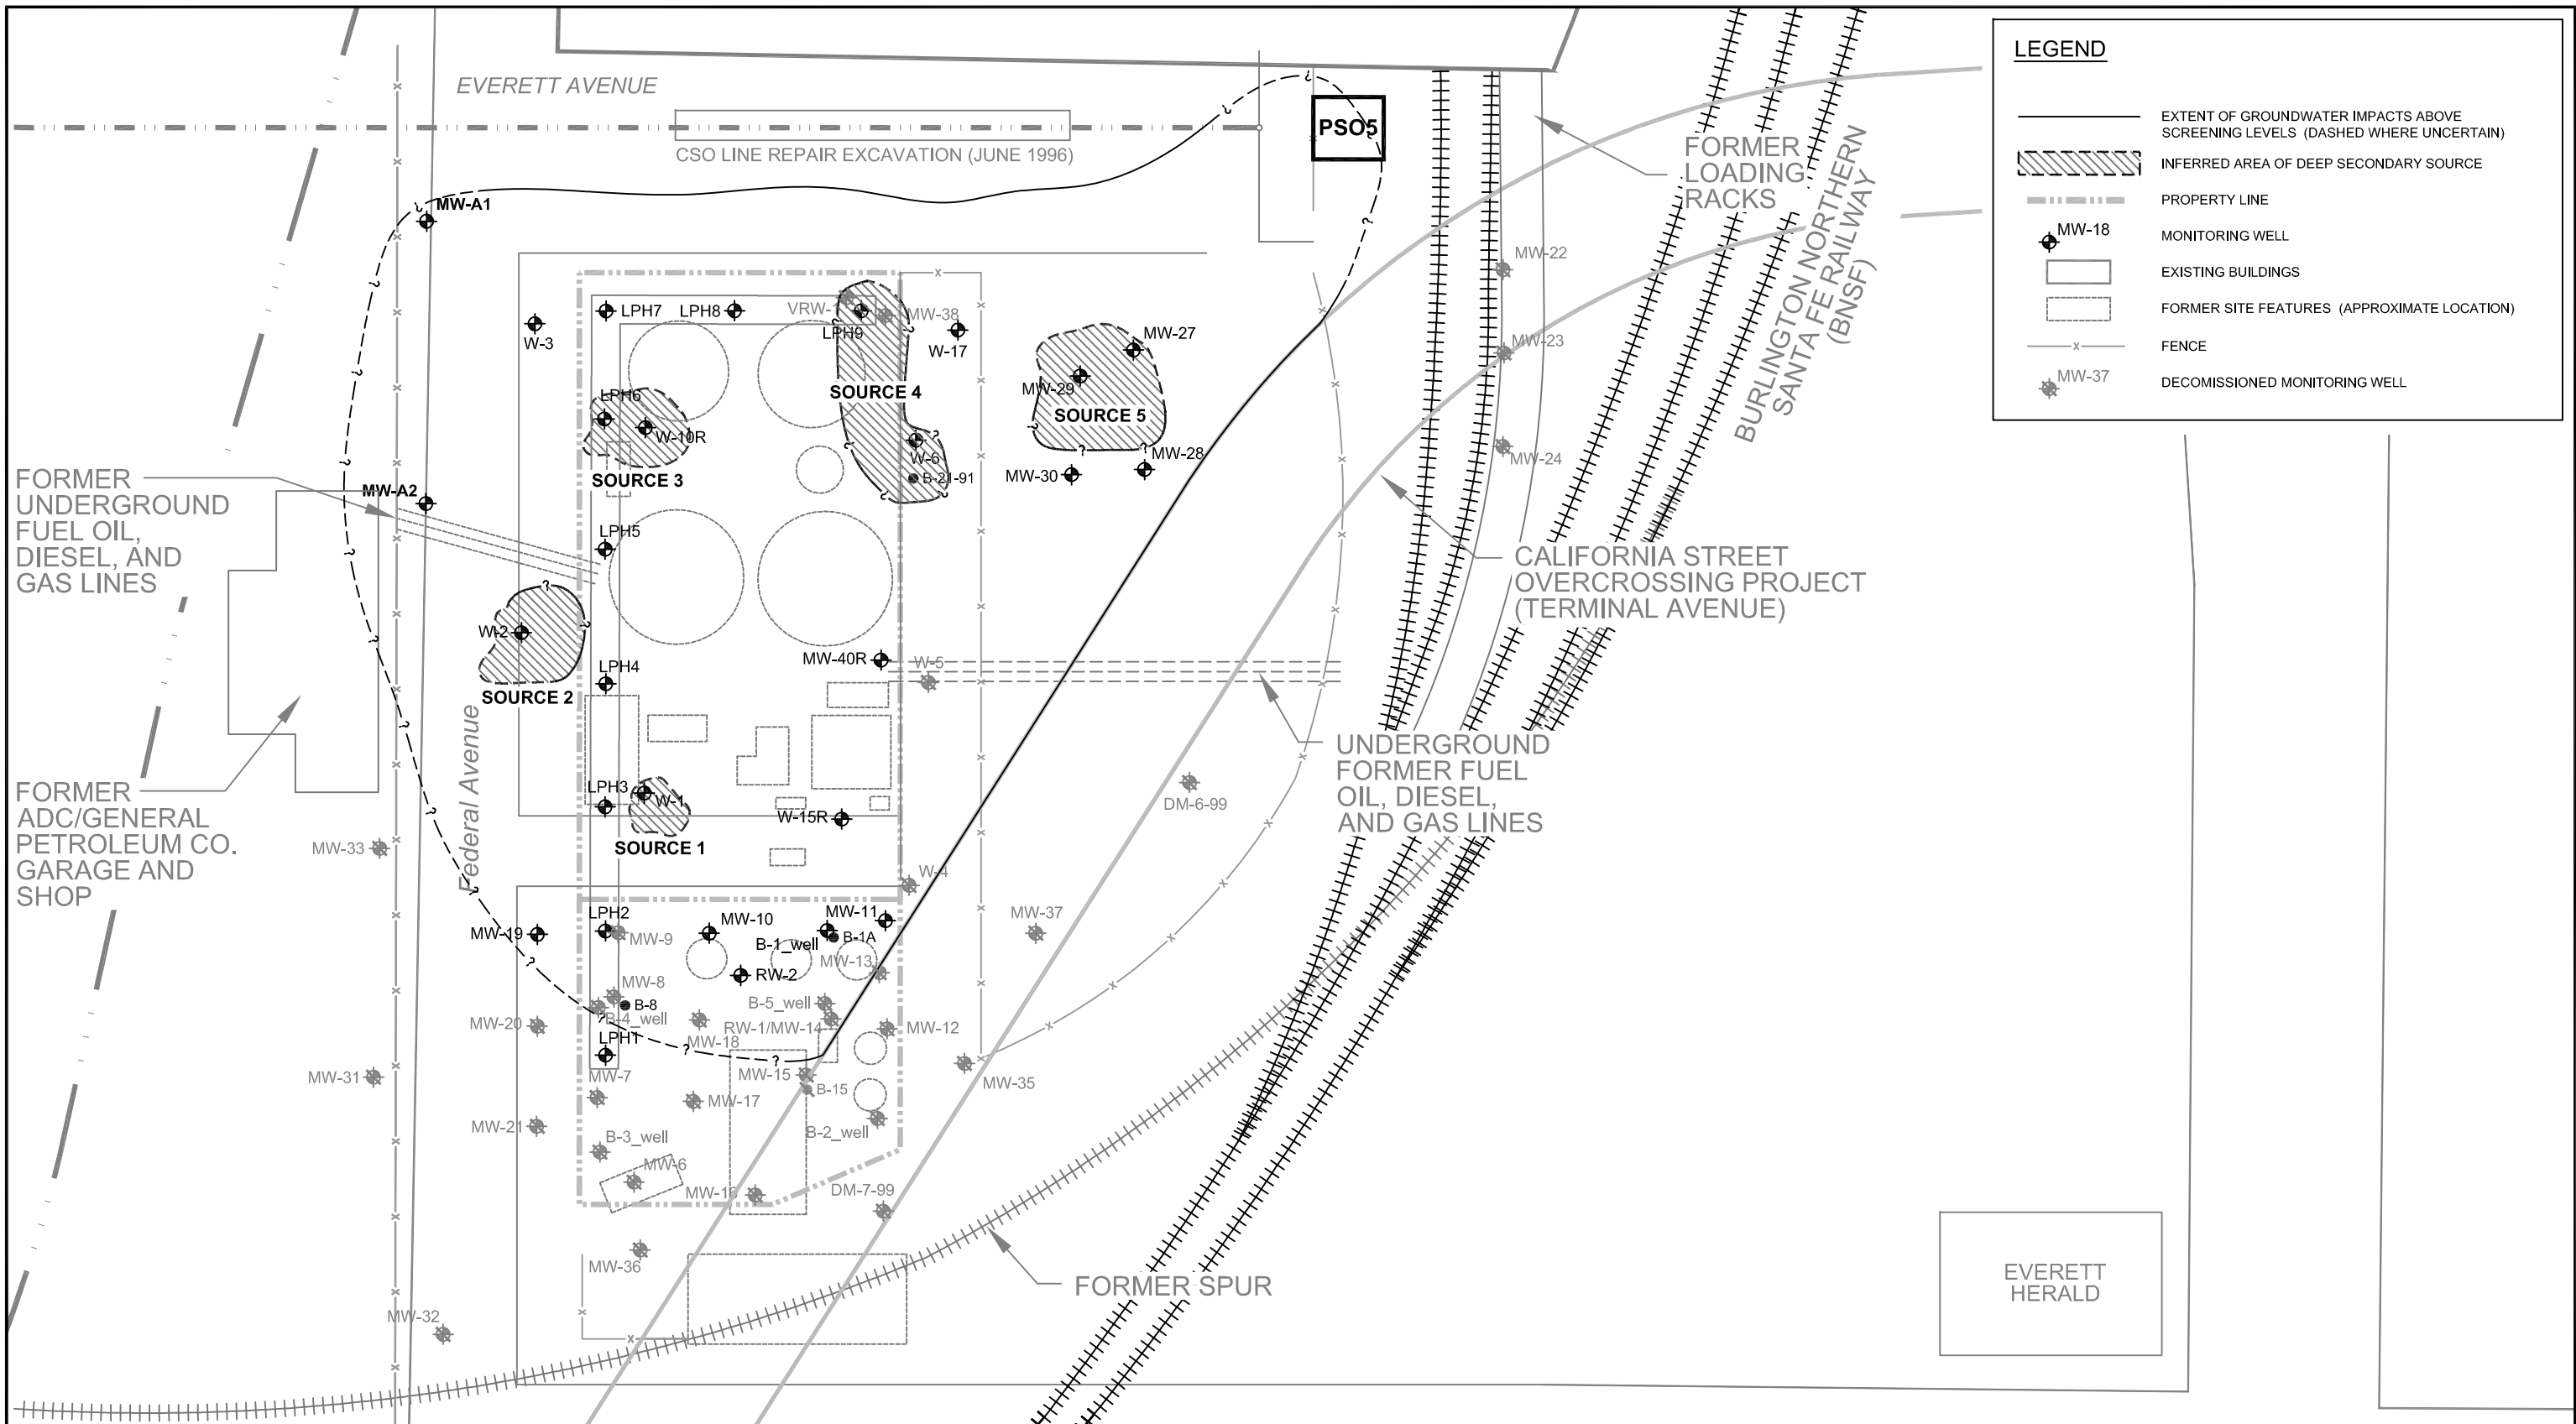
LEGEND	
	EXTENT OF GROUNDWATER IMPACTS ABOVE SCREENING LEVELS (DASHED WHERE UNCERTAIN)
	INFERRED AREA OF DEEP SECONDARY SOURCE
	PROPERTY LINE
	MW-18 MONITORING WELL
	EXISTING BUILDINGS
	FORMER SITE FEATURES (APPROXIMATE LOCATION)
	FENCE
	MW-37 DECOMMISSIONED MONITORING WELL

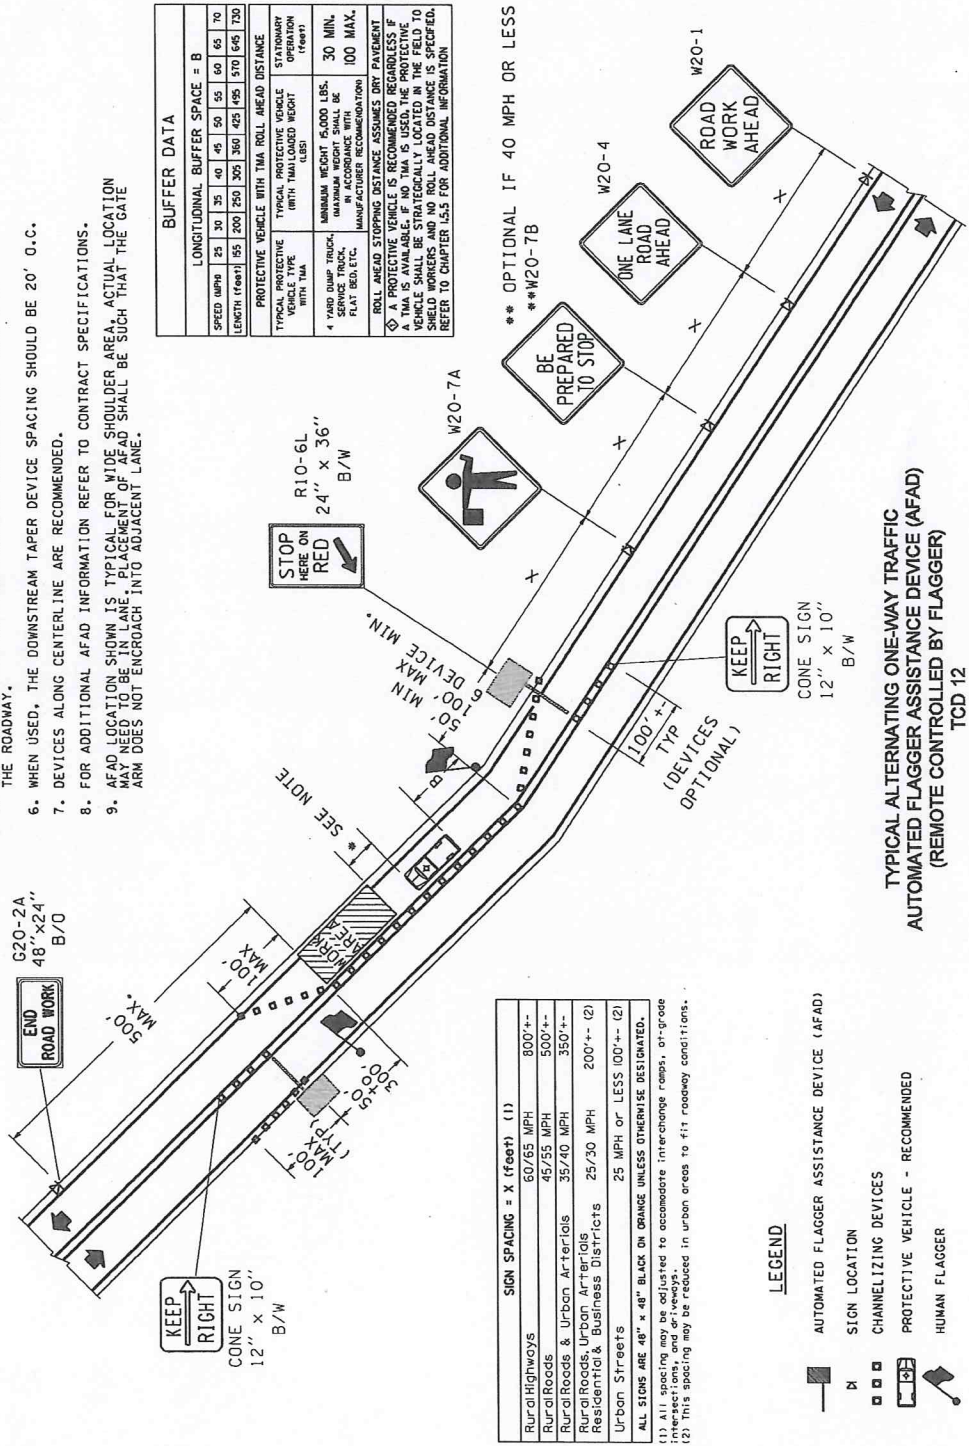
LONGITUDINAL BUFFER SPACE = B	
SPEED (mph)	25 30 35 40 45 50 55 60 65 70
LENGTH (feet)	150 200 250 300 350 400 450 500 550 600 645 700
