**STATE OF WASHINGTON
DEPARTMENT OF ECOLOGY**

AGREED ORDER for

**Focused Feasibility Study and Draft
Cleanup Action Plan – ExxonMobil ADC
Site**

No. DE **6184**

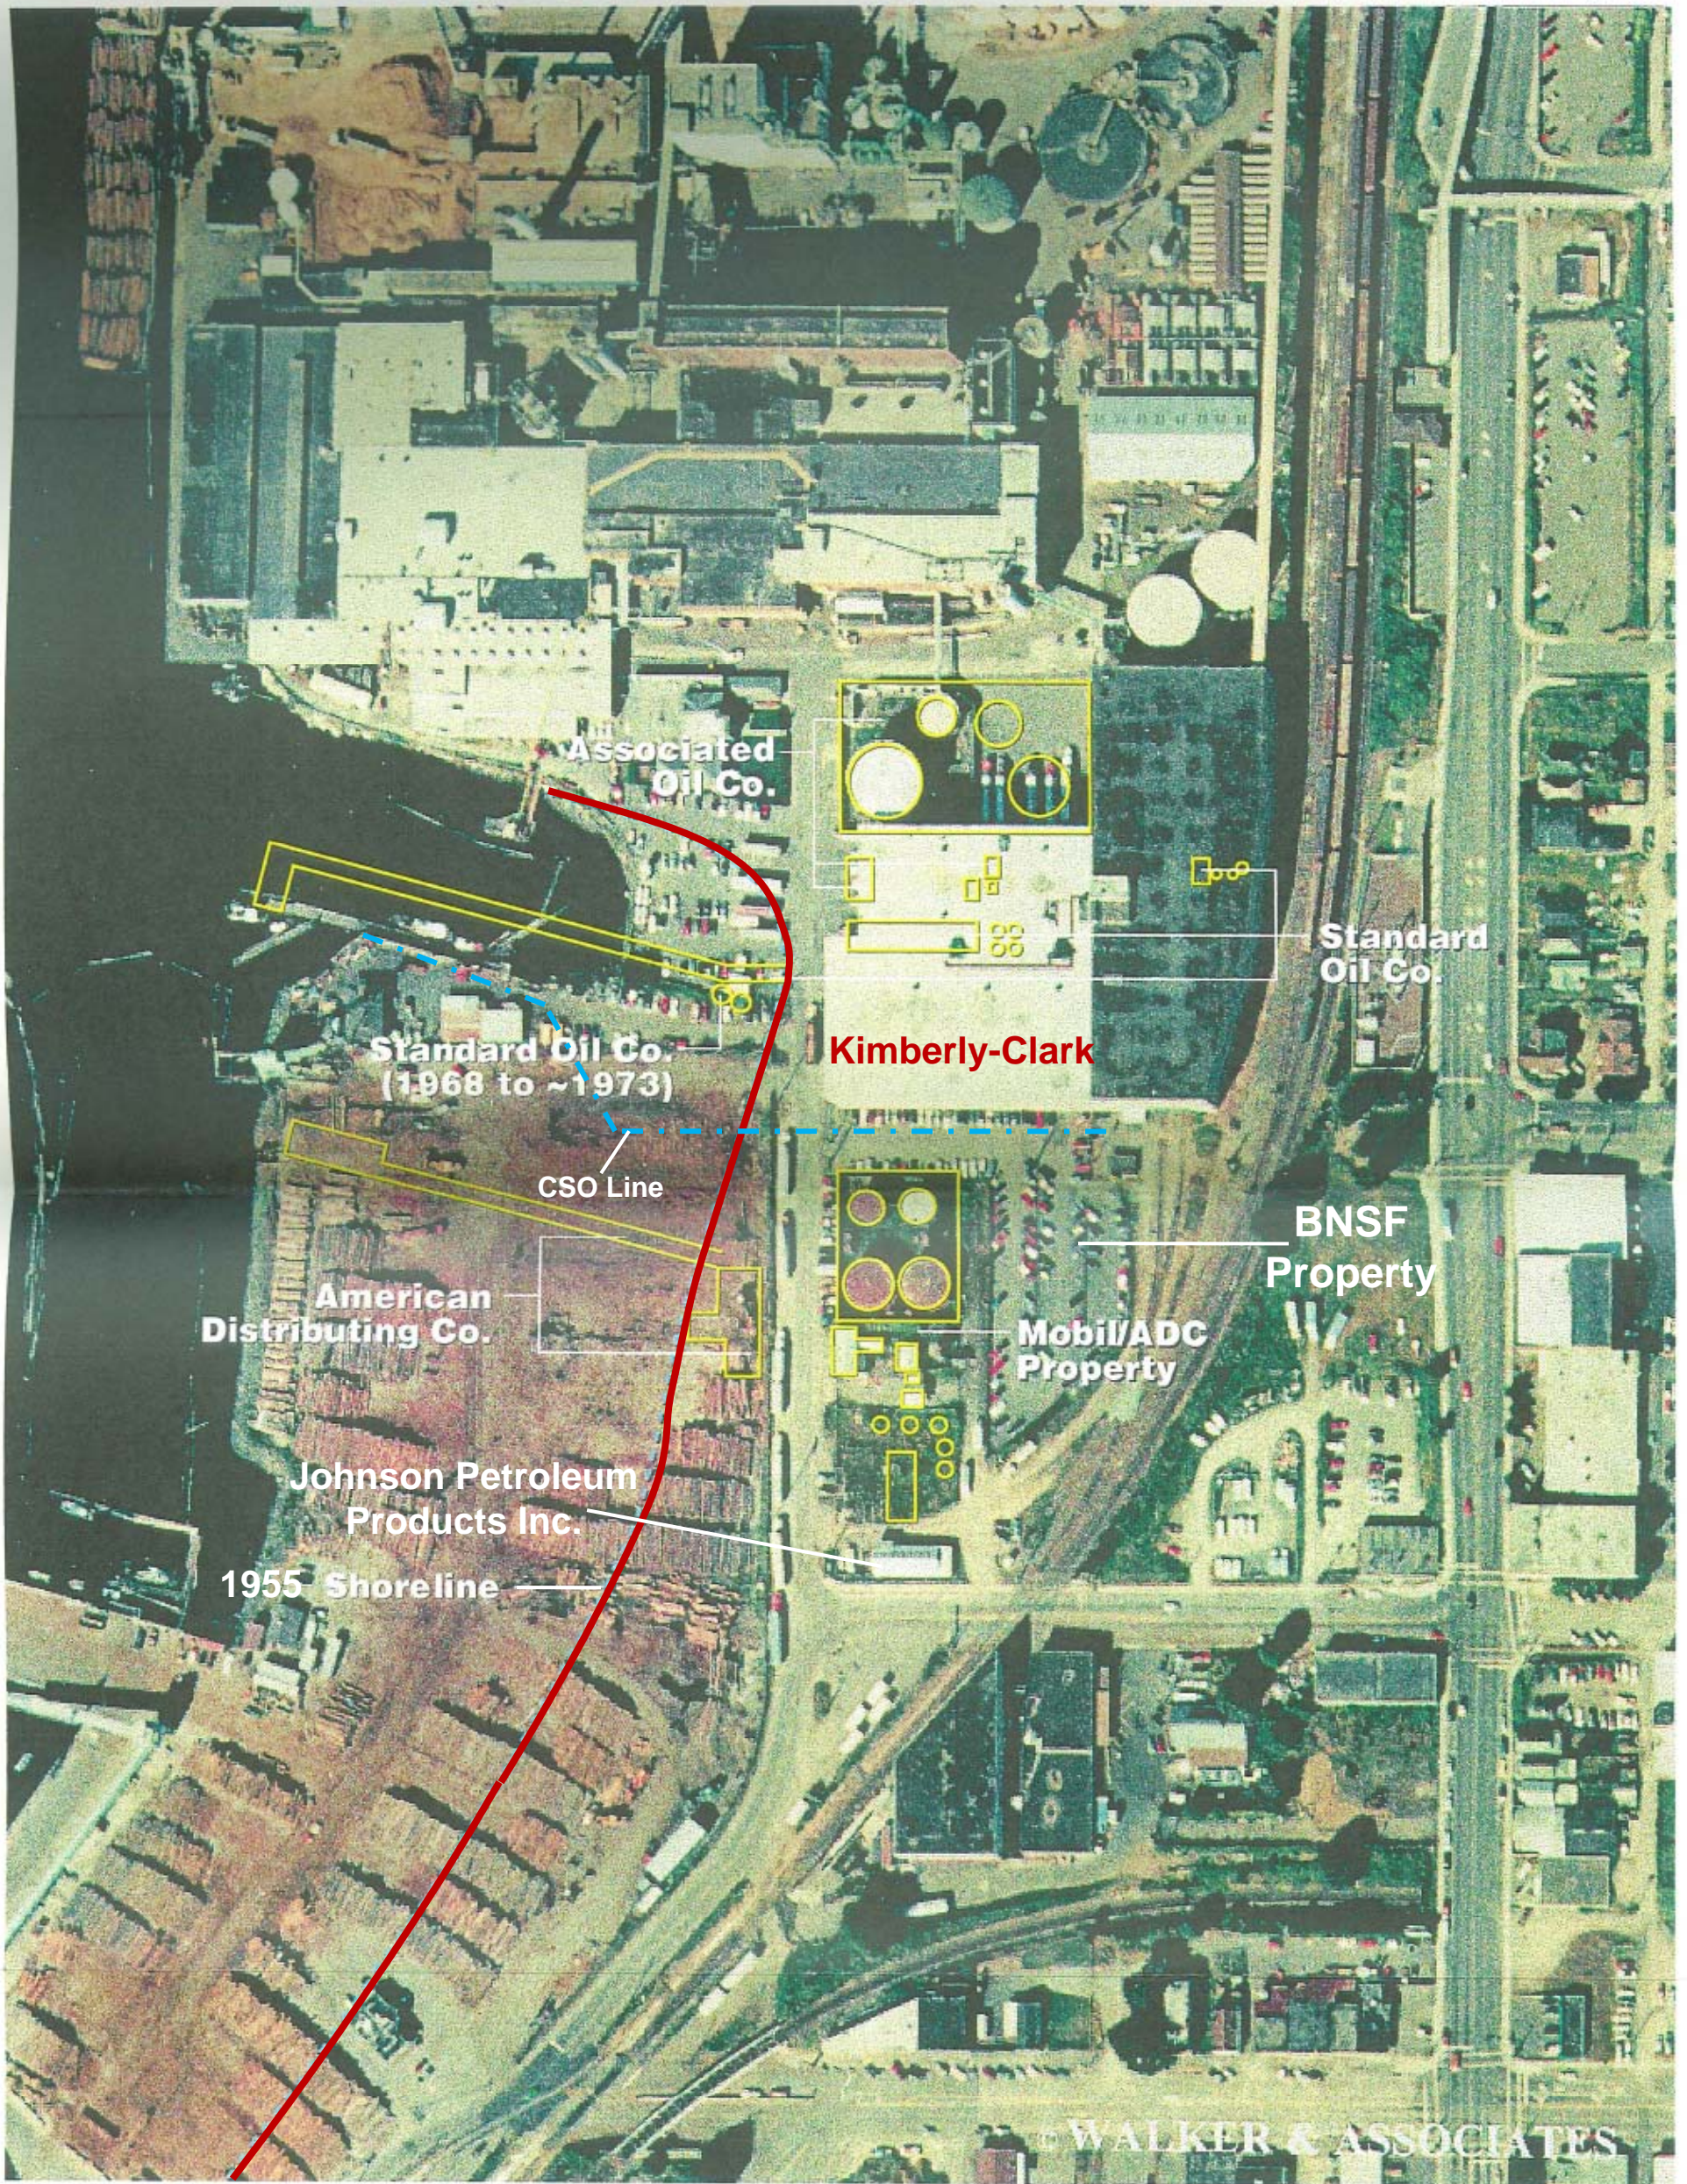
Exhibit A – Figure 5
1993 Aerial Photo Showing Historical Features
 (Source: Exponent July 23, 1998 RI/FS Report)

Figure 2-3. 1955 facility locations superimposed on 1993 aerial photograph of Federal Avenue site.

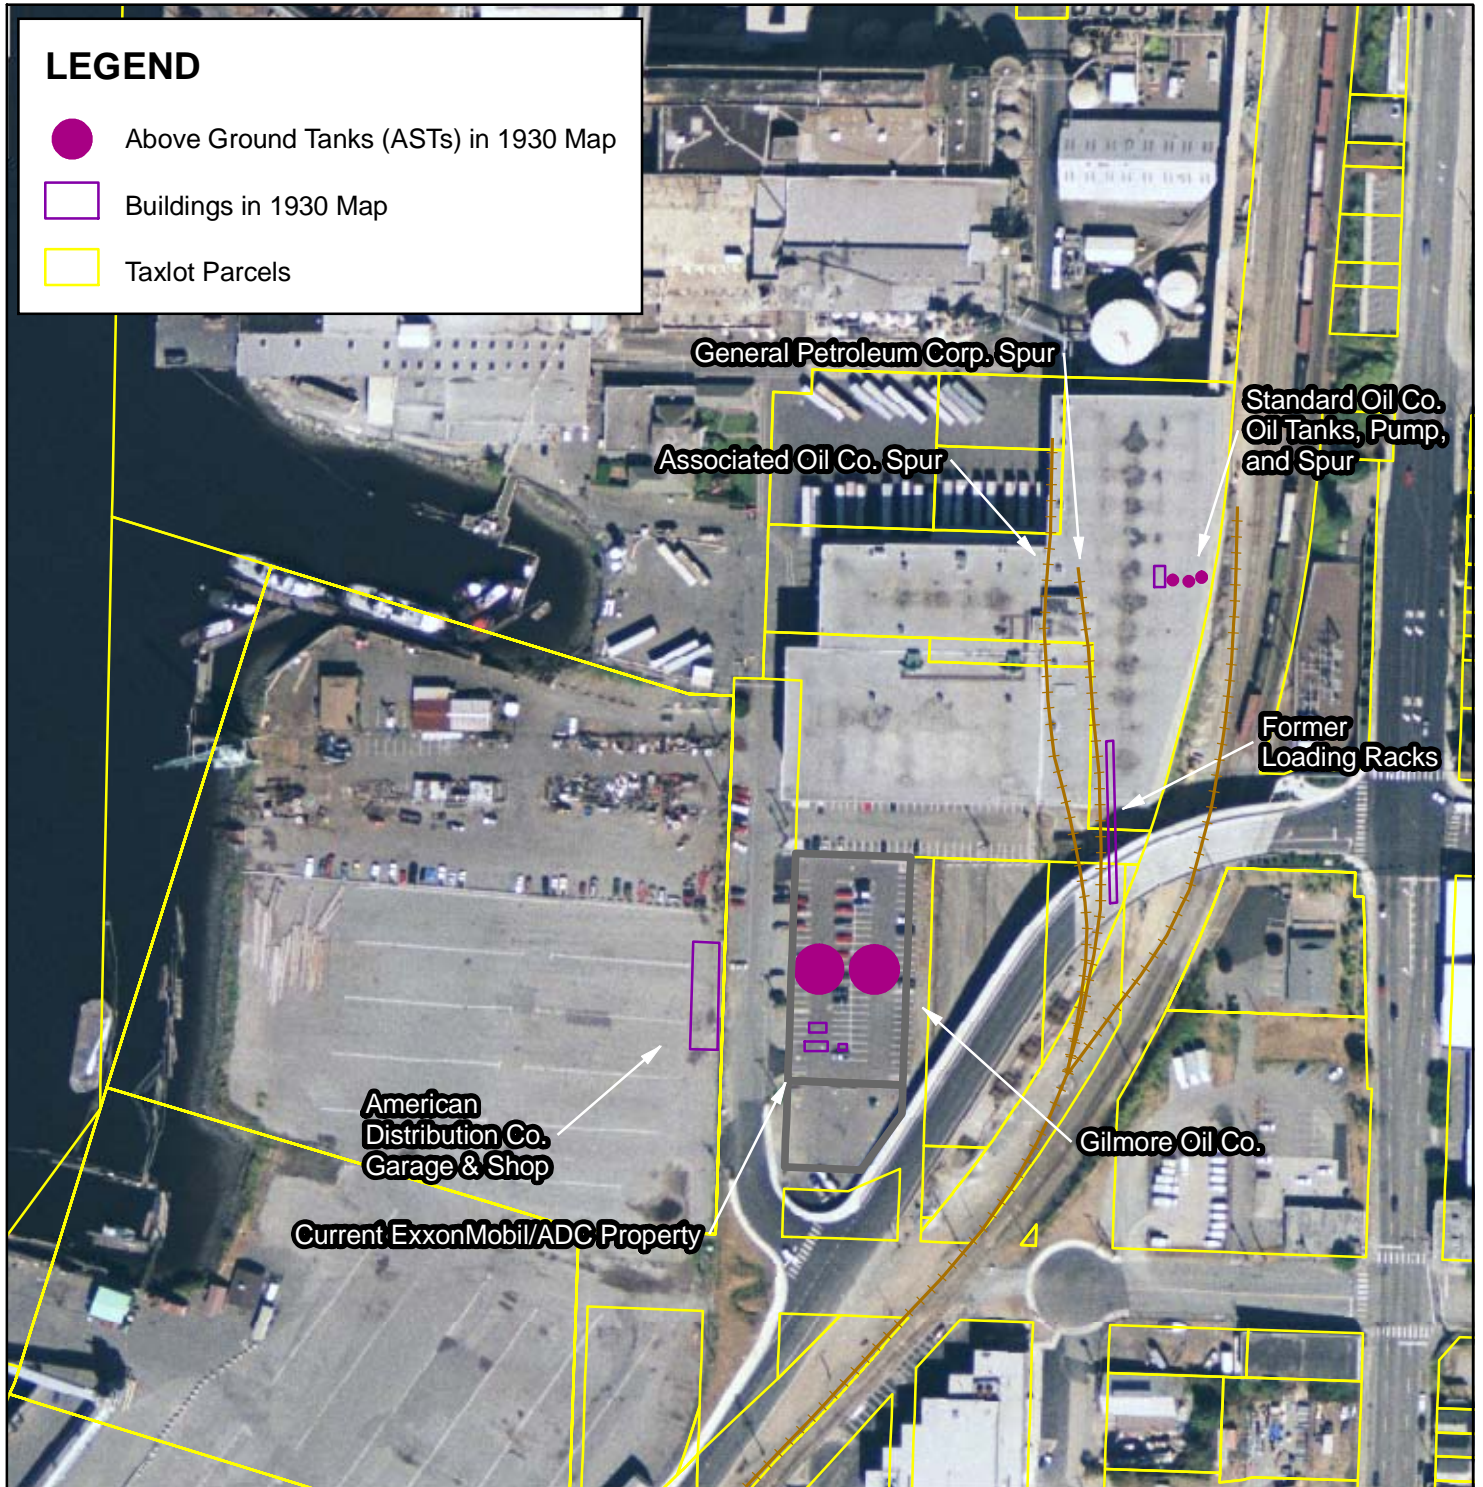
| PROJECTION: WA SP North | SCALE: 1 inch = 200 feet | FIGURE No.: FIGURE 4 |

- Above Ground Tanks (ASTs) in 1930 Map
- Buildings in 1930 Map
- Taxlot Parcels

TITLE: **FEATURES SEEN IN
 1930 GREAT NORTHERN RAILWAY EVERETT MAP
 OVER 2003 AERIAL**

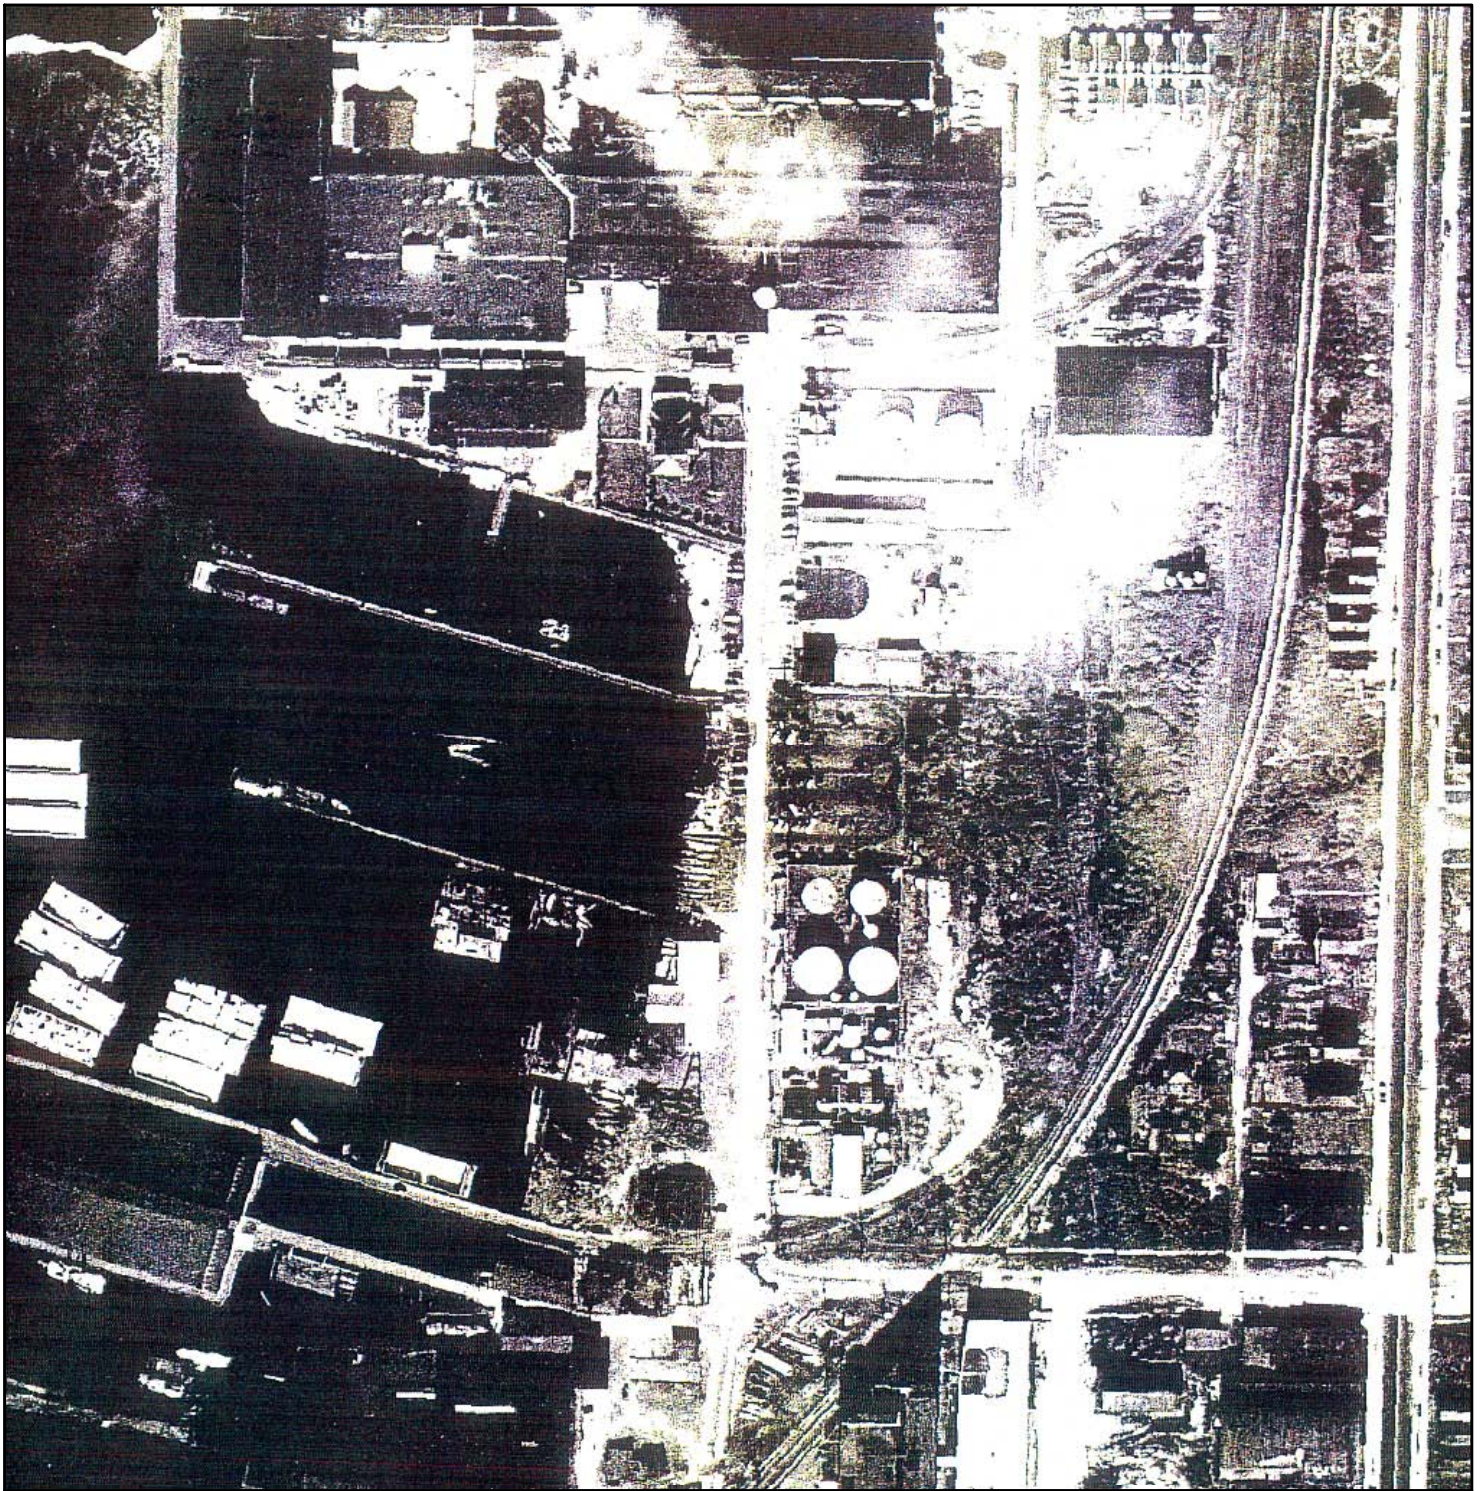
FIGURE No.: **FIGURE 5**

- Above Ground Tanks (ASTs) in 1947 Aerial
- Buildings in 1947 Aerial
- Taxlot Parcels

In 1947, four small and two large ASTs were located on the Associated Oil Company property to the north of the ADC Parcel, and three small Standard Oil ASTs remained next to the railroad spur (Figures 5 and 6).

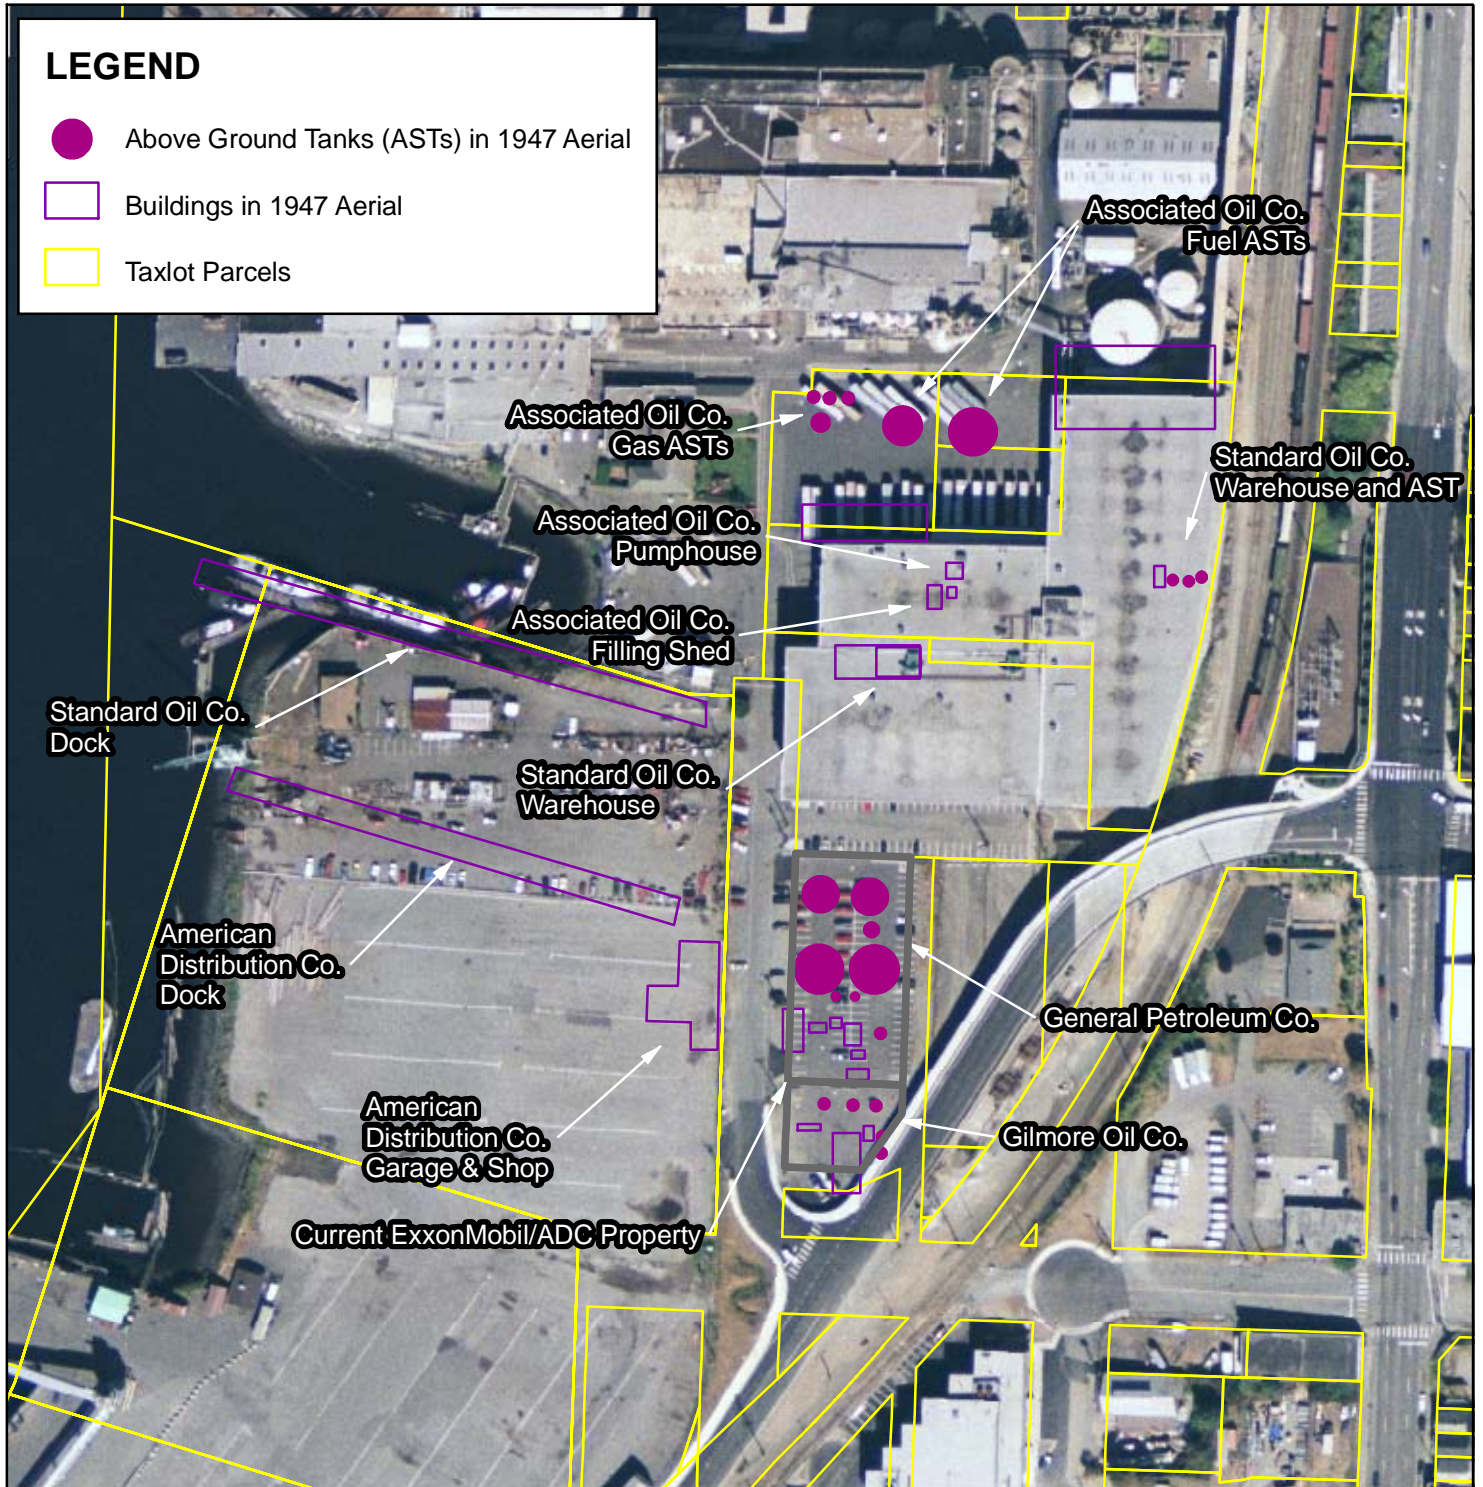
| | | PROJECTION: WA SP North | SCALE: 1 inch = 200 feet | FIGURE No.: FIGURE 6 | |

| TITLE: FEATURES SEEN IN 1947 AERIAL OVER 2003 AERIAL | | CHKD BY: AIS/MS | REV. NO.: 1 | PROJECT NO.: 9-915-15716C | |

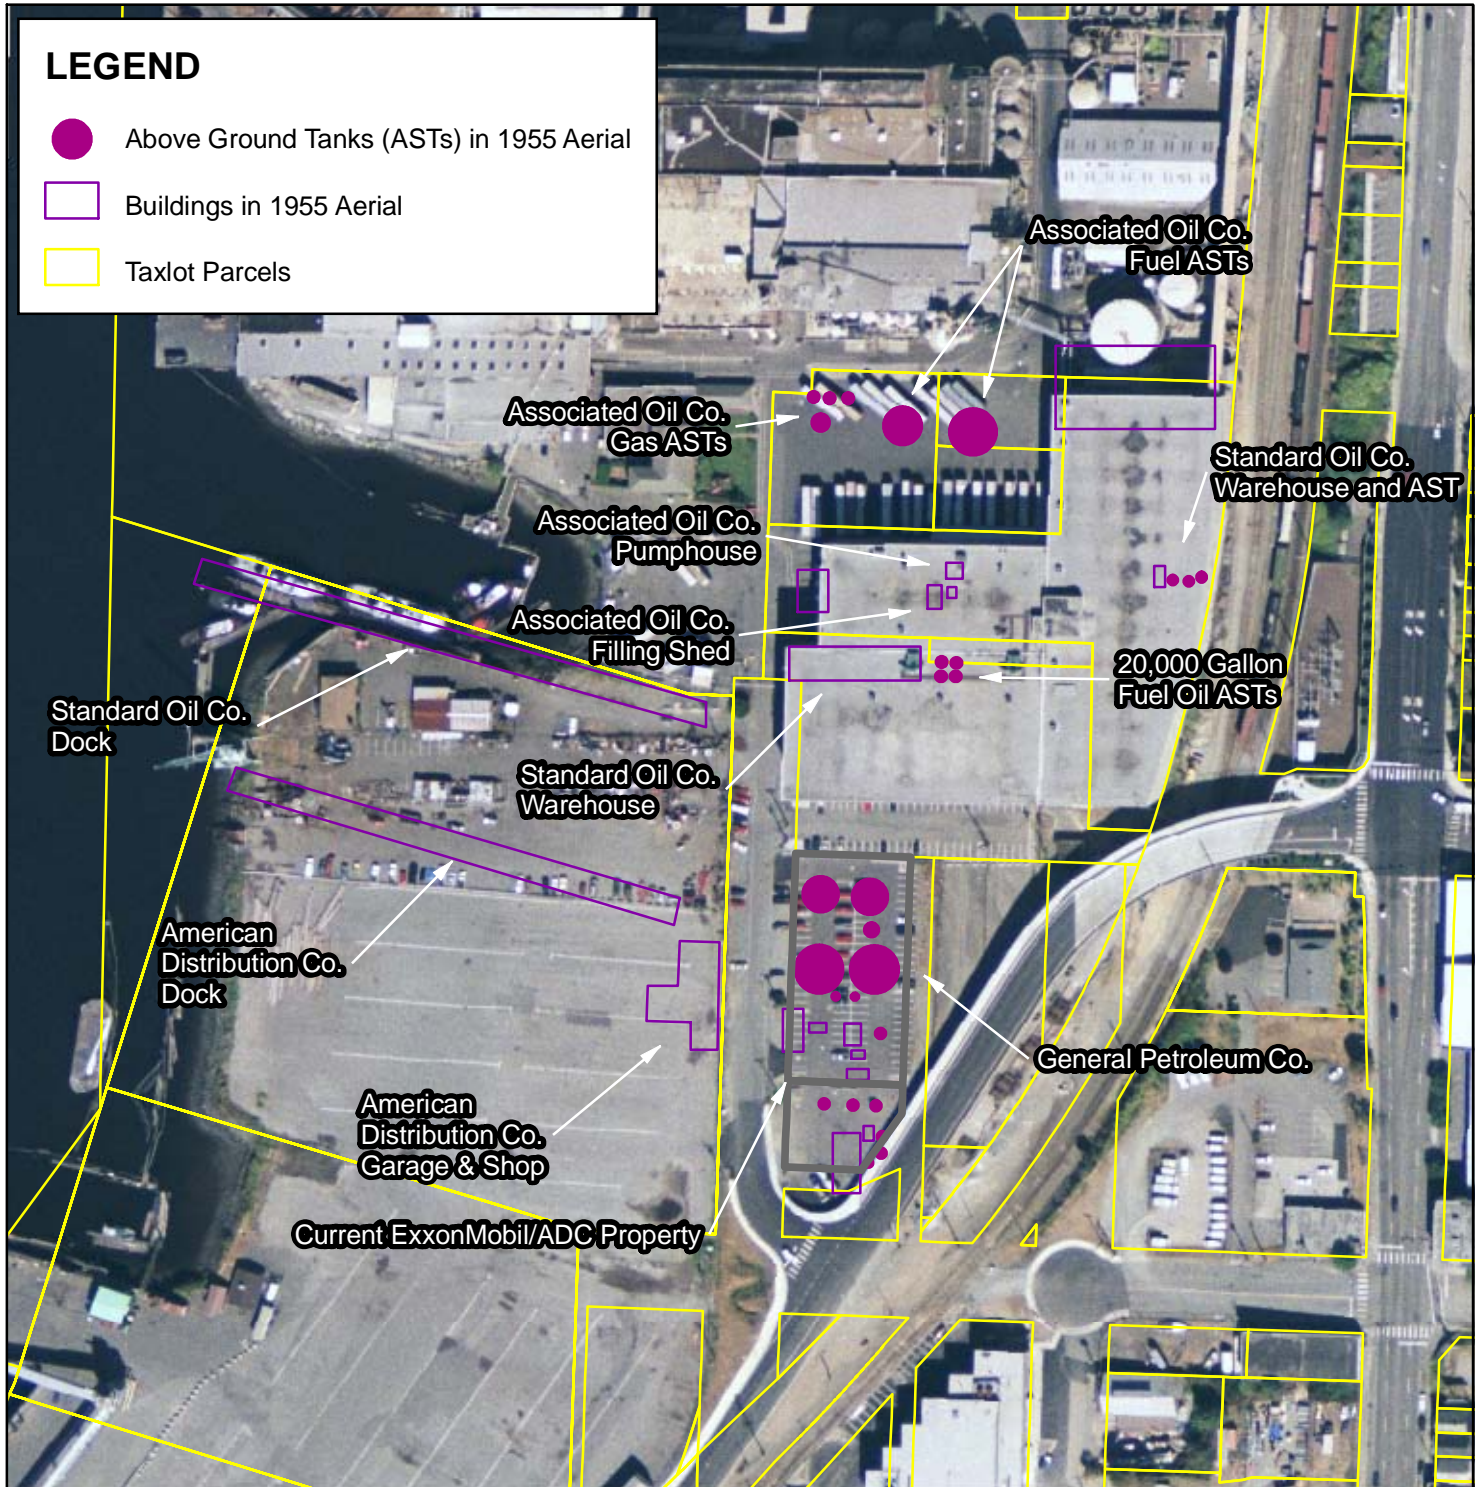
| | | PROJECTION: WA SP North | SCALE: 1 inch = 200 feet | FIGURE No.: FIGURE 8 | |

- Above Ground Tanks (ASTs) in 1955 Aerial
- Buildings in 1955 Aerial
- Taxlot Parcels

| TITLE: FEATURES SEEN IN 1955 AERIAL OVER 2003 AERIAL | | CHKD BY: AIS/MS | REV. NO.: 1 | PROJECT NO.: 9-915-15716C | |

According to a 1955 aerial photograph (Figure 7), four small ASTs were installed half-way between the Associated Oil Company tank farm and the General Petroleum tank farm (Figure 8). Standard issued a quit claim for the Standard parcel to Scott Paper Company in 1958. In 1963, Standard Oil sold its remaining property to Scott.

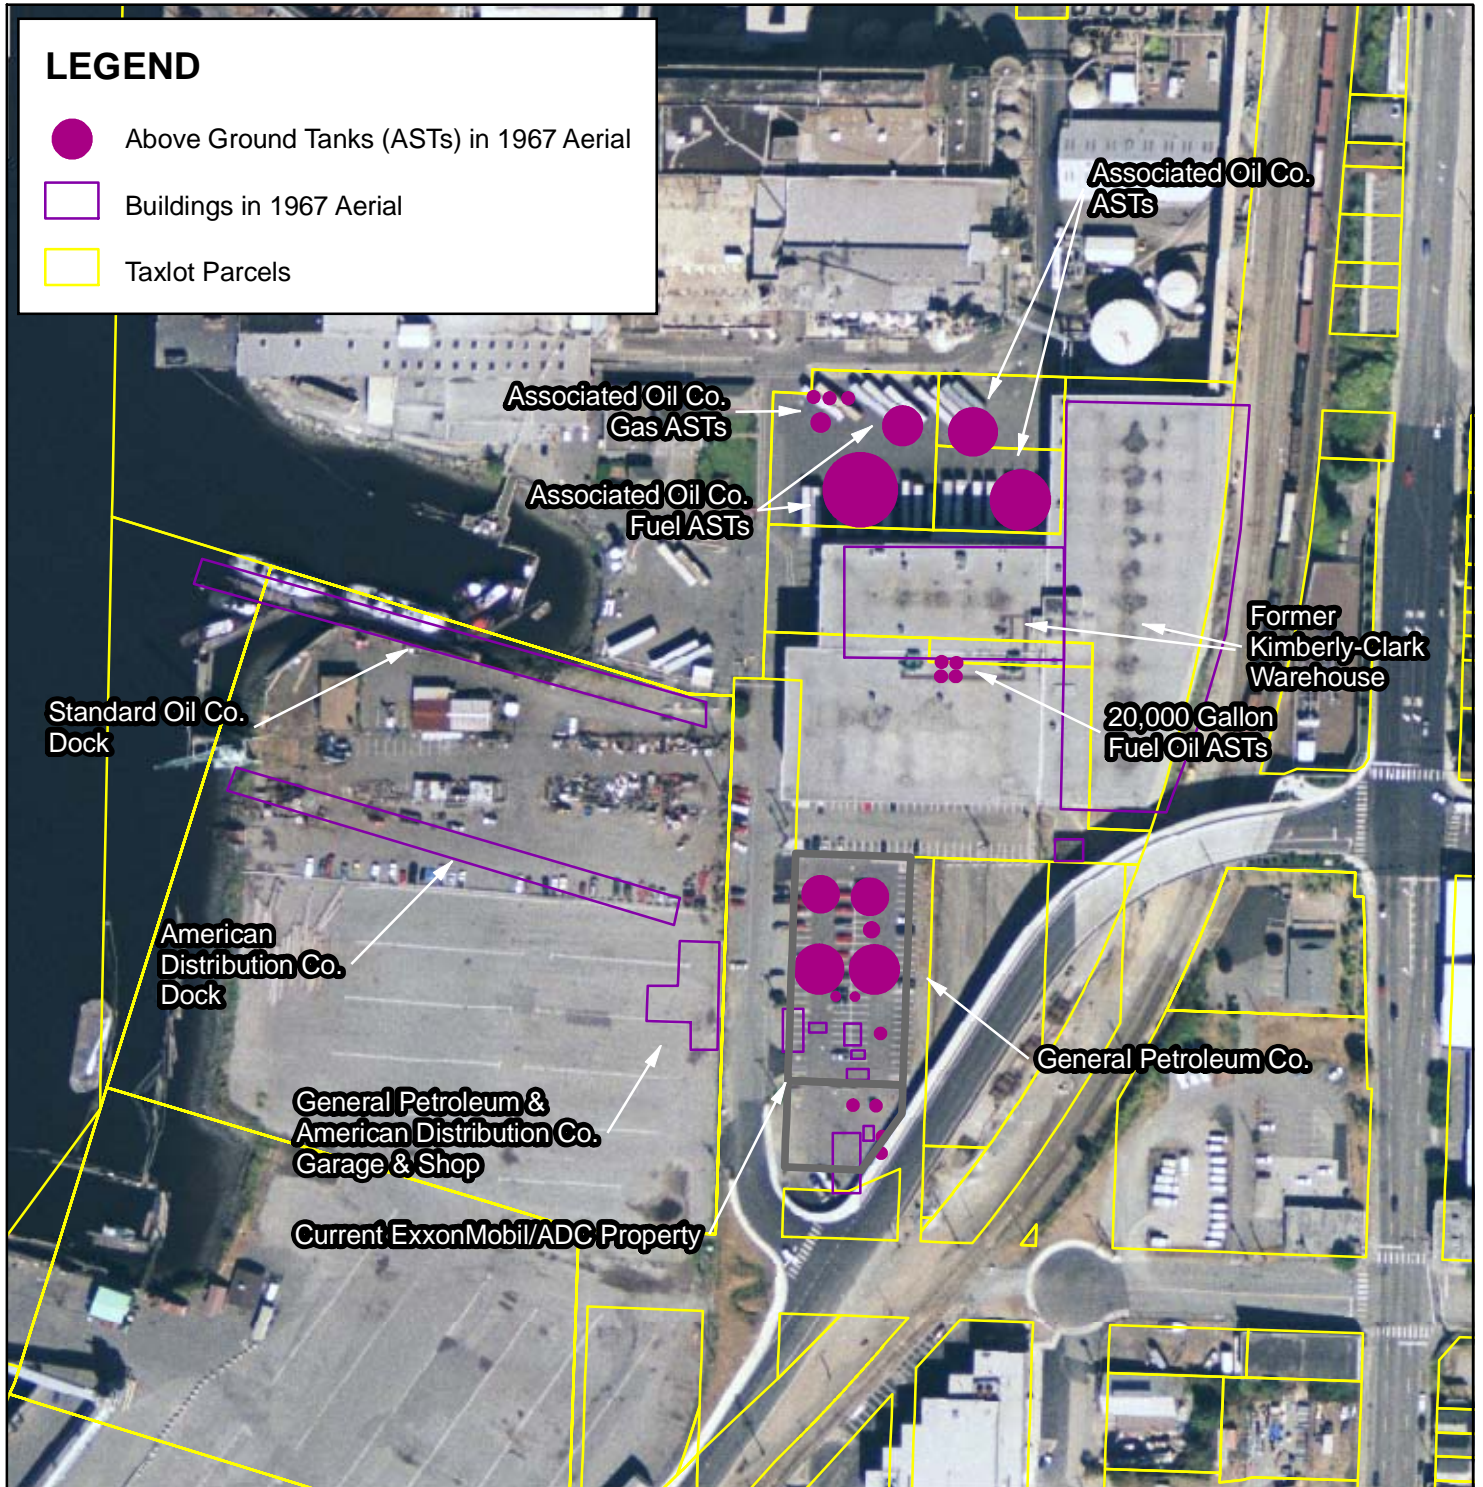
| | | PROJECTION: WA SP North | SCALE: 1 inch = 200 feet | FIGURE No.: FIGURE 10 | |

- Above Ground Tanks (ASTs) in 1967 Aerial
- Buildings in 1967 Aerial
- Taxlot Parcels

| TITLE: FEATURES SEEN IN 1967 AERIAL OVER 2003 AERIAL | | CHKD BY: AIS/MS | REV. NO.: 1 | PROJECT NO.: 9-915-15716C | |

According to a 1967 aerial photograph (Figure 9), the number of ASTs present on the Associated Oil property expanded from six to eight (as compared to the 1955 aerial photograph) with the addition of two large fuel oil ASTs. The four small fuel oil ASTs located just south of Associated Oil's fuel farm were also present on the 1967 aerial photograph. By that time, KC's T-shaped warehouse was built over three different former Standard ASTs (Figure 10).

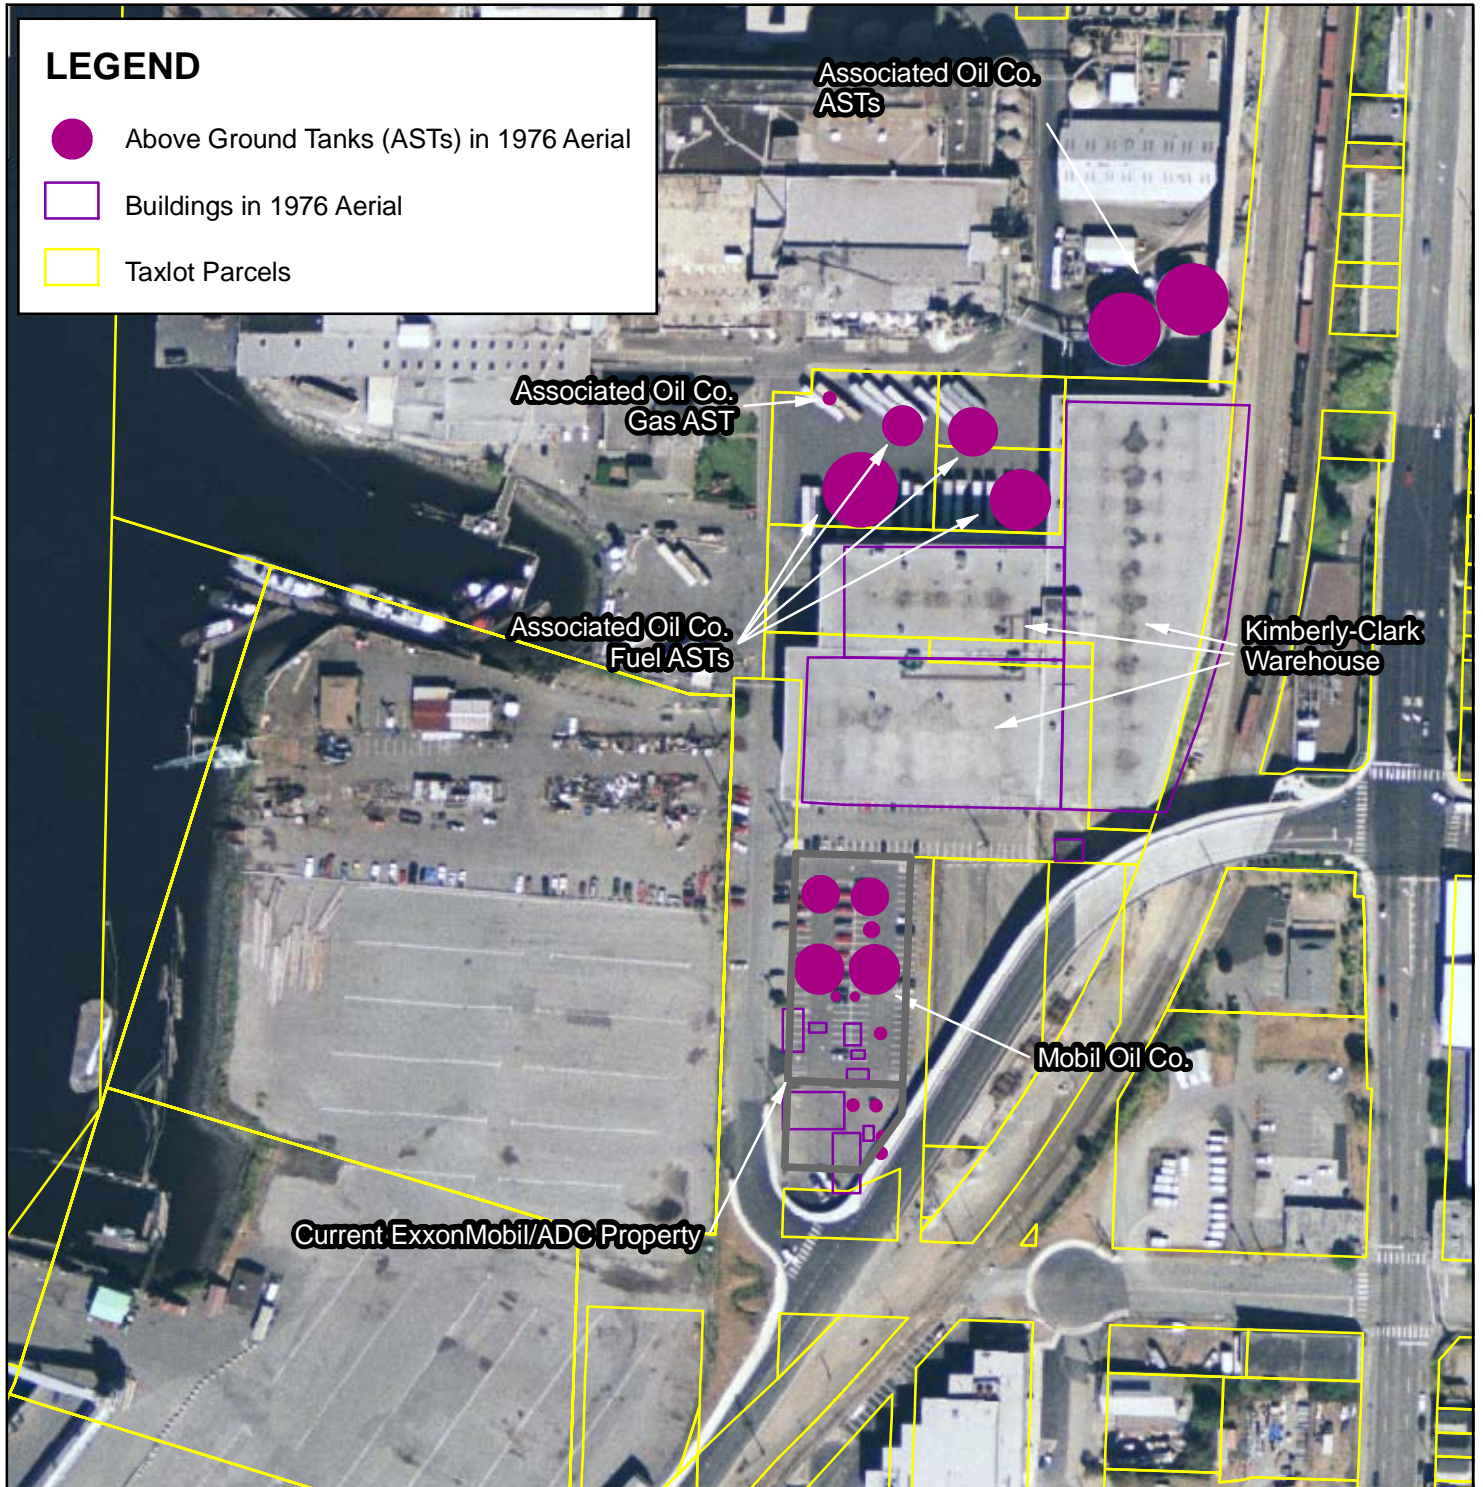
PROJECTION: WA SP North SCALE: 1 inch = 200 feet FIGURE No.: **FIGURE 12**

- Above Ground Tanks (ASTs) in 1976 Aerial
- Buildings in 1976 Aerial
- Taxlot Parcels

TITLE: **FEATURES SEEN IN
 1976 AERIAL
 OVER 2003 AERIAL**

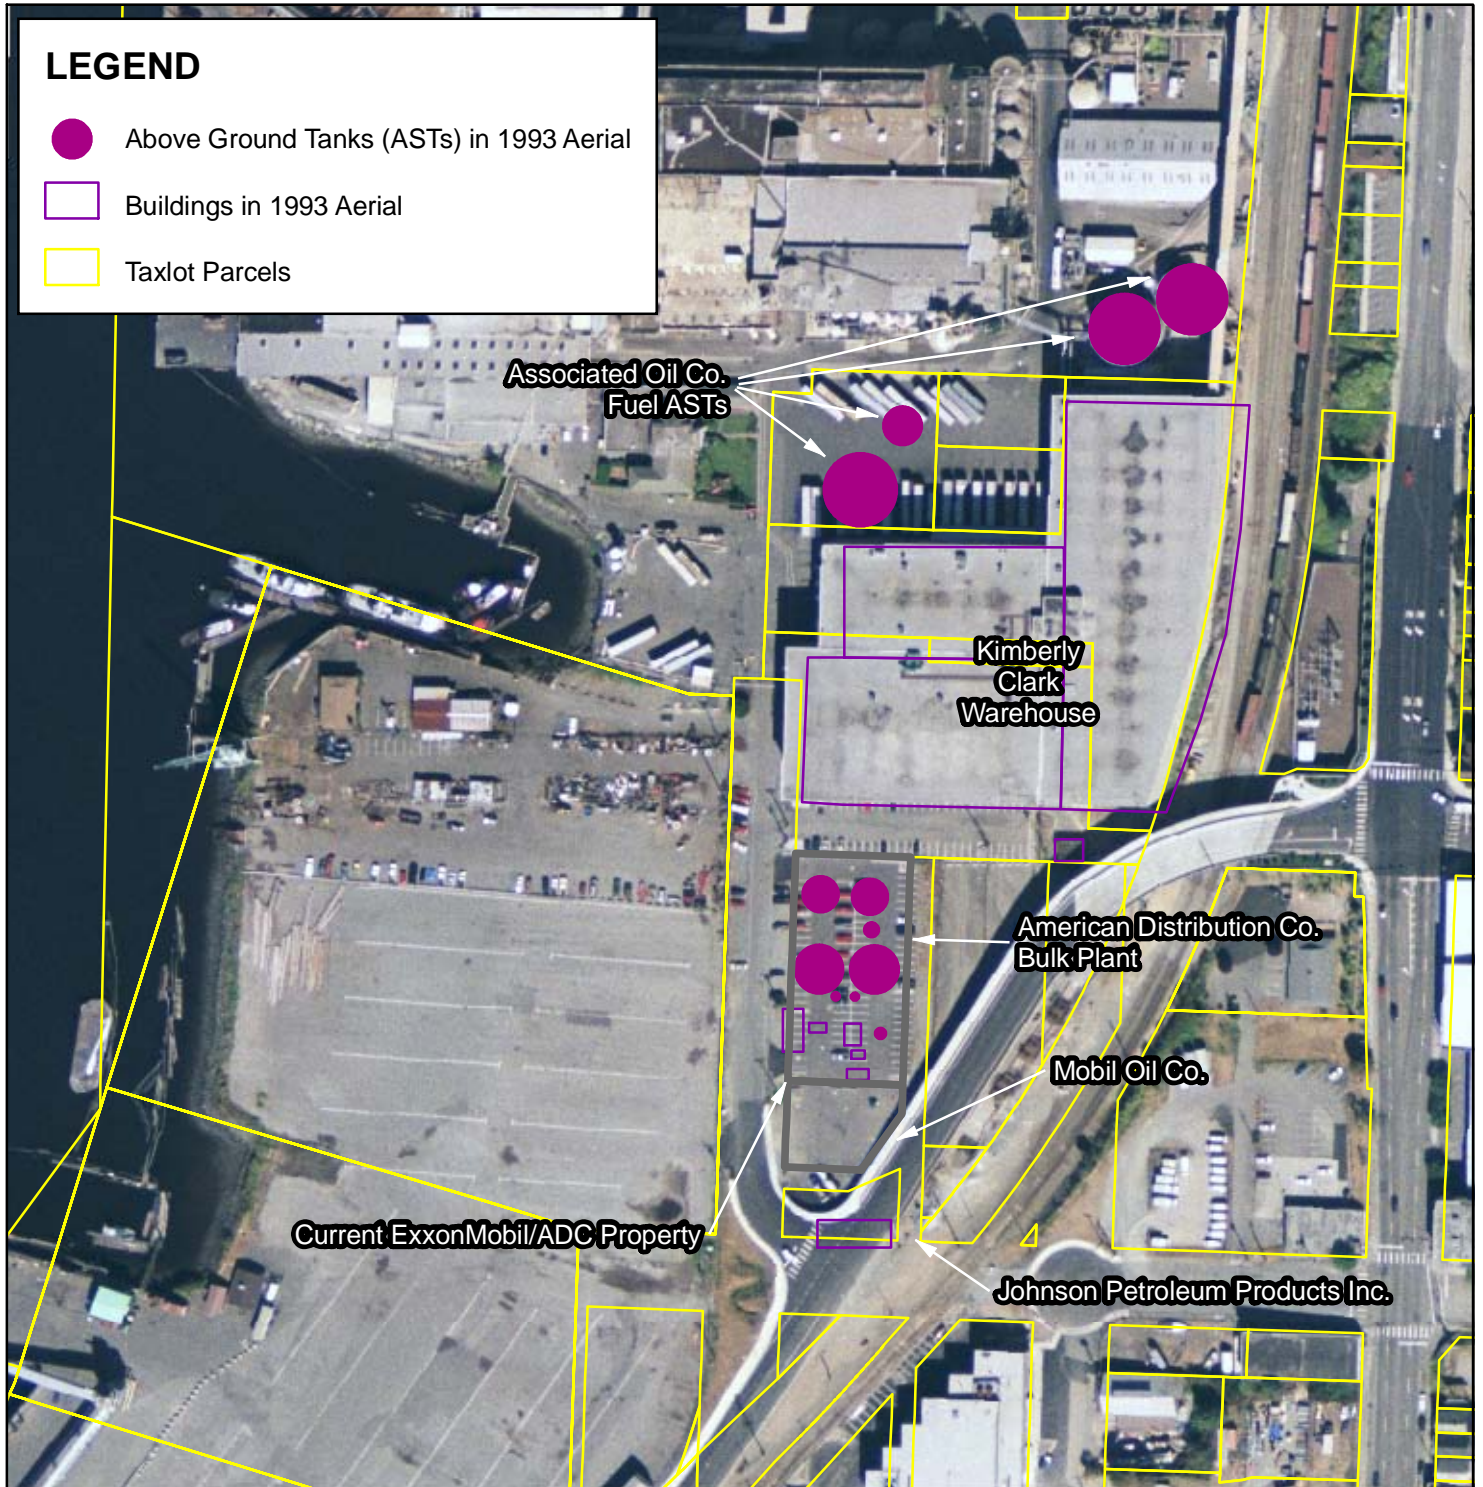
PROJECTION: WA SP North SCALE: 1 inch = 200 feet FIGURE No.: **FIGURE 14**

TITLE: **FEATURES SEEN IN
 1993 AERIAL
 OVER 2003 AERIAL**

In the late 1980s to early 1990s, Mr. Jack Johnston (part-owner of Johnston Petroleum) purchased the adjacent property south of the ExxonMobil Parcel from BNSF. The Johnston property has been used for parking vehicles, storing packaged goods and oils, and receiving containers (e.g. drums) to be shipped to a recycling facility. In 2001, the California Street Overcrossing ramp was constructed covering the Johnston Estate Parcel and the southeast corner of the ExxonMobil Parcel. The former Johnston property is depicted on Figure 14.
