**STATE OF WASHINGTON
DEPARTMENT OF ECOLOGY**

AGREED ORDER for

**Focused Feasibility Study and Draft
Cleanup Action Plan – ExxonMobil ADC
Site**

No. DE **6184**

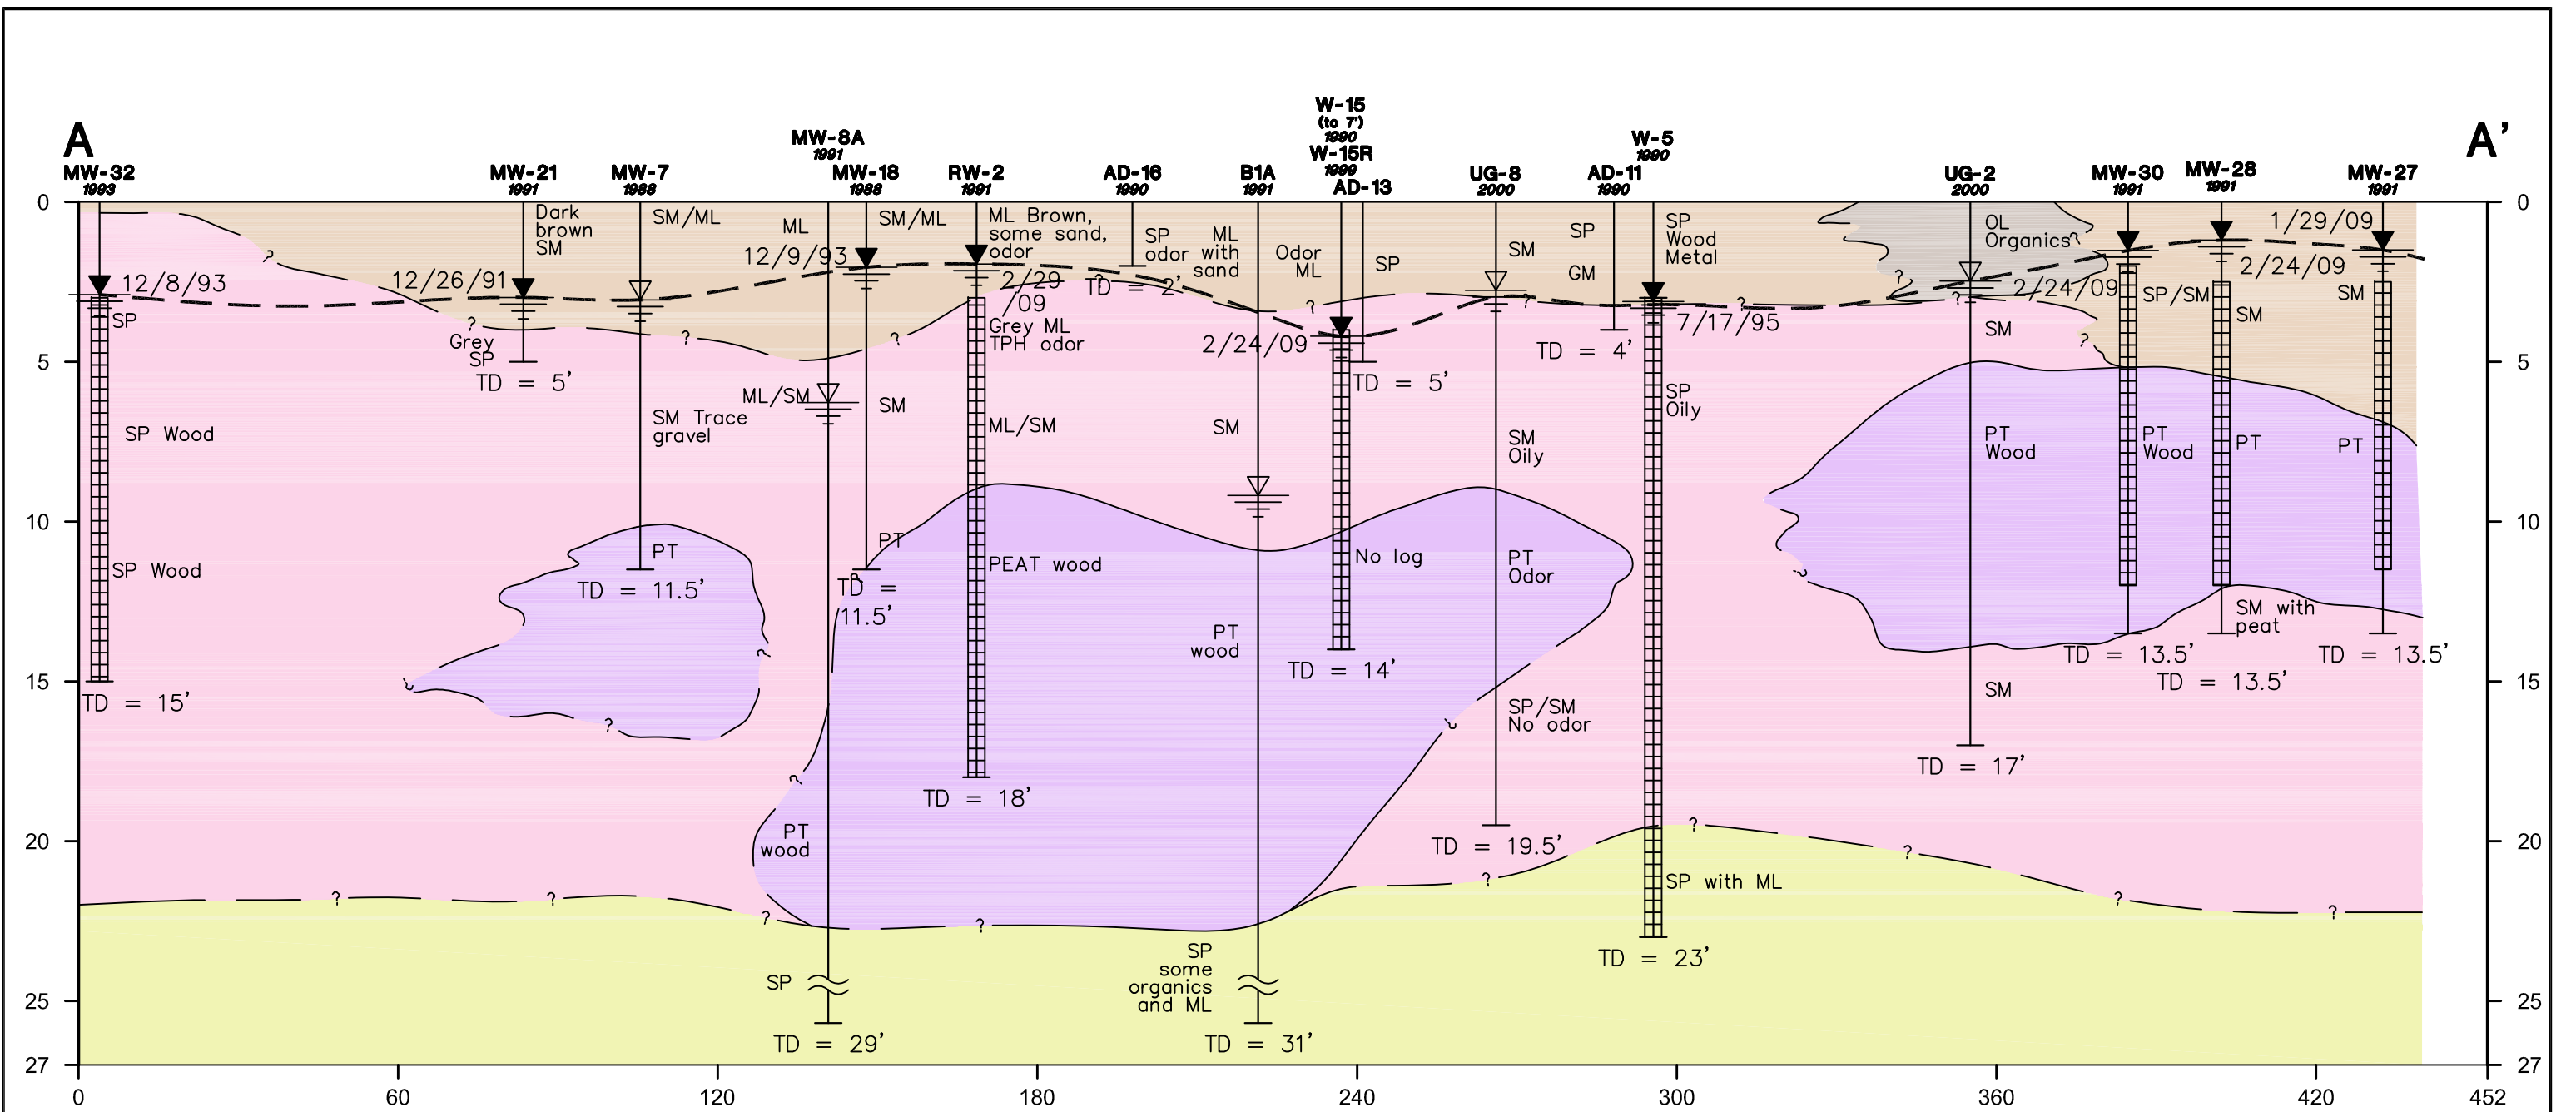
| FILL | MARSHLAND MATERIALS | TRANSITIONAL BEDS | 12/26/91 | Static water level measured after drilling and date measured | AD-16 1990 | Boring number and year installed | MW-30 1991 | Well number and year installed |

| SCALE IN VERTICAL FEET SCALE IN HORIZONTAL FEET | CLIENT LOGO CLIENT: EXXONMOBIL AND AMERICAN DISTRIBUTING COMPANY AMEC Earth & Environmental 11810 North Creek Parkway North Bothell, WA, U.S.A. 98011-8201 | DWN BY: JRS CHK'D BY: AS DATUM: NONE PROJECTION: NONE SCALE: AS SHOWN | PROJECT EXXONMOBIL/ADC PROPERTY ECOLOGY SITE ID 2728 TITLE GEOLOGIC CROSS SECTION A-A' | DATE: AUGUST 2009 PROJECT NO: 9-915-15716-C REV. NO.: FIGURE No. 16 |

Soil boring, monitoring well, and test pit logs are compiled in Appendix C. The stratigraphy underlying the Site is displayed on geologic cross-sections A-A', B-B', and C-C', which are presented on Figures 16 through 18, respectively. The locations of the cross-sections are shown on Figure 15.

The general geology, based on the previous subsurface investigations conducted at the Property and its surroundings, is described in Section 2.4.2. Soil boring, monitoring well, and test pit logs are compiled in Appendix C. The stratigraphy underlying the Site is displayed on geologic cross-sections A-A', B-B', and C-C', which are presented on Figures 16 through 18, respectively. The locations of the cross sections are shown on Figure 15.

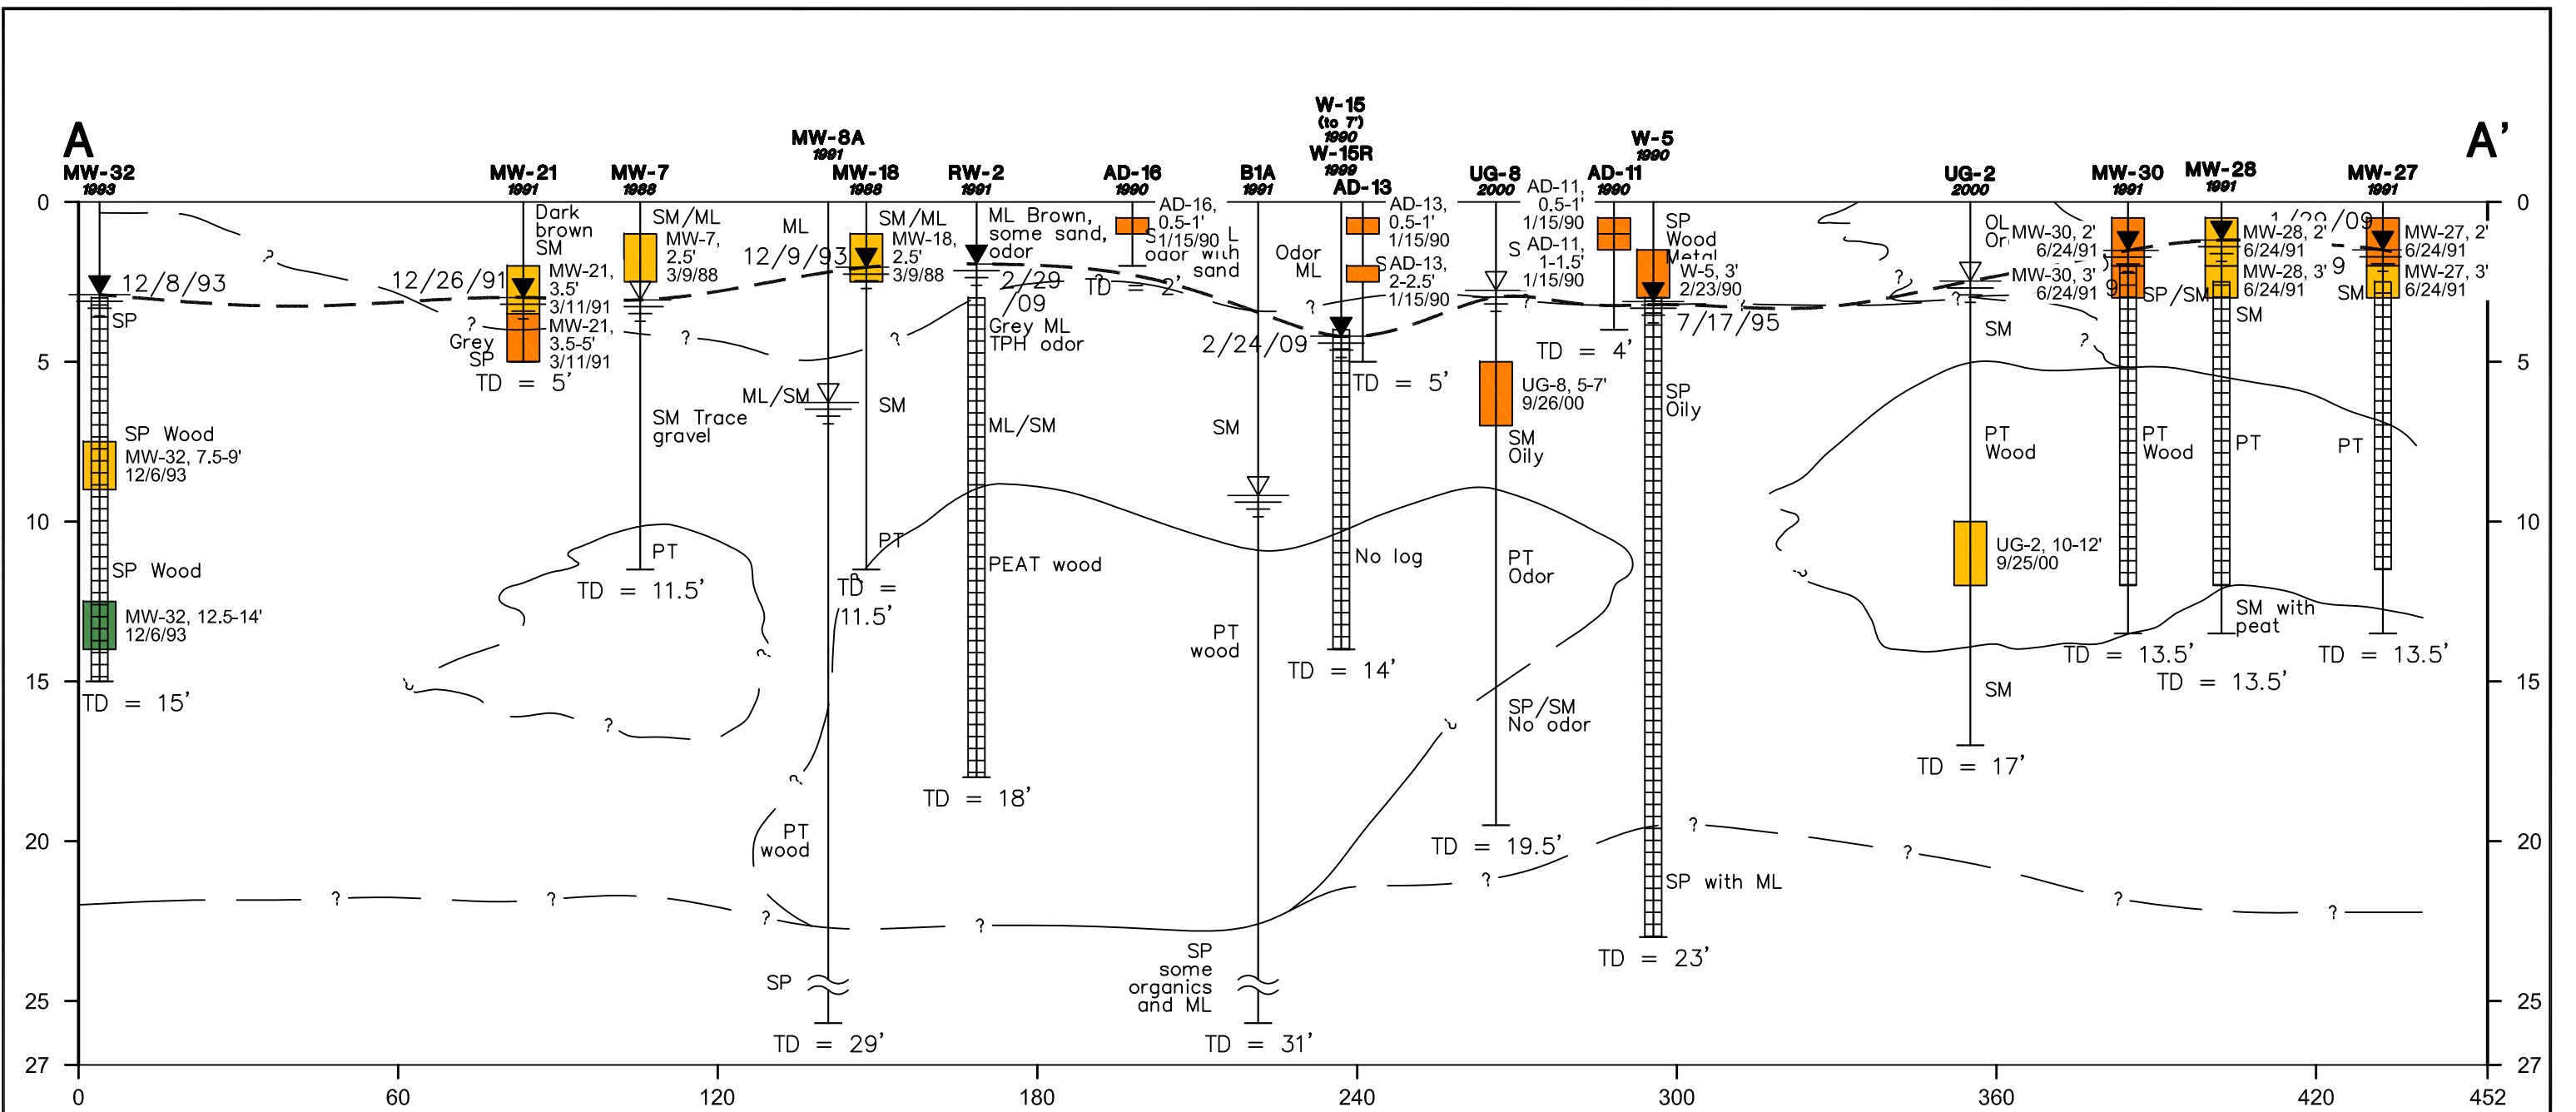
- 12/26/91: Static water level measured after drilling and date measured
- Water level during drilling
- Unconfined groundwater table
- AD-16 1990: Boring number and year installed
- MW-30 1991: Well number and year installed
- TD = 2': Total depth in feet
- TD = 15': Total depth in feet
- TPH-D or TPH (Undifferentiated):
 - Orange: Detected ≥ 2,000 mg/kg
 - Yellow: Detected < 2,000 mg/kg
 - Green: Not detected
- mg/kg: Milligram per kilogram
- UG-2, 10-12' 9/25/00: Sample depth and date collected

- TPH-D has been detected at concentrations above the MTCA Method A cleanup level of 2,000 mg/kg at the Property and to the north, west, and east (Figures 22 through 25). The majority of the samples with TPH concentrations above the MTCA Method A cleanup level were collected at shallow depths (less than 5 feet bgs). However, soil samples with exceedances of TPH were collected at depths of 7.5 feet bgs and greater in several borings. TPH-D and TPH-O were selected as indicator hazardous substances.
- TPH-G was not detected at concentrations above 30 mg/kg (MTCA Method A cleanup level if benzene is present) in soil samples collected to the south and southwest of the Property, but was detected at concentrations greater than 100 mg/kg in soil samples collected to the north, west, and east of the Site (Figures 26 to 29). Samples collected

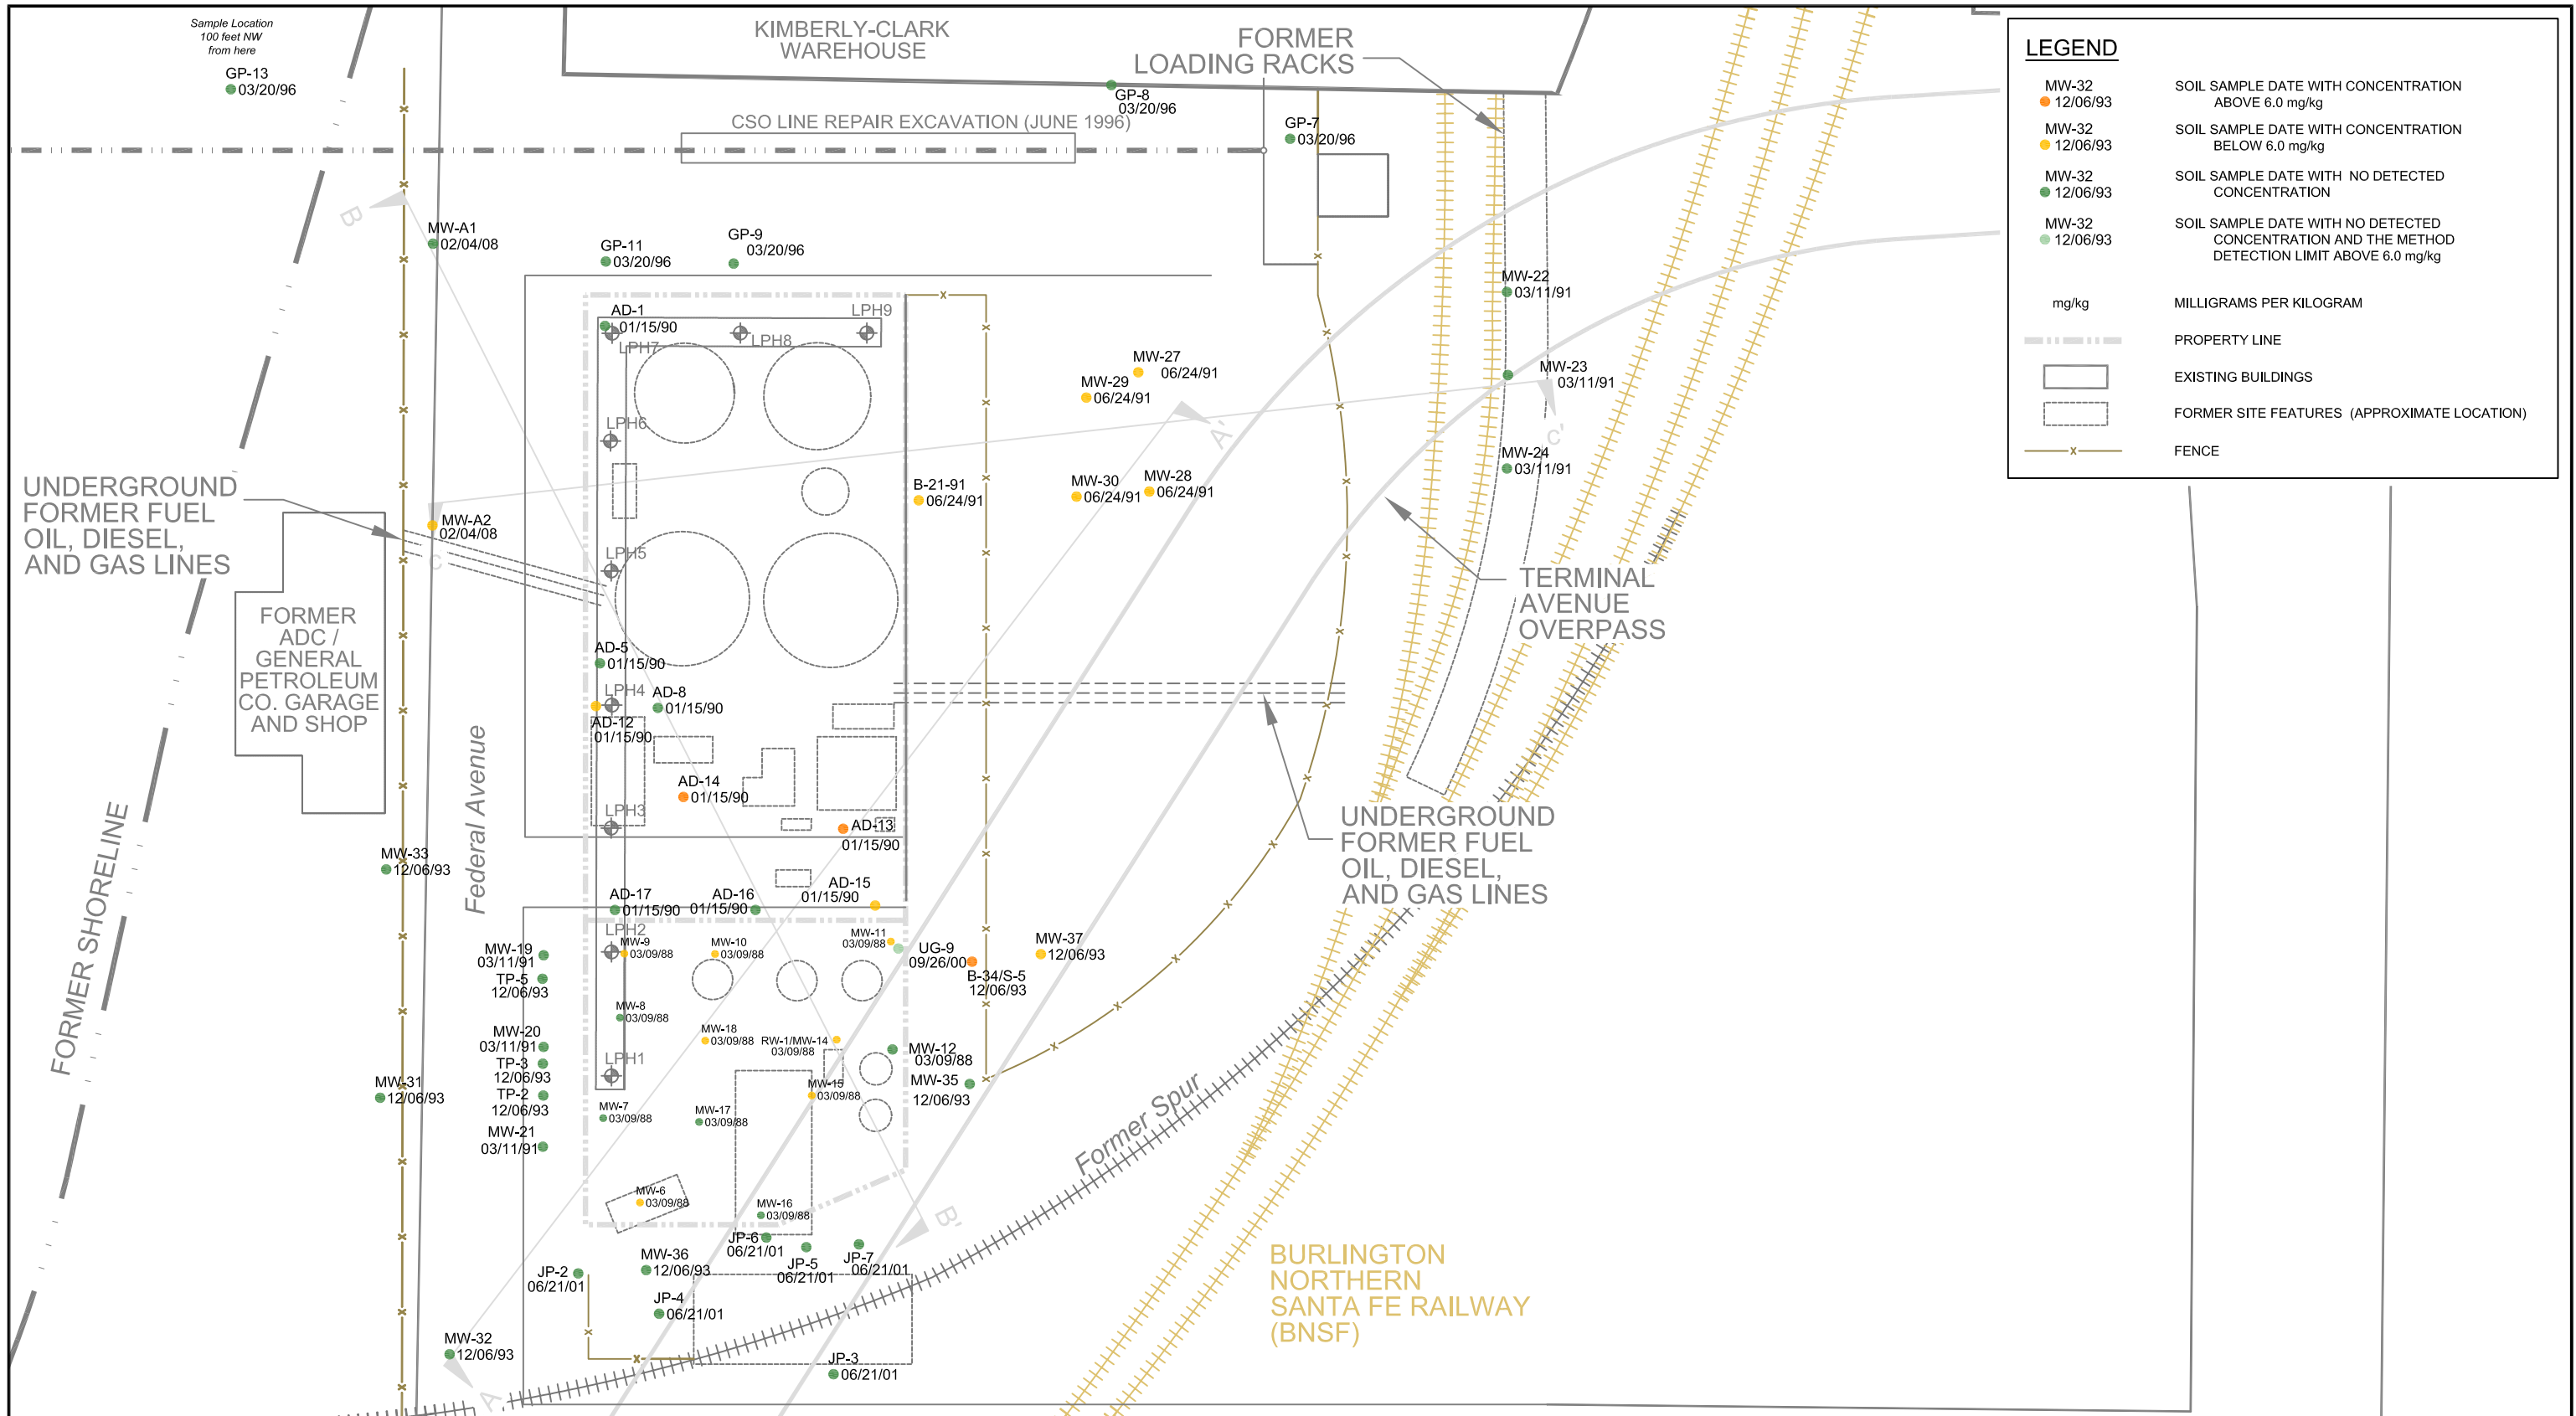
DATE: AUGUST 2009
 PROJECT NO: 9-915-15716-C
 REV. NO.: 1
 FIGURE No. 34

**HORIZONTAL DISTRIBUTION
 OF TOLUENE IN SOIL**

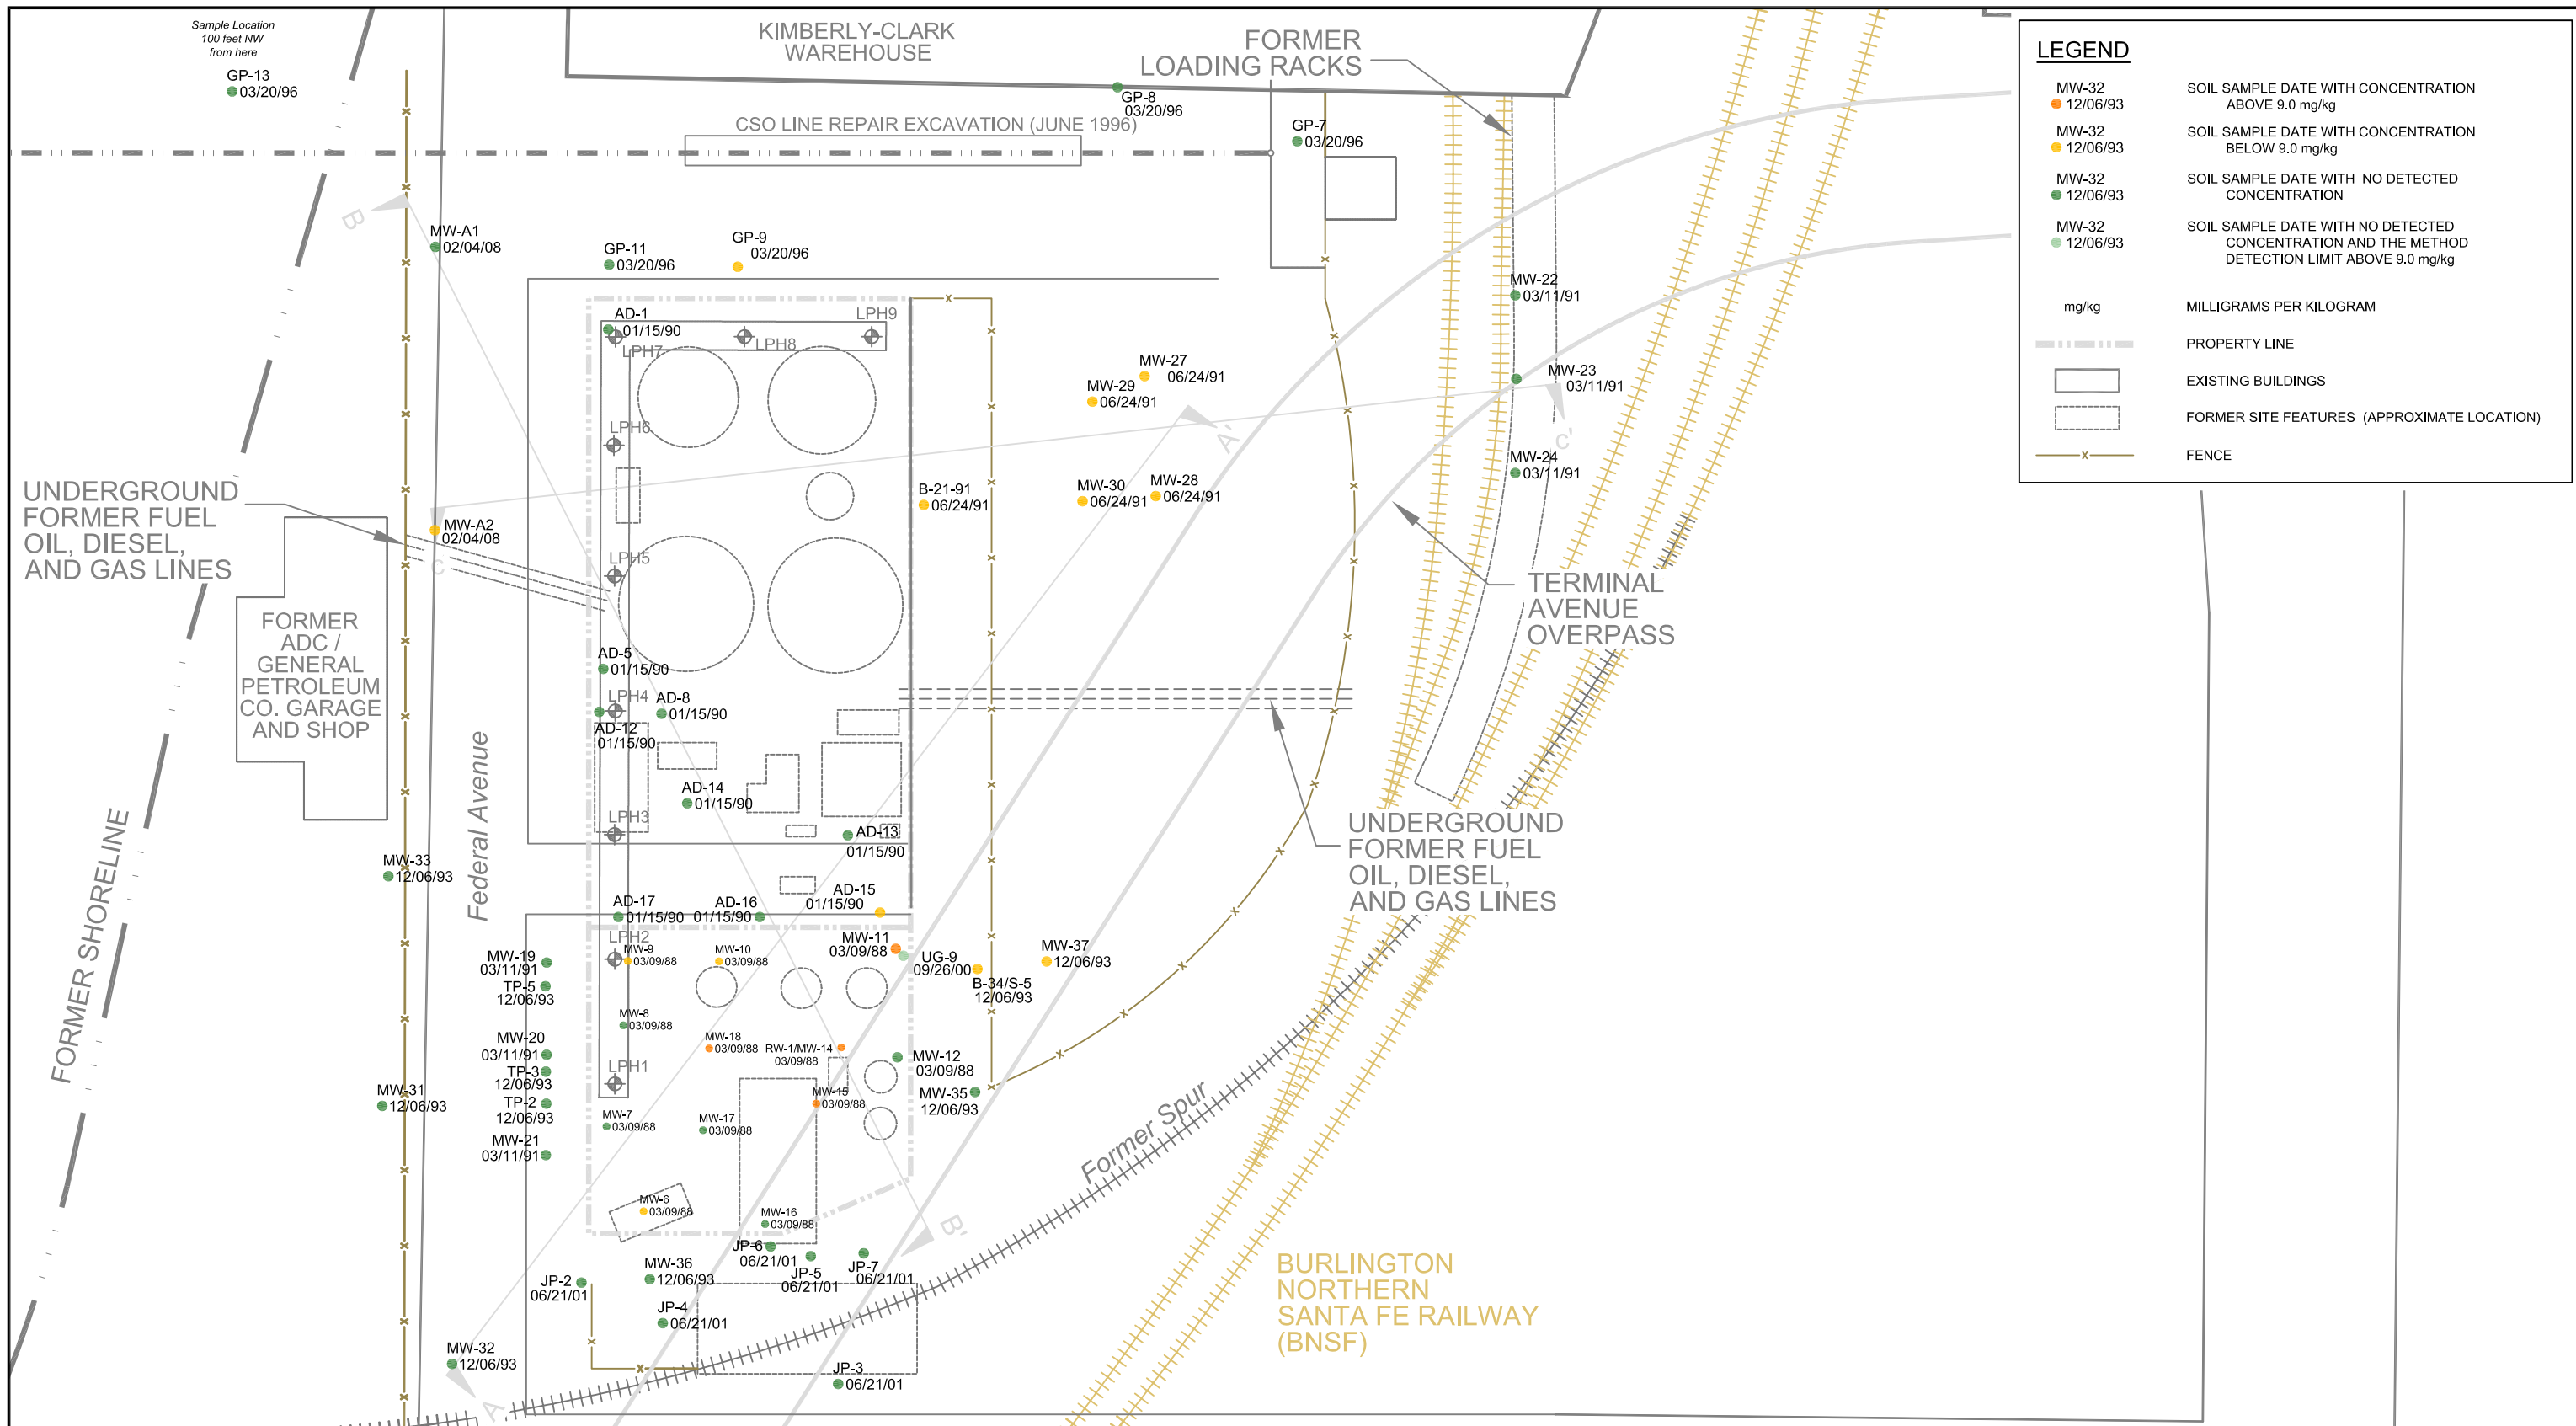
DATE: AUGUST 2009
 PROJECT NO: 9-915-15716-C
 REV. NO.: 1
 FIGURE No. 35

**HORIZONTAL DISTRIBUTION
 OF ETHYLBENZENE IN SOIL**

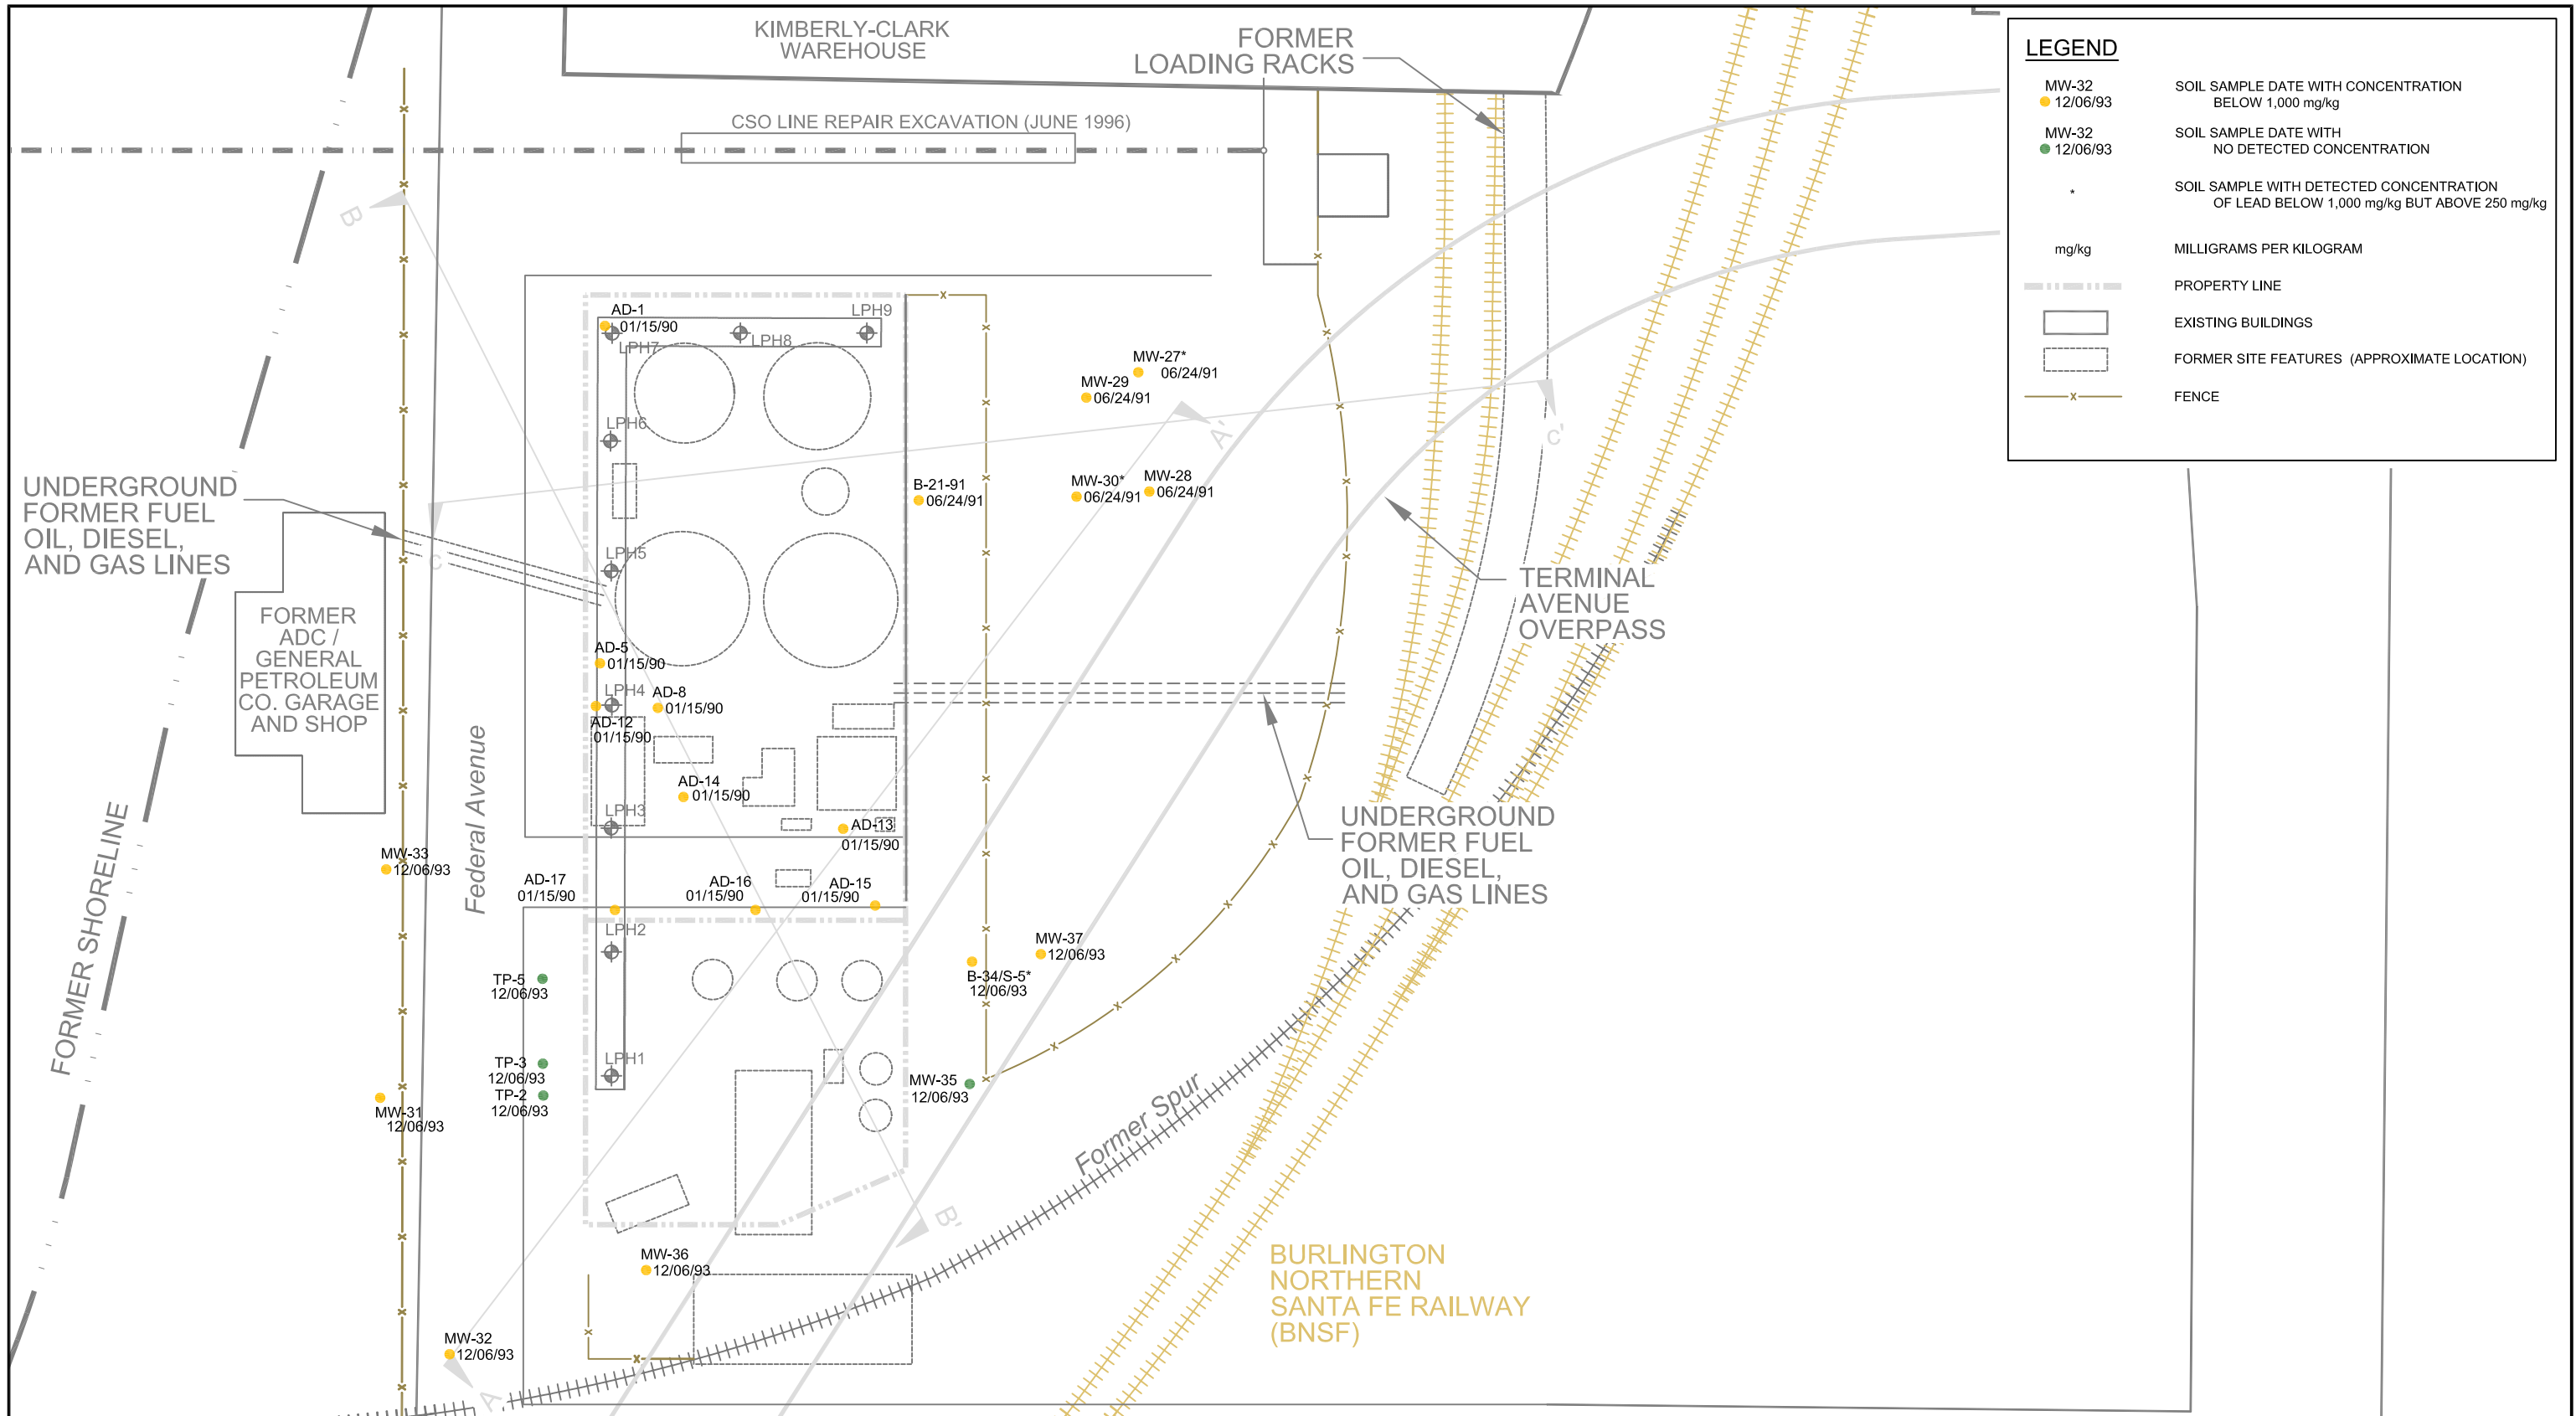
| | | AMEC Earth & Environmental 11810 North Creek Parkway North Bothell, WA, U.S.A. 98011-8201 | TITLE HORIZONTAL DISTRIBUTION OF TOTAL XYLENE IN SOIL | | |

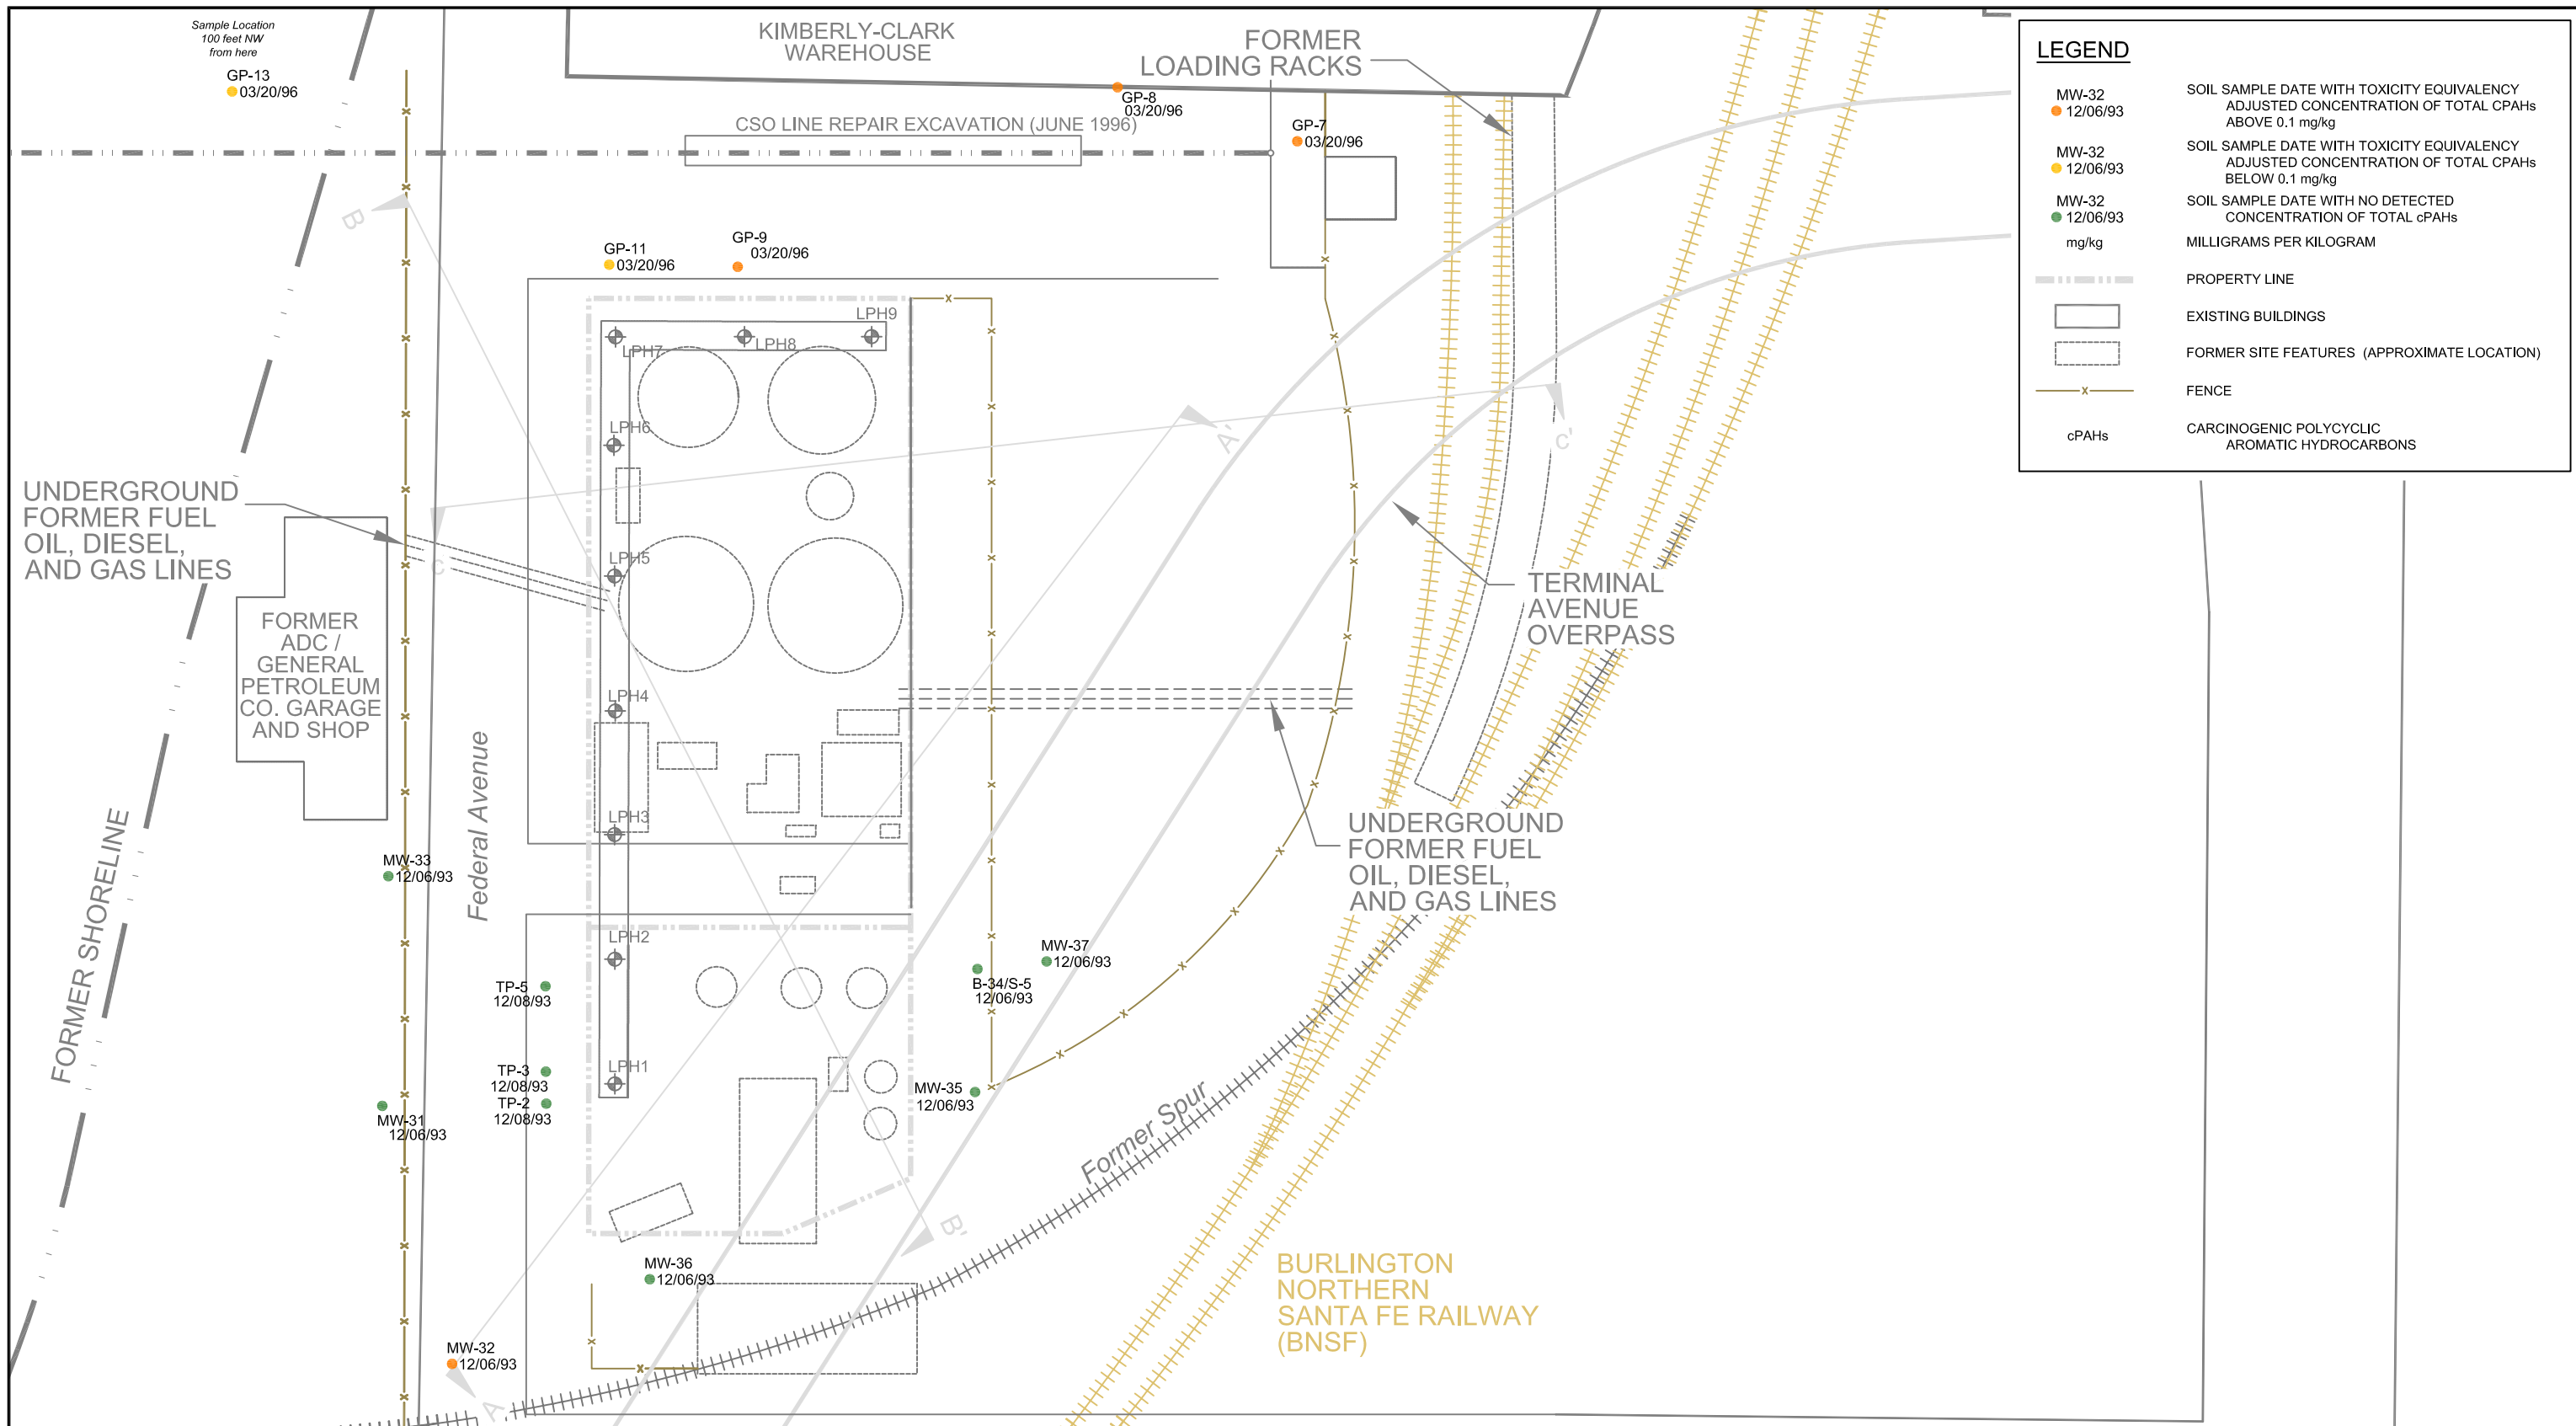
DATE: AUGUST 2009
 PROJECT NO: 9-915-15716-C
 REV. NO.: 1
 FIGURE No. 41

PROJECT
**EXXONMOBIL/ADC PROPERTY
 ECOLOGY SITE ID 2728**
 TITLE
**HORIZONTAL DISTRIBUTION
 OF ADJUSTED TOTAL cPAHs
 CONCENTRATION IN SOIL**
