**STATE OF WASHINGTON
DEPARTMENT OF ECOLOGY**

AGREED ORDER for

**Focused Feasibility Study and Draft
Cleanup Action Plan – ExxonMobil ADC
Site**

No. DE **6184**

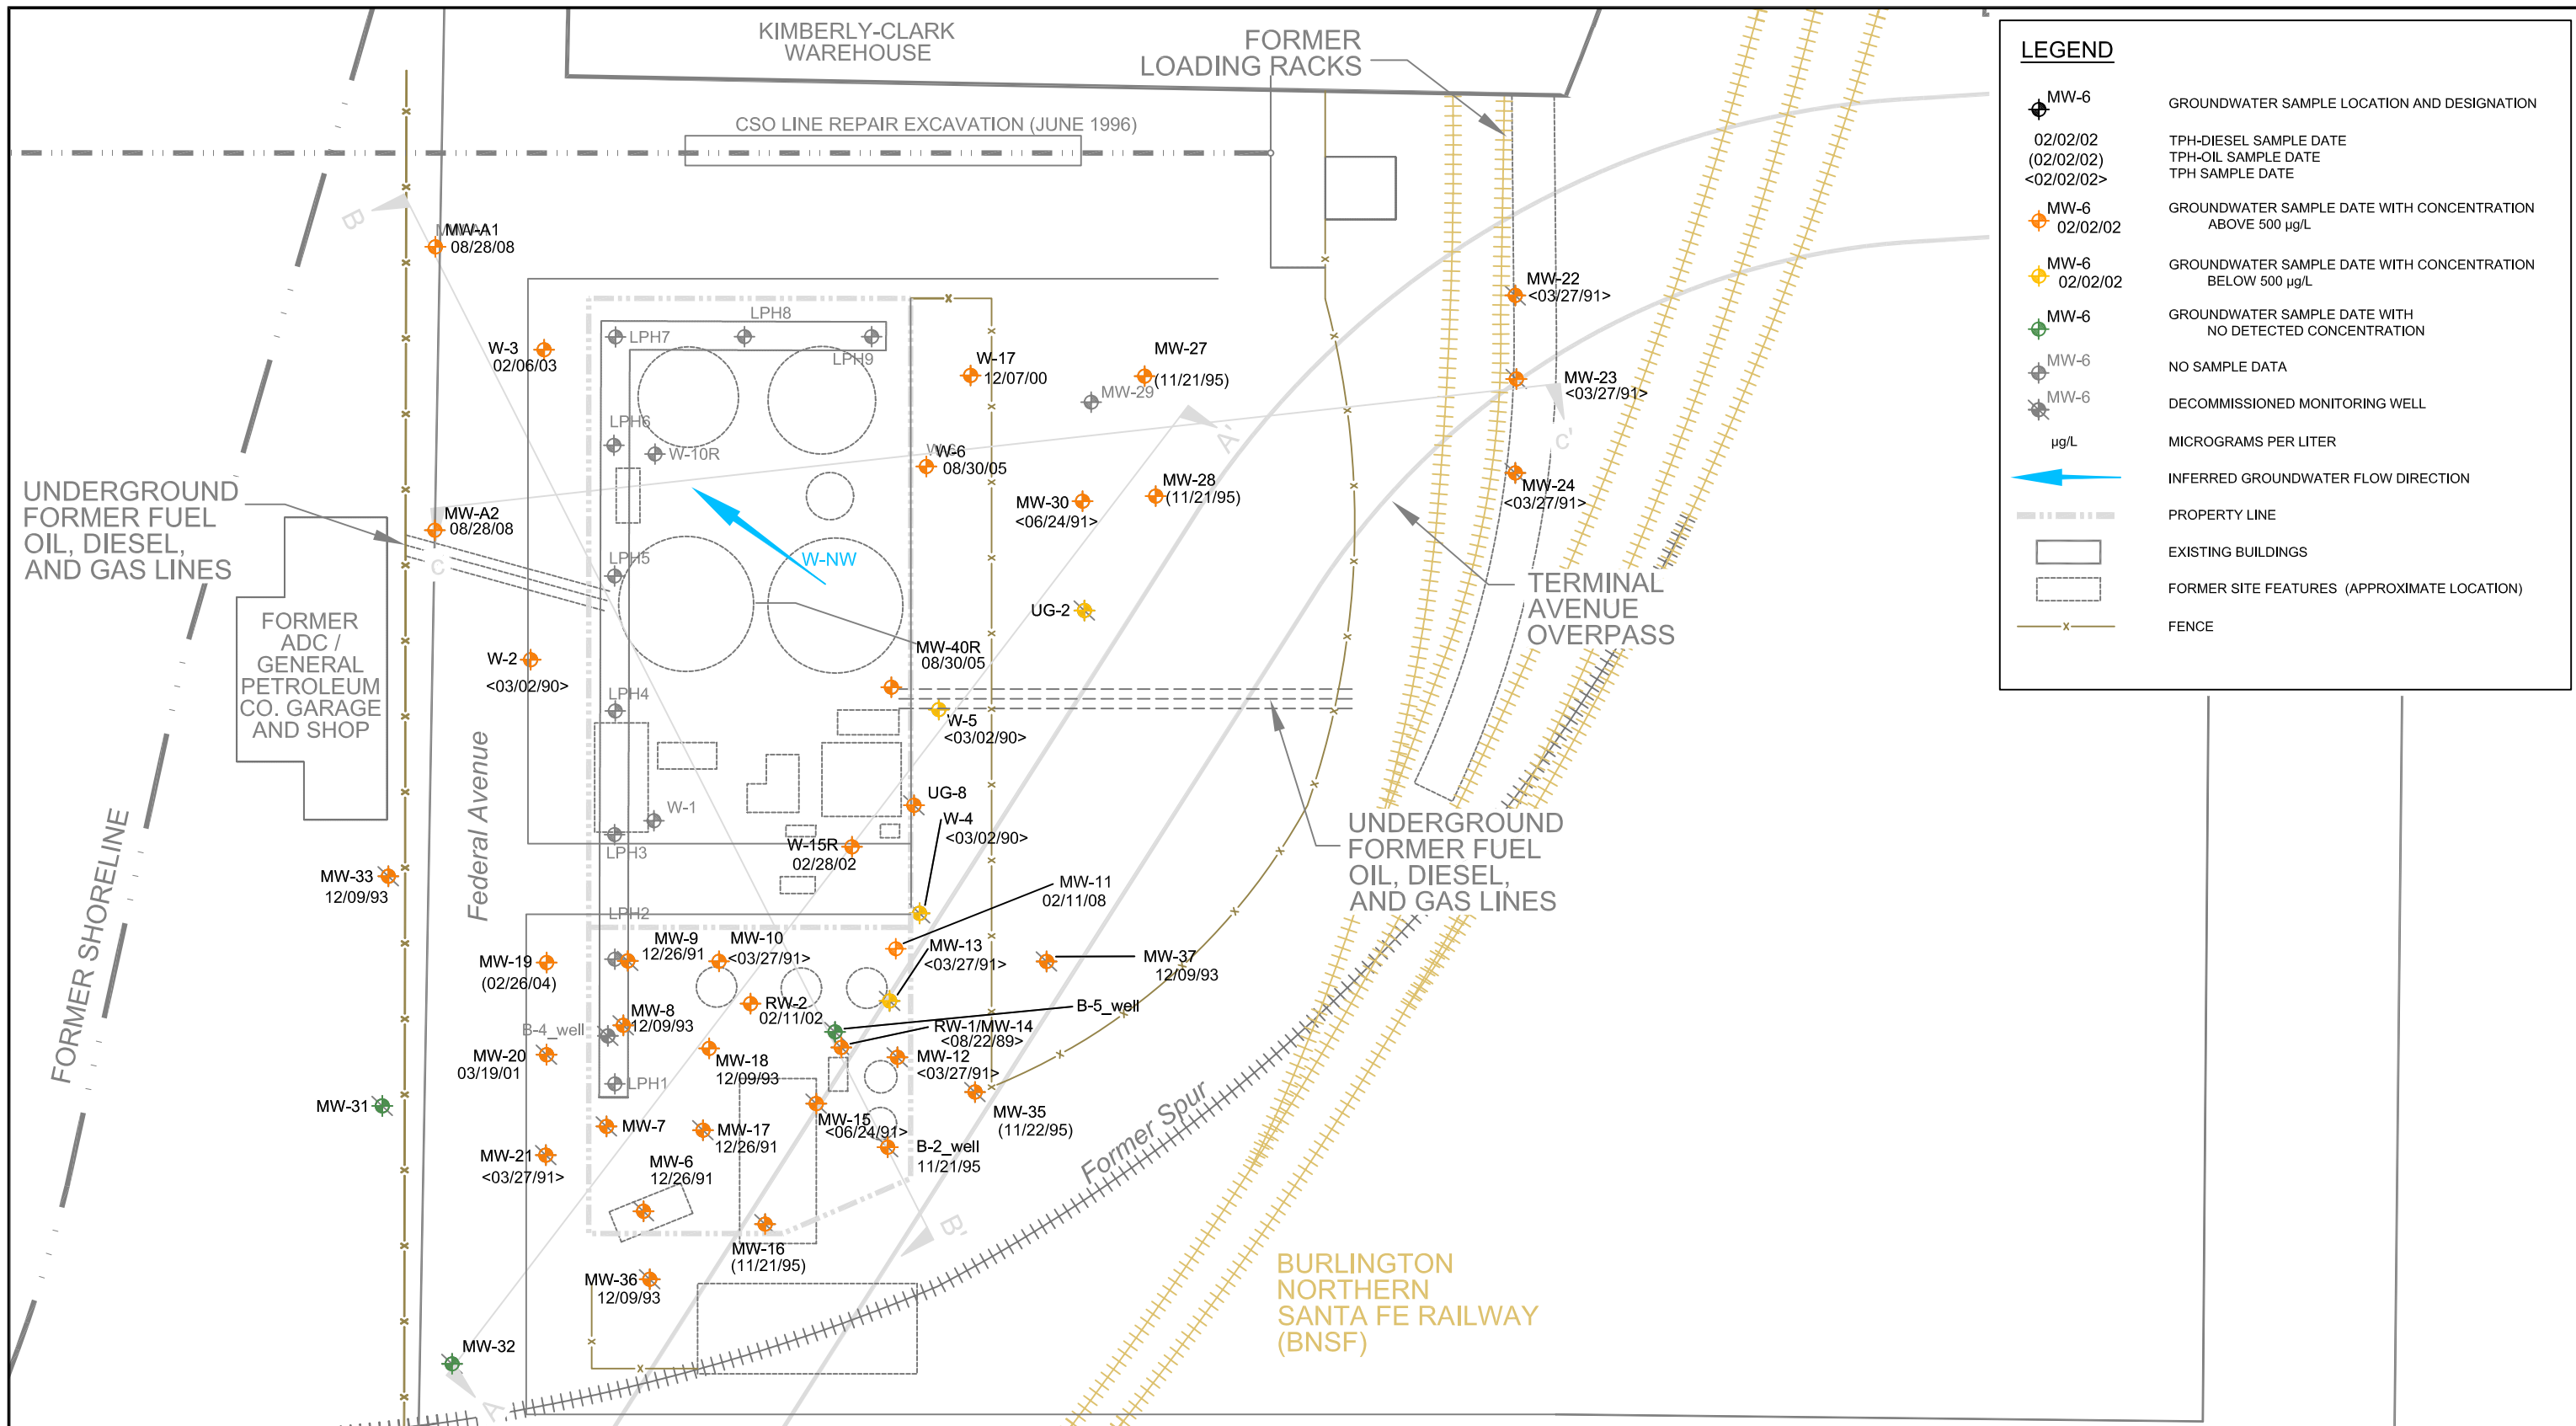
| | | | TITLE HISTORICAL DISTRIBUTION OF TPH-G IN GROUNDWATER MAXIMUM DETECTED VALUE | REV. NO.: 1 FIGURE No. 45 | |

| SOURCE: Modified from a map provided by City of Everett, ExxonMobil Oil Corporation and Environmental Resolution, Inc. 0 60 120 SCALE IN FEET | CLIENT LOGO | CLIENT: EXXONMOBIL AND AMERICAN DISTRIBUTING COMPANY AMEC Earth & Environmental 11810 North Creek Parkway North Bothell, WA, U.S.A. 98011-8201 | DWN BY: JRS / BRJ CHK'D BY: AIS/MS DATUM: NONE PROJECTION: NONE SCALE: 1" = 60' | PROJECT EXXONMOBIL/ADC PROPERTY ECOLOGY SITE ID 2728 | DATE: AUGUST 2009 PROJECT NO: 9-915-15716-C |

- TPH-G has been detected at concentrations above the MTCA Method A cleanup levels in groundwater samples collected from the monitoring wells installed at the Property as well as monitoring wells installed to the east and northeast of the Property (Figure 45). Therefore, TPH-G was selected as an indicator hazardous substance.

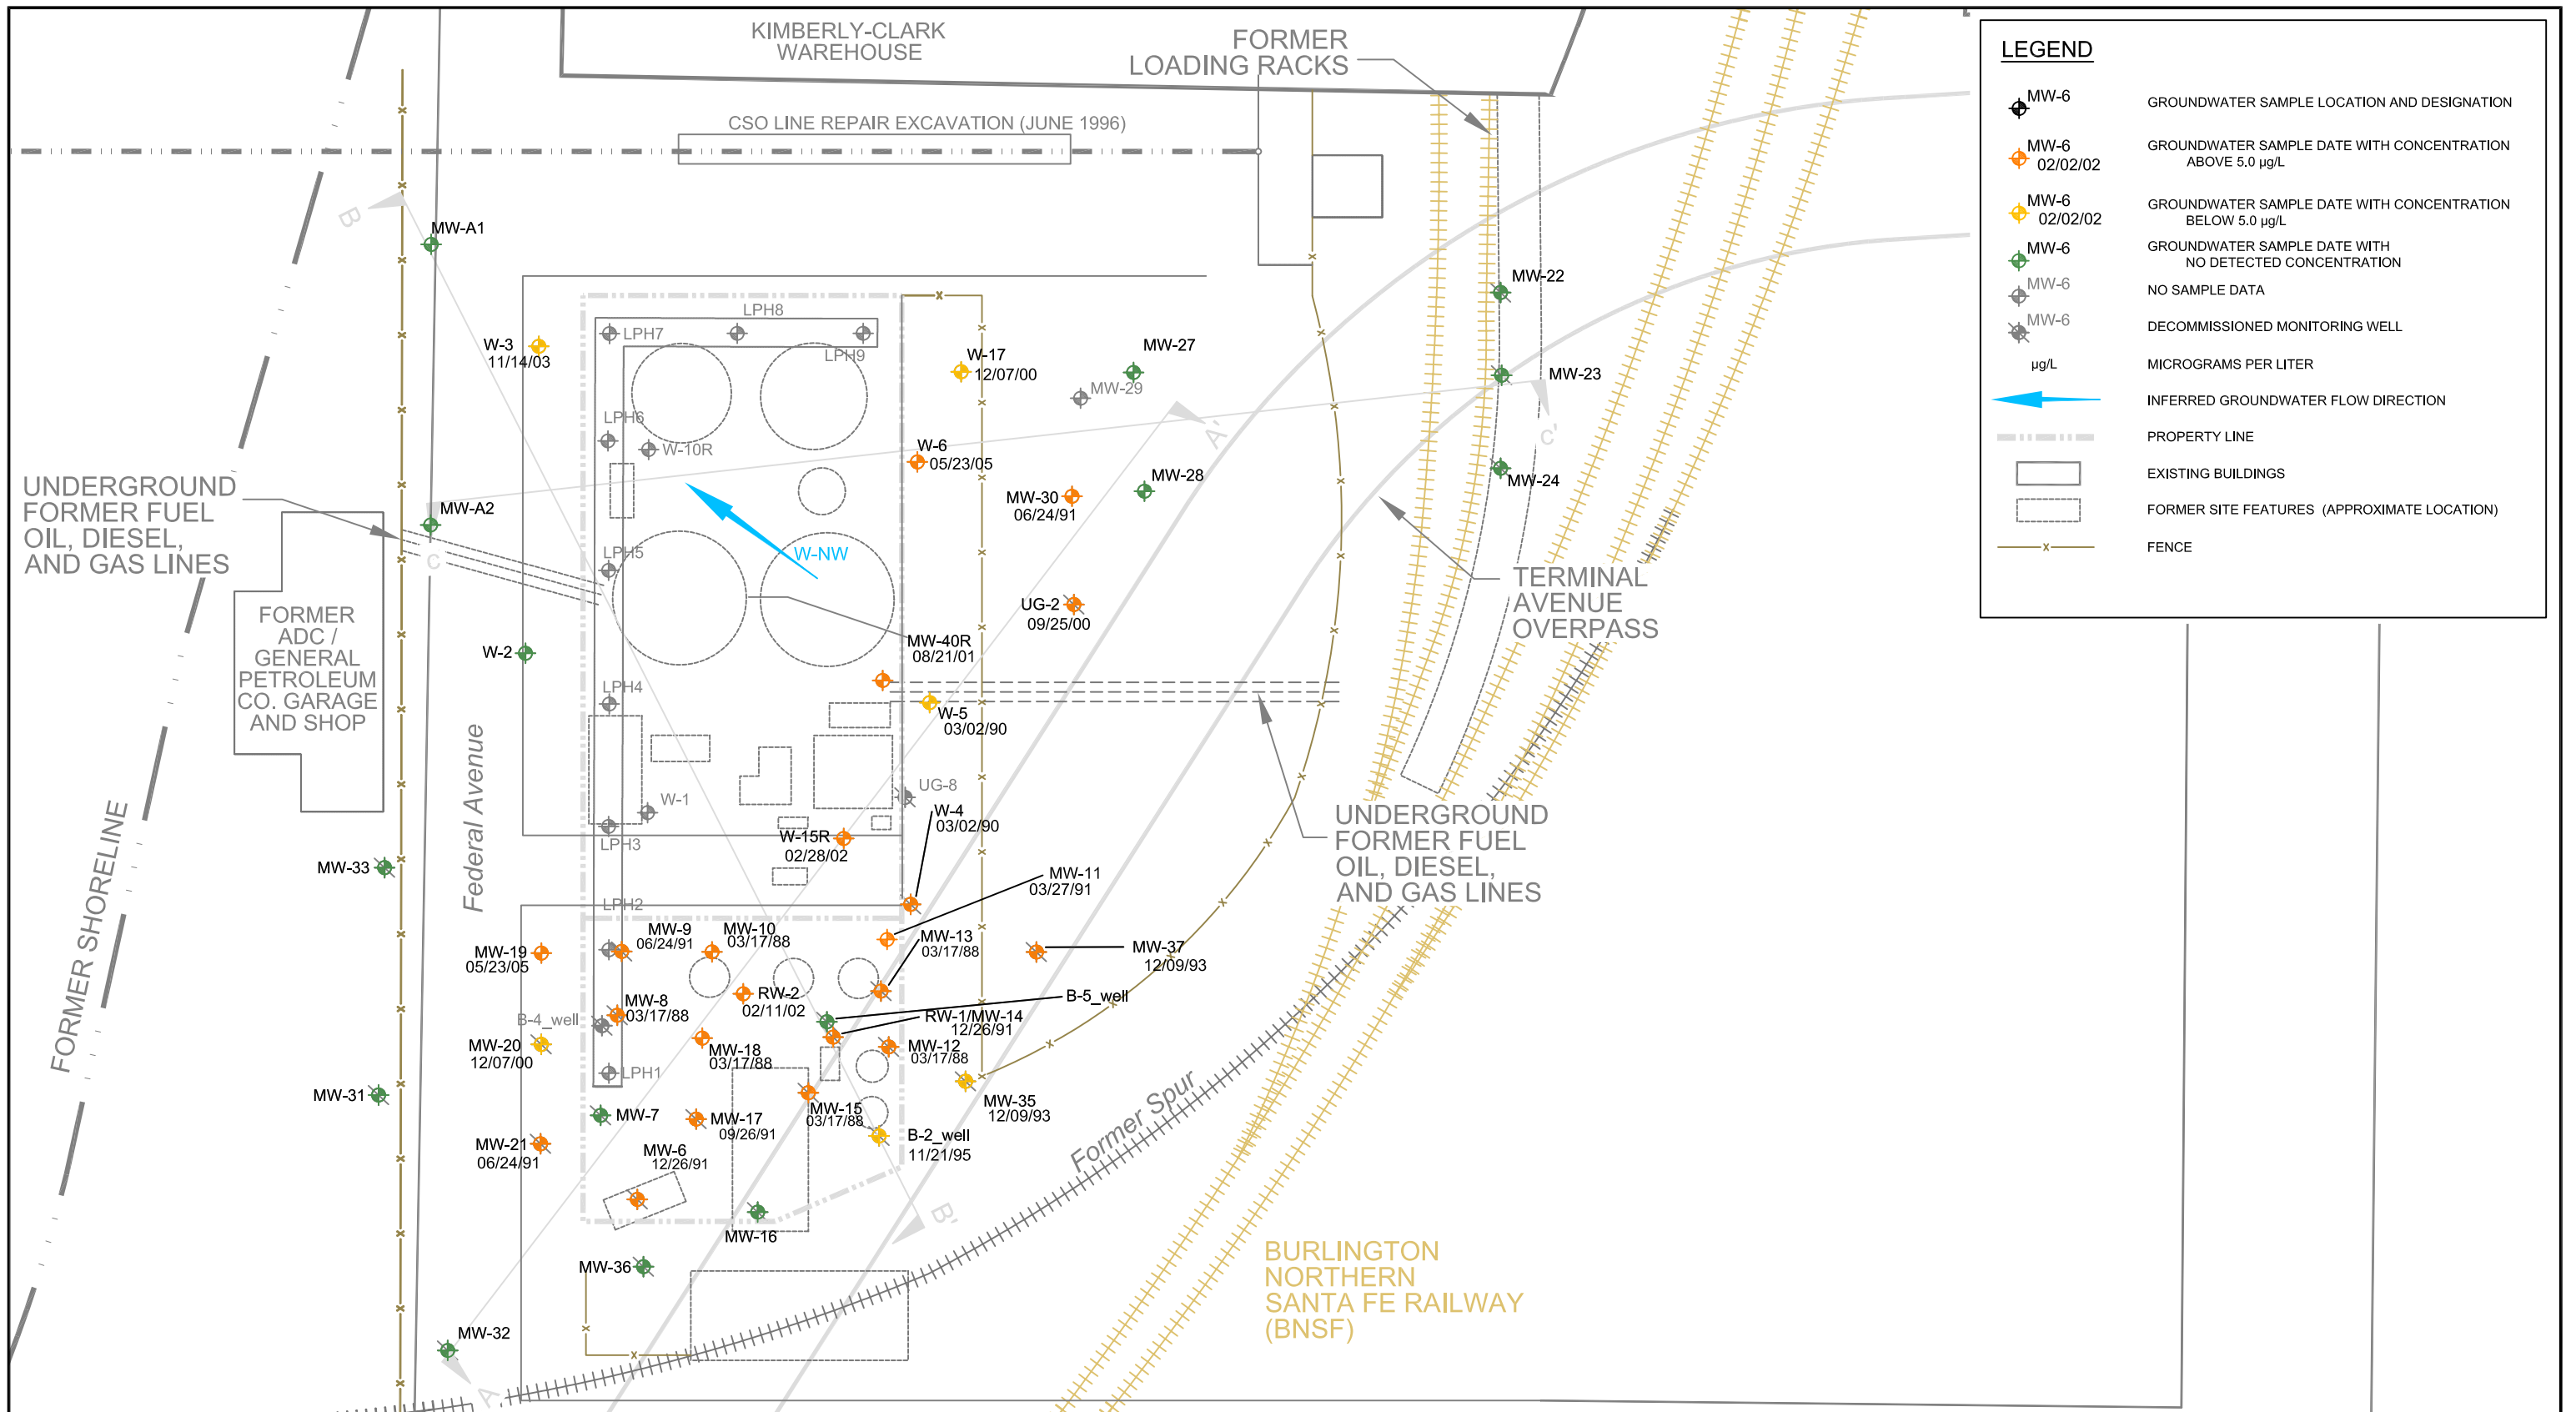
DATE:
 AUGUST 2009
 PROJECT NO:
 9-915-15716-C
 REV. NO.:
 1
 FIGURE No.
 46

PROJECT
**EXXONMOBIL/ADC PROPERTY
 ECOLOGY SITE ID 2728**
 TITLE
**HISTORICAL DISTRIBUTION OF
 BENZENE IN GROUNDWATER
 MAXIMUM DETECTED VALUE**

- Benzene has been detected in groundwater samples collected on- and off-Property at concentrations above the MTCA Method A cleanup levels (Figure 46). Therefore, benzene was selected as an indicator hazardous substance. Toluene, ethylbenzene, and total xylenes have also been detected in groundwater samples collected on- and off-Property (Figures 47, 48, and 49, respectively). No samples contained toluene and ethylbenzene at concentrations above the Method A cleanup levels (Figures 47 and 48). Only two samples collected from MW-15 and MW-18 in 1988 contained total xylenes at concentrations exceeding the MTCA Method A cleanup level (Figure 49). Since toluene, ethylbenzene, and total xylenes are not exceeding Method A unrestricted cleanup levels, with the exception of total xylene detections reported in two samples in 1988, those constituents in groundwater do not pose a risk to humans. None of these constituents was selected as an indicator hazardous substance.

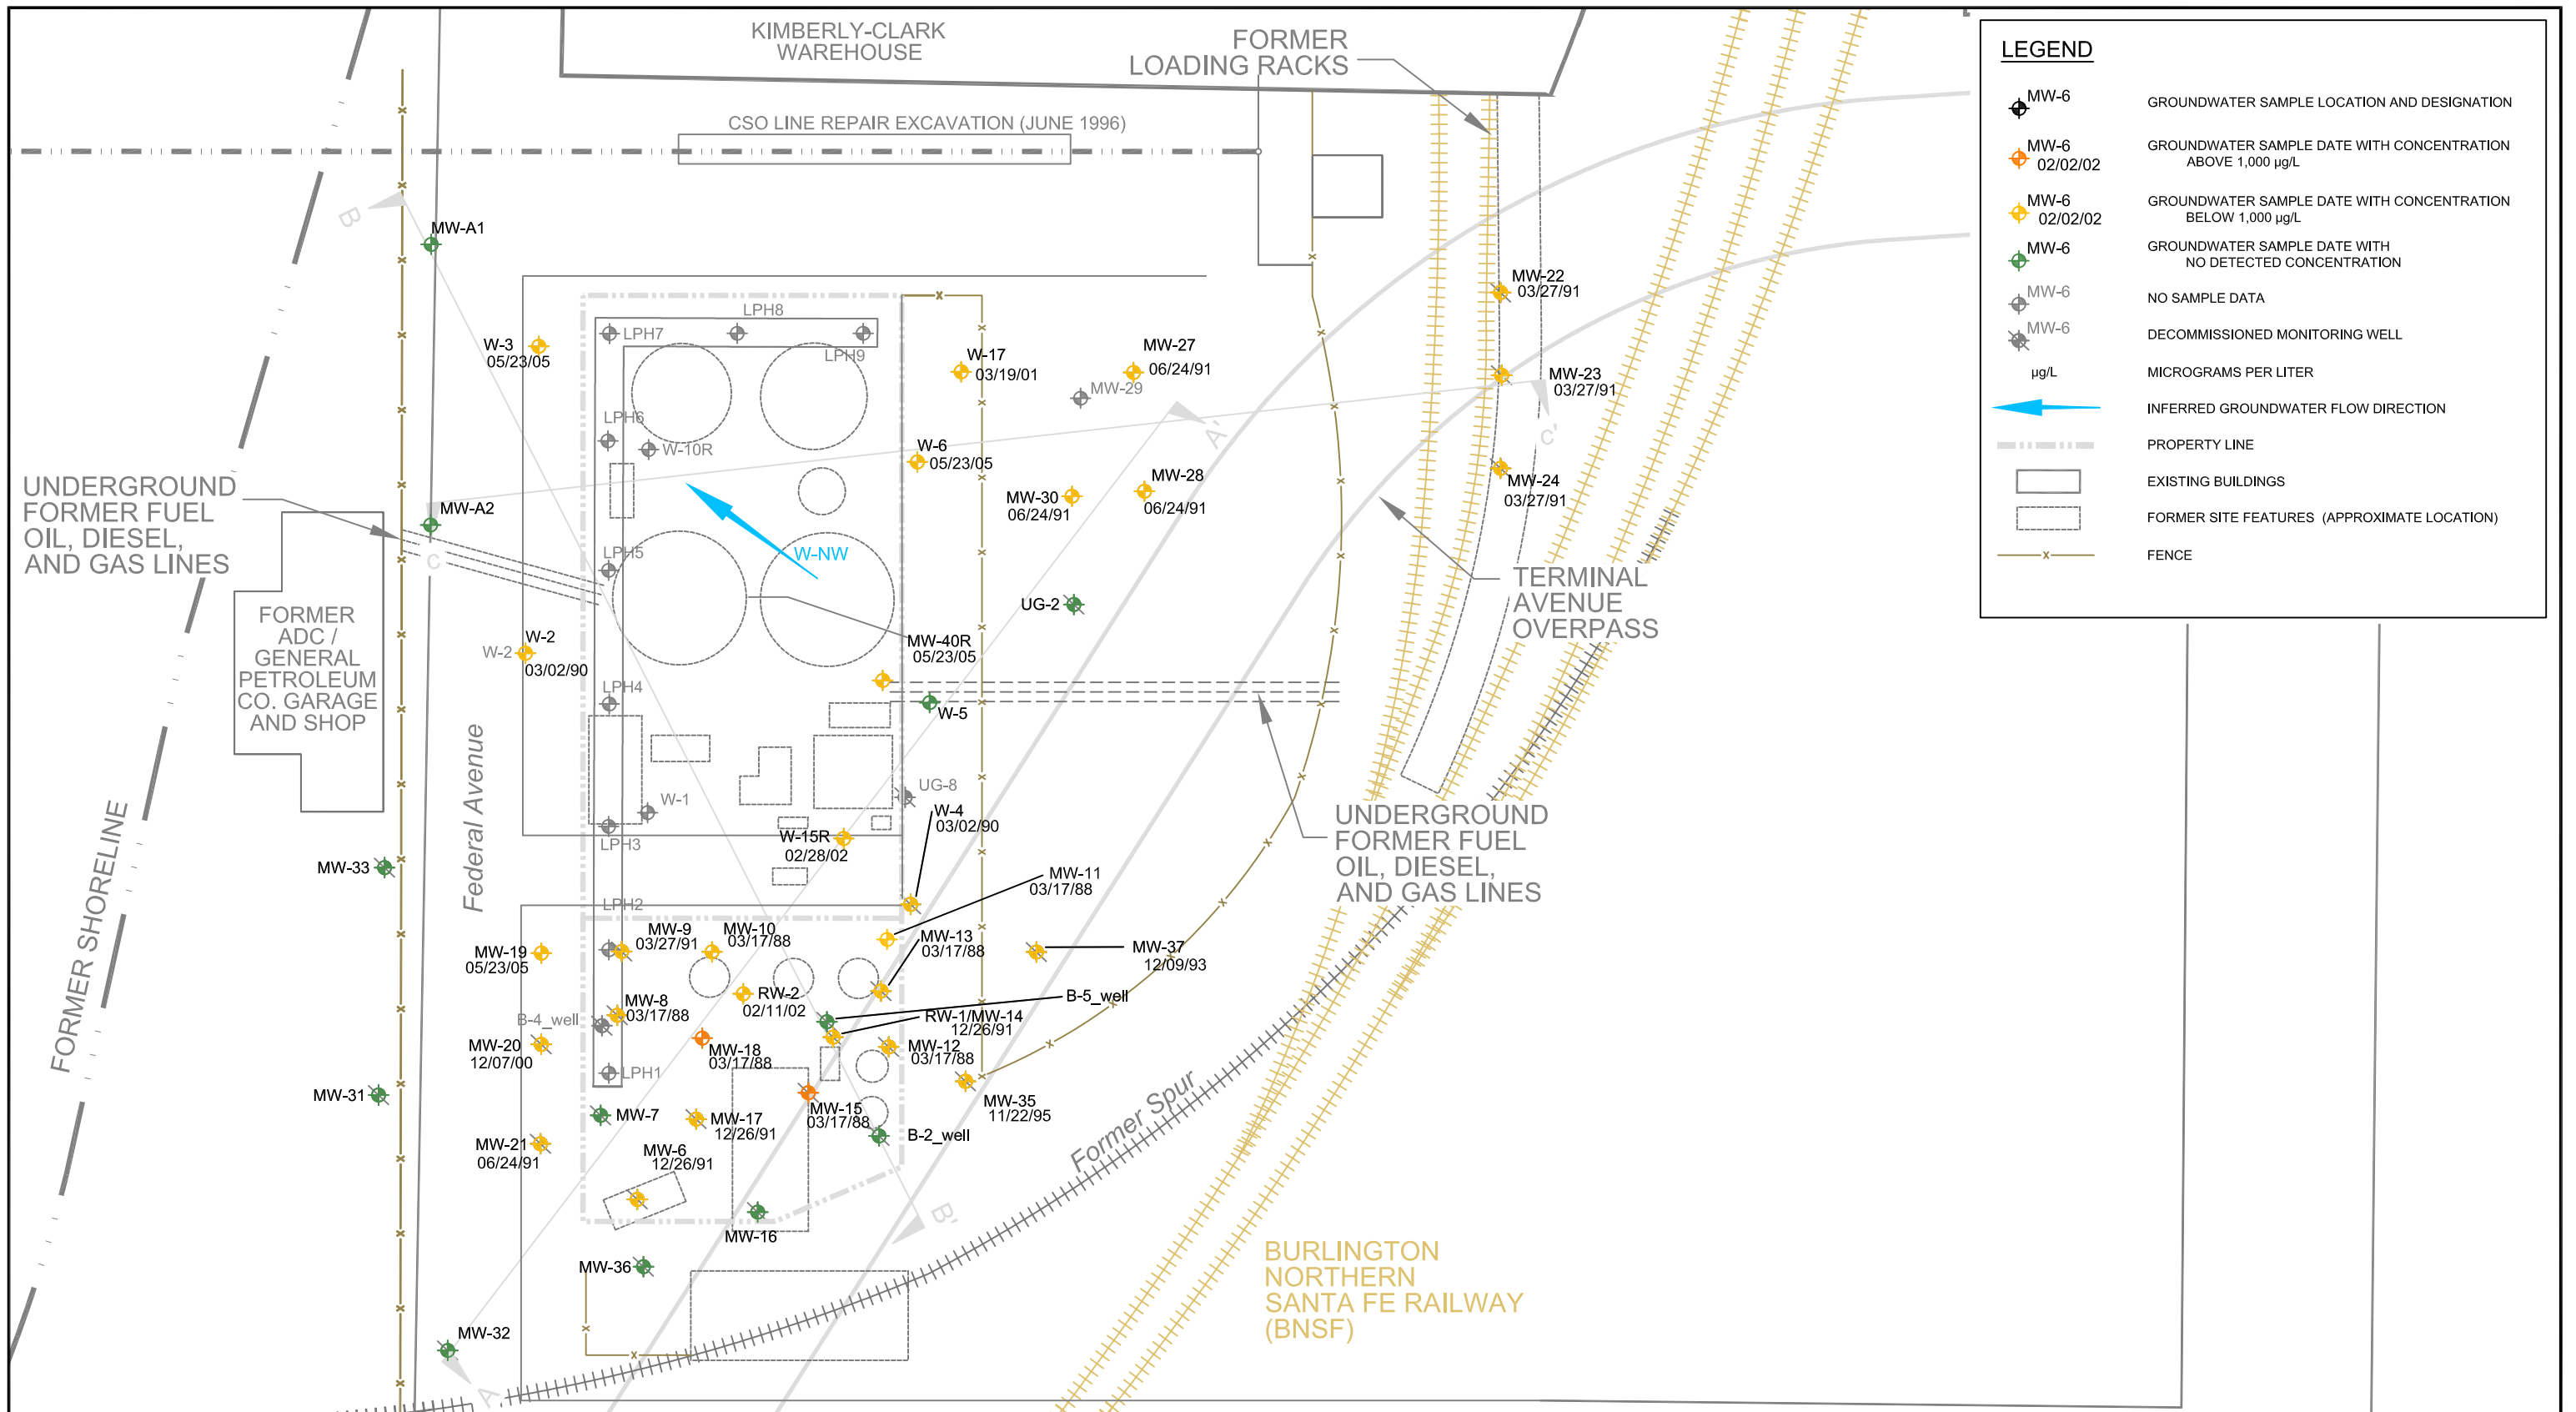
DATE: AUGUST 2009
PROJECT NO: 9-915-15716-C
REV. NO.: 1
FIGURE No. 49

**HISTORICAL DISTRIBUTION OF
TOTAL XYLENE IN GROUNDWATER
MAXIMUM DETECTED VALUE**

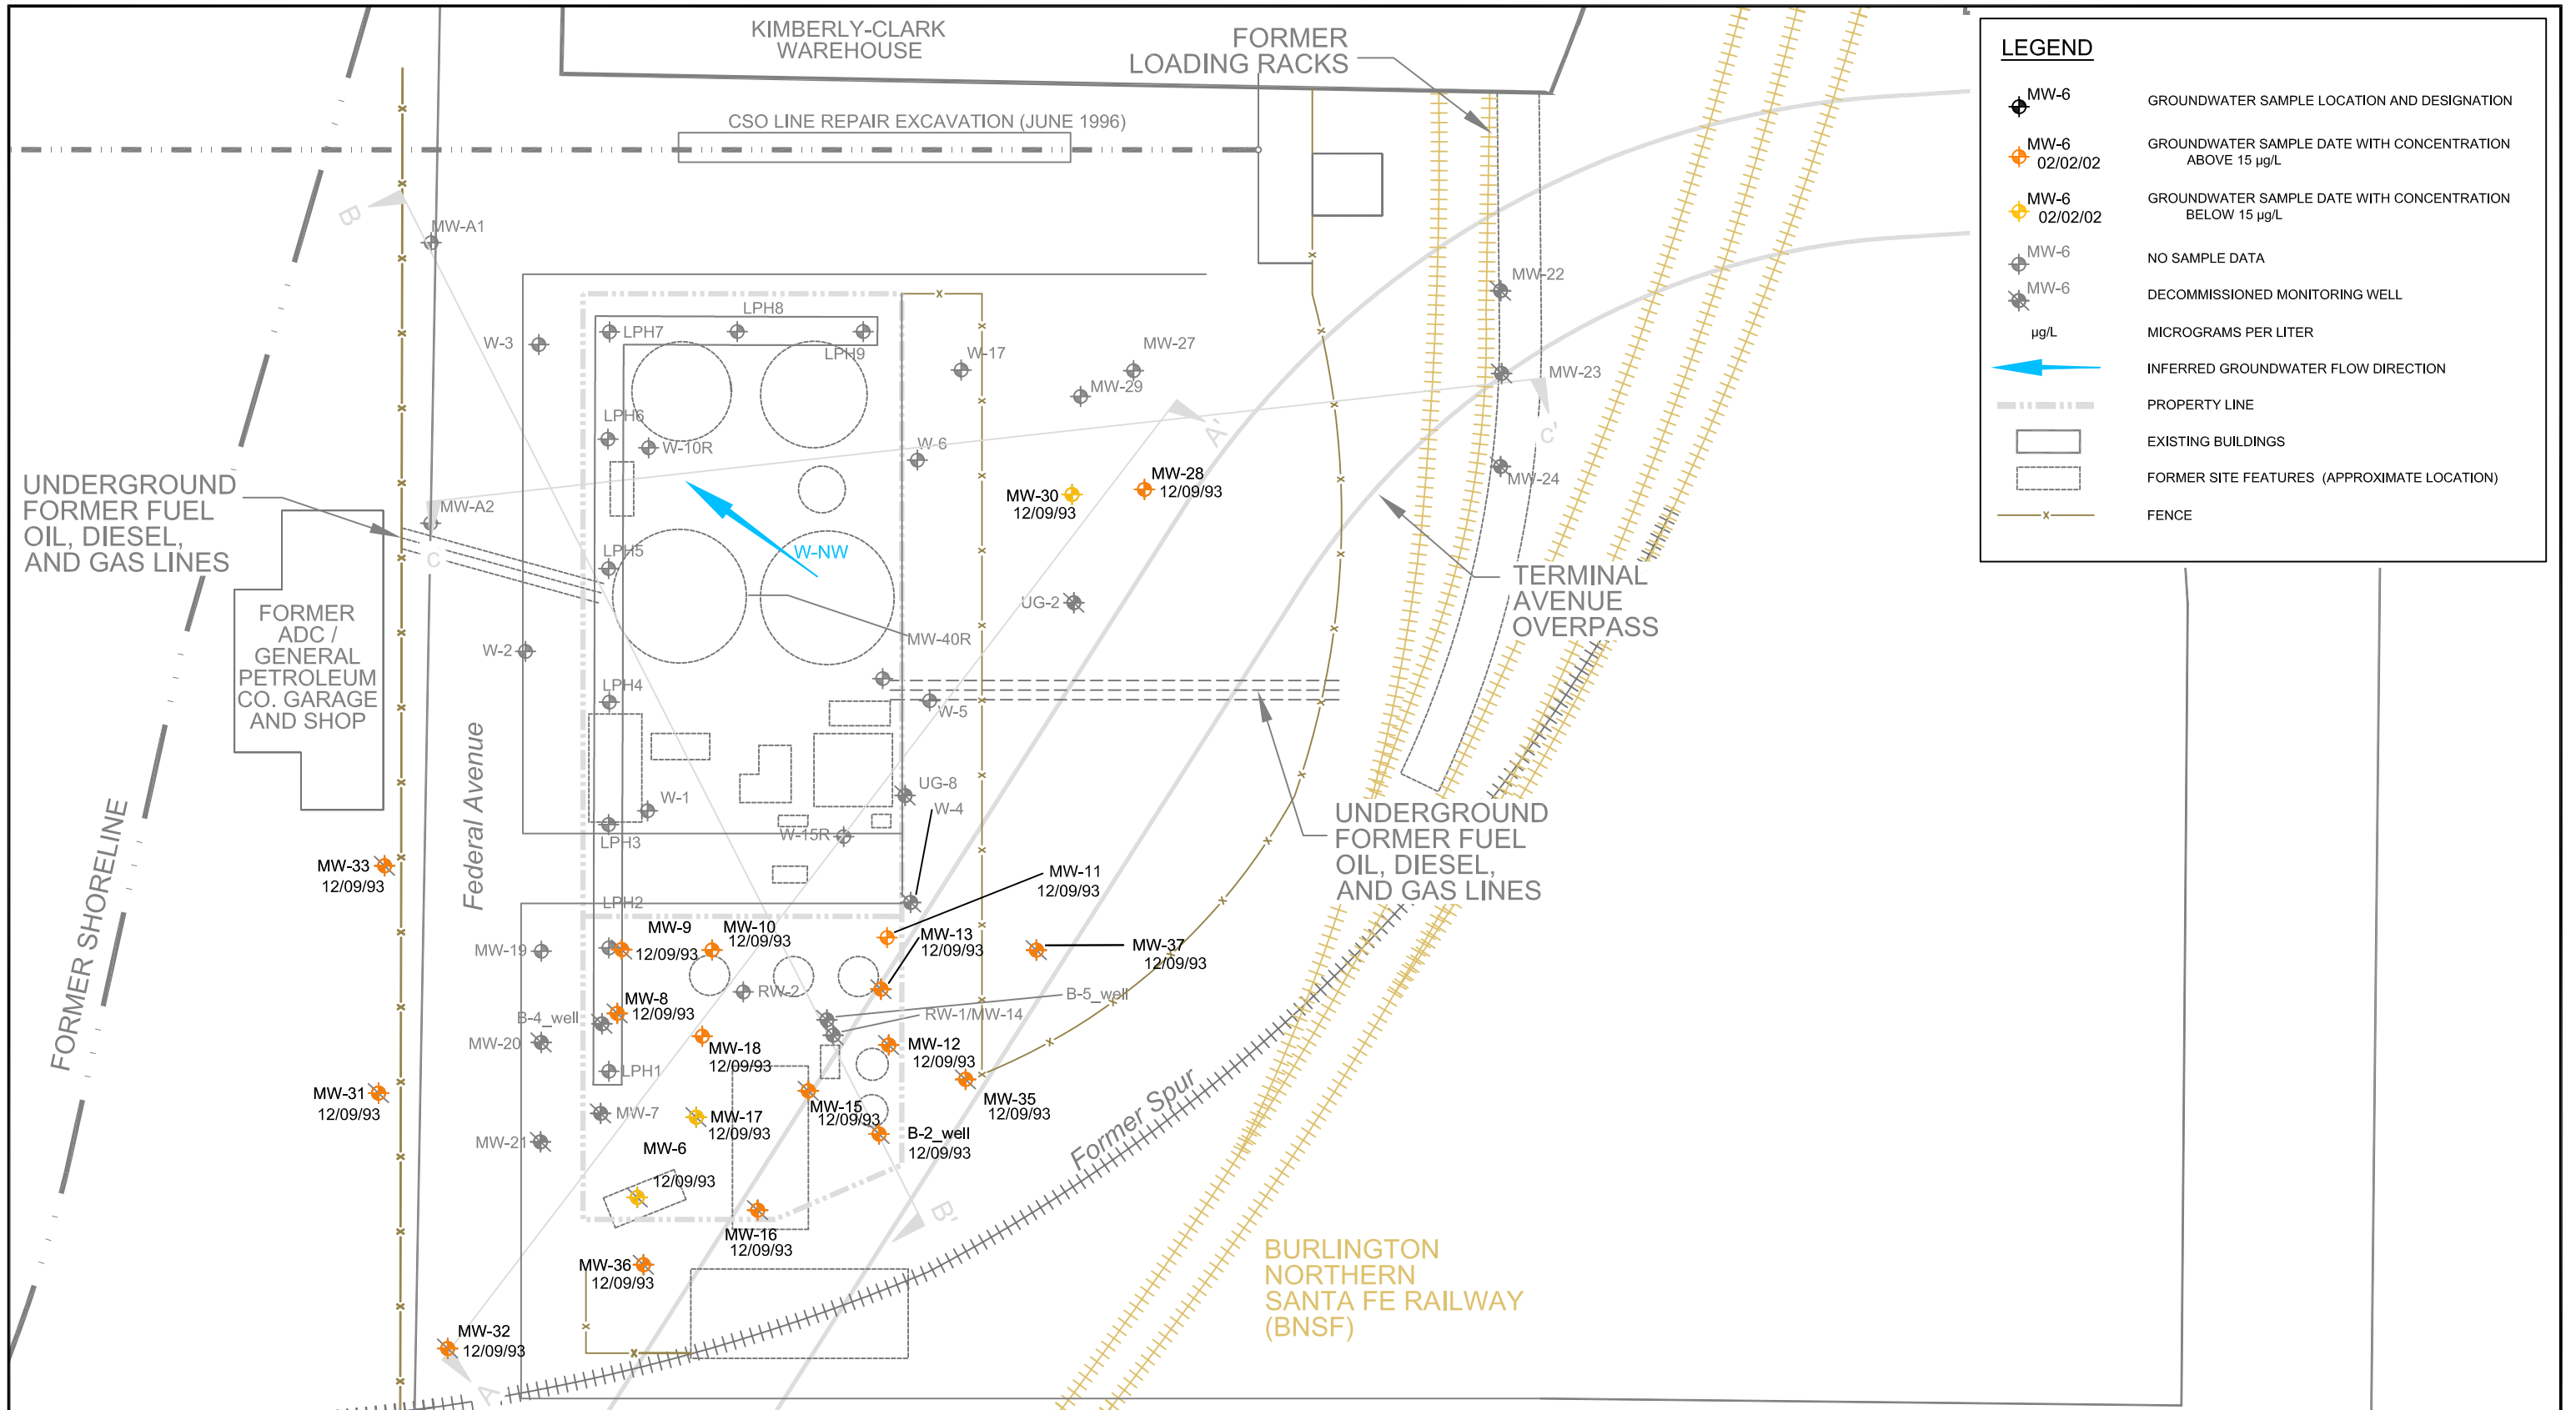
DATE: AUGUST 2009
PROJECT NO: 9-915-15716-C
REV. NO.: 1
FIGURE No. 50

**HISTORICAL DISTRIBUTION OF
TOTAL LEAD IN GROUNDWATER
MAXIMUM DETECTED VALUE**

- Total lead has been detected at concentrations above the MTCA Method A cleanup level in groundwater samples collected at the Site (Figure 50). Increased turbidity in groundwater samples may be attributed to soil lithology, increased organic content, screen size, and/or purging. High concentrations of total lead occurring in groundwater samples at the Site are most likely due to increased organic content in the formation being sampled. Due to the high turbidity of groundwater samples, total lead results in groundwater are not representative of groundwater quality due to the contribution of lead contained in suspended sediment. Dissolved lead has not been detected at concentrations above the MTCA Method A cleanup level in groundwater samples collected at the Site (Figure 51). Therefore, lead was not selected as an indicator hazardous substance.

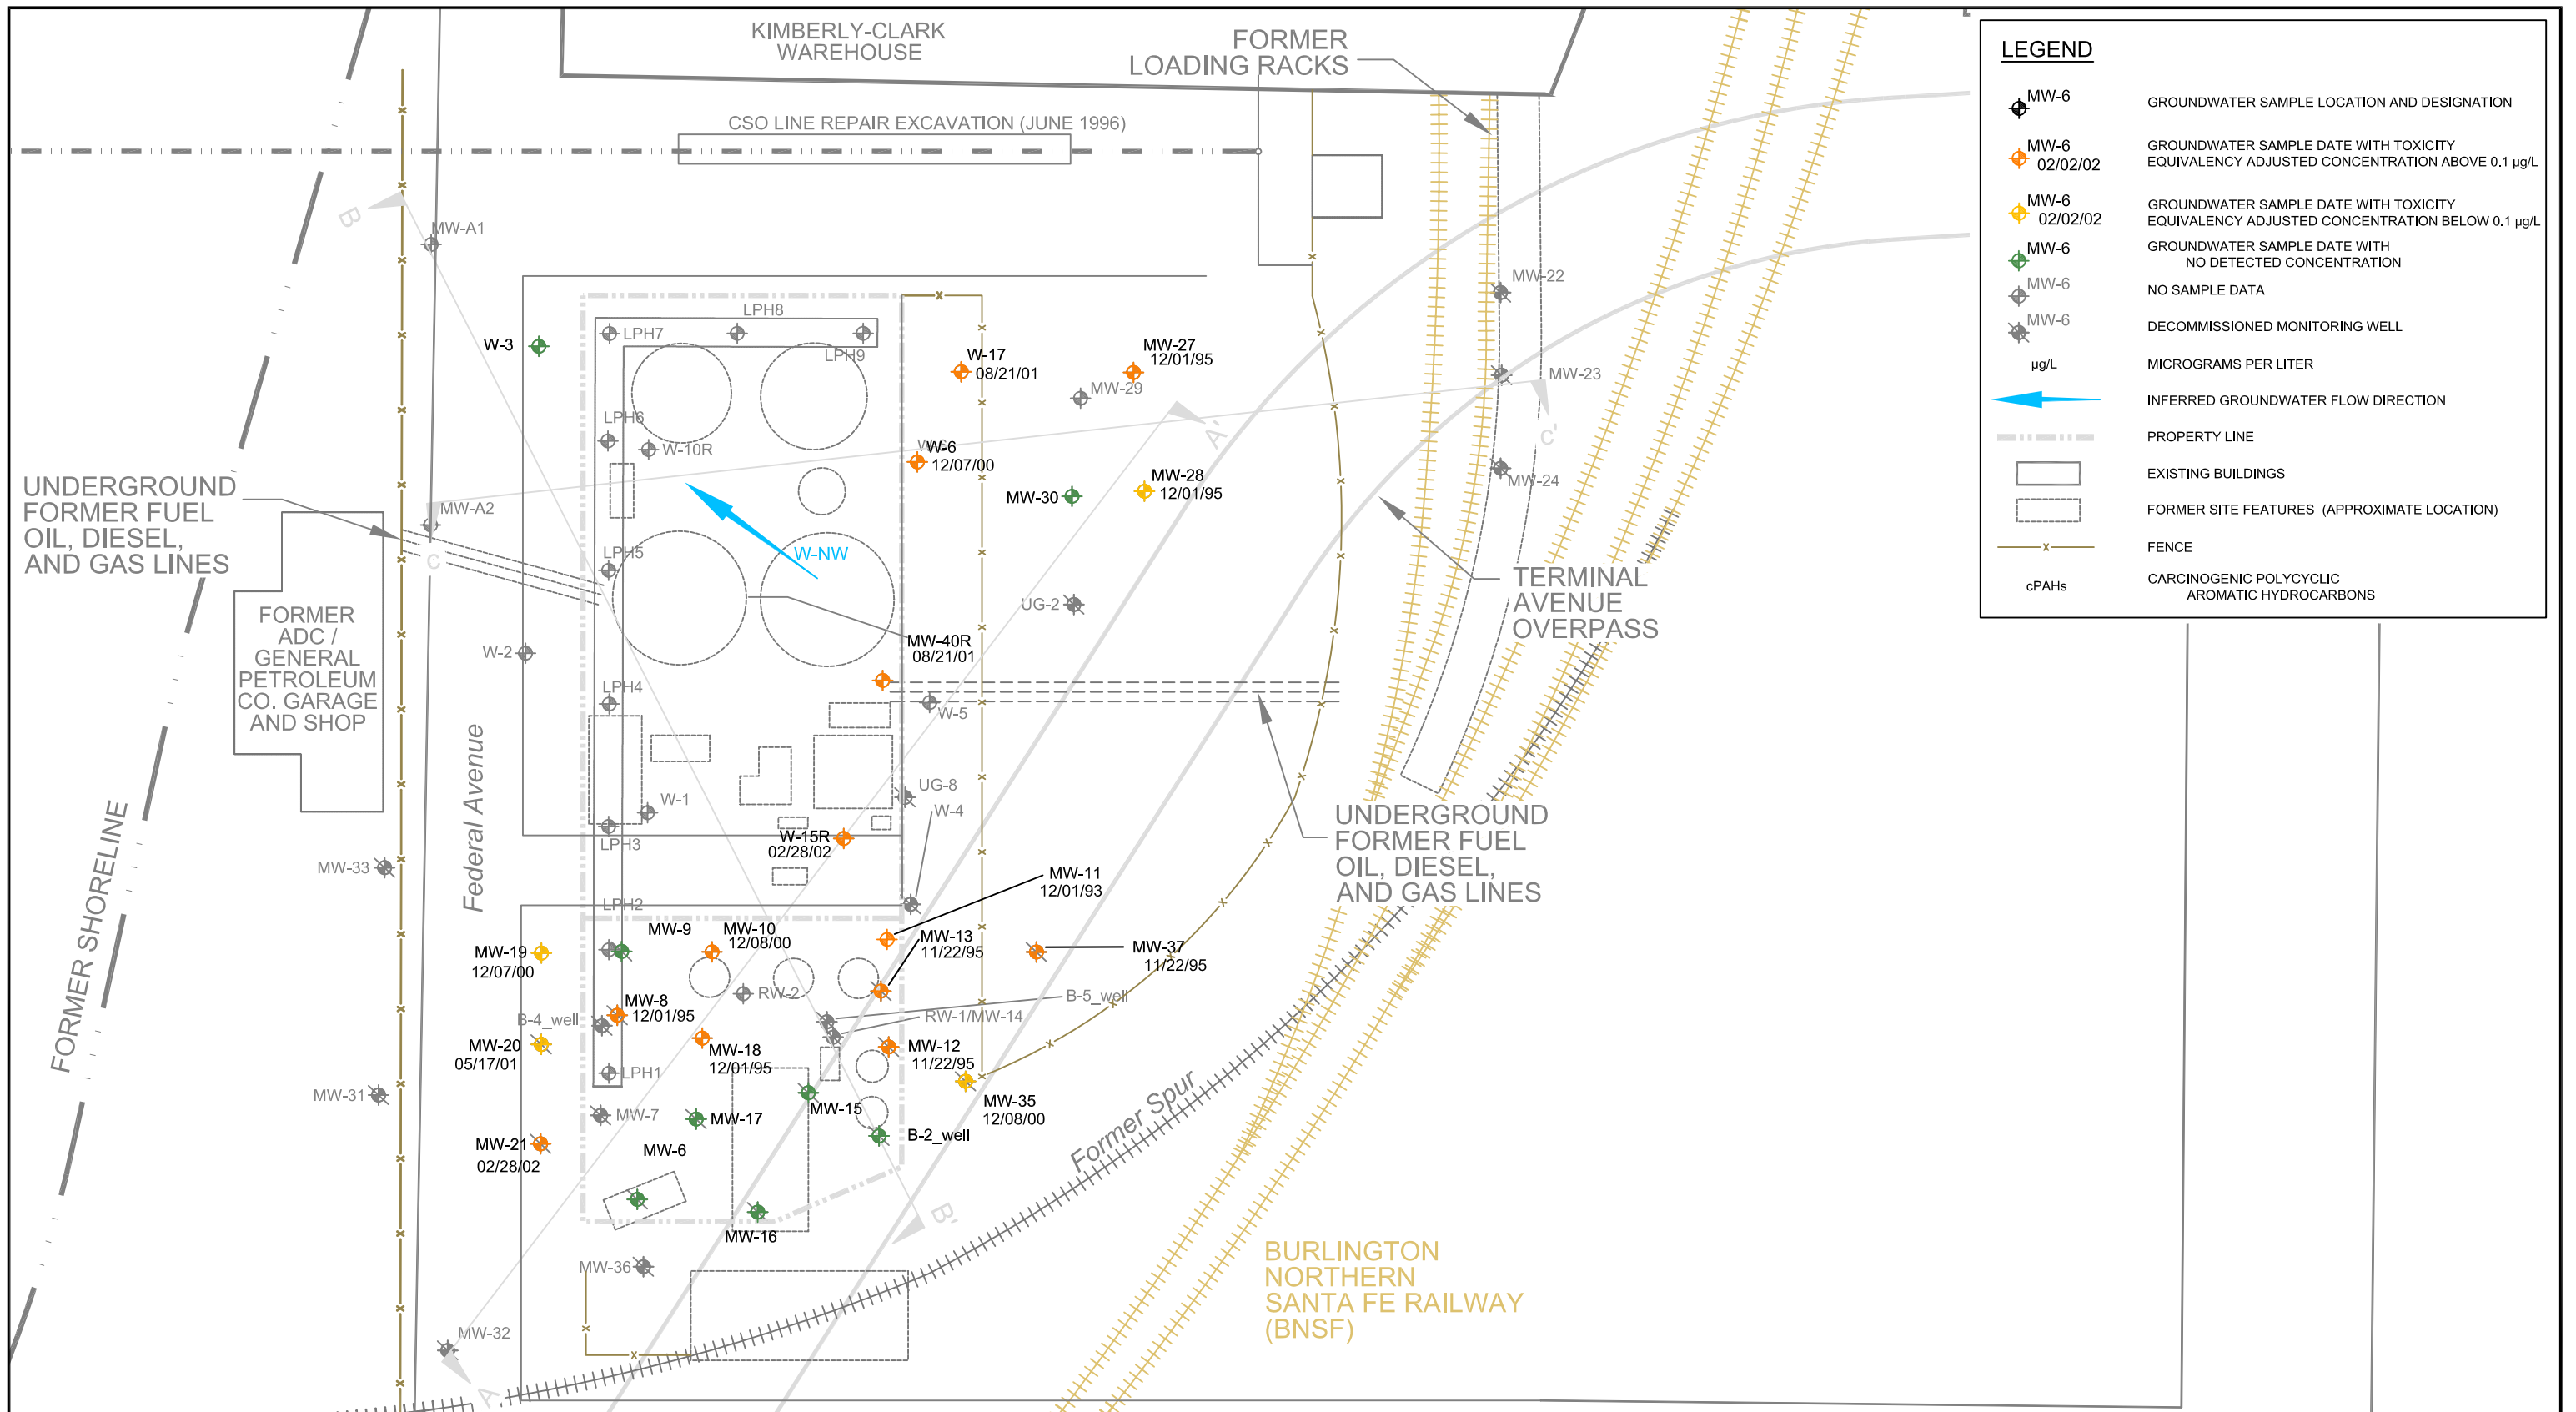
| | | EXXONMOBIL AND AMERICAN DISTRIBUTING COMPANY AMEC Earth & Environmental 11810 North Creek Parkway North Bothell, WA, U.S.A. 98011-8201 | TITLE: HISTORICAL DISTRIBUTION OF TOXICITY EQUIVALENCY ADJUSTED TOTAL cPAHs IN GROUNDWATER, MAXIMUM DETECTED VALUE | REV. NO.: 1 FIGURE No. 52 | |

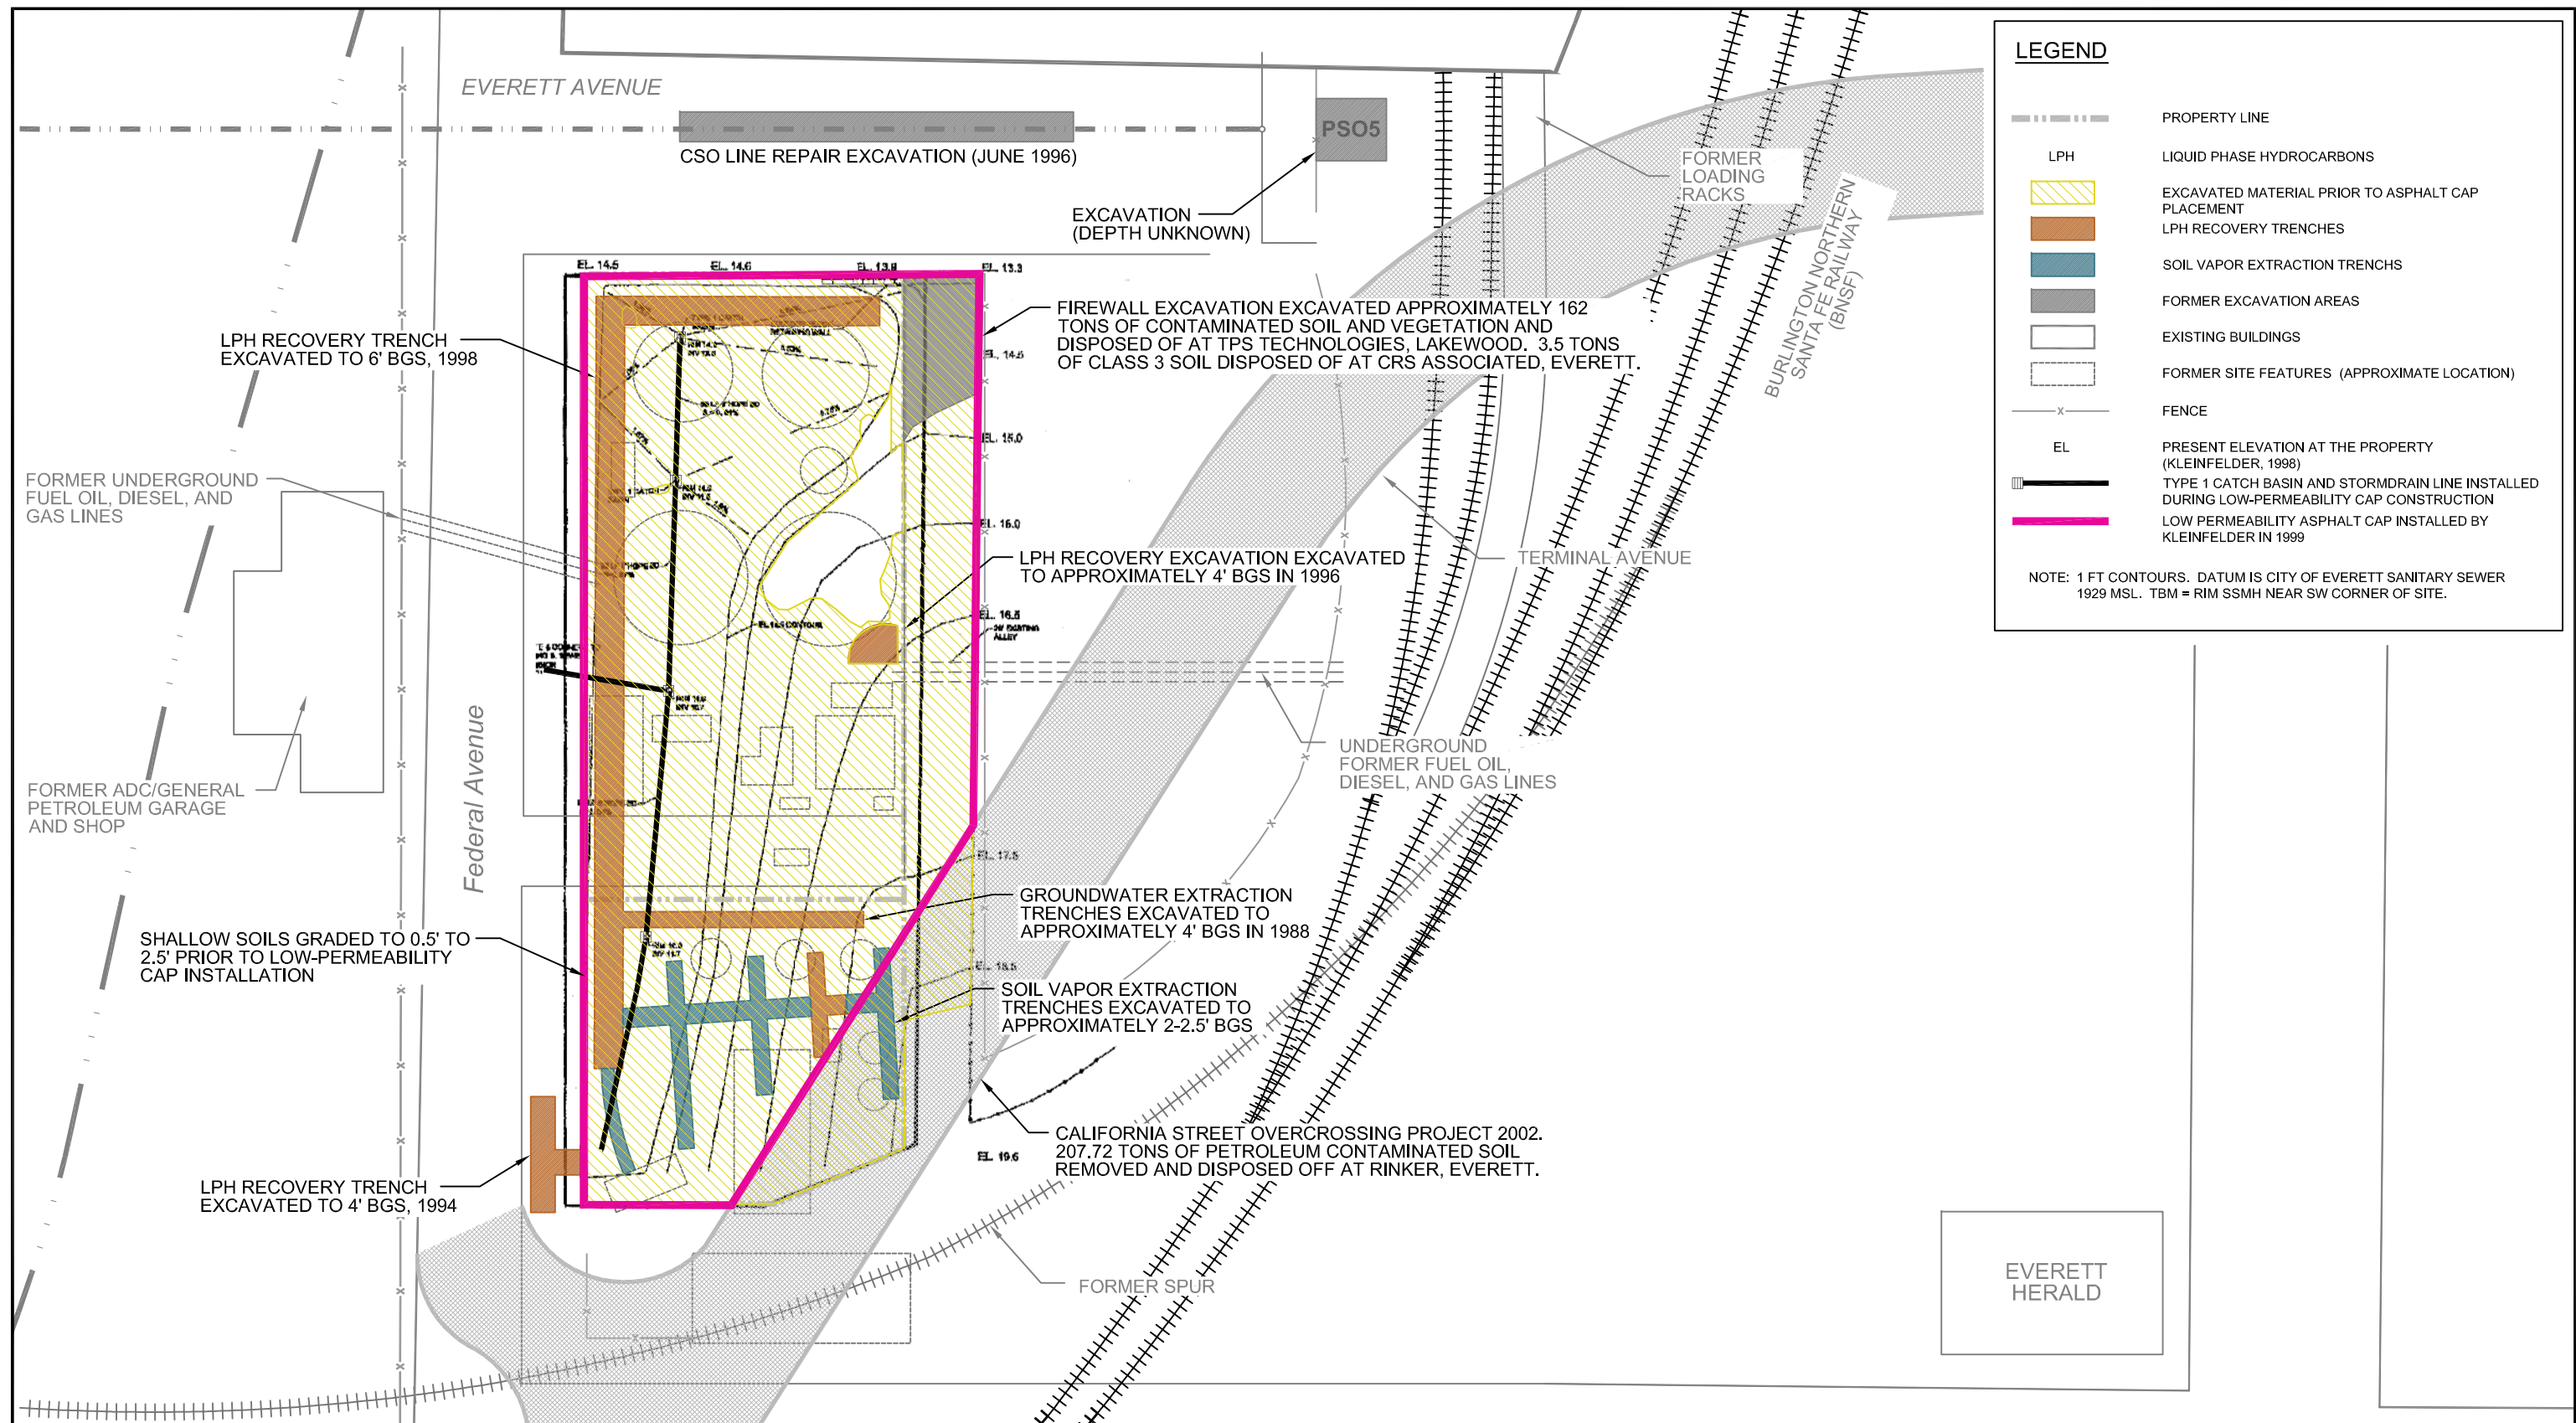
DATE: AUGUST 2009
PROJECT NO.: 9-915-15716-C
REV. NO.: 1
FIGURE No. 53

TITLE: HISTORICAL EXCAVATION LOCATIONS

Petroleum-affected soils along the overcrossing alignment extended from the west side of California Street to the center portion of the KC parking lot. The contamination was found to be present generally from 4 to 5 feet bgs. The petroleum-affected soils extended over an area of approximately 25,600 square feet and on average were approximately 8 feet thick. Thus, approximately 7,600 cubic yards of petroleum-contaminated soil was calculated to be present along the overcrossing alignment (URS, 2000a). In 2002, these soils were excavated and disposed of during CSTO construction project. According to weight tickets attached to e-mail from Shawn Severn (Premier) to Bill Joyce in 2002, 207.72 tons of contaminated soil associated with CSTO construction was excavated and disposed off at Rinker facility in Everett in 2002. Soil excavation areas are shown on Figure 53.

There are no secondary sources of contamination within the ExxonMobil Parcel due to extensive excavation activities on the Parcel and the surrounding properties to the west, east, and south (Figure 53).
