**STATE OF WASHINGTON
DEPARTMENT OF ECOLOGY**

AGREED ORDER for

**Focused Feasibility Study and Draft
Cleanup Action Plan – ExxonMobil ADC
Site**

No. DE **6184**

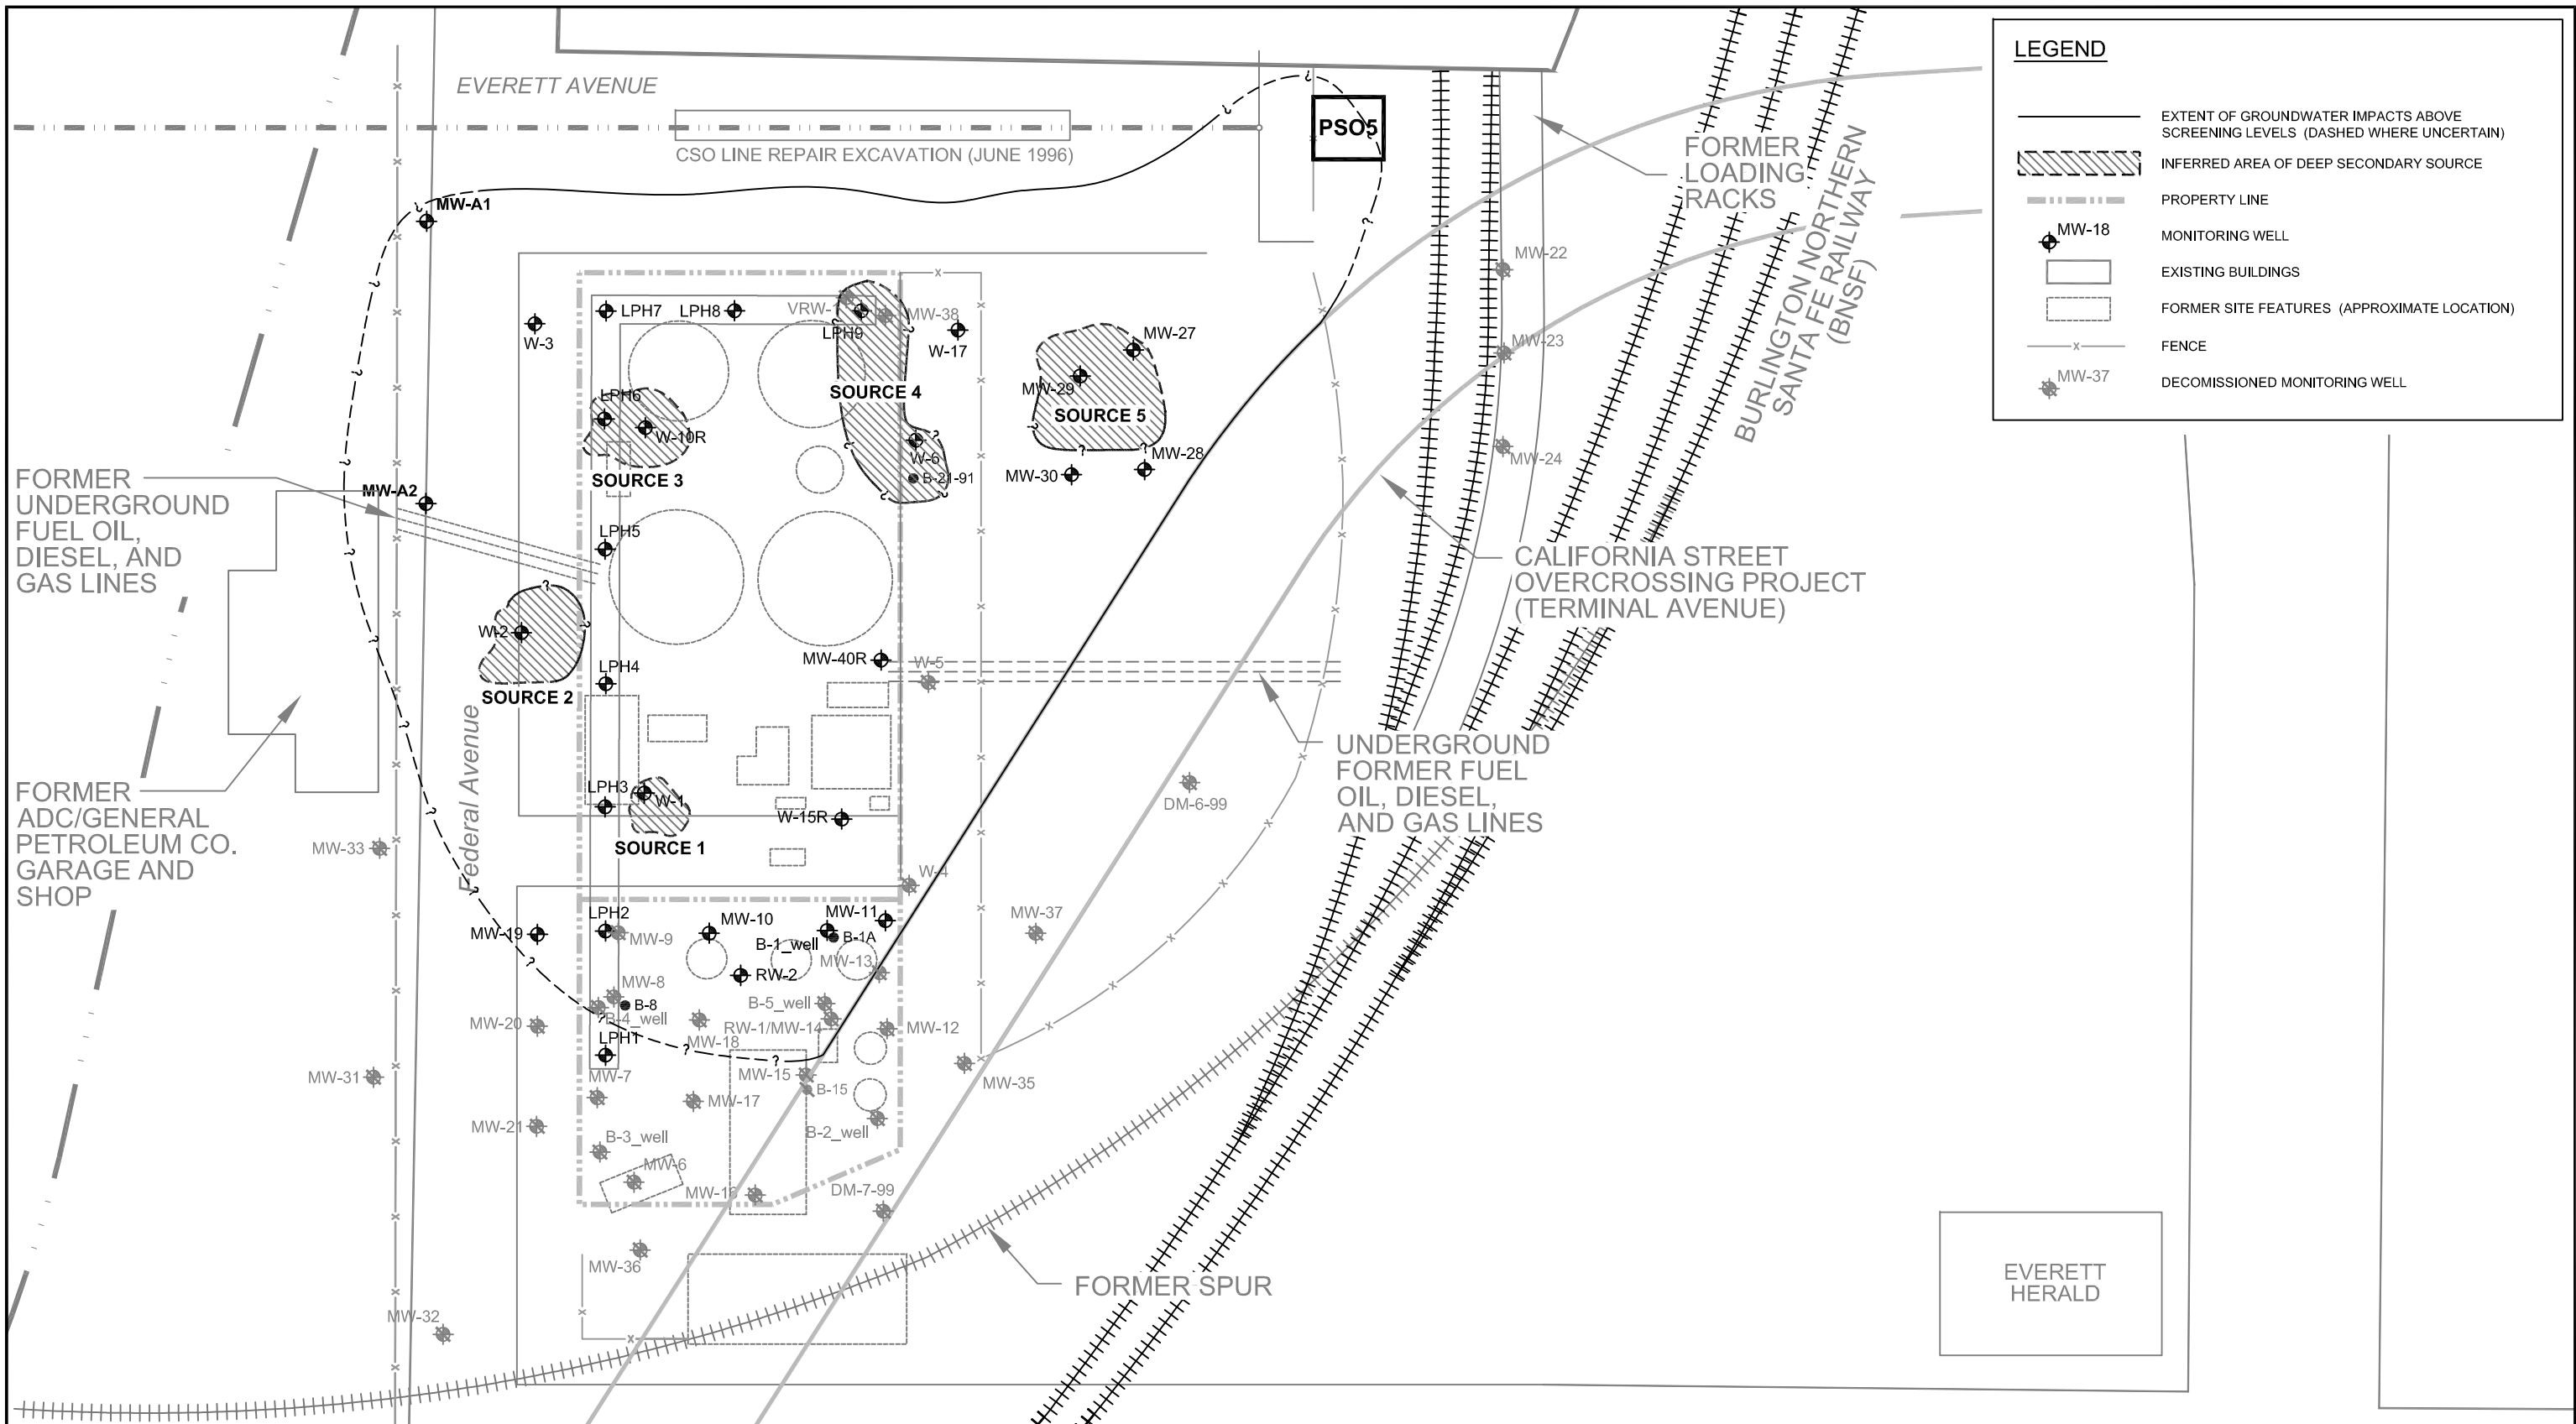
DATE: AUGUST 2009
PROJECT NO: 9-915-15716-C
REV. NO.: 1
FIGURE No. 54

| LEGEND | |
|---|---|
| | EXTENT OF GROUNDWATER IMPACTS ABOVE SCREENING LEVELS (DASHED WHERE UNCERTAIN) |

Presently, five discreet secondary source locations are identified based on the occurrence of free product. The secondary source areas are identified on Figure 54. These areas are vertically delineated based on the deepest occurrence of contaminated soil using the boring logs to determine wood waste containing hydrocarbons or other lithologies with strong odor and/or elevated analysis result.

Since the Property is capped, there are two potential transport mechanisms from soil—soil to groundwater, and soil to vapor. Leaching (including infiltration and percolation) can transport soil particles and solubilized constituents to groundwater. The primary area of concern on the site for transport of soil to groundwater is related to the secondary source areas (Figure 54).

An overview of the secondary source areas and the extent of groundwater impacted at concentrations above screening levels at the Site is presented in Figure 54. LPH is located primarily in the area northeast of the Property boundary in the vicinity of MW-27 and MW-29.

Five areas of affected soil and groundwater at the Site are illustrated on Figure 54. As detailed in Section 7.0, AMEC has identified certain data gaps to complete the FFS. These data gaps and the proposed supplemental field investigations to complete these data gaps are described below. The proposed field investigations are summarized on Figure 55.

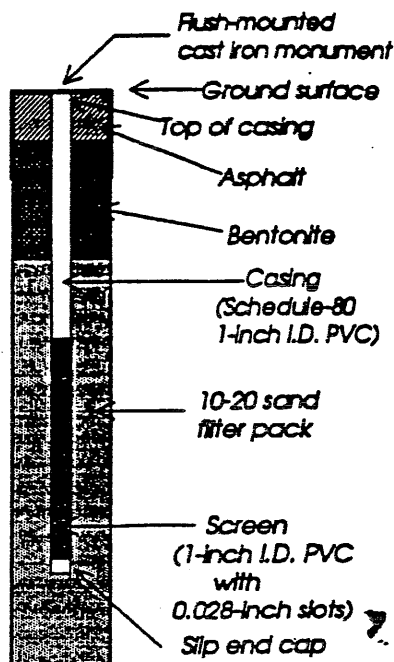
| DEPTH (feet) | SOIL DESCRIPTION | SAMPLE TYPE | SAMPLE NUMBER | BLOW COUNTS | OVM READING | GROUND WATER |
|---|---|---|---|---|---|---|
| | Fine to medium grained wood debris, petroleum odor, no LPH | | GP-6/ 6.0 | | | |
| 10 | Wood fragments saturated with very viscous LPH | | | | | |

Bottom of boring at 12 feet.

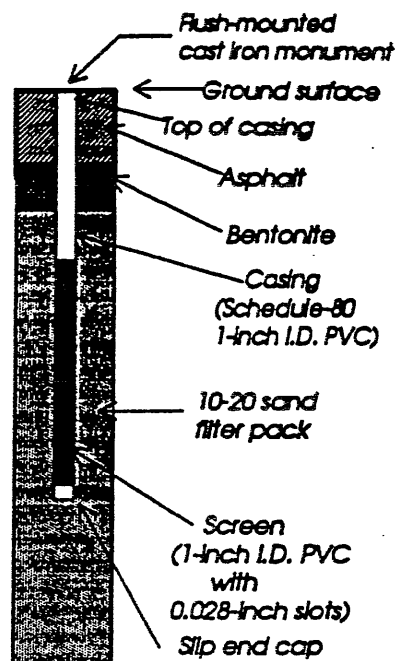
| DEPTH (feet) | SOIL DESCRIPTION | SAMPLE TYPE | SAMPLE NUMBER | BLOW COUNTS | QVM READING | GROUND WATER |
|---|--|---|---|---|---|---|
| | Wet to saturated, brown, silty, gravelly SAND, strong petroleum odor, minor LPH | | GP-11/ 8.0' | | 0.0 | |
| 10 | Saturated, black, fine SAND, trace petroleum odor | | GP-11/ 12.0' | | | |

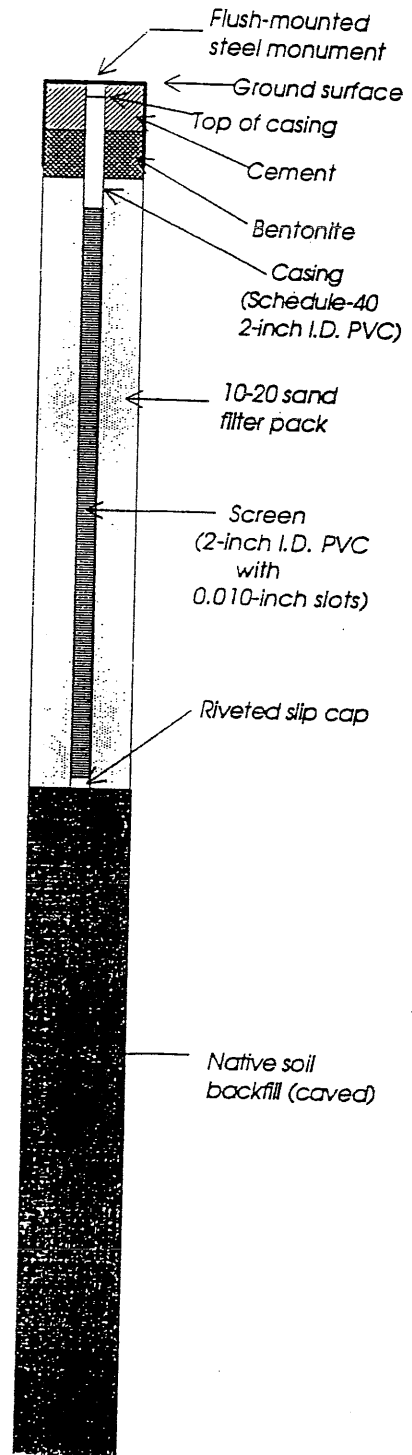
| DEPTH (feet) | SOIL DESCRIPTION | SAMPLE TYPE | SAMPLE NUMBER | BLOW COUNTS | OMV READING | GROUND WATER |
|---|--|---|---|---|---|---|
| 25 - 29 | Very stiff, saturated, brown, clayey SILT with organics (PEAT-Like) | | S-11 | 17 | 5 | |
| 30 | Bottom of boring at 29 feet. No unusual staining or petroleum-like odors observed. | | | | | |

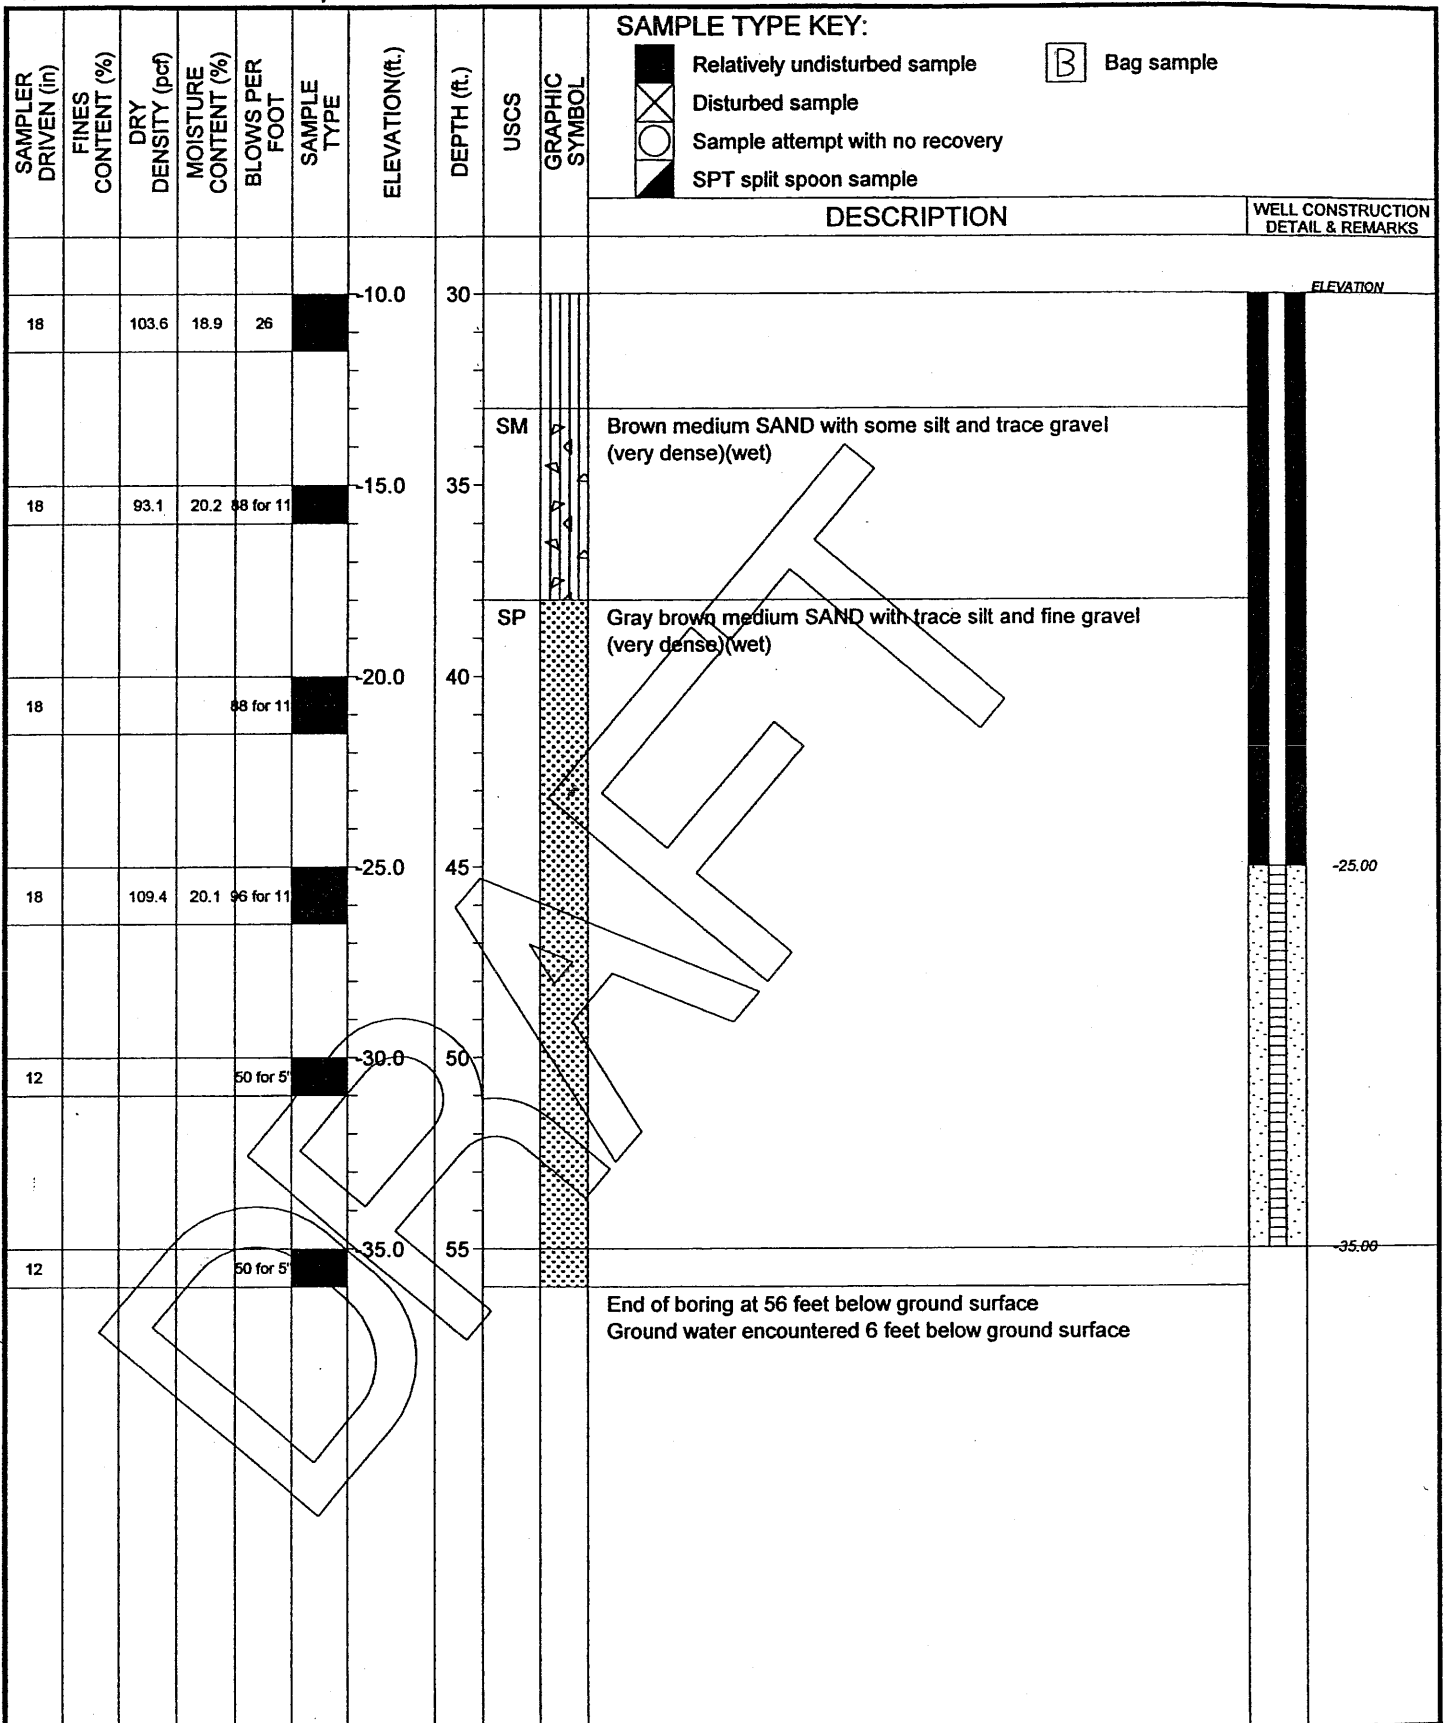
MONITORING WELL DM-6-99
 FIGURE A-8.1

- WELL SYMBOL KEY:**
- Bentonite grout
 - Bentonite plug
 - Filter Pack
 - Well screen
 - Concrete plug

NOTES: PID is a Photo Ionization Detector that detects the presence of volatile hydrocarbons

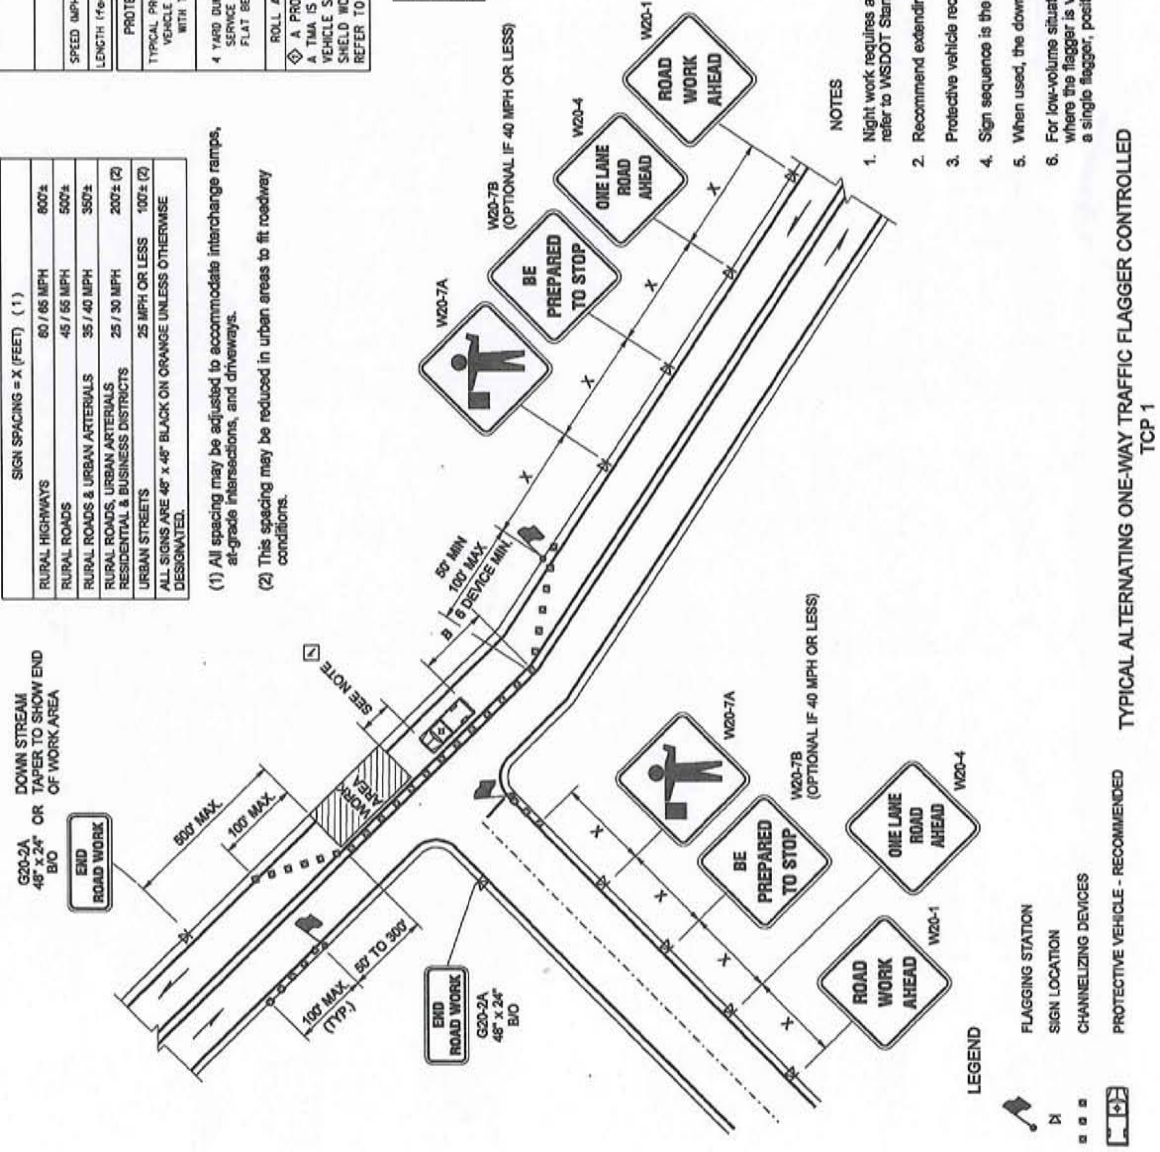
TYPICAL ALTERNATING ONE-WAY TRAFFIC FLAGGER CONTROLLED TCP 1

- NOTES**
- Night work requires additional roadway lighting at flagging stations, refer to WSDOT Standard Specifications for additional details.
 - Recommend extending channelizing device taper across shoulder.
 - Protective vehicle recommended - may be a work vehicle.
 - Sign sequence is the same for both directions of travel on the roadway.
 - When used, the downstream taper device spacing should be 20' O.C.
 - For low-volume situations with short work zones on straight roadways where the flagger is visible to road users approaching from both directions, a single flagger, positioned to be visible from both directions may be used.

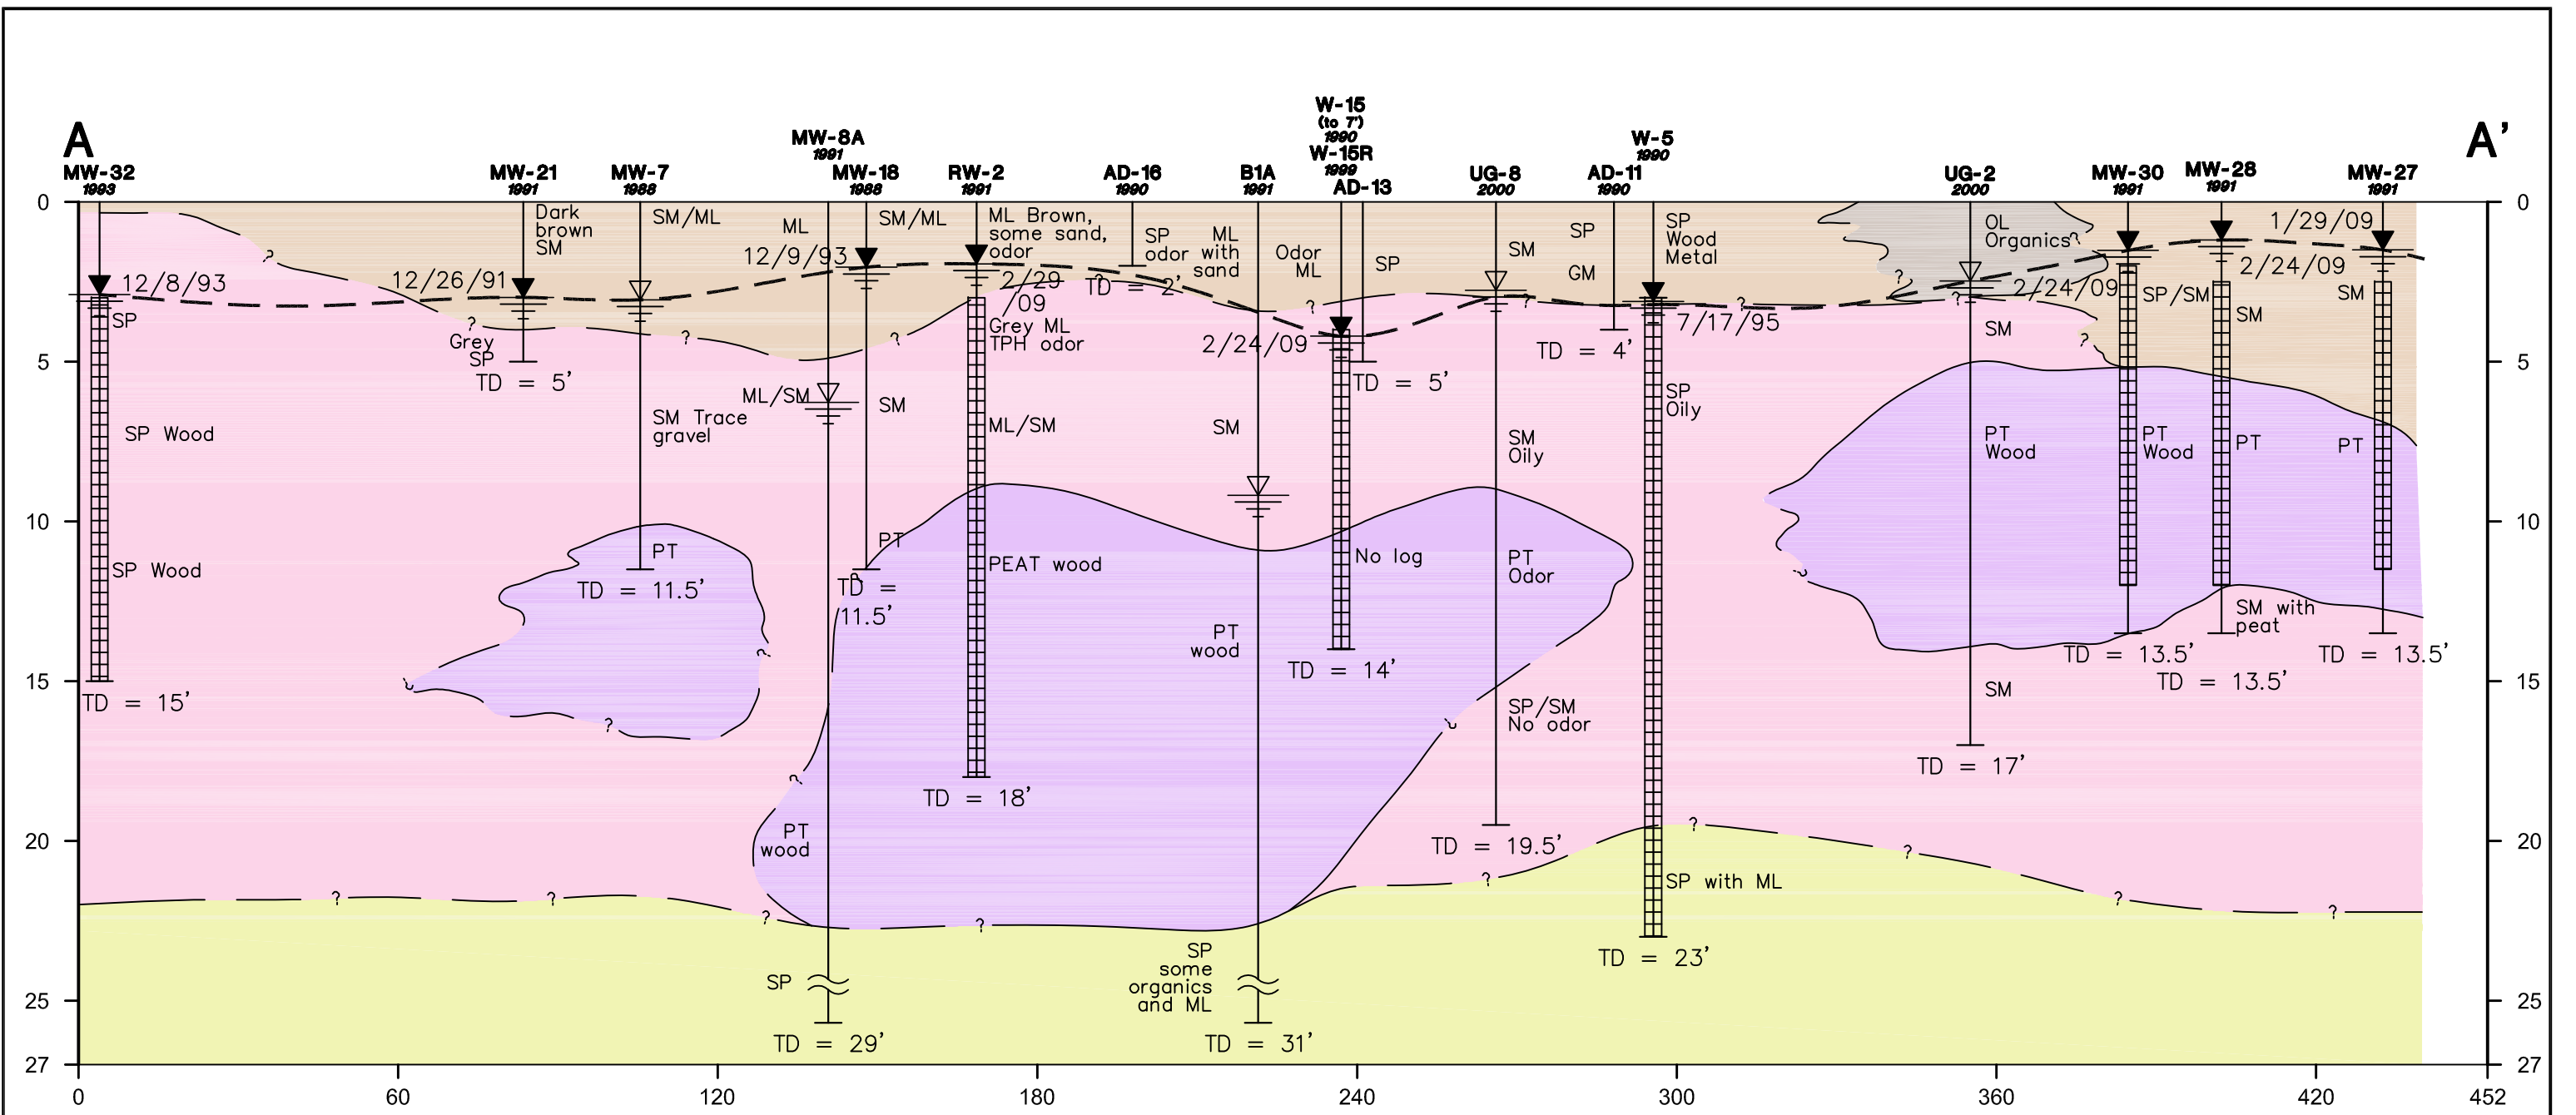
| FIGURE No. 15 |

| Figure 15 | Historical Explorations and Locations of Geologic Cross Sections A–A', B–B', and C–C' |

Soil boring, monitoring well, and test pit logs are compiled in Appendix C. The stratigraphy underlying the Site is displayed on geologic cross-sections A-A', B-B', and C-C', which are presented on Figures 16 through 18, respectively. The locations of the cross-sections are shown on Figure 15.

In July 2008, on behalf of the City of Everett Utilities Department, Floyd | Snider collected soil and water samples from an excavation at the CSO Puget Sound Outfall 5 (PSO 5) Overflow Structure (Figure 15). The overflow structure was built to control overflows from the CSO into Puget Sound. The project was located to the north-northeast of the Property. Water samples were analyzed during excavation dewatering to verify that water discharged to the City sewer system met the requirements of the City's industrial pretreatment requirements. Soil samples were collected to characterize soils for disposal. Soil samples were screened in the field. Soil samples that exhibited signs of contamination were not sampled, but instead disposed of under a Class III soil profile. Apparently clean soil samples were sampled per disposal specifications and disposed of as Class II soils. Appendix B contains the City of Everett's letter to Ecology and analytical data. The locations and depths of contaminated soil were not identified by Floyd | Snider or the City of Everett.

The general geology, based on the previous subsurface investigations conducted at the Property and its surroundings, is described in Section 2.4.2. Soil boring, monitoring well, and test pit logs are compiled in Appendix C. The stratigraphy underlying the Site is displayed on geologic cross-sections A-A', B-B', and C-C', which are presented on Figures 16 through 18, respectively. The locations of the cross sections are shown on Figure 15.

The thickness and continuation of the silt/clay layer was not completely assessed during previous subsurface investigations. Below is the list of deeper borings drilled in the area that encountered Quaternary-aged transitional beds in the borings. Boring locations are shown on Figure 15.

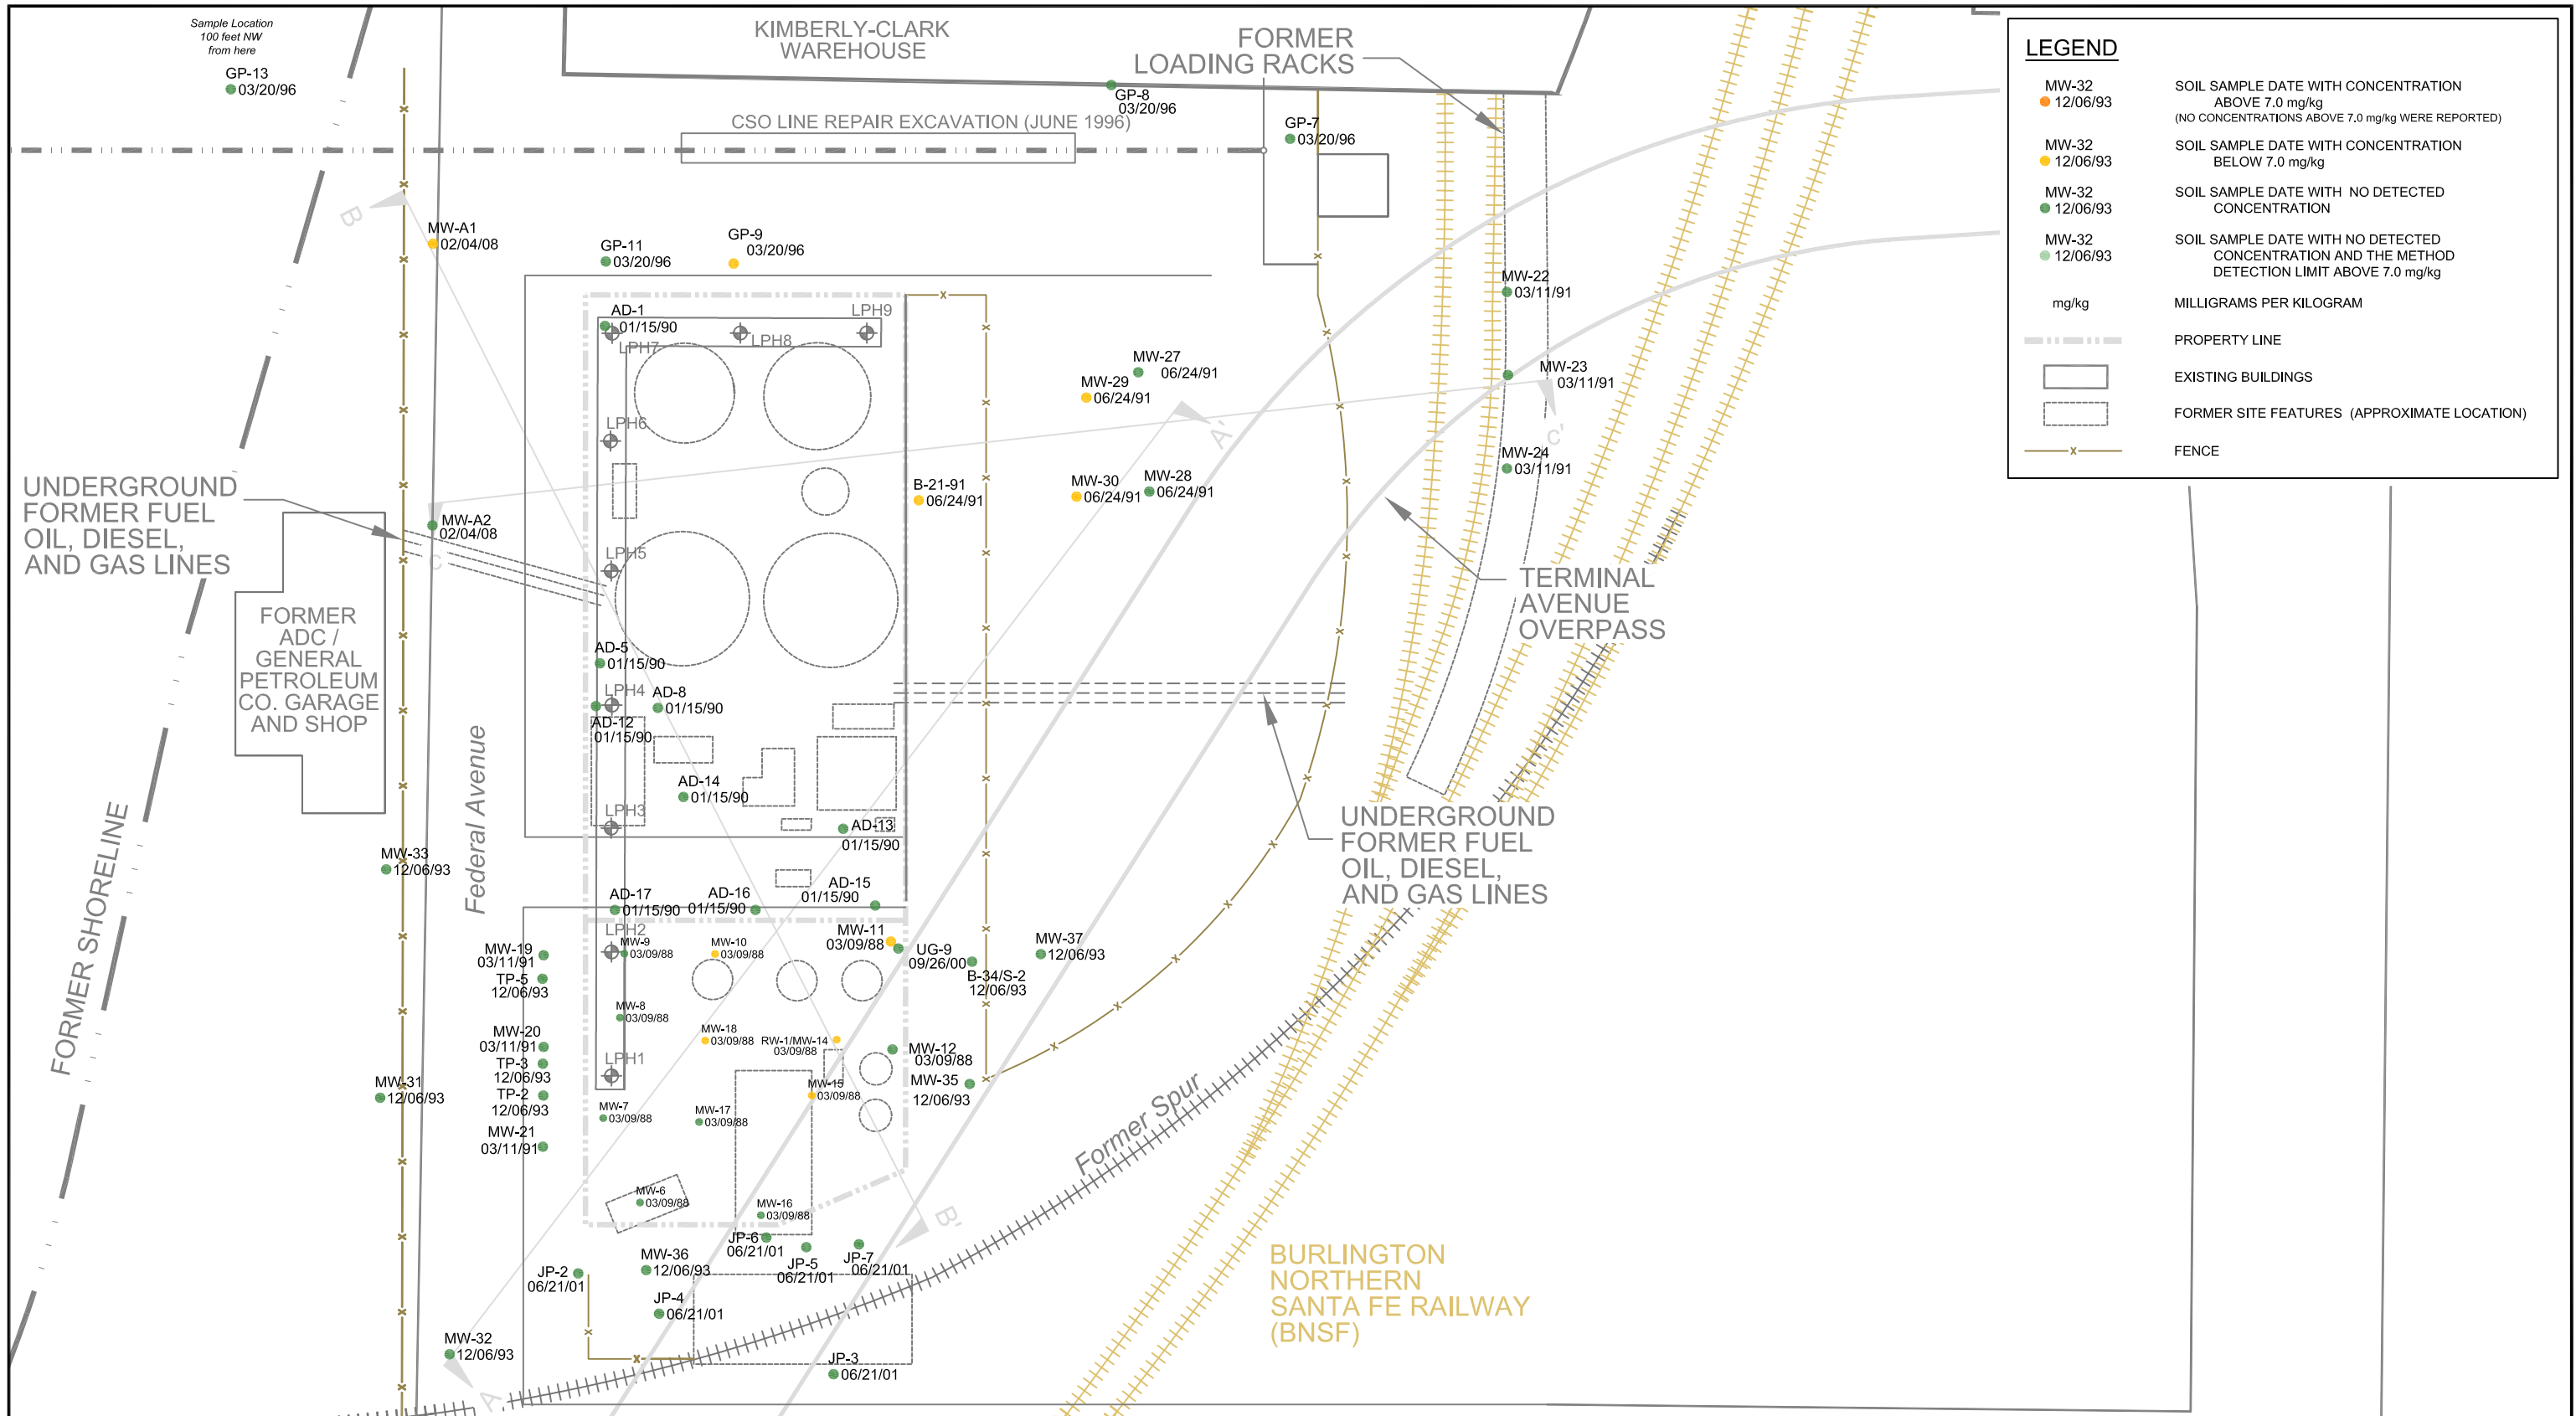
| | | AMEC Earth & Environmental 11810 North Creek Parkway North Bothell, WA, U.S.A. 98011-8201 | TITLE VERTICAL DISTRIBUTION OF BENZENE IN SOIL CROSS SECTION C-C' | REV. NO.: FIGURE No. 33 |

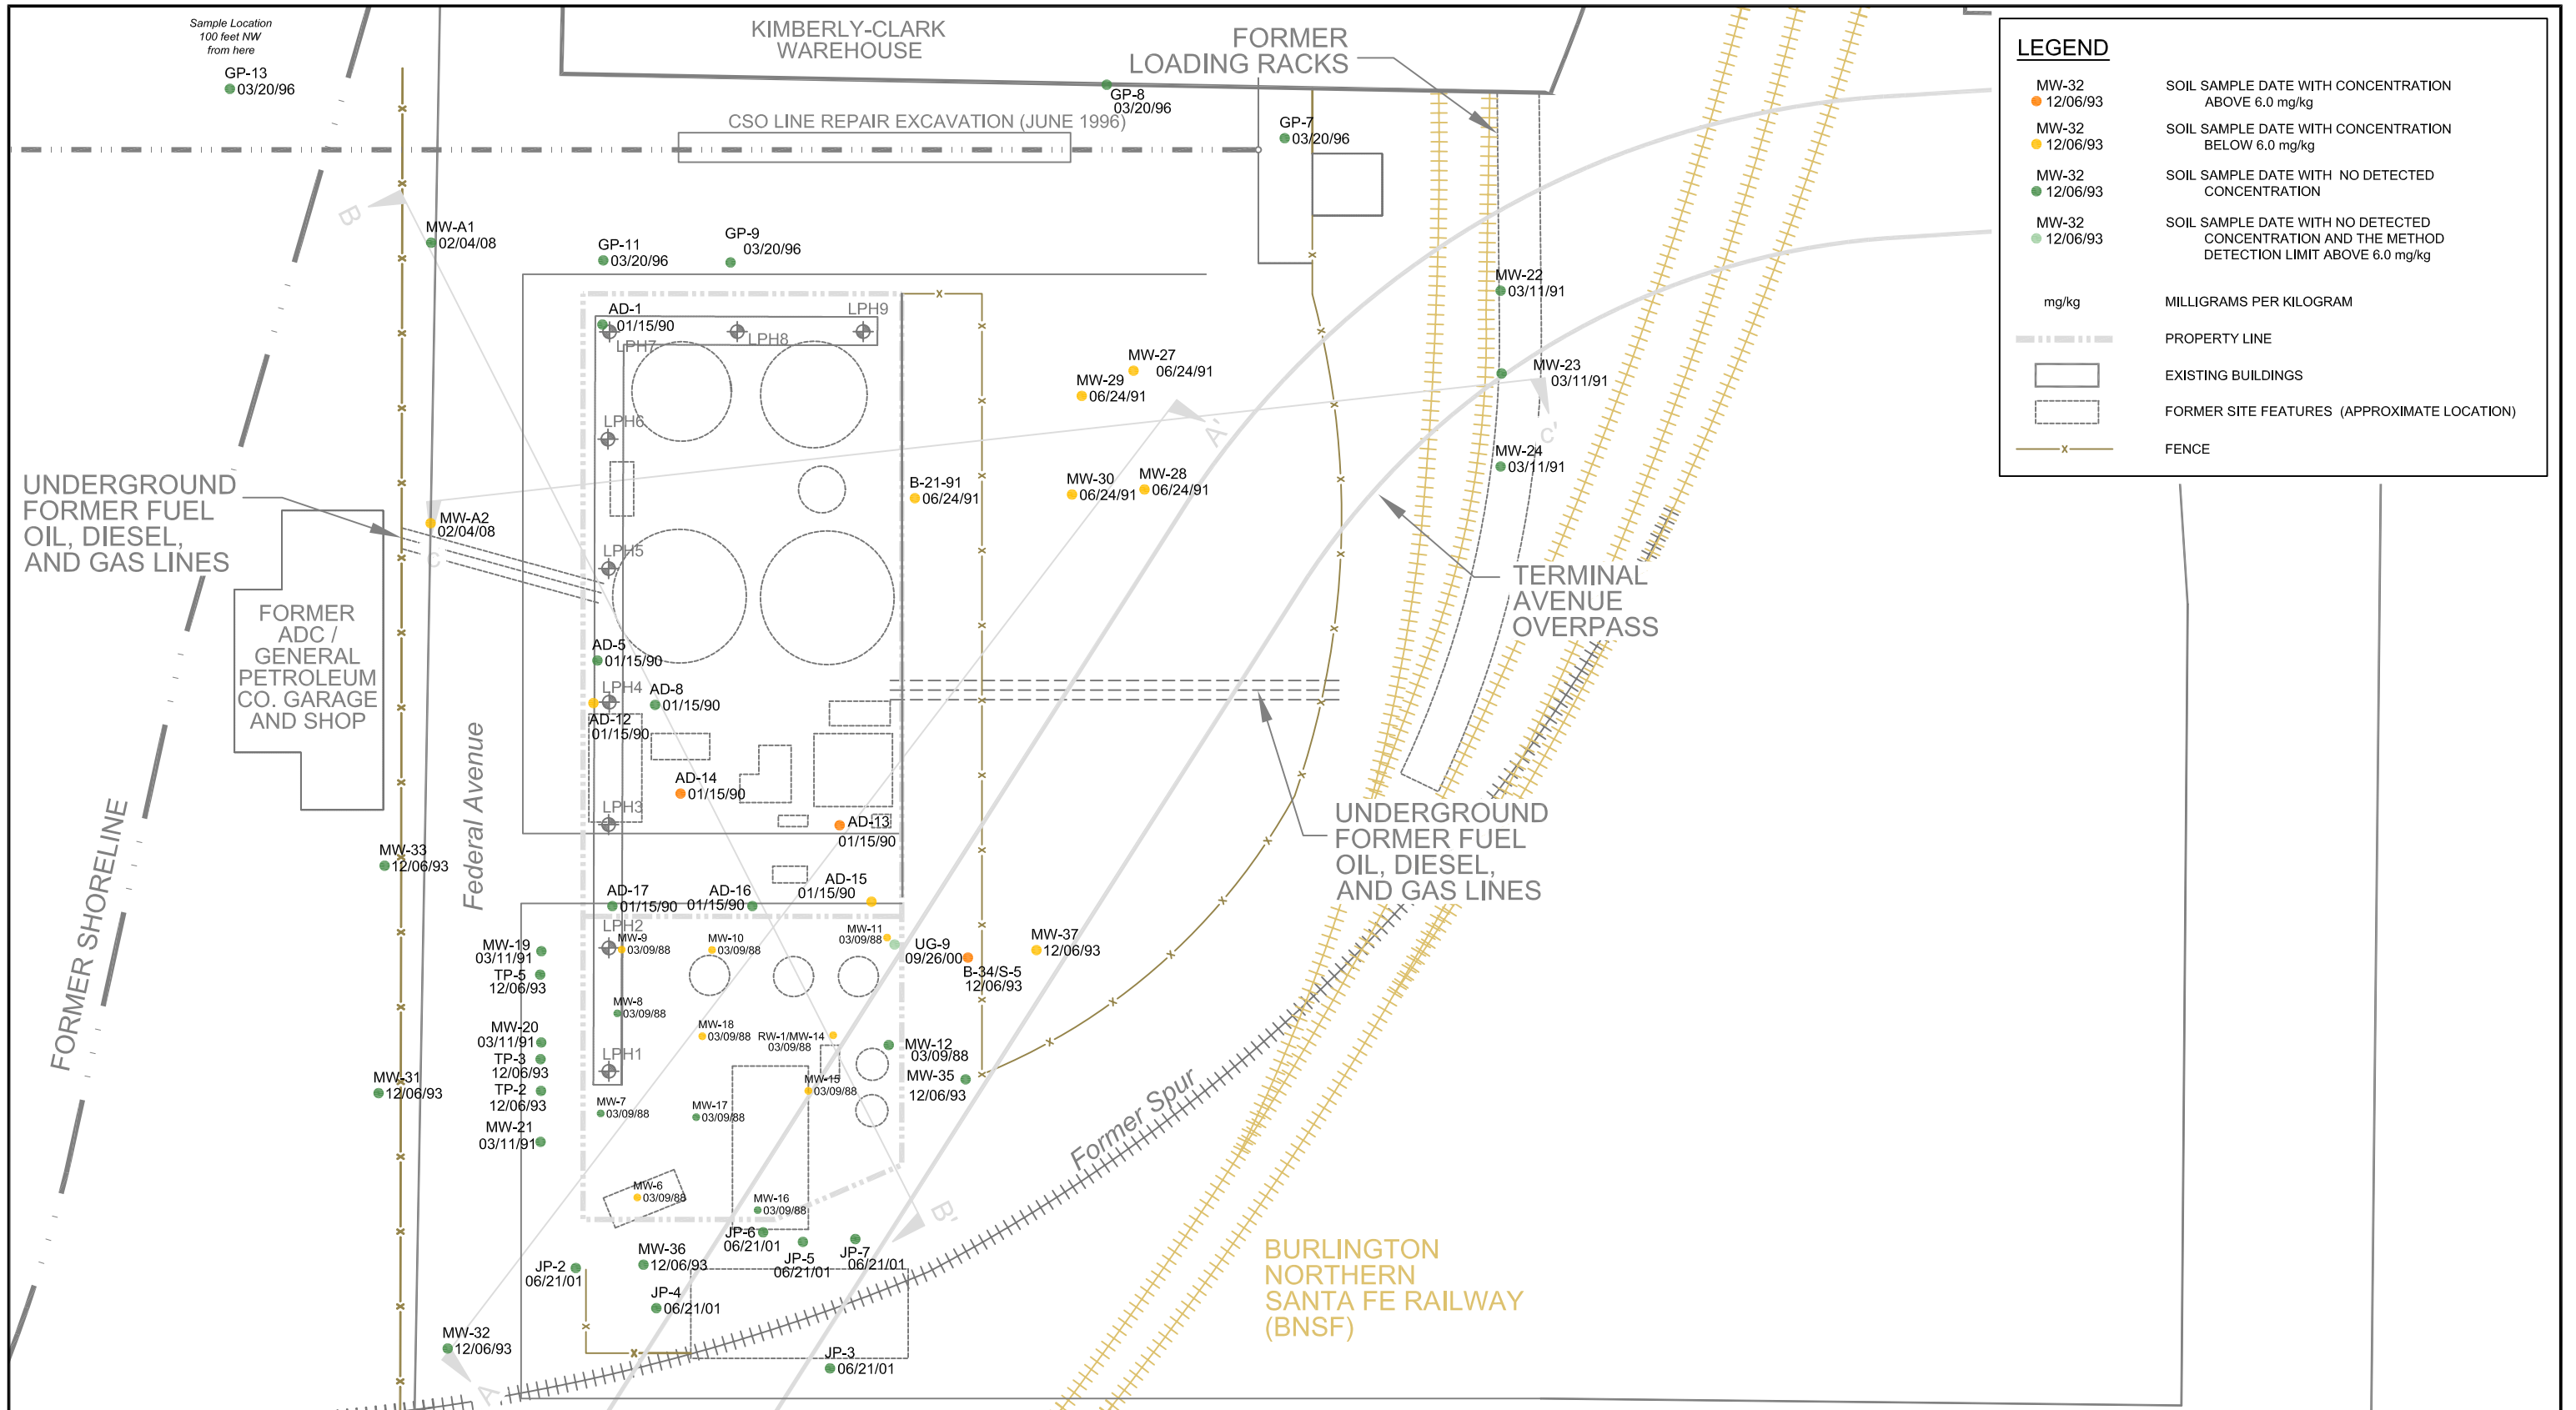
| SOURCE: Modified from a map provided by City of Everett, ExxonMobil Oil Corporation and Environmental Resolution, Inc. SCALE IN FEET | CLIENT LOGO | CLIENT: EXXONMOBIL AND AMERICAN DISTRIBUTING COMPANY | DWN BY: JRS / BRJ CHK'D BY: AIS DATUM: NONE PROJECTION: NONE SCALE: 1" = 60' | PROJECT EXXONMOBIL/ADC PROPERTY ECOLOGY SITE ID 2728 | DATE: AUGUST 2009 PROJECT NO: 9-915-15716-C REV. NO.: 1 FIGURE No. 35 |
| | | AMEC Earth & Environmental 11810 North Creek Parkway North Bothell, WA, U.S.A. 98011-8201 | TITLE HORIZONTAL DISTRIBUTION OF ETHYLBENZENE IN SOIL | | |
