**STATE OF WASHINGTON
DEPARTMENT OF ECOLOGY**

AGREED ORDER for

**Focused Feasibility Study and Draft
Cleanup Action Plan – ExxonMobil ADC
Site**

No. DE **6184**

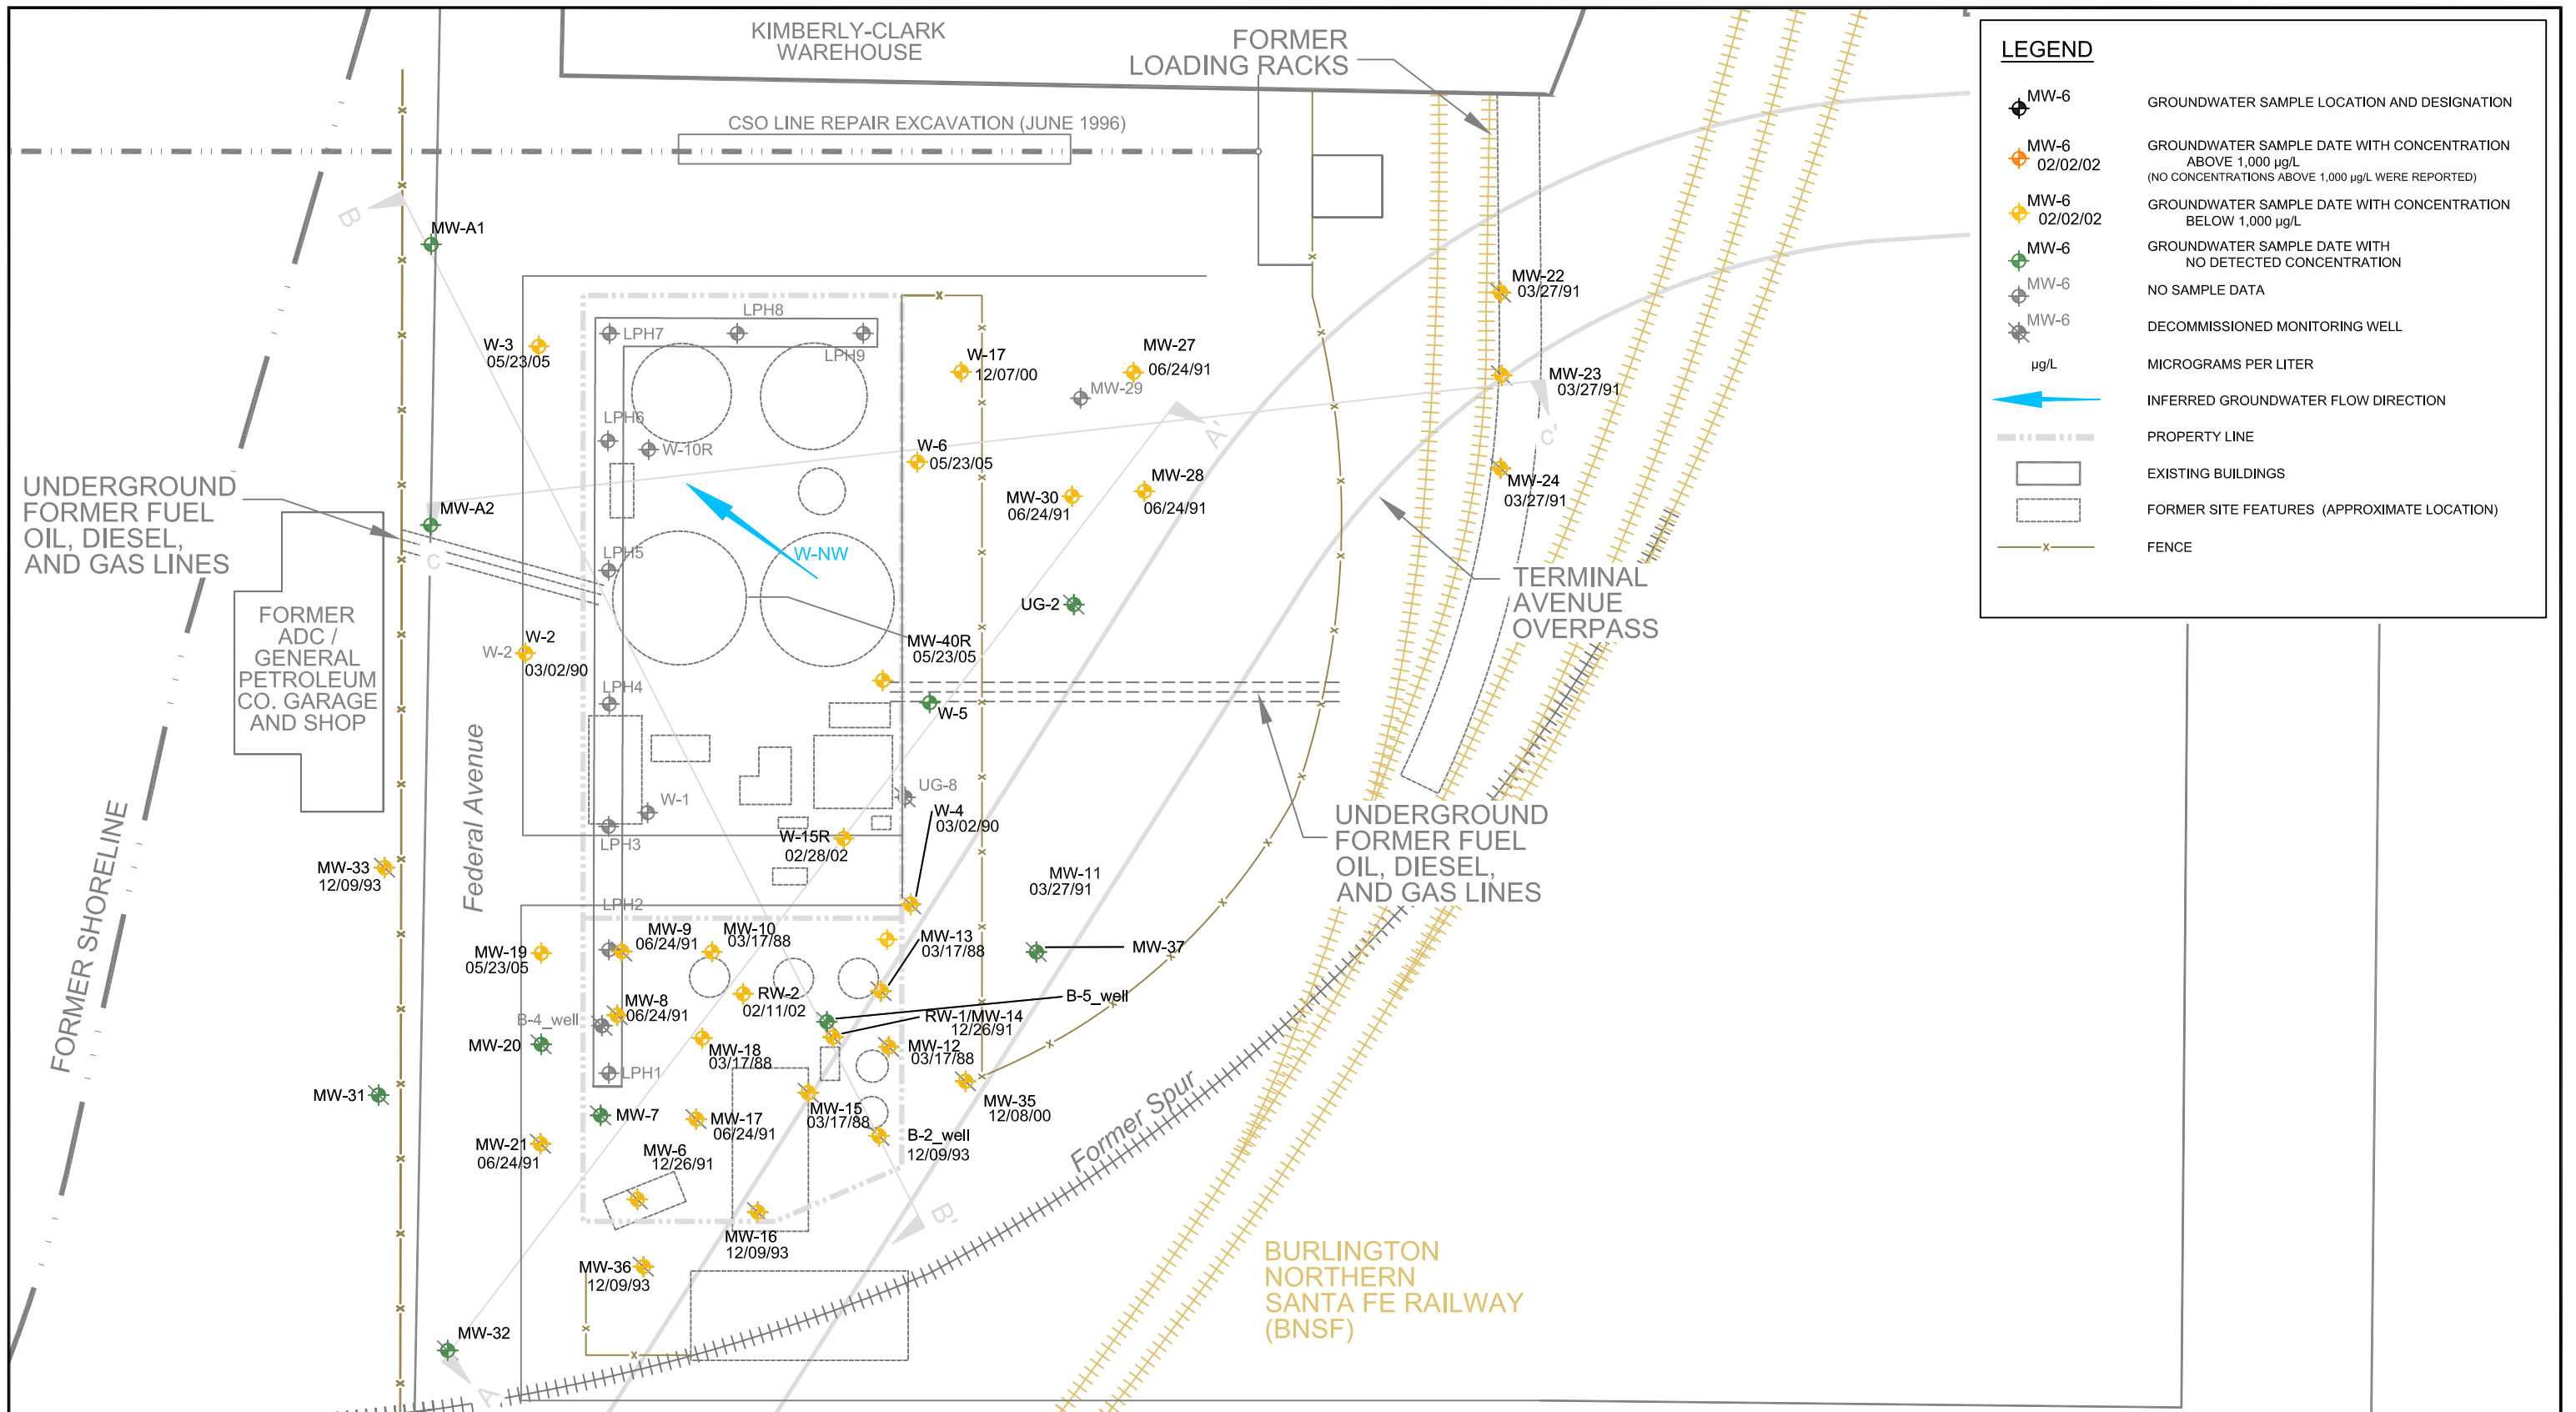
DATE:
 AUGUST 2009
 PROJECT NO:
 9-915-15716-C
 REV. NO.:
 1
 FIGURE No.
46

PROJECT
**EXXONMOBIL/ADC PROPERTY
 ECOLOGY SITE ID 2728**
 TITLE
**HISTORICAL DISTRIBUTION OF
 BENZENE IN GROUNDWATER
 MAXIMUM DETECTED VALUE**

Groundwater analytical data for BTEX are shown on Table 6. The historical distribution of benzene, toluene, ethylbenzene, and total xylenes in groundwater is shown on Figures 46 through 49, respectively. Historical analytical data for benzene in groundwater are limited for the ADC Parcel. Benzene has been detected at concentrations above the MTCA Method A cleanup level of 5 µg/L primarily on the ExxonMobil Parcel and to the east of the Property. Benzene has not been detected in groundwater samples collected south or west of the Property. Benzene concentration were reported in groundwater samples collected from monitoring wells MW-40R, MW-11, MW-19, MW-40R, MW-1A, MW-2A, W-3, and W-6) in February 2009 had either below the laboratory detection limits or below the MTCA Method cleanup levels. No ethylbenzene and/or toluene was detected at concentrations above the respective MTCA Method A cleanup level. One sample collected from MW-18 in 1988 had a concentration of total xylenes exceeding the MTCA Method A cleanup level. The extent of benzene impact downgradient of the Property can be inferred to be within the Federal Avenue right-of-way based on the fact that benzene was not detected in samples collected from MW-A1 and MW-A2, which are west of Federal Avenue. The extent of benzene impact upgradient from the Property can be partially inferred based on the fact that benzene was not detected in samples collected from monitoring wells MW-27 and MW-28. The extent of upgradient benzene impact can be inferred to be east of these monitoring wells and will be confirmed in the data gaps investigation. The extent of upgradient benzene impact to the east of the Property and south of MW-28 cannot be inferred based on available data, and is considered to be a data gap that will be addressed in the data gaps investigation.

- Benzene has been detected in groundwater samples collected on- and off-Property at concentrations above the MTCA Method A cleanup levels (Figure 46). Therefore, benzene was selected as an indicator hazardous substance. Toluene, ethylbenzene, and total xylenes have also been detected in groundwater samples collected on- and off-Property (Figures 47, 48, and 49, respectively). No samples contained toluene and ethylbenzene at concentrations above the Method A cleanup levels (Figures 47 and 48). Only two samples collected from MW-15 and MW-18 in 1988 contained total xylenes at concentrations exceeding the MTCA Method A cleanup level (Figure 49). Since toluene, ethylbenzene, and total xylenes are not exceeding Method A unrestricted cleanup levels, with the exception of total xylene detections reported in two samples in 1988, those constituents in groundwater do not pose a risk to humans. None of these constituents was selected as an indicator hazardous substance.

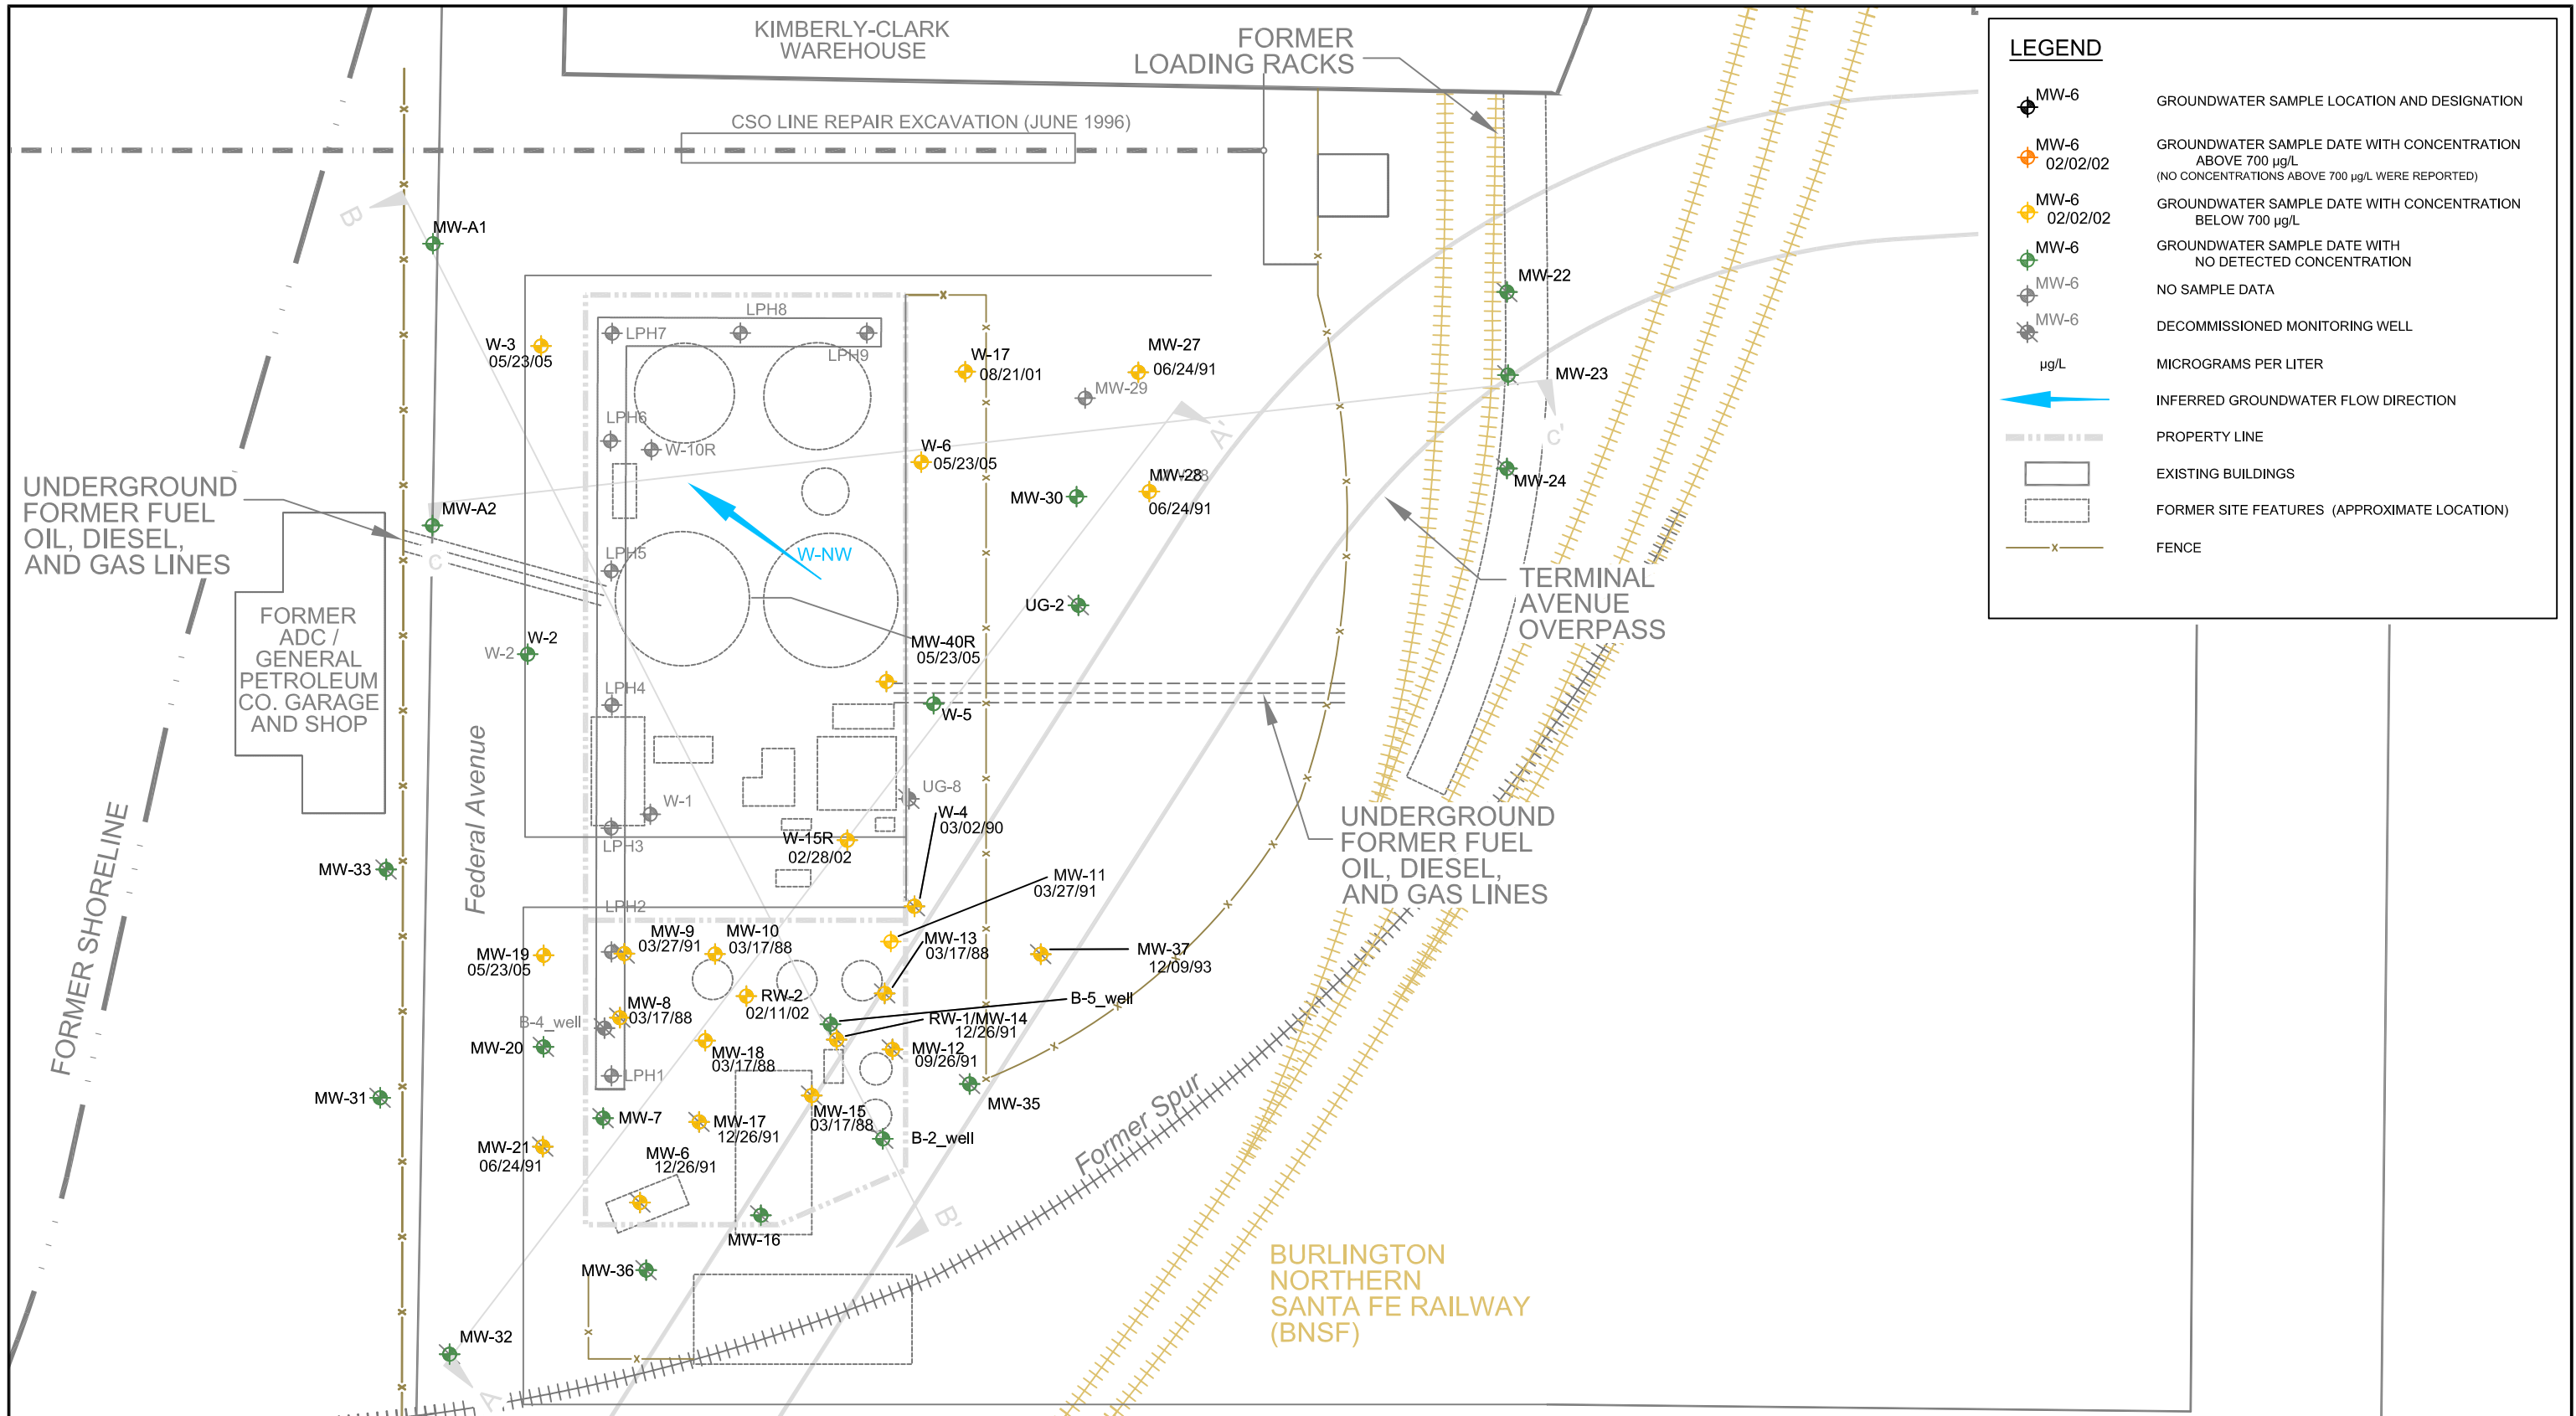
| | | AMEC Earth & Environmental 11810 North Creek Parkway North Bothell, WA, U.S.A. 98011-8201 | TITLE HISTORICAL DISTRIBUTION OF ETHYLBENZENE IN GROUNDWATER MAXIMUM DETECTED VALUE | REV. NO.: 1 FIGURE No. 48 | |

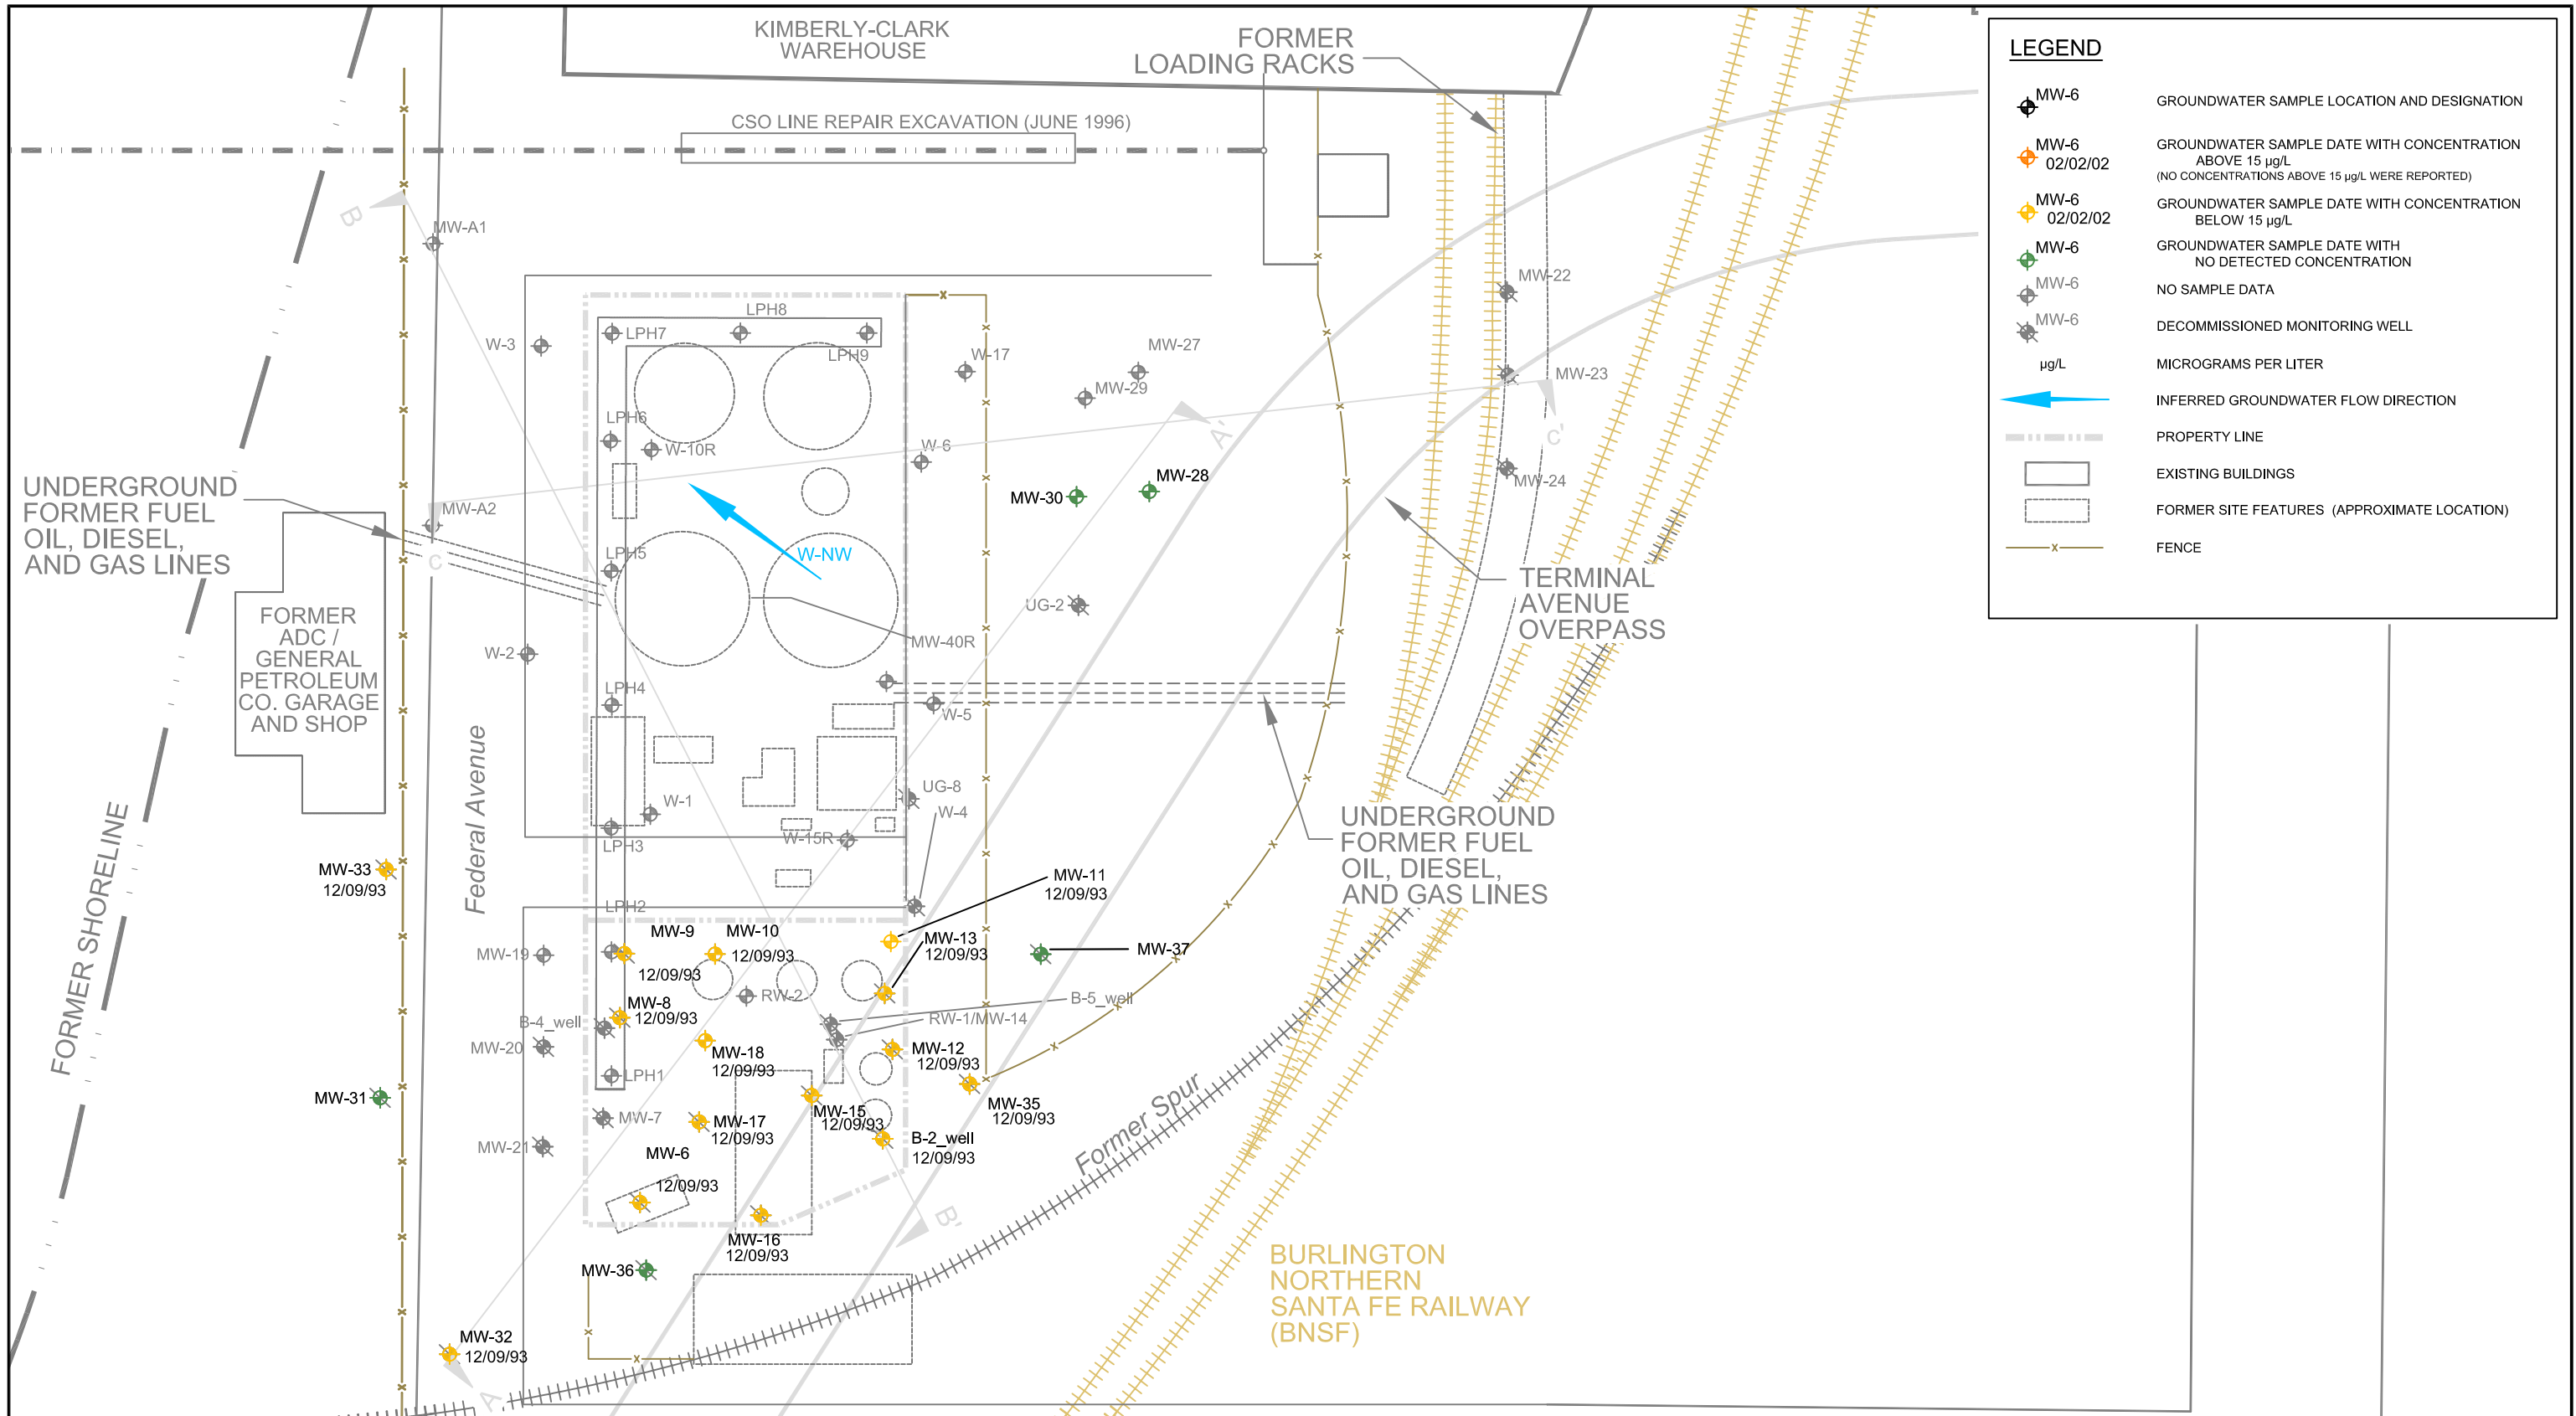
DATE: AUGUST 2009
PROJECT NO: 9-915-15716-C
REV. NO.: 1
FIGURE No. 50

**HISTORICAL DISTRIBUTION OF
TOTAL LEAD IN GROUNDWATER
MAXIMUM DETECTED VALUE**

Groundwater analytical data for total and dissolved lead are shown on Table 6. The historical distribution of total and dissolved lead in groundwater is shown on Figures 50 and 51, respectively. Total lead has been detected at concentrations above the MTCA Method A cleanup level of 15 µg/L in groundwater samples collected at the ExxonMobil Parcel. Historical analytical data for total and/or dissolved lead are not available for the ADC Parcel or from the area to the northwest of the Property. The upgradient and downgradient extent of total lead impact cannot be inferred based on available data.

- Total lead has been detected at concentrations above the MTCA Method A cleanup level in groundwater samples collected at the Site (Figure 50). Increased turbidity in groundwater samples may be attributed to soil lithology, increased organic content, screen size, and/or purging. High concentrations of total lead occurring in groundwater samples at the Site are most likely due to increased organic content in the formation being sampled. Due to the high turbidity of groundwater samples, total lead results in groundwater are not representative of groundwater quality due to the contribution of lead contained in suspended sediment. Dissolved lead has not been detected at concentrations above the MTCA Method A cleanup level in groundwater samples collected at the Site (Figure 51). Therefore, lead was not selected as an indicator hazardous substance.

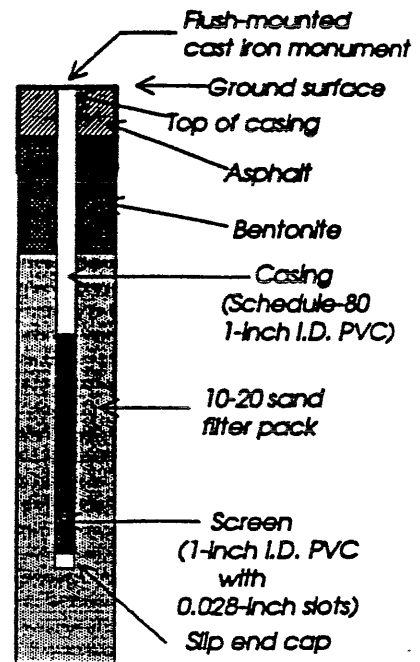
| DEPTH (feet) | SOIL DESCRIPTION | SAMPLE TYPE | SAMPLE NUMBER | BLOW COUNTS | OVM READING | GROUND WATER | TESTING |
|---|--|---|---|---|---|---|---|
| 5 | Moist to wet, gray, fine to medium SAND, petroleum odor at 7.0 feet | | GP-1/ 8.0' | | 27.0 | 3/22/96 ATD | |
| 10 | Grades to wet, gray, fine to coarse SAND (3-inch fine sandy silt layer at 10.0 feet) | | GP-1/ 10.0' | | 7.0 | | |

Bottom of boring at 12 feet.

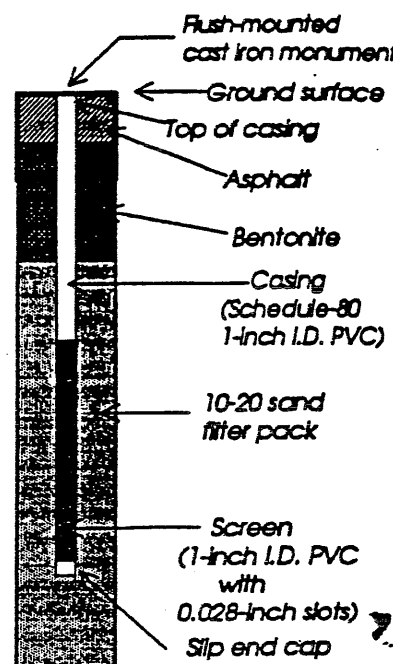
| DEPTH (feet) | SOIL DESCRIPTION | SAMPLE TYPE | SAMPLE NUMBER | BLOW COUNTS | OVM READING | GROUND WATER | TESTING |
|---|---|---|---|---|---|---|---|
| | Fine to medium grained wood debris, petroleum odor, no LPH | | GP-6/ 6.0 | | | | |
| 10 | Wood fragments saturated with very viscous LPH | | | | | | |

Bottom of boring at 12 feet.

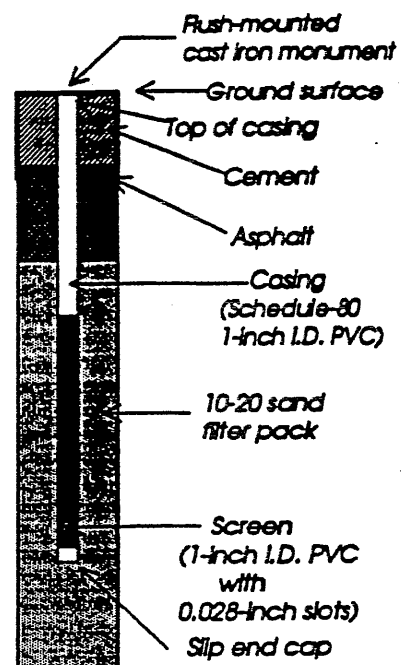
| DEPTH (feet) | SOIL DESCRIPTION | SAMPLE TYPE | SAMPLE NUMBER | BLOW COUNTS | OVM READING | GROUND WATER |
|---|--|---|---|---|---|---|
| 5 | Moist, gray, fine sandy SILT with some gravel, slight petroleum odor Woody debris saturated with LPH Moist to wet, gray/orange/brown, gravelly, medium to coarse SAND, petroleum odor Wet, brown stained gray, fine sandy SILT, strong petroleum odor, minor LPH Wet, brown, fine grained wood debris with LPH, minor saturated sand | | GP-10/ 7.0' | | | 3/22/96 |
| 10 | Saturated, gray, fine SAND with wood debris, strong sulfur odor, slight petroleum odor Wood fragments | | GP-10/ 11.0' | | 0.0 | |

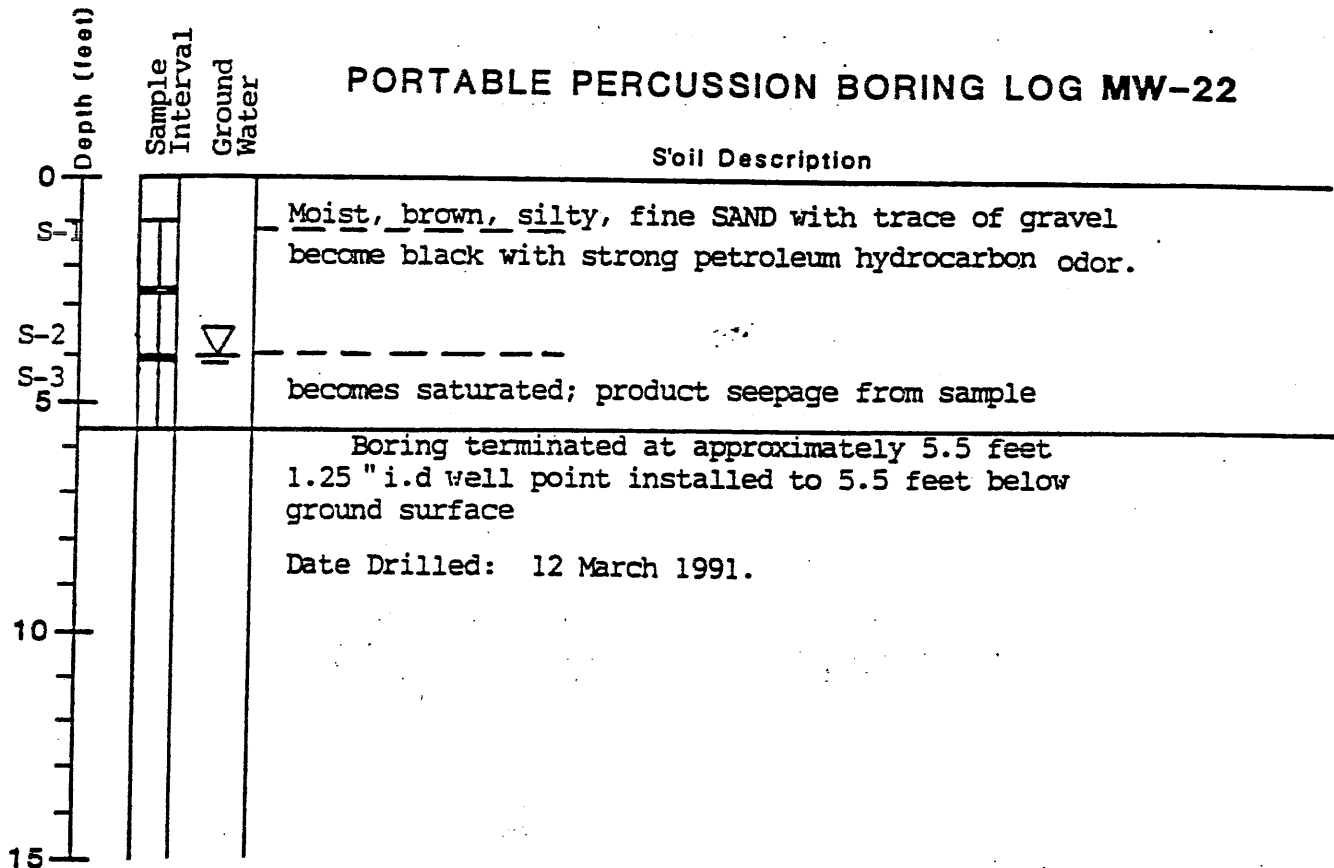
PORTABLE PERCUSSION BORING LOG MW-22

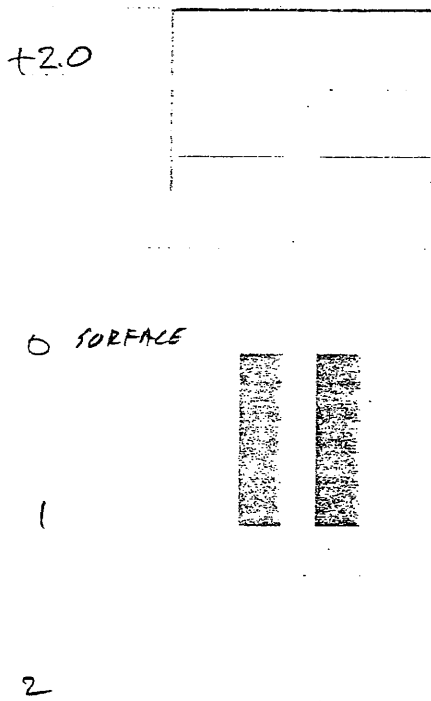
PROJECT No. 11-04558-09
PROJECT NAME MOBILE/ADK
BORING/WELL I.D. URW-1
DATE 6/5/96

ABOVE GROUND RISER HEIGHT (IF APPLICABLE) _____
MONUMENT TYPE (IF APPLICABLE) _____
WELL CAP TYPE locking

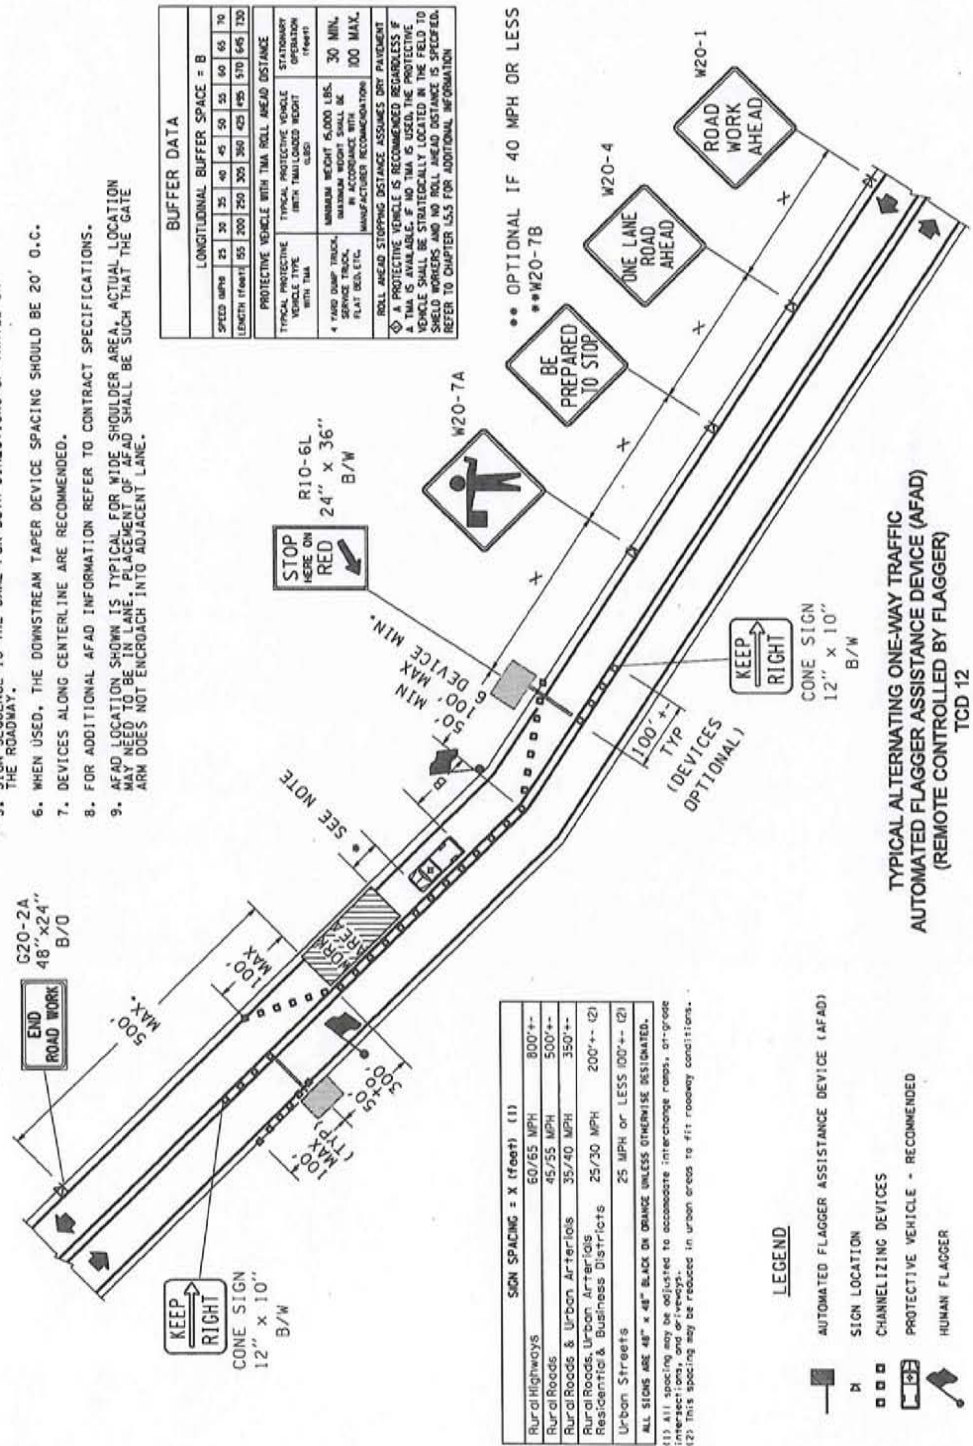
4. PROTECTIVE VEHICLE RECOMMENDED - MAY BE A WORK VEHICLE.
5. SIGN SEQUENCE IS THE SAME FOR BOTH DIRECTIONS OF TRAVEL ON THE ROADWAY.
6. WHEN USED, THE DOWNSTREAM TAPER DEVICE SPACING SHOULD BE 20' O.C.

7. DEVICES ALONG CENTERLINE ARE RECOMMENDED.
8. FOR ADDITIONAL AFAD INFORMATION REFER TO CONTRACT SPECIFICATIONS.
9. AFAD LOCATION SHOWN IS TYPICAL FOR WIDE SHOULDER AREA. ACTUAL LOCATION MAY NEED TO BE IN LANE. PLACEMENT OF AFAD SHALL BE SUCH THAT THE GATE ARM DOES NOT ENCRUSH INTO ADJACENT LANE.

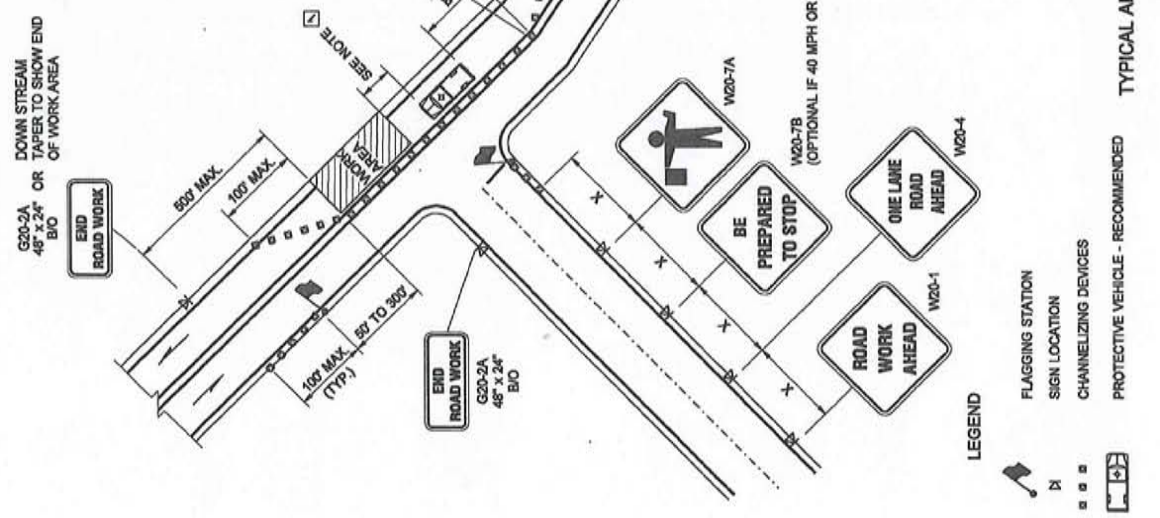
TYPICAL ALTERNATING ONE-WAY TRAFFIC FLAGGER CONTROLLED TCP 1

- NOTES**
- Night work requires additional roadway lighting at flagging stations, refer to WSDOT Standard Specifications for additional details.
 - Recommend extending channelizing device taper across shoulder.
 - Protective vehicle recommended - may be a work vehicle.
 - Sign sequence is the same for both directions of travel on the roadway.
 - When used, the downstream taper device spacing should be 20' O.C.
 - For low-volume situations with short work zones on straight roadways where the flagger is visible to road users approaching from both directions, a single flagger, positioned to be visible from both directions may be used.
