# **Lower Duwamish Waterway Source Control Action Plan for Early Action Area 4**

December 2007

Publication No. 07-09-004

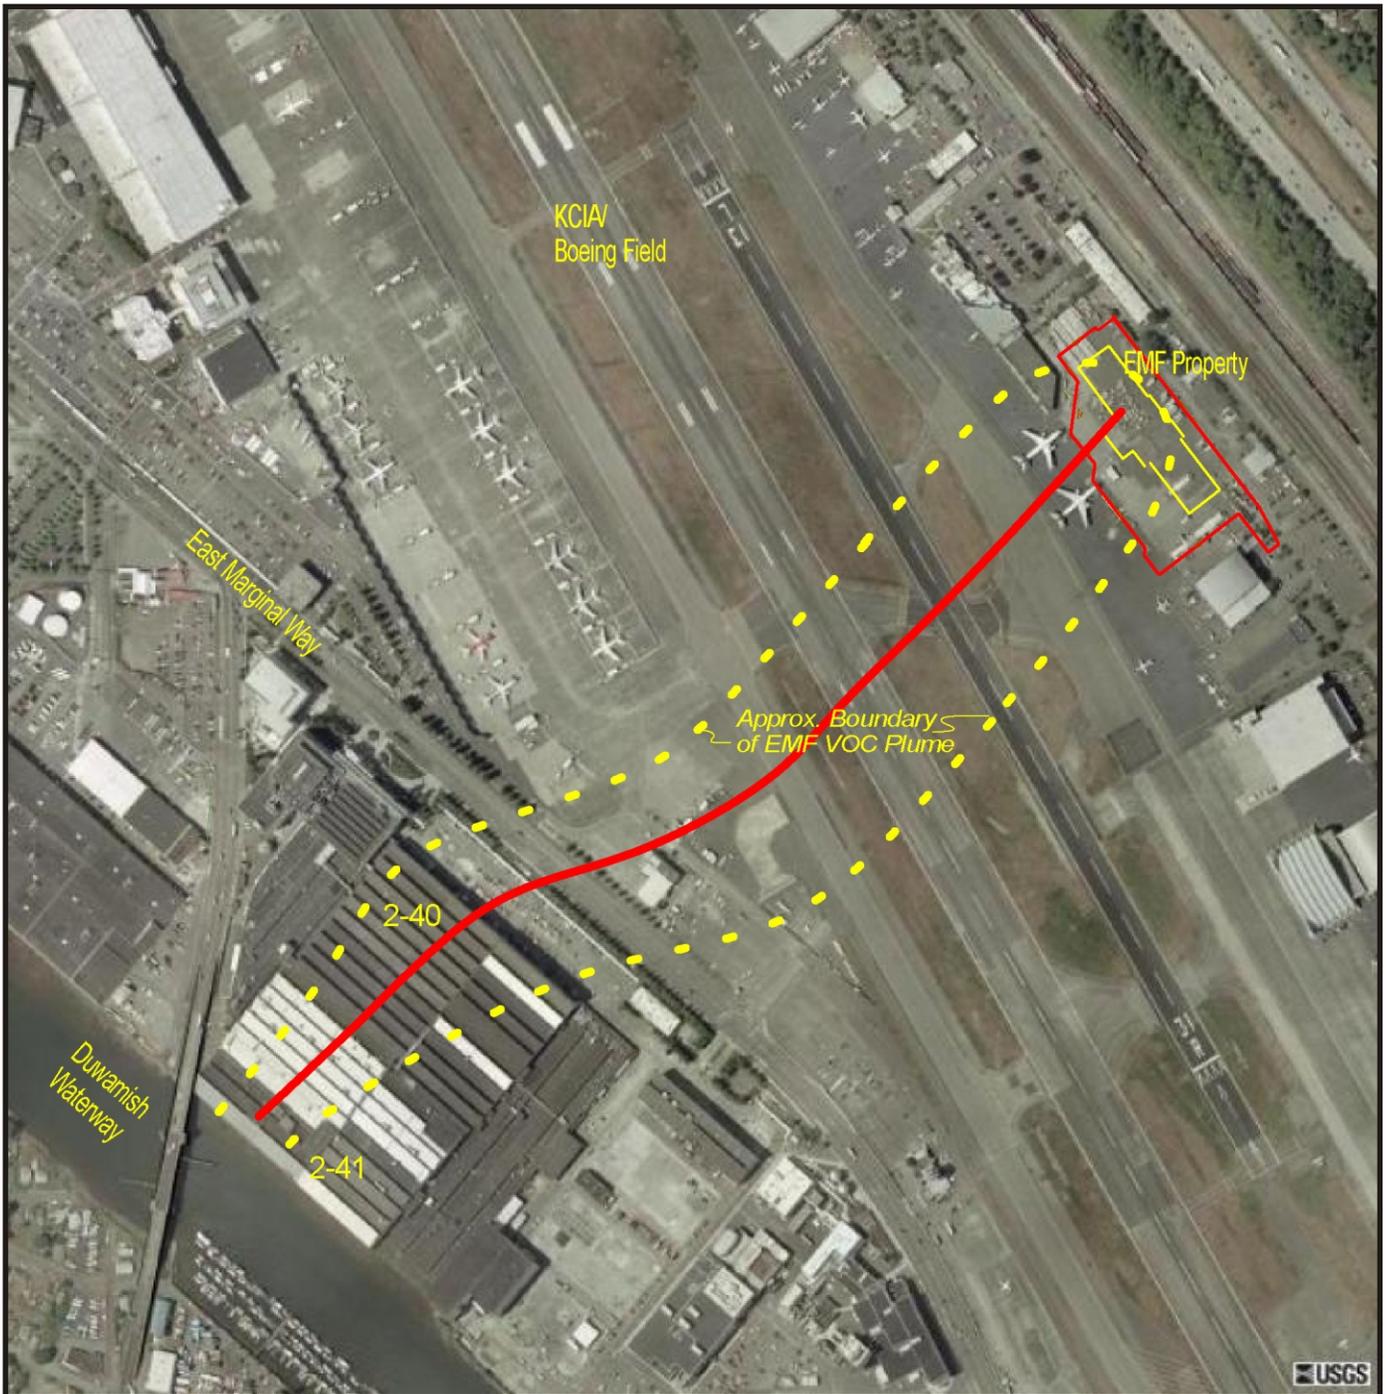
Figure 7  
LOCATION OF THE EMF PLUME  
AT BOEING PLANT 2

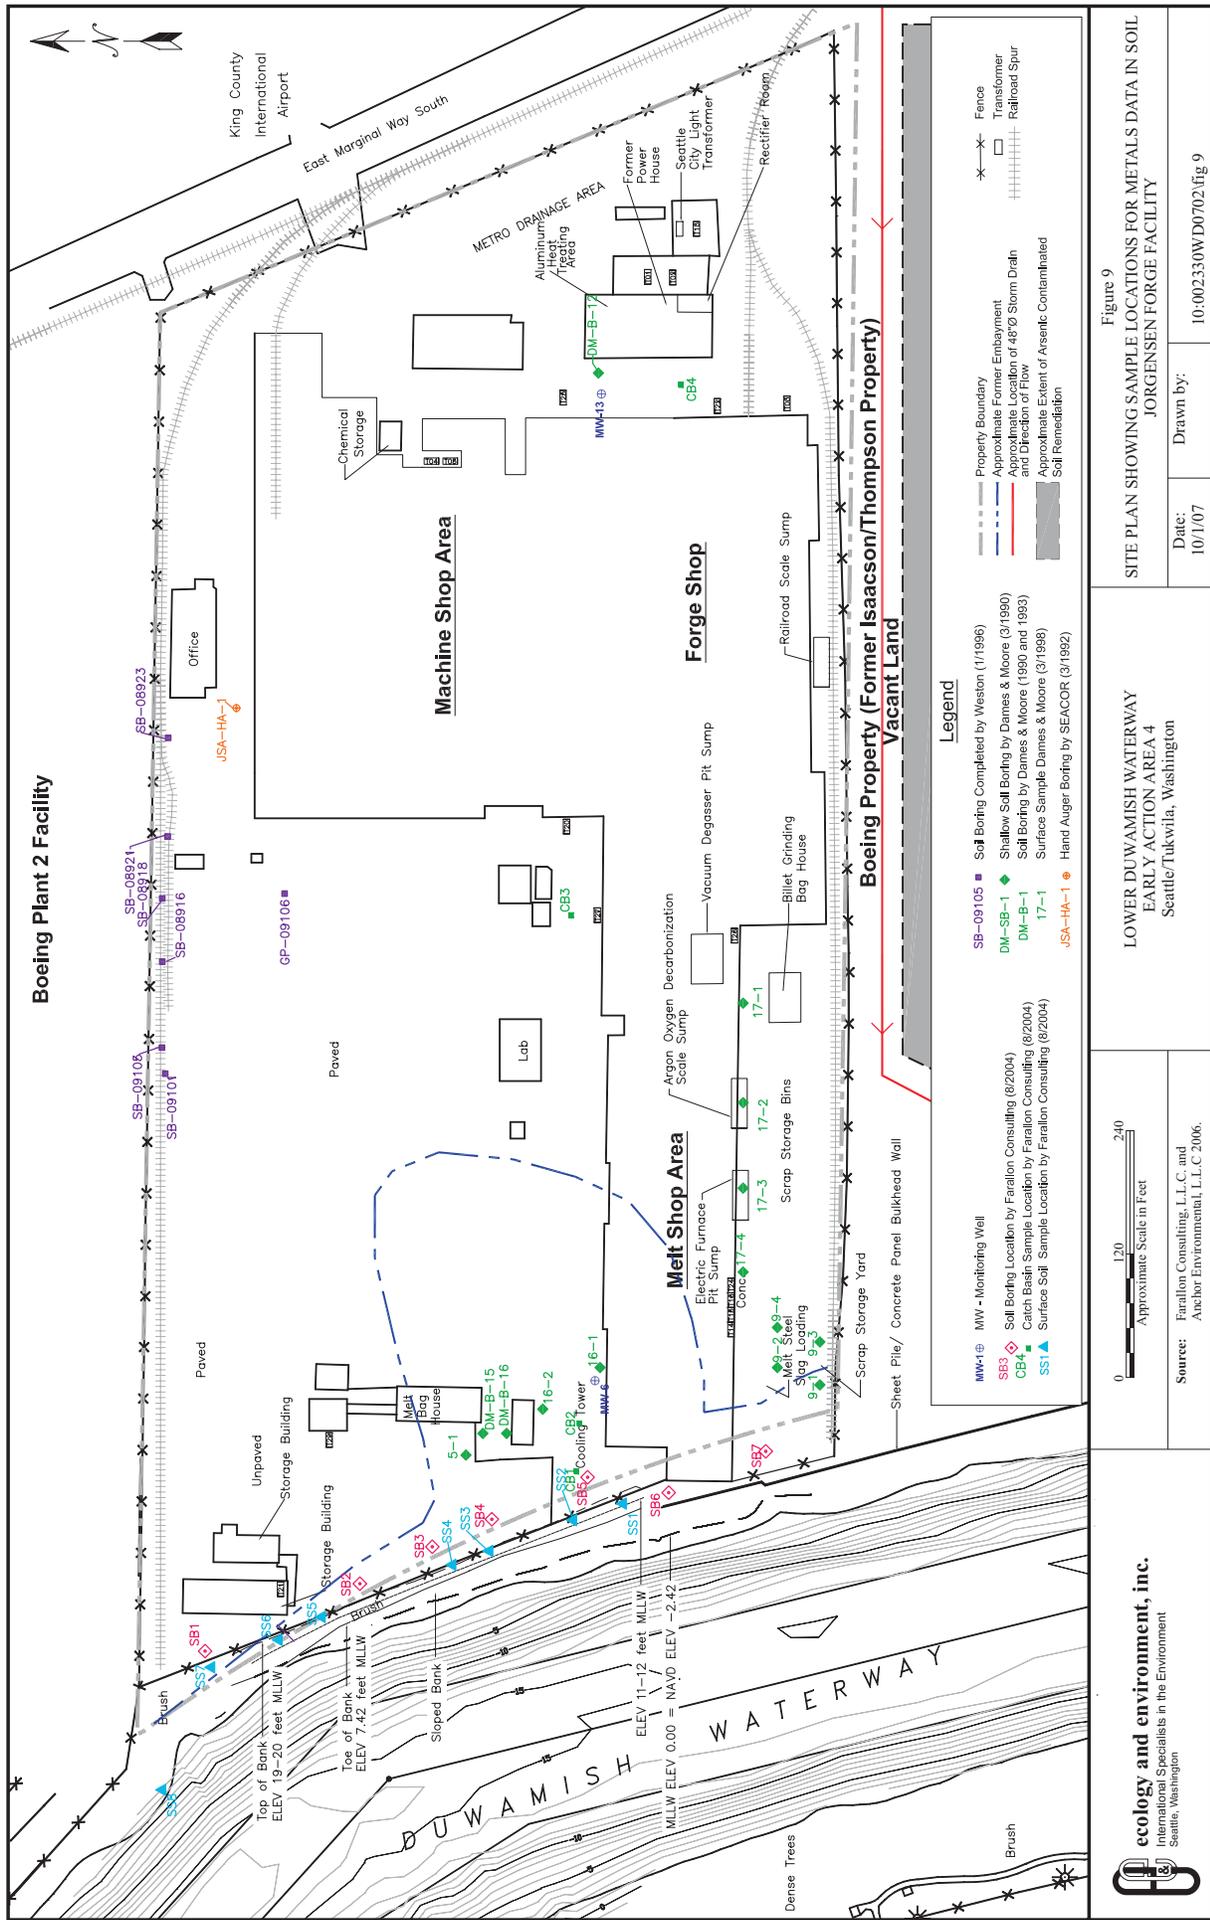
Figure 9  
**SITE PLAN SHOWING SAMPLE LOCATIONS FOR METALS DATA IN SOIL**  
**JORGENSEN FORGE FACILITY**  
 Date: 10/1/07  
 Drawn by: 10:002330W/D0702/fig\_9

- **Arsenic** was detected in subsurface fill samples (Figure 9) collected from two soil borings at concentrations of 61.7 mg/kg and 62.7 mg/kg, both of which exceeded the SMS Sediment Quality Standard (SQS) of 57 mg/kg for arsenic in sediment, but are below the Contaminant Screening Level (CSL) of 93 mg/kg. Concentrations of arsenic found in the five other samples ranged from 3.47 mg/kg to 25.7 mg/kg—below the SMS. Arsenic was also detected in the shoreline bank-face fill at concentrations ranging from 9.95 mg/kg to 64.9 mg/kg. One sample of the shoreline bank-face fill exceeded the SQS, but did not exceed the CSL.

- **Lead** concentrations, ranging from 543 mg/kg to 1,530 mg/kg, were observed in the subsurface fill, and concentrations of 1,010 mg/kg to 5,450 mg/kg were observed in shoreline bank-face fill samples. These concentrations exceeded the SQS criterion of 450 mg/kg and the CSL criterion of 530 mg/kg.

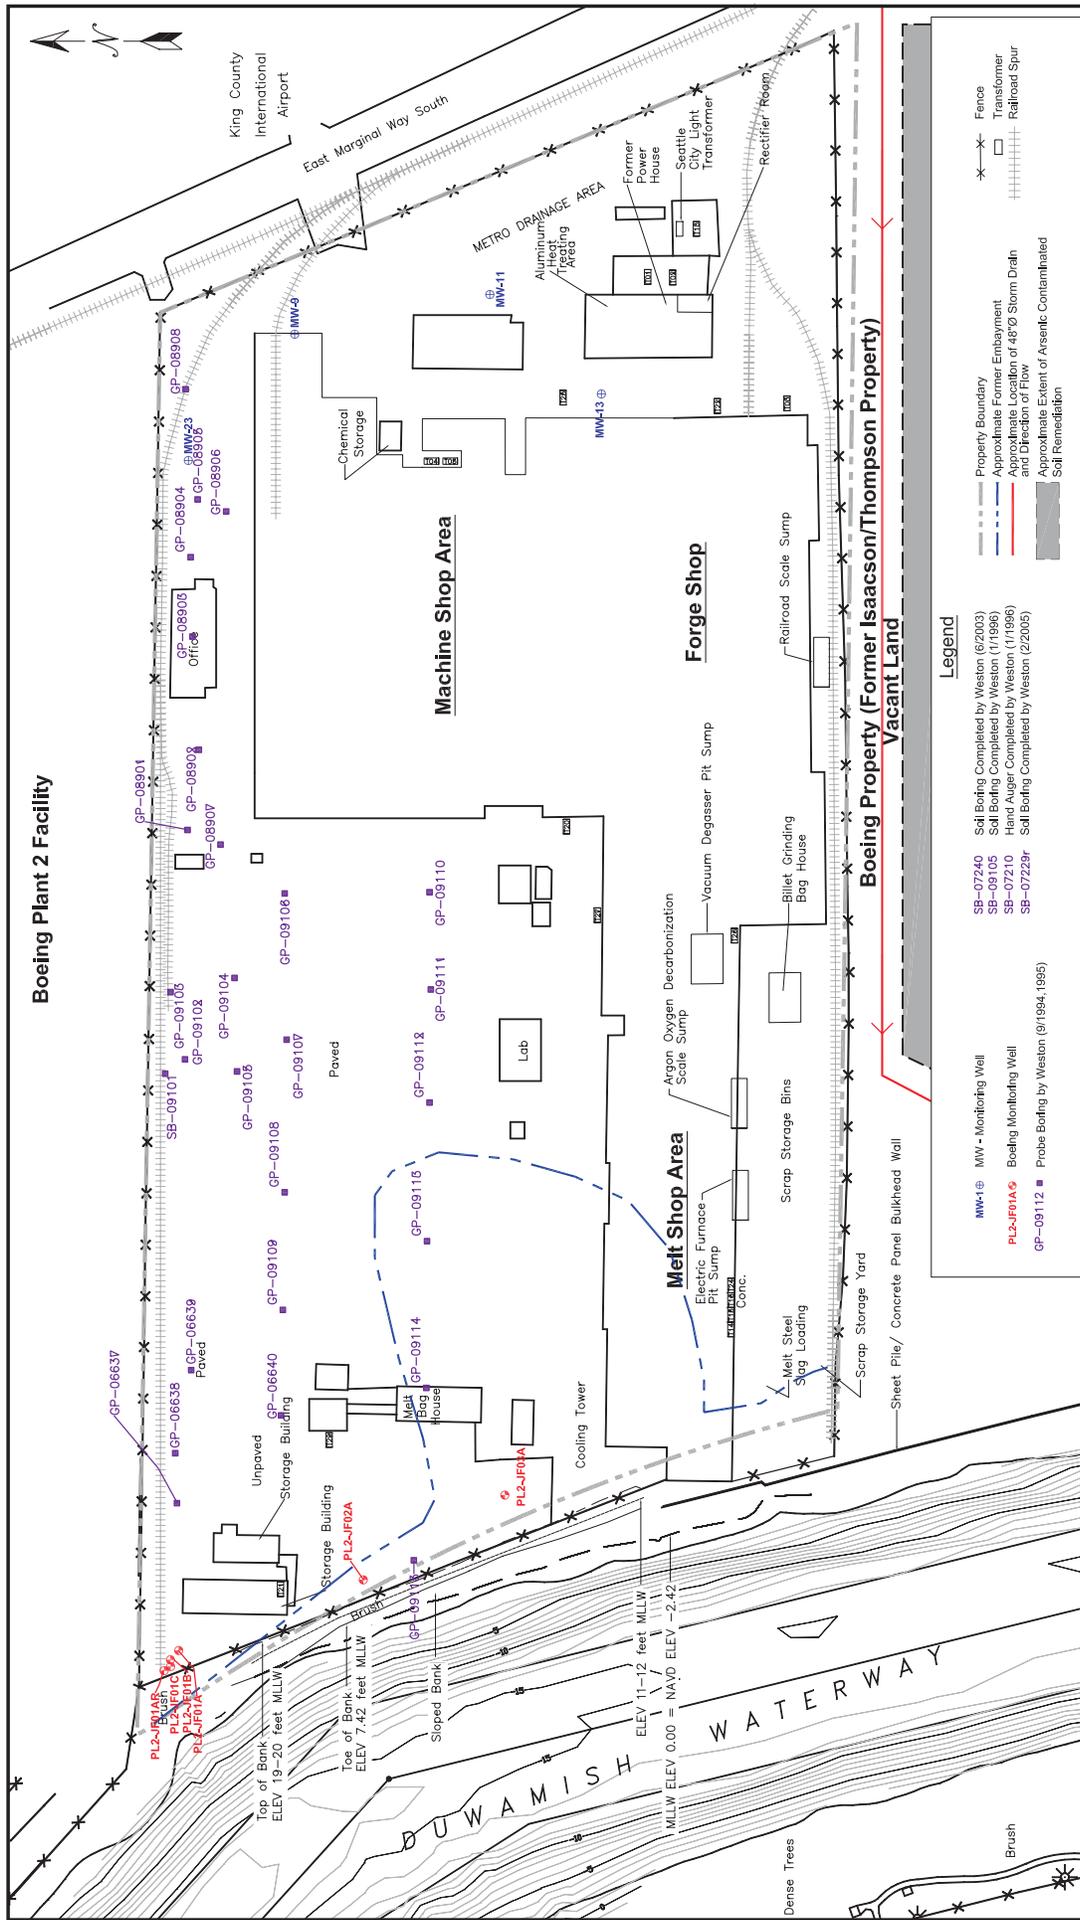
Figure 10  
 SITE PLAN SHOWING SAMPLE LOCATIONS FOR METALS DATA  
 IN GROUNDWATER  
 JORGENSEN FORGE FACILITY

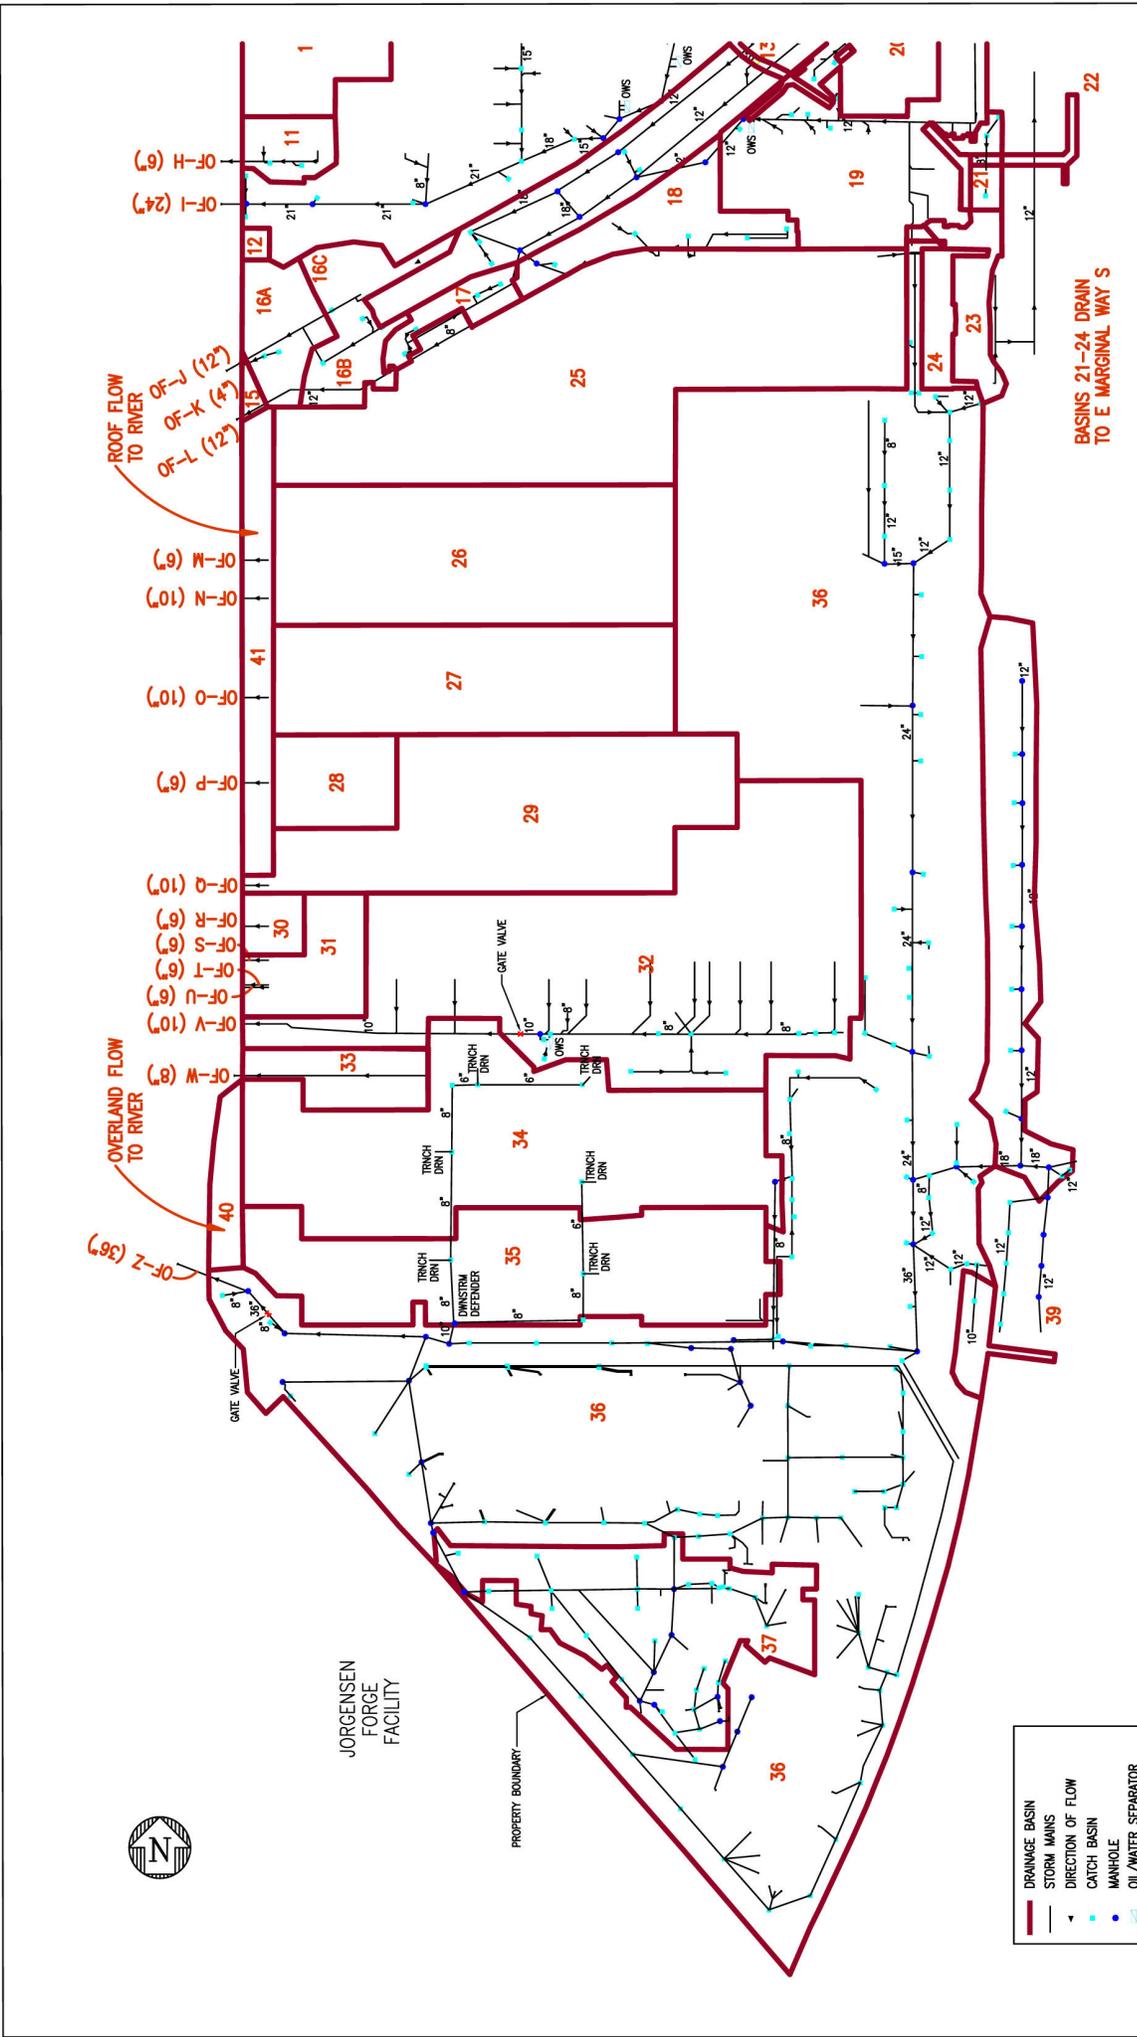
**Figure 18**  
**BOEING PLANT 2**  
**STORMWATER DRAINAGE SYSTEM - SOUTH END**  
**LOWER DRAINAGE WATERWAY**  
**EARLY ACTION AREA 4**  
 Seattle/Tukwila, Washington

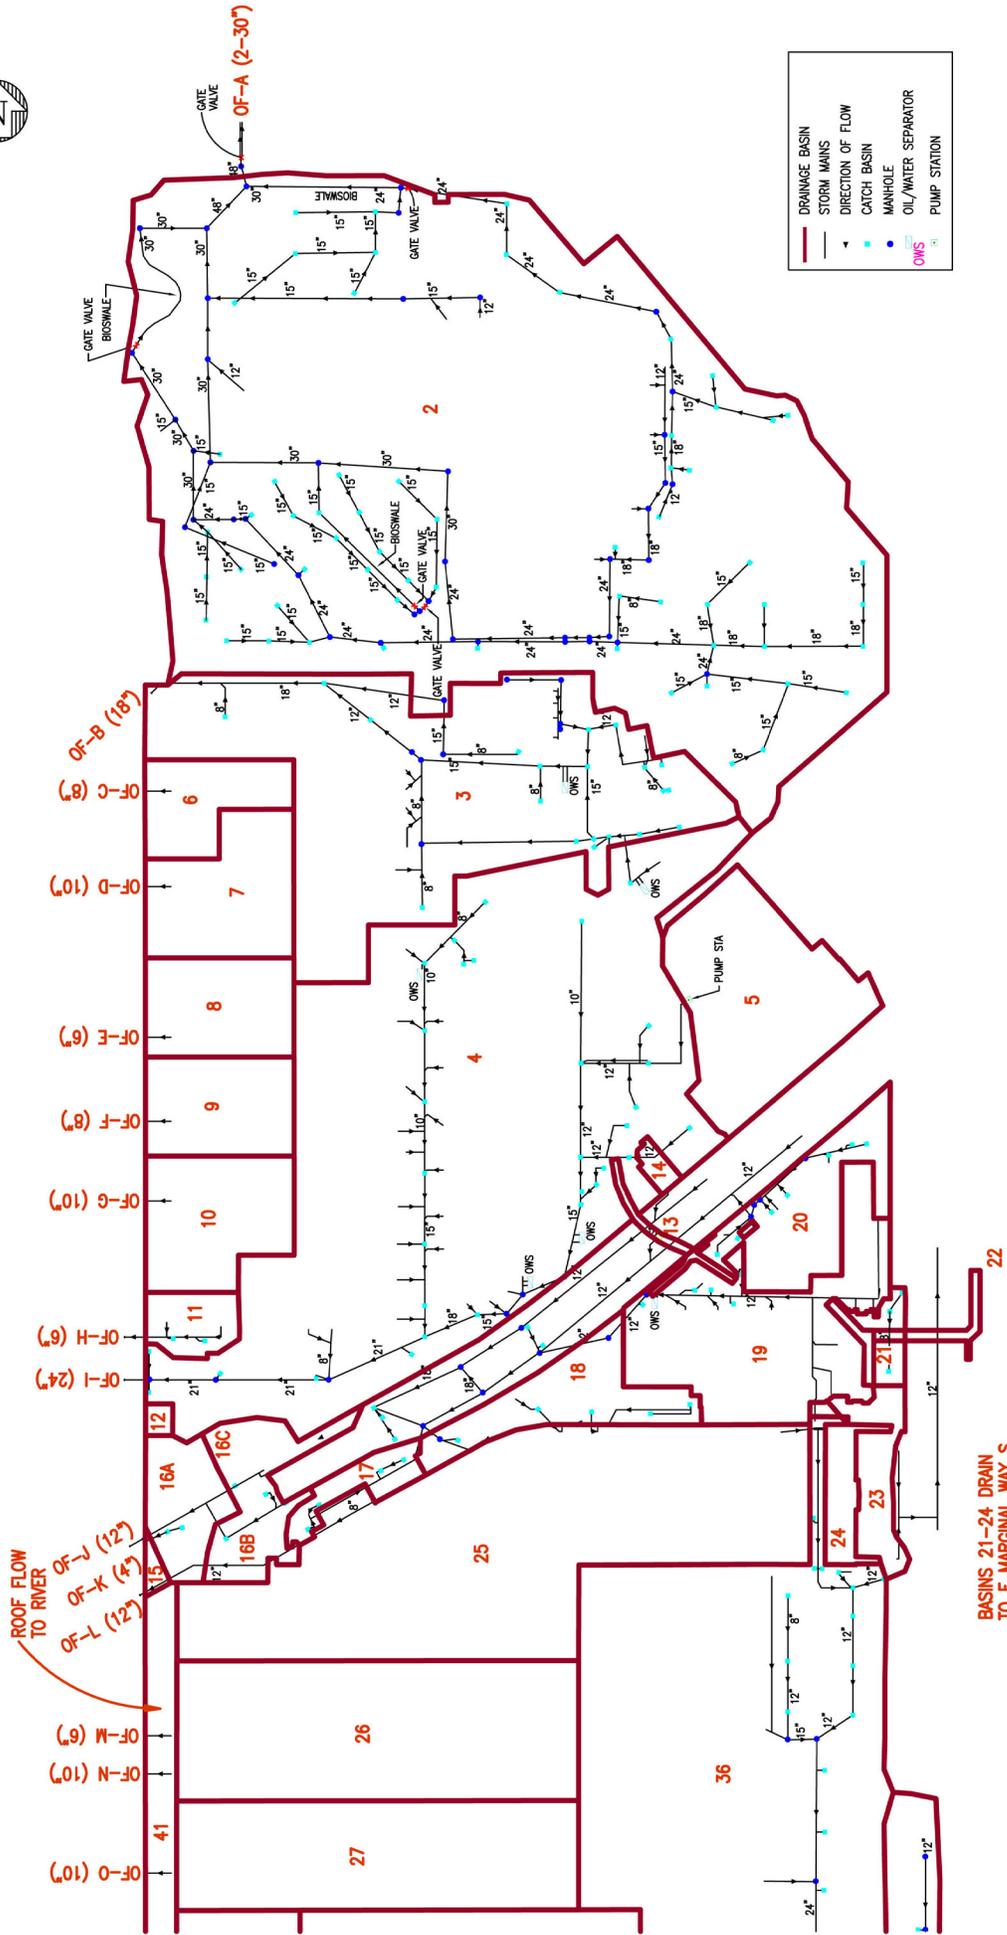
Figure 19  
 BOEING PLANT 2  
 STORMWATER DRAINAGE SYSTEM - NORTH END  
 LOWER DRAINAGE SYSTEM  
 EARLY ACTION AREA 4  
 Seattle/Tukwila, Washington  
 DATE: 12-18-07  
 SCALE: 1"=100'

BASINS 21-24 DRAIN  
 TO E MARGINAL WAY S

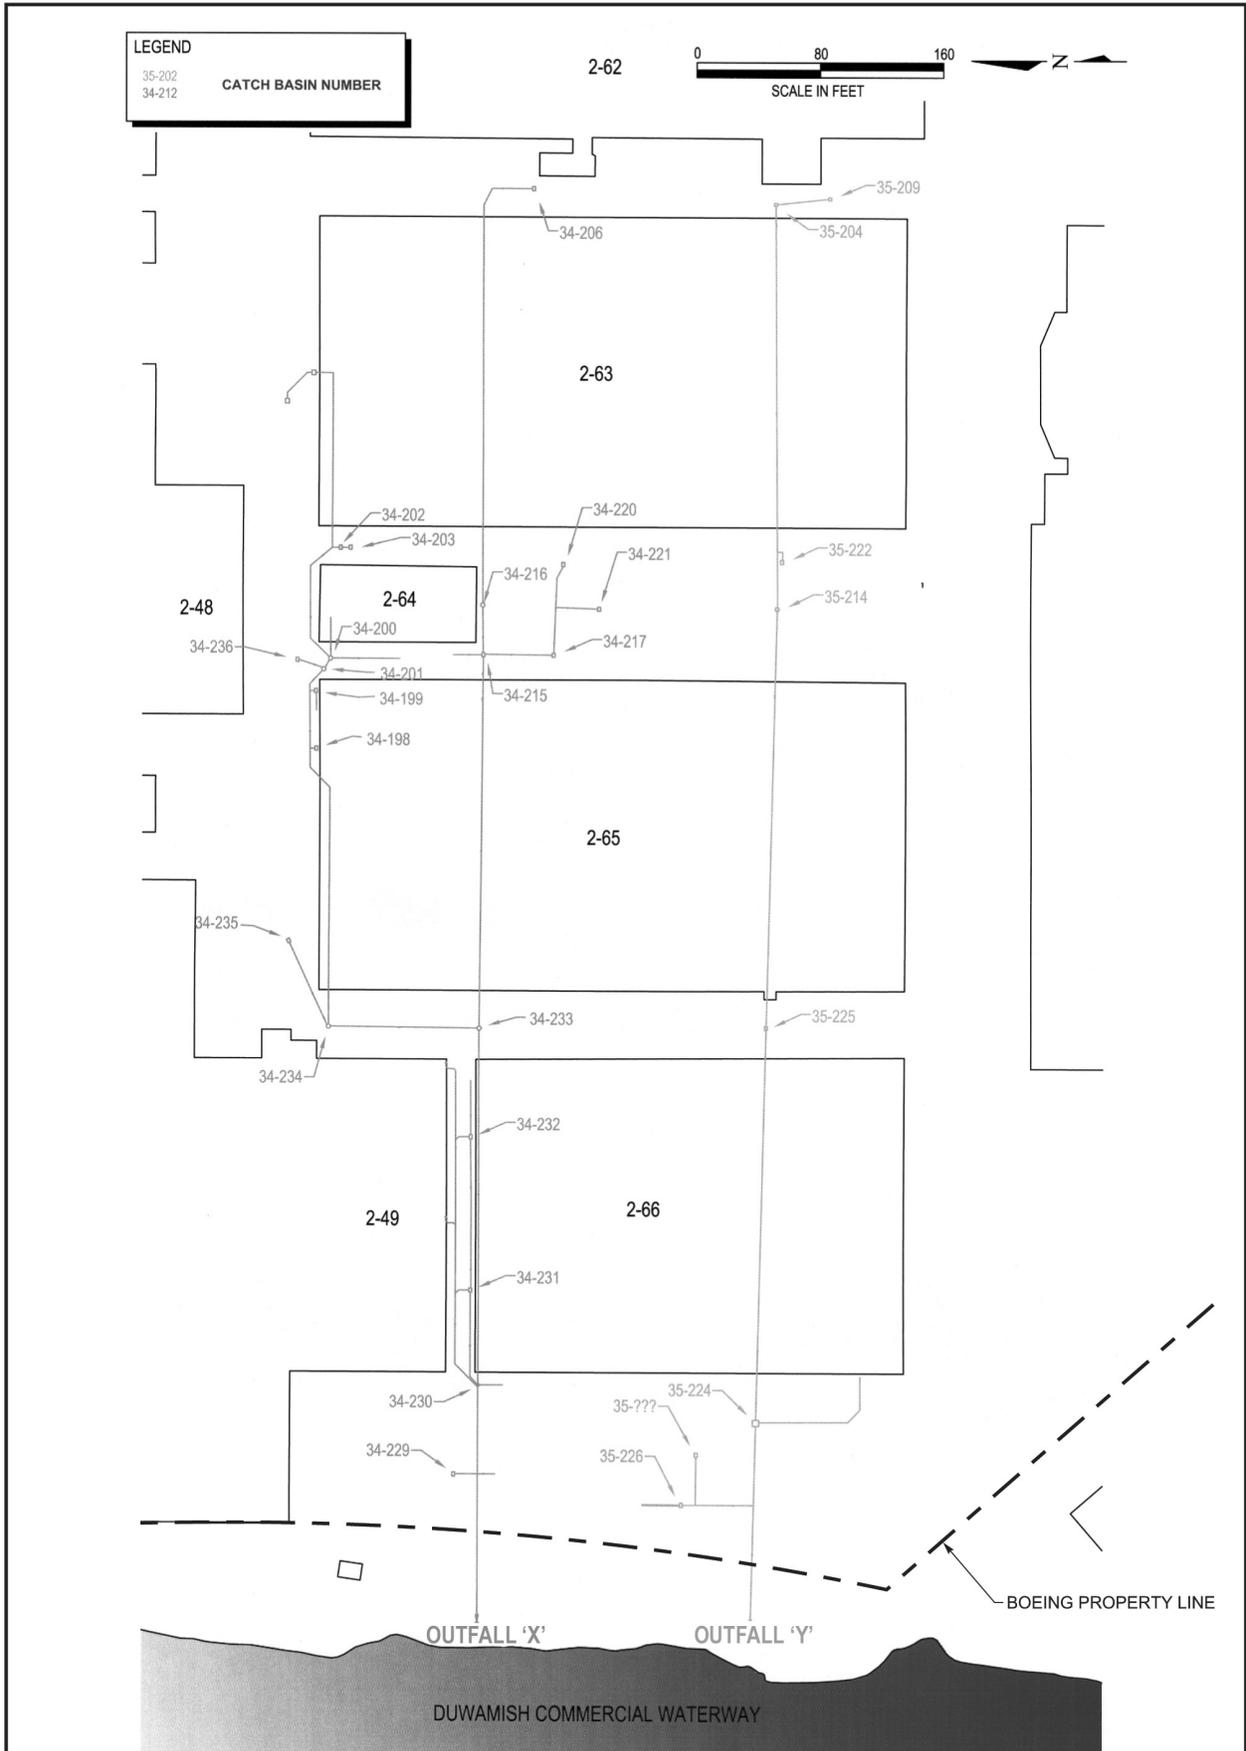
Figure 21

BOEING PLANT 2 FACILITY  
STORMWATER LINES X AND Y

Stormwater lines X and Y previously collected stormwater in the 2-60s and 2-66 CMS study areas, which housed buildings 2-66, 2-65, 2-64, 2-63 and 2-62 (Figure 21). These subject buildings, with the exception of Building 2-64, were removed in recent years, and all that remains are concrete slabs, asphalt paved areas, and stormwater drains. The removal work in 2-66 Area was completed in May 2007. Beginning in January 2006, a temporary stormwater collection and treatment system was installed to replace the drainage capacity of lines X and Y. This construction activity resulted in the temporary sealing of the surface of all the catch basins and manholes on lines X and Y, removing those lines from

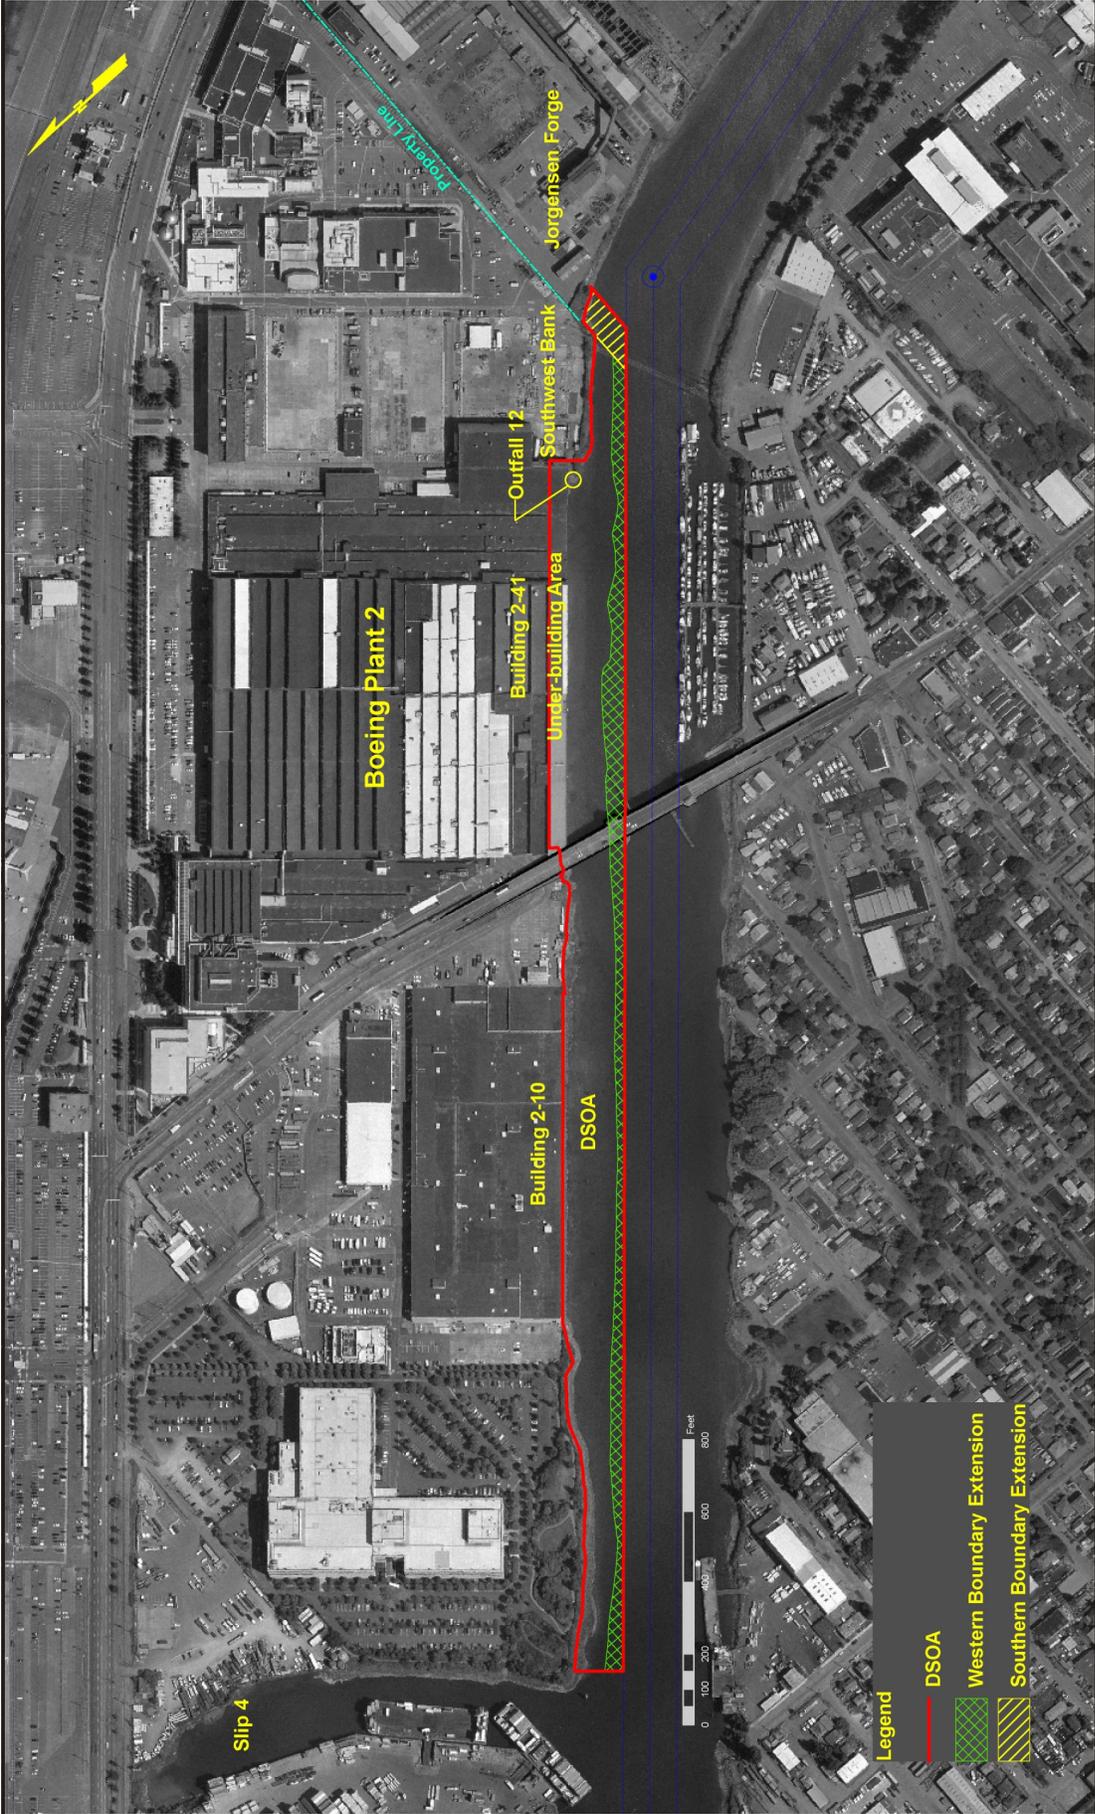
Figure 22

BOEING PLANT 2 FACILITY  
 LOCATION OF DUWAMISH SEDIMENT OTHER AREA AND  
 SOUTHWEST BANK CORRECTIVE MEASURE

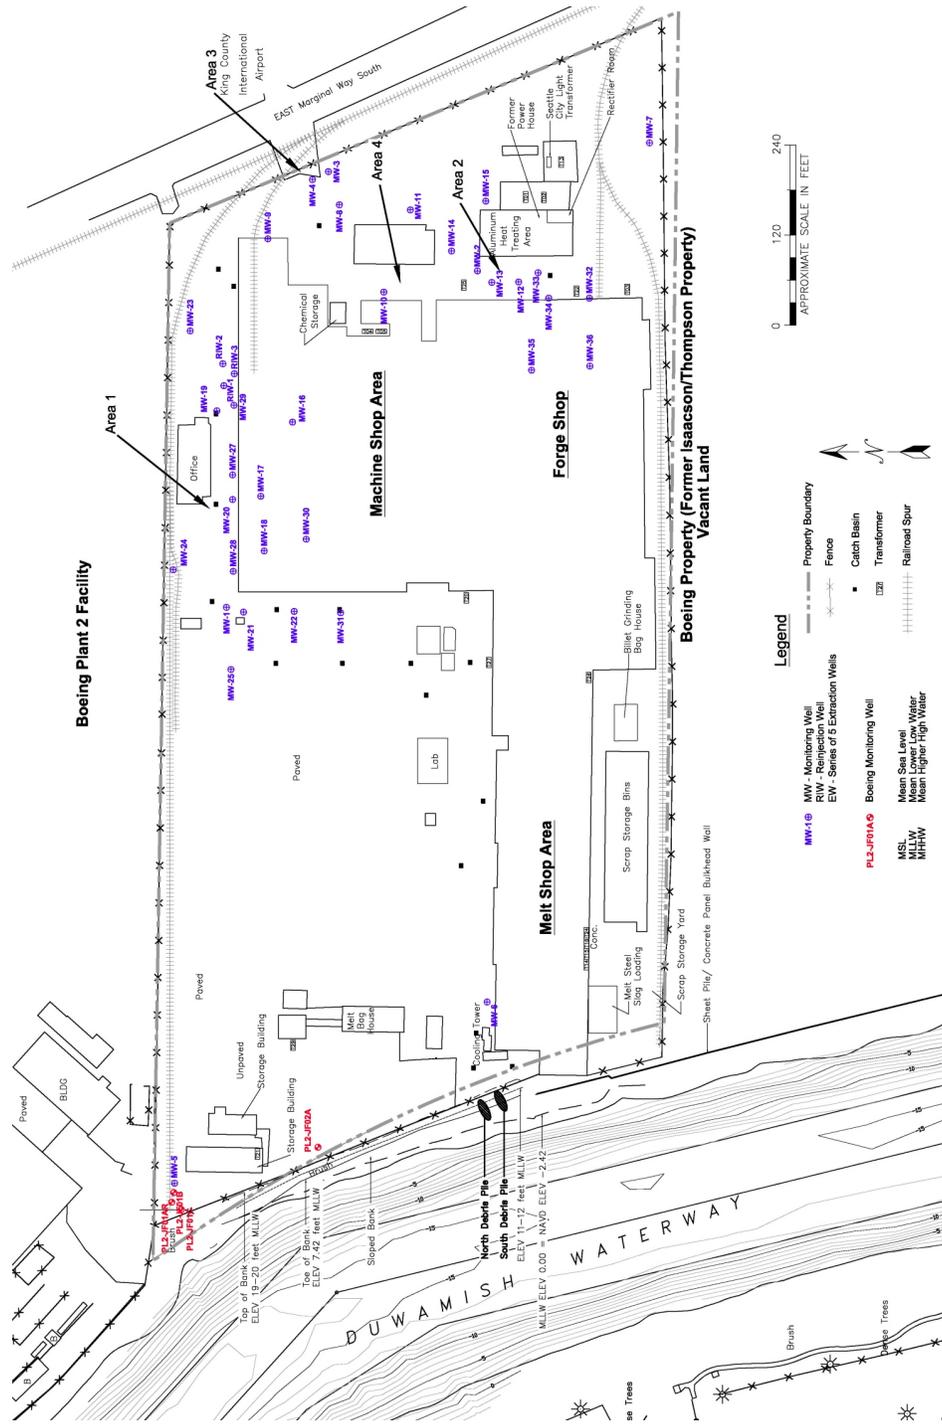
Figure 23  
 JORGENSEN FORGE FACILITY  
 LOCATION OF MONITORING WELLS

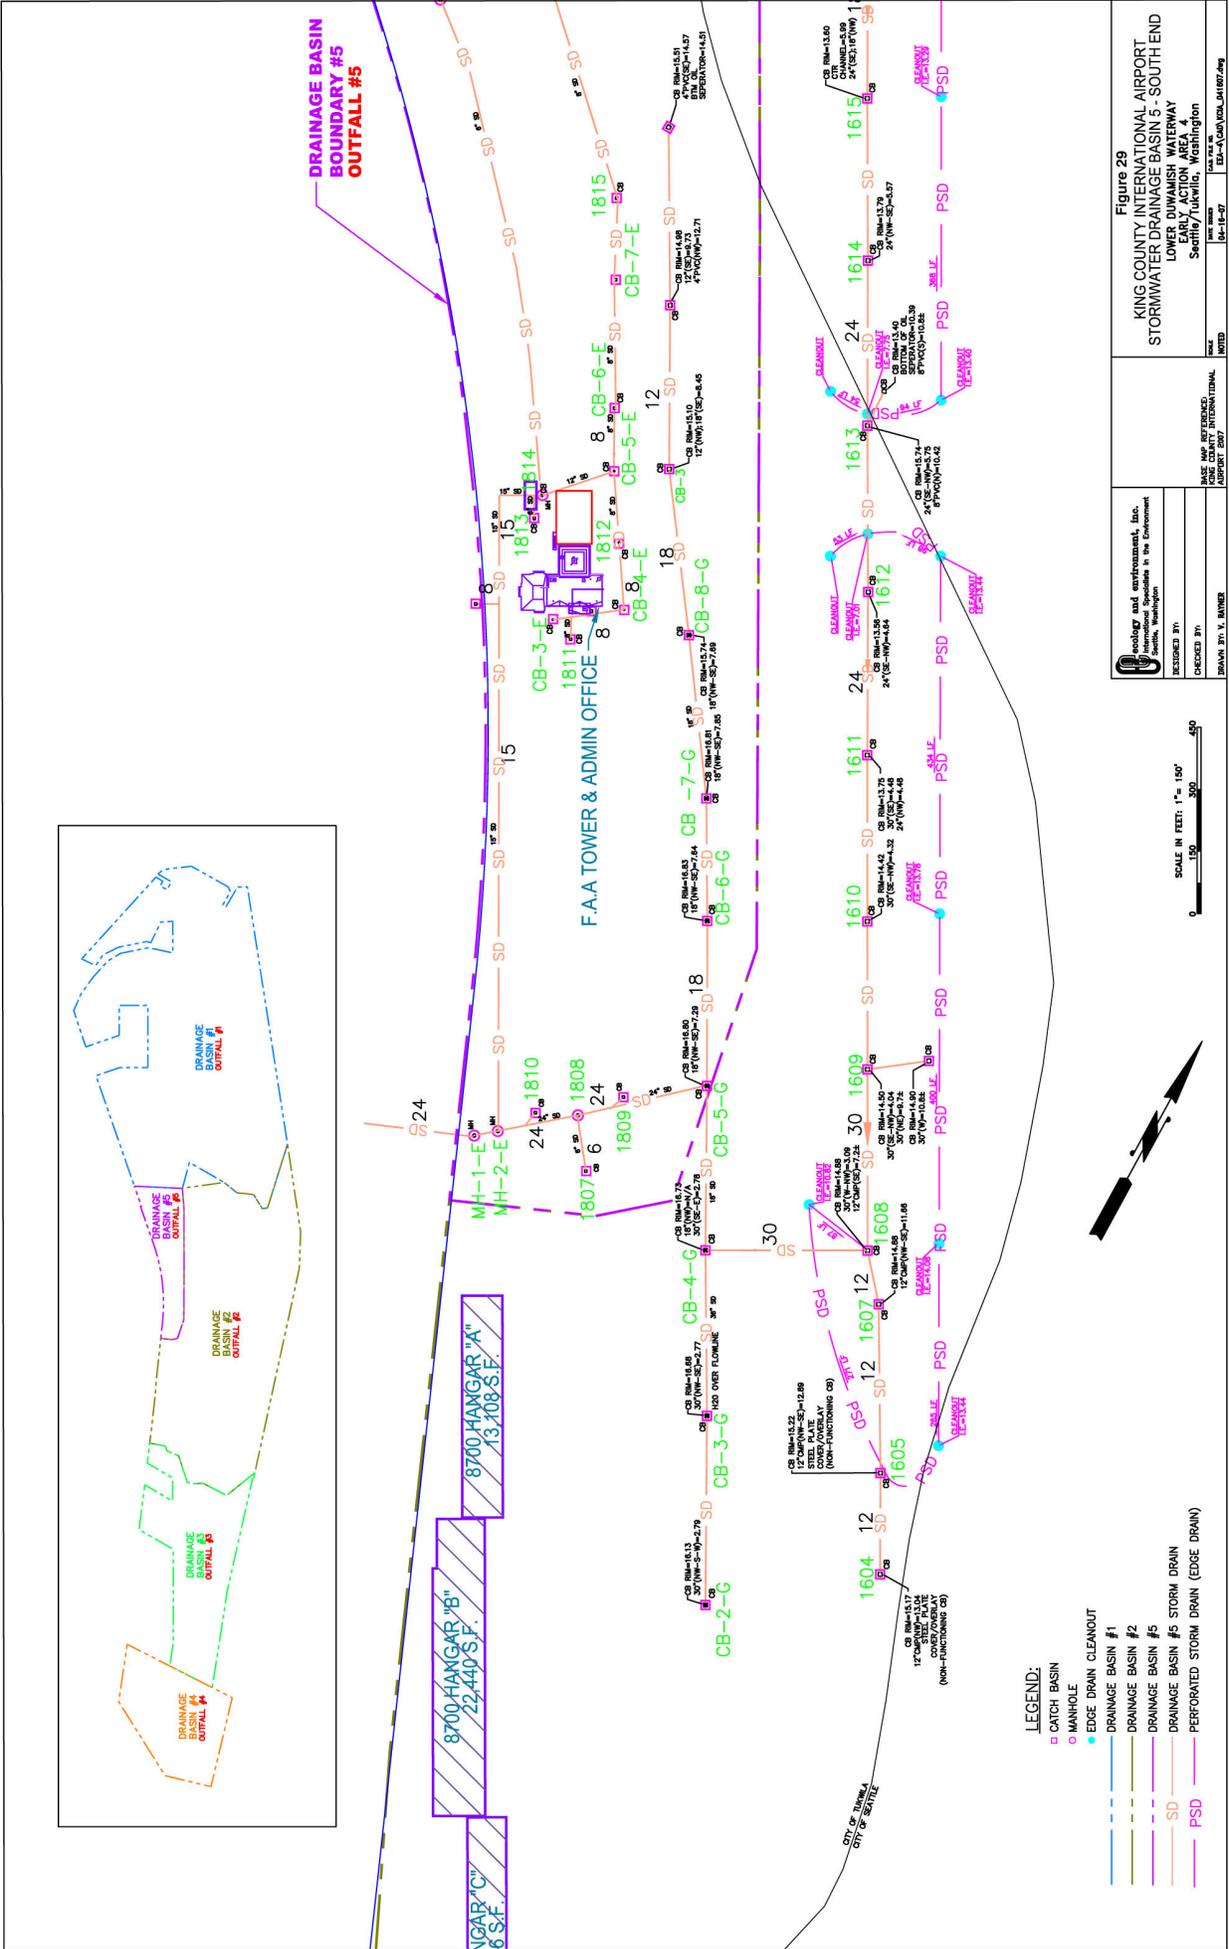
**Figure 29**  
**KING COUNTY INTERNATIONAL AIRPORT**  
**STORMWATER DRAINAGE BASIN 5 - SOUTH END**  
**LOWER OLYMPIA WATERWAY**  
**EARLY ACTION AREA 4**  
 Seattle/Tukwila, Washington

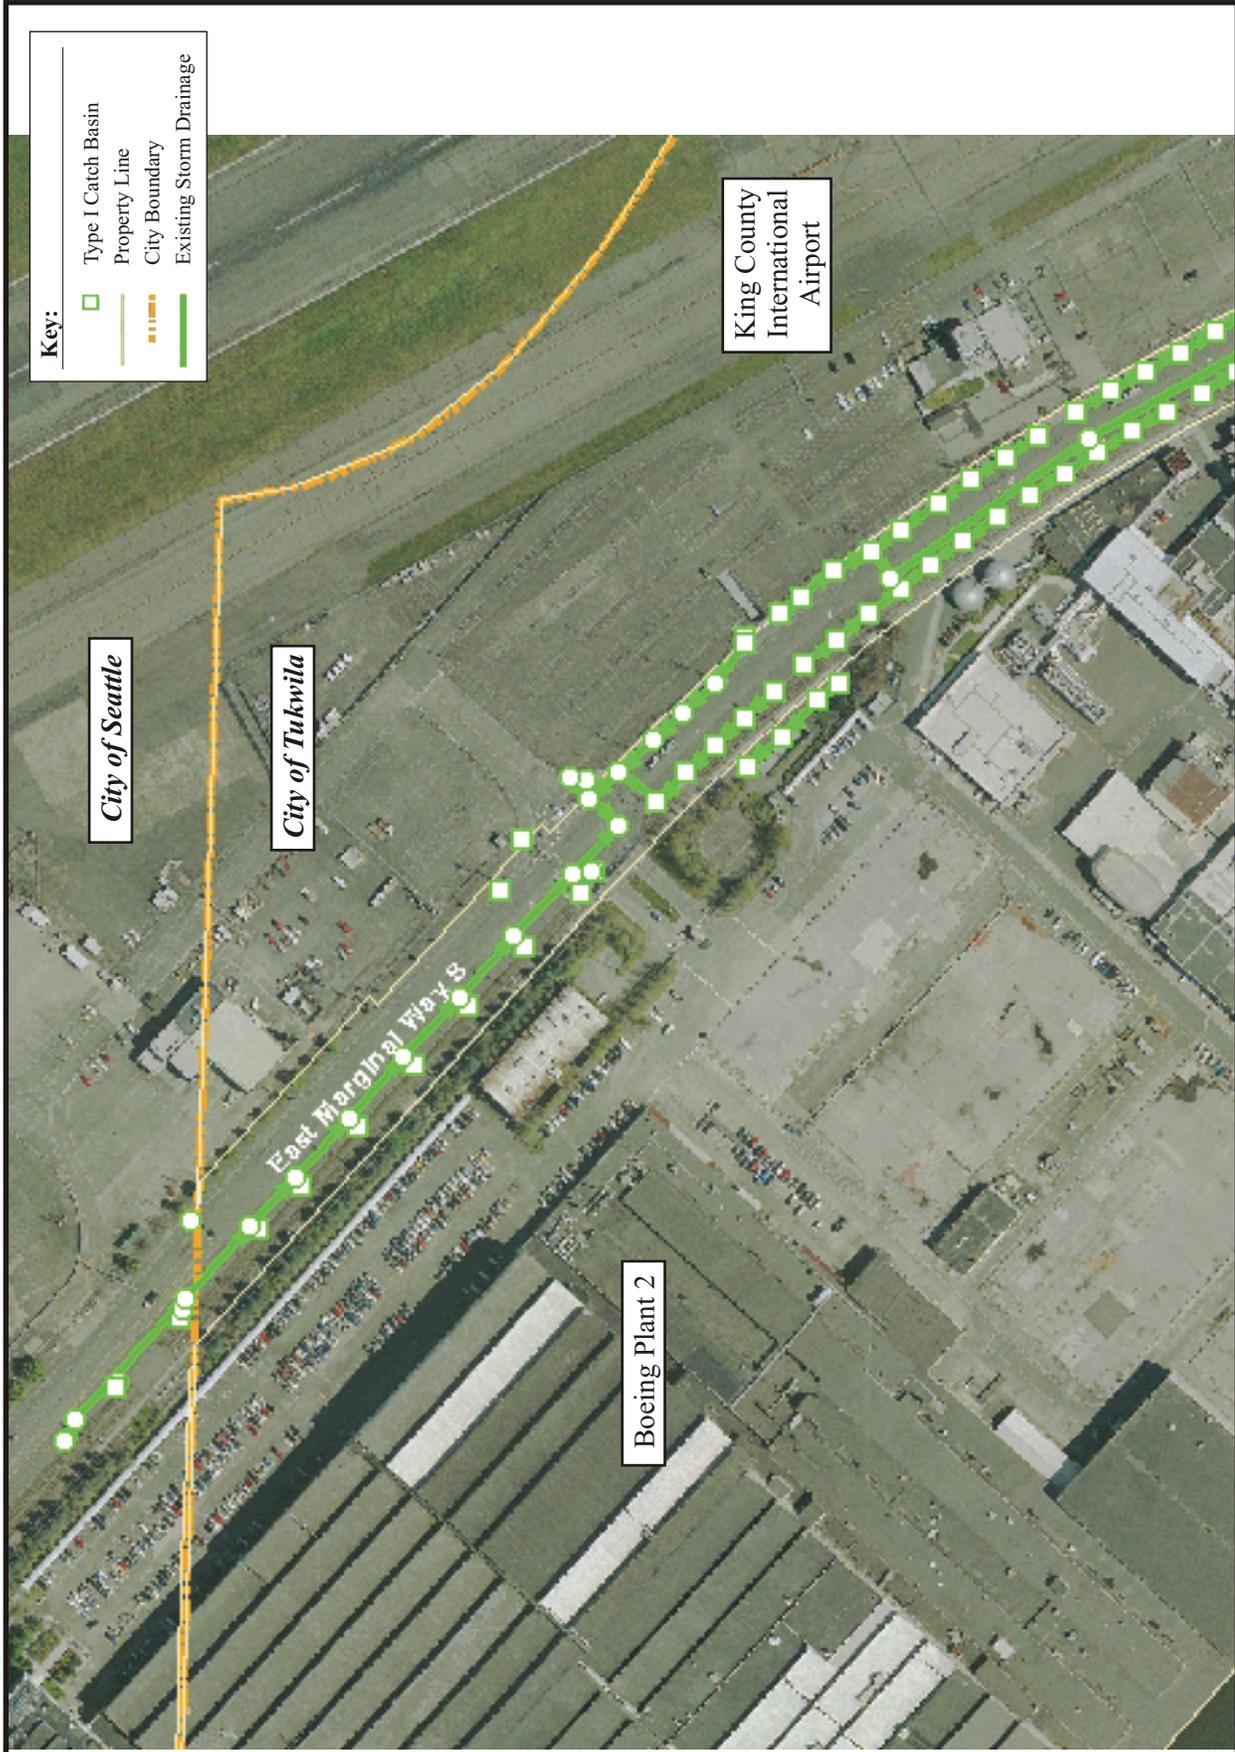
Figure 31

**EAST MARGINAL WAY SOUTH  
CITY OF TUKWILA STORMWATER  
DRAINAGE SYSTEM - NORTH PORTION**
