# **Lower Duwamish Waterway Source Control Action Plan for Early Action Area 4**

December 2007

Publication No. 07-09-004

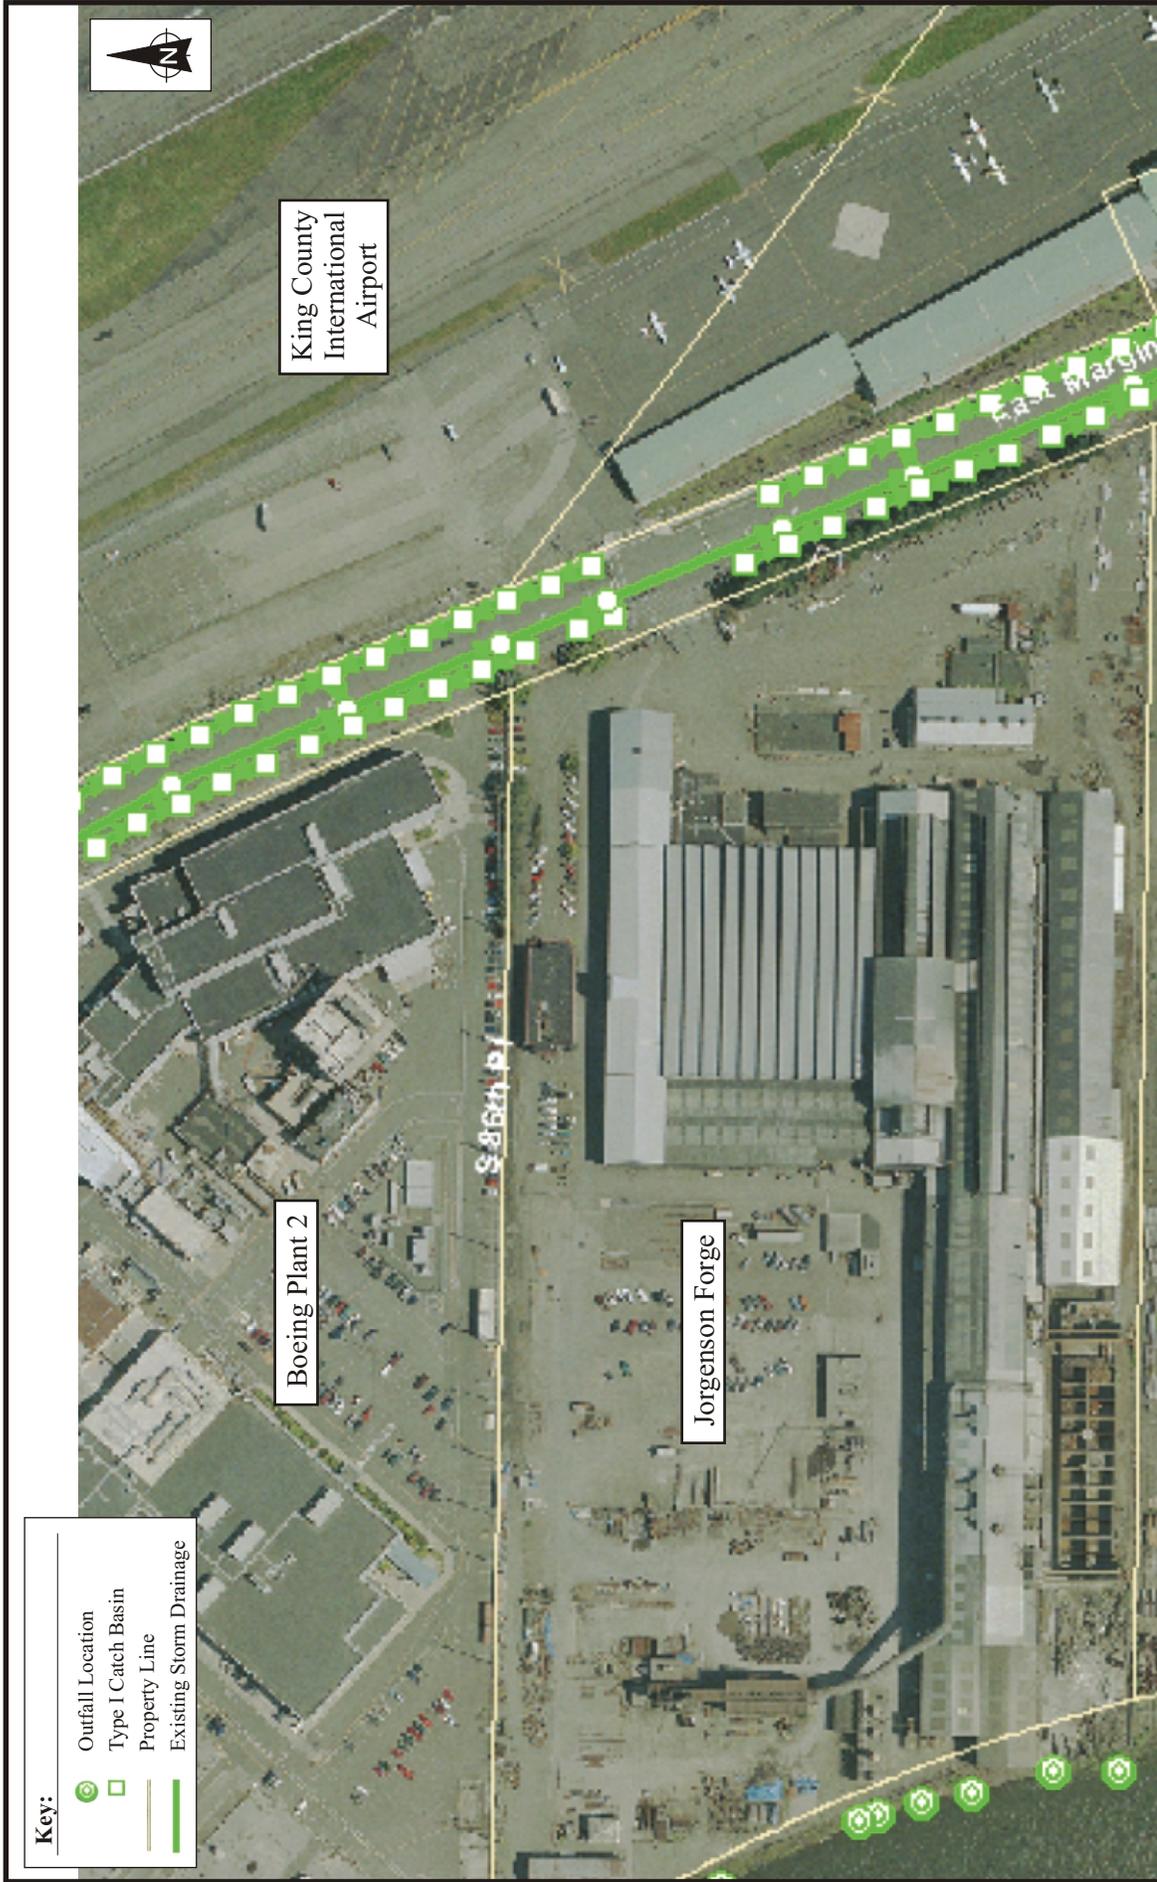
Figure 32

**EAST MARGINAL WAY SOUTH  
CITY OF TUKWILA STORMWATER  
DRAINAGE SYSTEM - SOUTH PORTION**

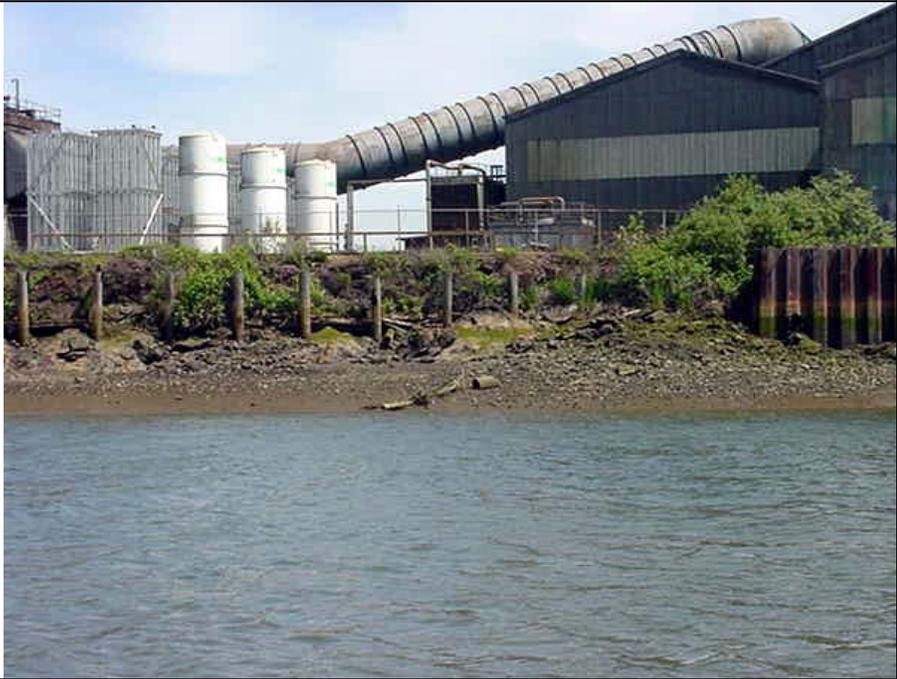
<b>EAA-4 PHOTOGRAPHIC LOG: 1</b>	
<b>Client name:</b> WA Dept. of Ecology	<b>Site Location:</b> Jorgensen bank along the Lower Duwamish Waterway
<b>Description:</b> View of the Jorgensen Forge from the LDW.

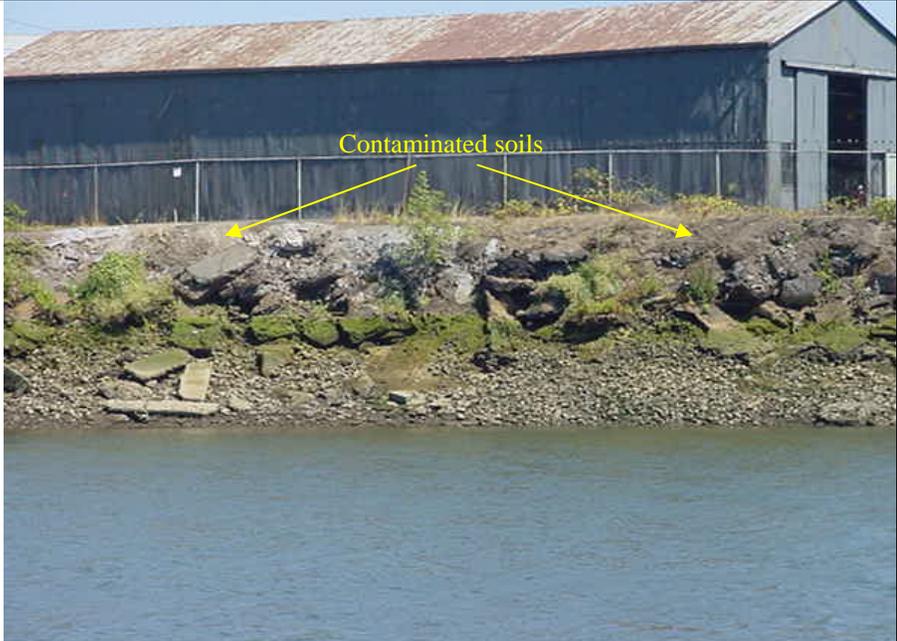
<b>EAA-4 PHOTOGRAPHIC LOG: 2</b>	
<b>Client name:</b> WA Dept. of Ecology	<b>Site Location:</b> Jorgensen bank along the Lower Duwamish Waterway
<b>Description:</b> Locations of contaminated soils along shoreline.

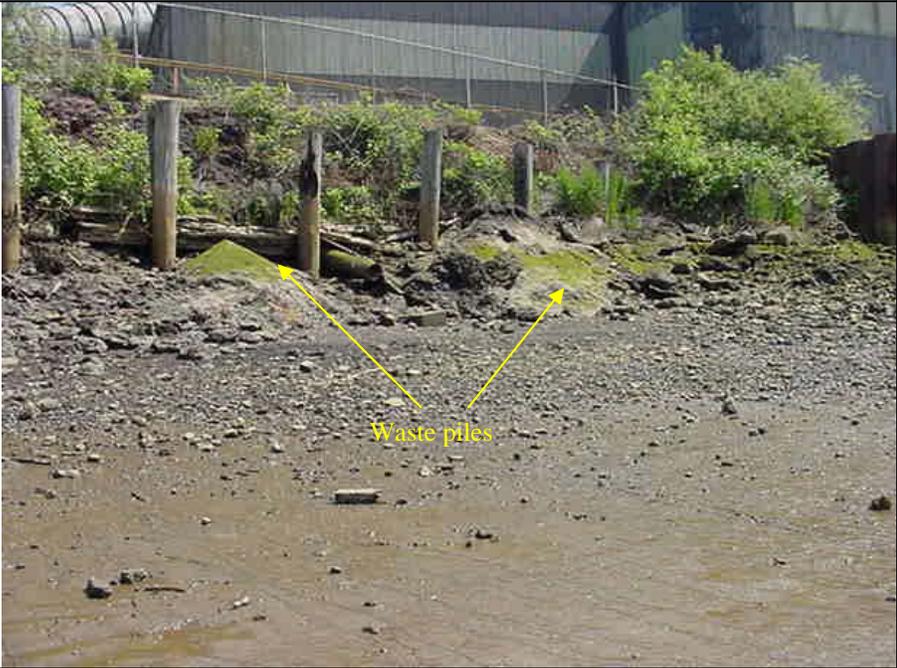
<b>EAA-4 PHOTOGRAPHIC LOG: 3</b>	
<b>Client name:</b> WA Dept. of Ecology	<b>Site Location:</b> Jorgensen bank along the Lower Duwamish Waterway
<b>Description:</b> PCB-containing waste piles, along the Jorgensen shoreline.

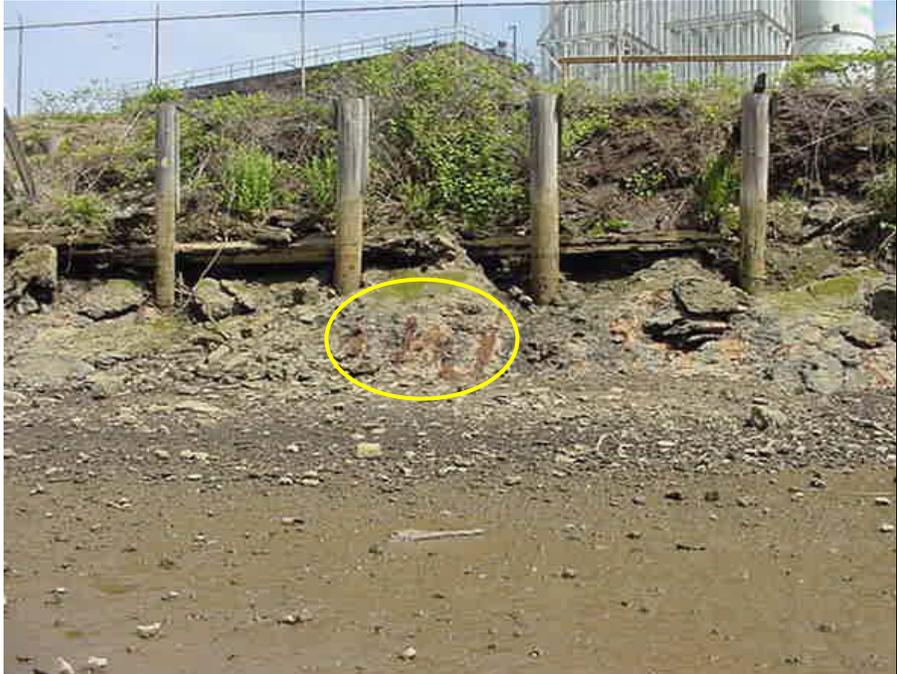
<b>EAA-4 PHOTOGRAPHIC LOG: 4</b>	
<b>Client name:</b> WA Dept. of Ecology	<b>Site Location:</b> Jorgensen bank along the Lower Duwamish Waterway
<b>Description:</b> Jorgensen Waste Piles. Scrap metal waste in circle.

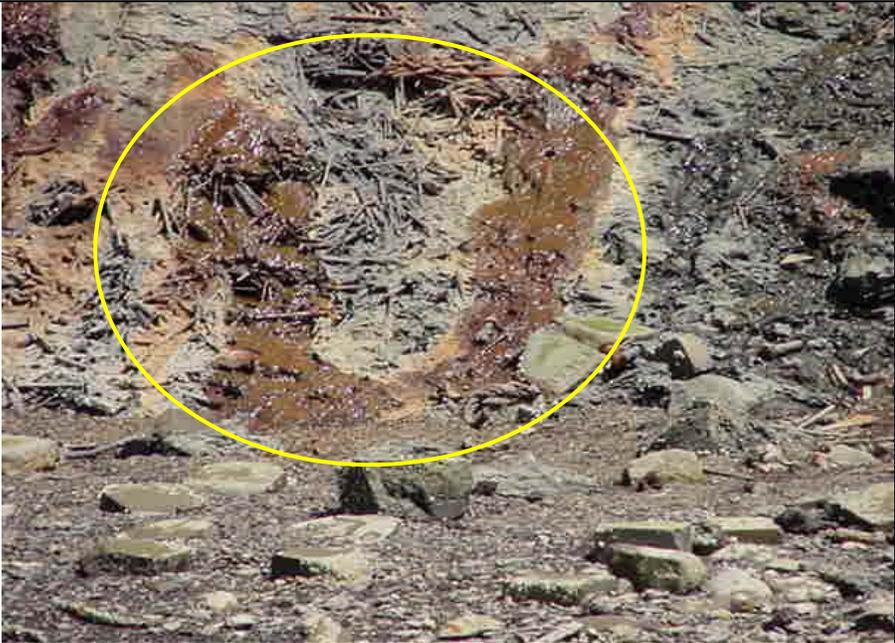
<b>EAA-4 PHOTOGRAPHIC LOG: 5</b>	
<b>Client name:</b> WA Dept. of Ecology	<b>Site Location:</b> Jorgensen bank along the Lower Duwamish Waterway
<b>Description:</b> Close up of scrap metal waste
