# PUBLIC REVIEW REMEDIAL INVESTIGATION AND FEASIBILITY STUDY REPORT

TRUCK CITY SITE

*Prepared for*  
**SKAGIT COUNTY**  
MOUNT VERNON, WASHINGTON  
*November 11, 2014*  
*Project No. 0714.02.02*

*Prepared by*  
*Maul Foster & Alongi, Inc.*  
*1329 North State Street, Suite 301*  
*Bellingham, WA 98225*

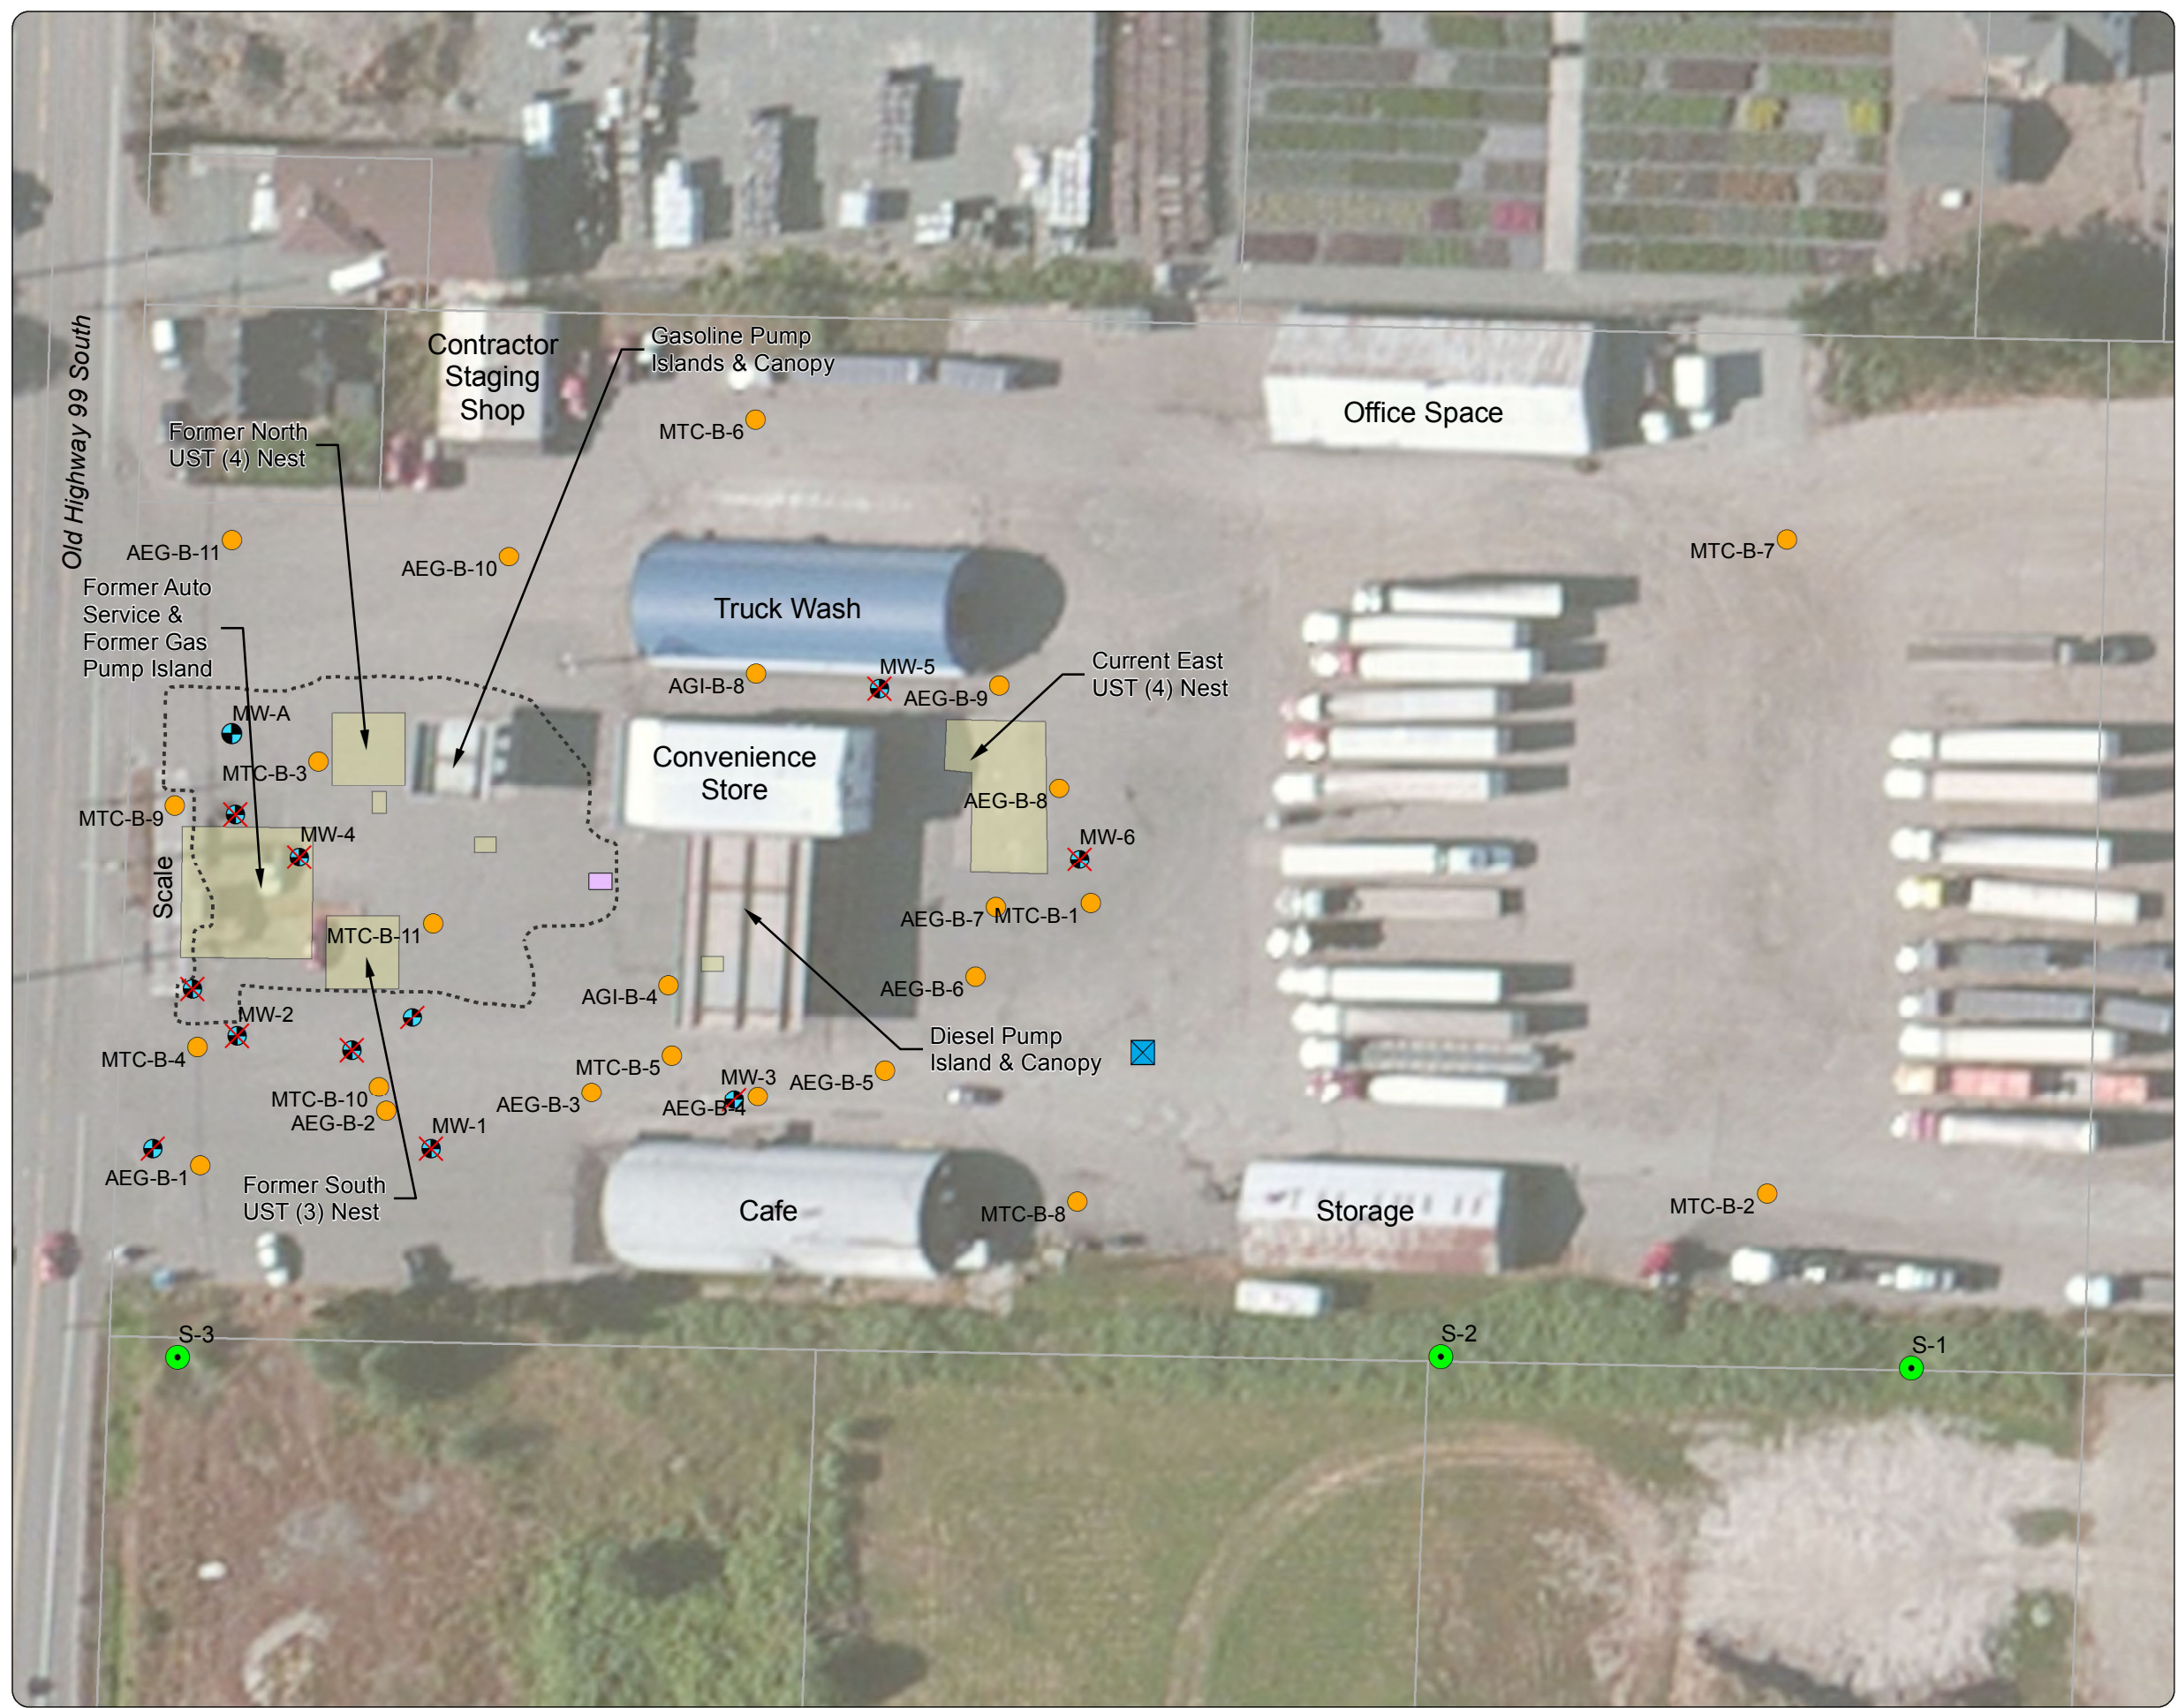
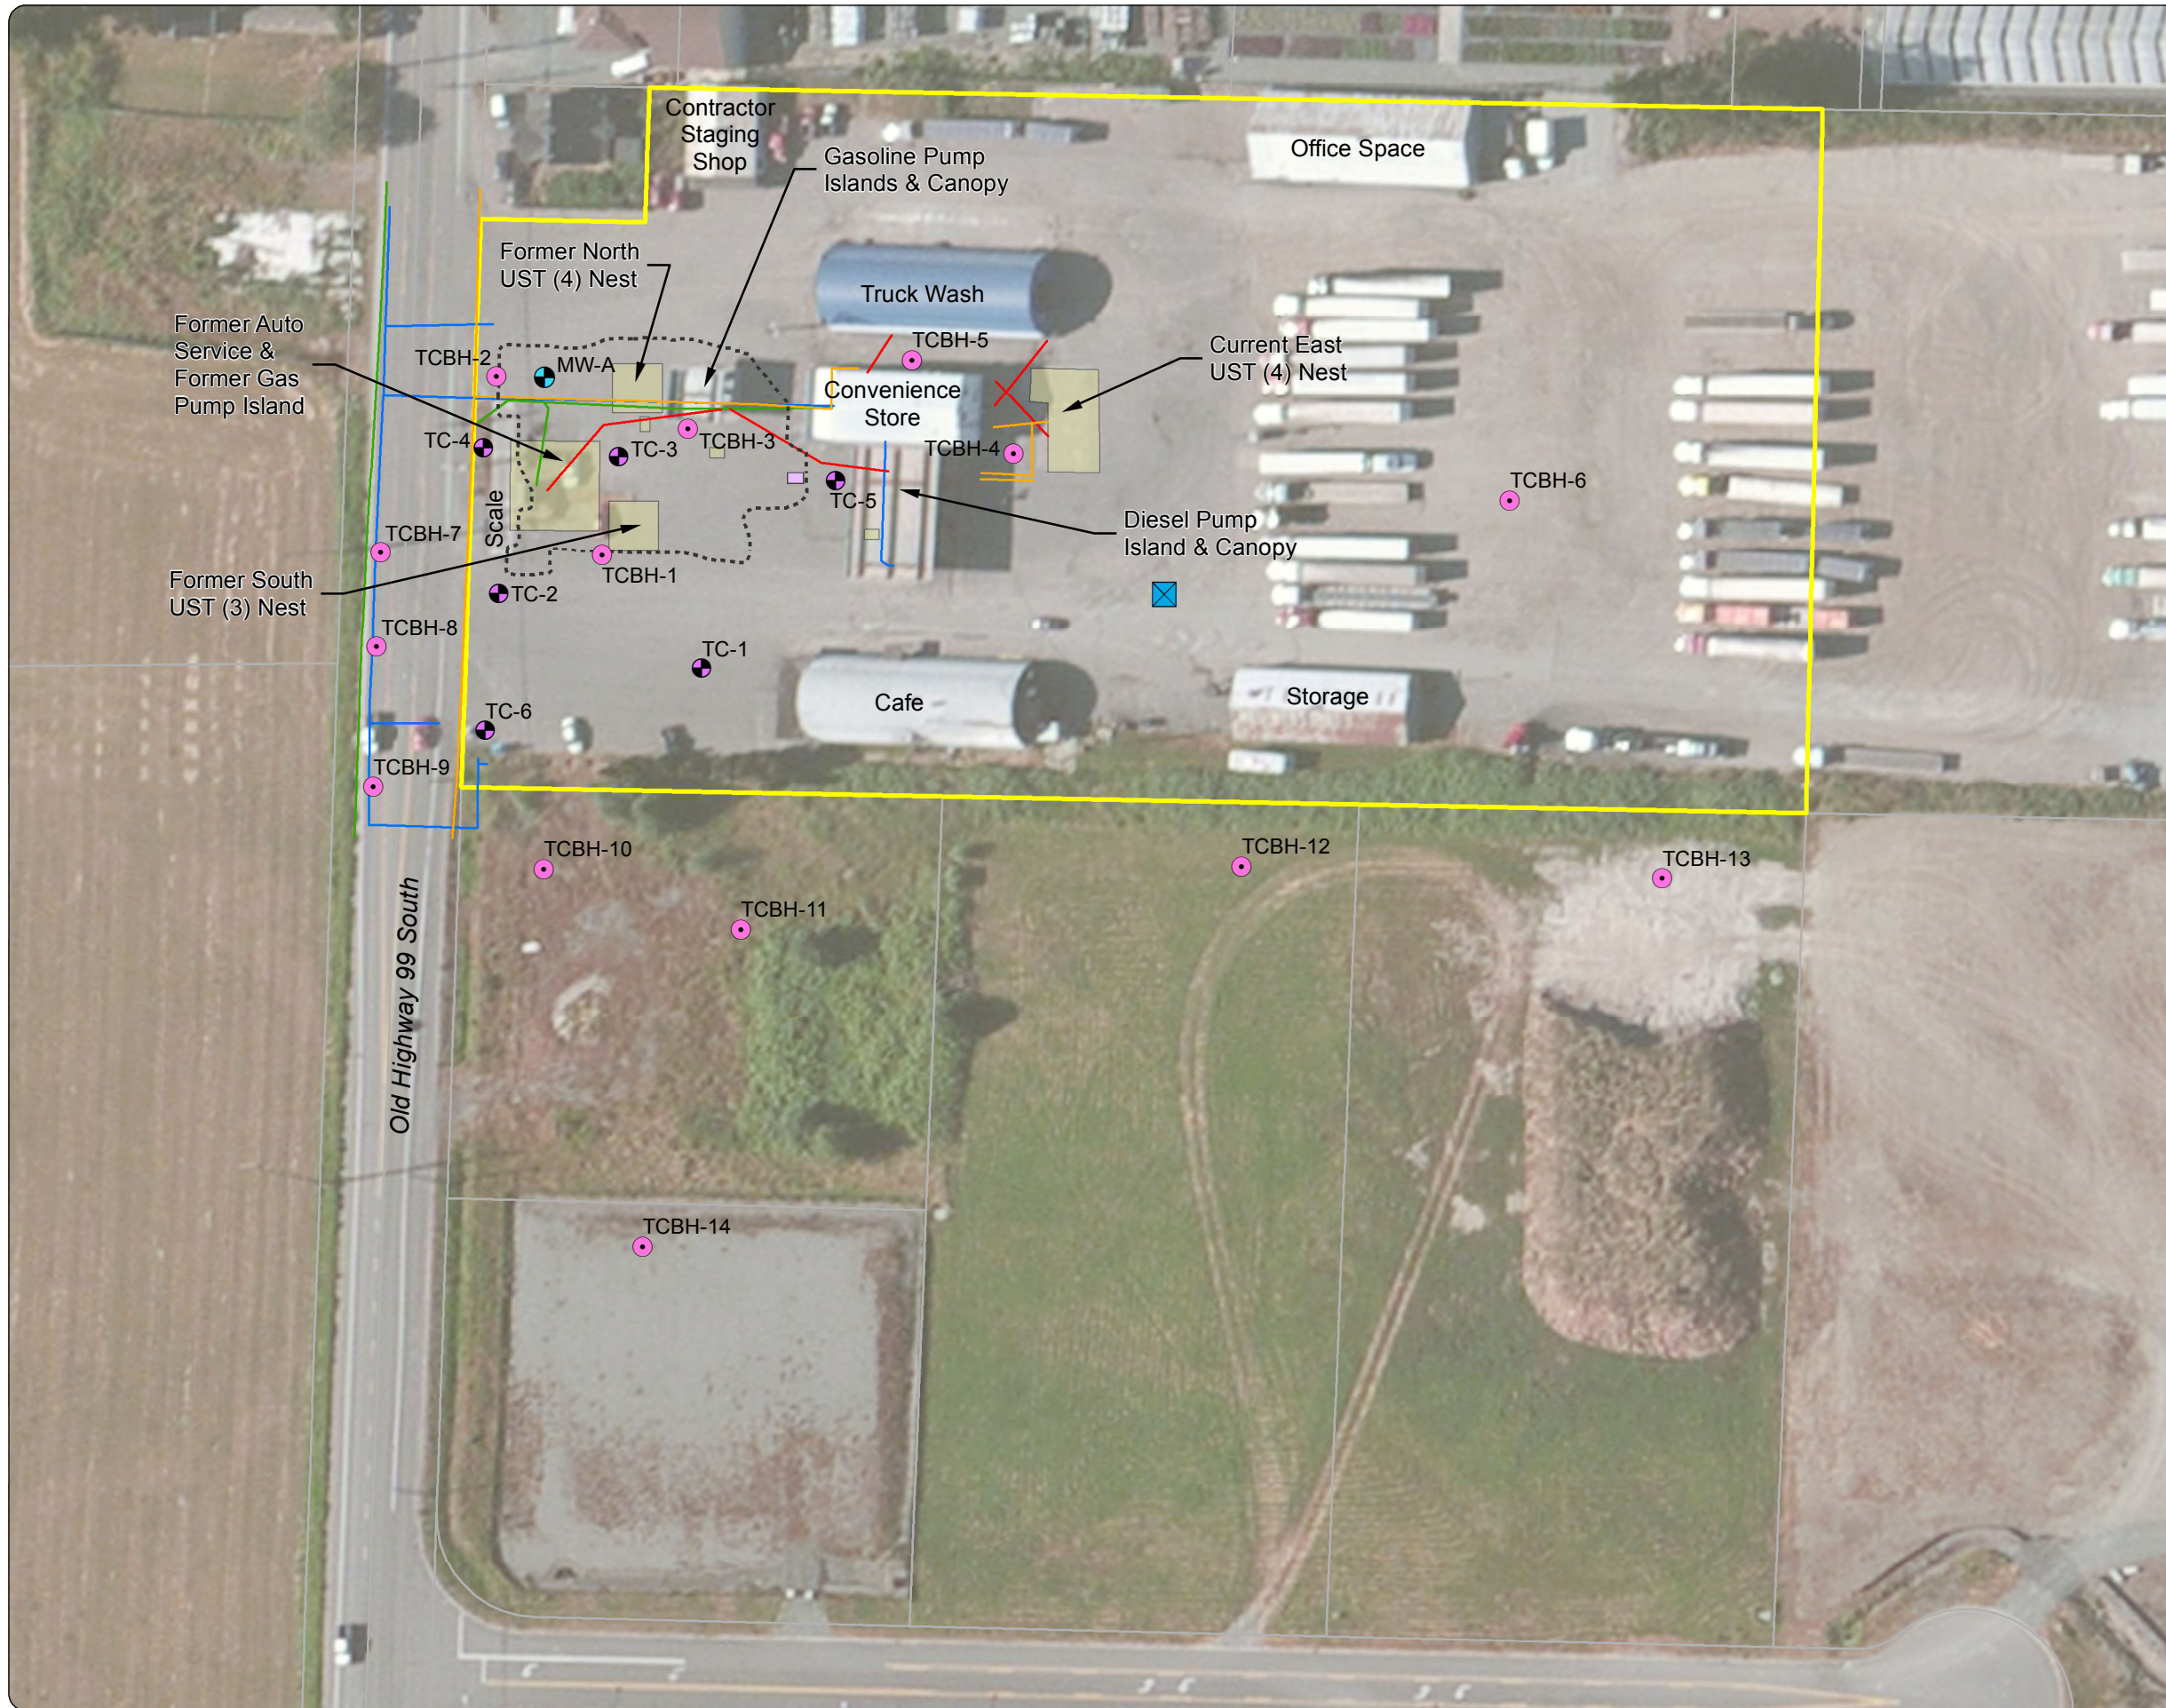
**Figure 4**  
**Site Features and**  
**Locations of Investigations**

The investigations included collection of groundwater and soil samples at the following locations (see Figure 4).

Fifteen former underground storage tank (UST) locations were identified at the Truck City parcel. Historical UST nests include the northern UST and southern UST nests, which had housed four USTs and three USTs, respectively (Figure 2). These USTs were decommissioned and removed in 1993 during an interim remedial action conducted by Ecology (Ecology, 1993). The USTs had a capacity of 5,000 gallons each. The current and only operational UST nest at the facility is the eastern UST nest, which houses three 5,000-gallon gasoline USTs and one 15,000-gallon diesel UST. This UST system was upgraded in 1998. Two 500-gallon USTs, located between the diesel pump islands and the gasoline pump islands, and a former septic tank, used as a waste oil tank, were also decommissioned and removed during the interim removal action. Additionally, a UST, of unknown size (and presumably a former heating oil tank), may be located beneath the retail store footprint. This UST reportedly was decommissioned in place. Figure 3 presents the Site's site features and previous environmental investigation features.

The gas station pump islands, fueling facilities, and truck scale (weigh station) are located in the western area of the Truck City parcel. The diesel pump islands and the Truck City parcel's current operational USTs are located in the central area of the parcel, adjacent south of the truck wash building. Long-term truck parking is designated in the east area of the parcel. Figure 4 presents the Site's current site features and recent investigation locations.

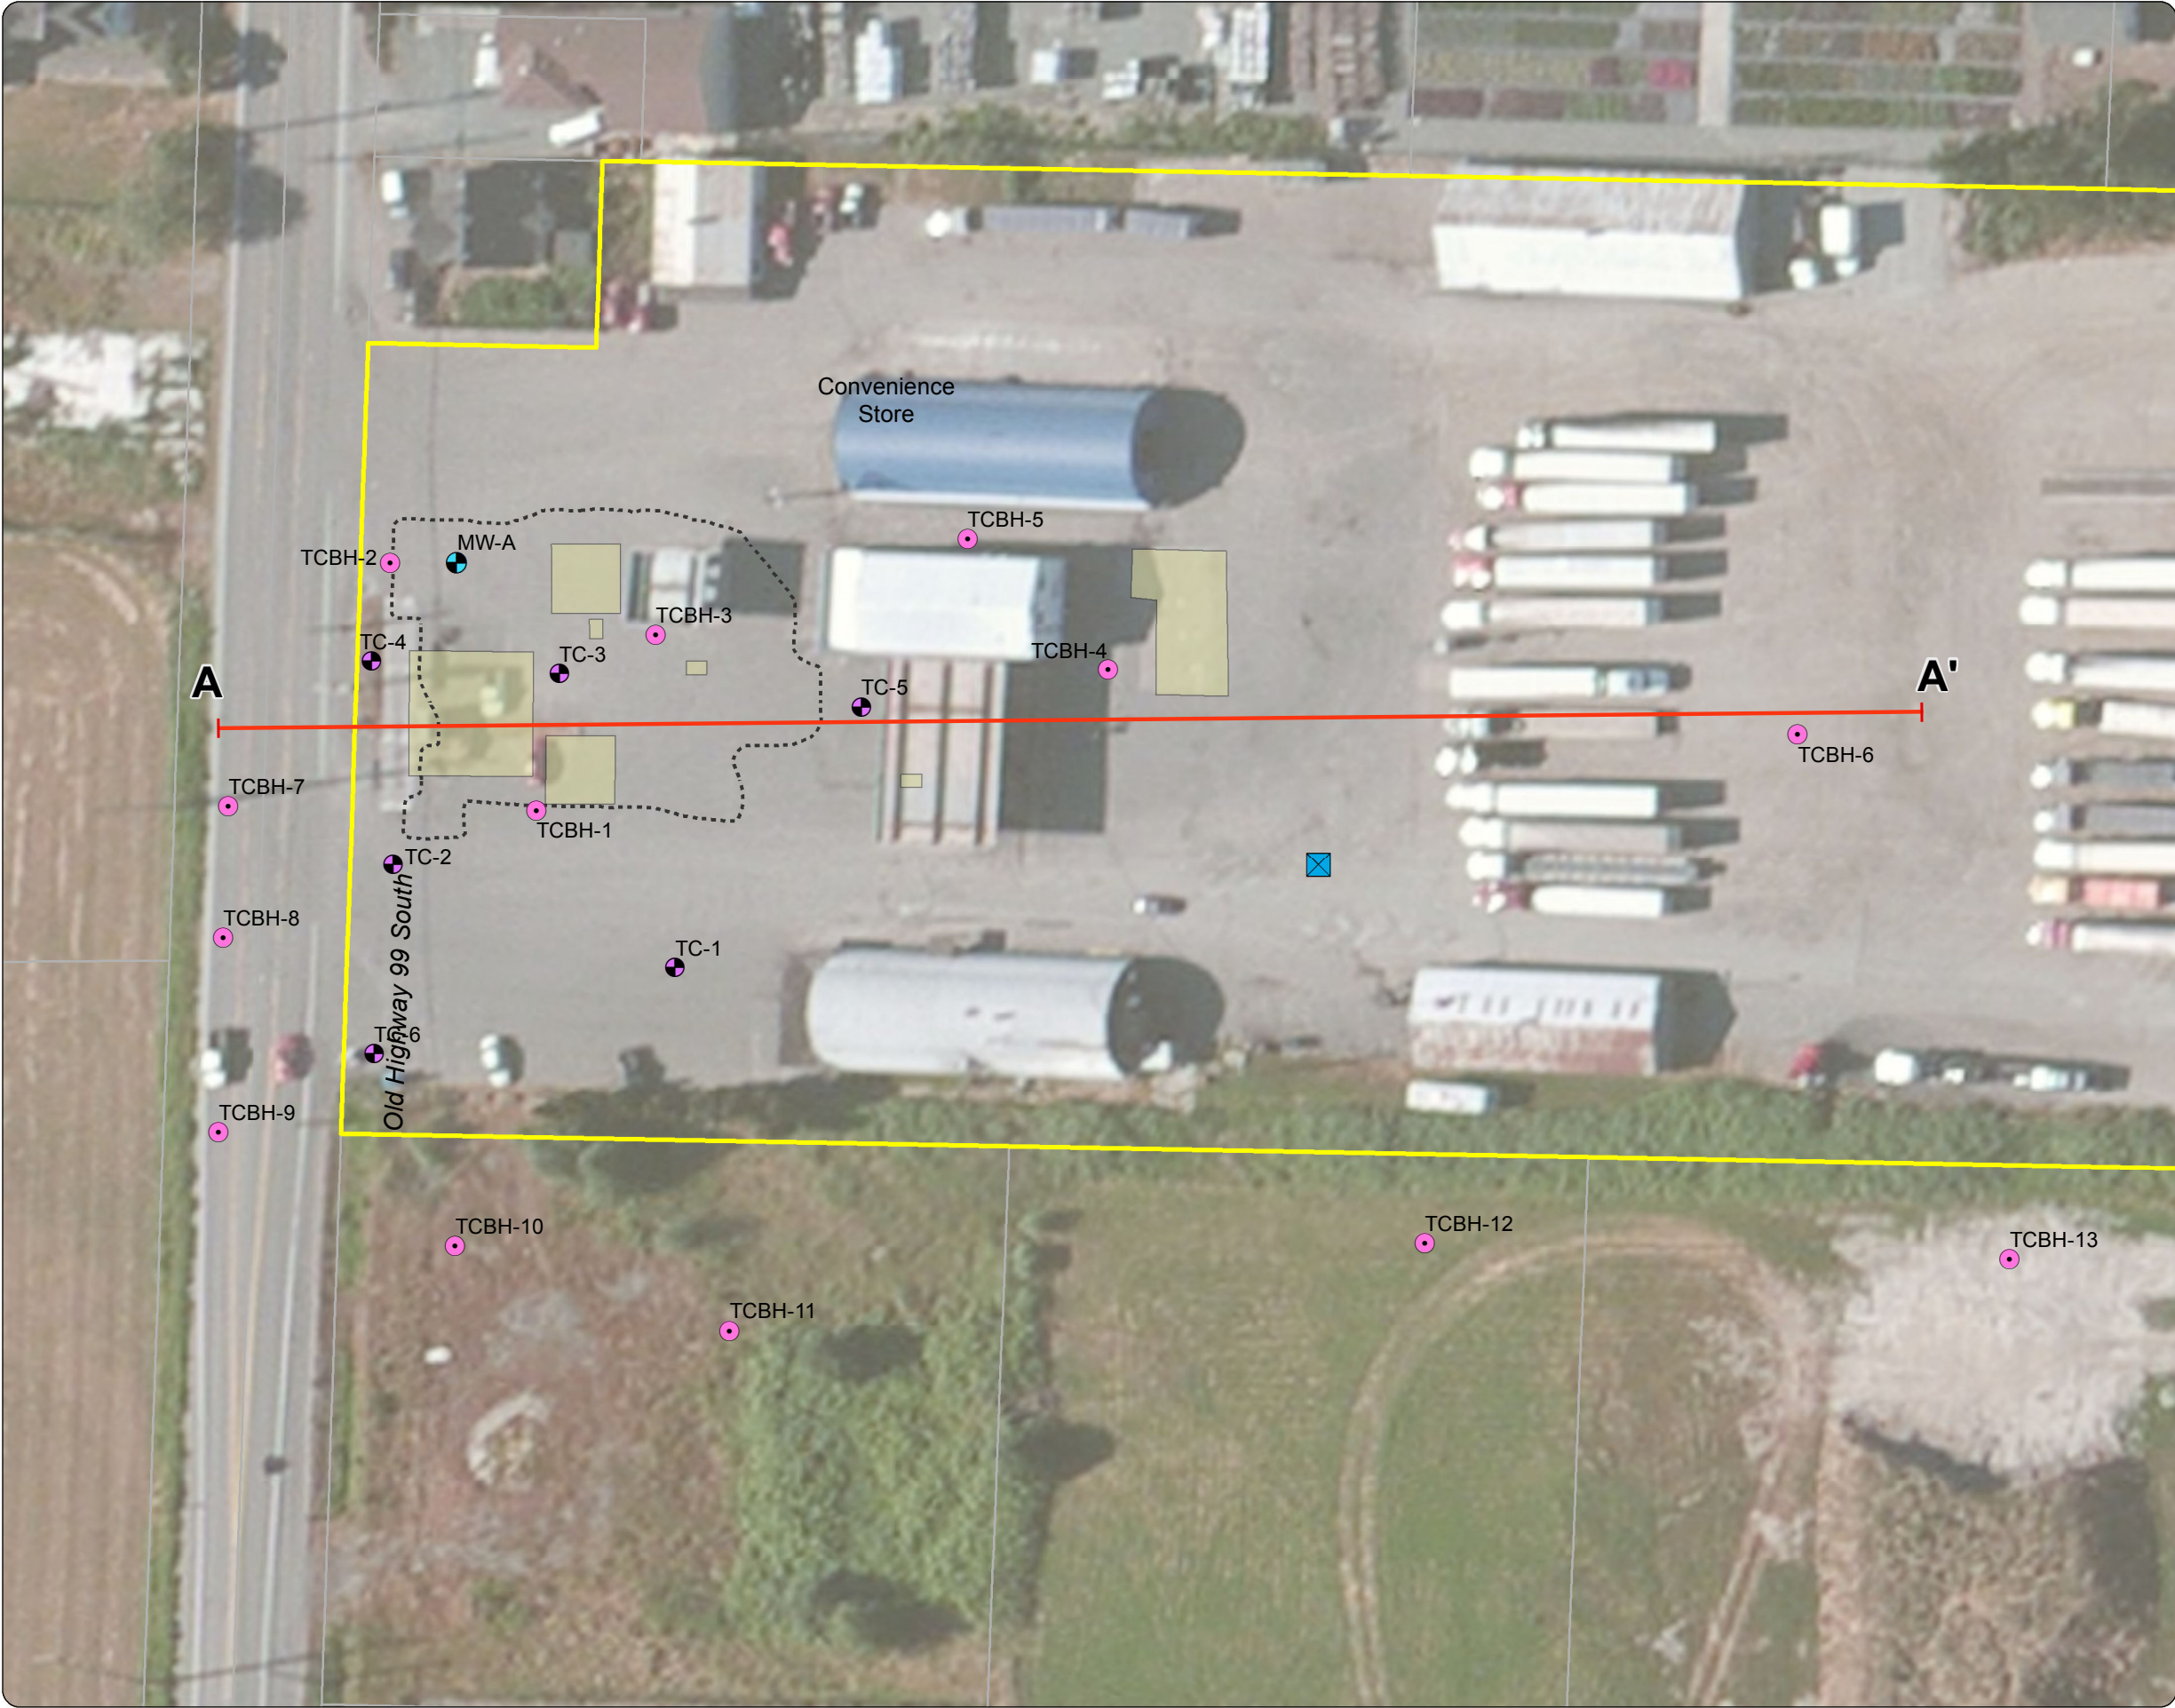
**Figure 5**  
**Cross Section Transect**  
Truck City Site  
Mount Vernon, Washington

The Site and vicinity have been mapped as recent alluvium and artificial fill. Alluvium deposits encountered at the Site, at locations of investigation, consist of floodplain sequences ranging from fluvial silty sand and well sorted sand, to silt with intervening clay. Fill, comprising sandy gravel to gravelly silty sand, was generally present to approximately 3 to 5 feet bgs at the Truck City parcel, except in the former UST nests, where soil remedial cleanup action by Ecology in 1993 overexcavated this area to depths of approximately 9.5 feet bgs. A cross section transect of the Site and corresponding geologic cross section are presented in Figures 5 and 6, respectively.

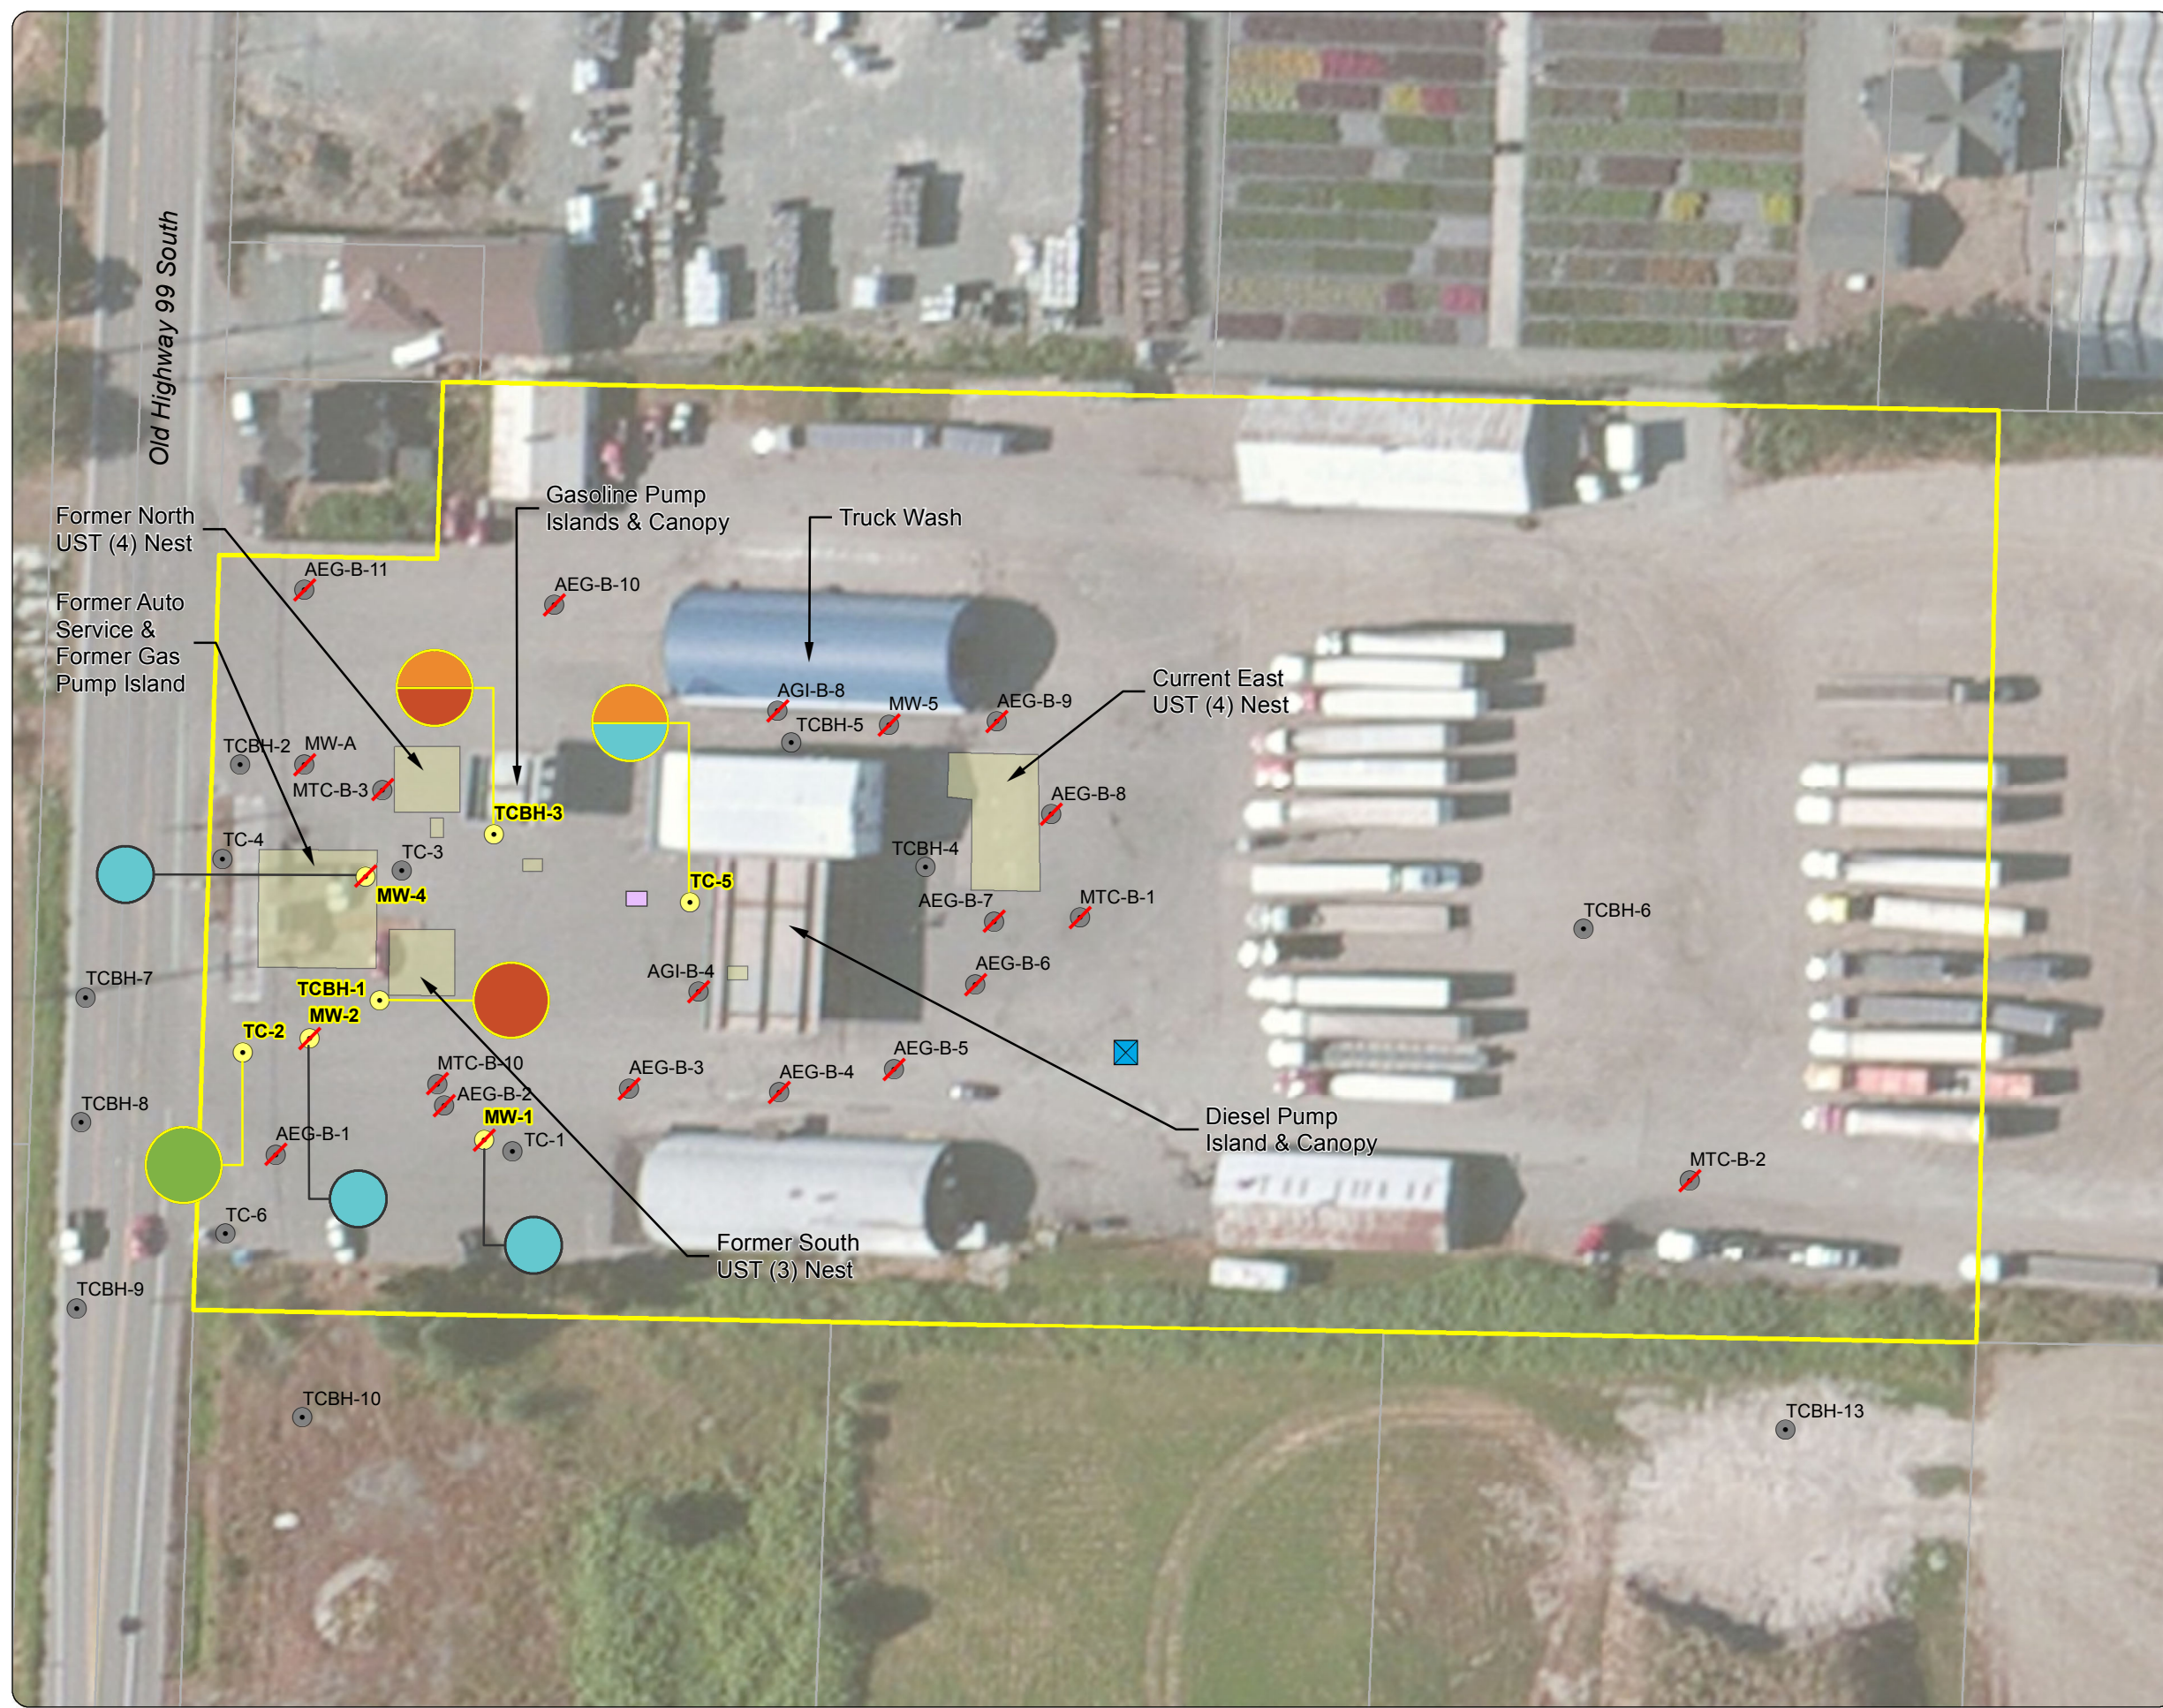
**Figure 10  
Groundwater  
Investigation Overview**

Truck City Site  
Mount Vernon, Washington

Gasoline-range TPH, at concentrations above the MTCA Method A CUL, were exhibited only at TCBH-3, TC-3, and TC-5 (380 to 1,900 micrograms per liter [ $\mu\text{g/L}$ ]). Elevated diesel-range TPH was detected only at TCBH-1 (790  $\mu\text{g/L}$ ). Elevated benzene was found only at TC-5 (22  $\mu\text{g/L}$ ). Additionally, arsenic (7.1  $\mu\text{g/L}$ ) was the only metal (total metals analysis) detected above the CUL; however, laboratory analysis for arsenic, as dissolved metals, indicated a detection of 1.37  $\mu\text{g/L}$ . Hence, it appears that the turbid groundwater sample with a heavy presence of sediments was the source of the elevated arsenic. The remaining COIs either were not detected or were detected at concentrations below their respective CULs (Table 2). The risk screening section (Section 6) includes a discussion of groundwater chemical detections compared to their respective CULs. Figure 10 presents an overview of the environmental investigation.
