REMEDIAL INVESTIGATION AND FEASIBILITY STUDY REPORT

TRUCK CITY SITE

Prepared for
SKAGIT COUNTY
MOUNT VERNON, WASHINGTON
January 5, 2015
Project No. 0714.02.02

Prepared by
Maul Foster & Alongi, Inc.
1329 North State Street, Suite 301
Bellingham, WA 98225

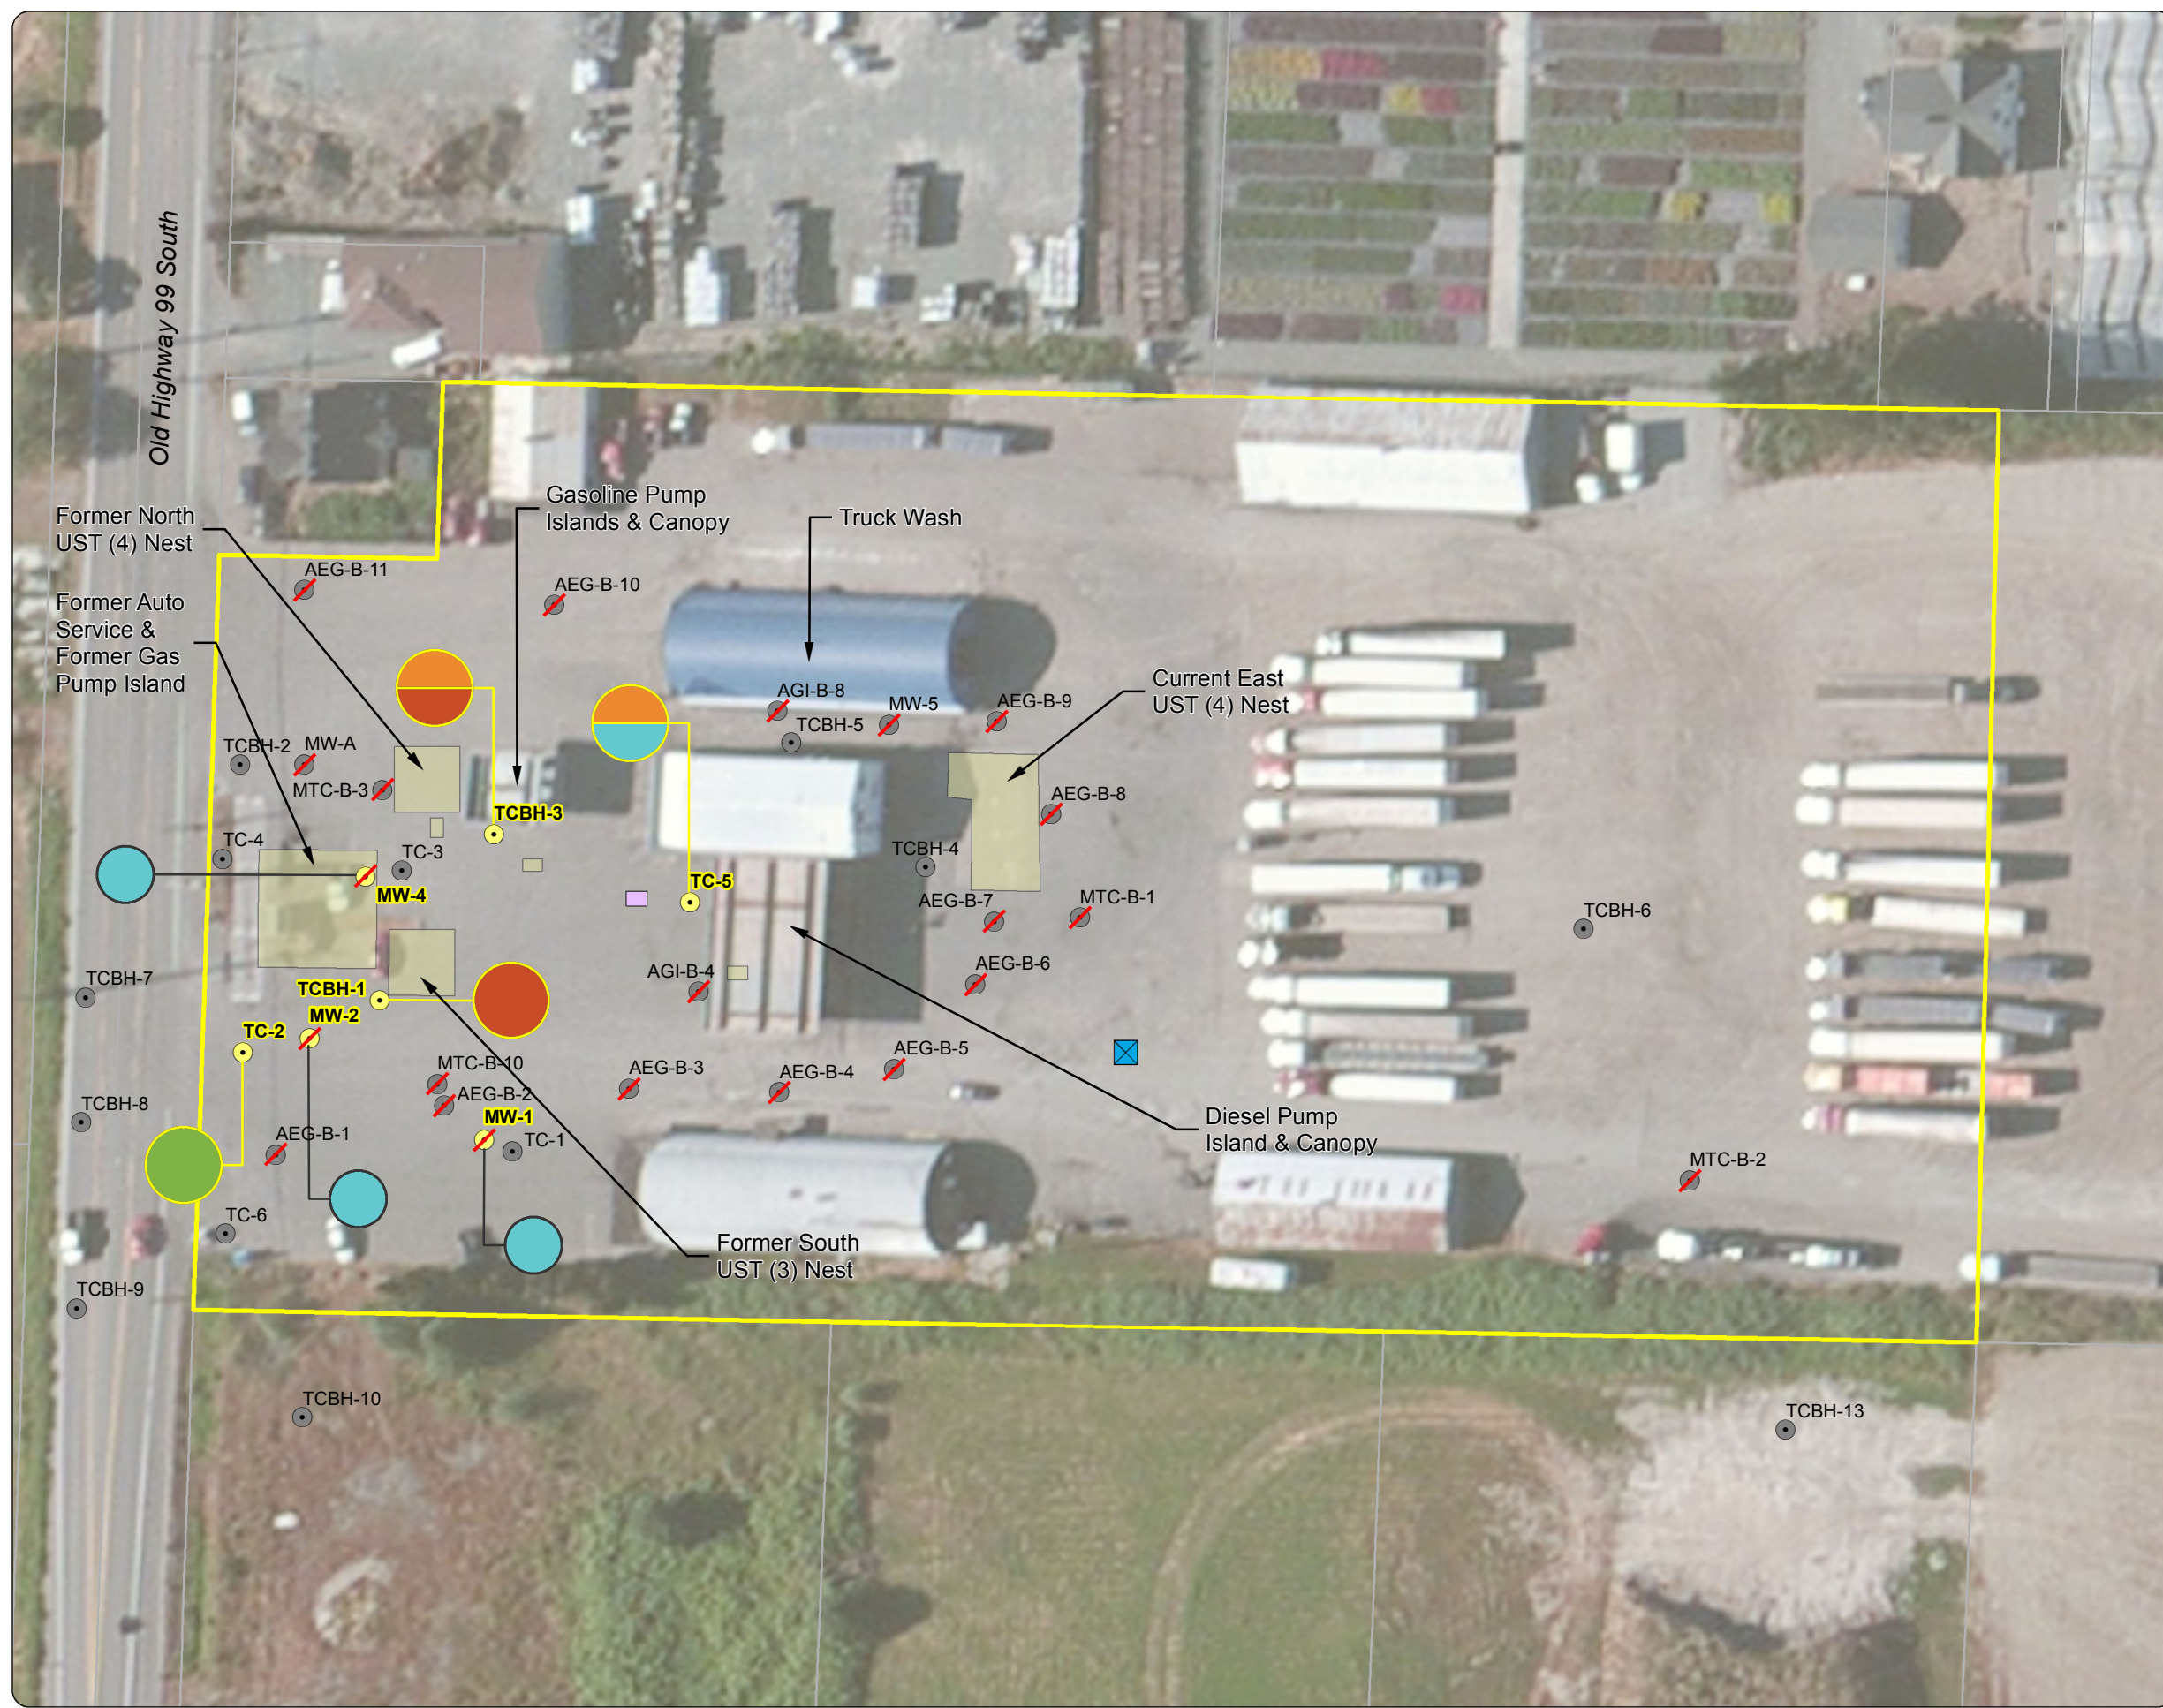
**Figure 10
Groundwater
Investigation Overview**

- Groundwater Exceedances**
- Gasoline TPH
 - Diesel TPH
 - Benzene
 - Arsenic¹

- Groundwater Exceedance MFA Borings/Wells: TCBH-1, TCBH-3, TC-2, TC-5.
- Historical Exceedance Historical AGI wells (1989): MW-1, MW-2, MW-4
- No Groundwater Exceedance Found
- Historical Monitoring Point - No Groundwater Exceedance
- Catch Basin
- USTs
- Septic System
- Site Boundary
- Parcel Boundary

Gasoline-range TPH, at concentrations above the MTCA Method A CUL, were exhibited only at TCBH-3, TC-3, and TC-5 (380 to 1,900 micrograms per liter [$\mu\text{g}/\text{L}$]). Elevated diesel-range TPH was detected only at TCBH-1 (790 $\mu\text{g}/\text{L}$). Elevated benzene was found only at TC-5 (22 $\mu\text{g}/\text{L}$). Additionally, arsenic (7.1 $\mu\text{g}/\text{L}$) was the only metal (total metals analysis) detected above the CUL; however, laboratory analysis for arsenic, as dissolved metals, indicated a detection of 1.37 $\mu\text{g}/\text{L}$. Hence, it appears that the turbid groundwater sample with a heavy presence of sediments was the source of the elevated arsenic. The remaining COIs either were not detected or were detected at concentrations below their respective CULs (Table 2). The risk screening section (Section 6) includes a discussion of groundwater chemical detections compared to their respective CULs. Figure 10 presents an overview of the environmental investigation.
