SITE INFORMATION: Cleanup Site ID: 2597 Upper Hudson Street Facility/Site ID: 6149702 4815 15th Avenue SW Seattle, King County, WA 98106 Section: 19 Latitude: 47 55925 Township: 24N Longitude: -122.35357 Range: 4F Tax/Parcel ID: 2840700005, 2840700070

Site Scored/ranked for the Hazardous Sites List Publication: August 2015

Site Overview Map

Upper Hudson Street

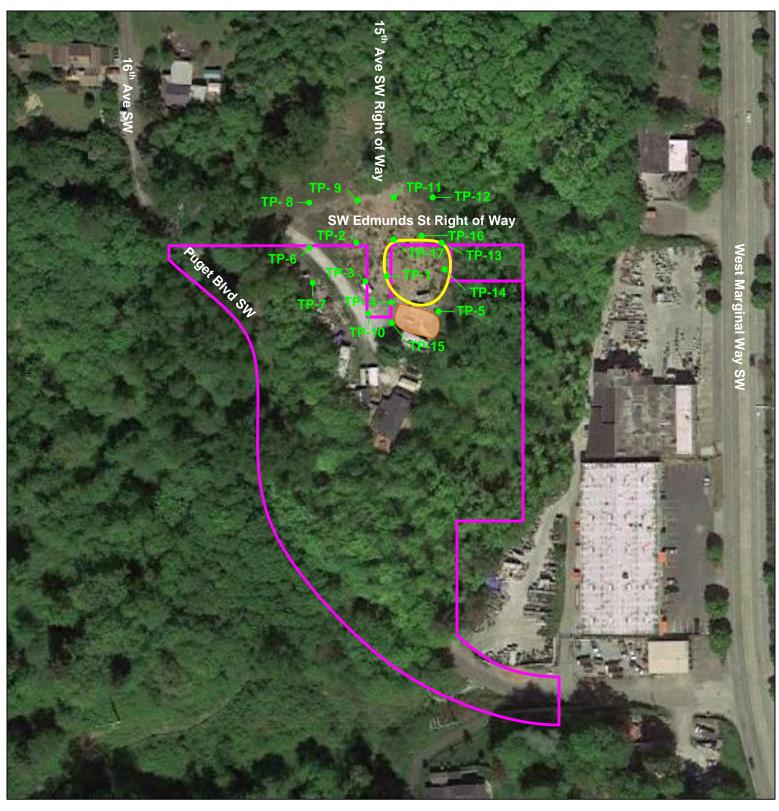
Excavation area (approximate)

Property location (approximate)

- Remaining soil contamination (approximate)
- Soil sample (approximate)
