**P.C.S. (Petroleum Contaminated Soil)**

**Removal & Disposal Report:**

**5050 Hannegan Road Bellingham, WA 98226**

## **P.C.S. (Petroleum Contaminated Soil) Report**

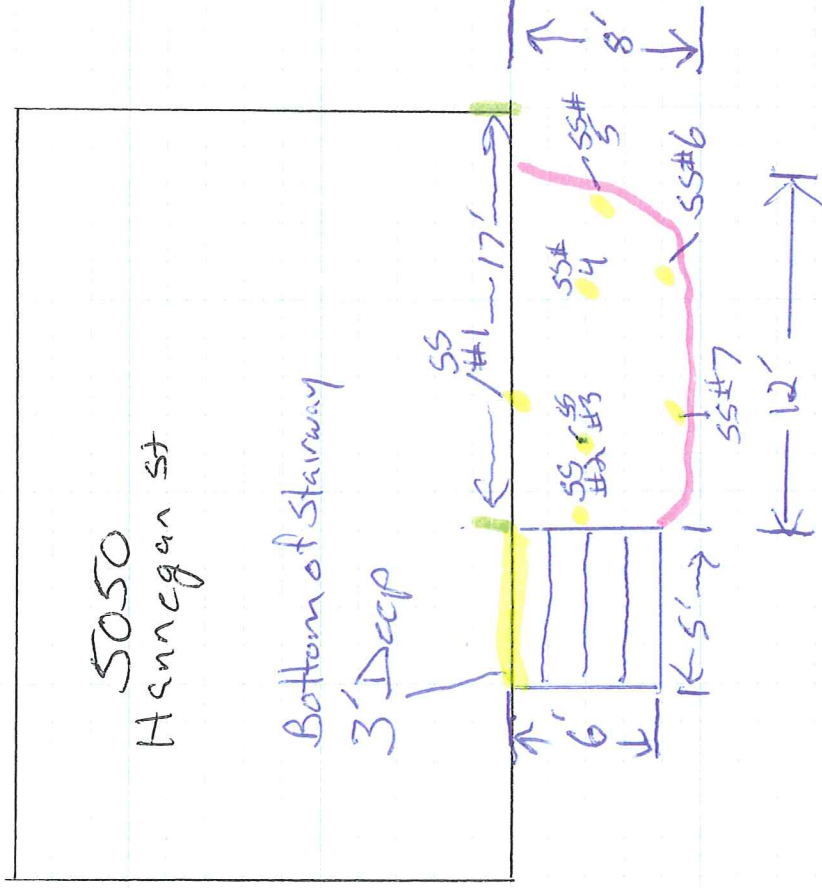
The excavation was 12'ft. in length North to South, and 8'in. in width East to West, and 8'<sup>in</sup>. in depth. (See site map in Appendix D).

- Stairway Wall to N. Corner of house
- Stairway Bottom @ 3'
- Soil Sample locations

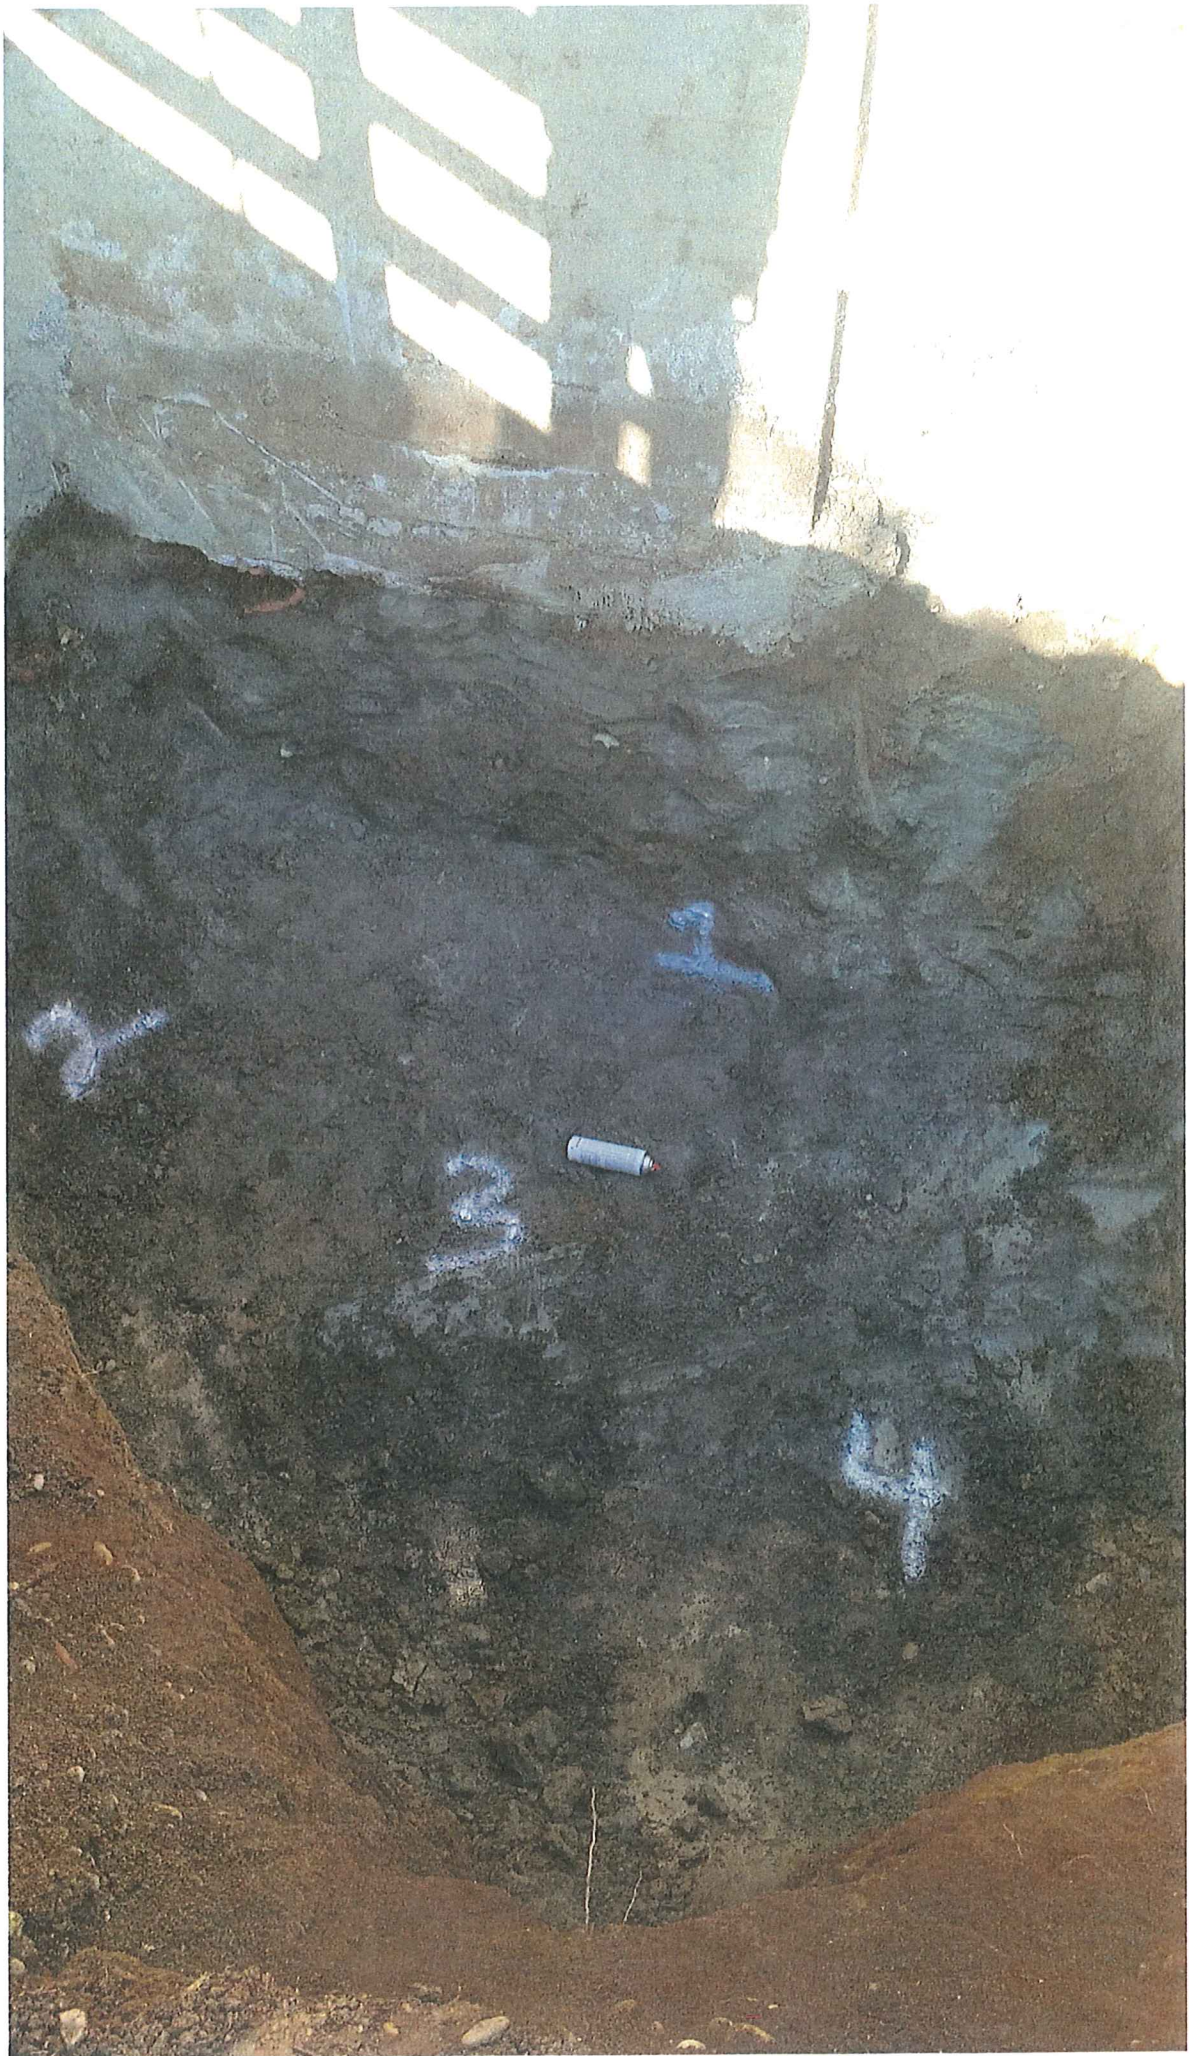
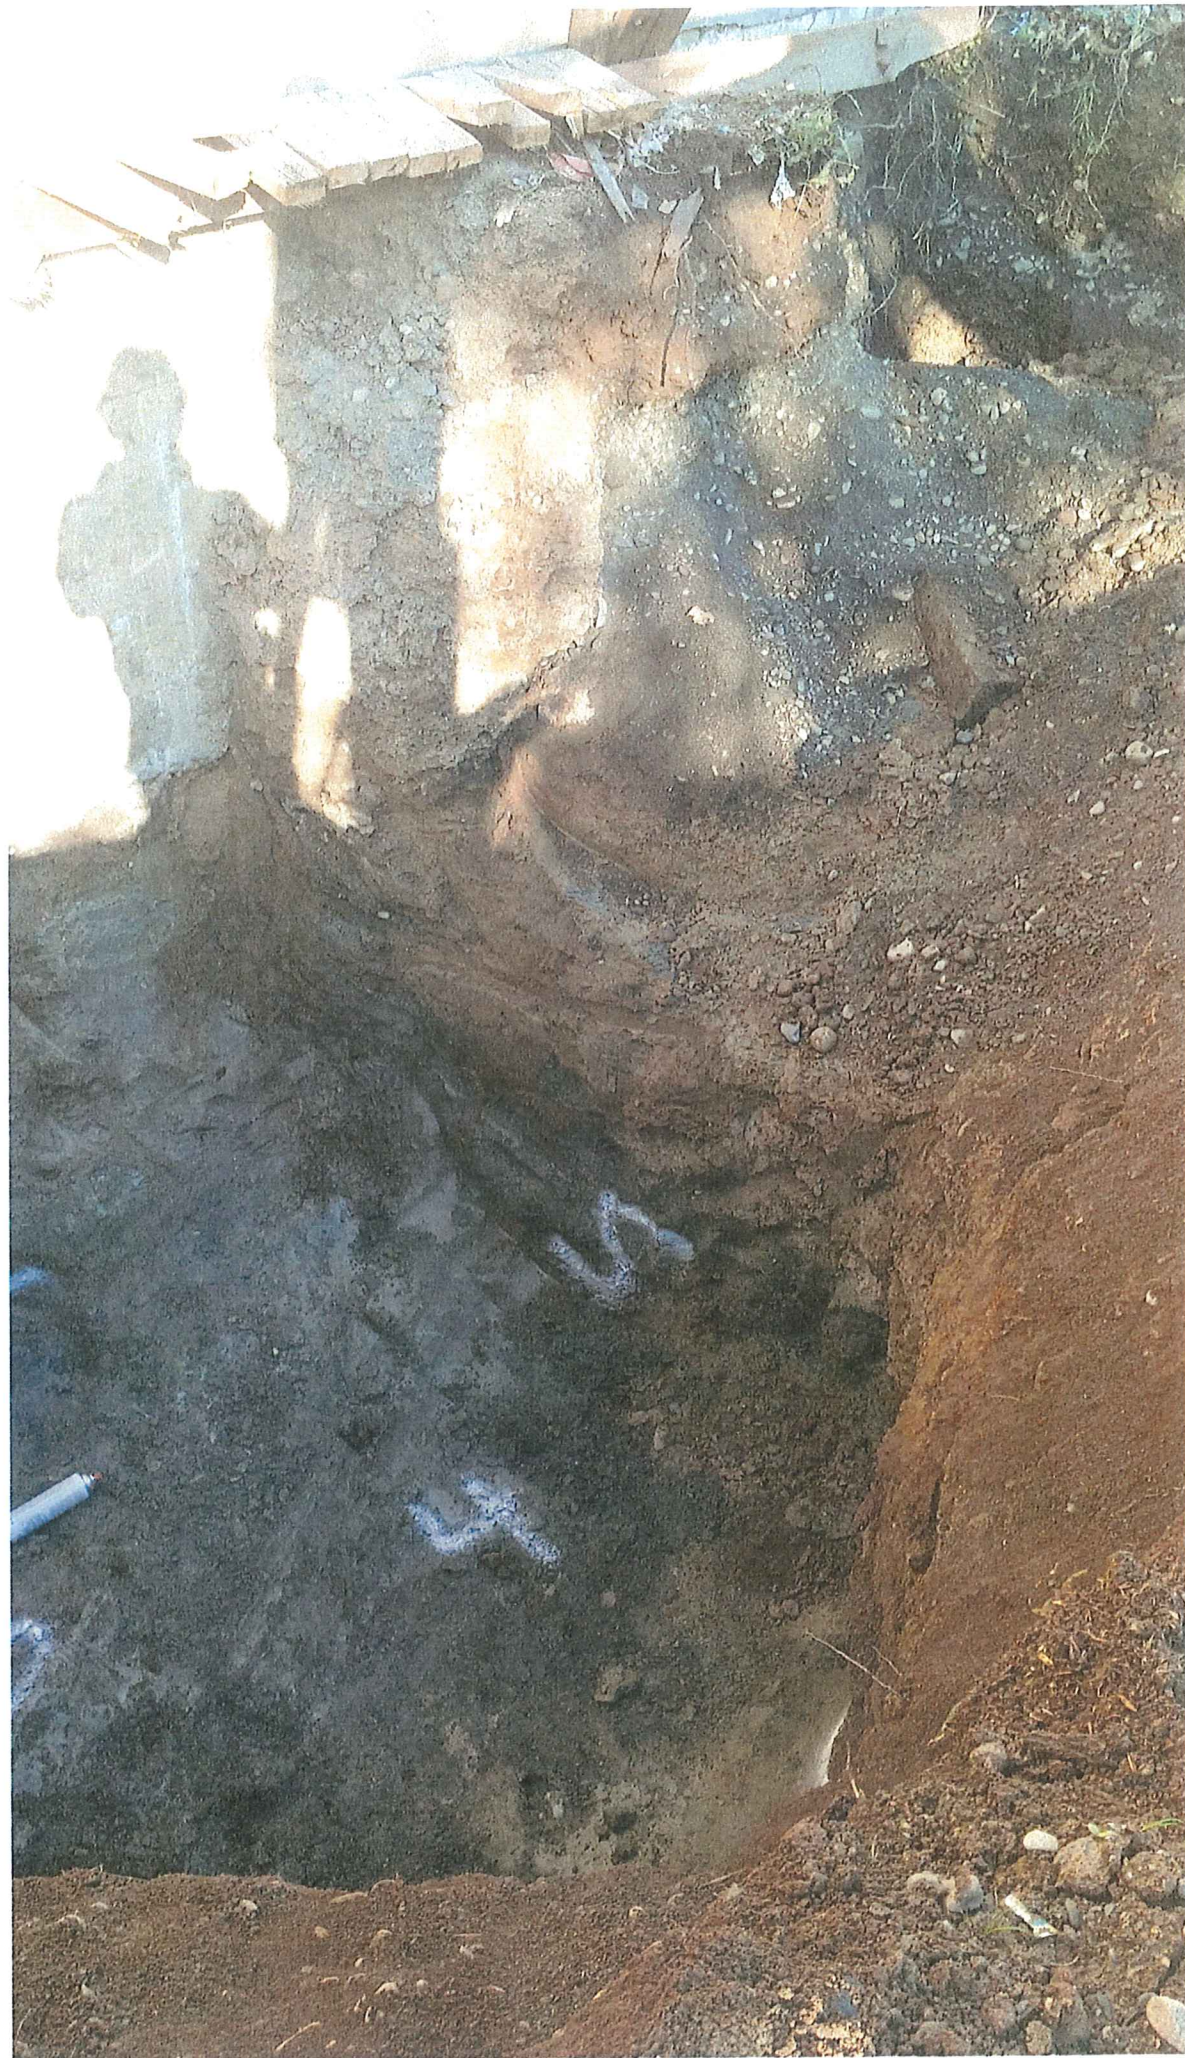
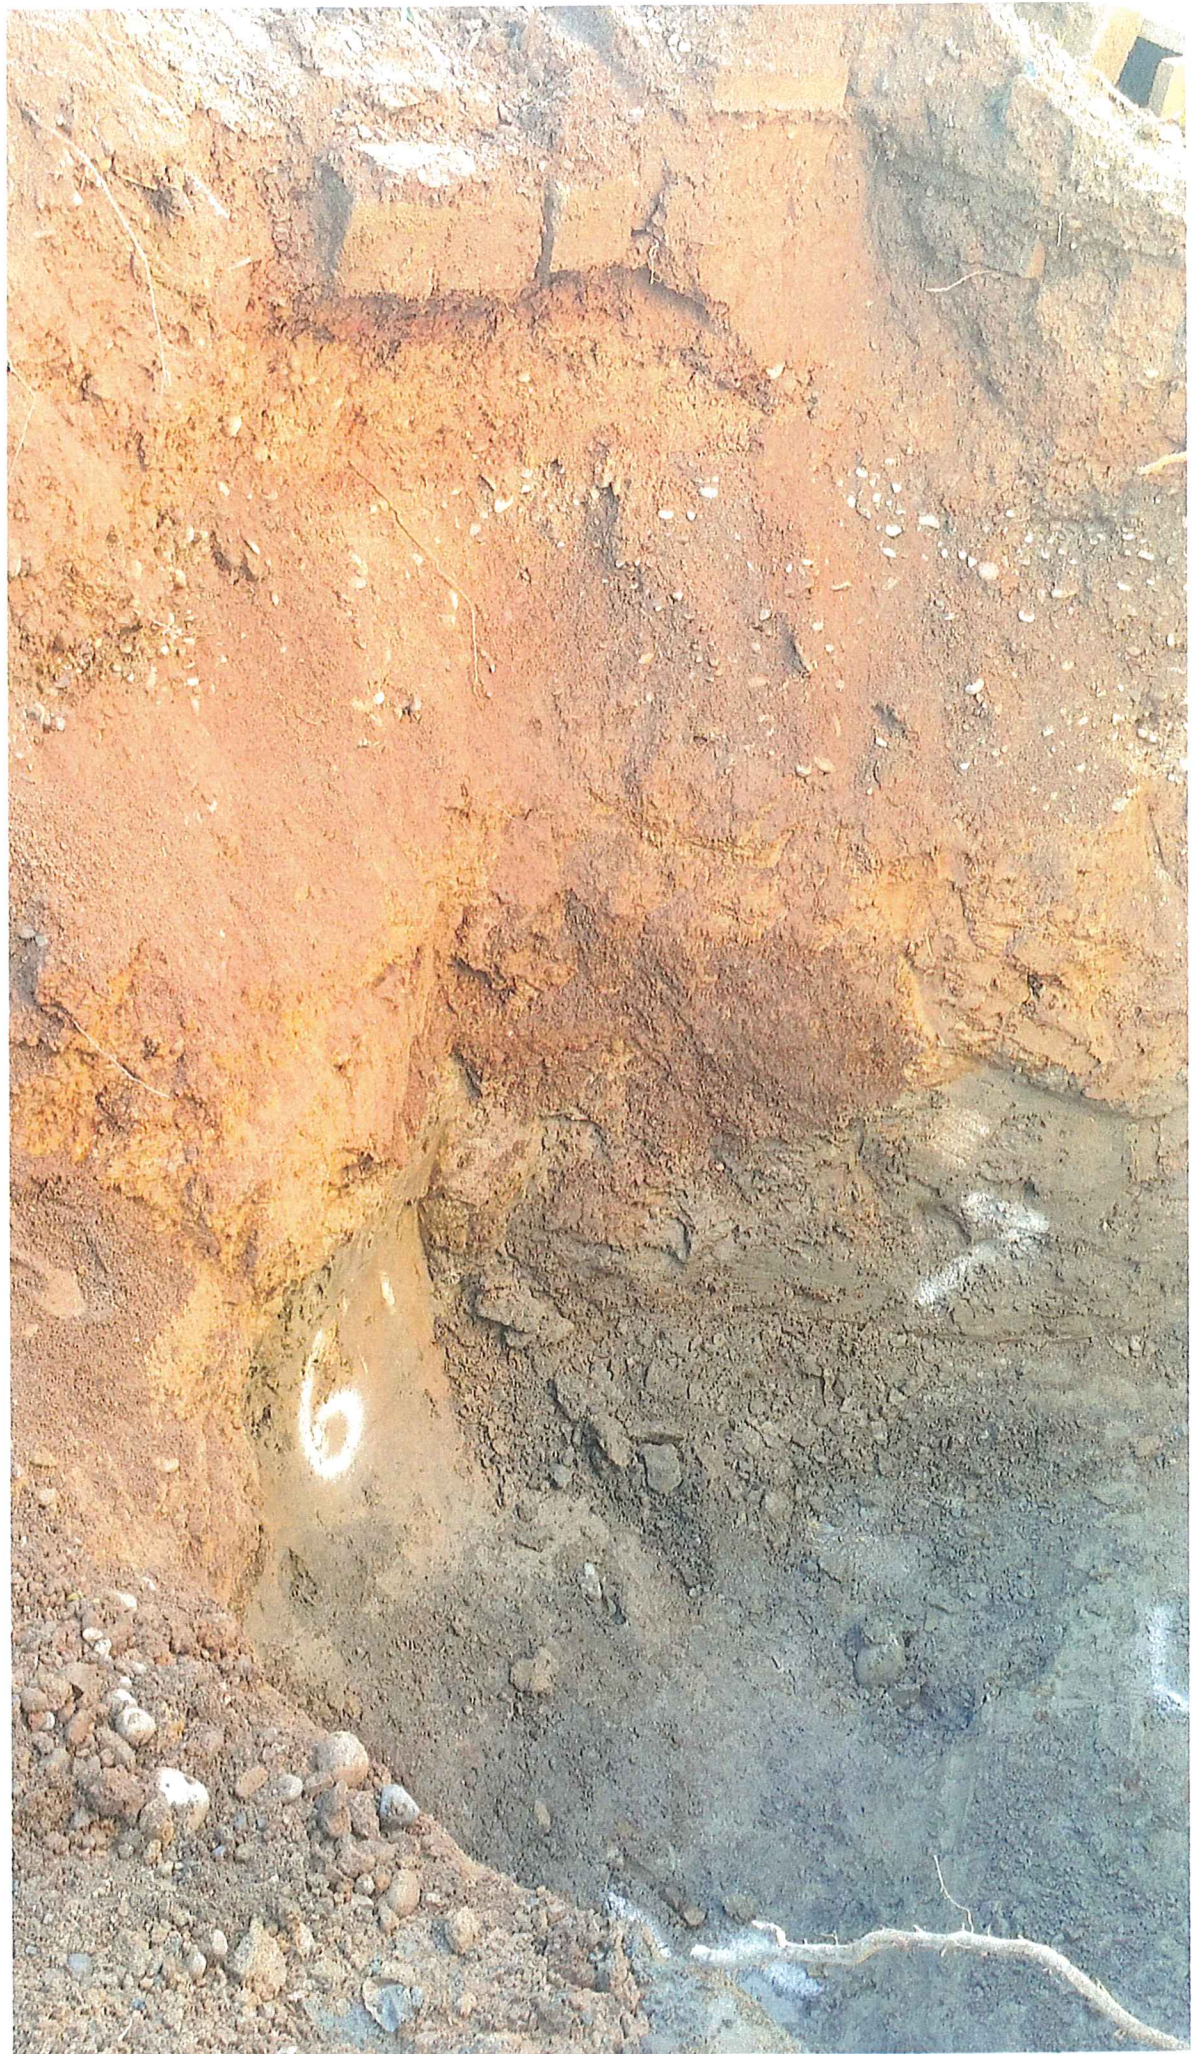
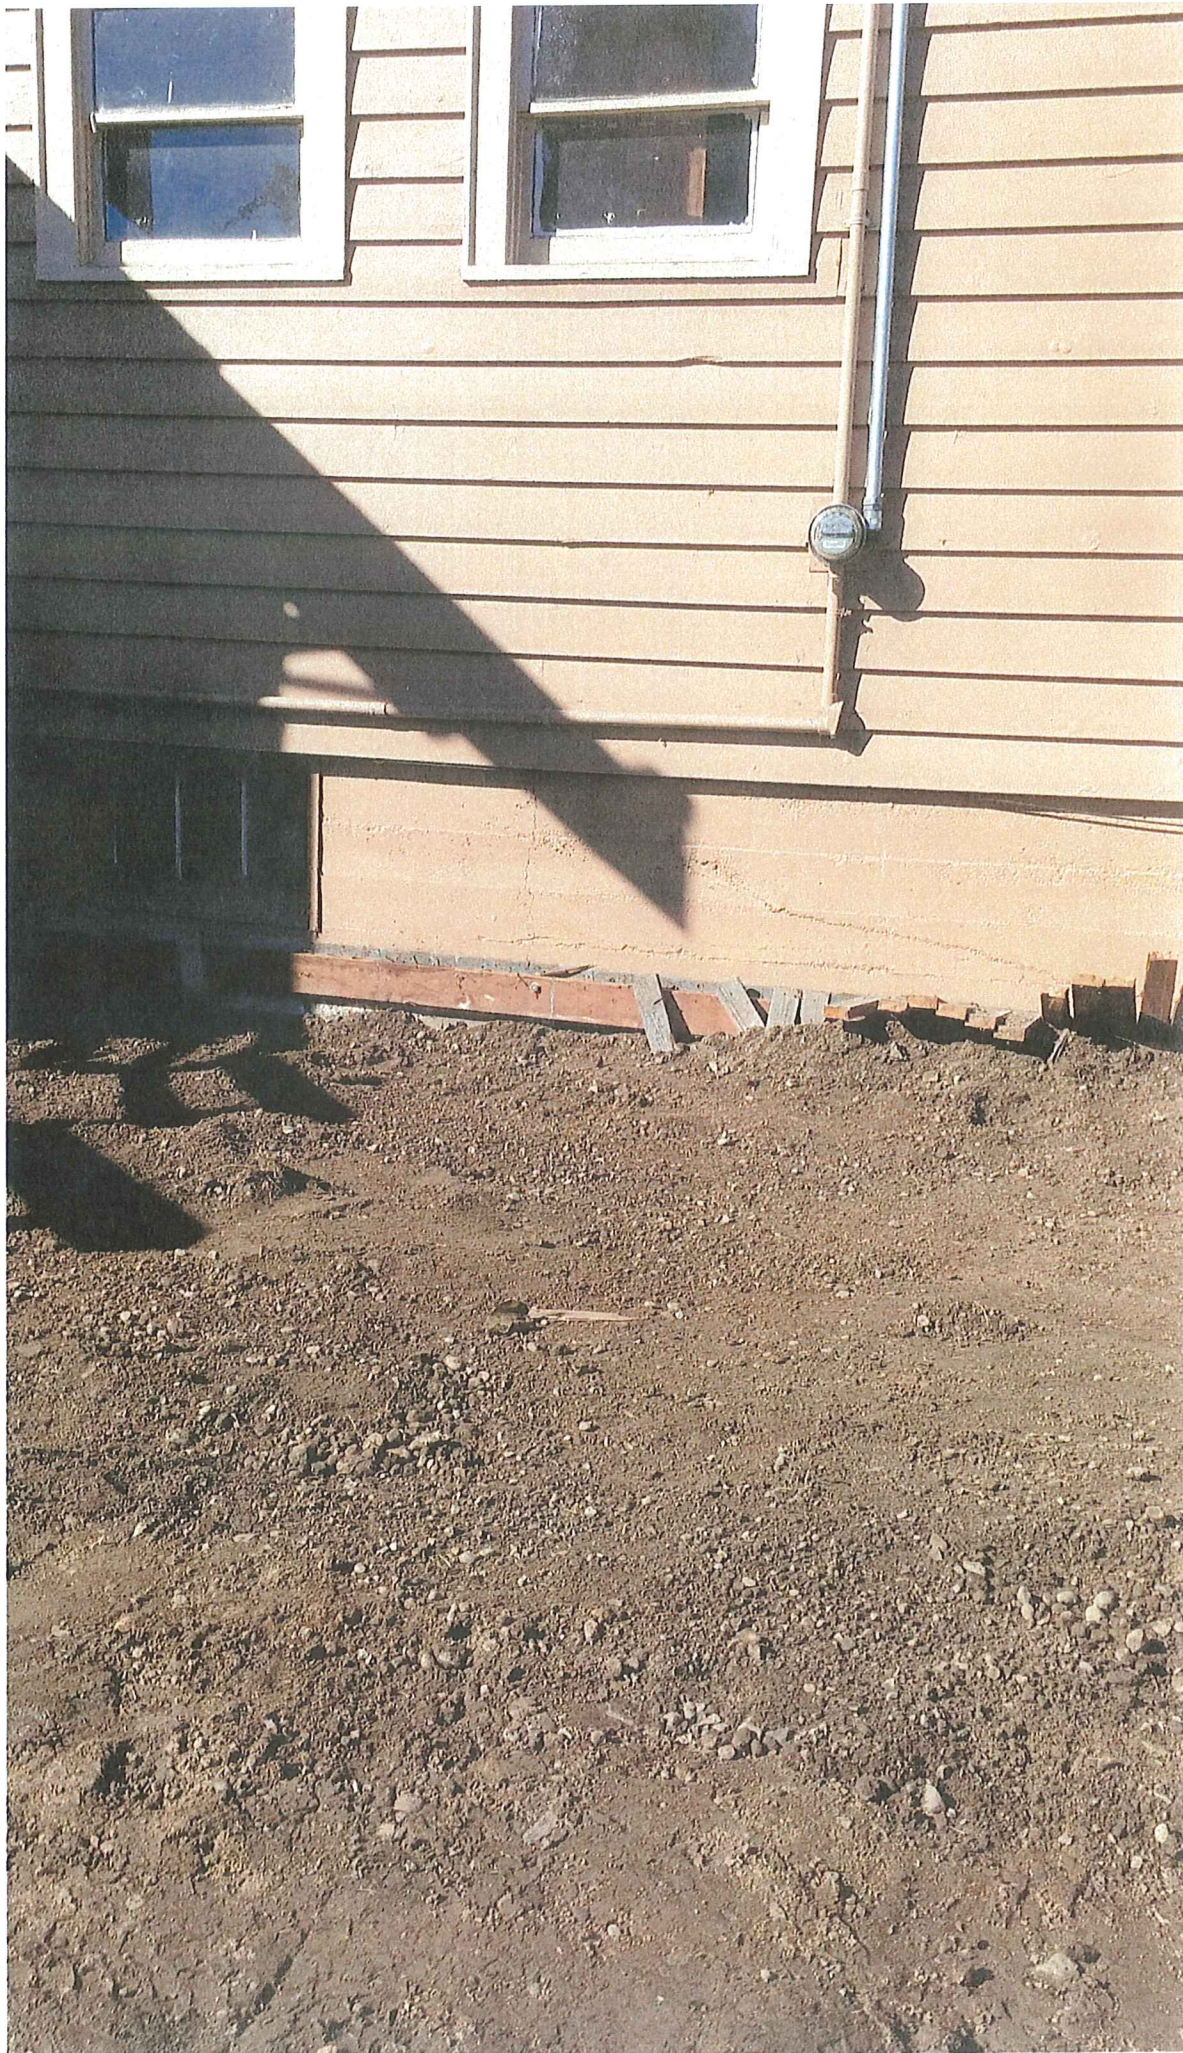
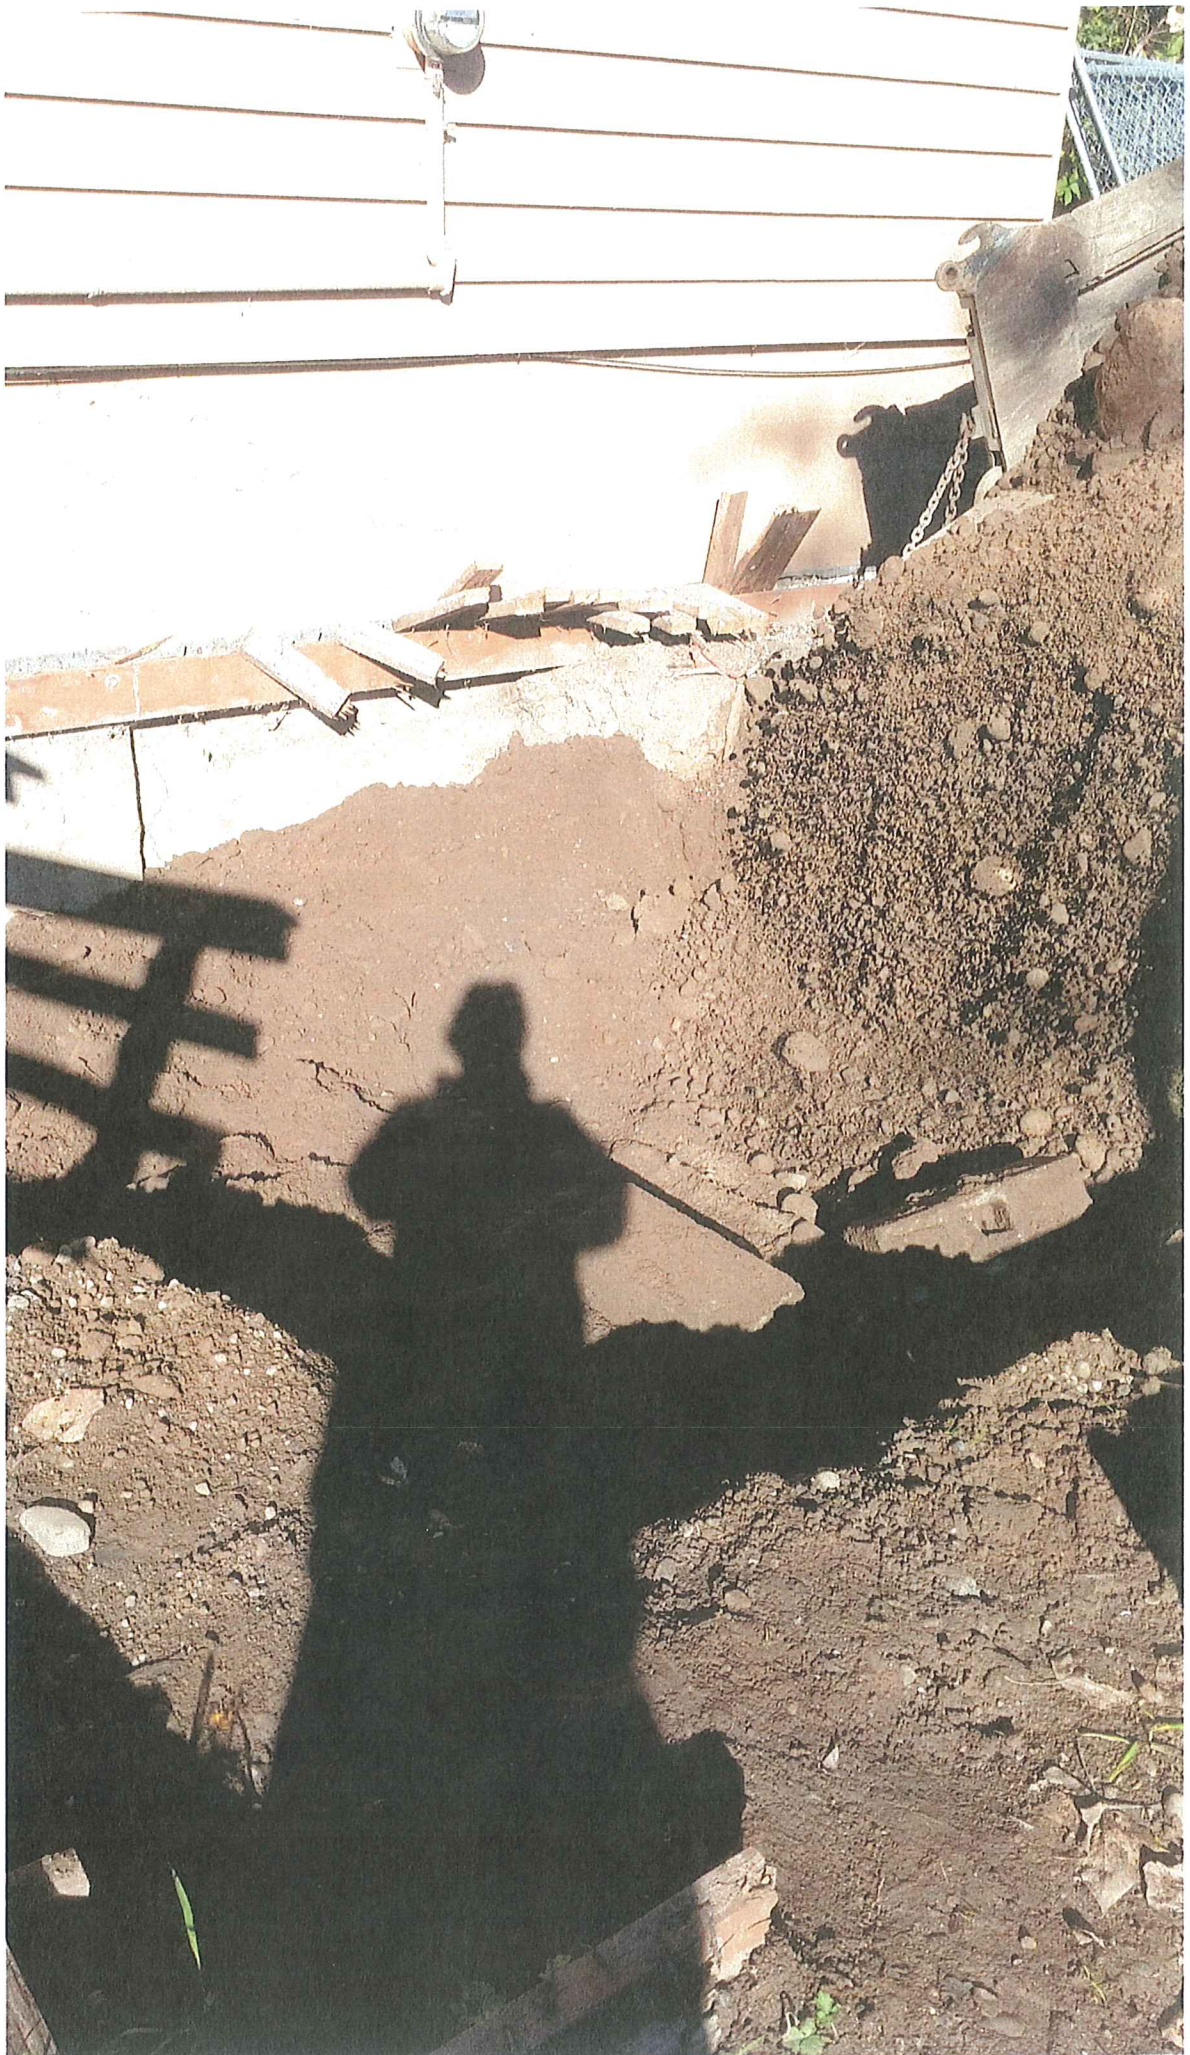
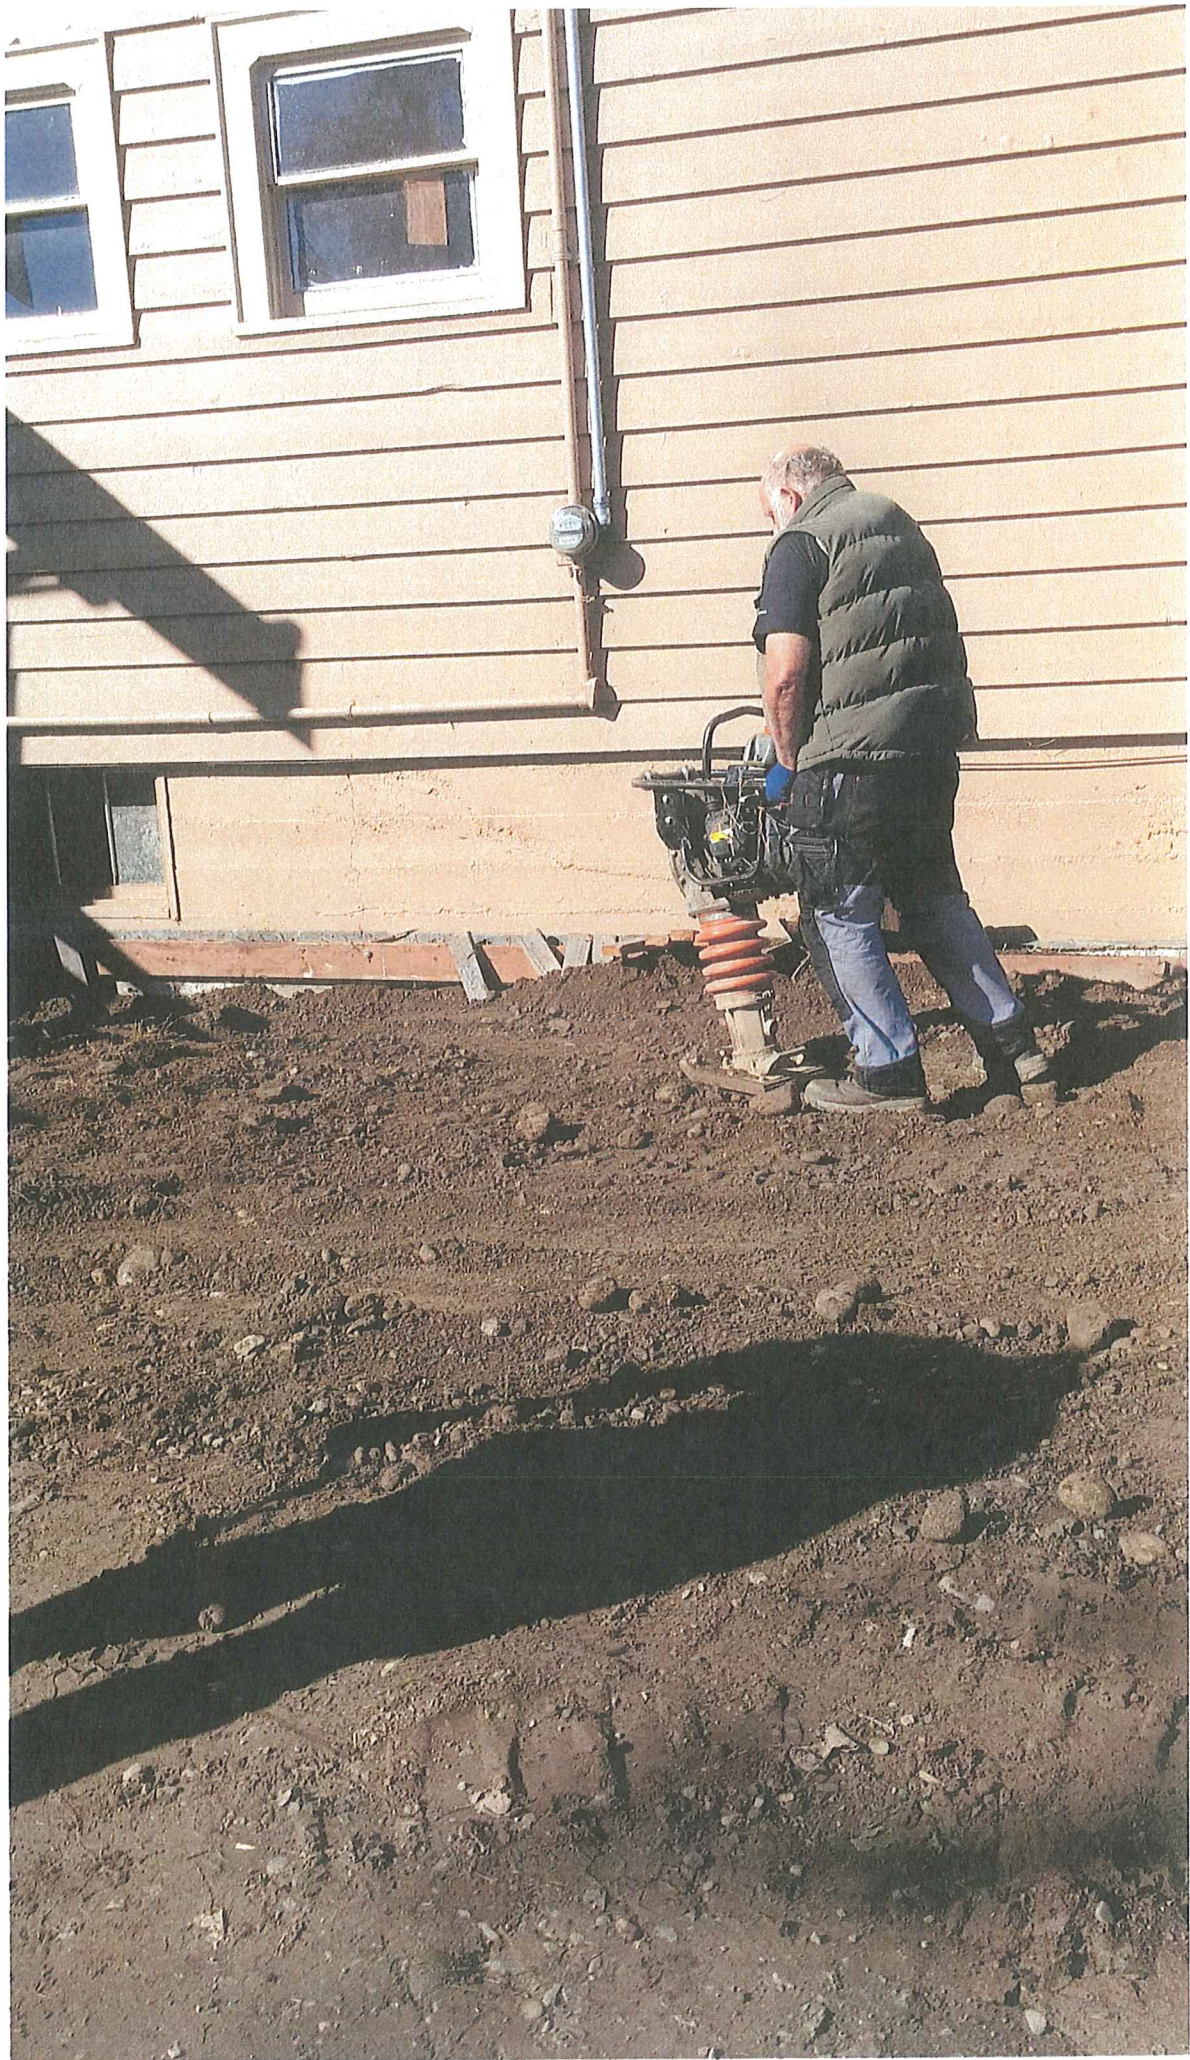
On September 22, 2015 6.79 tons of P.C.S. was removed and disposed of and taken to CEMEX in Everett Washington, (See Appendix A) The excavation looked good, sheen tests were done on floor soils, as well as side wall samples, with no sheen.

Seven soil samples were taken from the excavation, two (2) floor samples, and five (5) sidewall samples were taken and put into ALS provided sample jars and delivered to ALS Laboratories in Everett Washington for DX-Analysis.

(See Appendix E for photographs showing excavation and soil sample locations).

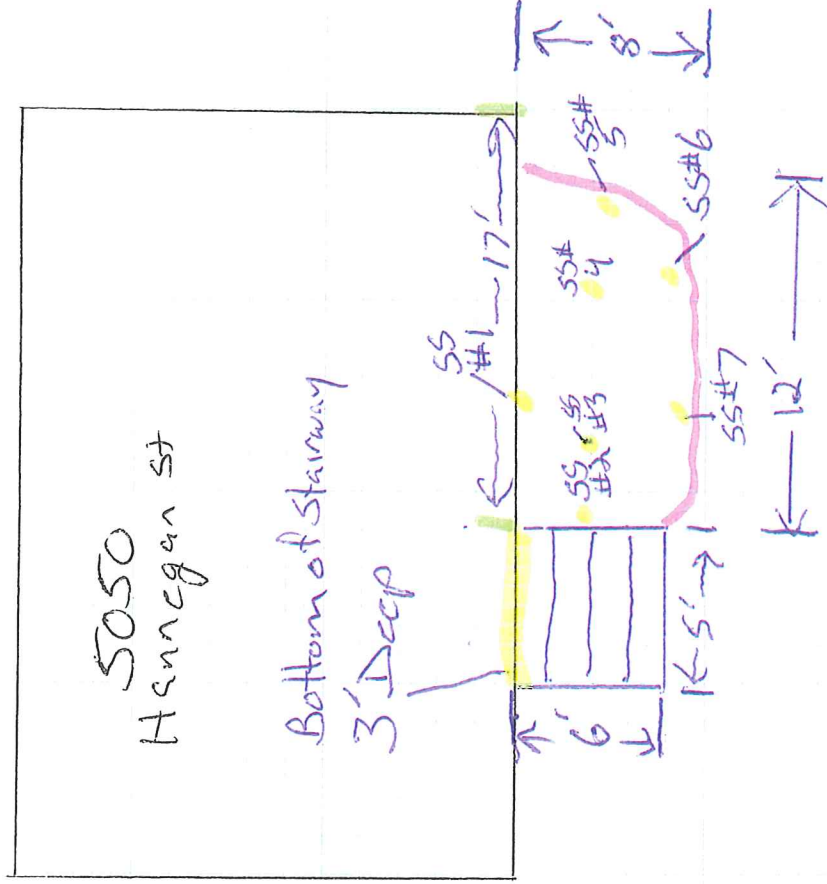
## Appendix F - Soil Sample Descriptions

SS#1 – West Sidewall – 4'ft. North of foundation wall @ 5'ft. deep.

SS#2 – South Sidewall – 3'ft. East of foundation wall @ 5.5'ft. deep.

SS#5 – North Wall – 5'ft. East of foundation @ 6'ft. deep.

SS#7 – South East sidewall – 2'ft. North of South wall @ 6'ft. deep.

- Stairway Wall to N. Corner of house 17'
- Stairway Bottom @ 3'
- Soil Sample locations
