## TECHNICAL MEMORANDUM

October 19, 2015

Re: Cornet Bay Marina Model Toxic Control Act (MTCA) Cleanup Mitigation Plan: Year 1  
Vegetation Monitoring Results

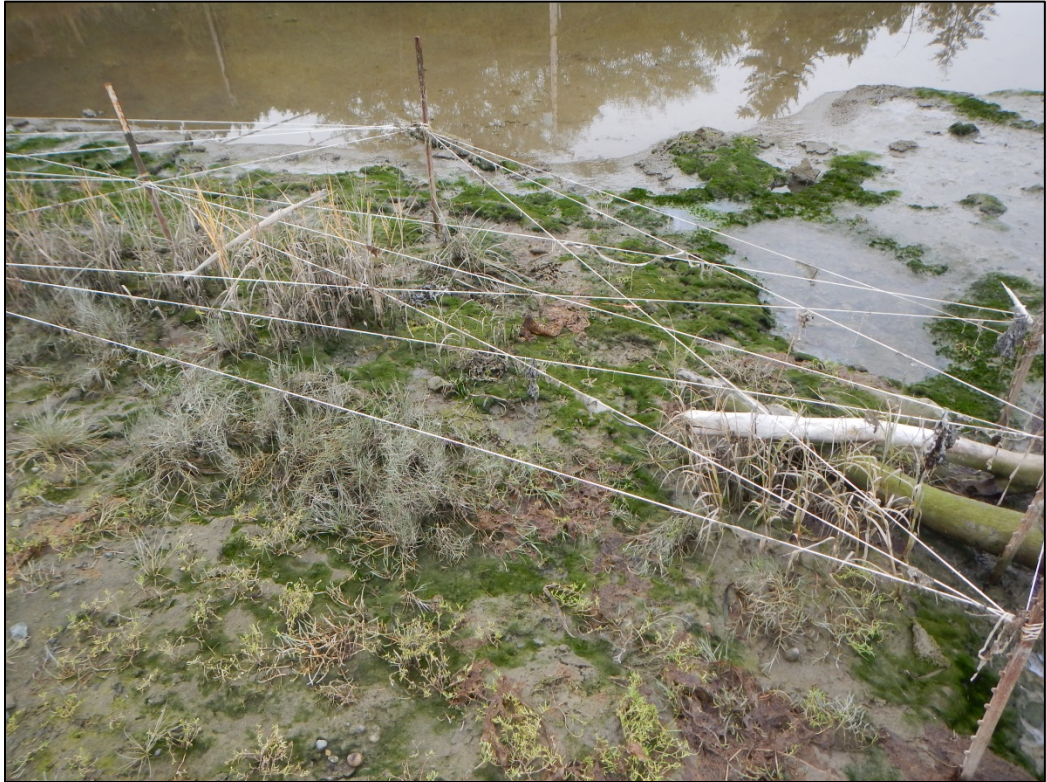
**Figure 7. Planted emergent area.**

Additionally, while there is no performance standard for the recently planted emergent area, Grette Associates completed a general assessment of the area to determine the overall health and success of the plantings. The planted emergent area is largely dominated by seashore saltgrass (*Distichlis spicata*) and Lyngby's sedge (*Carex lyngbyei*). Less dominant species observed in this area include saltmarsh bulrush (*Schoenoplectus maritimus*) and pickleweed (*Salicornia virginica*). Based on visual observations, the planted emergent area has approximately 60 percent aerial coverage.
