STATE OF WASHINGTON
DEPARTMENT OF ECOLOGY

Re: No Further Action Determination under WAC 173-340-515(5) for the following Hazardous Waste Site:

- Name: J. Marcel Building (formerly Juneau Street Associates Property)
- Address: 2320 Pacific Avenue, Tacoma
- Facility/Site No.: 28236738
- VCP No.: SW0911

ENCLOSURE A

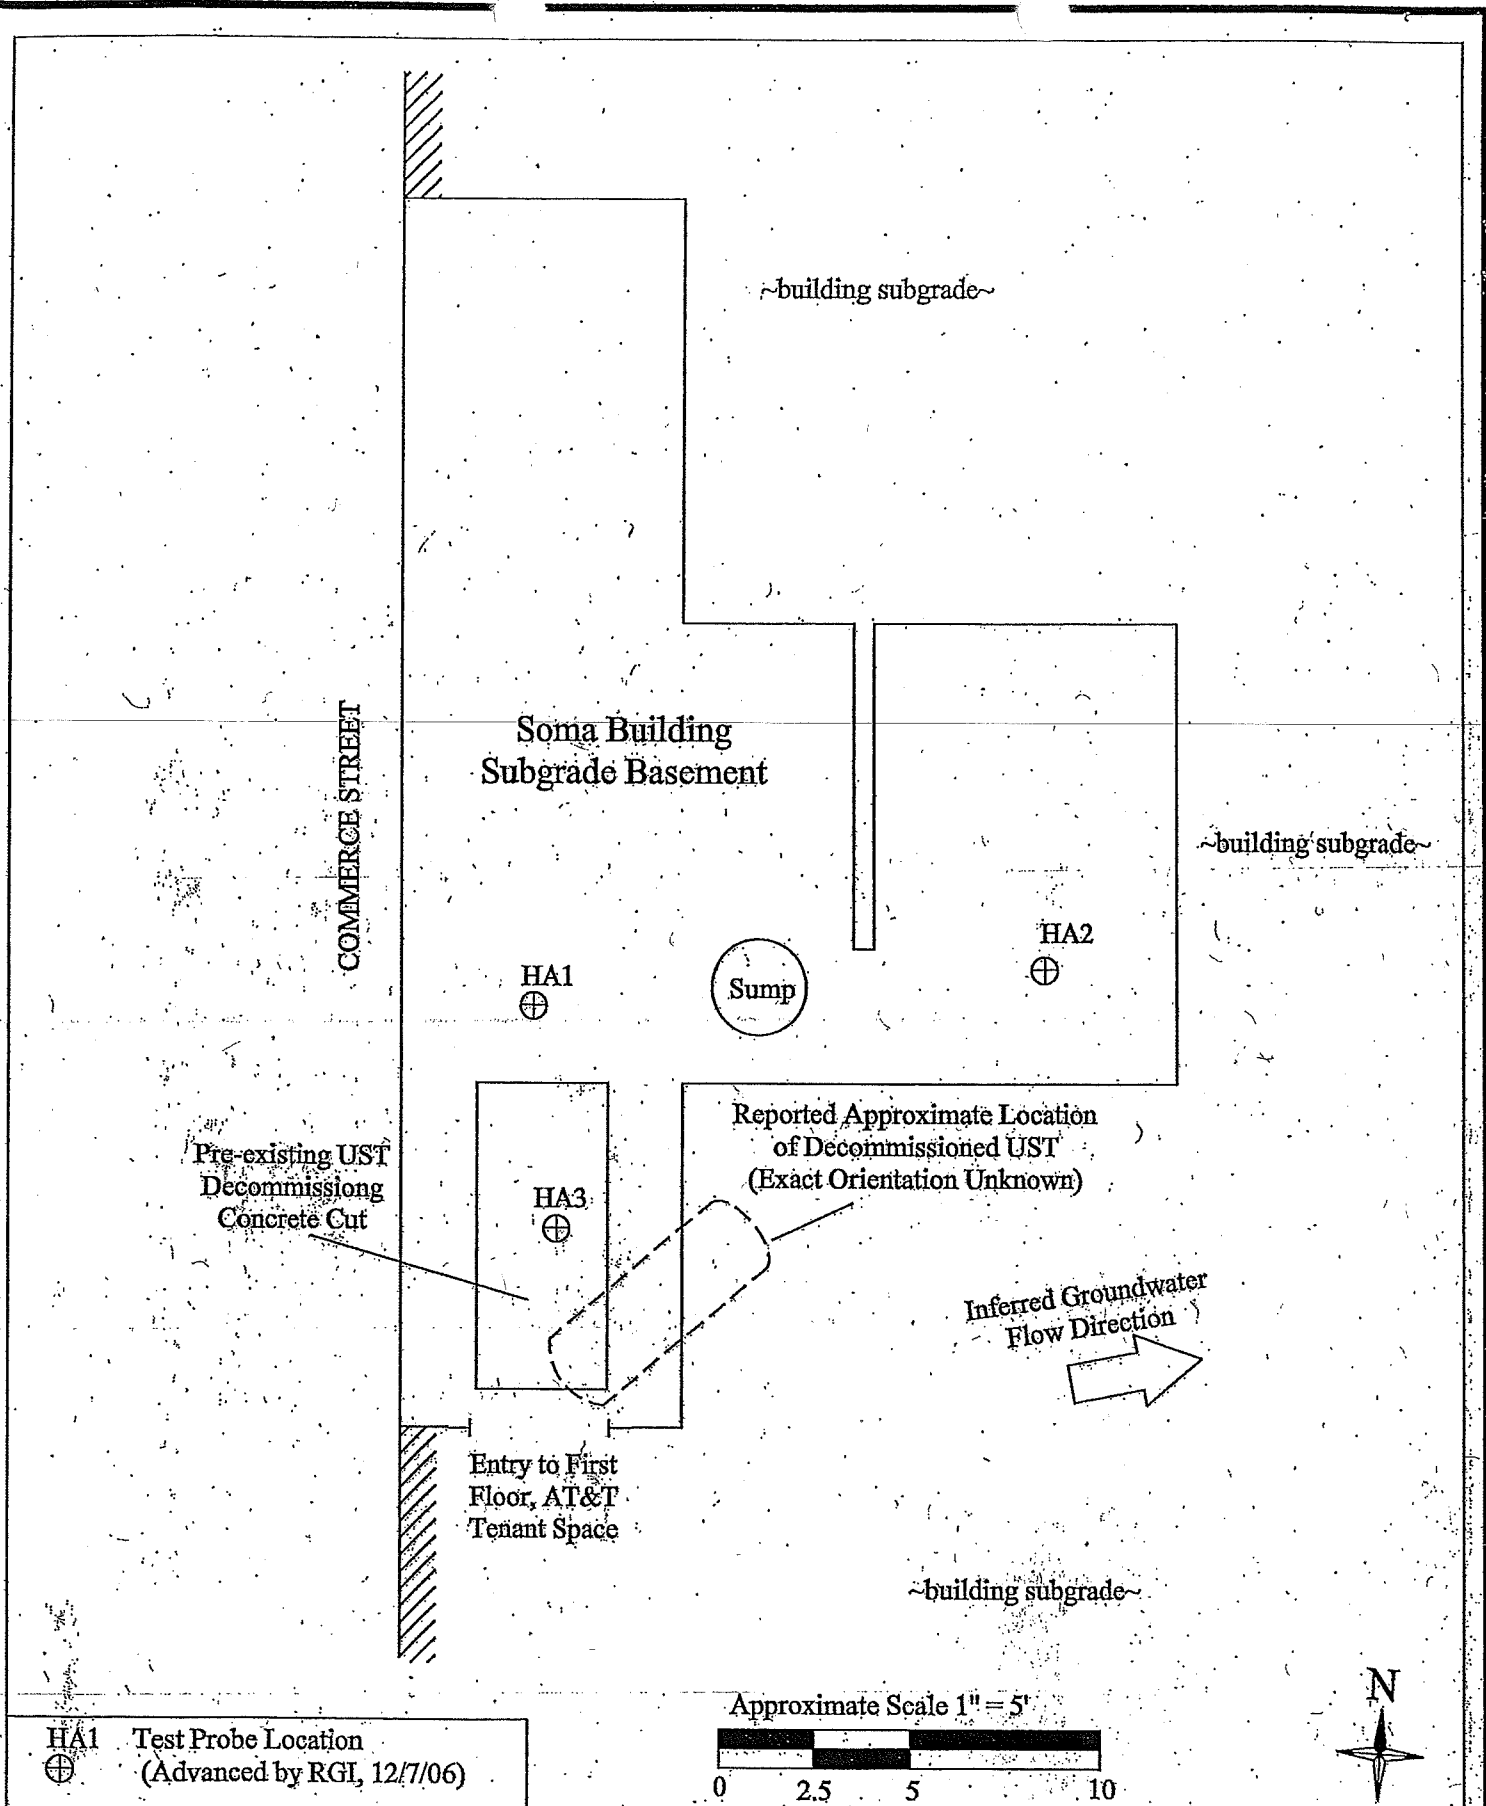
Figure 3

Site Plan

Reported Approximate Location of
Decommissioned UST (Exact
Orientation Unknown)

Sample ID	Field Screening	Diesel TPH	Oil TPH	Total cPAHs
HA3-SS	Screen	450	570	6.83

Sample ID	PID	Diesel TPH	Oil TPH	Total cPAHs
SP1-8	0	—	—	0.219
SP1-12	0	—	—	0.087
SP1-16	12.5	—	—	0
SP1-20	14	ND<28	ND<36	1.53

Sample ID	PID	Diesel TPH	Oil TPH	Total cPAHs
Soma-H2O	NA	ND<0.25	ND<0.40	0.01
Soma-H2O-2	NA	ND<0.25	ND<0.40	0.054

- Borings advanced by RGI on 12/07/06
- ⊗ Test probe advanced by RGI on 12/03/07
- Groundwater Sample Collected by RGI on 12/03/07

A total of three borings (HA-1 through HA-3) were installed to depths of 0.5 to 1 ft below the basement slab. Boring locations are shown in Figure 3. Borings HA-1 and HA-2 were advanced in an inferred cross-gradient and partially down-gradient direction of the former decommissioned UST. Boring HA-3 was advanced in soils
