RE: **Final Cleanup Action Plan**
Acme Bulk Fuel Plant
303 Thurston Avenue NE
Olympia, Washington

Associated Environmental Group, LLC (AEG) has prepared this Cleanup Action Plan (CAP) for the Acme Bulk Fuel Plant located at 303 Thurston Avenue NE Olympia, Washington 98501 (Site). The CAP describes the Site, environmental conditions, cleanup objectives, and the appropriate cleanup standards selected under the Washington State Department of Ecology (Ecology) Model Toxics Control Act (MTCA).

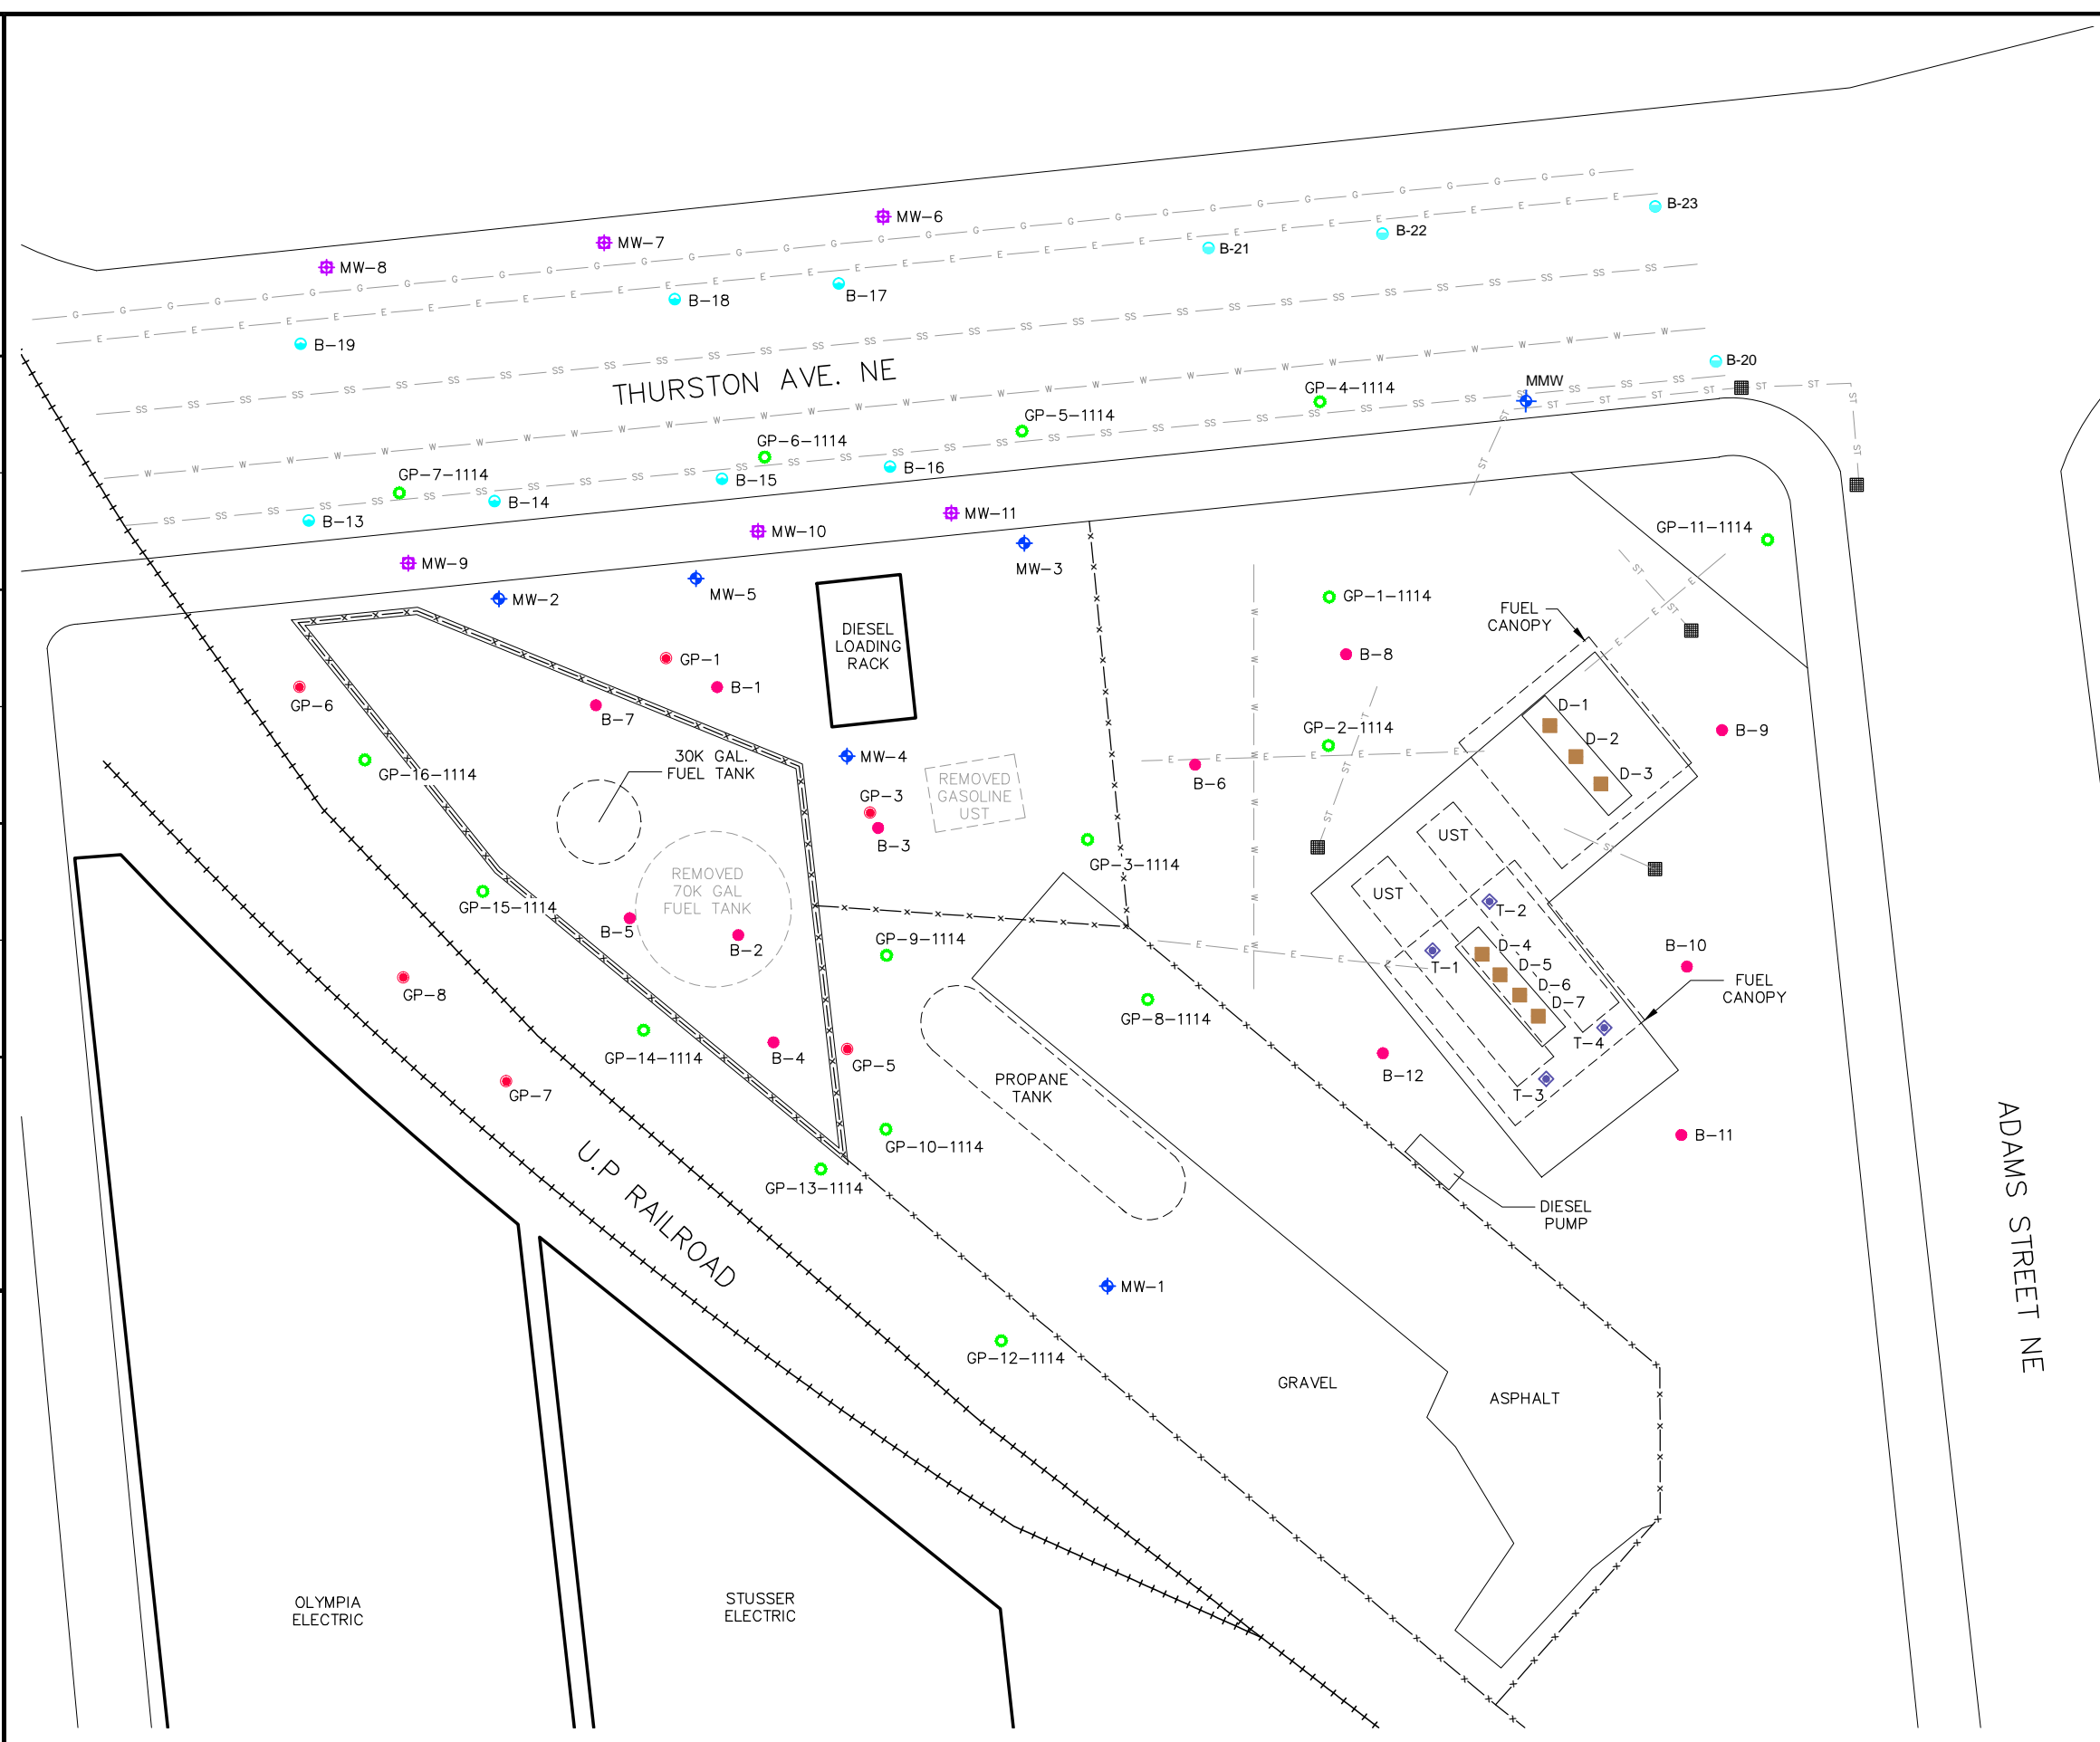
FIGURE 2
SITE MAP

AEG advanced a total of seven borings (refer to Figure 2, *Site Map*), four within the containment area [B-2, B-4, B-5, and B-7] and three outside of the containment area [B-1, B-3, and B-6]), to assess the following: 1) whether residual TPH contamination exists at the fuel spill area beneath and in vicinity area adjacent to the former 70,000-gallon AST; 2) further characterize areas immediately outside the containment wall area to assess whether the subsurface (soil and groundwater) remains impacted by diesel-range TPH (as formerly reported and confirmed by AECOM); and 3) the potential for migration of TPH and associated VOCs (from the diesel fuel spill on September 17, 2011) to migrate off property.

Refer to Tables 1 and 2 on Figure 2, *Site Map* for a summary of the soil and groundwater data collected by AEG.

Laboratory analytical results indicated no detectable concentrations of all constituents of concern (COCs) (gasoline-, diesel-, and heavy oil-range TPH; and associated VOCs) in all soil and groundwater samples collected in this area of the Site. Refer to Tables 1 and 2 on Figure 2, *Site Map* for a summary of the soil and groundwater data collected by AEG.

The Acme property is listed with the Thurston County Assessor as Parcel Number 78503100300, which is a triangular-shaped parcel and is about 0.60 acres. A general location map, illustrating approximate parcel boundaries, is provided as Figure 1, *Vicinity Map*. A Site diagram is included as Figure 2, *Site Map*.

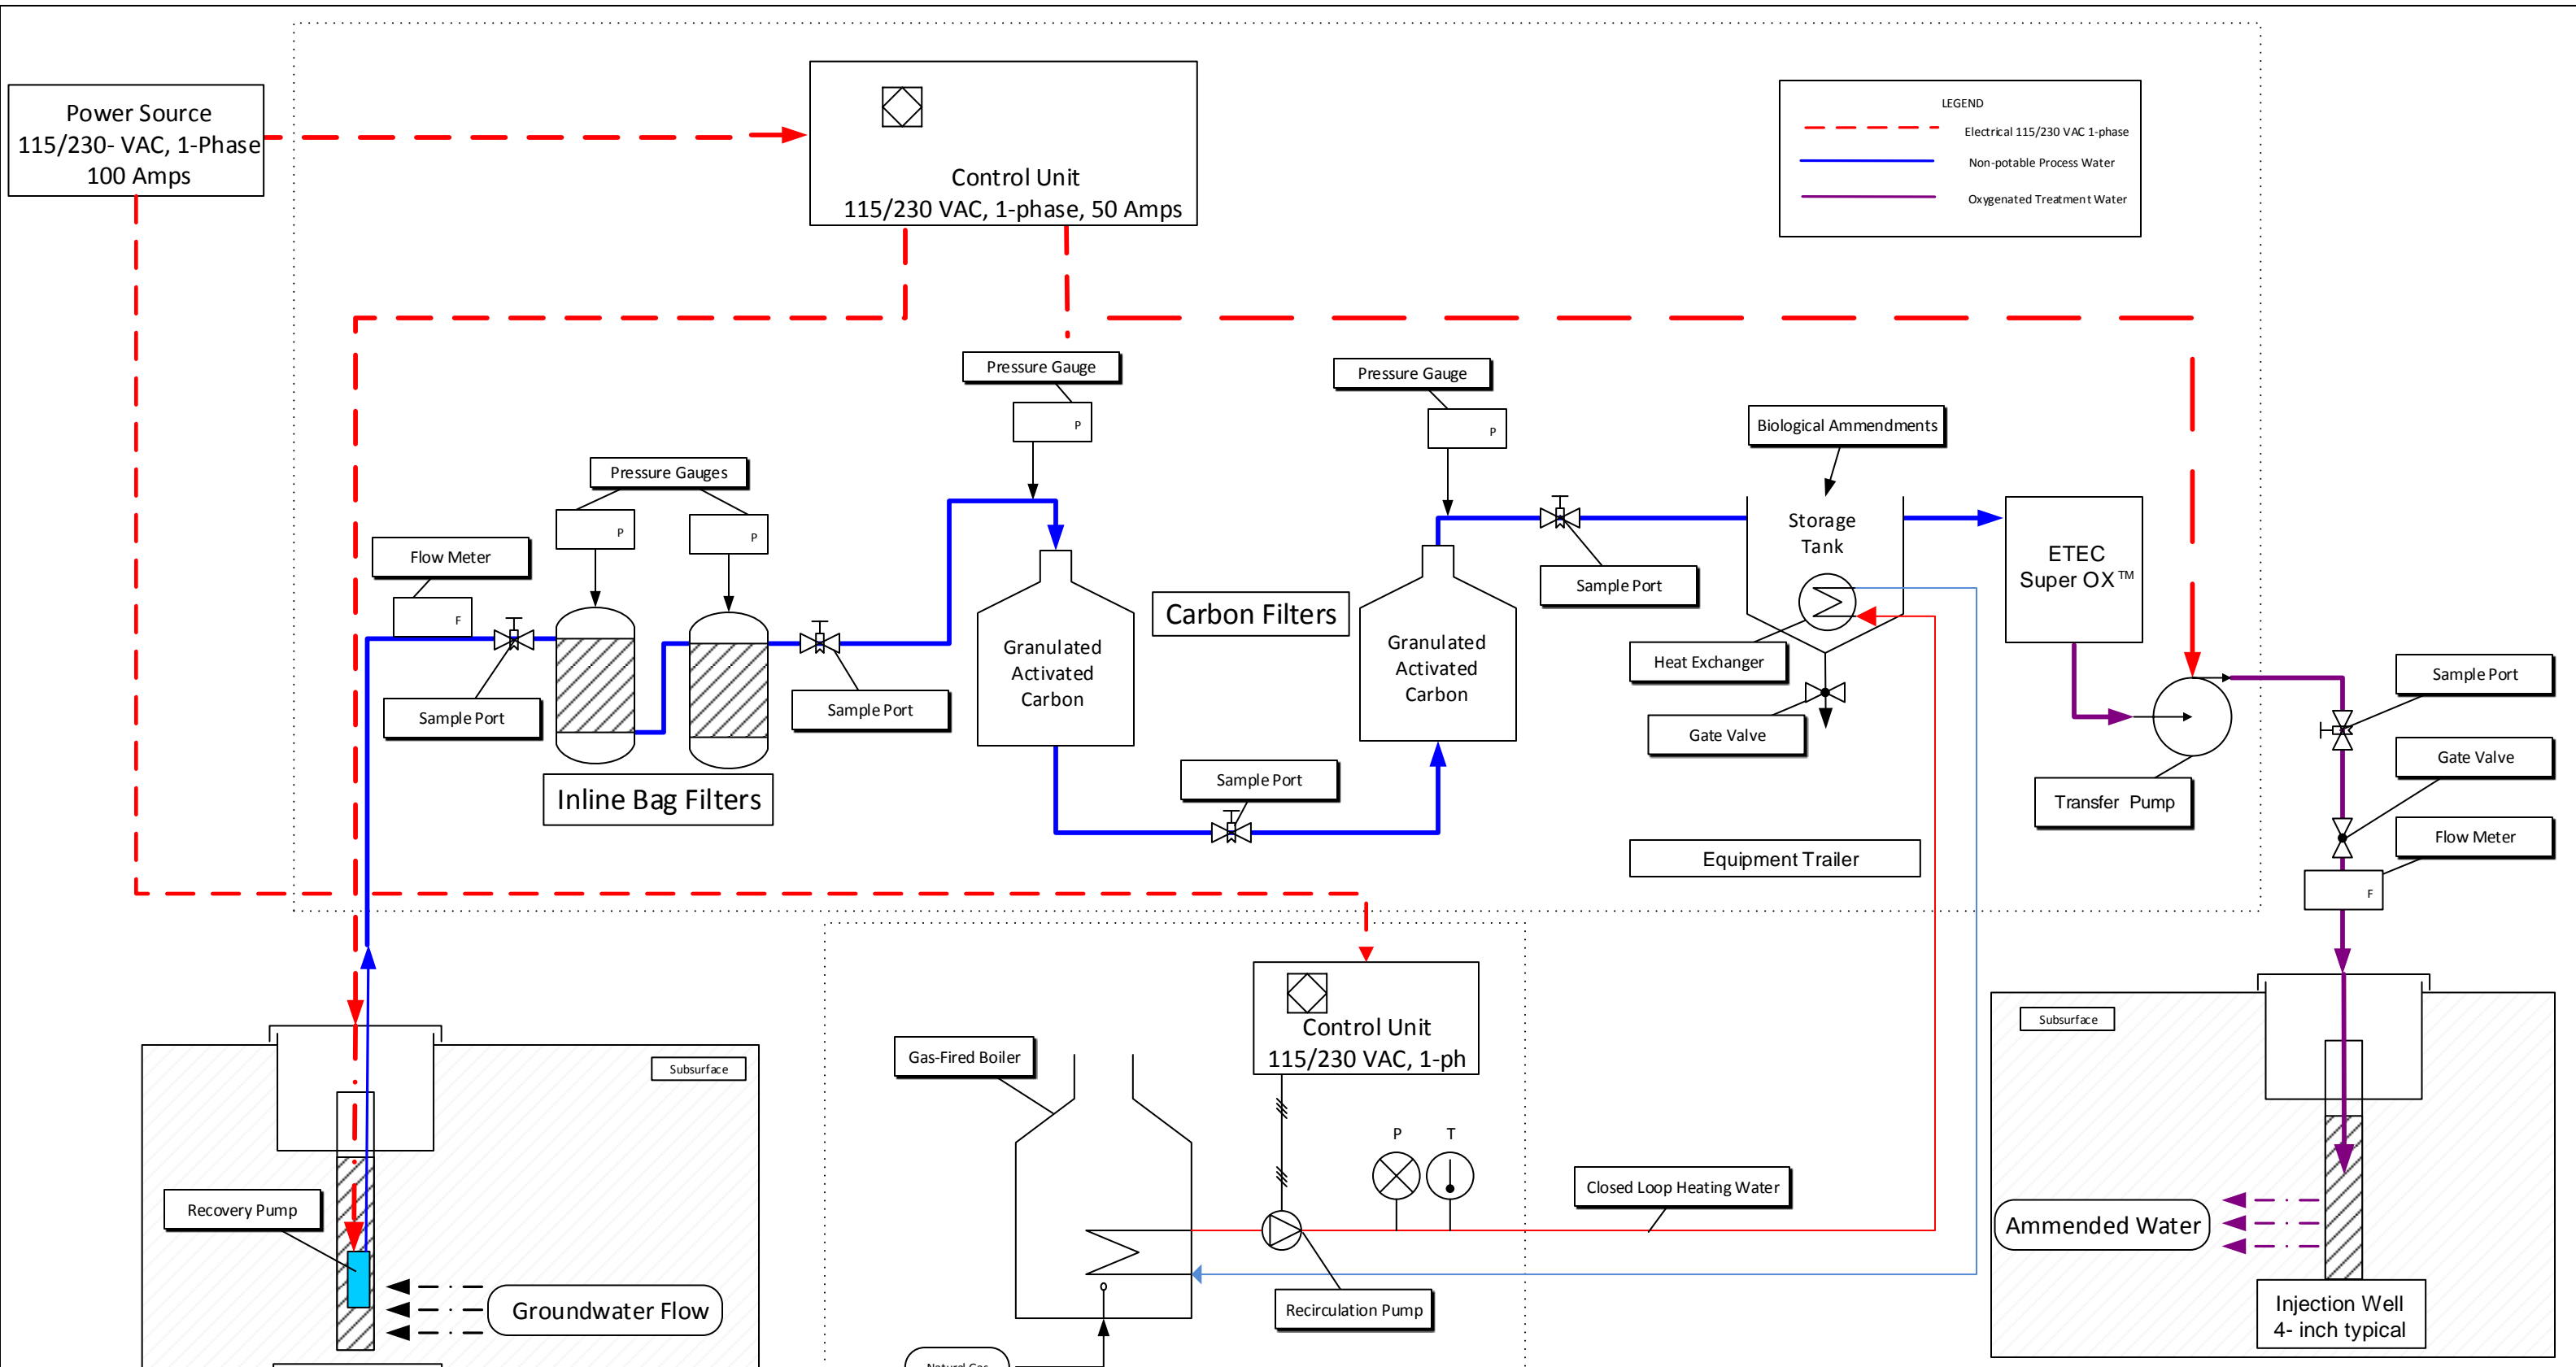
FIGURE 9

The system would be coupled with a boiler, an inoculant tank and a heat exchanger to heat the extracted groundwater to 90° F prior to re-injection into the injection wells (see *Figure 9 – In-Situ Heat Enhanced Bioremediation Process Flow Schematic*). It is expected that the groundwater in the treatment zone will increase in temperature by 10 to 30° F. This increased temperature will enhance desorption, increase solubility, and increase biodegradation rates by an order of magnitude, resulting in a significantly faster remedial timeframe capable of reaching low concentration goals (i.e., MTCA Method A cleanup levels).

**In-Situ Heat Enhance Bioremediation
Process Flow Schematic**

For the Site, thermally enhanced bioremediation/biodegradation would use a commercially available treatment system called the “*Dissolved Oxygen In-Situ Treatment (DO-IT™) system*”. This system utilizes extracted groundwater as a carrier for high levels of dissolved oxygen (>35 ppm) and biological enhancements. The DO-IT™ system recovers groundwater from the contaminant plume area and downgradient of the plume. Oxygen is added to the water by using small amounts of peroxide or ozone and then oxygenated treatment water is re-distributed to the subsurface to support high rates of in-situ microbial degradation. In this way, the bioremediation methods can work efficiently to degrade TPH/BTEX, while also facilitating hydraulic control and capture of the contaminant plume.

Groundwater Extraction System: Install new extraction wells in locations downgradient of remaining PCS with the proper depths and screened intervals. Typically, a Grundfos Rediflow 3 Environmental “run-dry” submersible pump is used as the extraction pump for this type of project. The motor leads, distribution manifolds, flow meters, sample ports, and control panel will be protected from damage in an equipment trailer.

Groundwater Re-injection: Install new, 4-inch diameter injection wells upgradient of the PCS area and screened in the unsaturated zone. These injection wells will be screened above and below the groundwater table to allow infiltration through the formation with minimal pressure.

The boiler will be piped to the heat exchange, including all pumps, controls, and safety components. The boiler vent stack will be provided and is to be installed on Site. The boiler operation is fully automatic and will conform to State of Washington boiler requirements. This low pressure boiler is recommended for this application as it will not require attendance but will have remote call capability if it goes off line.
