STATE OF WASHINGTON
DEPARTMENT OF ECOLOGY

Re: Further Action at the following Site:

- **Site Name:** Morrells Dry Cleaning
- **Site Address:** 608 North 1st Street, Tacoma, Washington 98403
- **Facility/Site No.:** 18489568
- **VCP Project No.:** SW1039

Issue Presented and Opinion

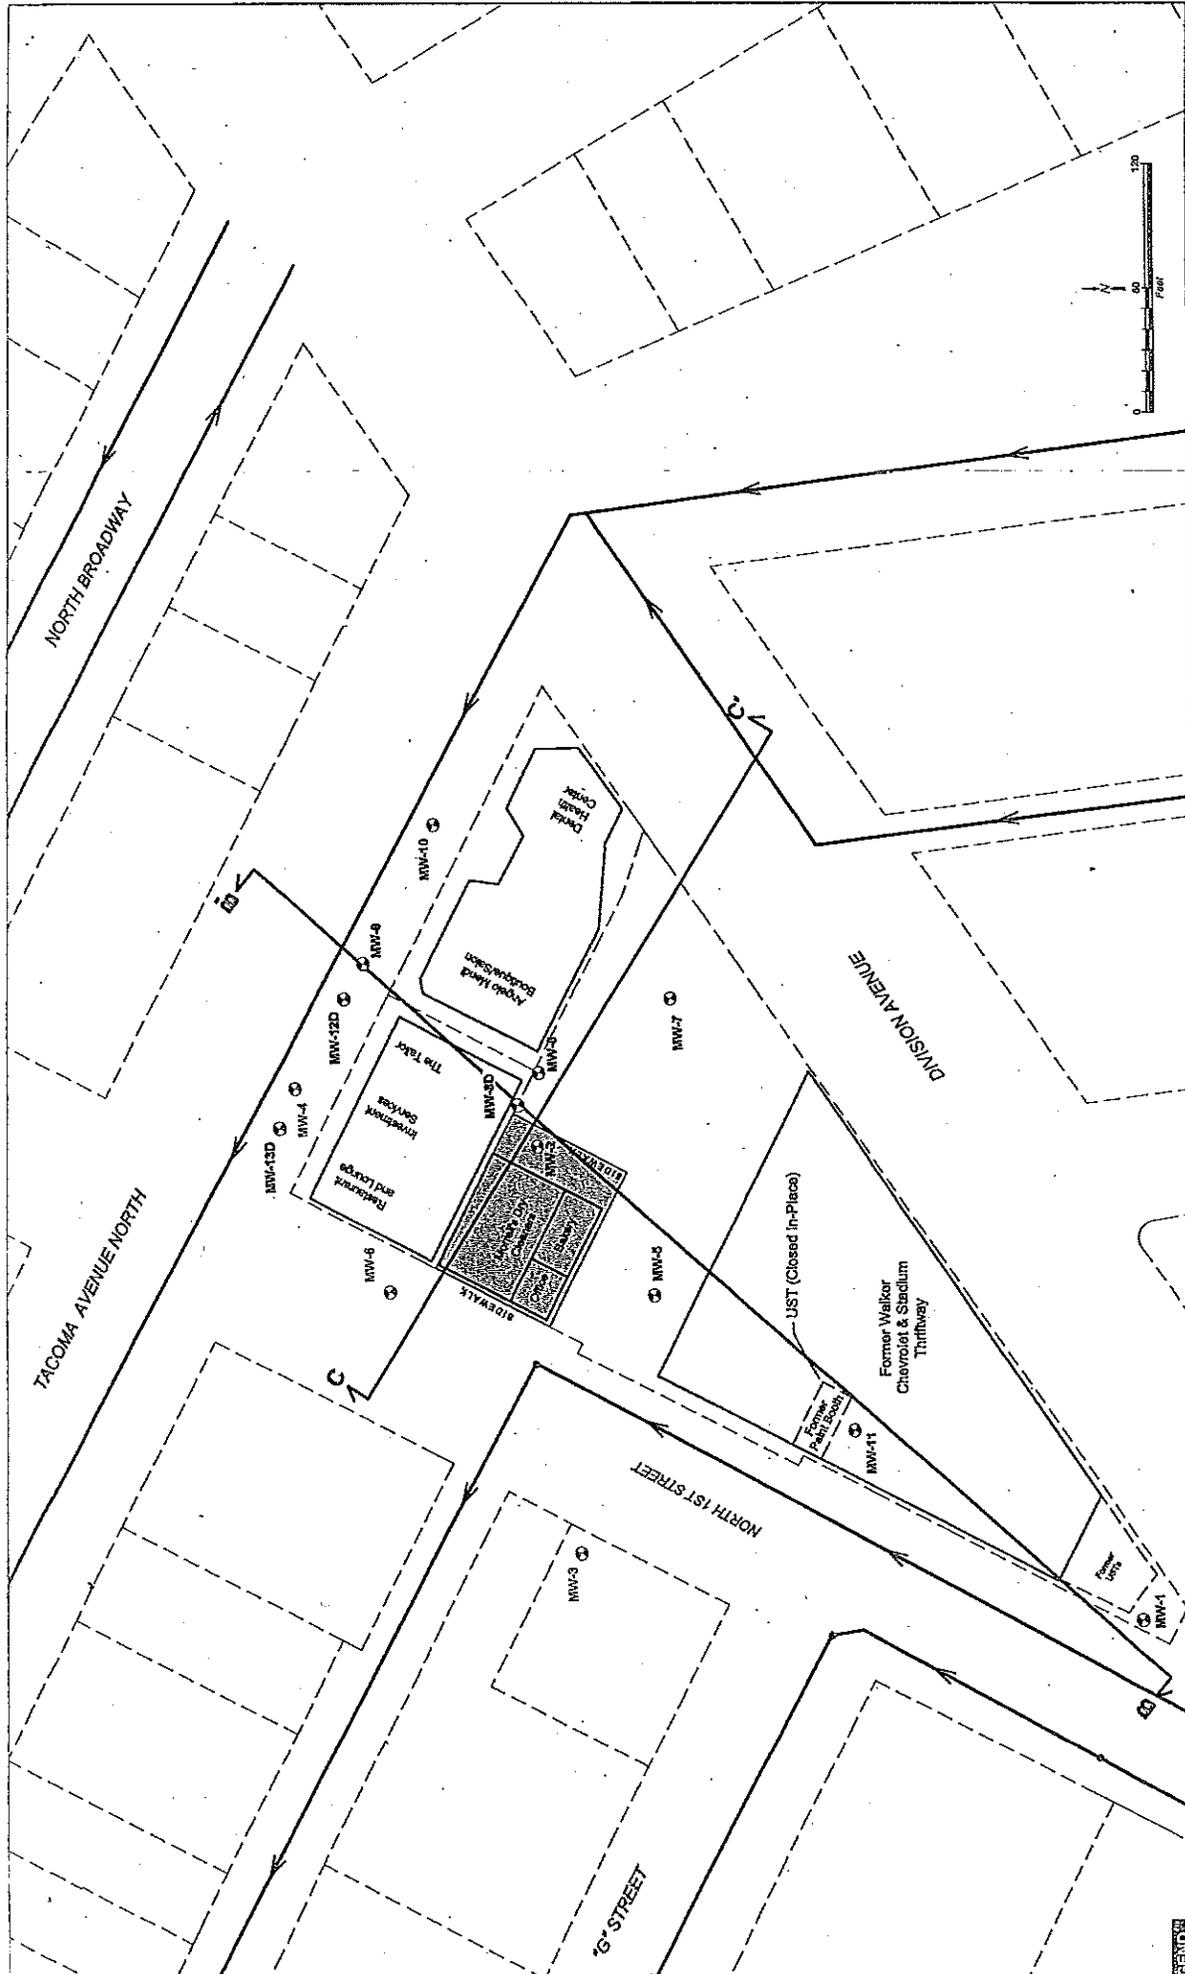
PROJECT NO.
080190
FIGURE NO.
2

Stemen installed eight groundwater-monitoring wells across the two sites. Monitoring Well MW-2 was the only well installed on the dry cleaner parcel; MW-8 was installed on the Titus parcel. The high concentrations of PCE and its daughter degradation products above their applicable MTCA Method A or ARAR Groundwater CUL in both MW-2 and MW-8 indicated a source beneath the dry cleaner (see Figure 2). Stemen also collected a groundwater sample from boring DCPLAS 2-W, which was adjacent to MW-2, for total lead. The analytical results indicated that total lead exceeded the MTCA Method A Groundwater CUL.

Well Location Plan
Morrell's Dry Cleaners, Former Walker Chevrolet Property
Tacoma, Washington

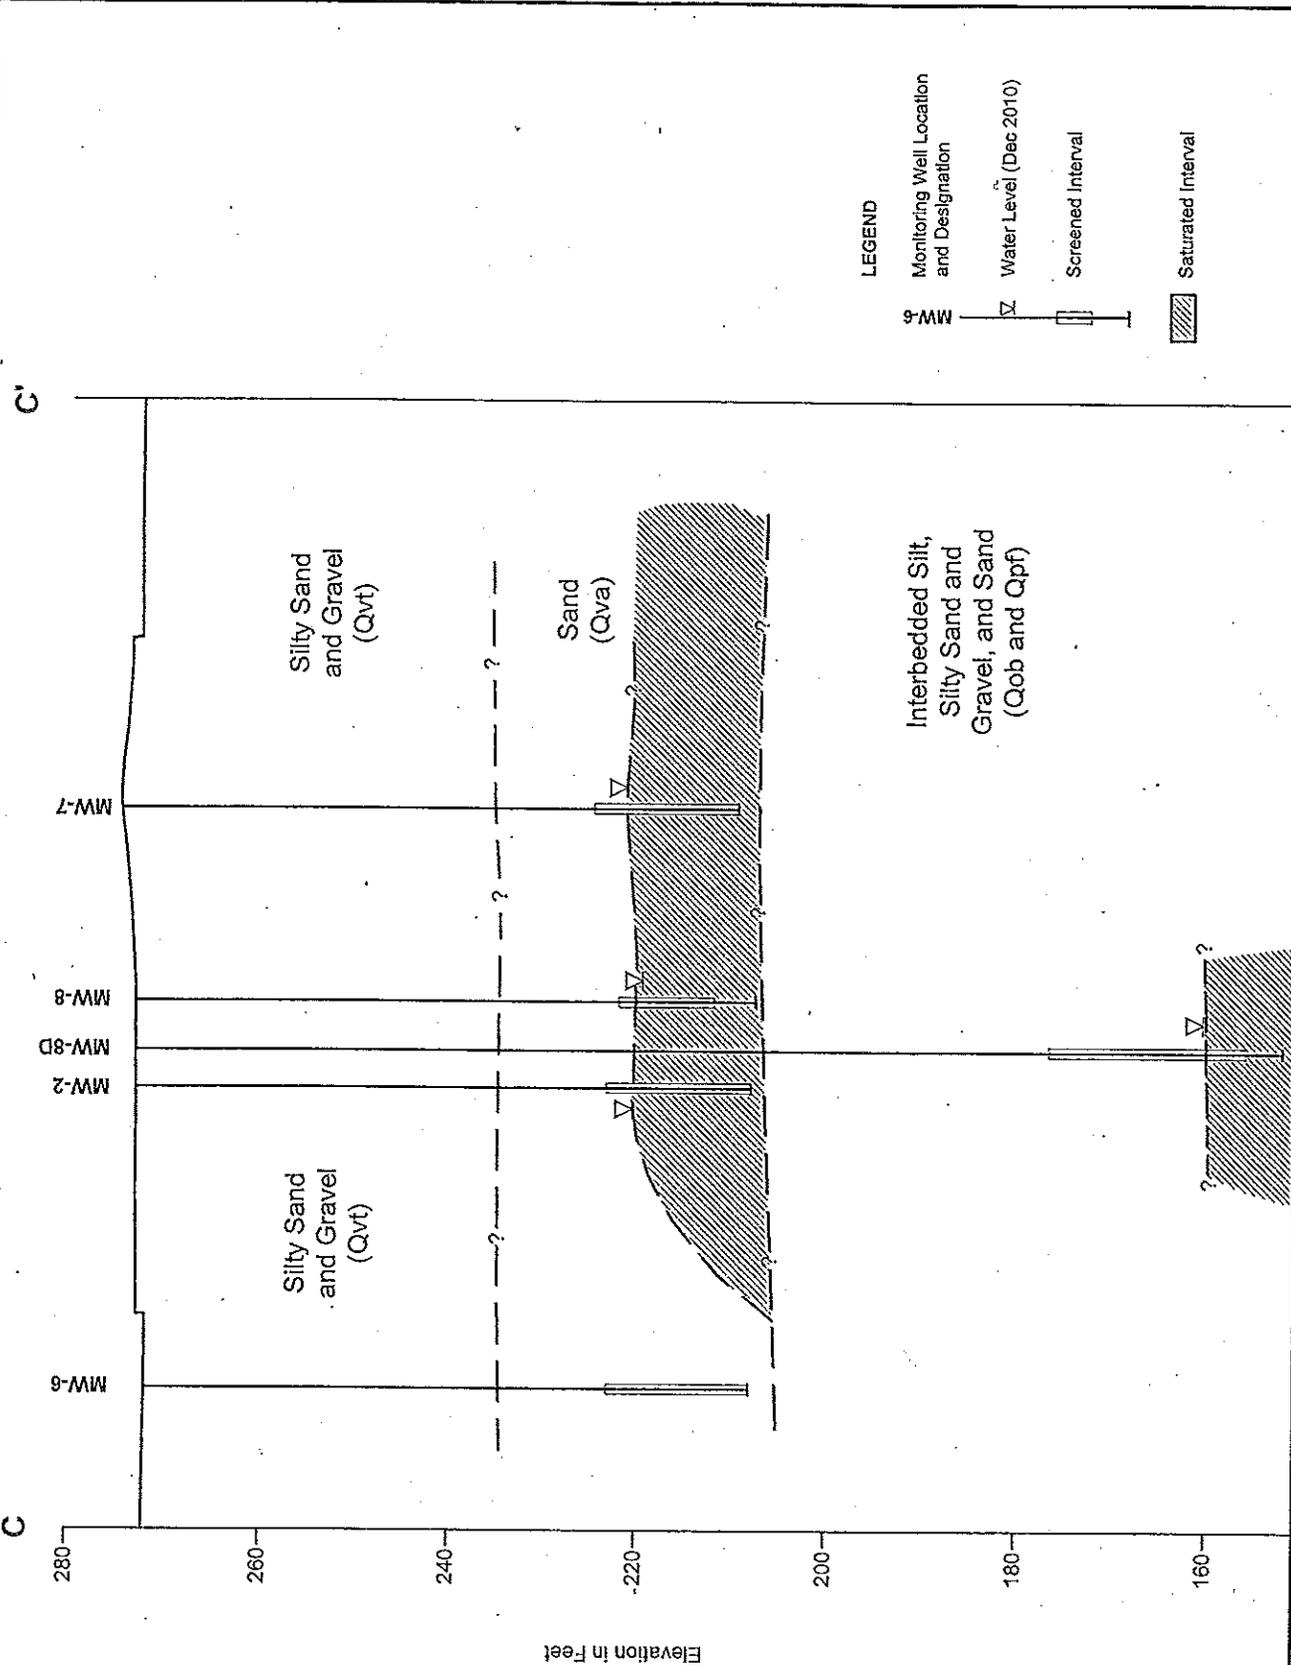
DATE	February 2011	PROJECT NO.	080190
DESIGNED BY	JM	FIGURE NO.	5
DRAWN BY	SCC		
REVIEWED BY

Cross Section C-C

Morrell's Dry Cleaners, Former Walker Chevrolet Property

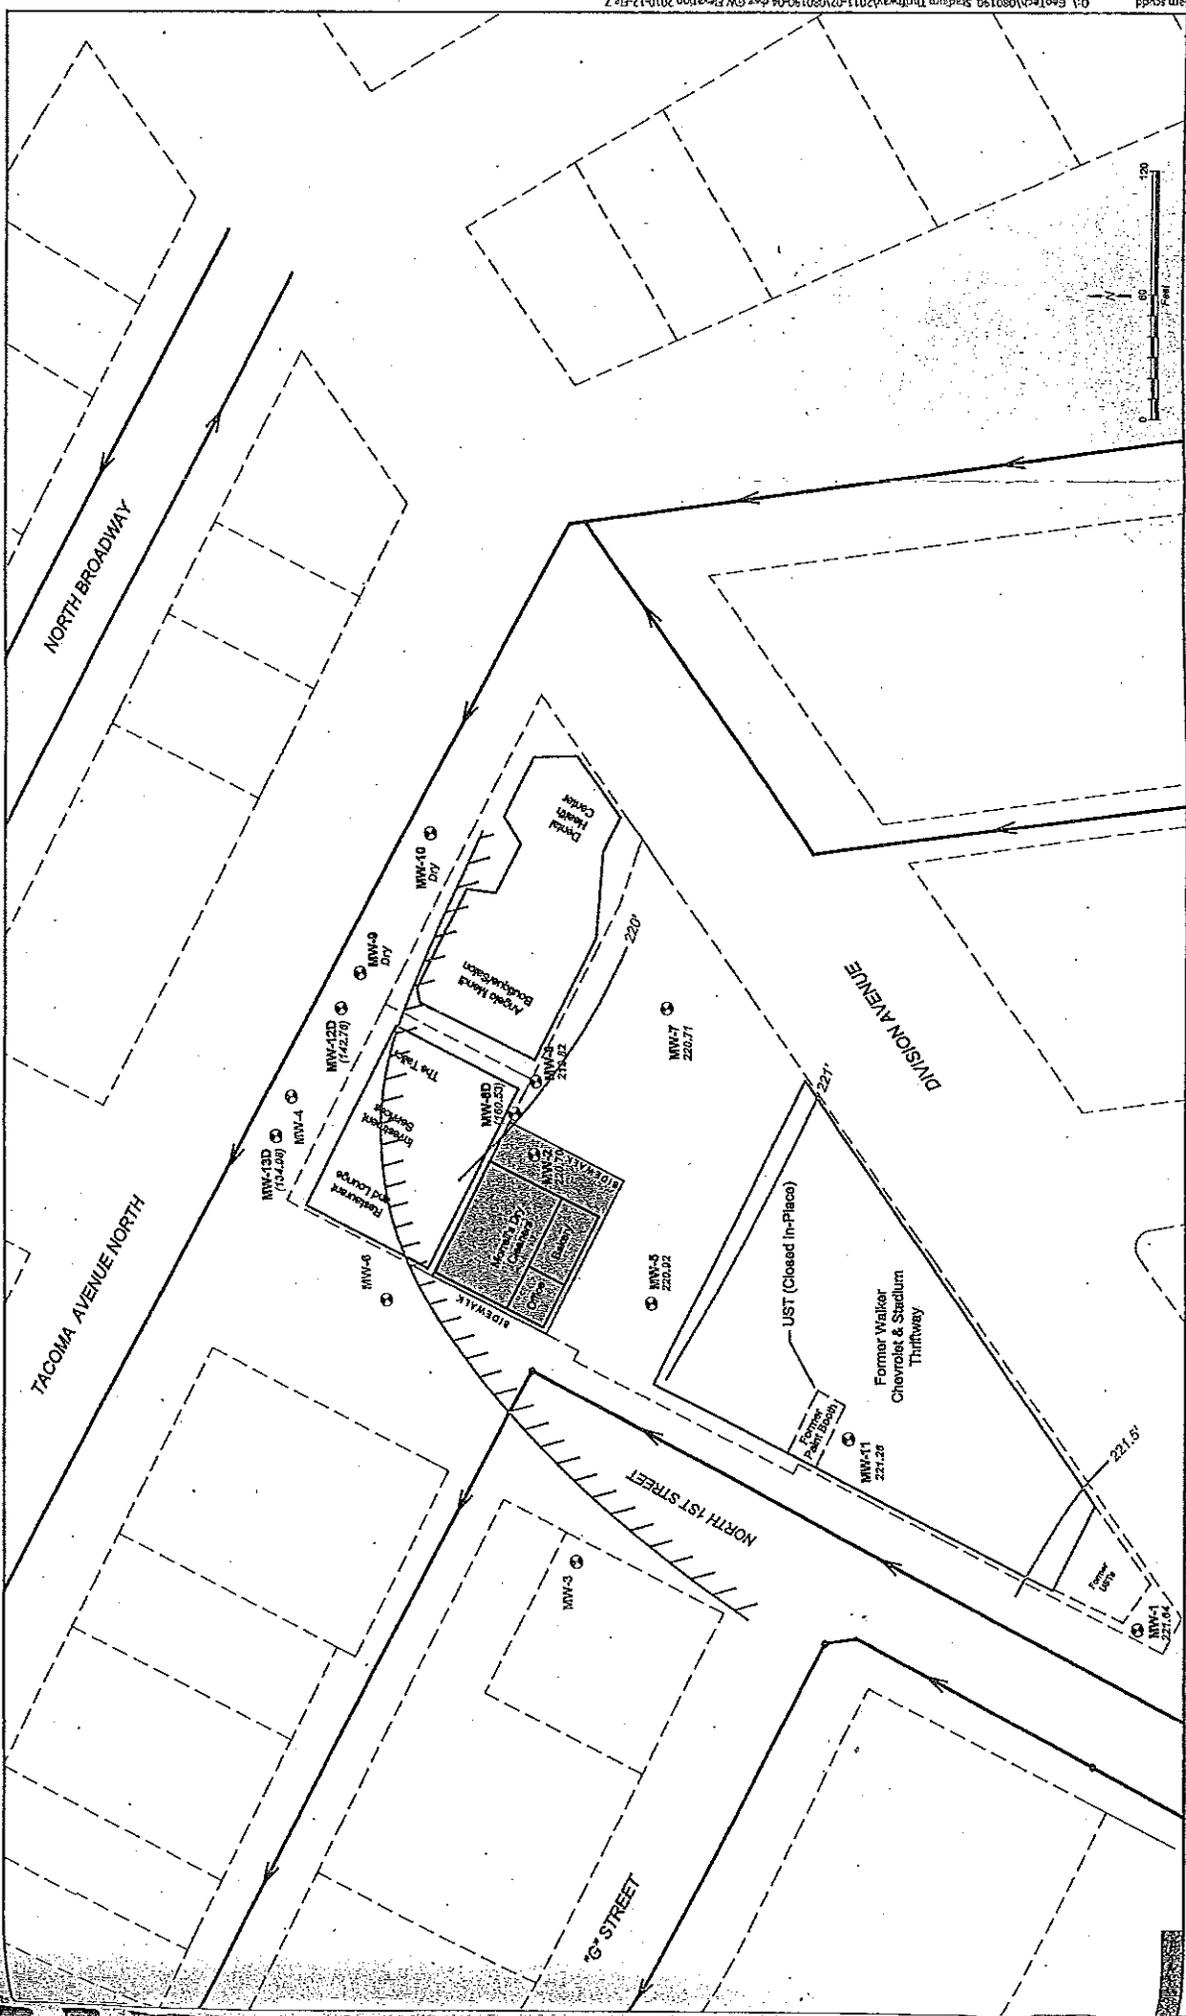
PROJECT NO.
080190
FIGURE NO.
7

Groundwater is generally 110 to 140 feet below ground surface (bgs) in the upland area of north Tacoma; however, locally under the Site there is a perched water table with groundwater at approximately 50 feet bgs. Most of the area around the Site is well developed and covered with impervious surfaces with the notable exception of Wright Park one block south of the Site, which may be a source of groundwater recharge.

December 2010
Groundwater Elevation Contour Map
Morrell's Dry Cleaners, Former Walker Chevrolet Property
Tacoma, Washington

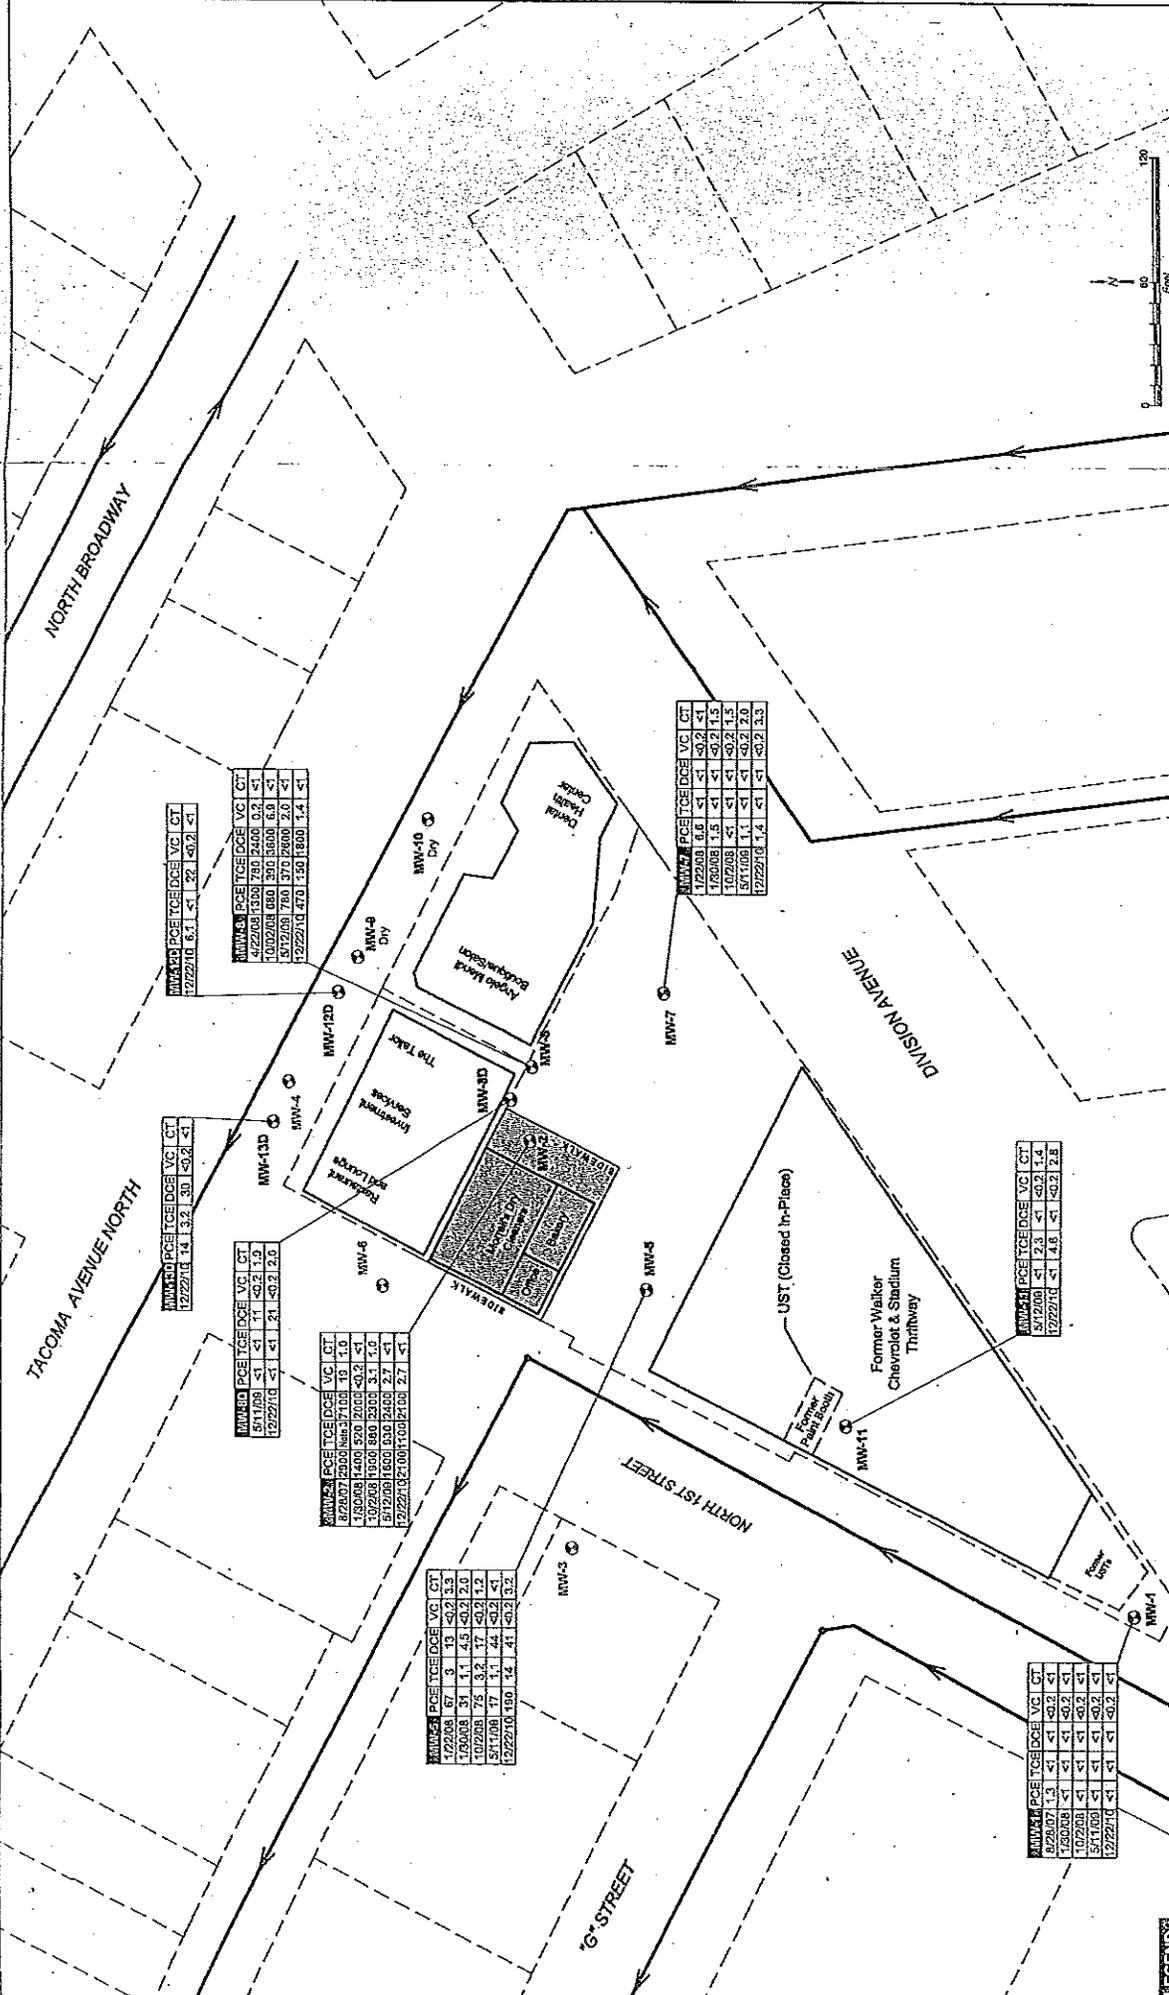
PROJECT NO. 080190
 FIGURE NO. 8

From October 2008 to present, Aspect conducted groundwater sampling and analysis. In May 2009, Aspect installed four additional monitoring wells, MW-8D, MW-9, MW-10, and MW-11. MW-9 and MW-10 were installed to approximately 70 feet bgs and did not produce groundwater in sufficient quantities to collect groundwater samples for analysis. These two wells, along with MW-3, MW-4, and MW-6, appeared to locally define the northern and eastern limits of the perched aquifer (see Figure 7). MW-11 was installed to a depth of approximately 70 feet bgs on the Titus parcel, up gradient of the dry cleaner parcel. Groundwater was found at approximately 50 feet bgs in the perched aquifer. MW-8D was installed to a depth of approximately 116 feet bgs between MW-2 and MW-8. The well was installed through the confining layer and into the lower aquifer, where groundwater was found at approximately 112 feet bgs. The constituents of concern (COCs) were compared to their respective MTCA Method A (or Method B*) Groundwater Cleanup Level (CUL) and were identified as PCE, TCE, DCE*, vinyl chloride, and carbon tetrachloride. The highest concentrations of PCE, TCE, DCE*, and vinyl chloride were $2,900 \mu\text{g/L}$, $1,100 \mu\text{g/L}$, $7,100 \mu\text{g/L}$, and $19 \mu\text{g/L}$, respectively, and were found in the groundwater from MW-2, indicating a potential source from beneath the dry cleaner. The MTCA Method A (or Method B*) Groundwater CULs are $5 \mu\text{g/L}$, $5 \mu\text{g/L}$, $16 \mu\text{g/L}$, and $0.2 \mu\text{g/L}$, respectively. PCE and TCE were detected above their respective MTCA Method A CULs in MW-5 and MW-7. Carbon tetrachloride was also detected in MW-5, MW-7, MW-11, and in the deeper well MW-8D, all located up gradient from the Site on the Titus parcel at similar concentrations. No apparent source for this COC has yet been identified (see Figure 8 and Table 2).

In October 2010, Aspect installed two more monitoring wells in Tacoma Avenue North, northwest of MW-9 and MW-10. The wells, MW-12D and MW-13D, were installed to investigate and delineate the VOC contamination in the deep aquifer north of the dry cleaner parcel. In November 2010, all network wells were monitored using passive diffusion bags; the analytical results were consistent with previous analytical results. Low concentrations of PCE, TCE, and DCE were detected above their respective MTCA CULs in both MW-12D and MW-13D (see Figure 8 and Table 2).

Groundwater Quality Data
 Morrell's Dry Cleaners, Former Walker Chevrolet Property
 Tacoma, Washington

Note:
 1) Red value indicates a detection exceeding the MTCAs screening level.
 2) For the sample collected from MW-2 on 8/28/07, the lab reported 1,800 µg/L benzene and <1 µg/L TCE. This is likely an error; apparently the gas chromatograph peak identified by the lab as benzene was actually a TCE peak.

2. Ecology believes the perched aquifer has been fully defined. The lower aquifer contamination has yet to be fully delineated. Stemen found total lead in the groundwater near MW-2 in September 2008 and it has not been evaluated for since. Ecology recommends an additional deep well be installed at a down gradient location to better define the PCE plume. The COCs for groundwater will be PCE, TCE, DCE, vinyl chloride, benzene, toluene, ethylbenzene, and total xylenes (BTEX), naphthalene, and metals (total lead).

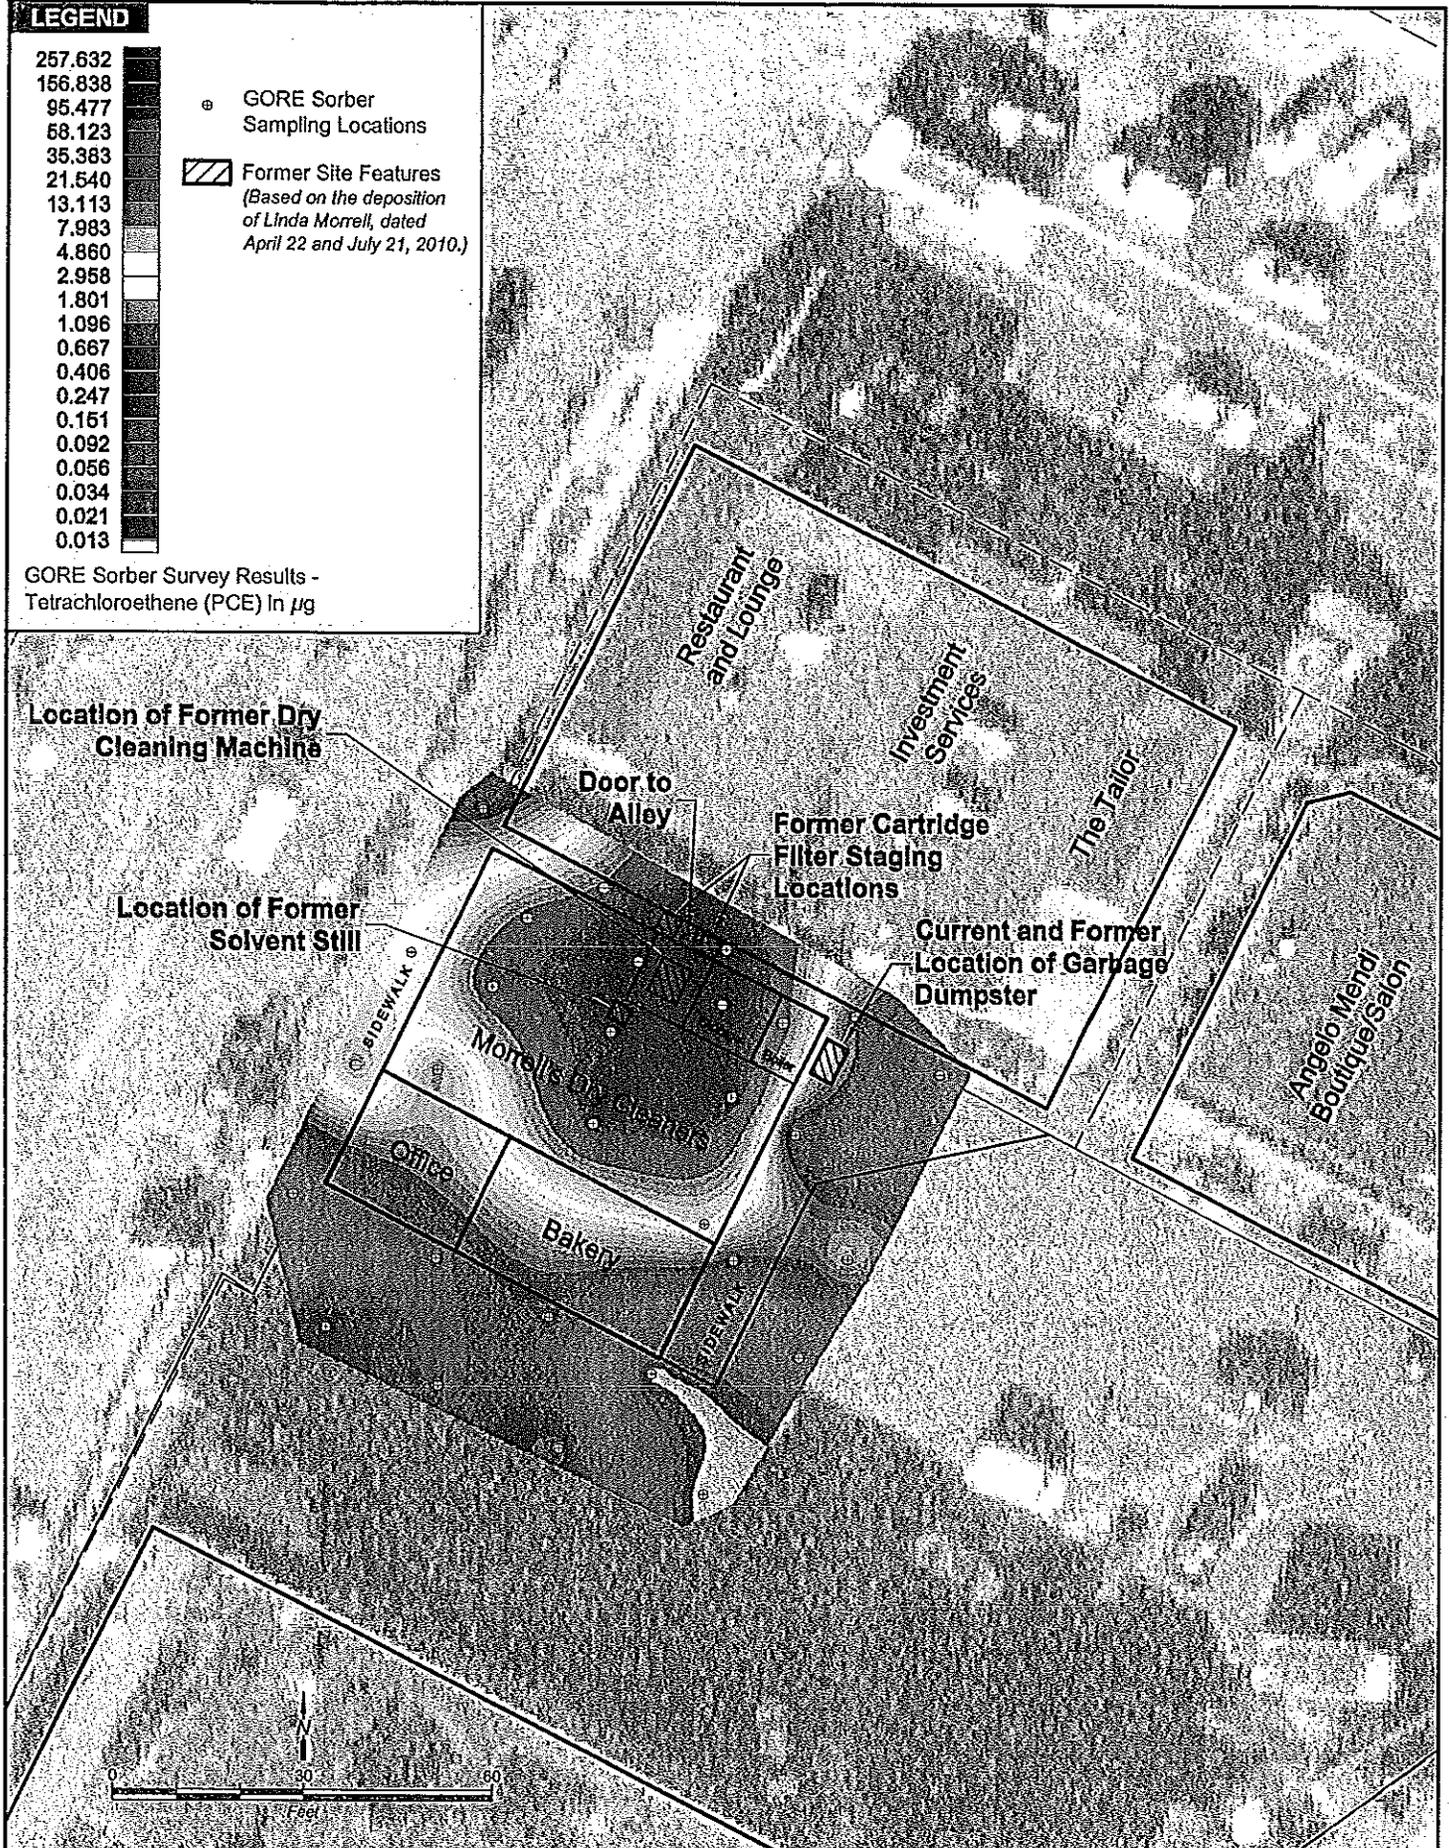
PROJECT NO.	080190
FIGURE NO.	9

In January 2010, Aspect conducted a soil gas survey at the Site using Gore® passive diffusion modules (PDFs) emplaced underneath the building floor slab, sidewalk, and parking lot. Analysis of the modules indicated that PCE, TCE, DCE, and trans-1,2-dichloroethene were present at elevated concentrations. Contoured results indicated areas of PCE mass near suspected sources of contamination (see Figure 9).

GORE Sorber Survey Results - Tetrachloroethene (PCE) In µg

GORE® Module Results-PCE

3. Soil vapor contamination above the MTCA Method B SGSL is present in the subsurface beneath the dry cleaner building. No off-parcel soil vapor data was collected; however, interpretation and extrapolation of the Gore[®] PDF results would suggest that indoor air on other parcels to the north of the dry cleaner building may also be affected and should be evaluated. Ecology recommends the soil vapor pathway be fully evaluated on the Site and Summa[™]-type canisters should be used in that evaluation. A Tier II indoor sampling assessment sampling plan should be developed and presented to Ecology for review and approval. The COCs for the soil vapor assessment are PCE, TCE, DCE, vinyl chloride, benzene, toluene, ethylbenzene, and total xylenes (BTEX), and naphthalene. Ecology's "Guidance for Evaluating Soil Vapor Intrusion in Washington State: Investigation and Remedial Action" can be found at:

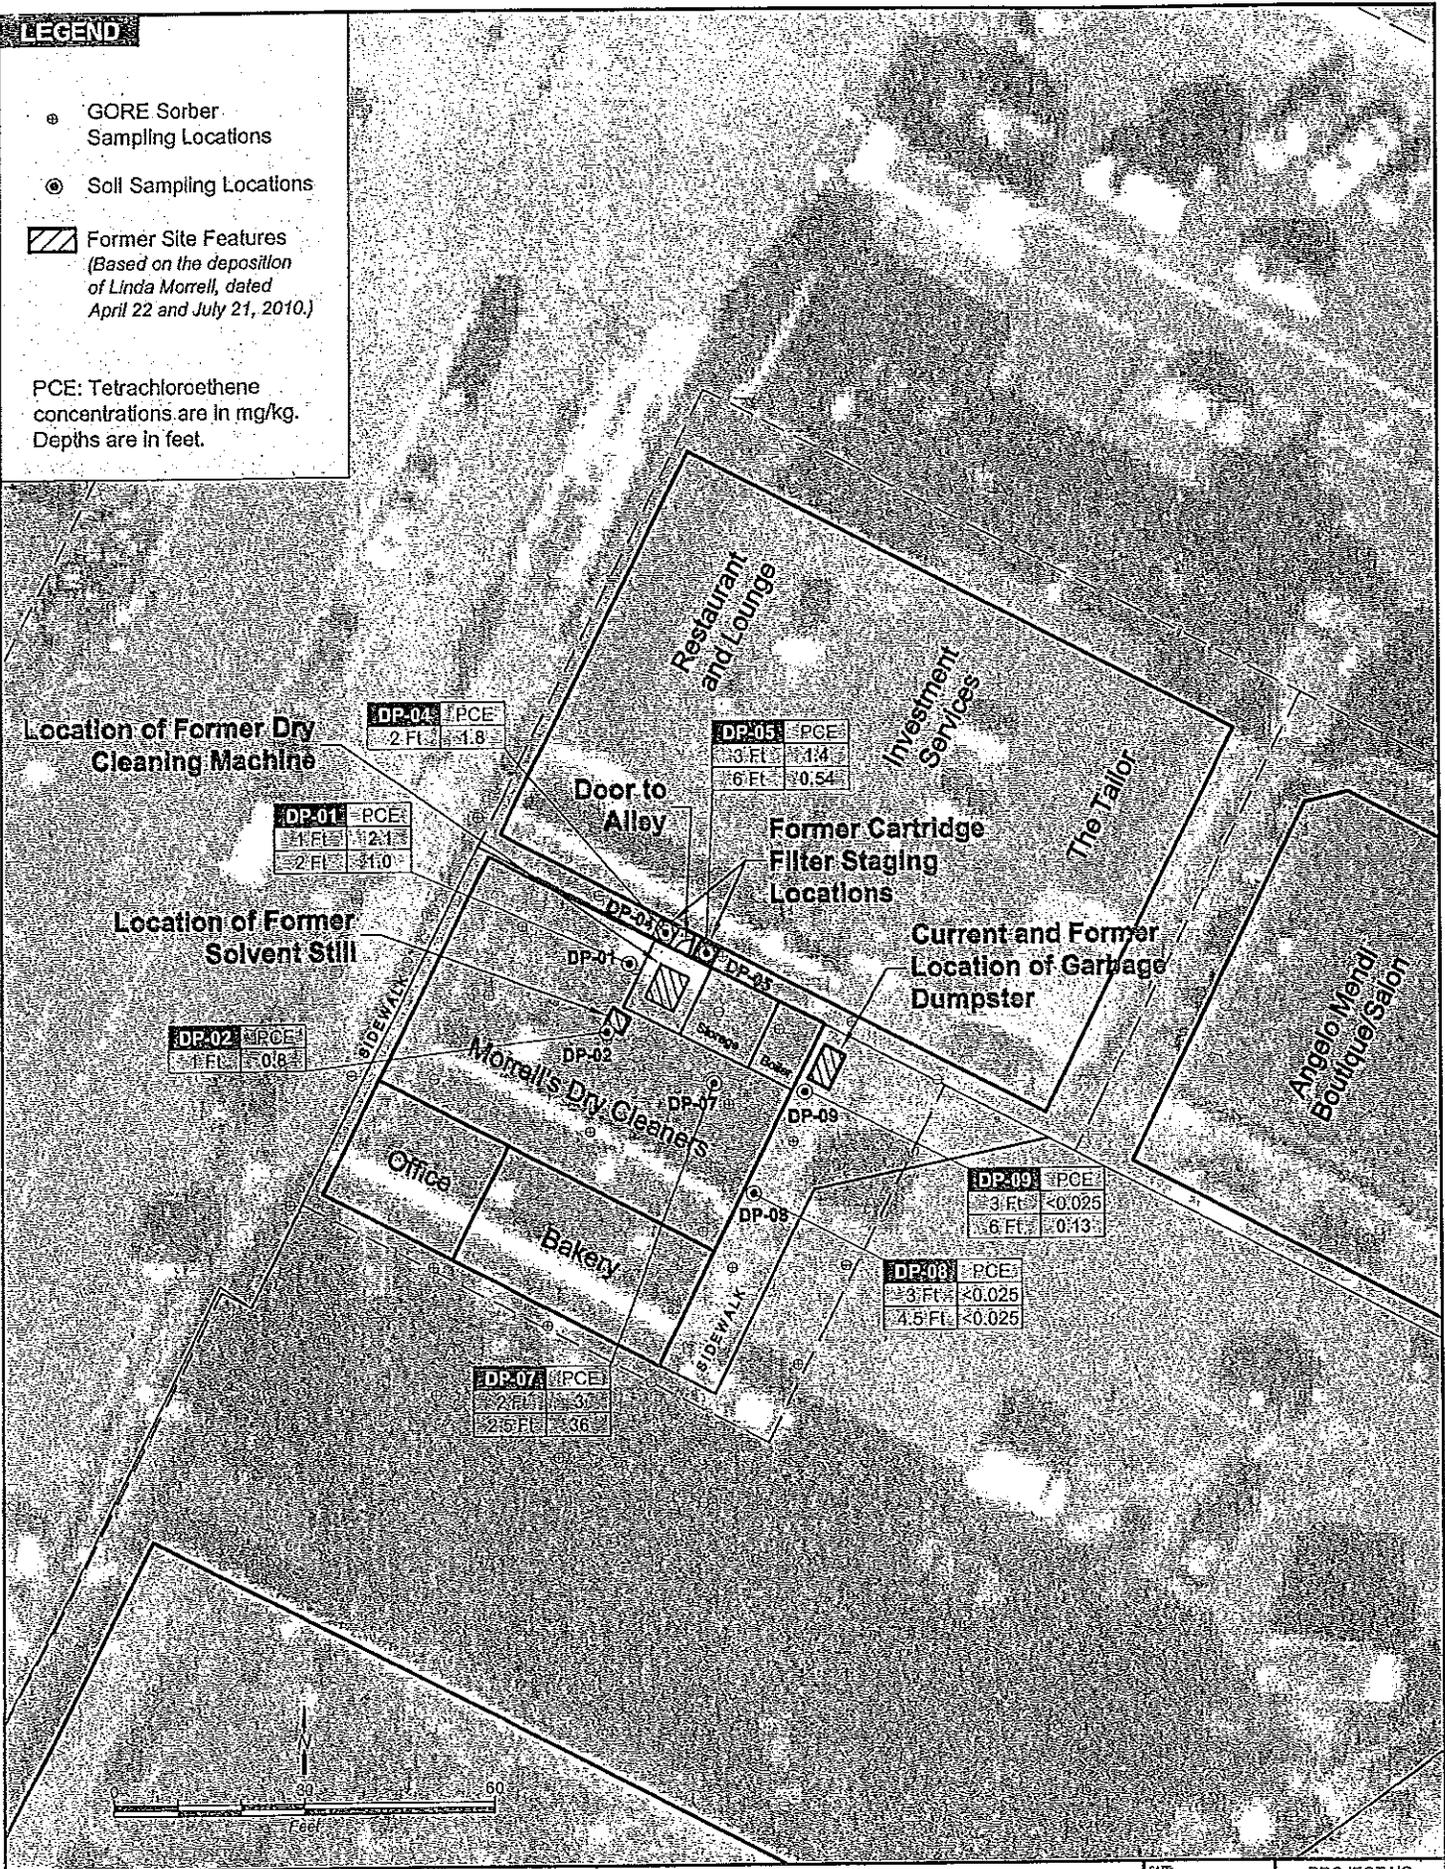
PROJECT NO.	080190
FIGURE NO.

In October 2010, Aspect conducted soil sampling activities based on the Gore[®] PDF results. COCs detected were PCE, TCE, and DCE at concentrations exceeding their respective MTCA CULs. The soil analytical results were generally consistent with the Gore[®] PDF results, indicating potential source locations under the former PCE dry cleaning machine, solvent still, and filter storage area outside the door to the alley on the north side of the building (see Figure 10 and Table 3).

Location of Former Dry Cleaning Machine

Location of Former Solvent Still

DP-07	PCE
2 Ft.	37
2.5 Ft.	36

PCE Concentrations in Soil

1. The vertical extent of the PCE and TCE present in the Site soil has not been fully delineated. Soil contamination above the applicable MTCA Method A Soil CUL below 6 feet bgs is undefined. Naphthalene was detected above its MTCA CUL; the full horizontal extent of this contamination has not been delineated and no discussion on potential sources occurred in the February 2011 report. Total lead was detected in groundwater from DC PLAS-2-W (near MW-2); no analytical soil data for metals was presented for review and no discussion or speculation on potential sources was included in any previous report. The vertical and horizontal extent of soil contamination needs to be delineated. The soil COCs for further analysis are PCE, TCE, DCE, vinyl chloride, benzene, toluene, ethylbenzene, and total xylenes (BTEX), naphthalene, and metals (lead).
