## Soil Excavation and Remediation Report

**Lake Goodwin Gas Station  
4726 Lakewood Road  
Stanwood, WA**

*Slotta Design & Consulting (SD&C)  
PO Box 2071  
Kirkland, WA 98083*

October 13, 2015

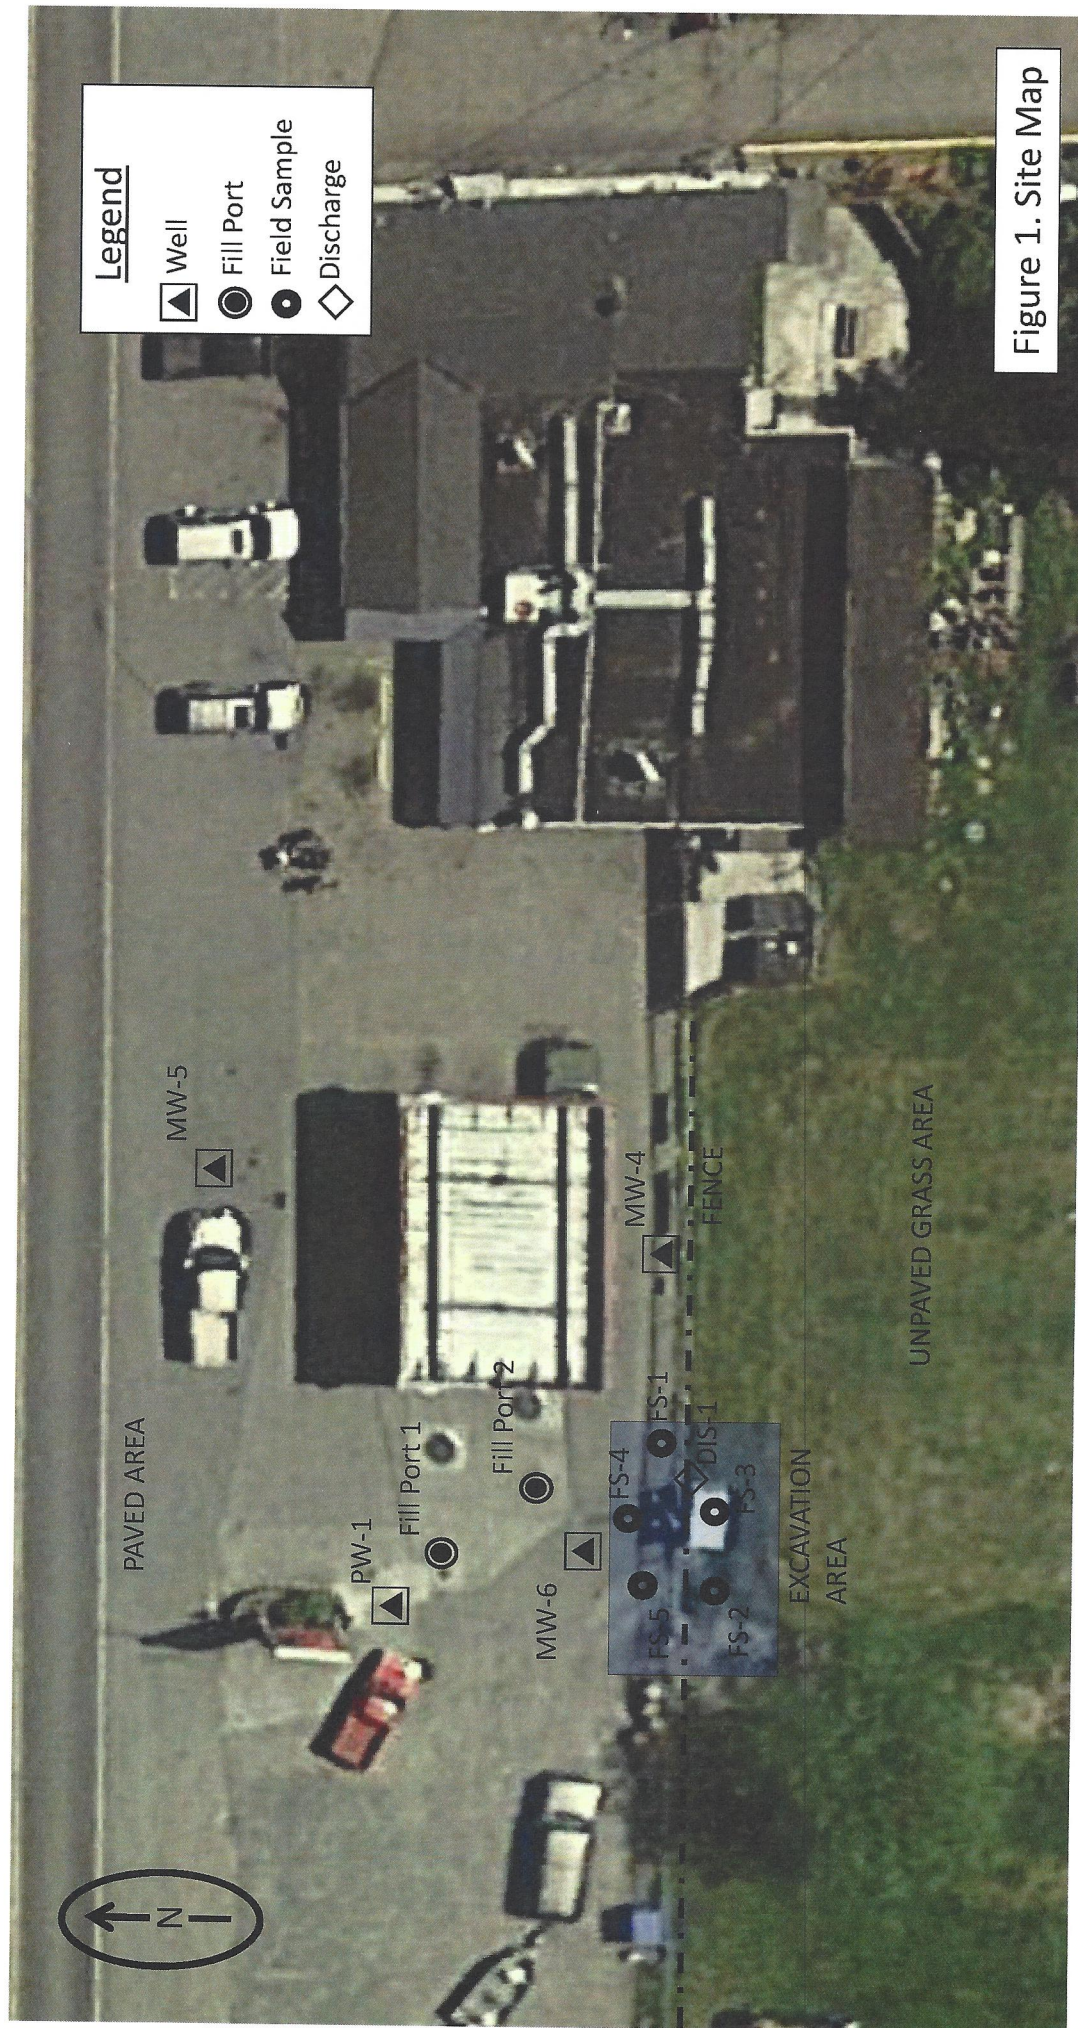
Figure 1. Site Map

On Wednesday December 11, 2013 a Harris Distributing (Harris) employee spilled gasoline onto the ground while delivering fuel into Fill Port 1 shown in Figure 1. The volume of the release is currently unknown. Based on review of security camera footage of the spill, the release occurred during a 2.5 minute period during the UST filling operation.

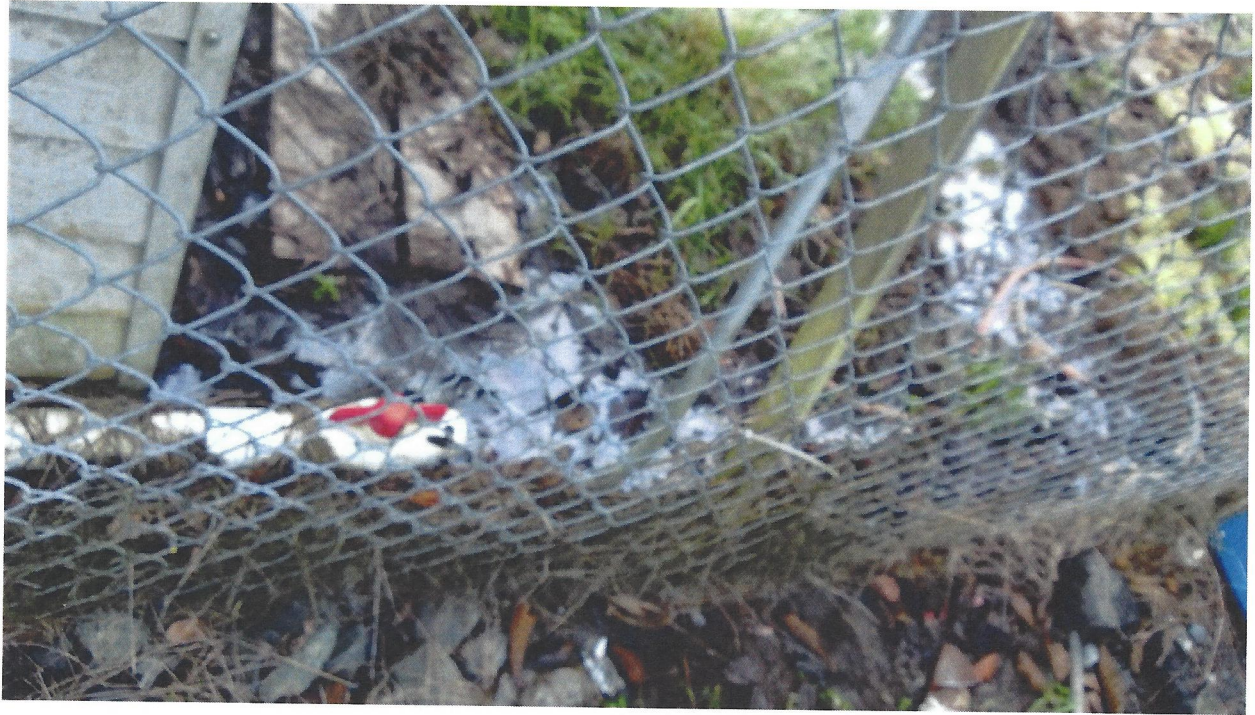
Picture 1. Discharge flow from paved area.

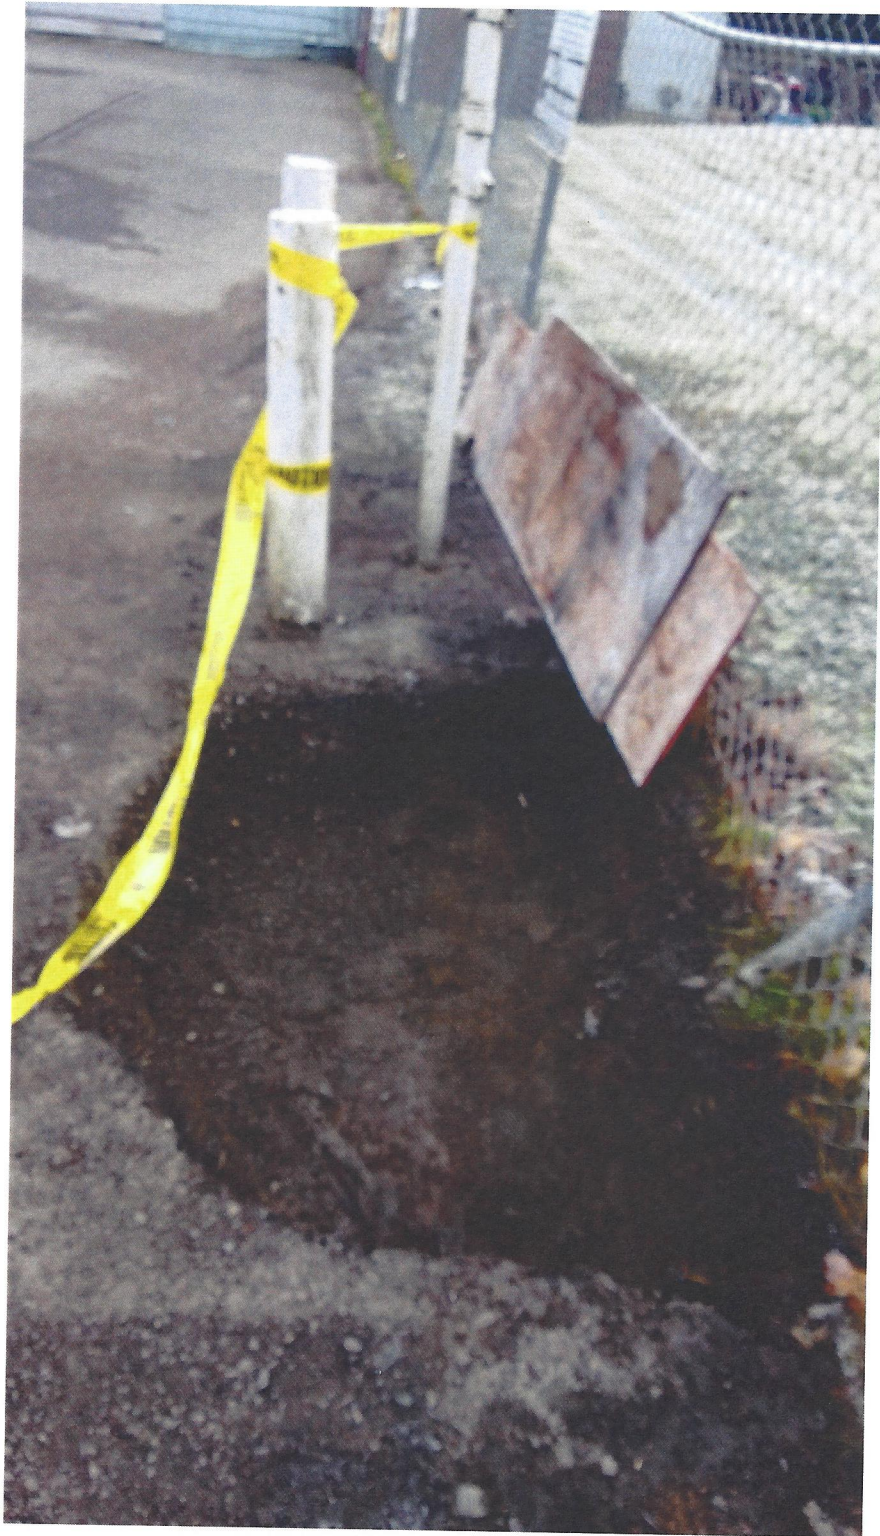
Picture 2. Excavation performed by Harrison Distributing.

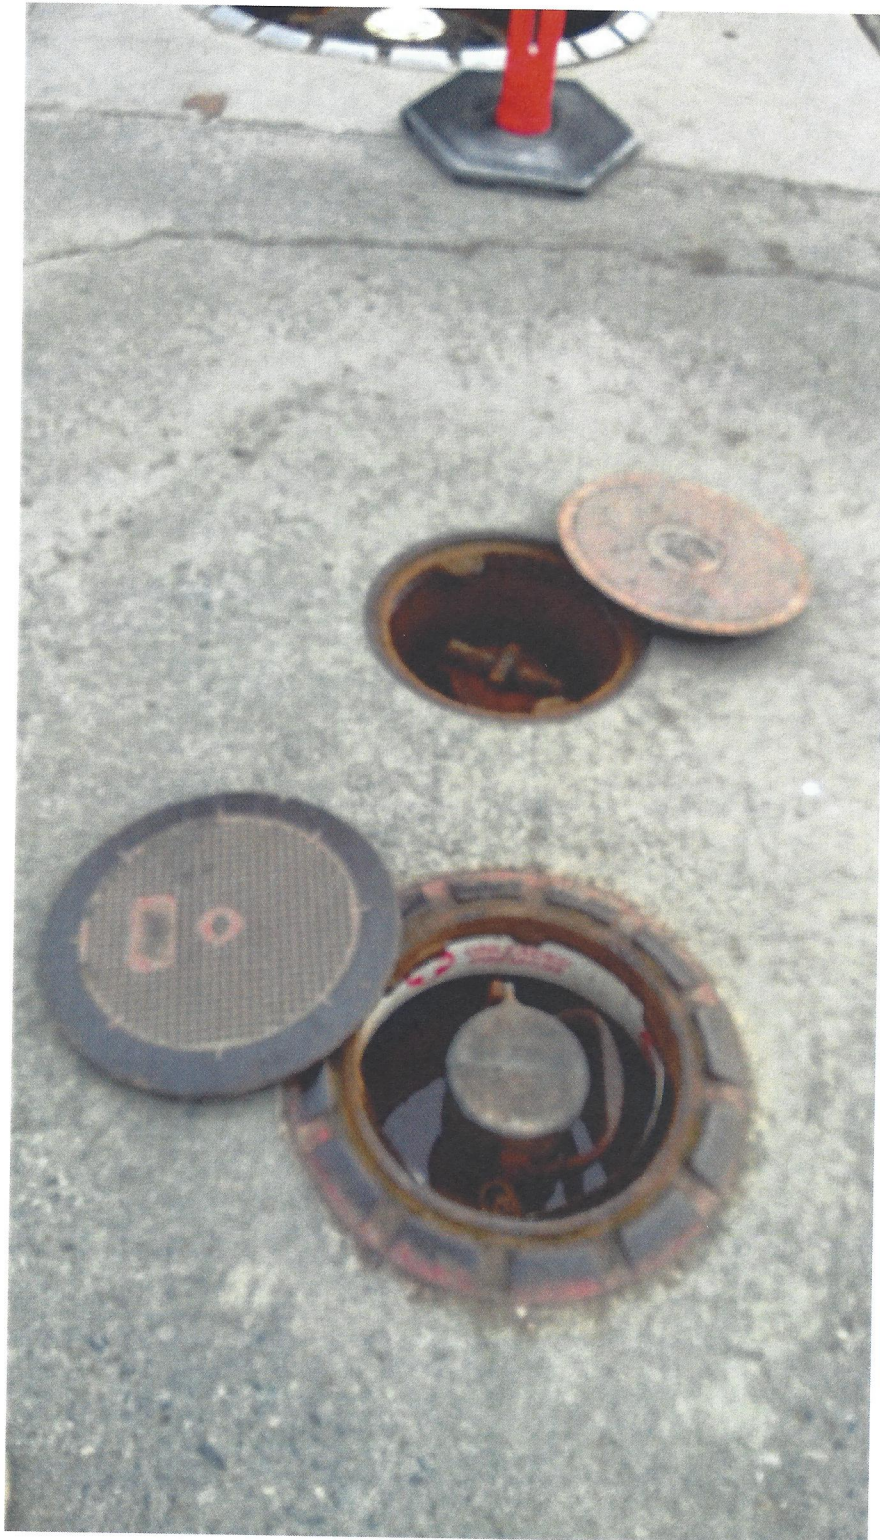
Picture 3. Fill port where spill occurred filled with gasoline.

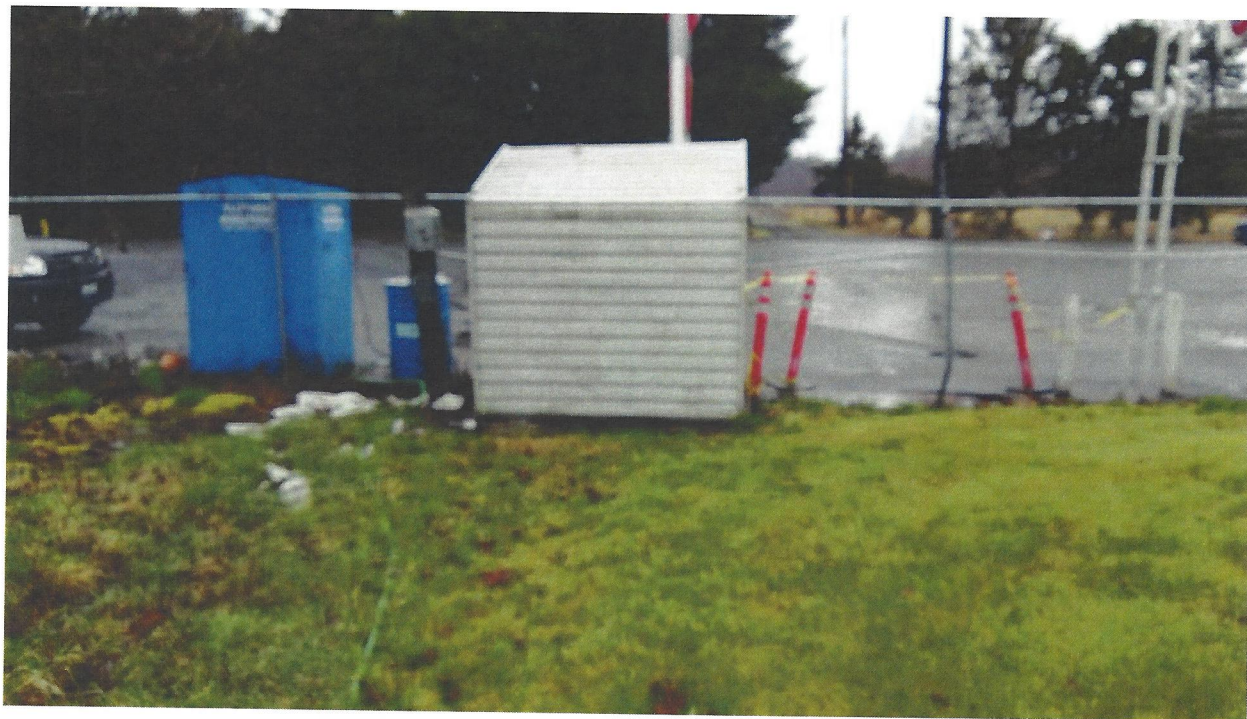
Picture 5. Downstream surface water discharge swale before excavation. Diapers placed in swale to absorb surface contamination.

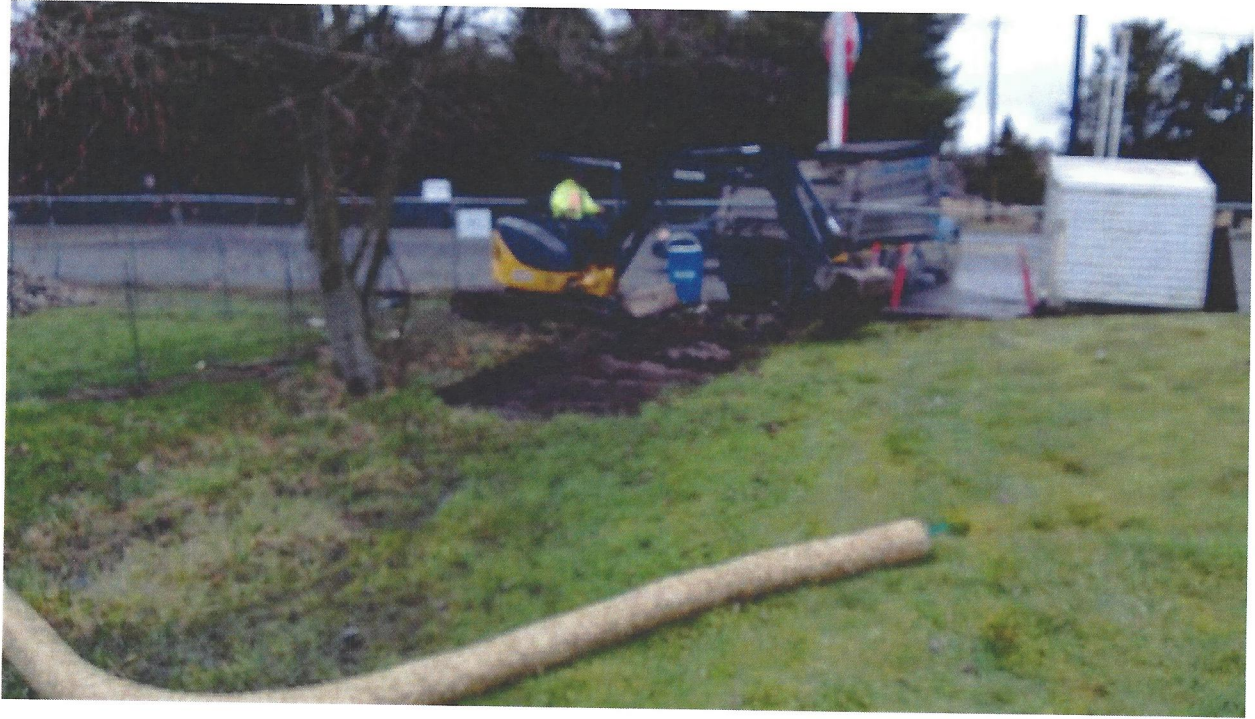
Picture 6. Excavation of downstream surface water swale.

Based on the initial sample results, On March 4, 2014, SD&C directed the excavation of the gasoline release area which was conducted by Wes Roberts Construction (WRC) of Stanwood, WA. The impacted soil was excavated to a depth of one foot in the area shown in Figure 1. A total of 39.1 tons of Class 3 contaminated soil was removed from an approximately 800 sq. ft. area and disposed off-site at Cemex USA (CEMEX) located in Everett, WA, during March 5<sup>th</sup> and 6<sup>th</sup>. Photos of the excavation events are in Appendix A.

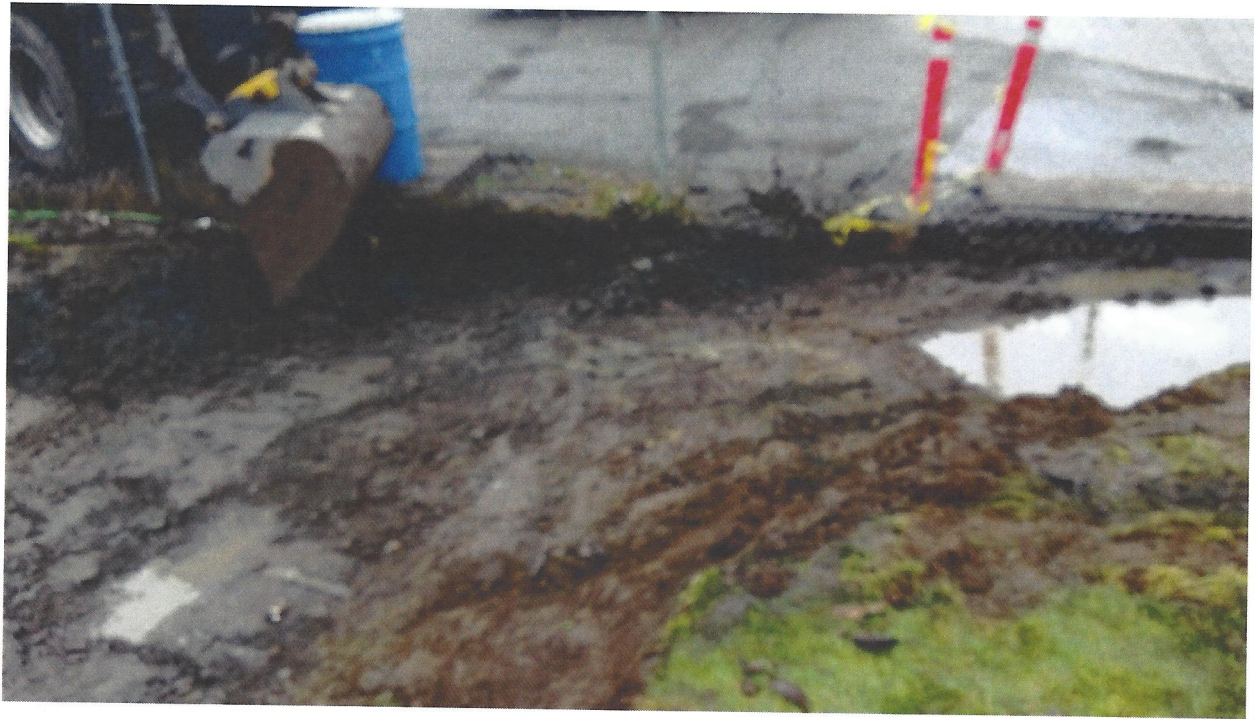
Picture 7. Excavation of non-paved contaminated area.

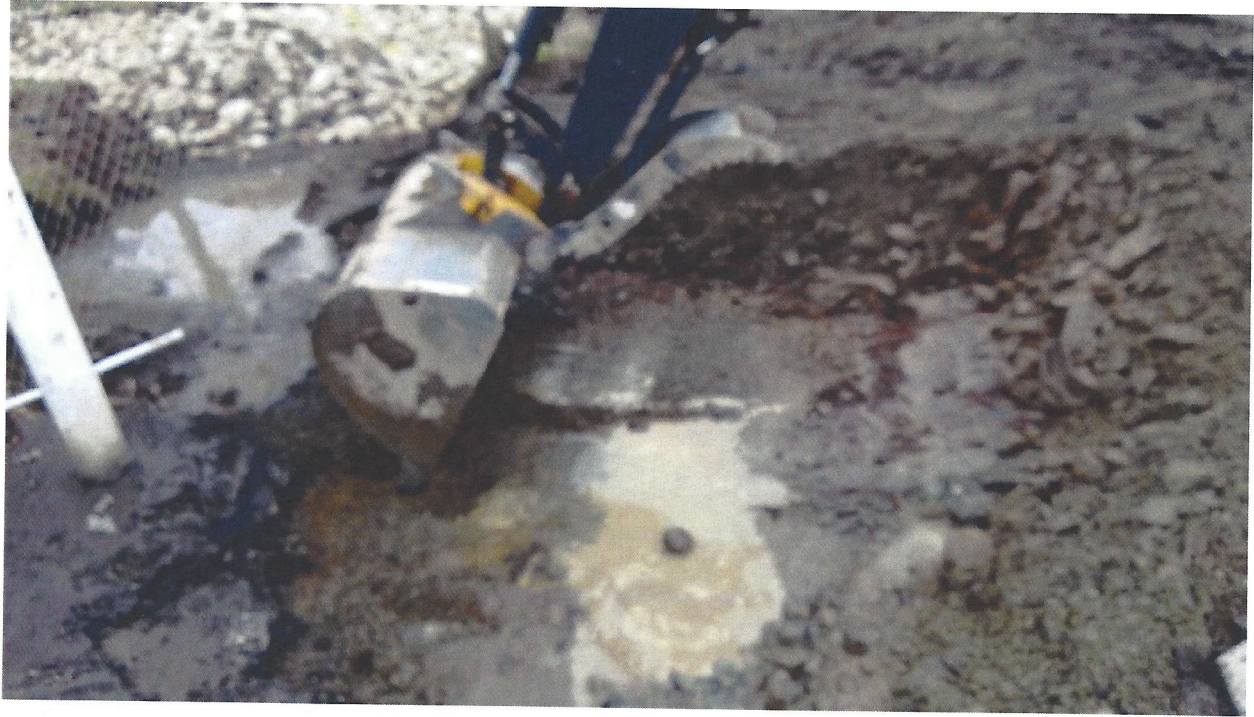
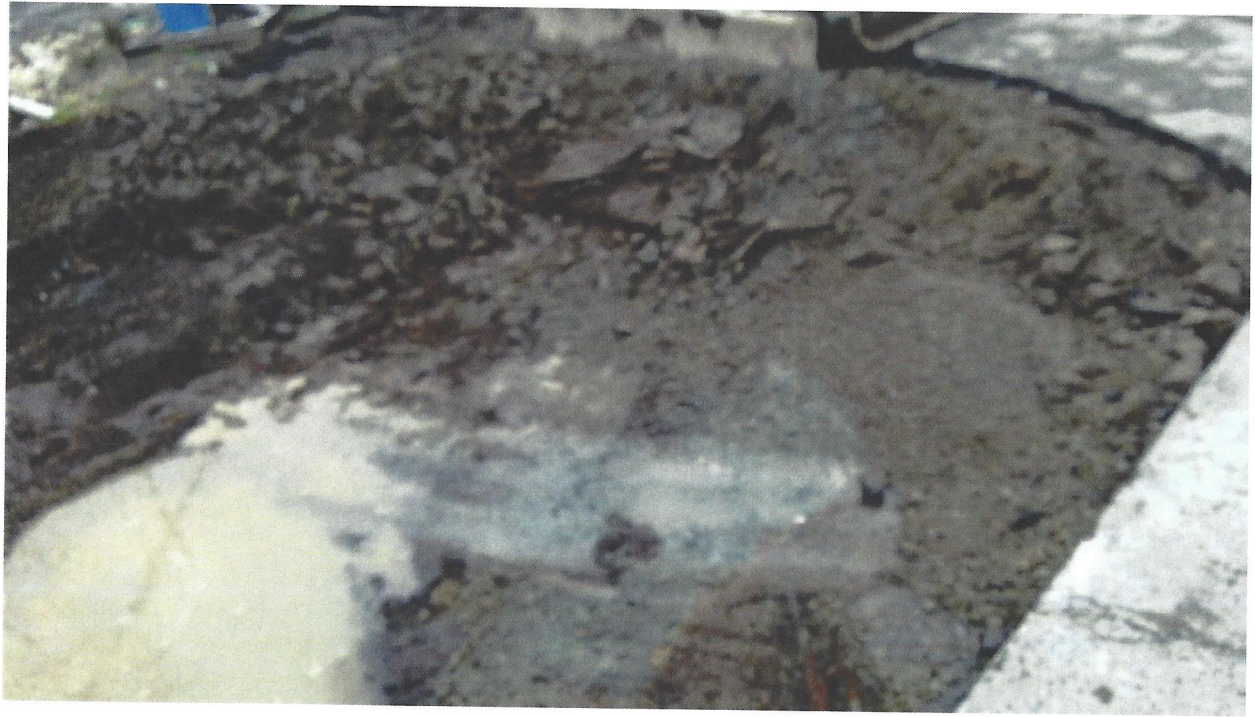
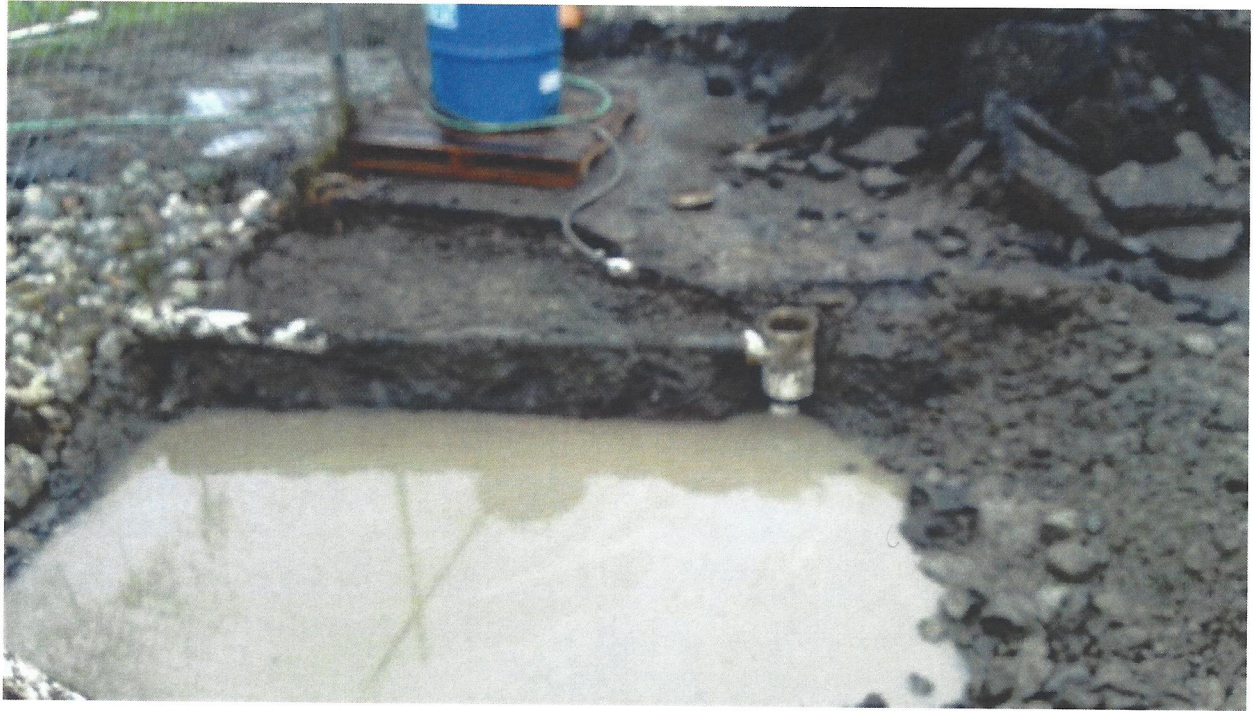
Picture 8. Excavation of paved contaminated area.

Picture 9. Excavation of paved contaminated area.

Picture 10. Excavation of paved contaminated area.

Backfill material consisted of 18.46 tons of ¾" washed rock supplied by WRC. Piping was placed in the swale excavation area. The excavation area beneath the asphalt north of the swale was repaved by HDK Asphalt Replacement. Quantity records for materials supplied during the remedial activities are summarized in Appendix C.
