**INTERIM ACTION REPORT  
HOOVER ELEMENTARY SCHOOL  
YAKIMA, WASHINGTON**

**Facility/Site ID # 9465028**

**January 20, 2011**

**Prepared by Washington State Department of Ecology  
Toxics Cleanup Program  
Mark Dunbar (509) 454-7836**

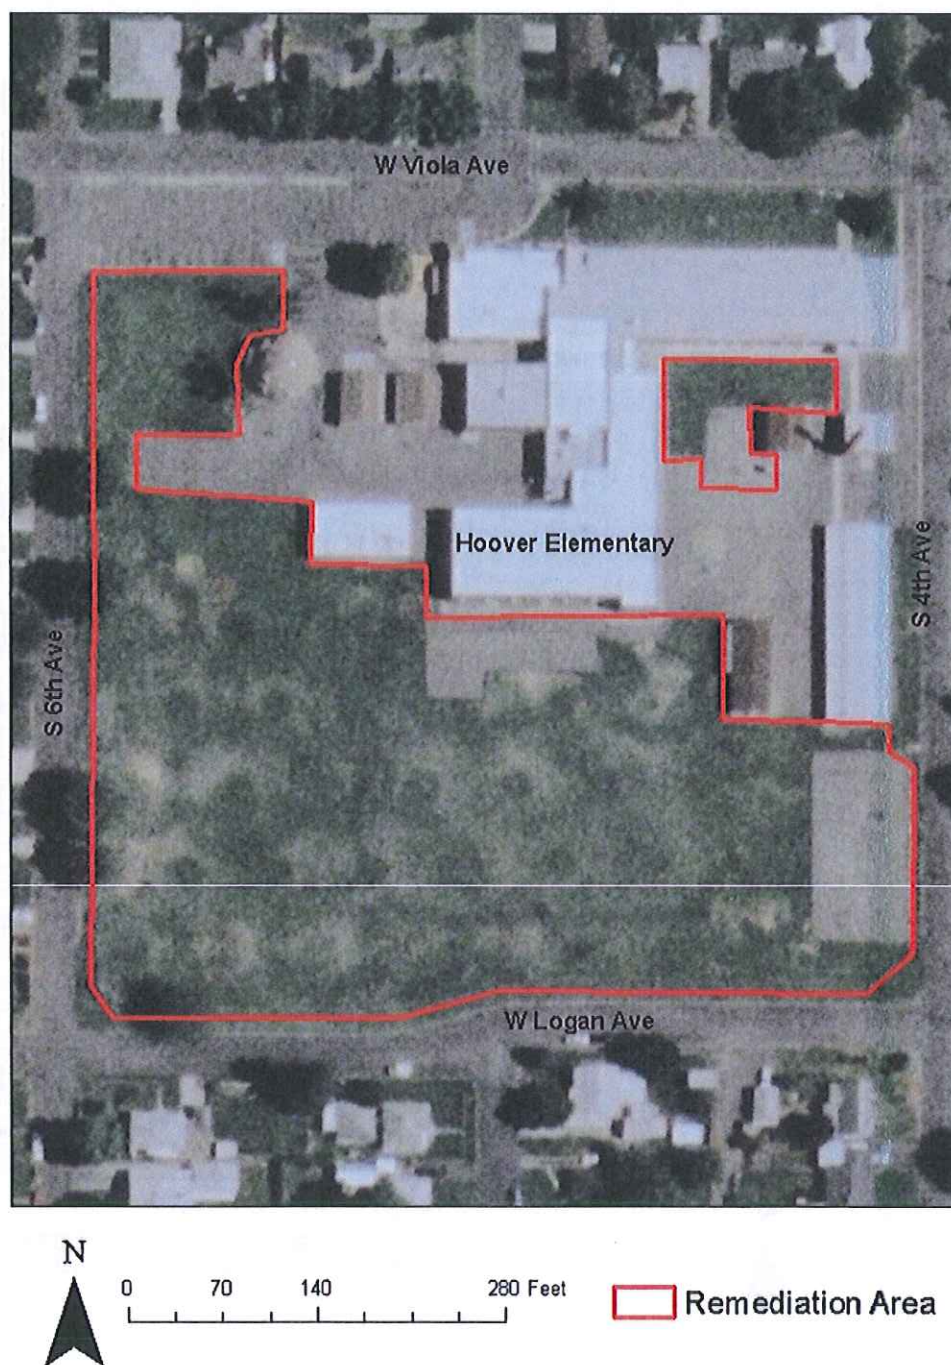
**Figure A-2: Remediation Area Map**

**Hoover Elementary  
400 W Viola Ave**

To prevent exposure to contaminated soil, a geotextile barrier and 8-inch cap of clean soil and grass sod were installed over the existing play area. Play equipment pits were excavated to a depth of 16 inches, lined with geotextile fabric, and filled with engineered wood fiber. Because contamination was not removed from the site, a restrictive covenant will be issued to restrict future development or improvements on the site that could expose contaminated soil.

Capping of existing soil with clean soil was chosen as the most efficient remedial option for the site. The remedial process was carried out as follows: Contaminated soil was excavated at hardscape edges such as pavement and foundations to allow the soil cap to meet existing grade. Existing grass turf was tilled to a depth of approximately six inches using a tractor-drawn rototiller, and the tilled surface was flattened with a roller in preparation for the cap. A permeable geotextile fabric was rolled out over the existing soil surface with 12 inches of overlap at the seams. A minimum of eight inches of clean, lightly compacted topsoil was then placed on top of the geotextile fabric. Following topsoil import and grading, grass sod was installed on the remediated area. Play equipment pits were also remediated. The pits were excavated to a depth of 16 inches and a 4-inch layer of pea gravel was applied to the bottom for drainage. The pits were then lined with geotextile fabric and filled to two inches above grade with engineered wood fiber. Prior to import, the clean topsoil was tested for the presence of lead, arsenic, pesticides, and petroleum products. No contaminants of concern were detected, and neither lead nor arsenic were detected above background concentrations. Excavated soils were stockpiled on site and characterized for disposal. Analytic results of the excavated soil samples indicated that the soil did not designate as a hazardous waste. All excavated soils were disposed at Terrace Heights landfill.

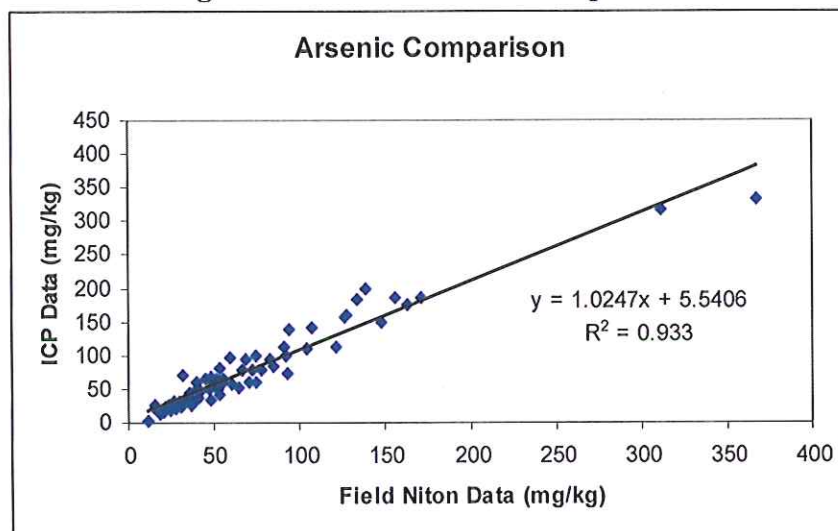
Figure B-1: 2002 Arsenic Comparison

The use of portable XRF units for the determination of soil elemental concentrations has been described by EPA Method 6200 and has been found to provide, "a rapid field screening procedure" for site characterization [US EPA]. Results from the study conducted by Ecology in 2002 (as shown in the graphs below) found that a portable Niton XRF had a correlation coefficient ( $R^2$  value) between field and Inductively-Coupled Plasma (ICP) laboratory analyses of 0.8057 for lead and 0.933 for arsenic. In addition, a verification study conducted by the EPA Superfund Innovative Technology Evaluation (SITE) Monitoring and Measurement Technology (MMT) Program provides additional support for the use of this technology. The investigation compared an Innov-x XRF model, similar to the one used by Ecology, with reference laboratory data and showed a correlation coefficient of 0.8762 for arsenic and 0.91 for lead [US EPA]. All of this data shows that an XRF can be an effective tool for characterizing large contamination sites.

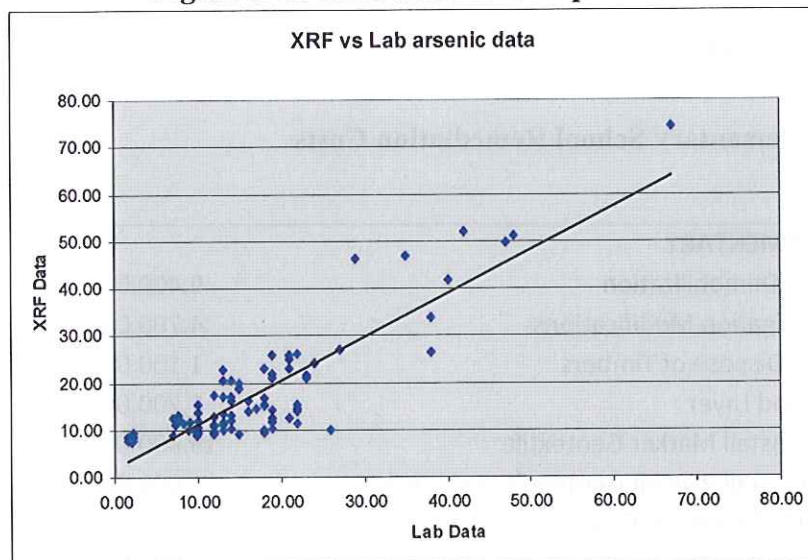
**Figure B-3: 2006 Arsenic Comparison**

Following the completion of the remediation projects conducted in 2006, additional samples were collected for comparison between XRF and Lab ICP methods. A total of 95 additional samples were collected and analyzed by both methods. These samples were analyzed by XRF prior to packaging in clean sealed jar. The analysis (as shown in the graphs below) found that the Innov-X XRF had a correlation coefficient ( $R^2$  value) between field and Inductively-Coupled Plasma (ICP) laboratory analyses of 0.779 for arsenic and 0.893 for lead. It should be noted that many of the data points were actually detection limits of both analysis methods for samples where lead or arsenic was not detected. When those non-detect data points are removed, the analysis found that the Innov-X XRF had a correlation coefficient ( $R^2$  value) between field and Inductively-Coupled Plasma (ICP) laboratory analyses of 0.838 for arsenic and 0.879 for lead.

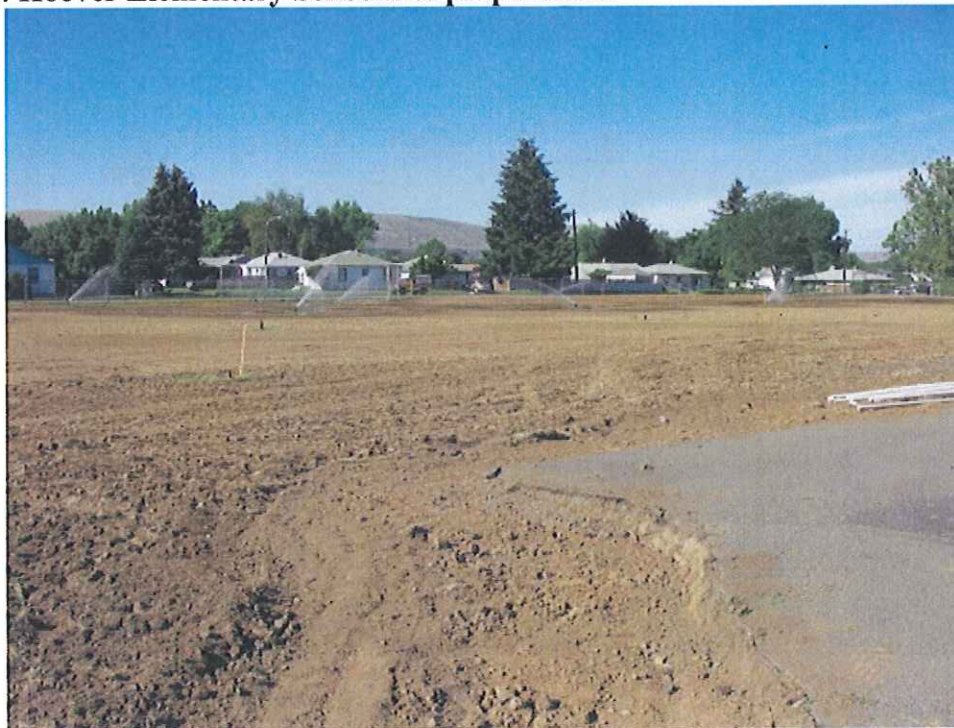
**Photo D-1: Hoover Elementary School site preparation.**

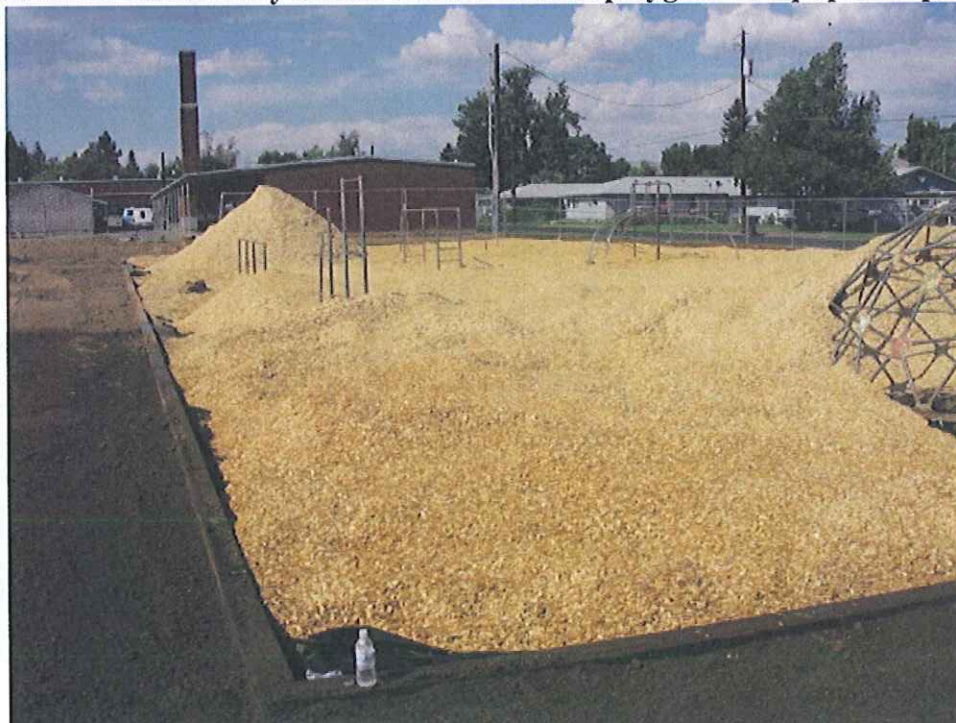
**Photo D-2: Hoover Elementary School construction of playground equipment pit.**

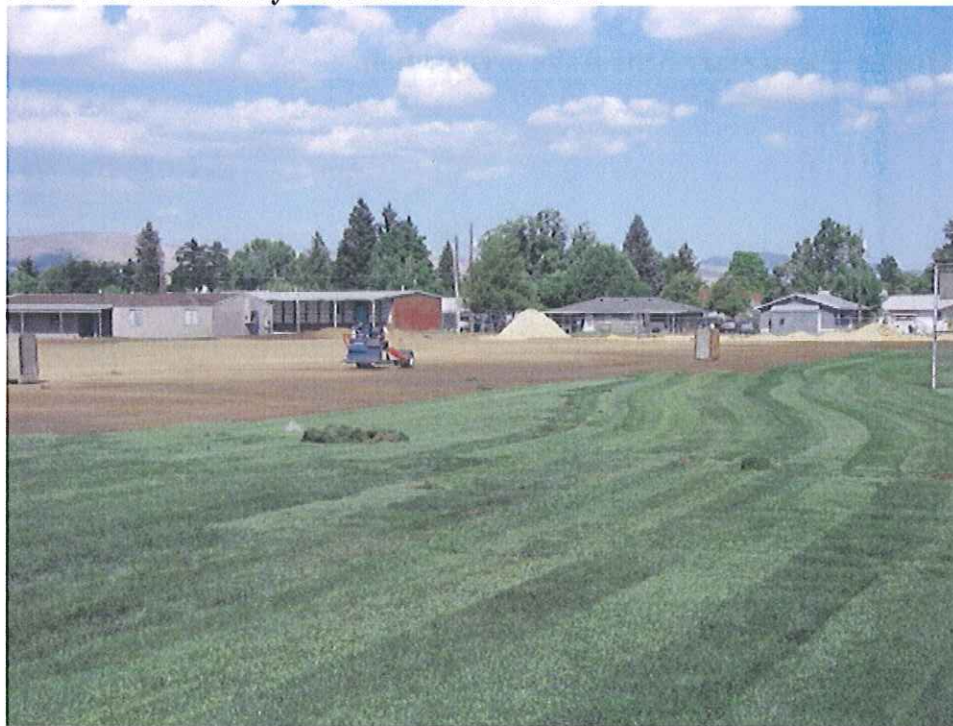
**Photo D-3: Hoover Elementary School sod installation.**

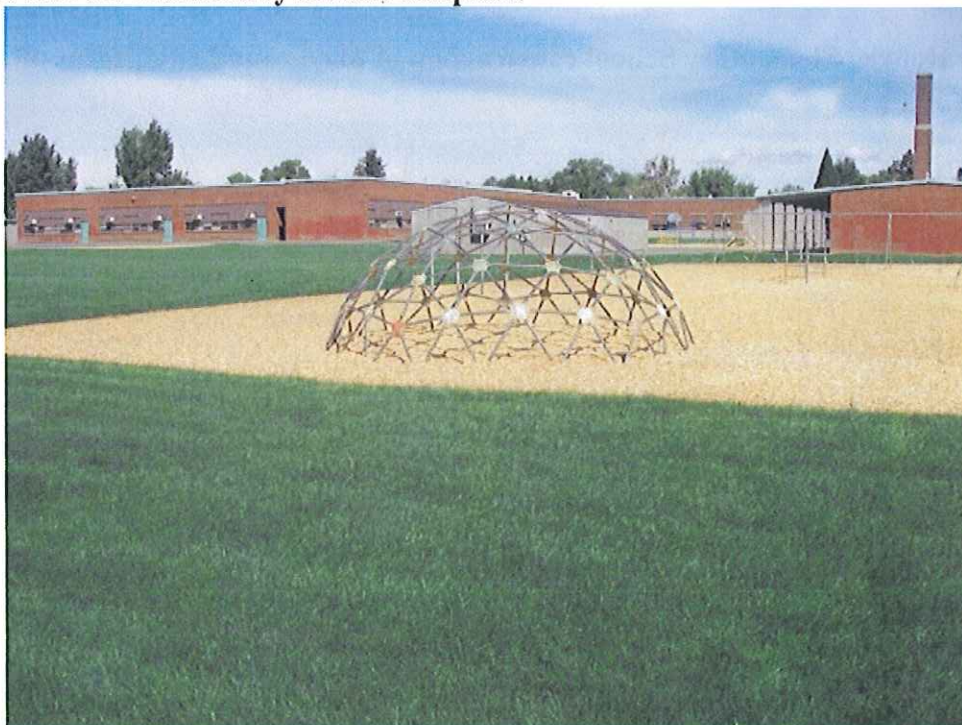
**Photo D-4: Hoover Elementary School complete.**
