**INTERIM ACTION REPORT
GARFIELD ELEMENTARY SCHOOL
YAKIMA, WASHINGTON**

Facility/Site ID # 1308202

January 20, 2011

**Prepared by Washington State Department of Ecology
Toxics Cleanup Program
Mark Dunbar (509) 454-7836**

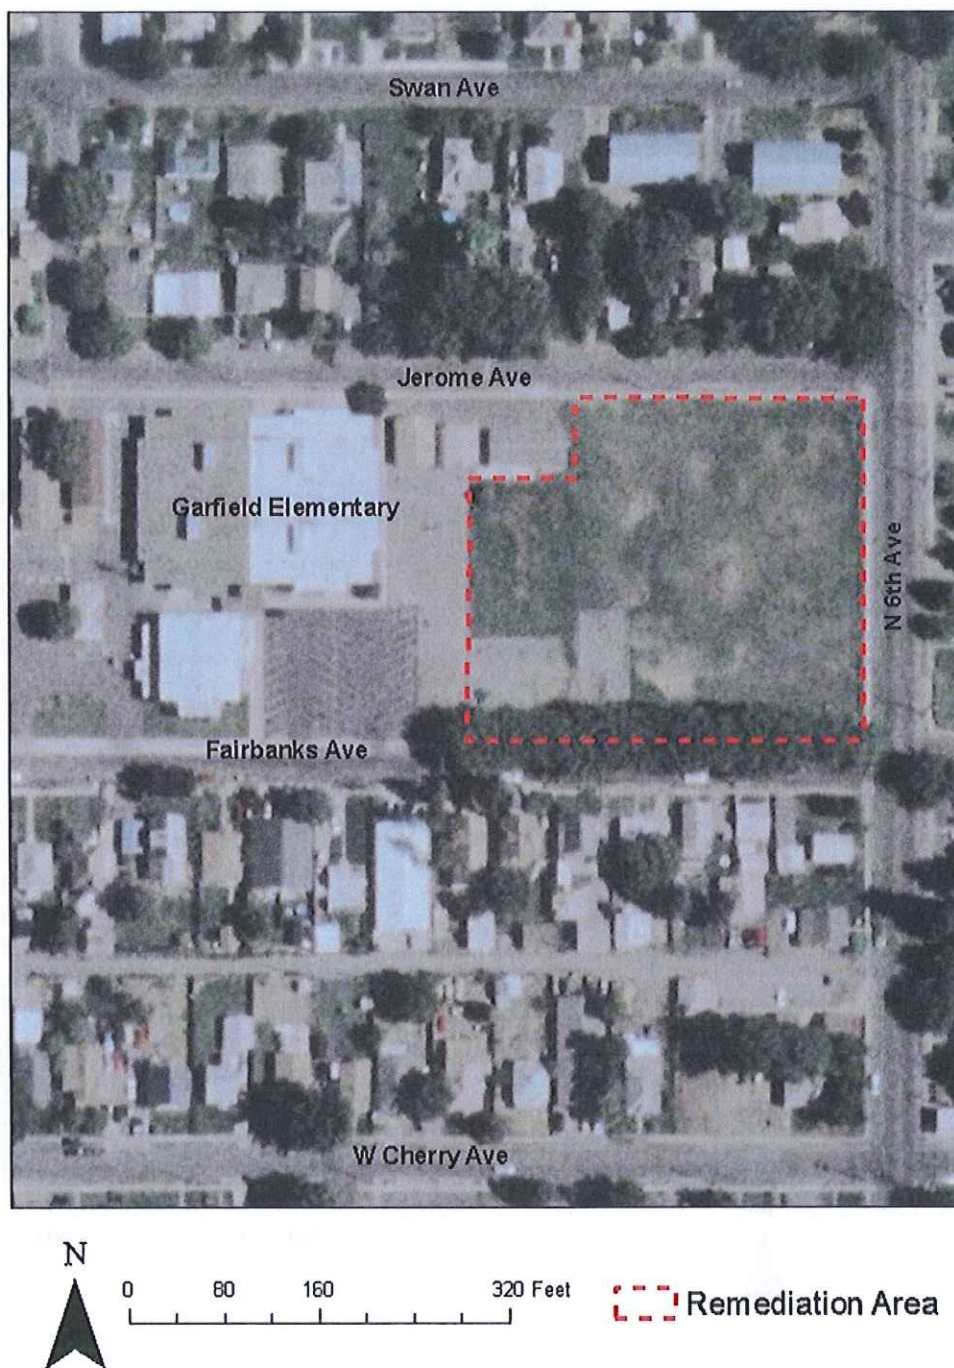
Figure A-2: Remediation Area Map

**Garfield Elementary
612 N 6th Ave**

To prevent exposure to contaminated soil, a geotextile barrier and an 8-inch cap of clean soil and grass sod were installed over the existing play area. Play equipment pits were excavated to a depth of 16 inches, lined with geotextile fabric, and filled with engineered wood fiber. Because contamination was not removed from the site, a restrictive covenant will be issued to restrict future development or improvements on the site that could expose contaminated soil.

Capping of existing soil with clean soil was chosen as the most efficient remedial option for the site. The remedial process was carried out as follows: Contaminated soil was excavated at hardscape edges such as pavement and foundations to allow the soil cap to meet existing grade. Existing grass turf was tilled to a depth of approximately six inches using a tractor-drawn rototiller, and the tilled surface was flattened with a roller in preparation for the cap. A permeable geotextile fabric was rolled out over the existing soil surface with 12 inches of overlap at the seams. A minimum of eight inches of clean, lightly compacted topsoil was then placed on top of the geotextile fabric. Following topsoil import and grading, grass sod was installed on the remediated area. Play equipment pits were also remediated. The pits were excavated to a depth of 16 inches and a 4-inch layer of pea gravel was applied to the bottom for drainage. The pits were then lined with geotextile fabric and filled to two inches above grade with engineered wood fiber. Prior to import, the clean topsoil was tested for the presence of lead, arsenic, pesticides, and petroleum products. No contaminants of concern were detected, and neither lead nor arsenic were detected above background concentrations. Excavated soils were stockpiled on site and characterized for disposal. Analytic results of the excavated soil samples indicated that the soil did not designate as a hazardous waste. All excavated soils were disposed at Terrace Heights landfill.

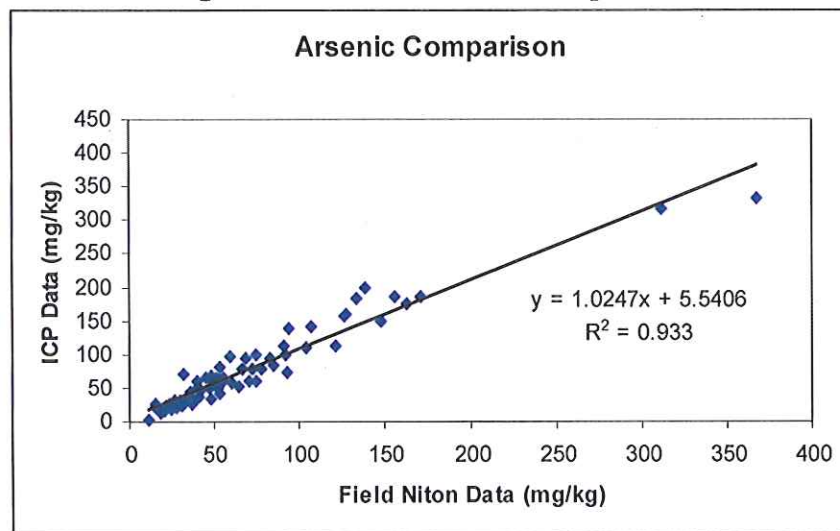
Figure B-1: 2002 Arsenic Comparison

The use of portable XRF units for the determination of soil elemental concentrations has been described by EPA Method 6200 and has been found to provide, "a rapid field screening procedure" for site characterization [US EPA]. Results from the study conducted by Ecology in 2002 (as shown in the graphs below) found that a portable Niton XRF had a correlation coefficient (R^2 value) between field and Inductively-Coupled Plasma (ICP) laboratory analyses of 0.8057 for lead and 0.933 for arsenic. In addition, a verification study conducted by the EPA Superfund Innovative Technology Evaluation (SITE) Monitoring and Measurement Technology (MMT) Program provides additional support for the use of this technology. The investigation compared an Innov-x XRF model, similar to the one used by Ecology, with reference laboratory data and showed a correlation coefficient of 0.8762 for arsenic and 0.91 for lead [US EPA]. All of this data shows that an XRF can be an effective tool for characterizing large contamination sites.

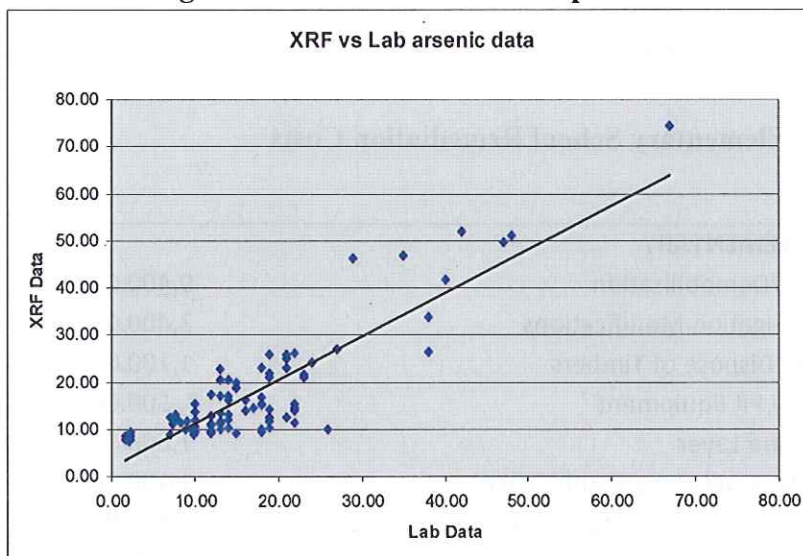
Figure B-3: 2006 Arsenic Comparison

Following the completion of the remediation projects conducted in 2006, additional samples were collected for comparison between XRF and Lab ICP methods. A total of 95 additional samples were collected and analyzed by both methods. These samples were analyzed by XRF prior to packaging in clean sealed jar. The analysis (as shown in the graphs below) found that the Innov-X XRF had a correlation coefficient (R^2 value) between field and Inductively-Coupled Plasma (ICP) laboratory analyses of 0.779 for arsenic and 0.893 for lead. It should be noted that many of the data points were actually detection limits of both analysis methods for samples where lead or arsenic was not detected. When those non-detect data points are removed, the analysis found that the Innov-X XRF had a correlation coefficient (R^2 value) between field and Inductively-Coupled Plasma (ICP) laboratory analyses of 0.838 for arsenic and 0.879 for lead.

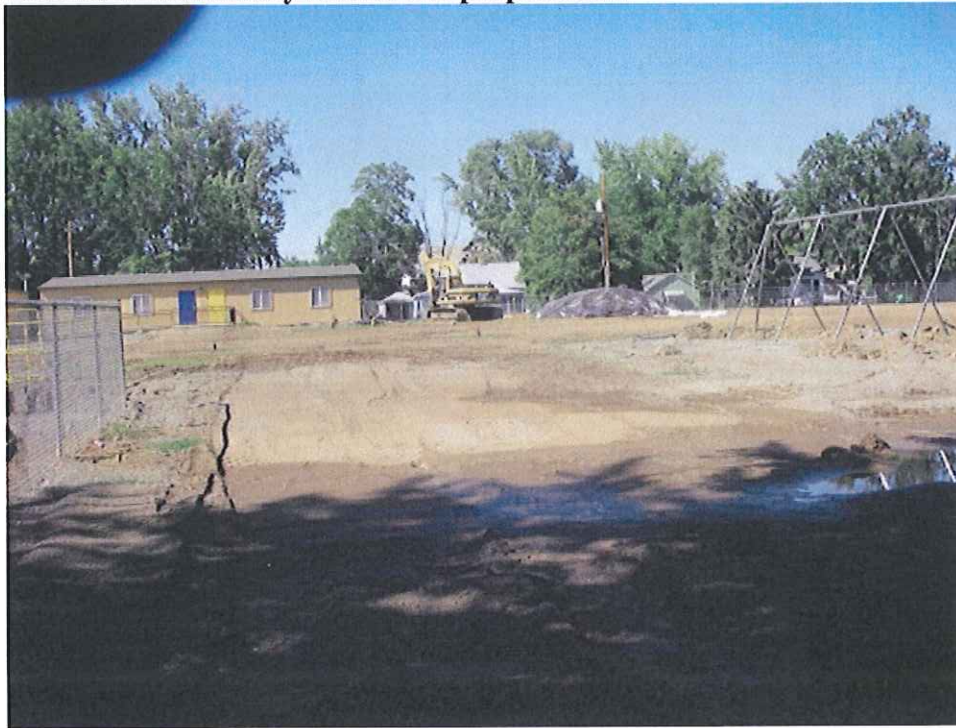
Photo D-1: Garfield Elementary School site preparation.

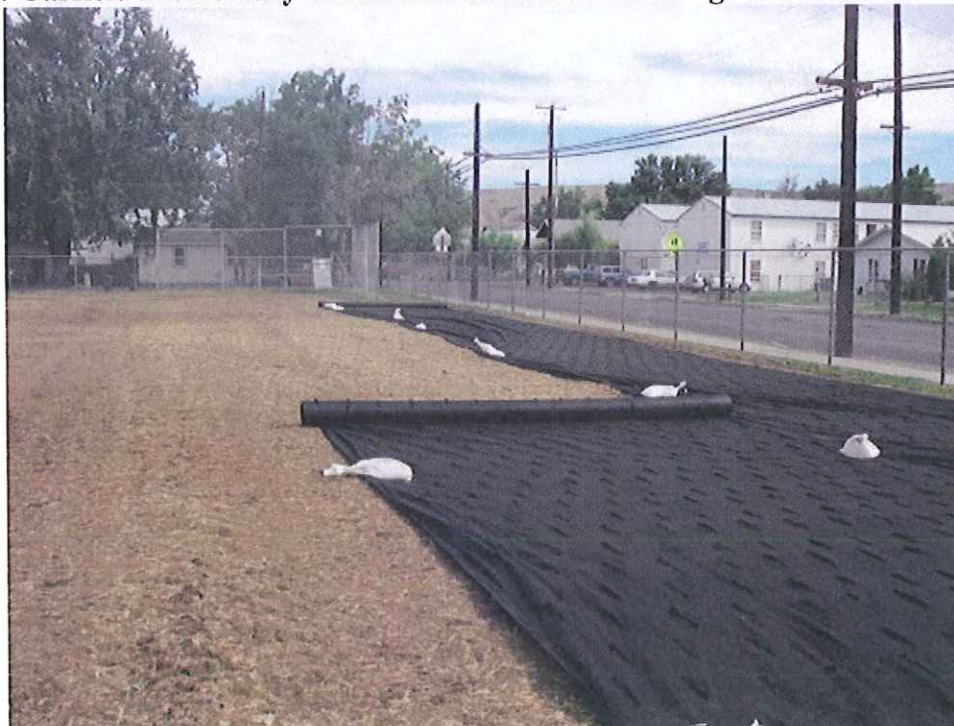
Photo D-2: Garfield Elementary School installation of marker geotextile.

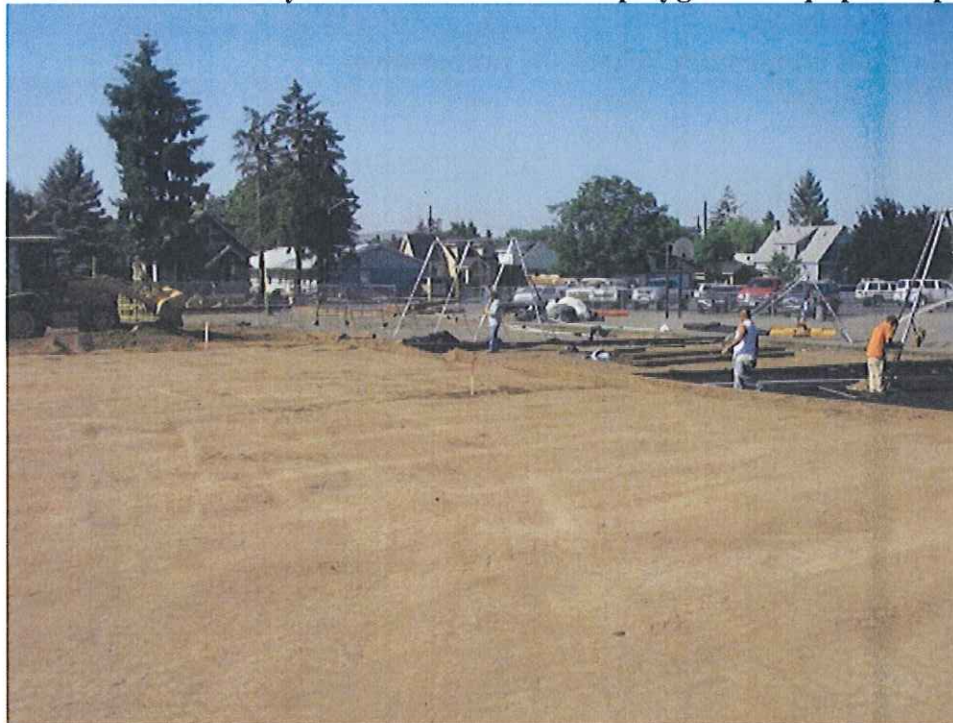
Photo D-3: Garfield Elementary School construction of playground equipment pit.

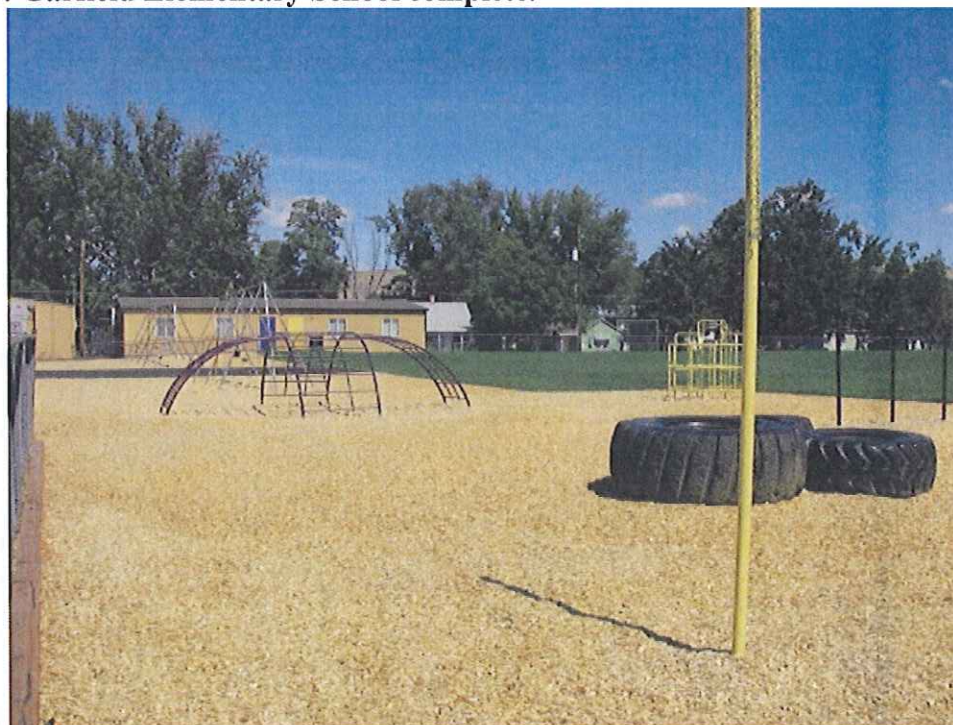
Photo D-4: Garfield Elementary School complete.

Soil samples collected at Garfield Elementary indicated lead and arsenic contamination existed in surface soils at concentrations above MTCA Method A cleanup levels. The course of action taken was to cap contaminated soils with clean soil and grass sod. Some contaminated soils were excavated to allow the soil cap to meet existing grade. A permeable geotextile fabric was placed over top of contaminated soils. Clean topsoil was placed over the geotextile, and sod was applied to restore the site to the original condition. Play equipment pits were excavated and lined with geotextile fabric, then filled with engineered wood fiber. As a result of the Interim Action, lead and arsenic contaminated soil is contained within the site, and a restrictive covenant will be filed to restrict future improvements or redevelopment of the site.
