INITIAL INVESTIGATION FIELD REPORT

Site Name (Name over door): Poulsbo Village Fuel	Site Address (including City, State and Zip): 19560 7th Ave NE Poulsbo, WA 98370	Phone/email:
Site Contact, Title, Business: Donna L Hewitt DLH Environmental Consulting	Site Contact Address (including City, State and Zip):	Phone/email: 206-632-3123
Site Owner, Title, Business: Mr. Sawinder Bajwa MTS Enterprises LLC	Site Owner Address (including City, State and Zip): 19560 7th Ave NE Poulsbo, WA 98370	Phone/email:
ALT Owner Contact, Title, Business: Mr. Sawinder Bajwa MTS Enterprises LLC	ALT Owner Contact Address (including City, State and Zip): 1574 NE Odin St Poulsbo, WA 98370	Phone/email:
Previous Site Owner(s):	Additional Info:	
Alternate Site Name(s): Poulsbo Village 76	Additional Info:

VILLAGE FUEL
19560 7th AVE NE, POULSBO, WA

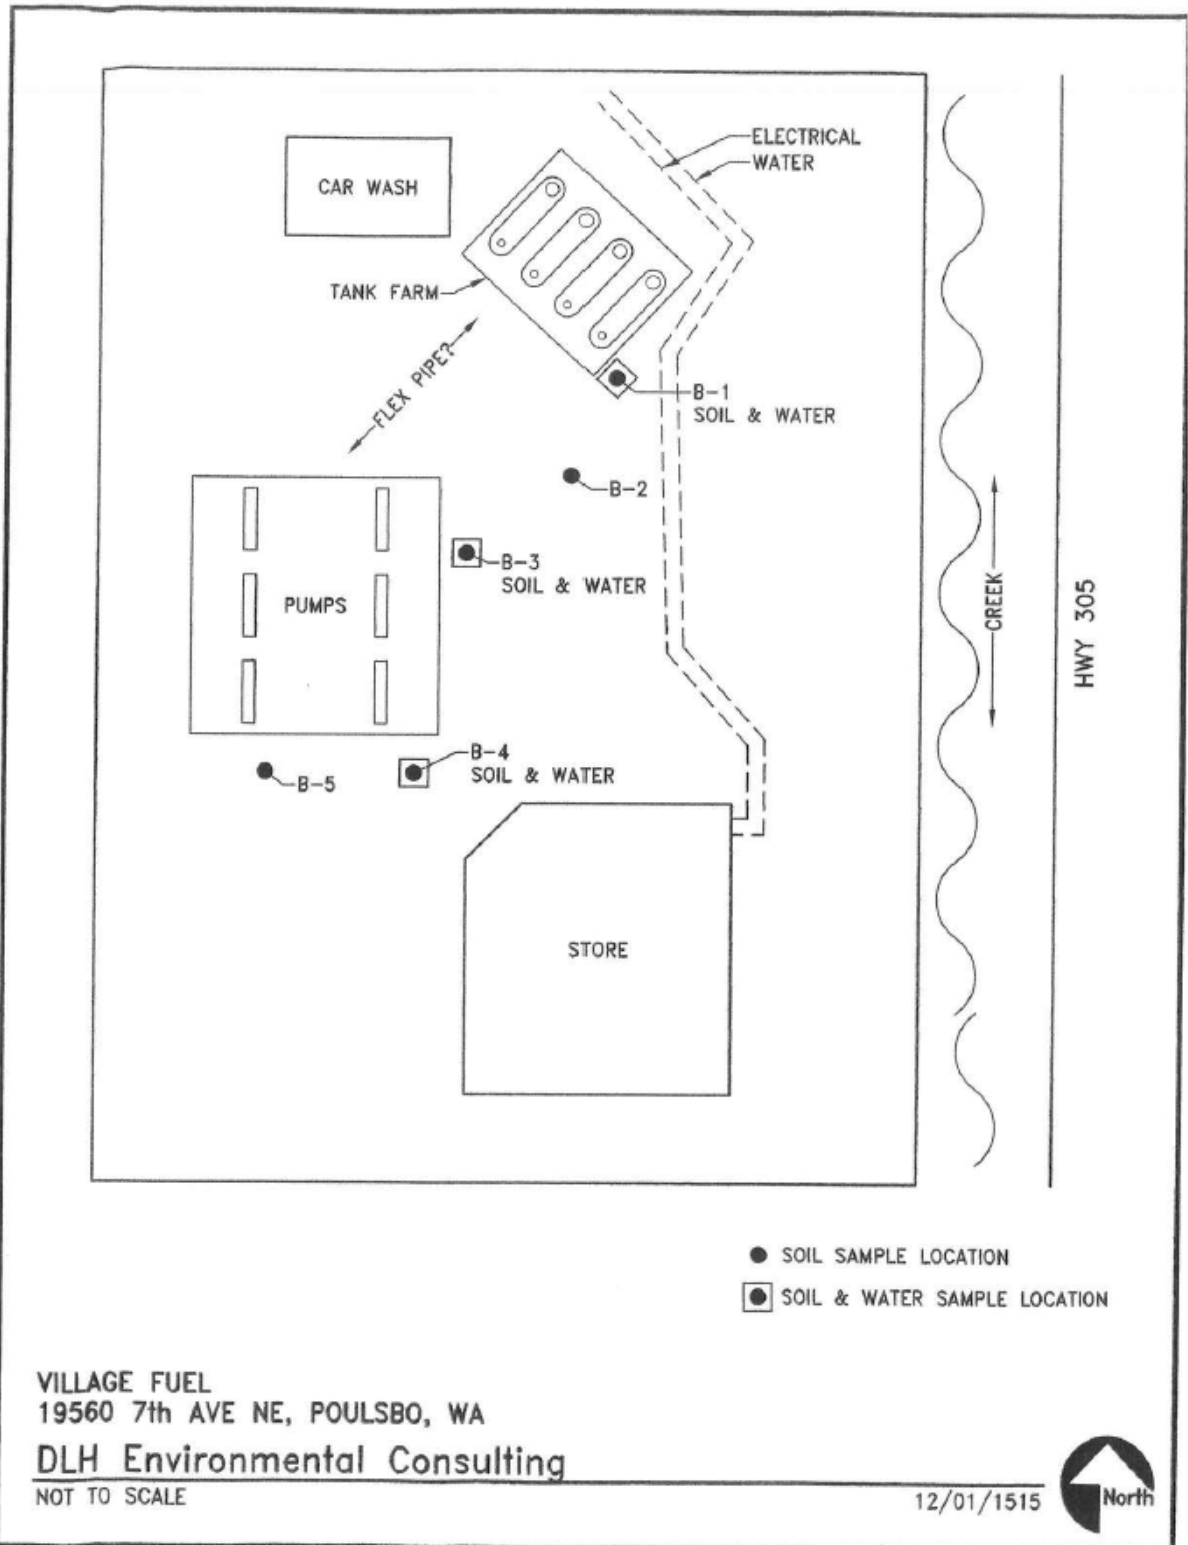
1/25/2016 report: Five soil borings were installed and three temporary water wells were completed at this operational gas station. MW-1 (the well closest to the tank nest) groundwater sample: TPH-G= 9,000ppb; Benzene= 97ppb; Ethylbenzene= 920ppb. All soil samples from MW-1 soil boring were below 3ppm for TPH-G & below 0.2ppm for BTEX at depths of 15 ft, 20 ft, 22 ft, & 25 ft. Recommend CSCS List for groundwater contamination.
