Phase II Environmental Site Assessment

Rufus 2.0 Development
Blocks 14, 19 and 20, Denny Triangle
Seattle, Washington 98101

June 7, 2012

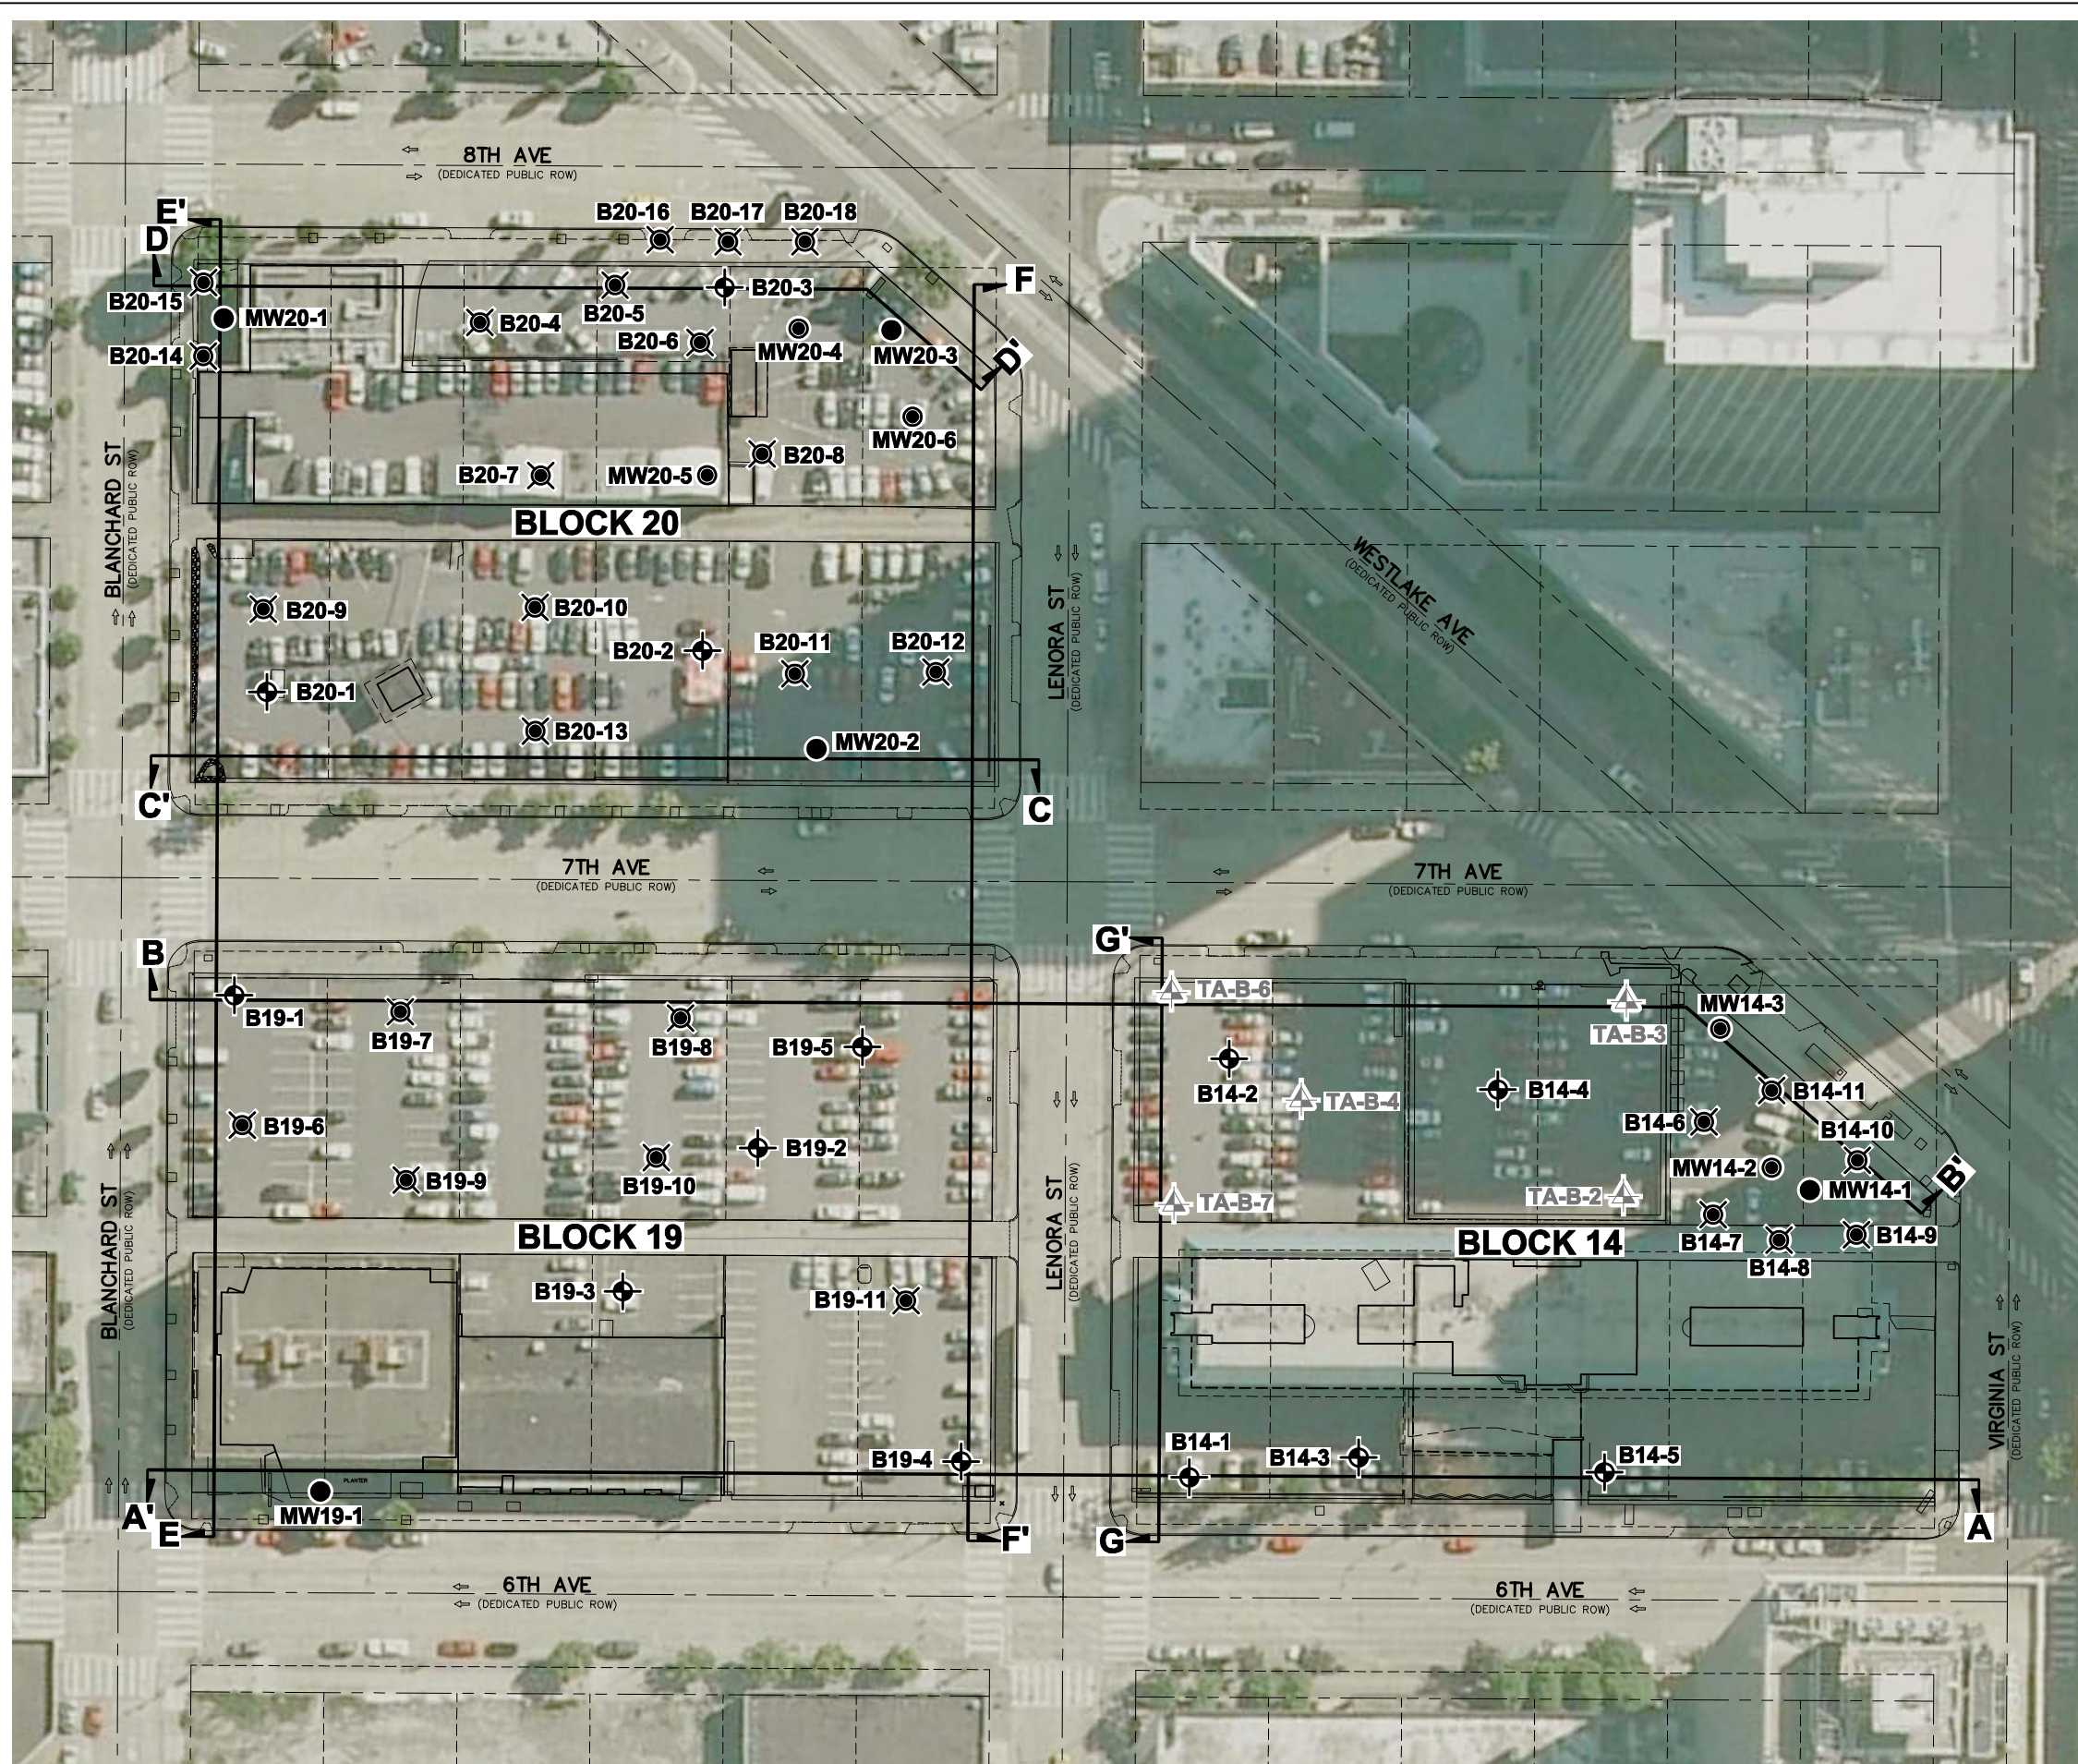
Overview Site Plan	
Rufus 2.0 Development Seattle, Washington	
GEOENGINEERS	Figure 2

- MW14-3 ● Shallow Monitoring Wells Completed in April 2012
- B14-6 ⊗ Direct-Push Borings Completed in April 2012
- B14-1 ⊕ Hollow-stem Auger Borings Completed in February 2012
- MW19-1 ● Monitoring Well Completed in February 2012
- TA-B-2 ⊕ Boring/Monitoring Completed by Others
- A A' Cross-Section Location

These blocks are referred to herein as the “Subject Properties.” The Subject Properties are shown relative to surrounding physical features on the Vicinity Map, Figure 1. The site layout, including site structures, boring locations and cross-section lines are shown on the Site Plan, Figure 2.

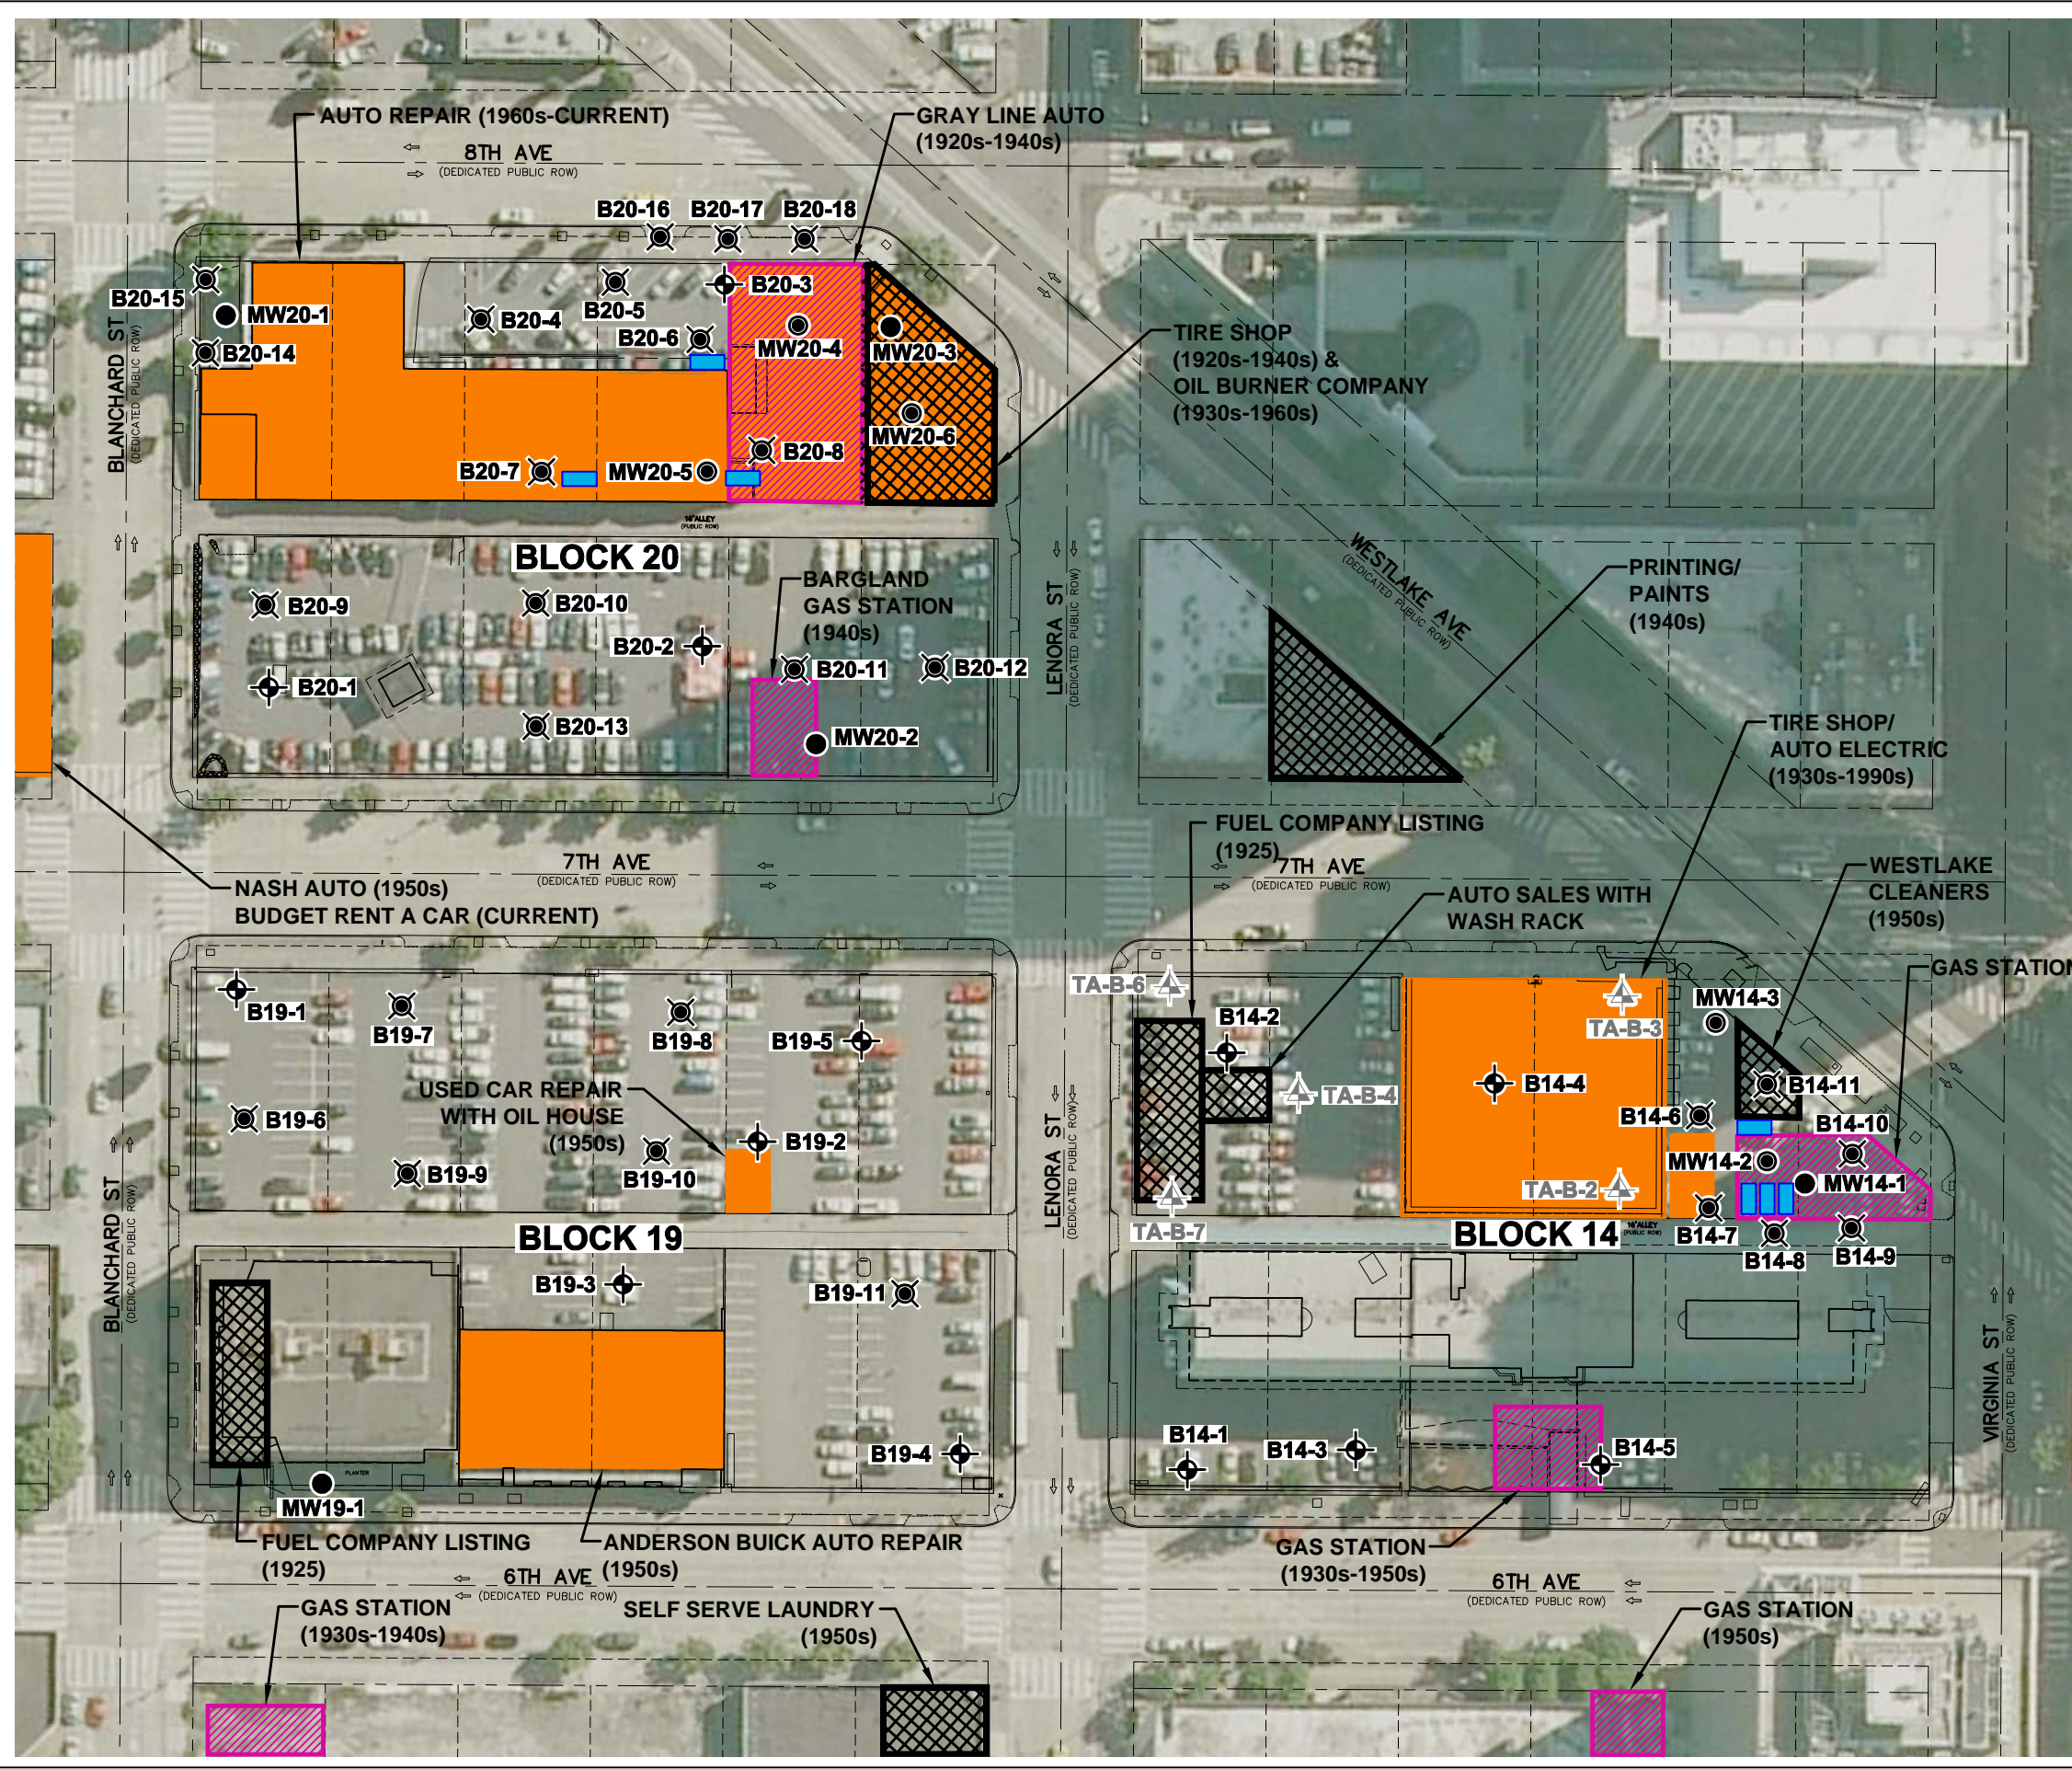
GEOENGINEERS **Figure 3**

- MW14-3 ● Shallow Monitoring Wells Completed in April 2012
- B14-6 ⊗ Direct-Push Borings Completed in April 2012
- B14-1 ⊕ Hollow-stem Auger Borings Completed in February 2012
- MW19-1 ● Monitoring Well Completed in February 2012
- TA-B-2 ⊕ Boring/Monitoring Completed by Others
- Orange Box Historical Auto Repair Building Footprint
- Pink Hatched Box Former Gas Station General Location
- Blue Box Possible or Known Former UST Area
- Black Hatched Box Other Use of Potential Concern as Indicated

Several current and historic potential sources of contamination were identified on and adjacent to the Subject Properties, including current and former auto repair facilities, former gasoline service stations, dry cleaners and fill soil. These historic uses are shown on Figure 3. We understand based on historic research that in the early 1900s, soil was moved from, and onto, the Subject Properties from what was formerly Denny Hill during the Denny Hill Cut and Regrade activities and that it is likely that imported soil from an unknown source was also placed on portions of Block 14 and Block 20.

The historic sources of potential contamination are shown graphically on Figure 3.

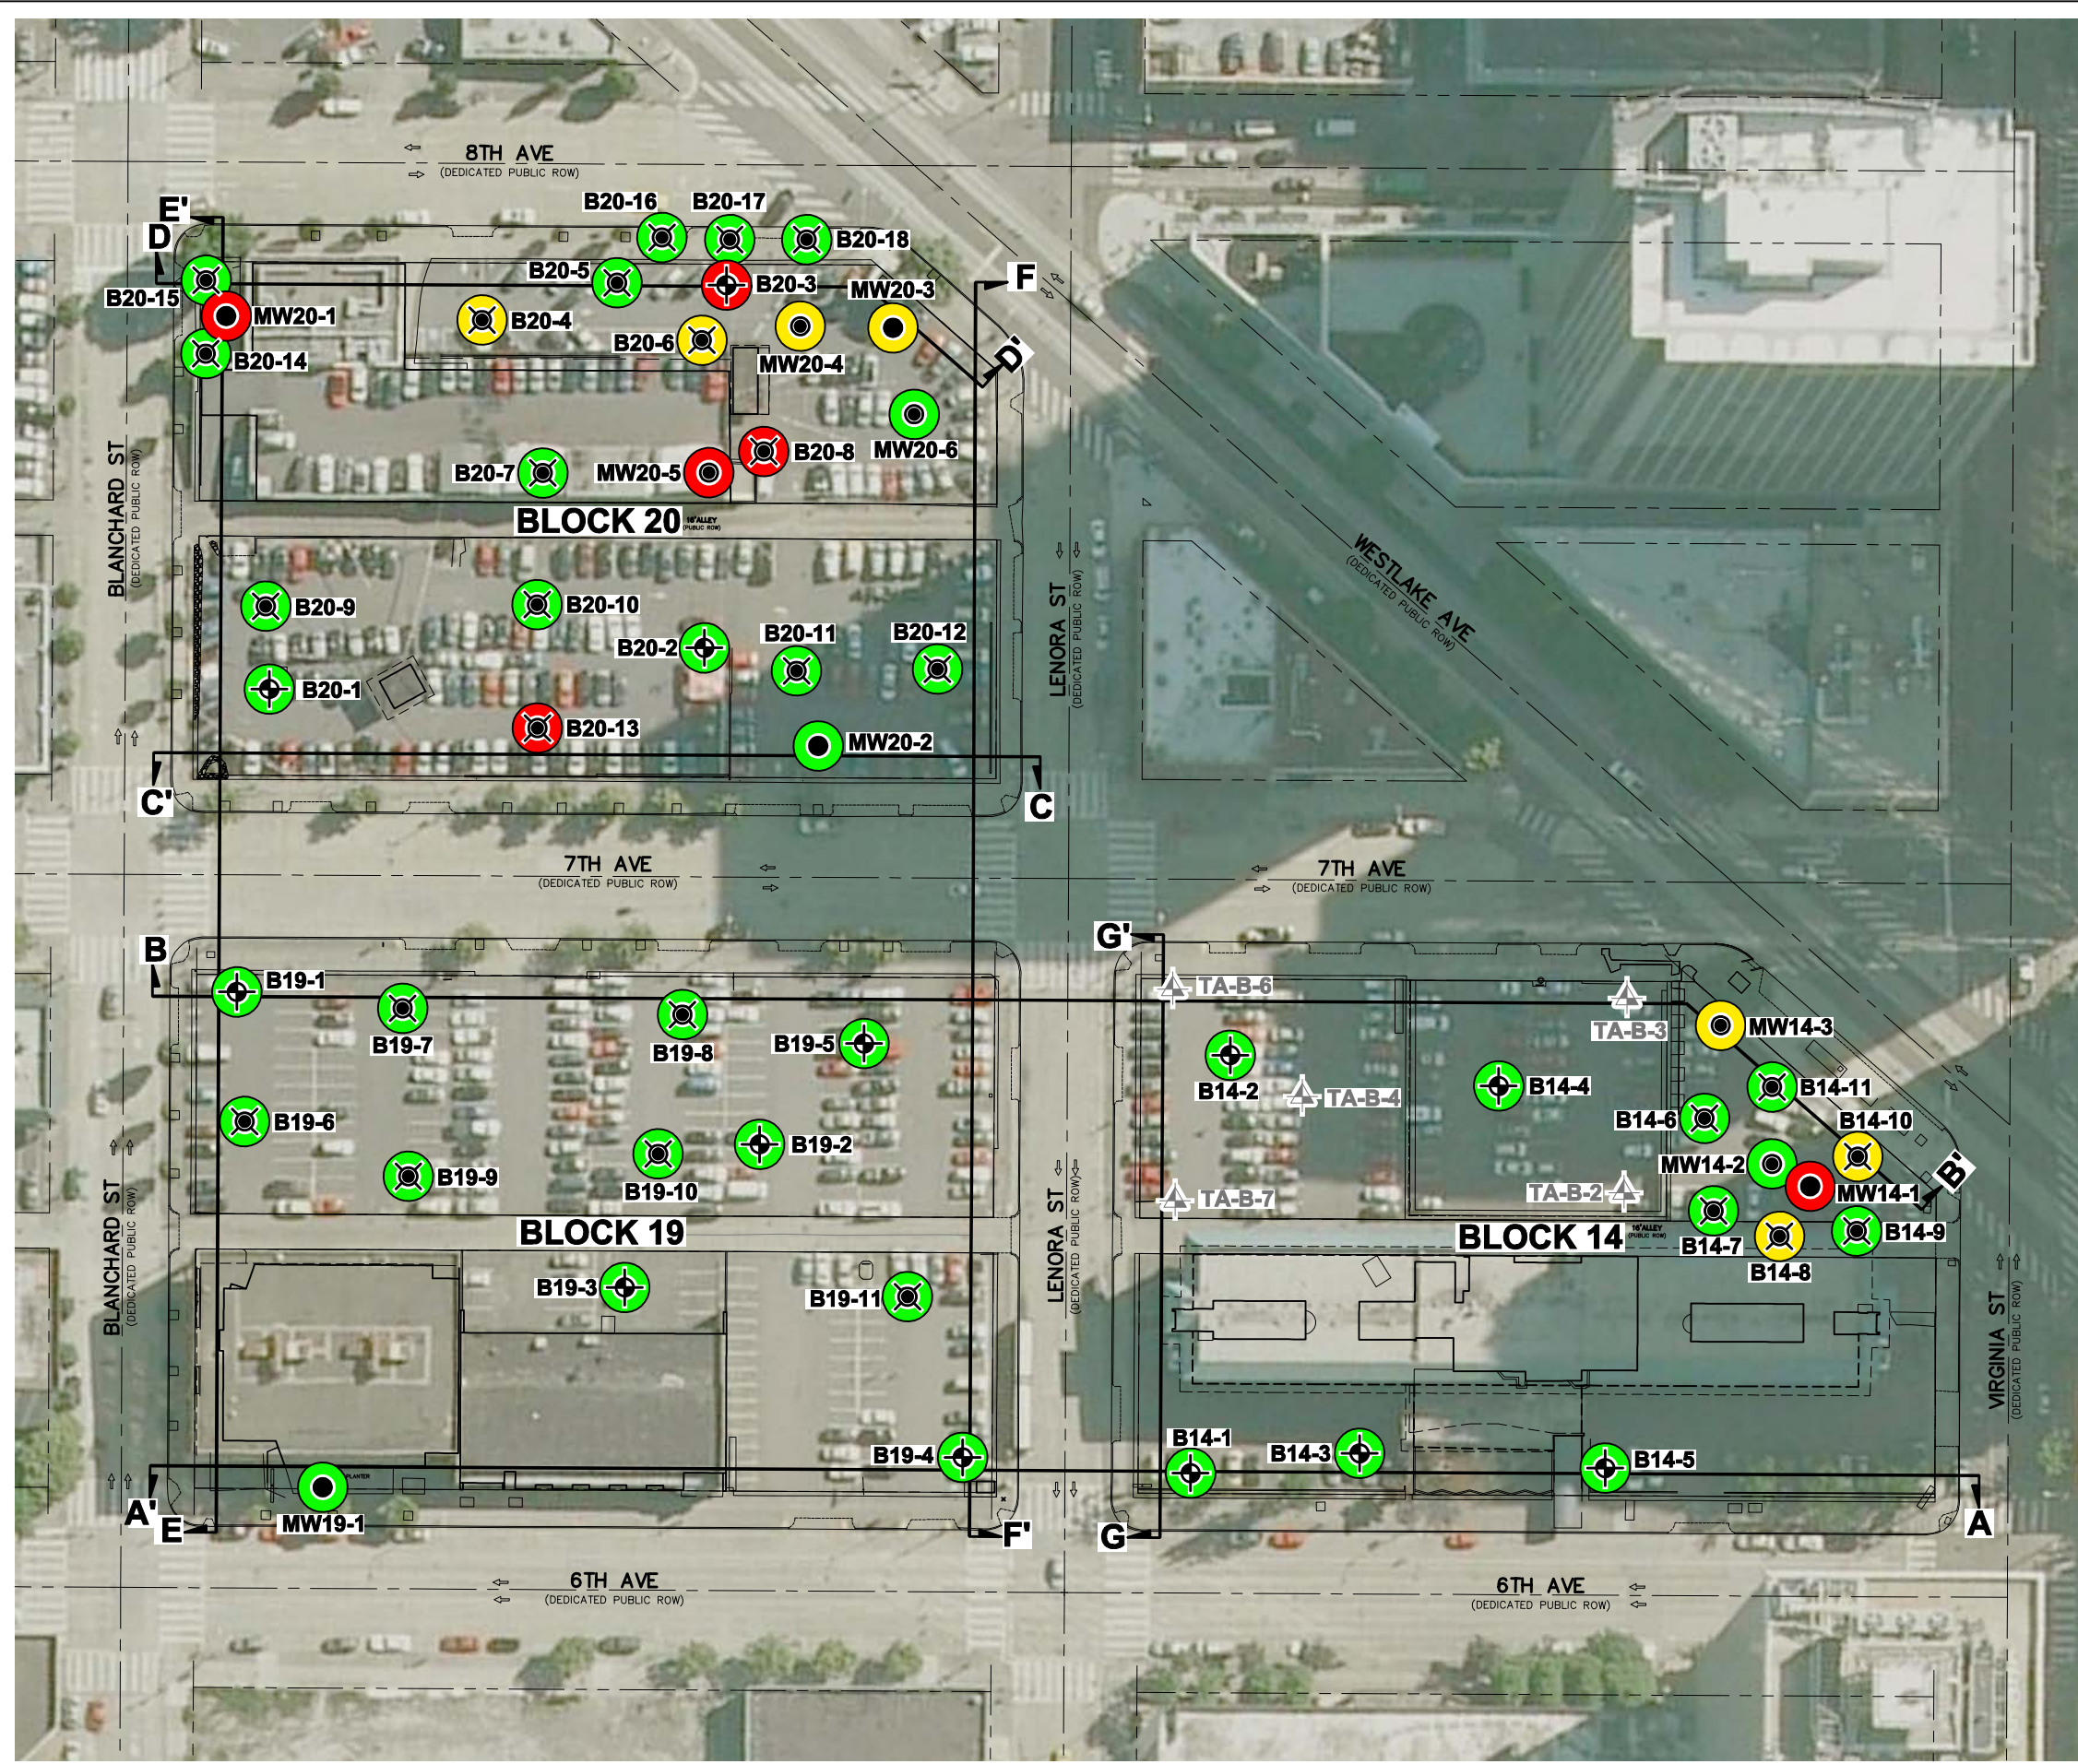
Soil Contamination Identified during 2012 Subsurface Exploration	
Rufus 2.0 Development Seattle, Washington	
GEOENGINEERS	Figure 4

● Contaminants of concern were not detected. Metals were detected at concentrations similar to natural background concentrations.

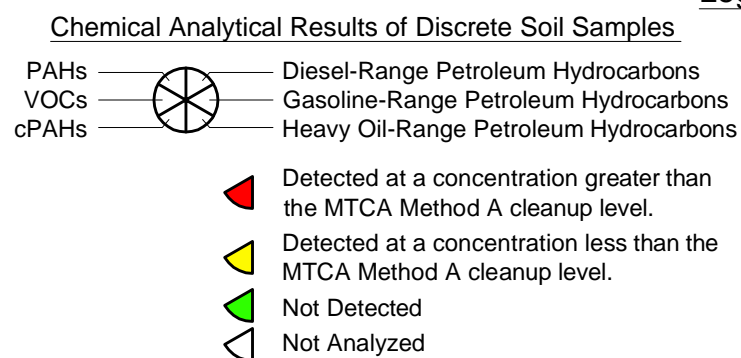
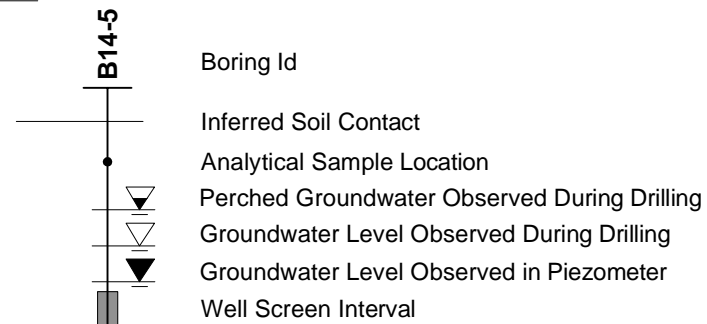
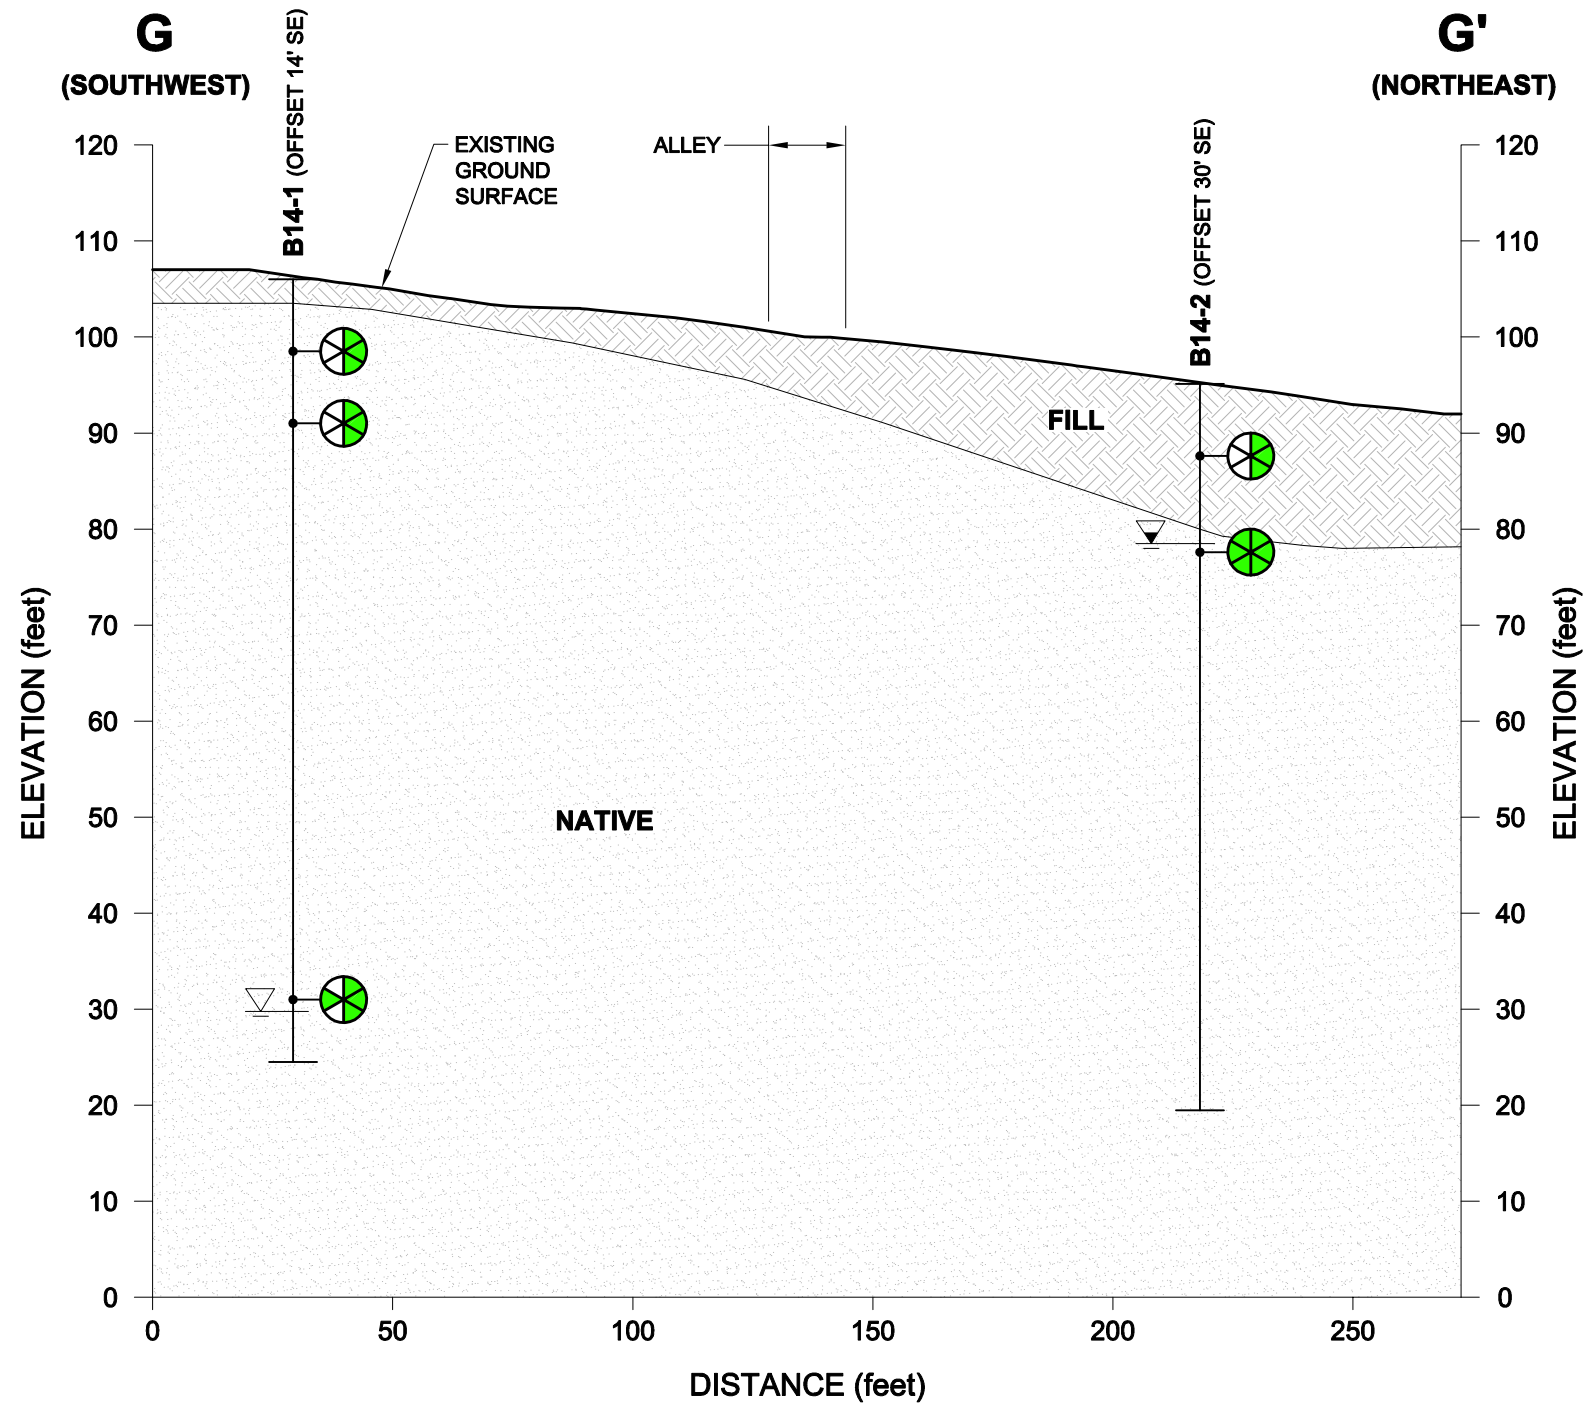
Cross-Section F-F'	
Rufus 2.0 Development Seattle, Washington	
	Figure 10

Chemical Analytical Results of Discrete Soil Samples

- PAHs — — Diesel-Range Petroleum Hydrocarbons
- VOCs — — Gasoline-Range Petroleum Hydrocarbons
- cPAHs — — Heavy Oil-Range Petroleum Hydrocarbons

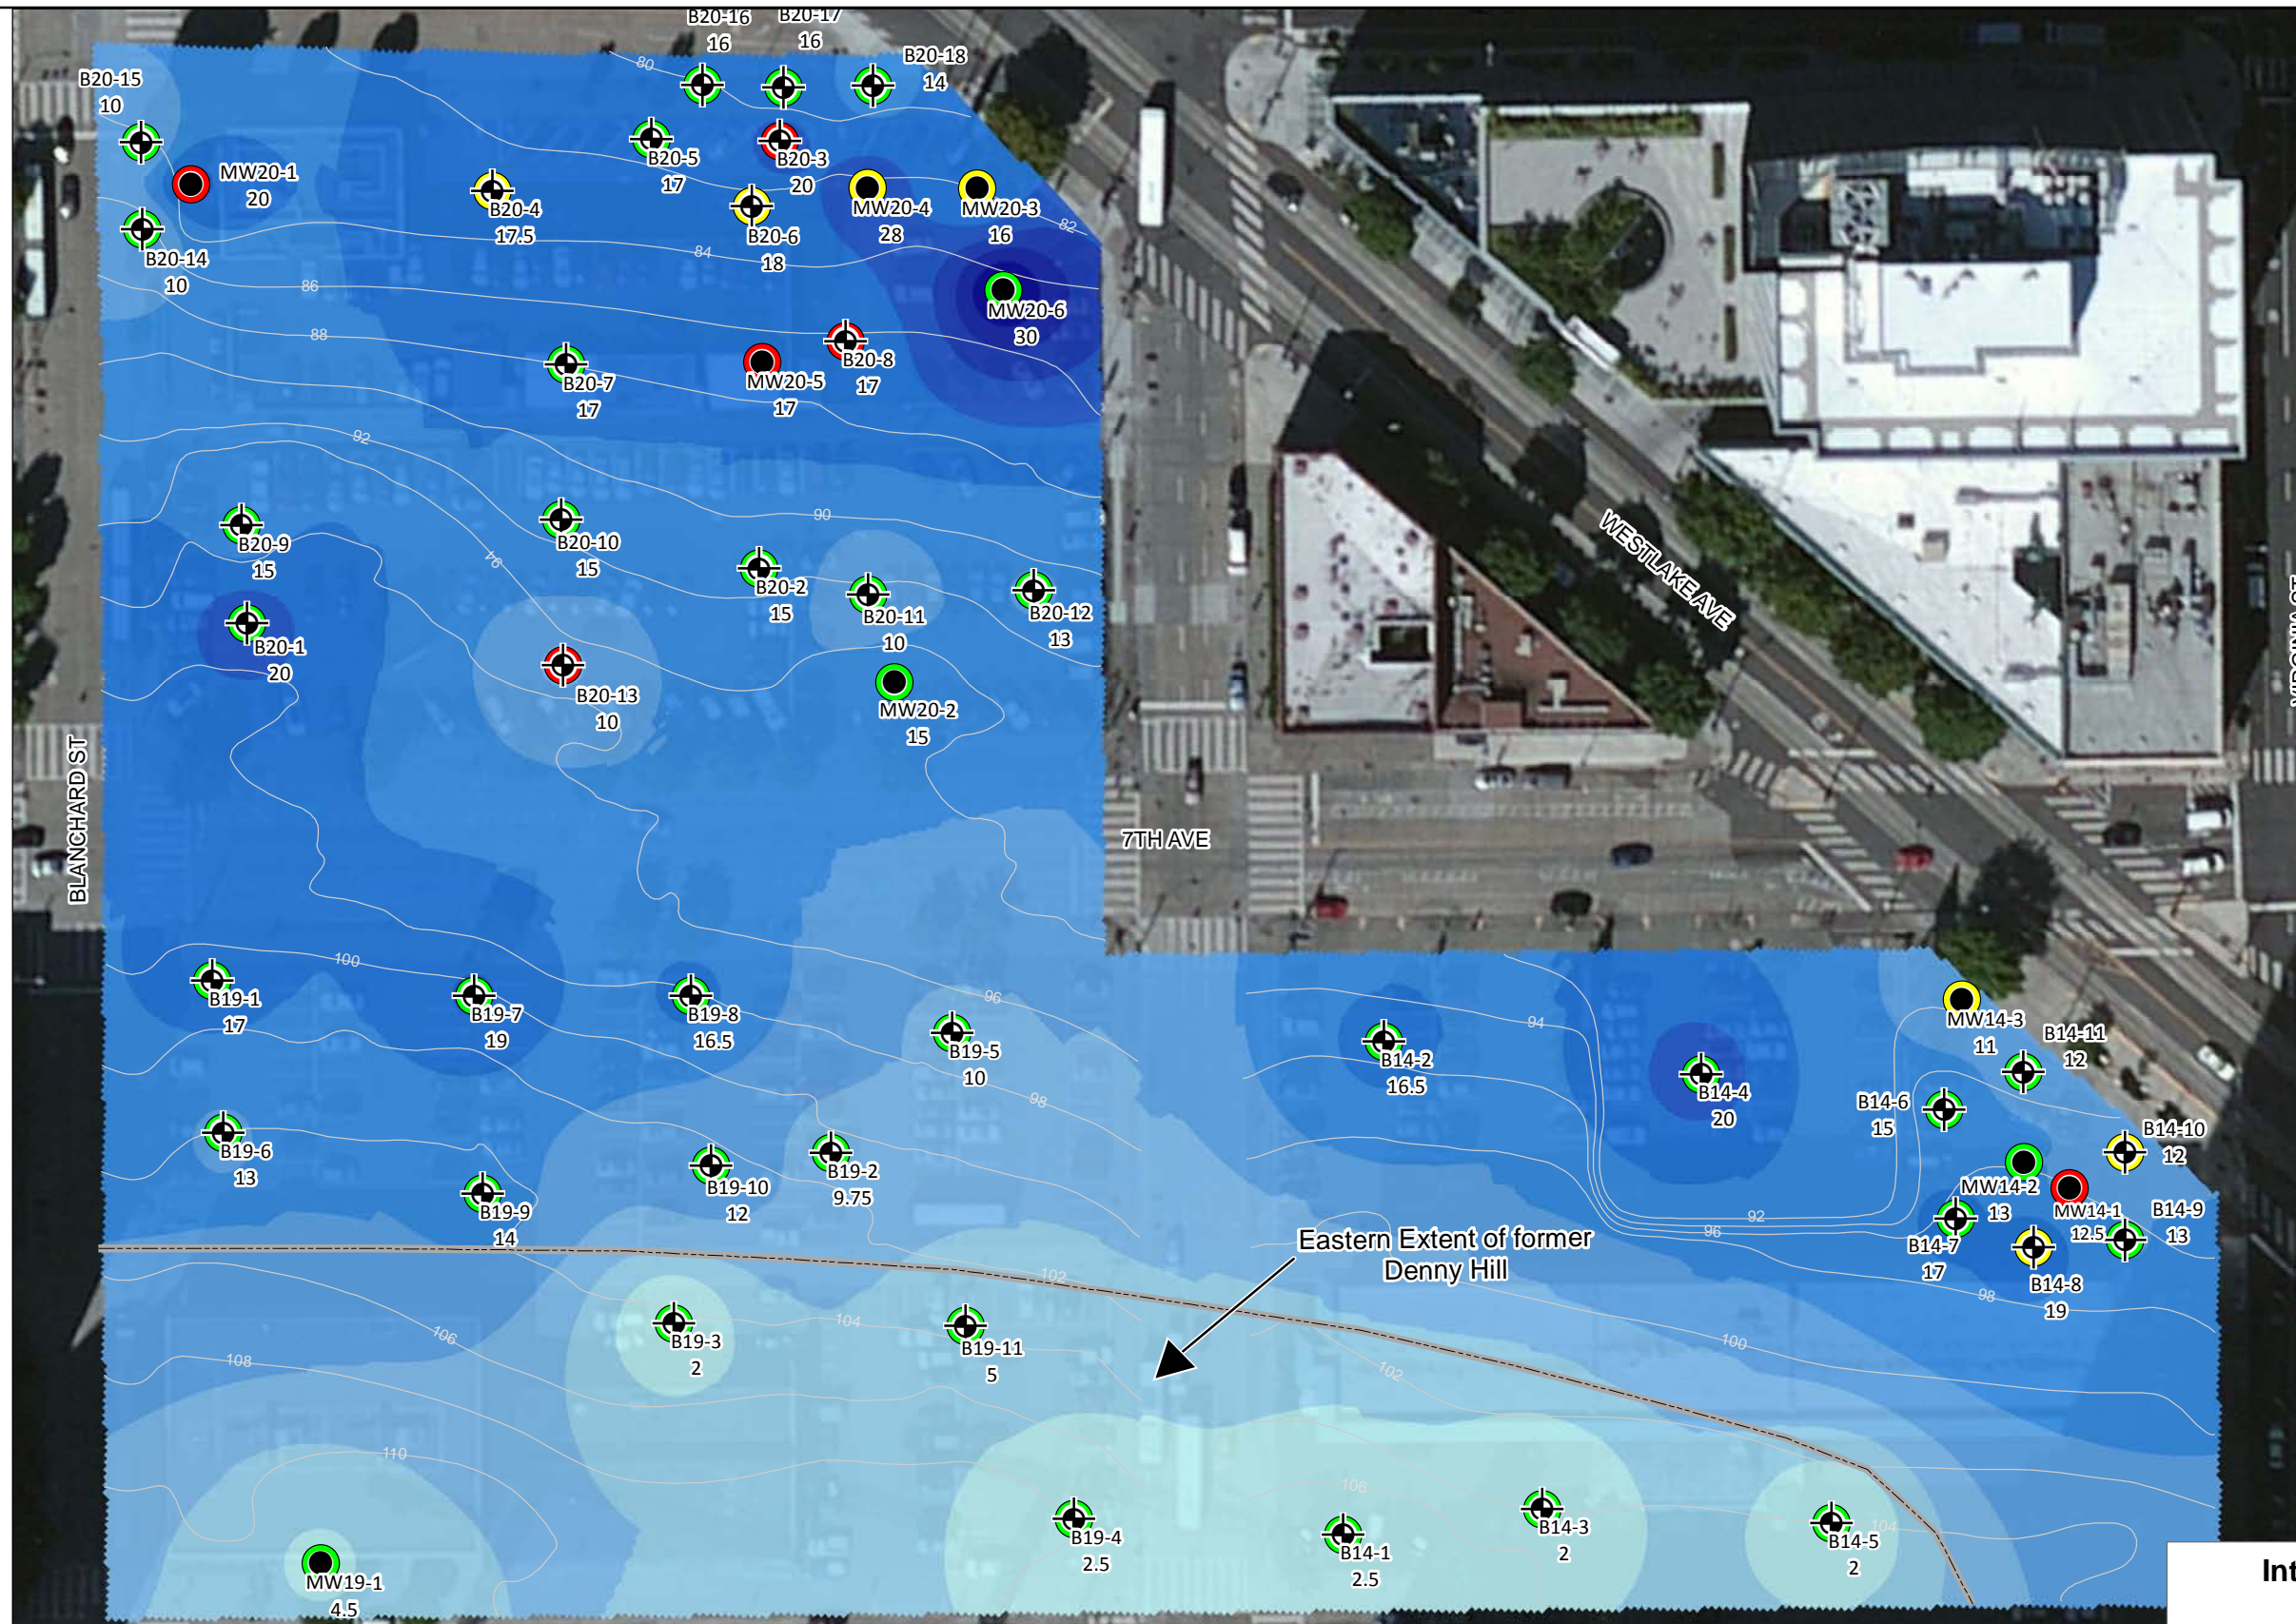
B14-1 2.5 Boring ID Fill Thickness

MW14-1 12.5 Monitoring Well ID Fill Thickness

Fill of varying thickness (between less than 2 feet and approximately 17 feet thick [later revised to 30 feet thick]) was observed in borings completed across the Subject Properties. Imported, undocumented fill soil commonly contains contaminants. Further study was warranted to better understand the fill origin, type, location and thickness across the Subject Properties. Additional evaluation of the fill through historic research and follow-up (Step 2) explorations was completed.

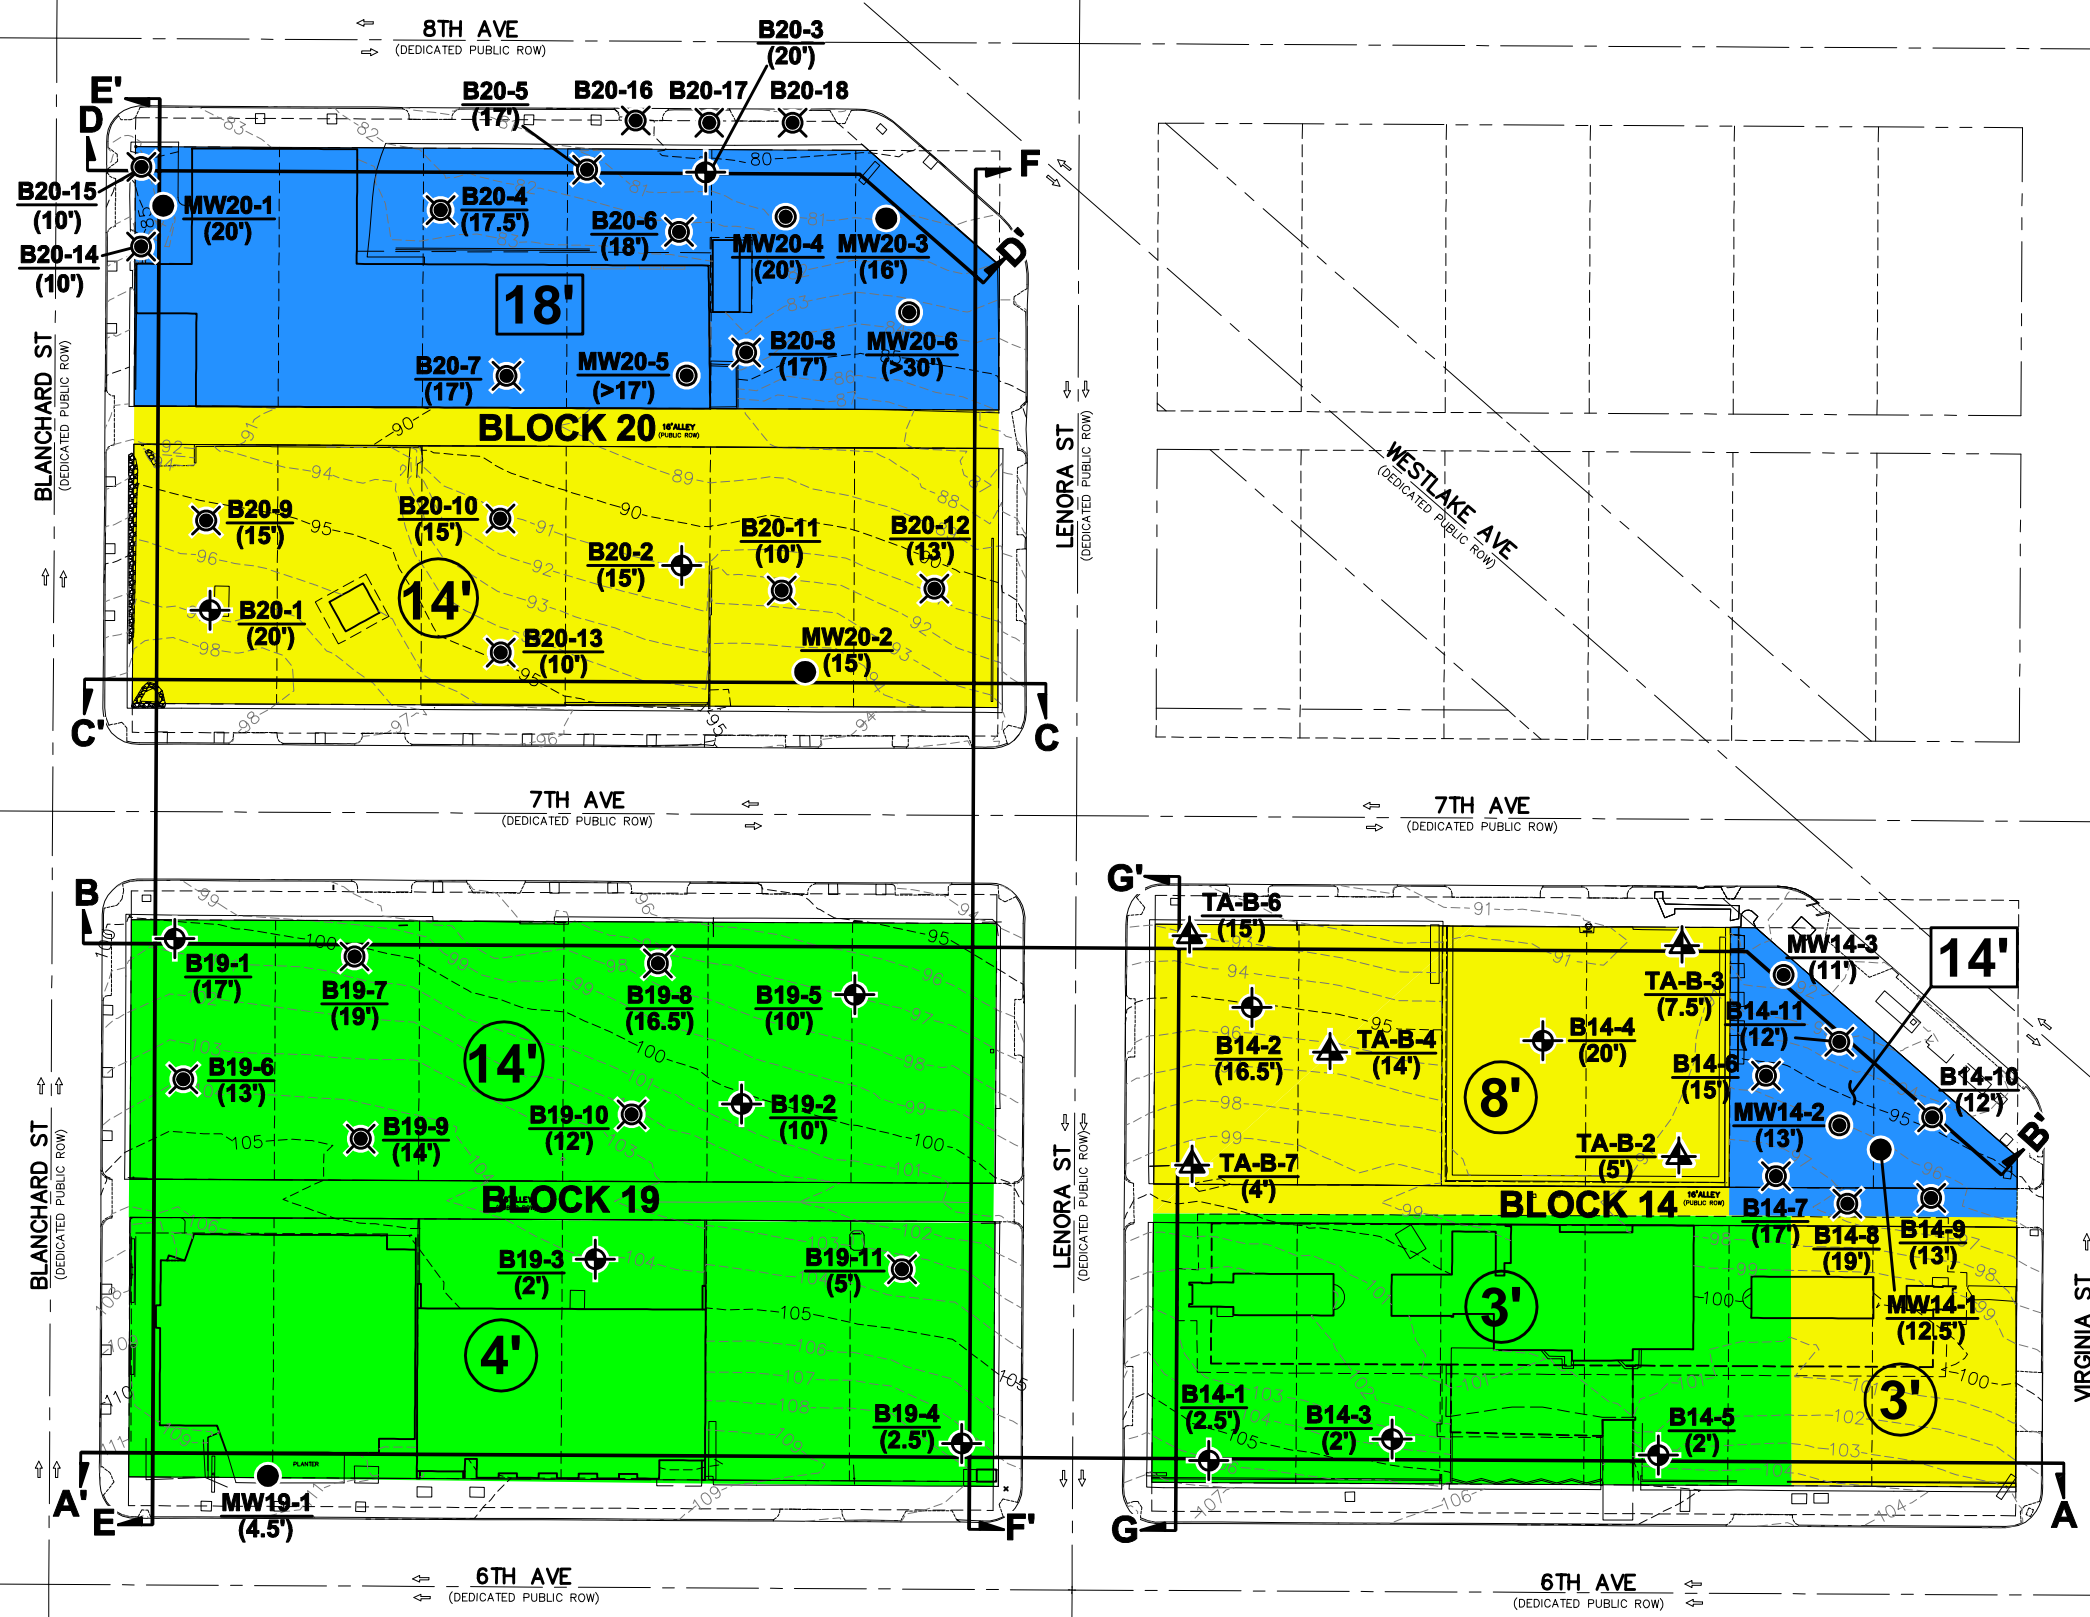
- MW14-3 ● Shallow Monitoring Wells Completed in April 2012
- B14-6 ⊗ Direct-Push Borings Completed in April 2012
- B14-1 ⊕ Hollow-stem Auger Borings Completed in February 2012
- MW19-1 ● Monitoring Well Completed in February 2012
- TA-B-2 ⊕ Boring/Monitoring Completed by Others
- (2') Approximate Fill Thickness Observed in the Boring

Petroleum, metals and/or PAH-contaminated soil exceeding MTCA cleanup levels is present in the Southeast corner of Block 14 (former Budget Rent-A-Car) and on the western half of Block 20 (Toyota). Figure 13 of this report shows the areal location of soil with contaminants that exceed MTCA cleanup levels. The findings of this study show that contaminated soil is located in areas where historic sources of contamination and/or imported fill exist. Contaminated soil exceeding MTCA cleanup levels was not found in areas where Denny Hill used to be located, nor was contaminated soil found in areas extending to the borings that we completed off-property to the east and north of Block 20.
