**Fish Relocation, Willow Creek
Former Unocal/Chevron Edmonds Terminal Site
Edmonds, WA**

Attachment 1
Fish Relocation Pictures, Willow Creek

Former Unocal/Chevron Edmonds Terminal Site
Edmonds, WA

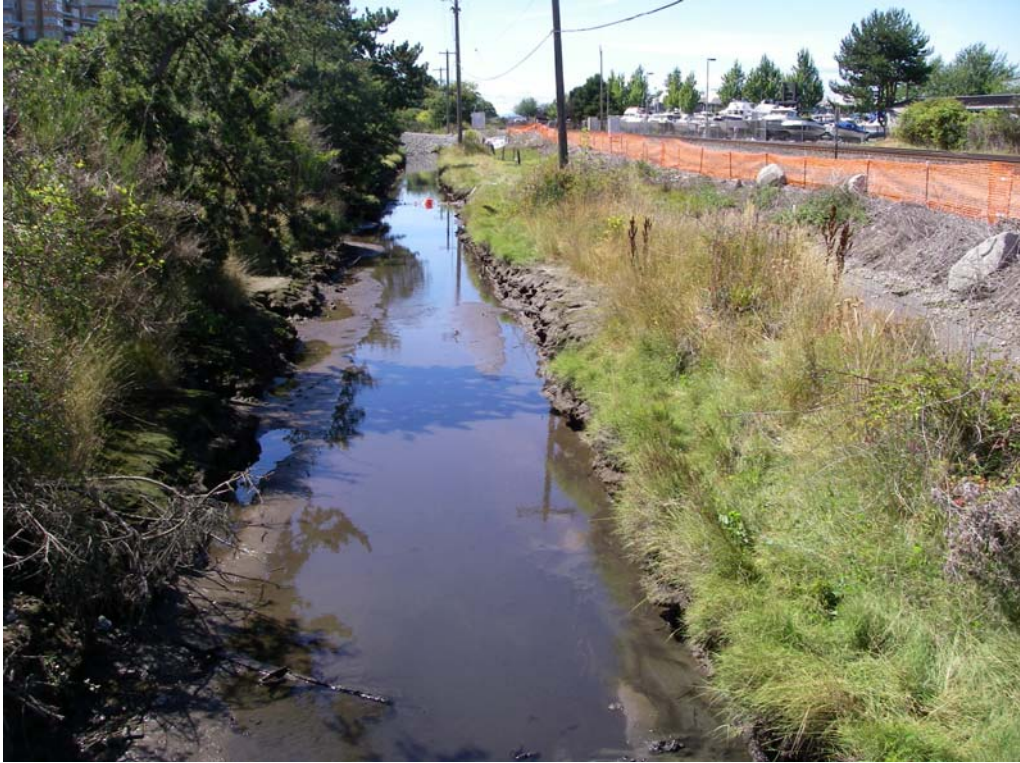
Remediation Area

On August 13 and 14, 2008 fish were removed and relocated from a 430 foot section of Willow Creek, a small tributary (approximately 10 ft wide) of Puget Sound at the Chevron Edmonds Terminal Site located in Edmonds, Washington. This low-gradient section of stream is being remediated due to the presence of petroleum hydrocarbons in fine-grained sediments (primarily silt and sand) (ARCADIS, 2008). Prior to remedial activities, two coffer dams were constructed at the upstream and downstream ends of the area to minimize flow from the incoming tide and upstream salt marsh (Edmonds Marsh). Pumps were used to route the upstream flow around the remediation area, as well as to pump saltwater from downstream into the salt marsh. Pumps were also used in between the dams to lower the water level to an average of 1 to 2 feet to increase fish removal efficiency. Backpack electrofishing units were initially used, followed by seining techniques to capture live fish and relocate them either upstream or downstream of the dams in Willow Creek. In total, approximately 5,565 live fish were captured and relocated during the removal effort (Table 1). Of these, 5,562 were threespine stickleback (*Gasterosteus aculeatus*; about 1 to 2.5" long), two were prickly sculpin (*Cottus asper*; each about 7" long), and one was a starry flounder (*Platichthys stellatus*; about 3" long). No threatened or endangered (T/E) fish species, including salmonids, were observed. Details of the fish relocation effort are provided below. Photographs of the removal effort are contained in Attachment 1.

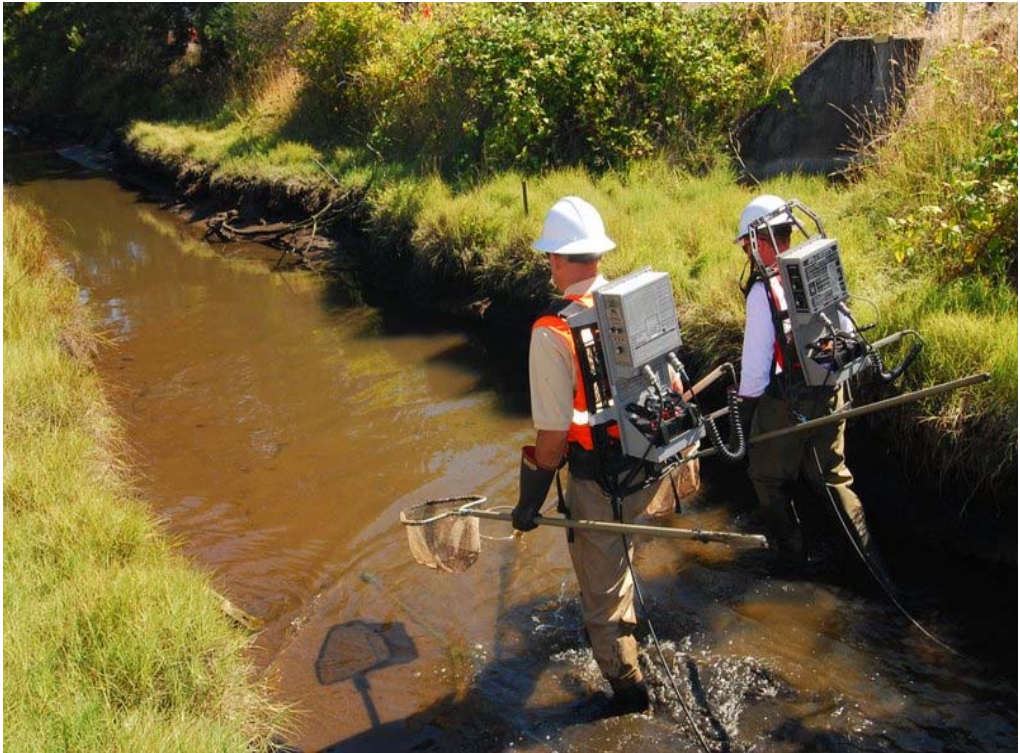
Backpack Electrofishing (Insert Picture)

Water conductivity was measured prior to fish removal to determine the potential effectiveness of electrofishing. General water quality parameters (temperature, pH, dissolved oxygen, turbidity, ORP) were also measured to determine the comparability of conditions between the remediation area and the relocation release points (Table 2). In general, water quality was similar between the dams and the release areas immediately upstream or downstream of the dams. However, conductivity readings generally indicated salinity was too high for effective electrofishing (i.e., conductivity ranged from 2.9 to 12.5 mS/cm³; backpack electrofishing equipment typically operates in the range of 0.01 to 1.5 mS/cm³). Regardless, one complete pass of the remediation area between the dams was conducted using two backpack electrofishing units following the setting guidelines in NMFS (2000). This was done because: 1) Electrofishing is considered to be one of the most effective sampling techniques for capturing live fish; 2) the Washington Department of Ecology (DOE) requested fishery biologists trained in electrofishing conduct the removal; and 3) initial salinity readings taken during low-tide, when freshwater inputs were greatest from upstream, were close to the operating range of the equipment. The electrofishing effort, however, did not produce any fish. Fish were observed in the vicinity of the equipment, but were not stunned, presumably due to the high conductivity of the water (i.e., the electrical current dissipated at the anodes and did not produce an effective field).

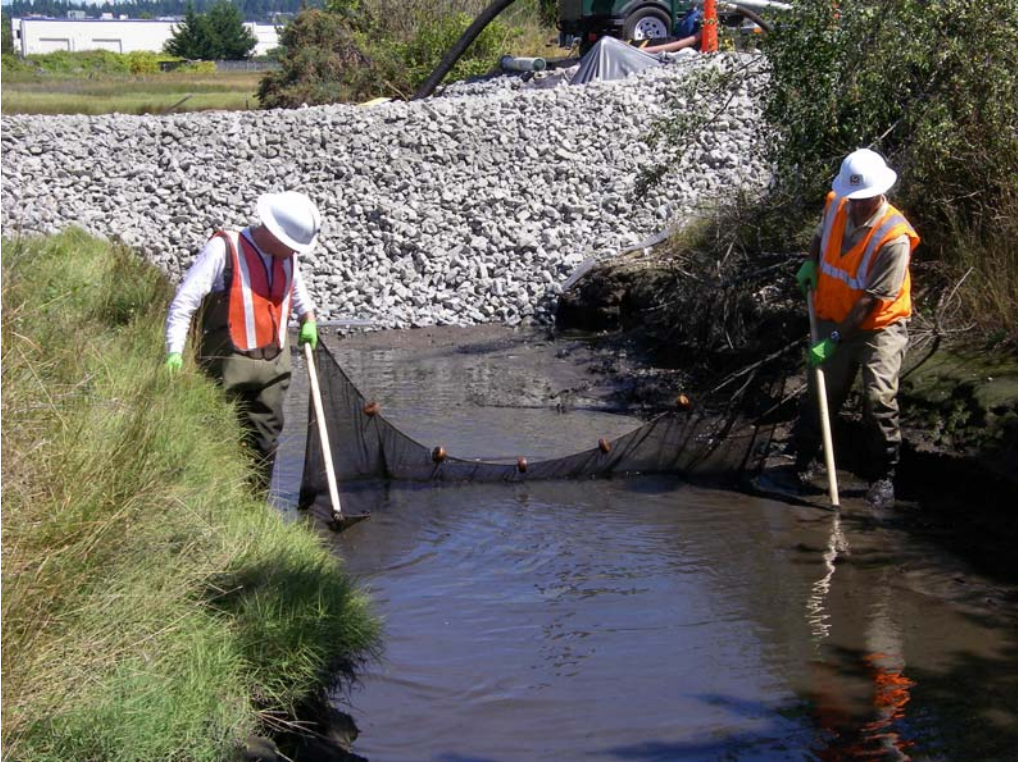
Coffer Dam and Seining

Because electrofishing was not successful, fish were captured and removed from the remediation area using seining techniques. Prior to seining, two 1/4" mesh block nets were set up between the dams to prevent fish movement, effectively dividing the area into thirds. Block nets were also placed at the upstream and downstream coffer dams to keep fish away from the pump and discharge areas. Fish were removed from each of the three sections (upper, middle, and lower) using a 10 ft wide x 4 ft high seine with 1/8" mesh, working from one end to the other, trapping fish against the block nets. At least three, and up to five passes per day of each section were conducted to remove as many fish as possible (Table 1). Special care was taken to look for any potential T/E species, especially salmonids. Once captured, fish were removed from the seine, counted, then placed in a bucket with site water and an aerator, and transported to a suitable release site either upstream or downstream of the coffer dams. Care was taken to minimize

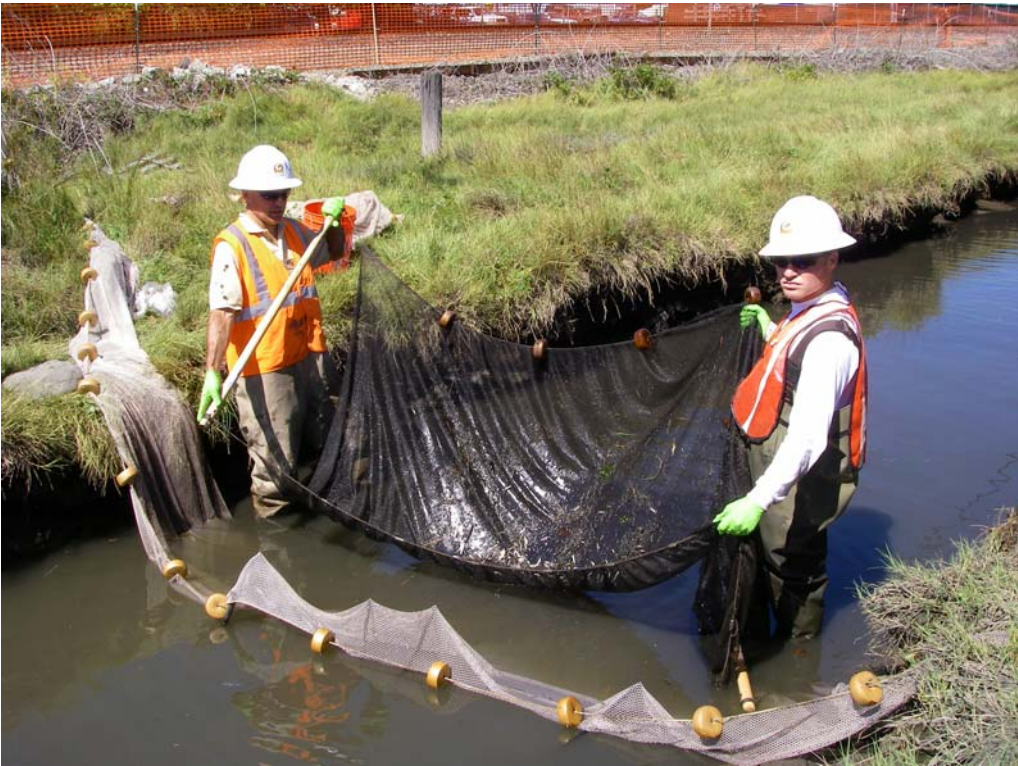
Seining to Block Net

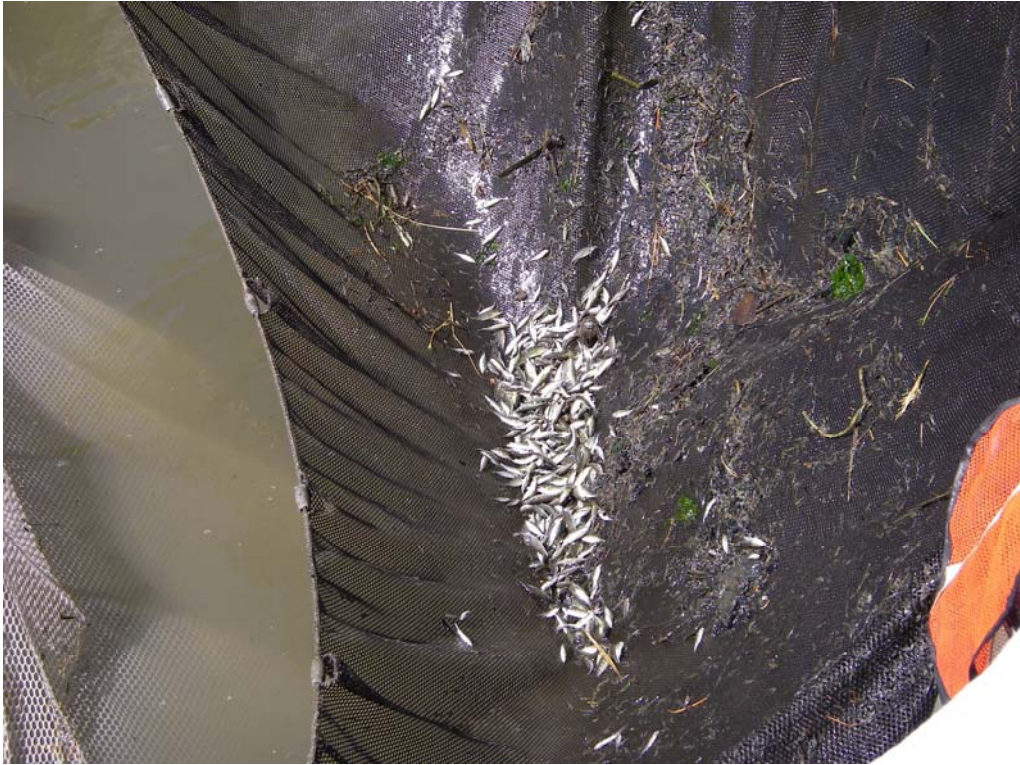
Seine Catch

The results of the fish removal effort show that approximately 82% of the fish were relocated on the first day (18% on the second day; Table 1). On August 13, 2008 approximately 4,549 fish were captured and moved. Two of these were prickly sculpin (7" long), one was a starry flounder (3" long), and the rest were threespine stickleback (1 to 2.5" long). On the second day, August 14, 2008 approximately 1,016 fish were captured and moved. All were threespine stickleback of similar size. In total approximately 5,565 live fish were relocated (5,562 stickleback, two sculpin, and one flounder). No T/E fish species, including salmonids, or other aquatic organisms, such as mussels, clams, or crustaceans were observed during the removal effort, or during the oversight provided on August 12, 15, and 18, 2008. In comparing the catch rate from the highest first seine pass to the lowest last seine pass in each of the three sections (upper, middle, and lower), the catch rate decreased from 650 to 17 fish in the upper section (2.6%), from 2,306 to 28 fish in the middle section (1.2%), and from 270 to 0 fish in the lower section (0%). This shows that catch rates dropped significantly indicating the majority of fish had been removed during the initial passes. Additionally, due to the high number of fish that were captured, it is unlikely that other fish species were present and went unnoticed during the relocation event. The low number of species observed in this section of Willow Creek may be due to habitat limitations such as little to no structure, channelization, homogenous silt and sand substrates, and low gradient.
