INITIAL INVESTIGATION FIELD REPORT

ERTS # 613497
County Kitsap
Parcel # 362501-4-002-1006
FS ID # 18708 CSID # 11446

Site Name (e.g., Co. name over door): Kitsap Rifle & Revolver Club	Site Address (including City and Zip+4): 4900 Seabeck Hwy NW, Bremerton, WA 98312	Site Phone: (360)373-1007 () -
Site Contact and Title (if any): Marcus Carter, Executive Officer	Site Contact Address (including City and Zip+4) if any: 4900 Seabeck Hwy NW, Bremerton, WA 98312	Site Contact Phone: (360)895-0724 () -
Site Owner: Kitsap Rifle & Revolver Club	Site Owner Address (including City and Zip+4): 4900 Seabeck Hwy NW, Bremerton, WA 98312	Site Owner Phone: (360)373-1007 () -
Site Owner Contact (if any): Bradford Smith, President	Site Owner Contact Address (including City and Zip+4) if any: 4900 Seabeck Hwy NW, Bremerton, WA 98312	Owner Contact Phone: (253)857-6069 () -
Previous/Additional Site Owner(s):	Previous/Additional Site Owner(s) Address (including City and Zip+4):	Phone: () - () -
Alternate Site Names:	Comments:	Is property > 10 acres? Yes <input checked="" type="checkbox"/> No <input type="checkbox"/>

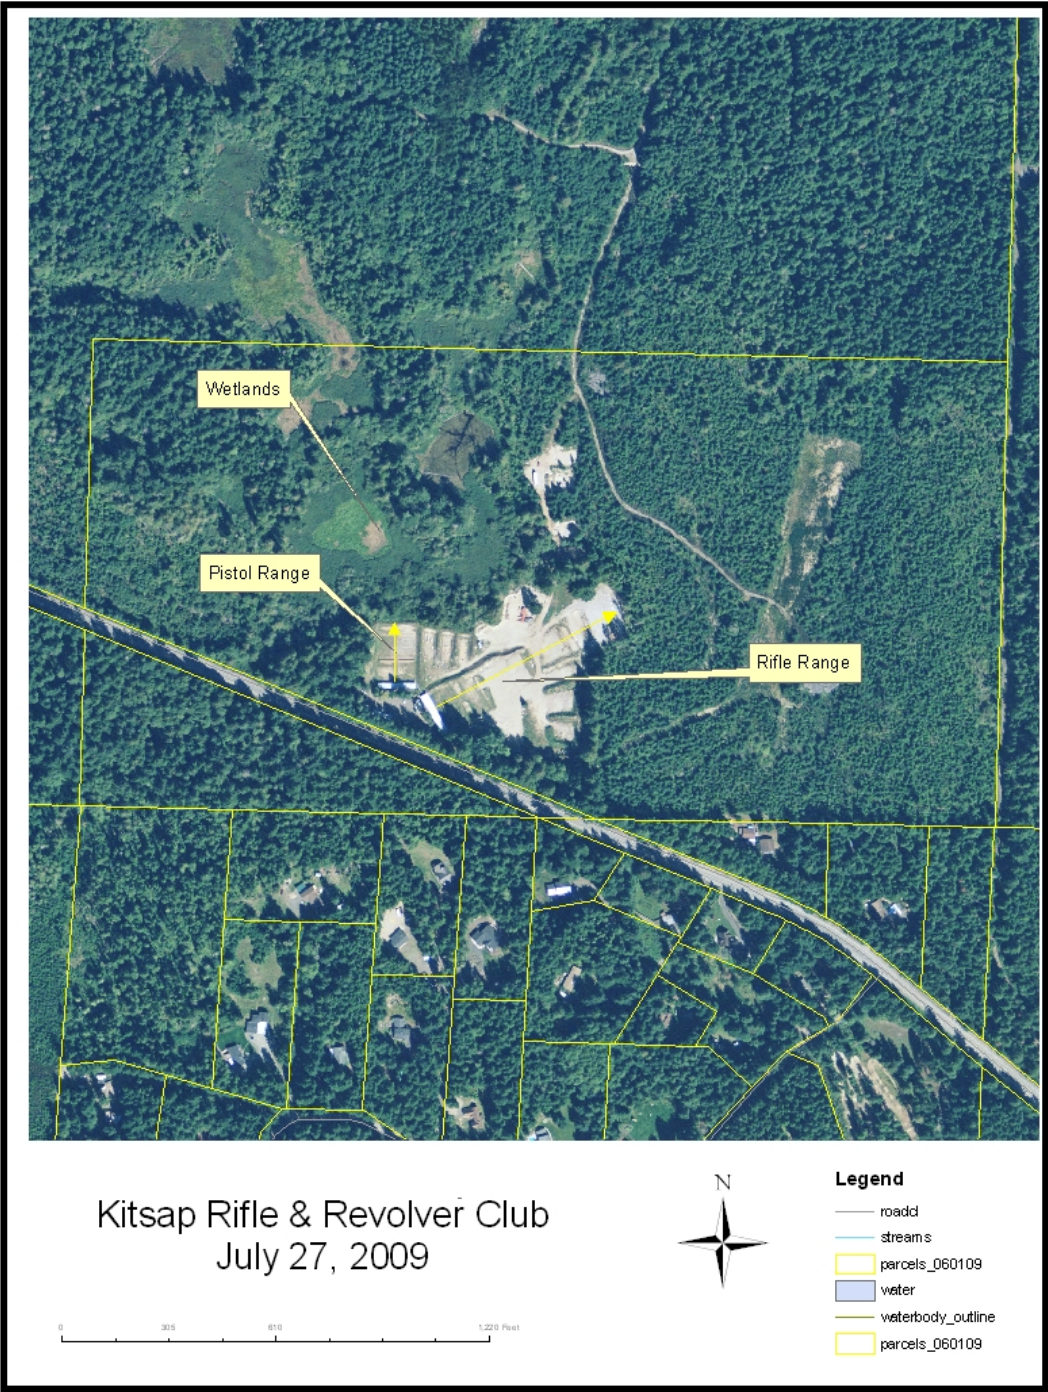
SITE MAP/DIAGRAM

North	Approximate scale: 1 inch = 200 feet
ERTS Number 613497	County: Kitsap
Inspector: Grant Holdcroft	Date: 8/17/2010
