INITIAL INVESTIGATION FIELD REPORT

<u>Site Name (Name over door):</u> Food Mart 2470	<u>Site Address (including City, State and Zip):</u> 5235 Delridge Way SW Seattle, WA 98106	<u>Phone</u> (206) 932-0991 <u>Email</u>
<u>Site Contact, Title, Business:</u> Kristopher Kern, Project Geologist ES Engineering Services	<u>Site Contact Address (including City, State and Zip):</u> 1036 W Taft Ave Orange, CA 92865	<u>Phone</u> (714) 919-6530 <u>Email</u> kkern@es-online.com
<u>Site Owner, Title, Business:</u> GTY-Pacific Leasing LLC	<u>Site Owner Address (including City, State and Zip):</u> 2 Jericho Plaza #110-WIN Jericho, NY 11753	<u>Phone</u> <u>Email</u>
<u>Site Owner Contact, Title, Business:</u>	<u>Site Owner Contact Address (including City, State and Zip):</u>	<u>Phone</u> <u>Email</u>
<u>Previous Site Owner(s):</u>	<u>Additional Info (for any Site Information Item):</u>	
<u>Alternate Site Name(s):</u> Jackpot 2470, Delridge Food Mart

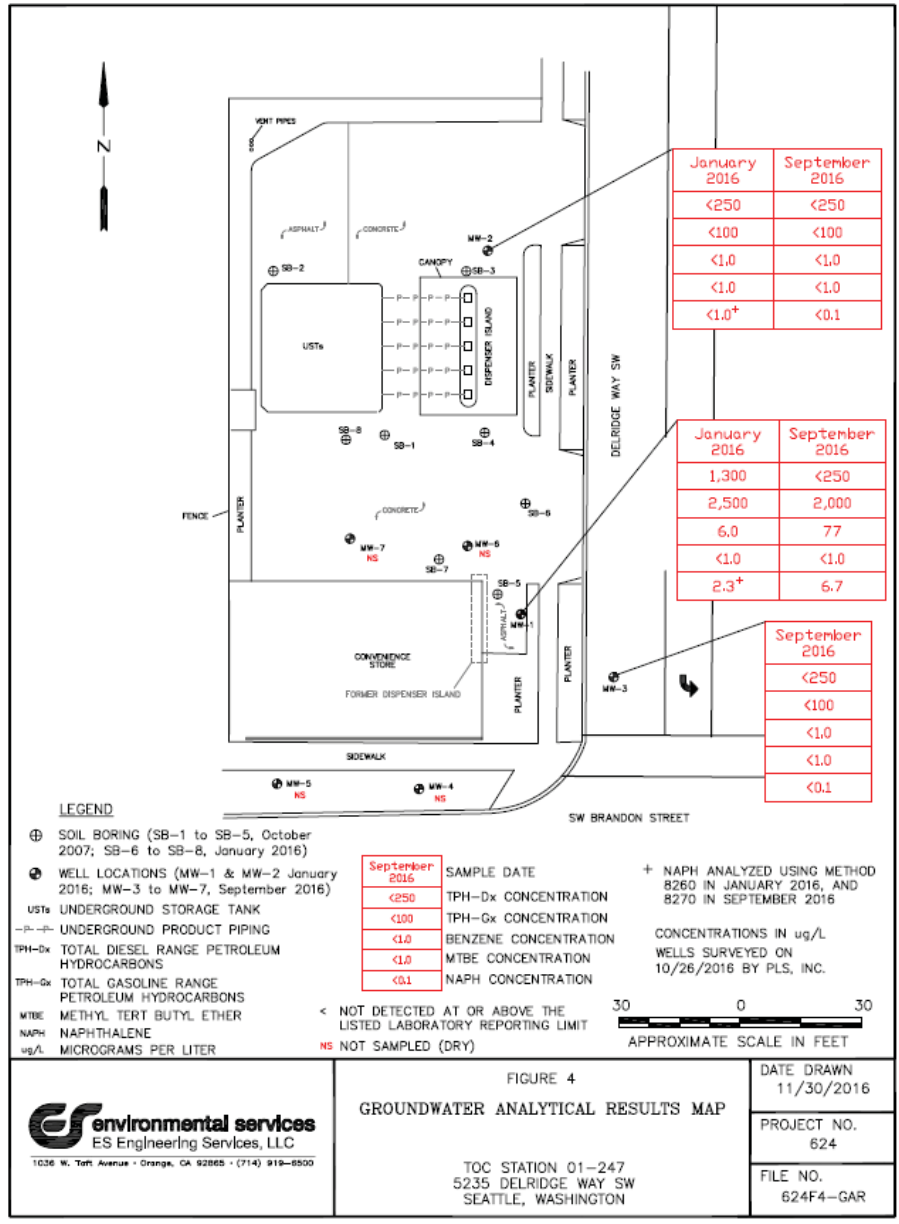
W:\03_Site Assessment & Remediation\Eagle Canyon (PCL\FN)-2470 - Delridge Way NW, Seattle, WA\Reports\2016 Well Installation Report\FIGURES\624.dwg

Additional Site Assessment and Well Installation Report by Environmental Services, dated 12/9/2016 documents soil and groundwater samples above MTCA Method A cleanup levels. Highest soil sample (SB-7 January 2016): TPH-G= 18,000ppm / Benzene= 0.16ppm. Highest groundwater sample (MW-1 January 2016) TPH-D= 1,300ppb; TPH-G= 2,500ppb. (MW-1 September 2016) Benzene= 77ppb.
