South Park Landfill

Remedial Investigation/ Feasibility Study

July 2017

PUBLIC REVIEW DRAFT

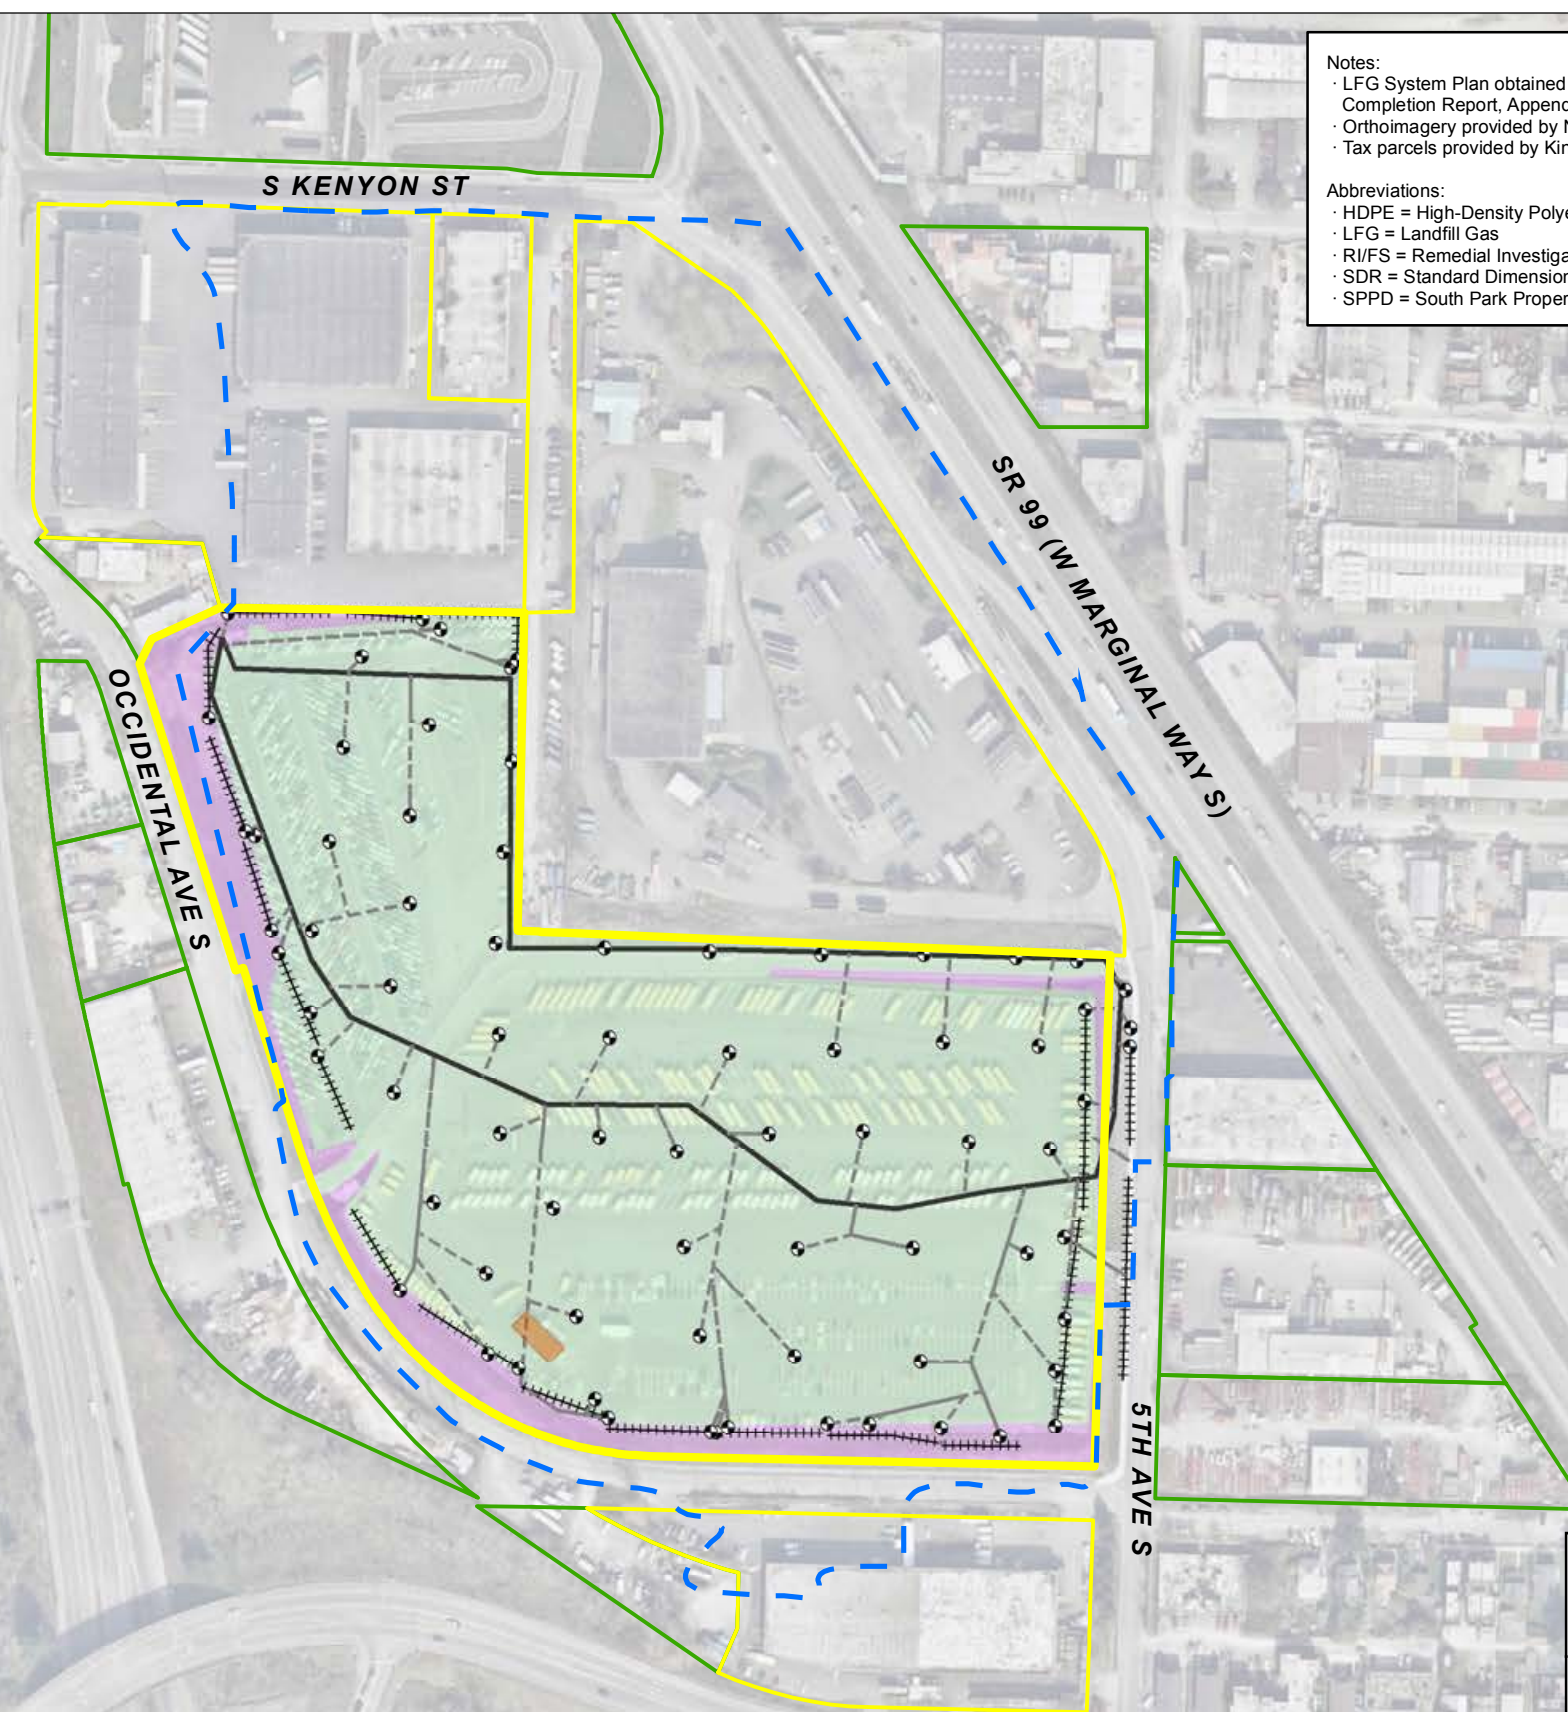
Figure 2.4
SPPD Current Configuration

- SPPD Redevelopment Included:**
1. Site regrading to accommodate paving and above grade buildings.
 2. Installation of an active LFG control system.
 3. Installation of stormwater collection system with bioswales for treatment prior to discharge into public stormwater system.
 4. Installation of asphaltic concrete cap or low permeability membrane cap over any area where landfilling occurred.

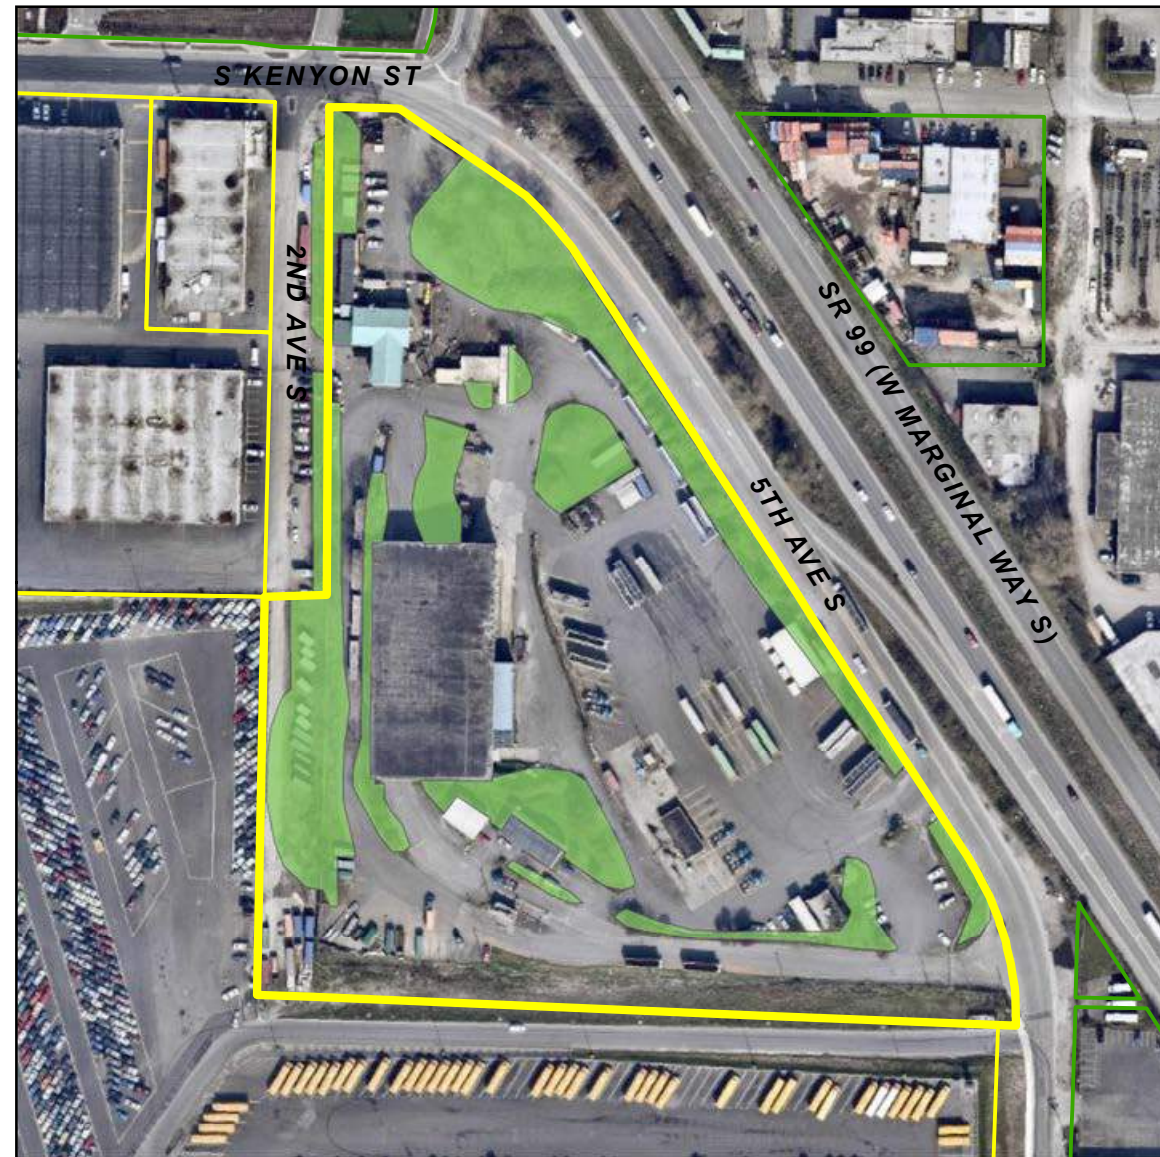
Current Site Plan

Current conditions at the SRDS parcel include an active solid waste transfer facility for Seattle. The parcel contains several large paved areas and buildings. Areas in green are either existing landscaped areas or areas along 2nd Avenue South with a gravel surface for parking.

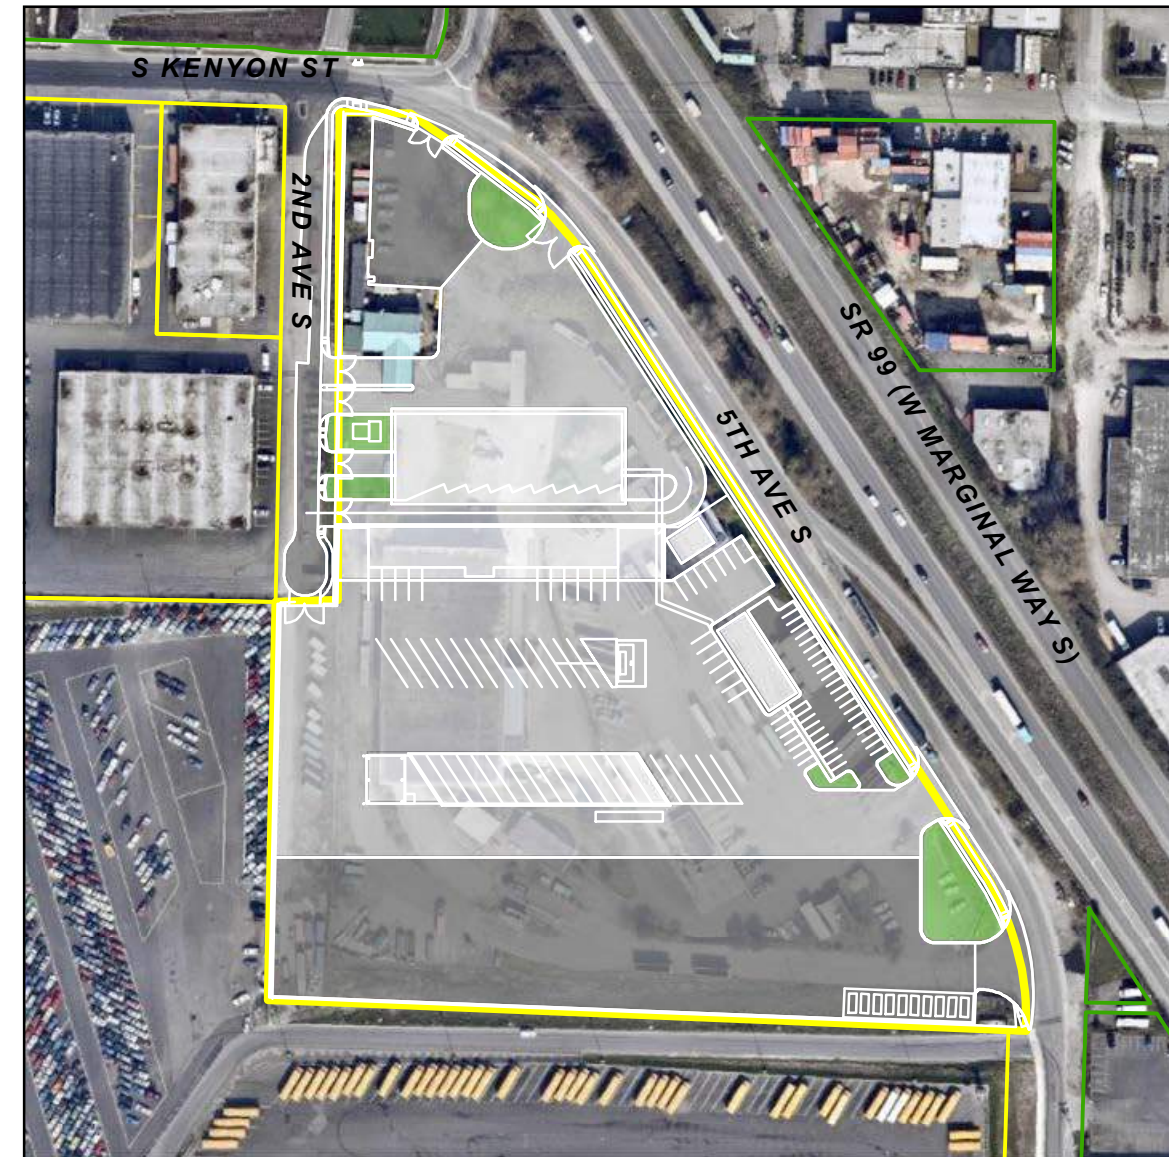
Proposed Future Site Plan

Beginning in 2017, the parcel will be developed to other uses. Between demolition of existing structures and development of new structures, an Interim Action under the MTCA Agreed Order will be conducted to implement remedial action requirements. Design is underway and will incorporate LFG controls, a new cap and stormwater system, and location of long-term monitoring wells and LFG probes.

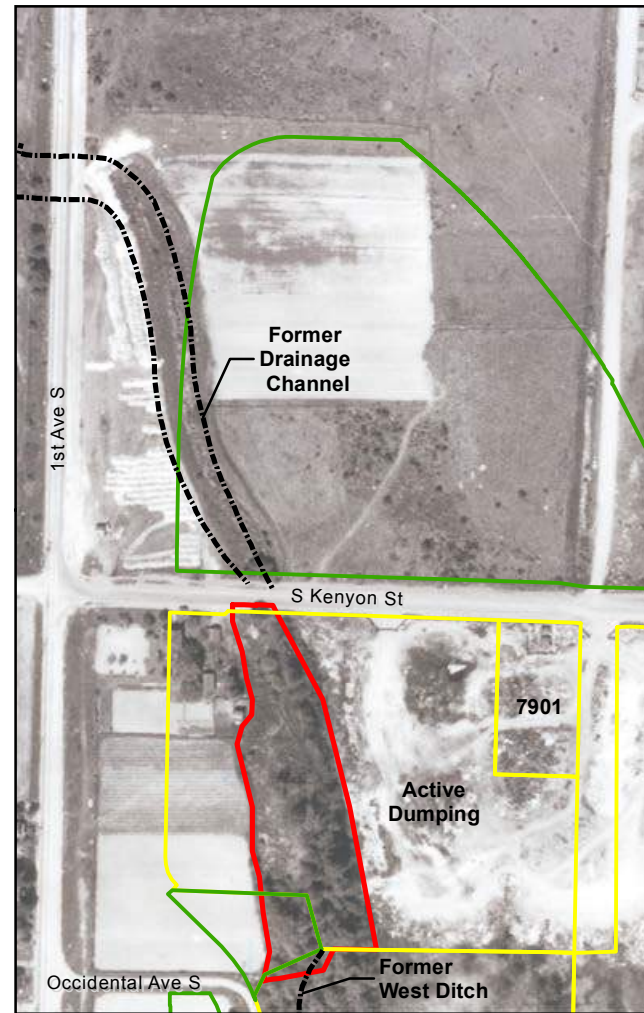
1946

Activities on the KIP and 7901 parcels include active dumping, farming, commercial operating, and residential.

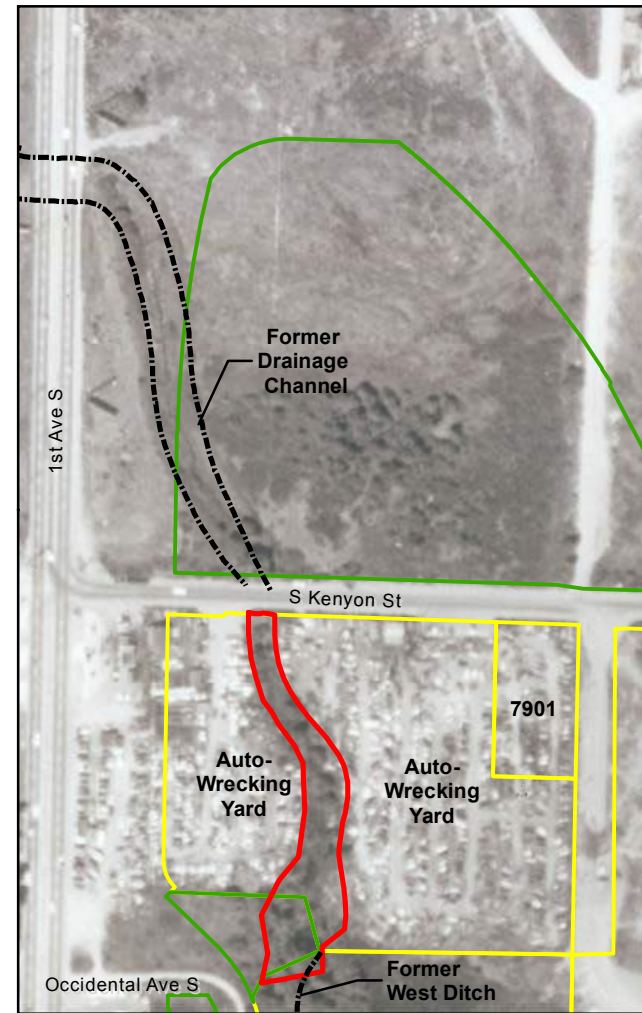
1960

Activities on the KIP and 7901 parcels include auto-wrecking.

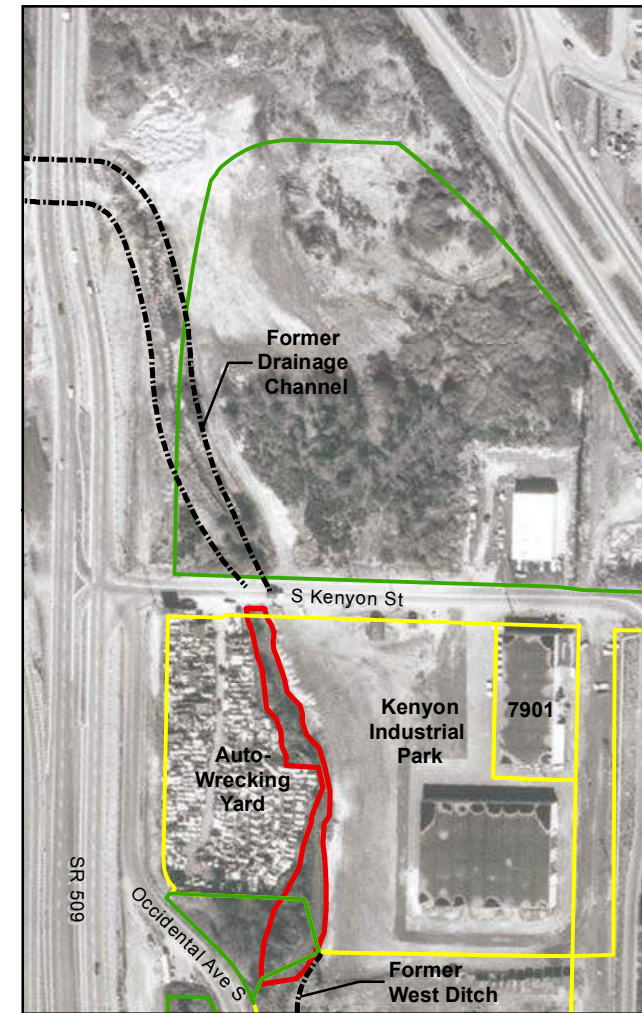
1969

Activities on the KIP parcel include auto-wrecking and the development of a building on the present day KIP parcel and another on the 7901 parcel.

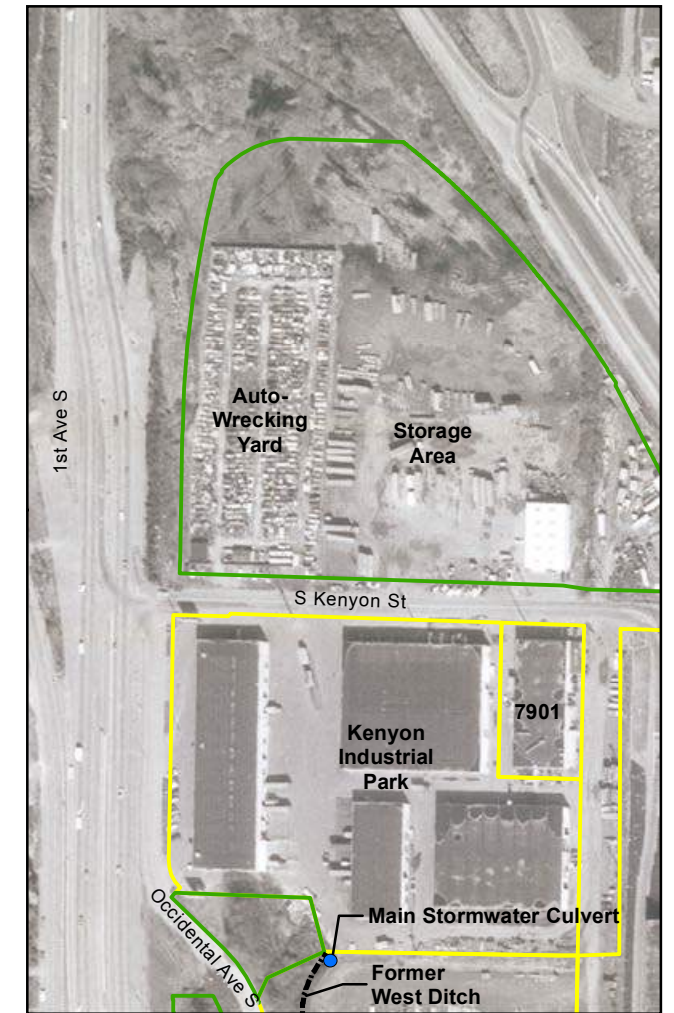
1974

Activities on the KIP parcel include filling of the swale, development of the three remaining buildings, paving, and building of a stormwater collection system.

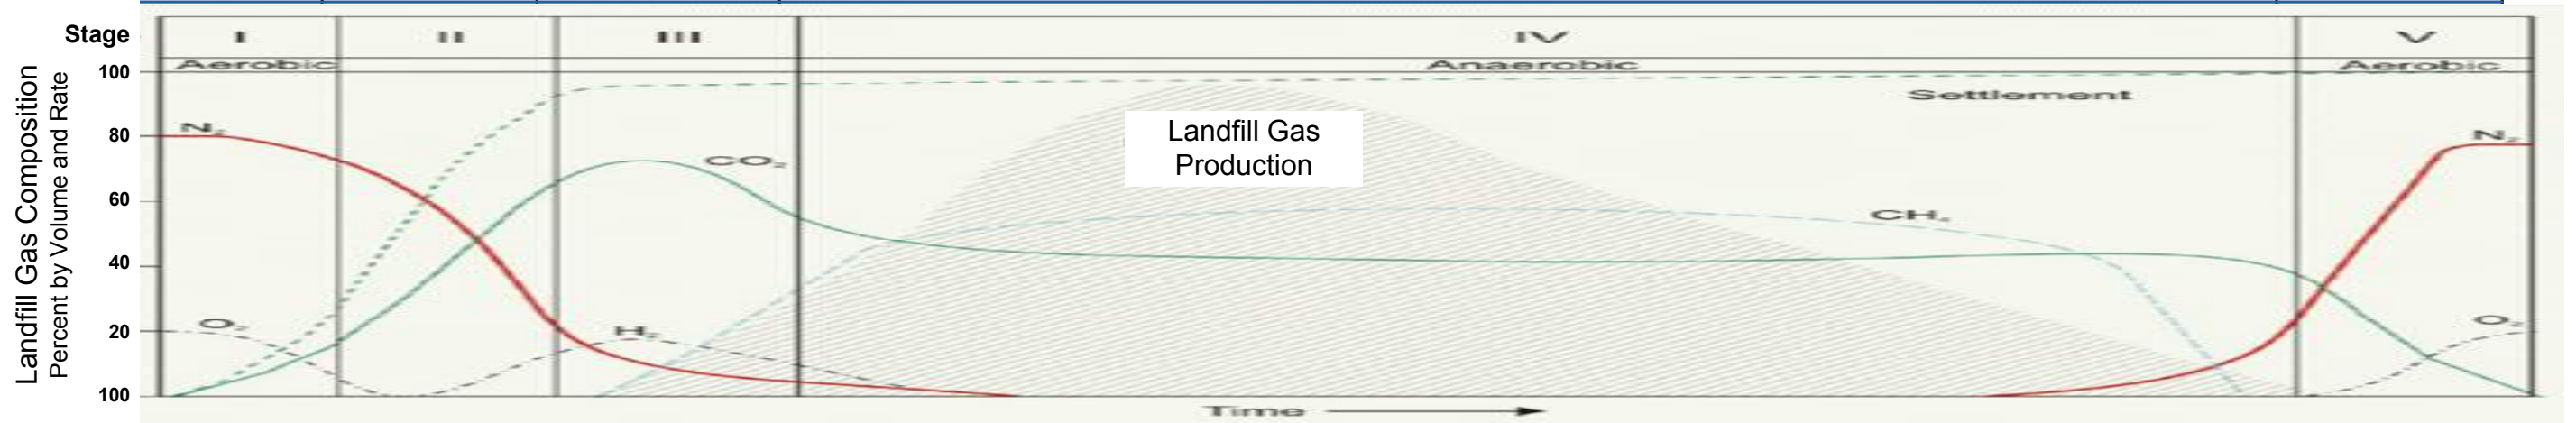
STAGE 1	STAGE 2	STAGE 3	STAGE 4	STAGE 5
Description	This stage occurs under aerobic conditions during placement of waste and for a period of days/weeks following. During this stage, H ₂ O and CO ₂ are the main products. As wastes hydrolyze, the leachate becomes salty from the dissolution of major cations (sodium, potassium, calcium, and magnesium), chloride from food and other degradable waste, and carbonate from the CO ₂ . The leachate is neutral in pH and salty.	Stage 1 processes resulted in a depletion of O ₂ in the waste and changed the waste to anaerobic conditions. Carbohydrates, proteins, and lipids are further decomposed to CO ₂ , H ₂ , ammonia, and organic acids. Gas concentrations in the waste during Stage 2 may rise to levels of up to 80% CO ₂ and 20% H ₂ . Organic acids that are produced at this stage make the leachate acidic, with acetic acid becoming one of the major constituents.	During this stage under anaerobic conditions, the H ₂ and CO ₂ levels begin to decrease. The low H ₂ levels promote the methane-generating micro-organisms, the methanogens, which begin to generate methane and CO ₂ . The leachate continues to be salty and slightly acidic. The common solvents, PCE and TCE, which were relatively stable during the first two stages, now readily undergo reductive dechlorination to produce DCEs and vinyl chloride.	This stage is the main landfill gas (LFG) generation stage with the LFG typically composed of approximately 60% methane and 40% CO ₂ . The reactions during this stage are relatively slow, taking many years for completion. The conditions continue to be anaerobic as in Stages 2 and 3. Stage 4 typically commences 6 months to several years after the waste has been placed in the landfill depending on the water content and water circulation. Significant concentrations of LFG are generated after between 3 and 12 months, depending on the available micro-organisms and waste-degradation products. The LFG will continue to be generated for periods of between 15 and 30 years after final deposition of waste, but can continue to generate low levels of LFG for up to 100 years after waste placement. Early in this stage the majority of the easily degraded wastes, such as food, have been degraded. The salt content of the leachate decreases; the organic acids are consumed by micro-organisms as soon as they are produced to maintain the methane production and the leachate returns to neutral. Very little solvent (TCE and PCE) remains because it is degraded to DCEs as quickly as it comes into contact with the methanogenic microbes. The methanogenic microbes then convert the DCEs to vinyl chloride and vinyl chloride to non-toxic end-products. This conversion will continue past vinyl chloride as long as there is sufficient waste degradation occurring in the landfill mass to maintain methanogenic conditions.	This final stage of degradation occurs when the acids used in the production of methane and CO ₂ have been depleted and the landfill returns to aerobic conditions.

Processes	Waste placement and burial Primary physical breakdown, hydrolysis, and aerobic degradation	Hydrolysis and fermentation	Acetogenesis	Methanogenesis	Oxidation
Leachate	Aerobic, salty	Organic acids, ammonia, anaerobic, pH begins to drop	Anaerobic, salty, pH acidic due to acetic acid	Anaerobic, slightly salty, near neutral pH	Aerobic, neutral pH
Landfill Gas	CO ₂ & H ₂ O	H ₂ , CO ₂ , H ₂ O, & NH ₃	H ₂ , CO ₂ , H ₂ O, NH ₃ , & CH ₄	CH ₄ & CO ₂	CO ₂

Figure: Changes in the Production and Composition of Landfill Gas with Time (based on Farquhar and Rovers 1973 with additions from Golder 2011).

Solid waste landfills, which have been extensively studied across the country and are well understood, can be classified into five main stages on the basis of the aging, or breakdown, of wastes within the landfill. Active landfill cells begin in Stage 1, in which the refuse/waste is largely intact, and progress through Stage 4 as the refuse decomposes and the cell is closed. An old, Stage 5 landfill, on the other hand, is one in which the wastes are so degraded that the landfill processes are negligible.

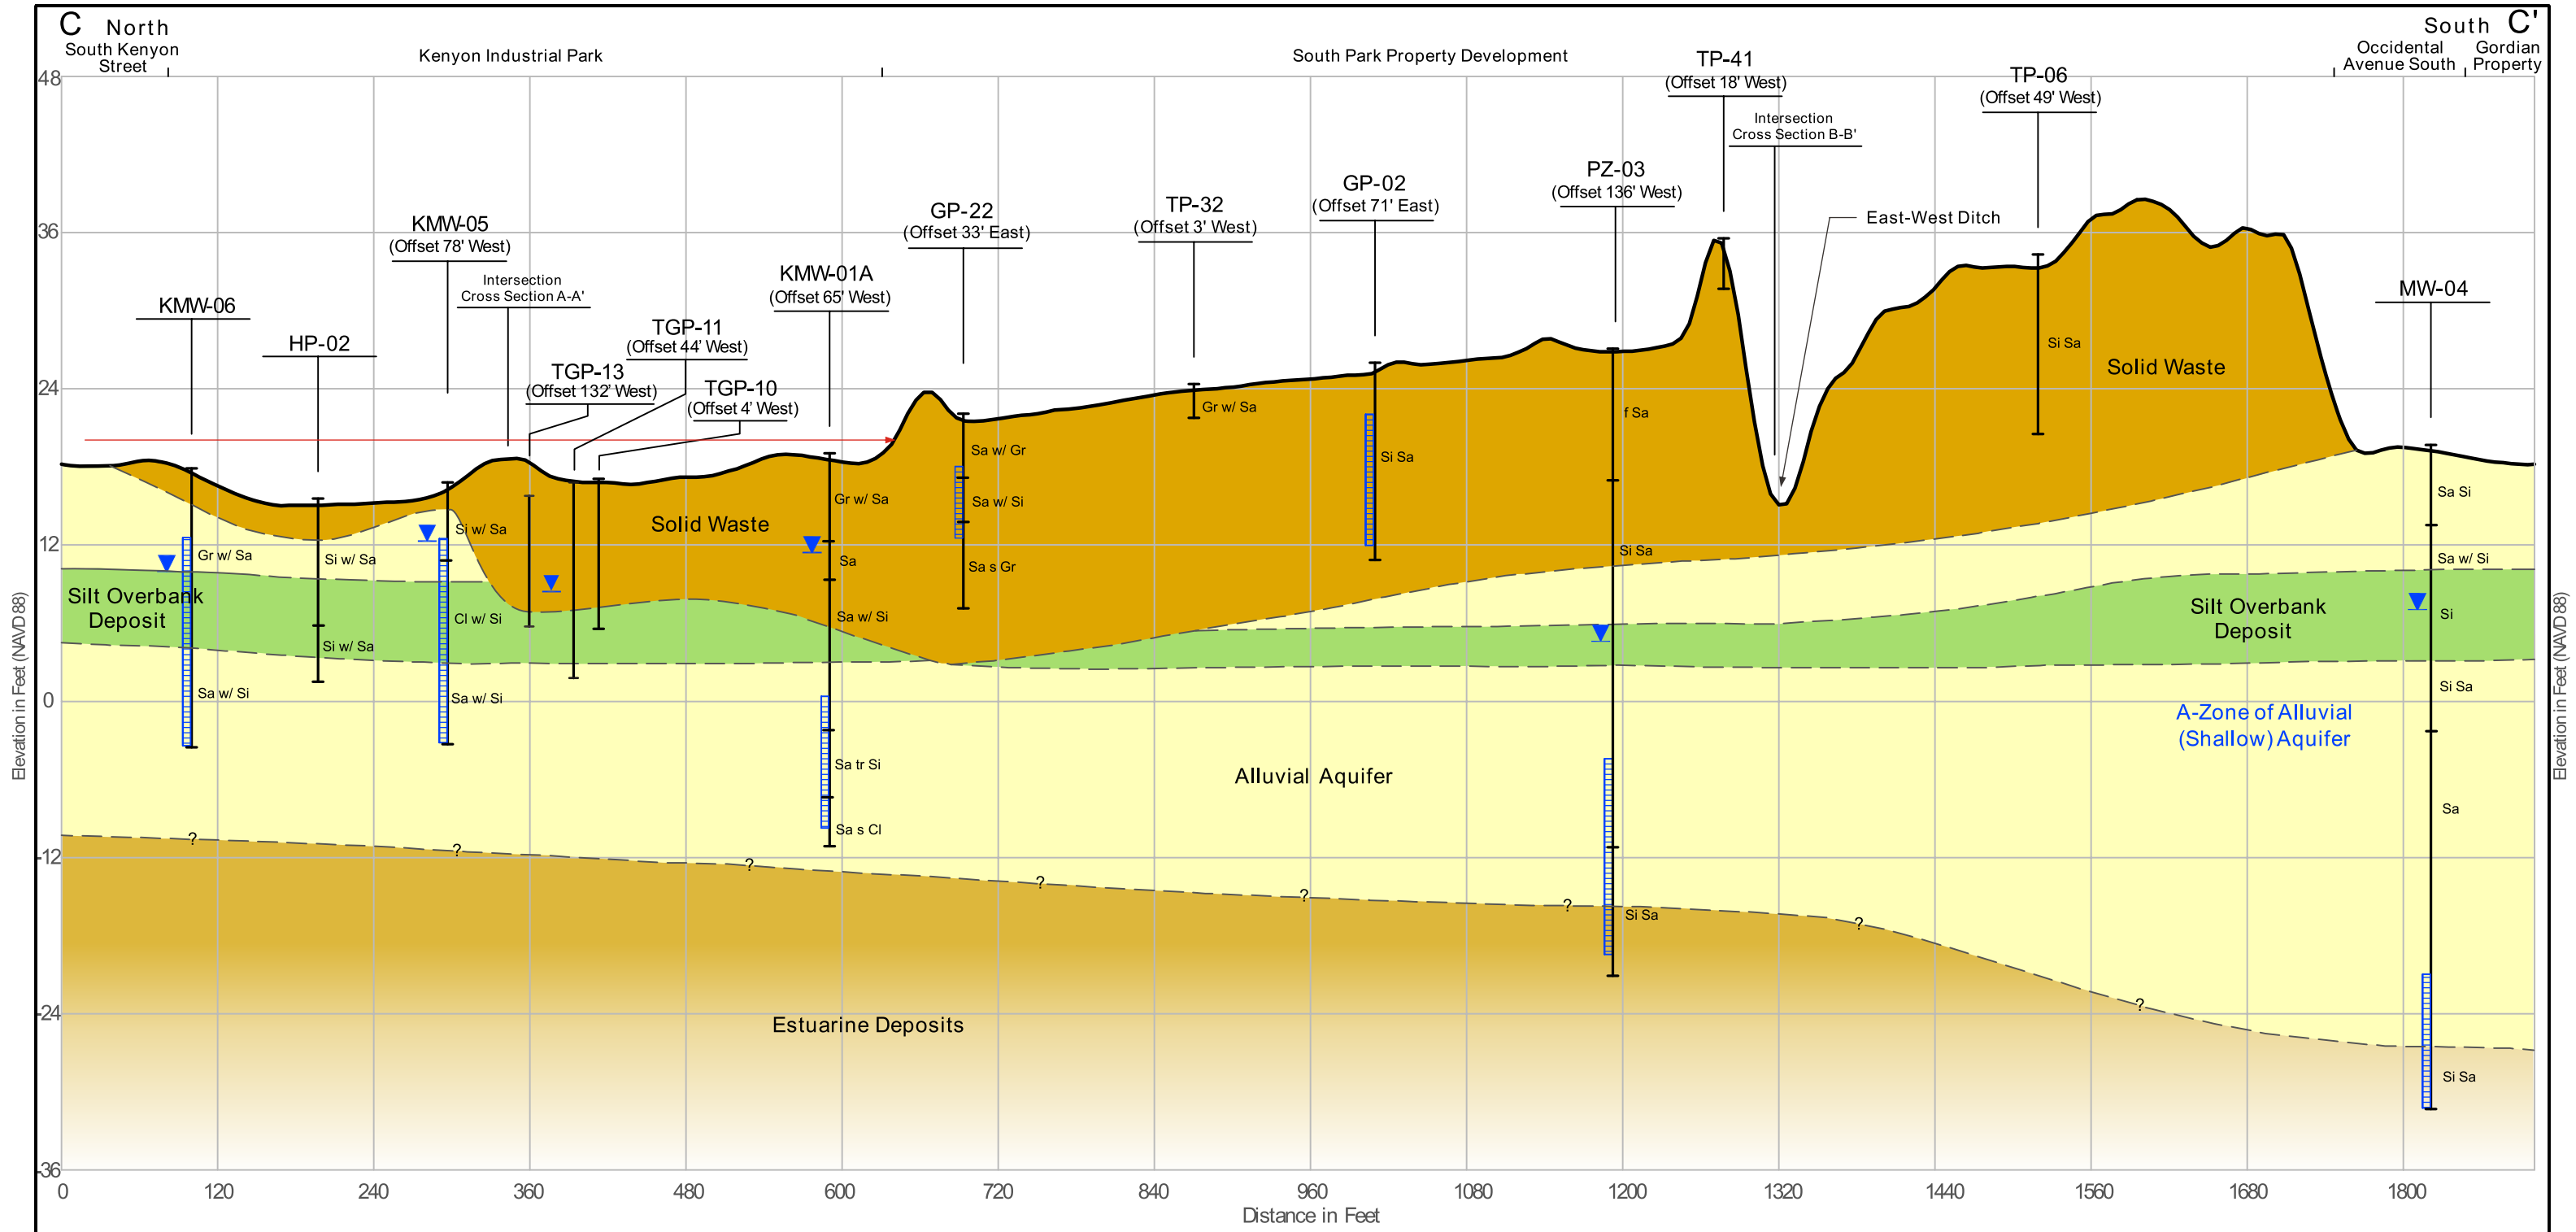
**Figure 5.5
Cross Section C-C'**

- Static Water Level (January or March 2011)
- Approximate Ground Surface
- Approximate Geologic Unit Contact
- Inferred Geologic Unit Contact

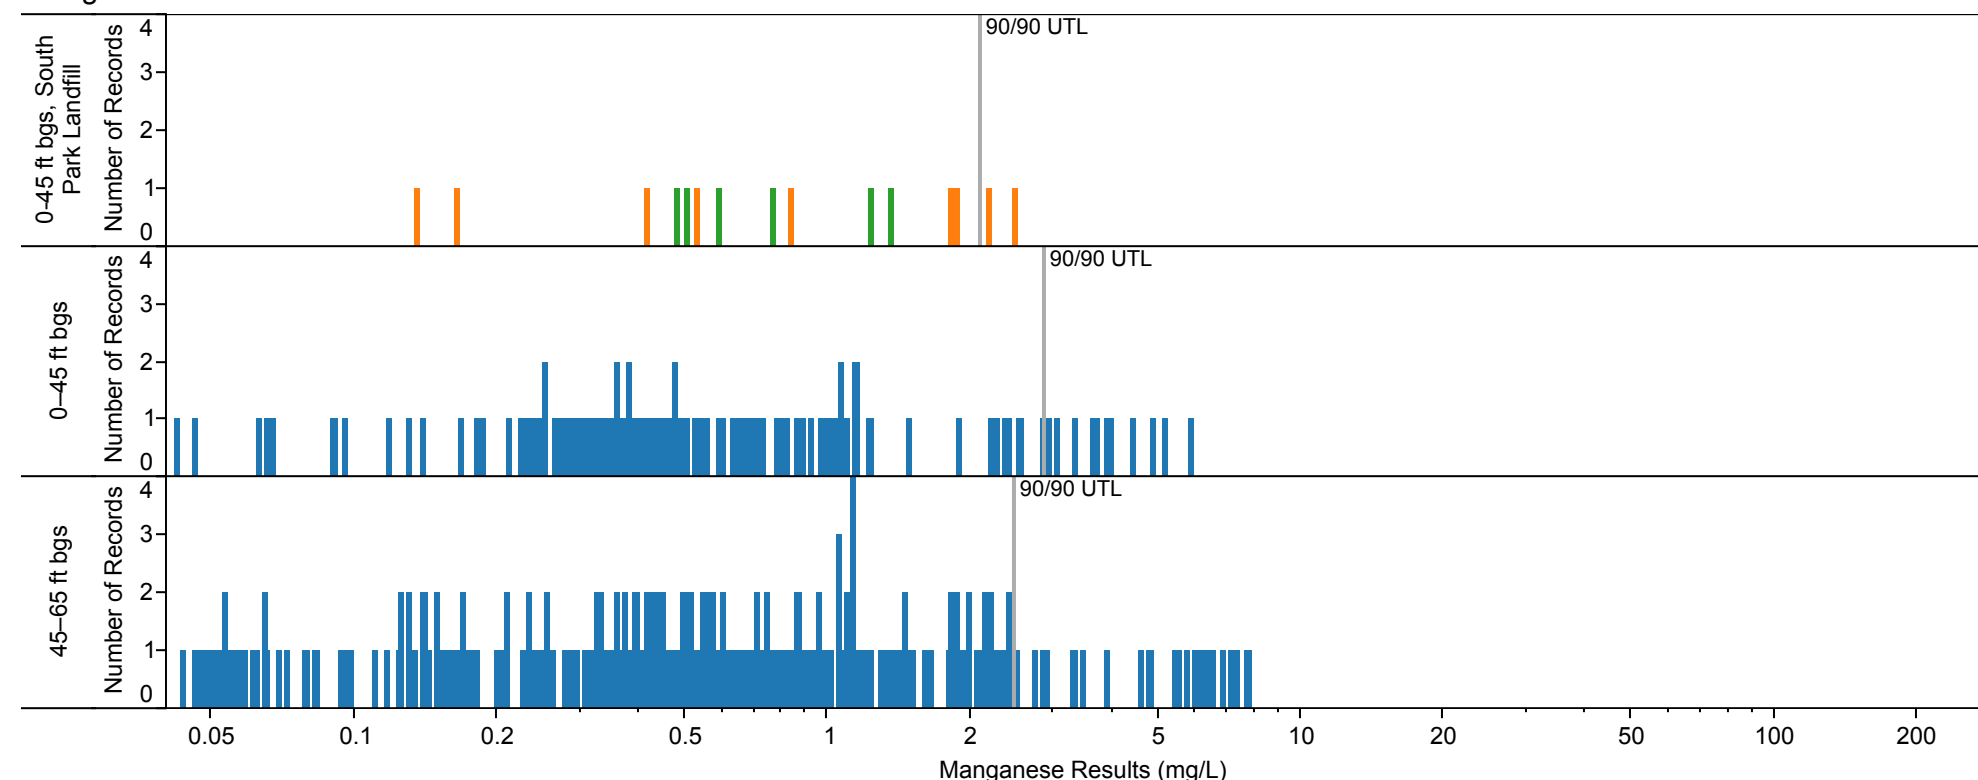
Map shows location of groundwater wells where iron and manganese data are available. Data used are primarily from depths deeper than 40 feet bgs where contamination is too low to affect iron and manganese concentrations. Green wells are background locations within the South Park Landfill site.
