November 1, 2017  
G-Logics Project Number 01-0868-J

**Subject: Summary Memo  
October 2017, Fifth Quarter Groundwater Sampling Results  
Remediation Support and Cleanup Action Report  
Gilman Square  
615 NW Gilman Blvd  
Issaquah, WA**

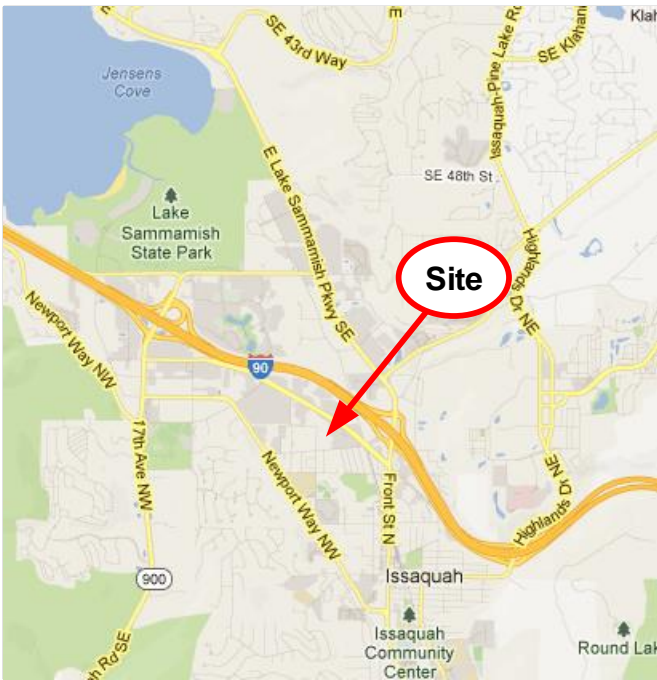
Figure  
2

This memo presents the results from the fifth quarter of groundwater sampling conducted in October 2017 at the Gilman Square Site (Figure 1). For this project, samples were collected from three groundwater-monitoring wells (GL-MW-11, GL-MW-12, and GL-MW-13). Sampling locations are shown on attached Figure 2.

**Current Well Locations, Vinyl Chloride Concentration Data**  
**Gilman Square**  
 615 Northwest Gilman Blvd  
 Issaquah, Washington
