**Public Review Draft
Remedial Investigation Report
Goose Lake Site
Shelton, Washington**

January 12, 2018

Prepared for
Rayonier Advanced Materials

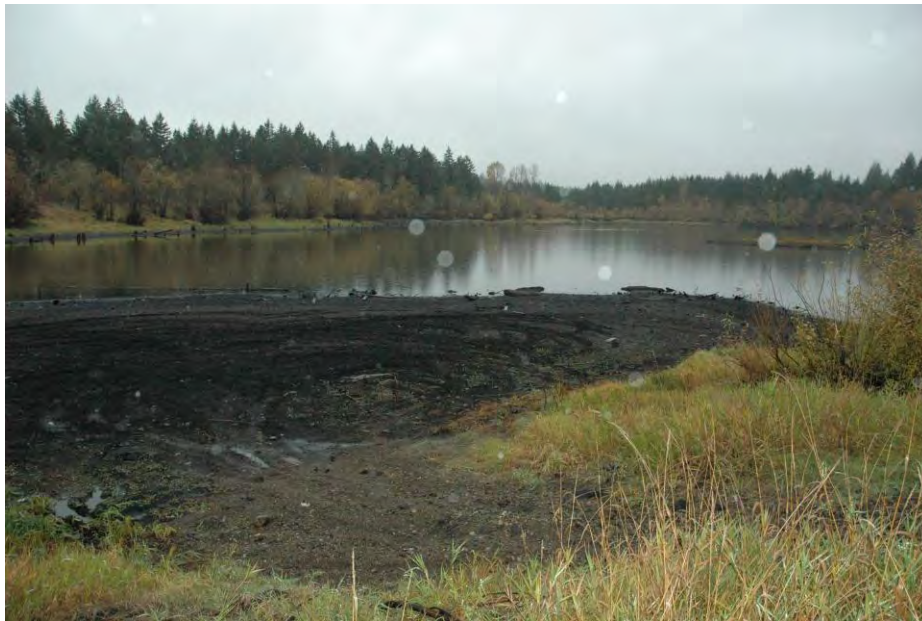
Figure 7. View of Goose Lake facing west. Foreground shows fill pad (landfill encroachment) at east end of the Lake. The small island mentioned above is visible at right side of photo.

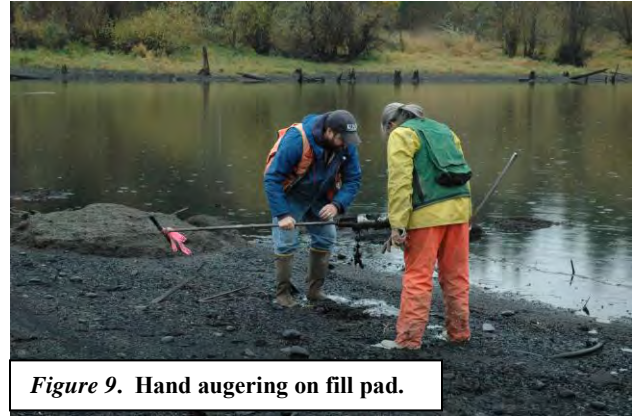
Figure 9. Hand augering on fill pad.
