Draft Remedial Investigation and Feasibility Report

Simplot Grower Solutions
1800 W. 1st Street
Warden, Washington 98857

November 2013
Revised June 2014
Update March 2018

HDR Engineering, Inc.
412 East Parkcenter Boulevard
Suite 100
Boise, Idaho 83706

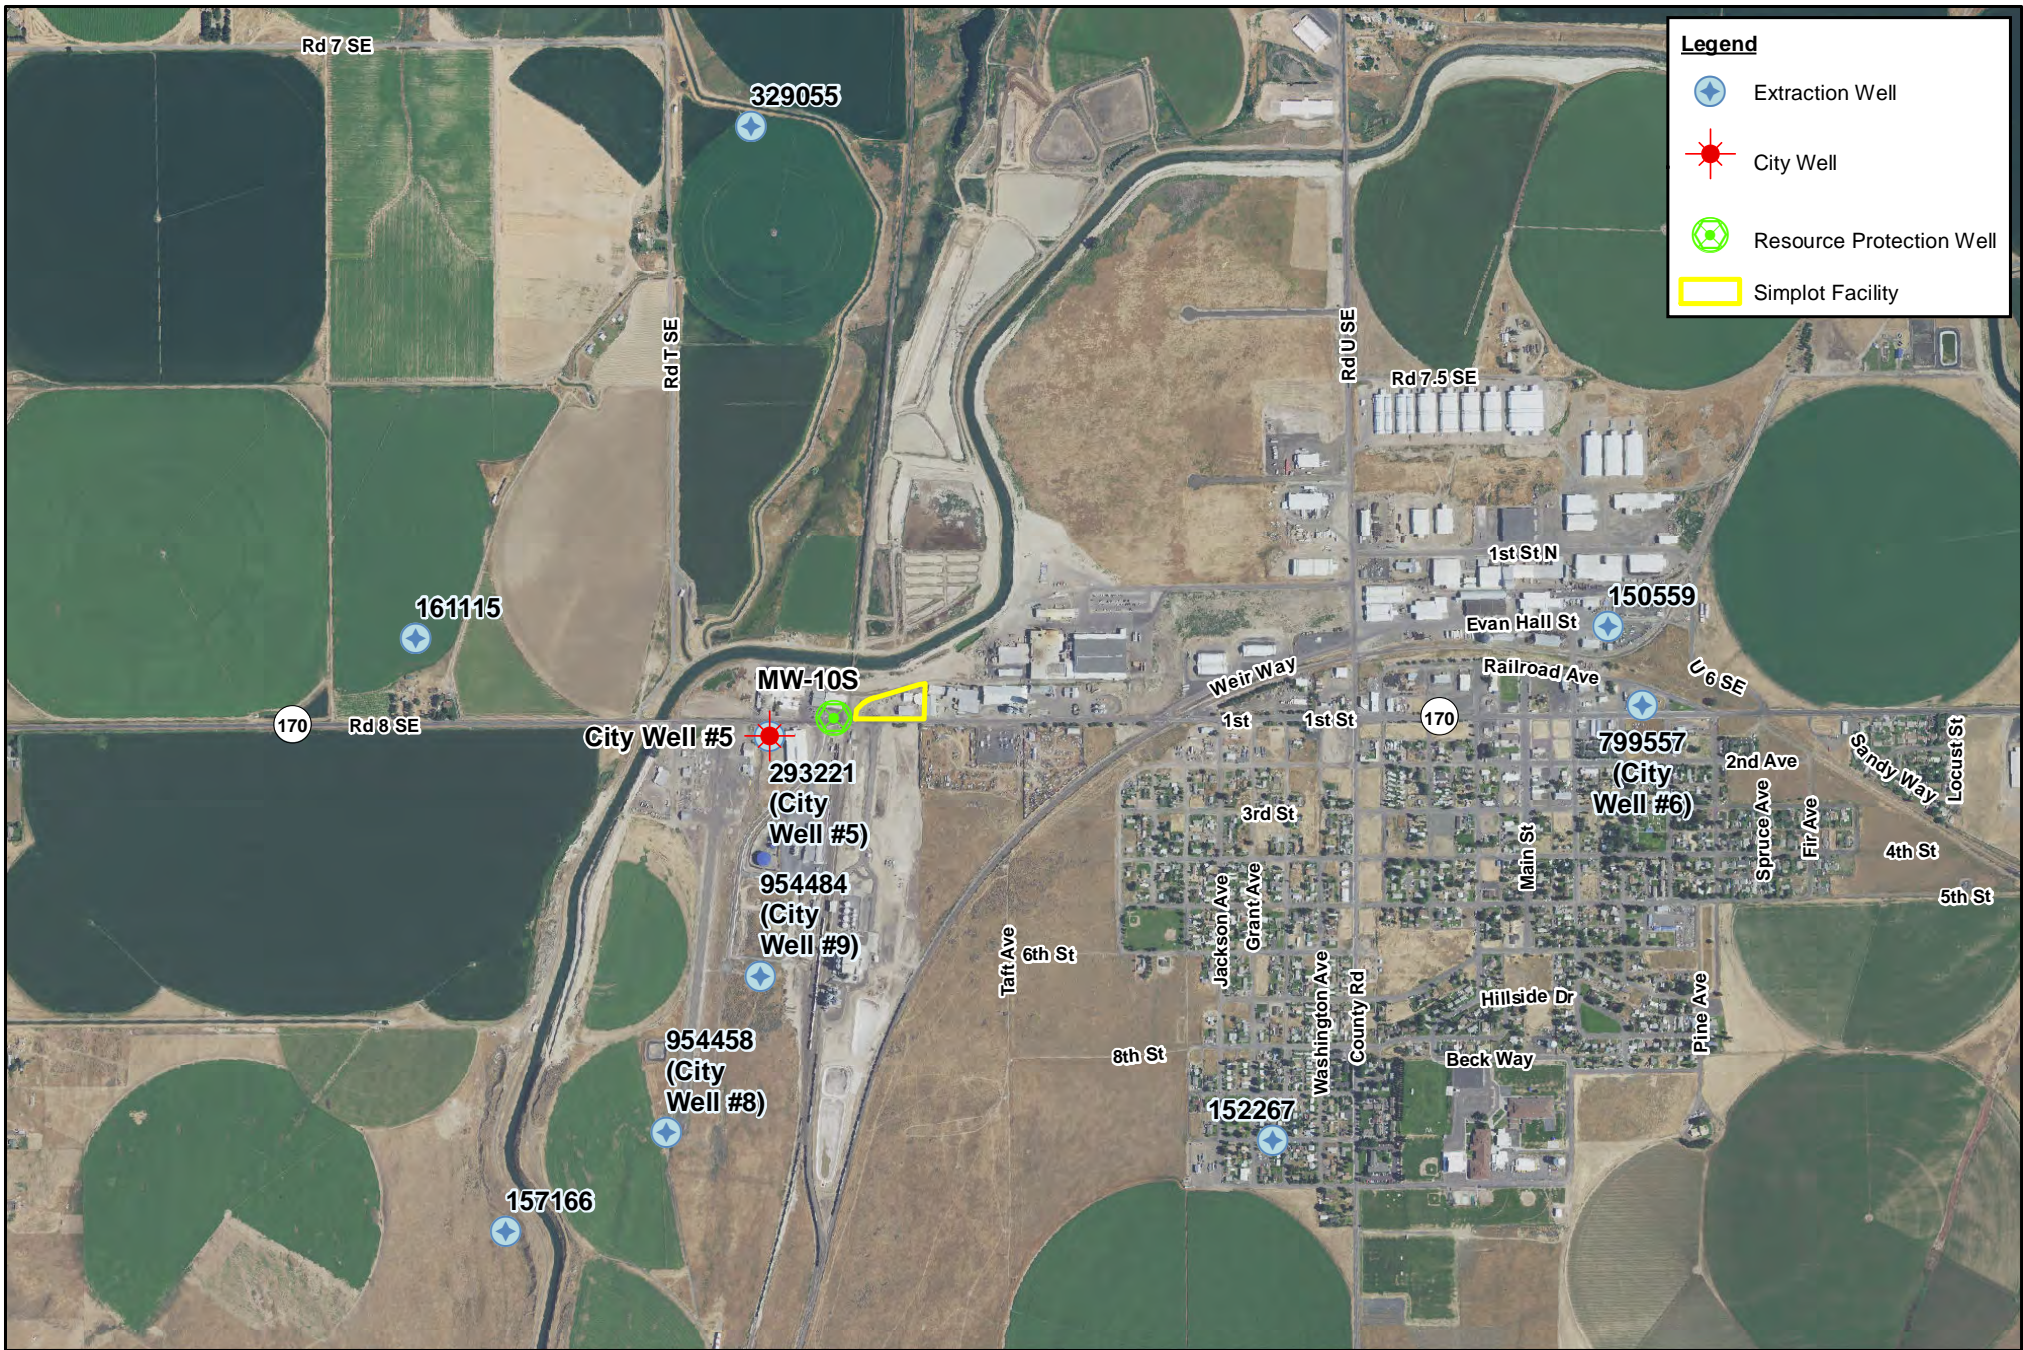
**Figure 3. Extraction Wells Within 1-Mile
Simplot Grower Solutions, City of Warden, WA**

Well log information for the Wanapum and Grande Ronde aquifers indicates that the groundwater head elevations decline with depth. Based on searches through the Washington Department of Ecology's well database (updated February 2018), there are nine extraction wells within a 1-mile radius of the site. (Per WAC 173-160-010, an extraction well includes wells that withdraw groundwater for drinking, feedlots, irrigation, dewatering and drainage, infiltration, industrial processes, washing and rinsing, heating and cooling.) For several of the identified wells, there is no information about what kind of wells they are except that they are water wells.

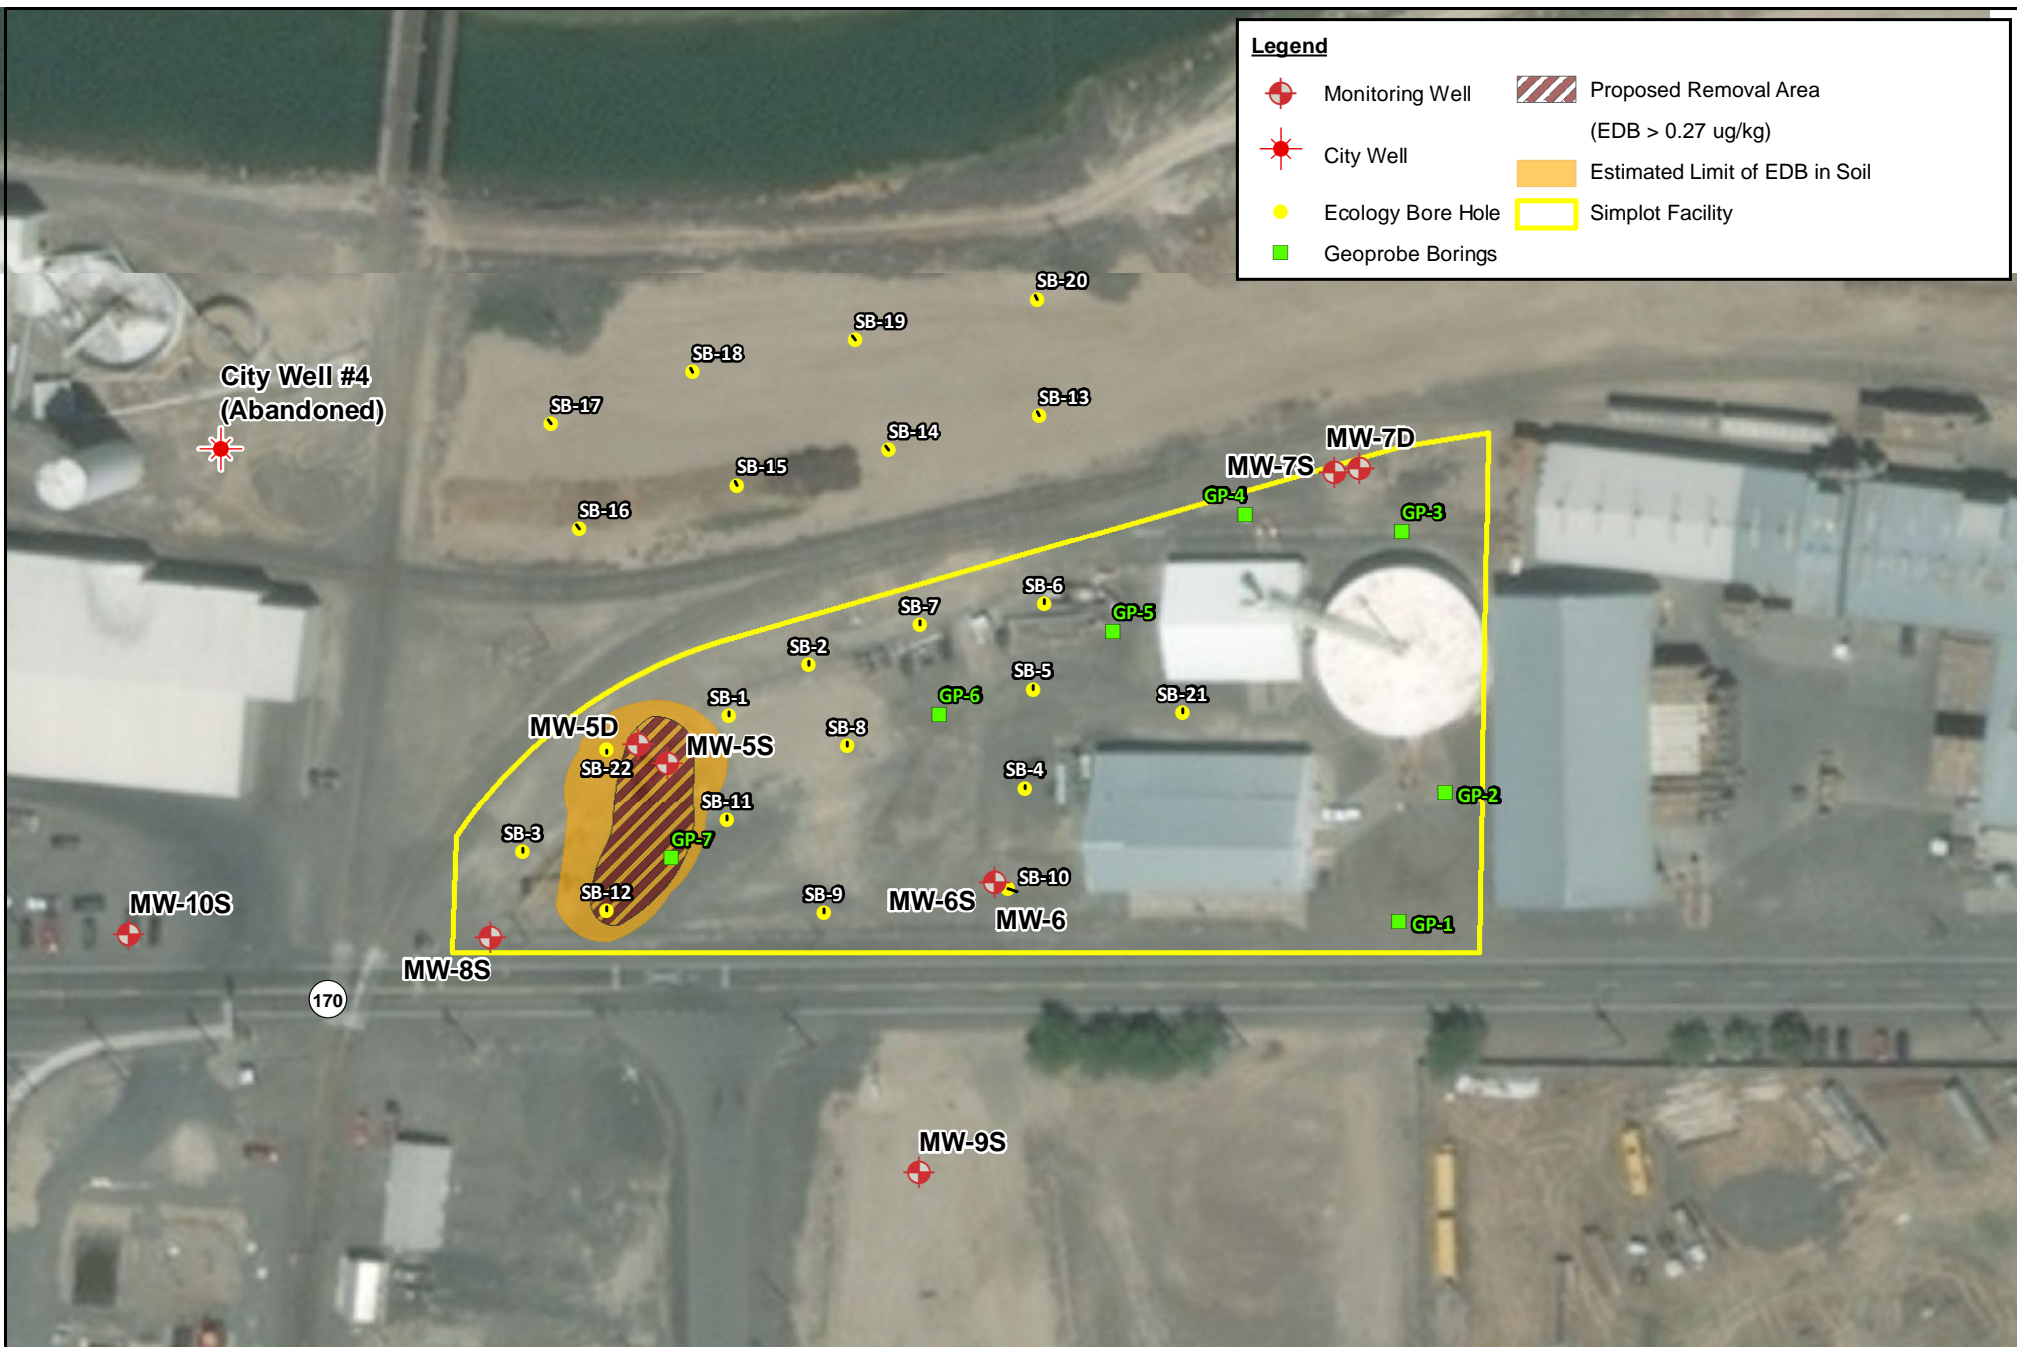
- Monitoring Well
- City Well
- Ecology Bore Hole
- Geoprobe Borings
- Proposed Removal Area (EDB > 0.27 ug/kg)
- Estimated Limit of EDB in Soil
- Simplot Facility

**Figure 17. Estimated Limit of EDB in Soil
Simplot Grower Solutions,
1800 W 1st St., Warden, WA 98857**
