Subject: Work Plan Addendum No. 1 for Follow-up Sample Collection and Testing at the Former Mill A Marine Area, Everett, Washington

Former Mill A Marine Area
Sediment Investigation
Everett, Washington

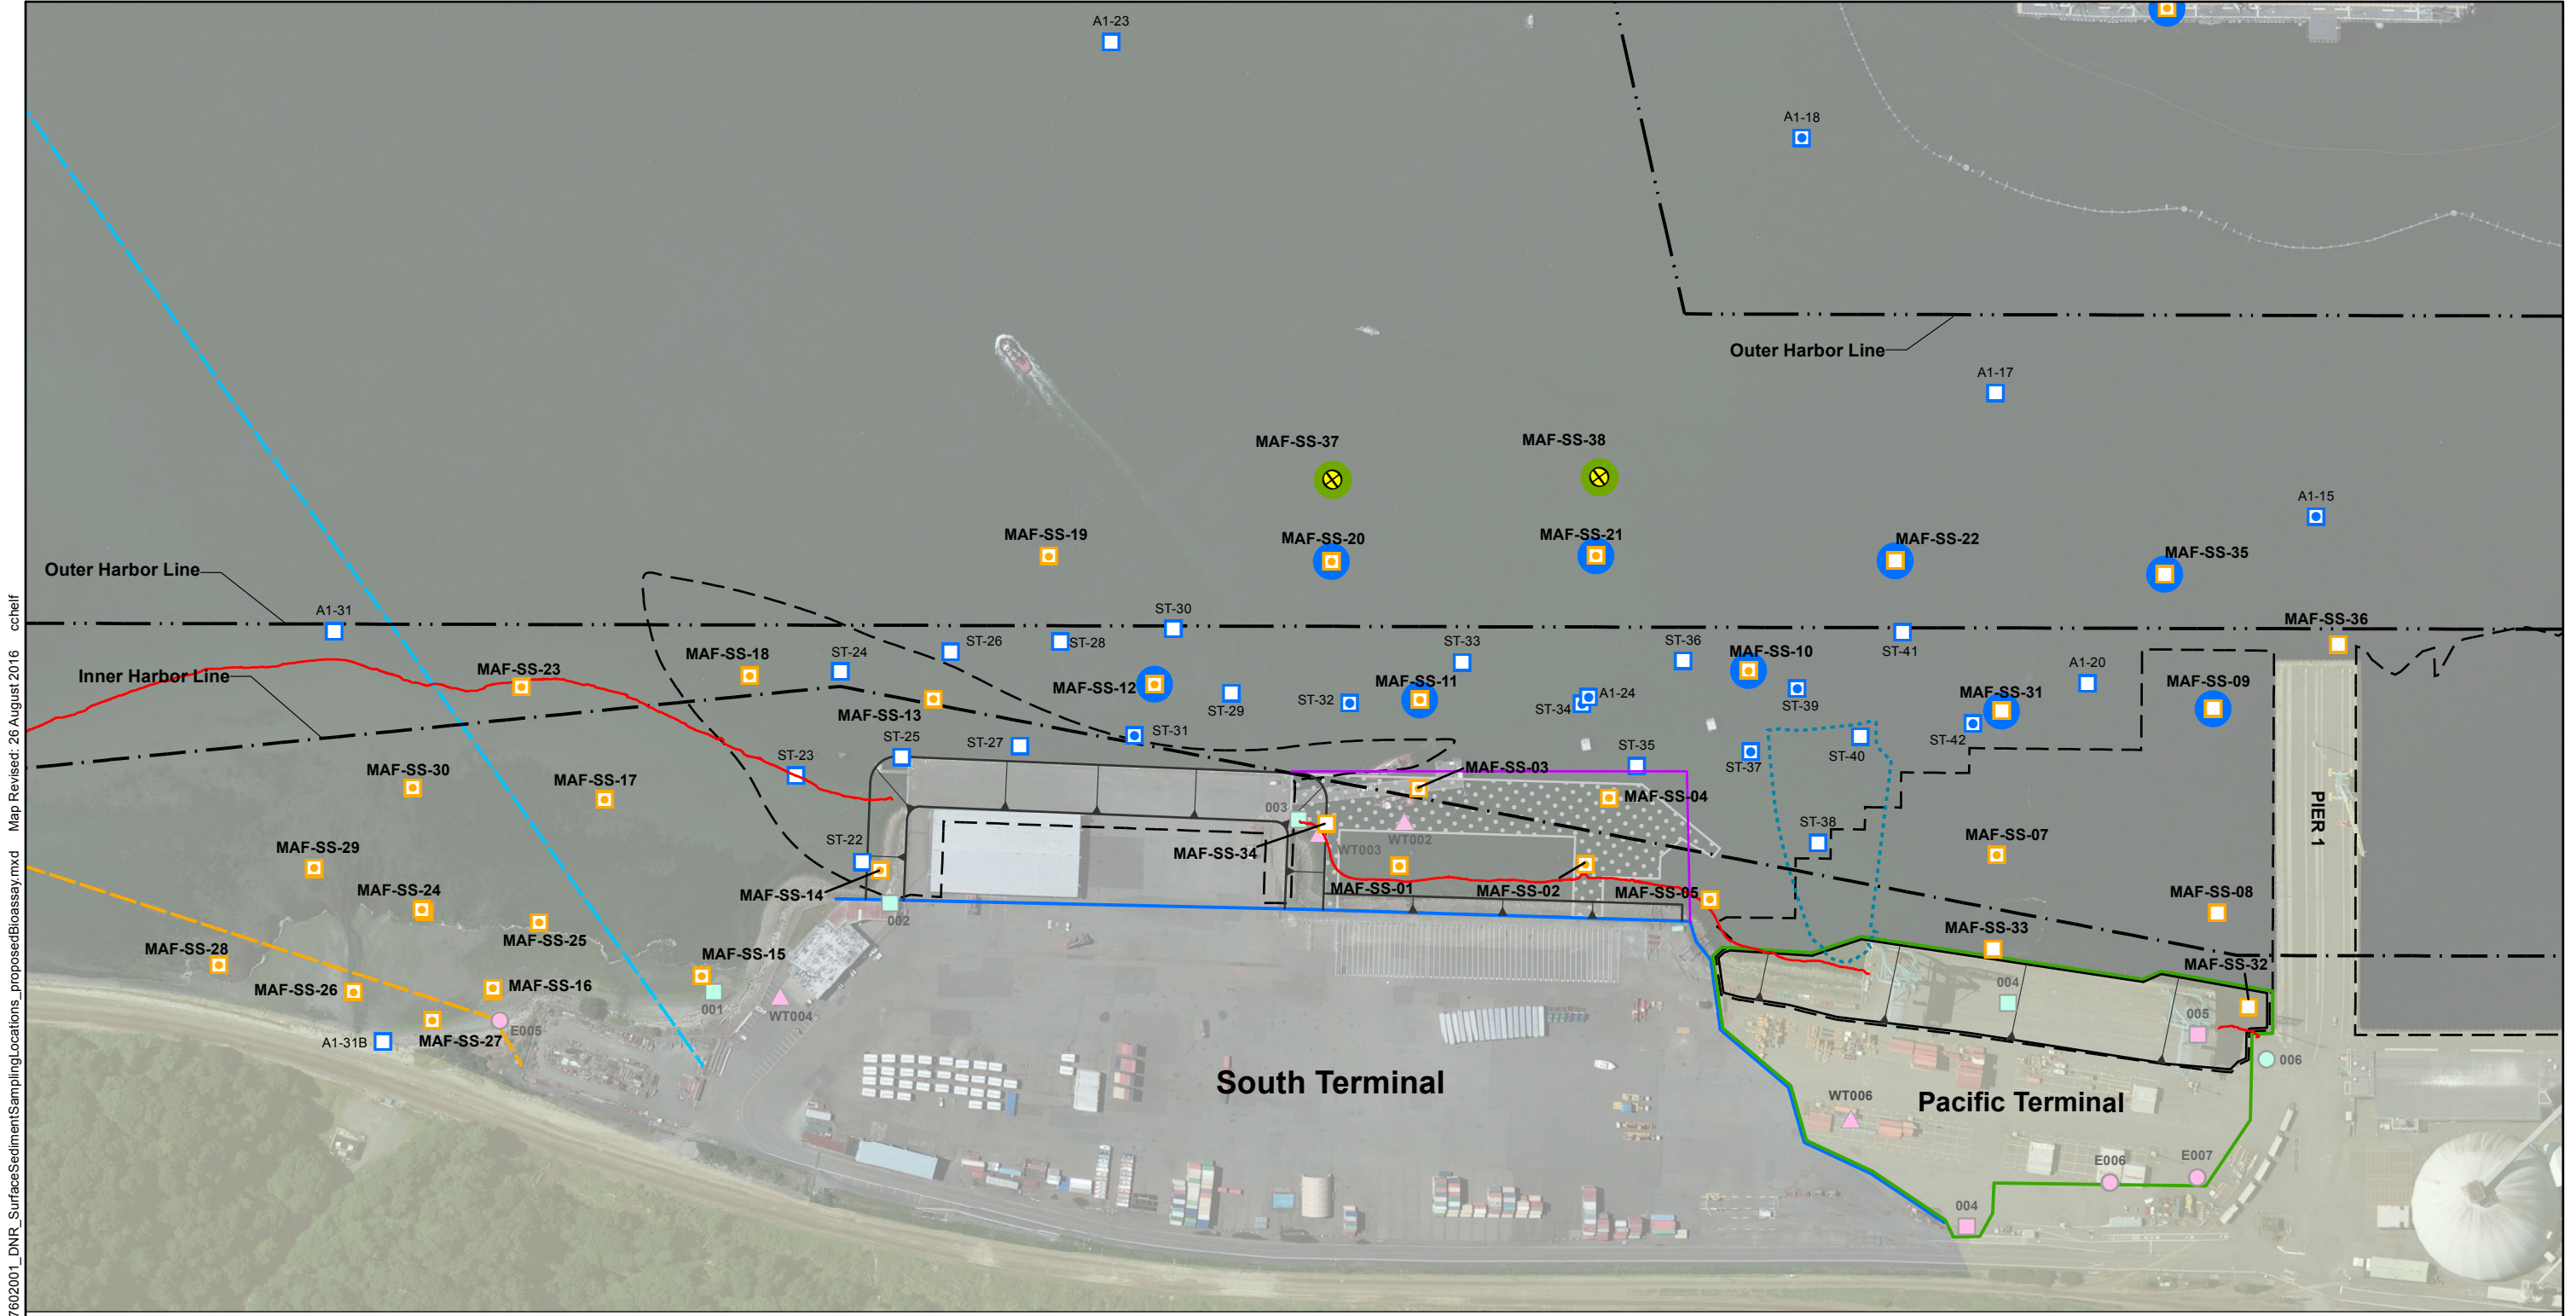
Figure 1 identifies the proposed bioassay testing locations and Table 2 provides coordinates for each sampling location and a description.

At the request of Ecology, two new surface sediment locations will be sampled (MAF-SS-37 and MAF-SS-38) northwest of MAF-SS-20 and MAF-SS-21 to further evaluate the extent of potential benthic community impacts. The two new sample locations are shown on Figure 1. These samples will be analyzed for conventional parameters and the chemical analytes that were exceeding the SMS criteria in sediment from adjacent sample locations MAF-SS-20 and MAF-SS-21. The conventional and chemical analyses will include the following:

Surface Sediment Sample Locations for Bioassay Testing and Benthic Evaluation

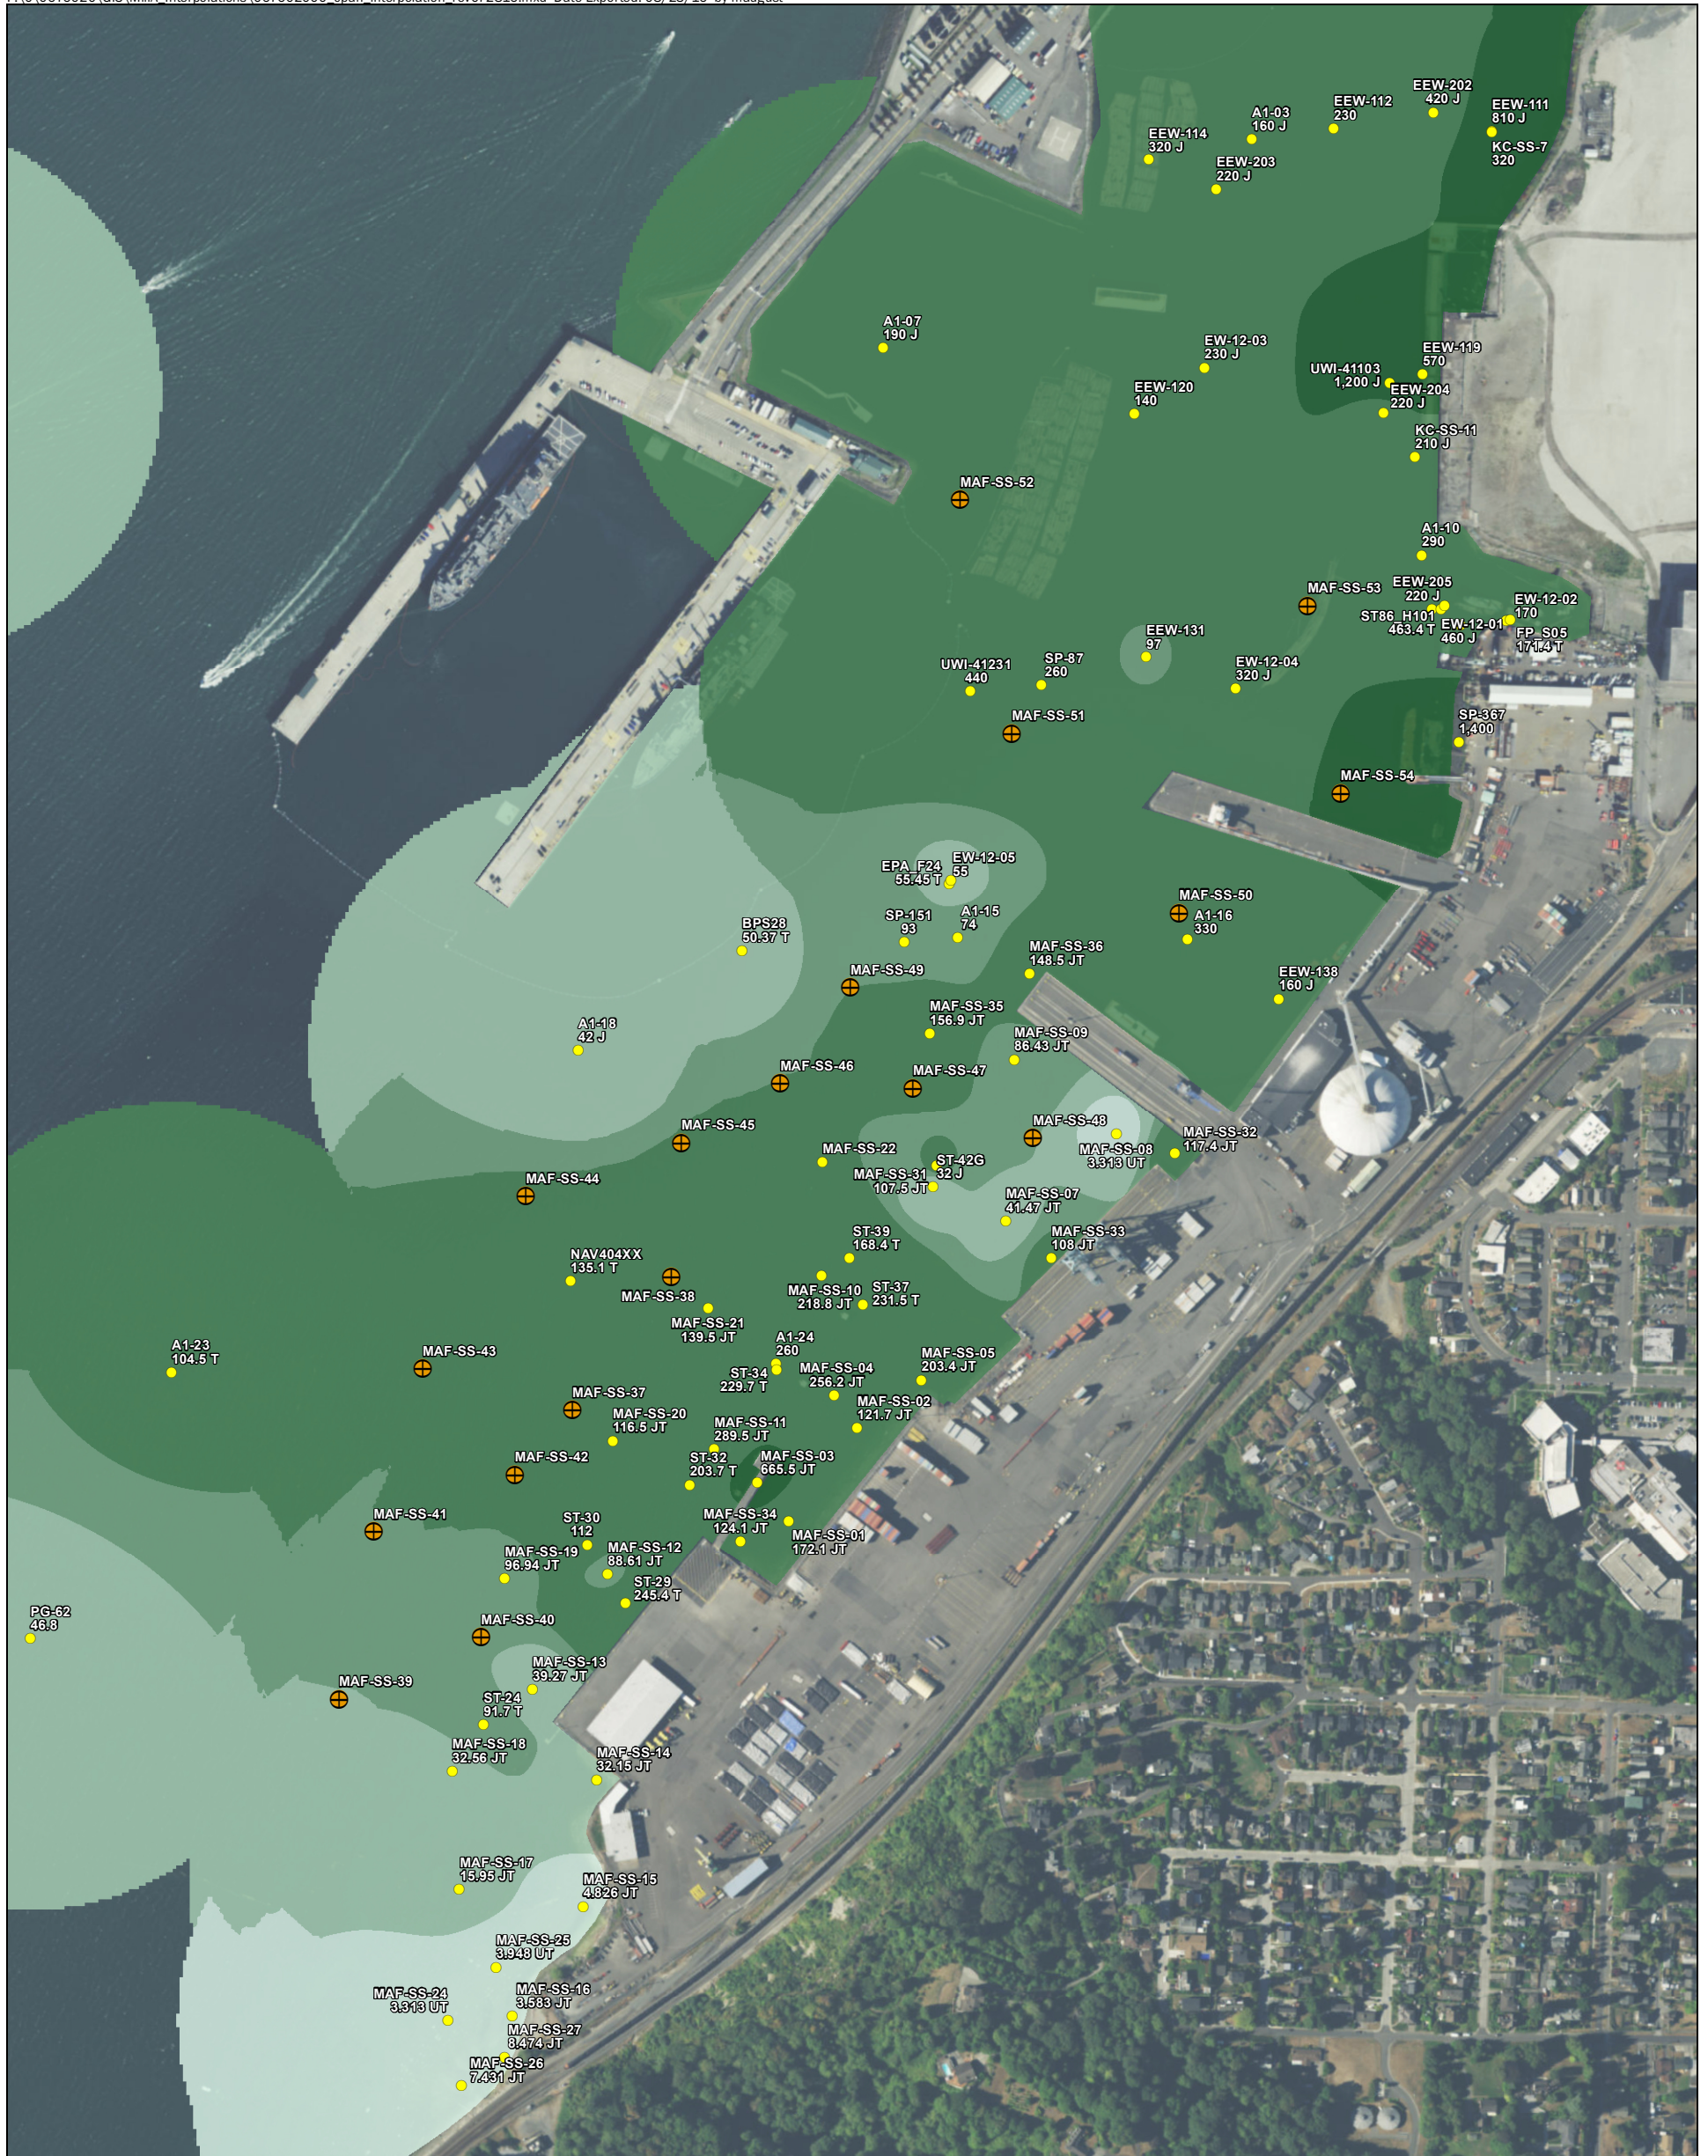
cPAH Concentrations and Proposed Sample Locations	
Former Mill A Marine Area Sediment Investigation Everett, Washington	
	Figure 2

Based on discussions with Ecology during the meeting held on July 26, 2016, it was agreed that additional surface sediment samples for cPAH analysis may help inform the boundary delineation for the Site, and between the Site and adjacent areas. A total of 18 new surface samples will be collected for cPAH analysis and potential future PAH fingerprinting analyses. The proposed sample locations are shown on Figure 2. Sampling and analysis for cPAHs will be performed in accordance with the protocols in the Marine Area SAP (GeoEngineers 2014a). A separate protocol for fingerprinting analysis will be developed if performed. The results for chemical analysis for cPAHs will be compared to bioaccumulation screening levels for protection of human health and higher trophic level species.
