### **Map 1. T-91 Phase 2 proposed and actual surface and subsurface sediment sampling locations**

Map 2. T-91 Phase 2 sampling results - all SMS

### **Map 3. T-91 Phase 2 sampling results - PAHs and SVOCs**

**Map 4. T-91 Phase 2 sampling results - total PCBs****DRAFT**

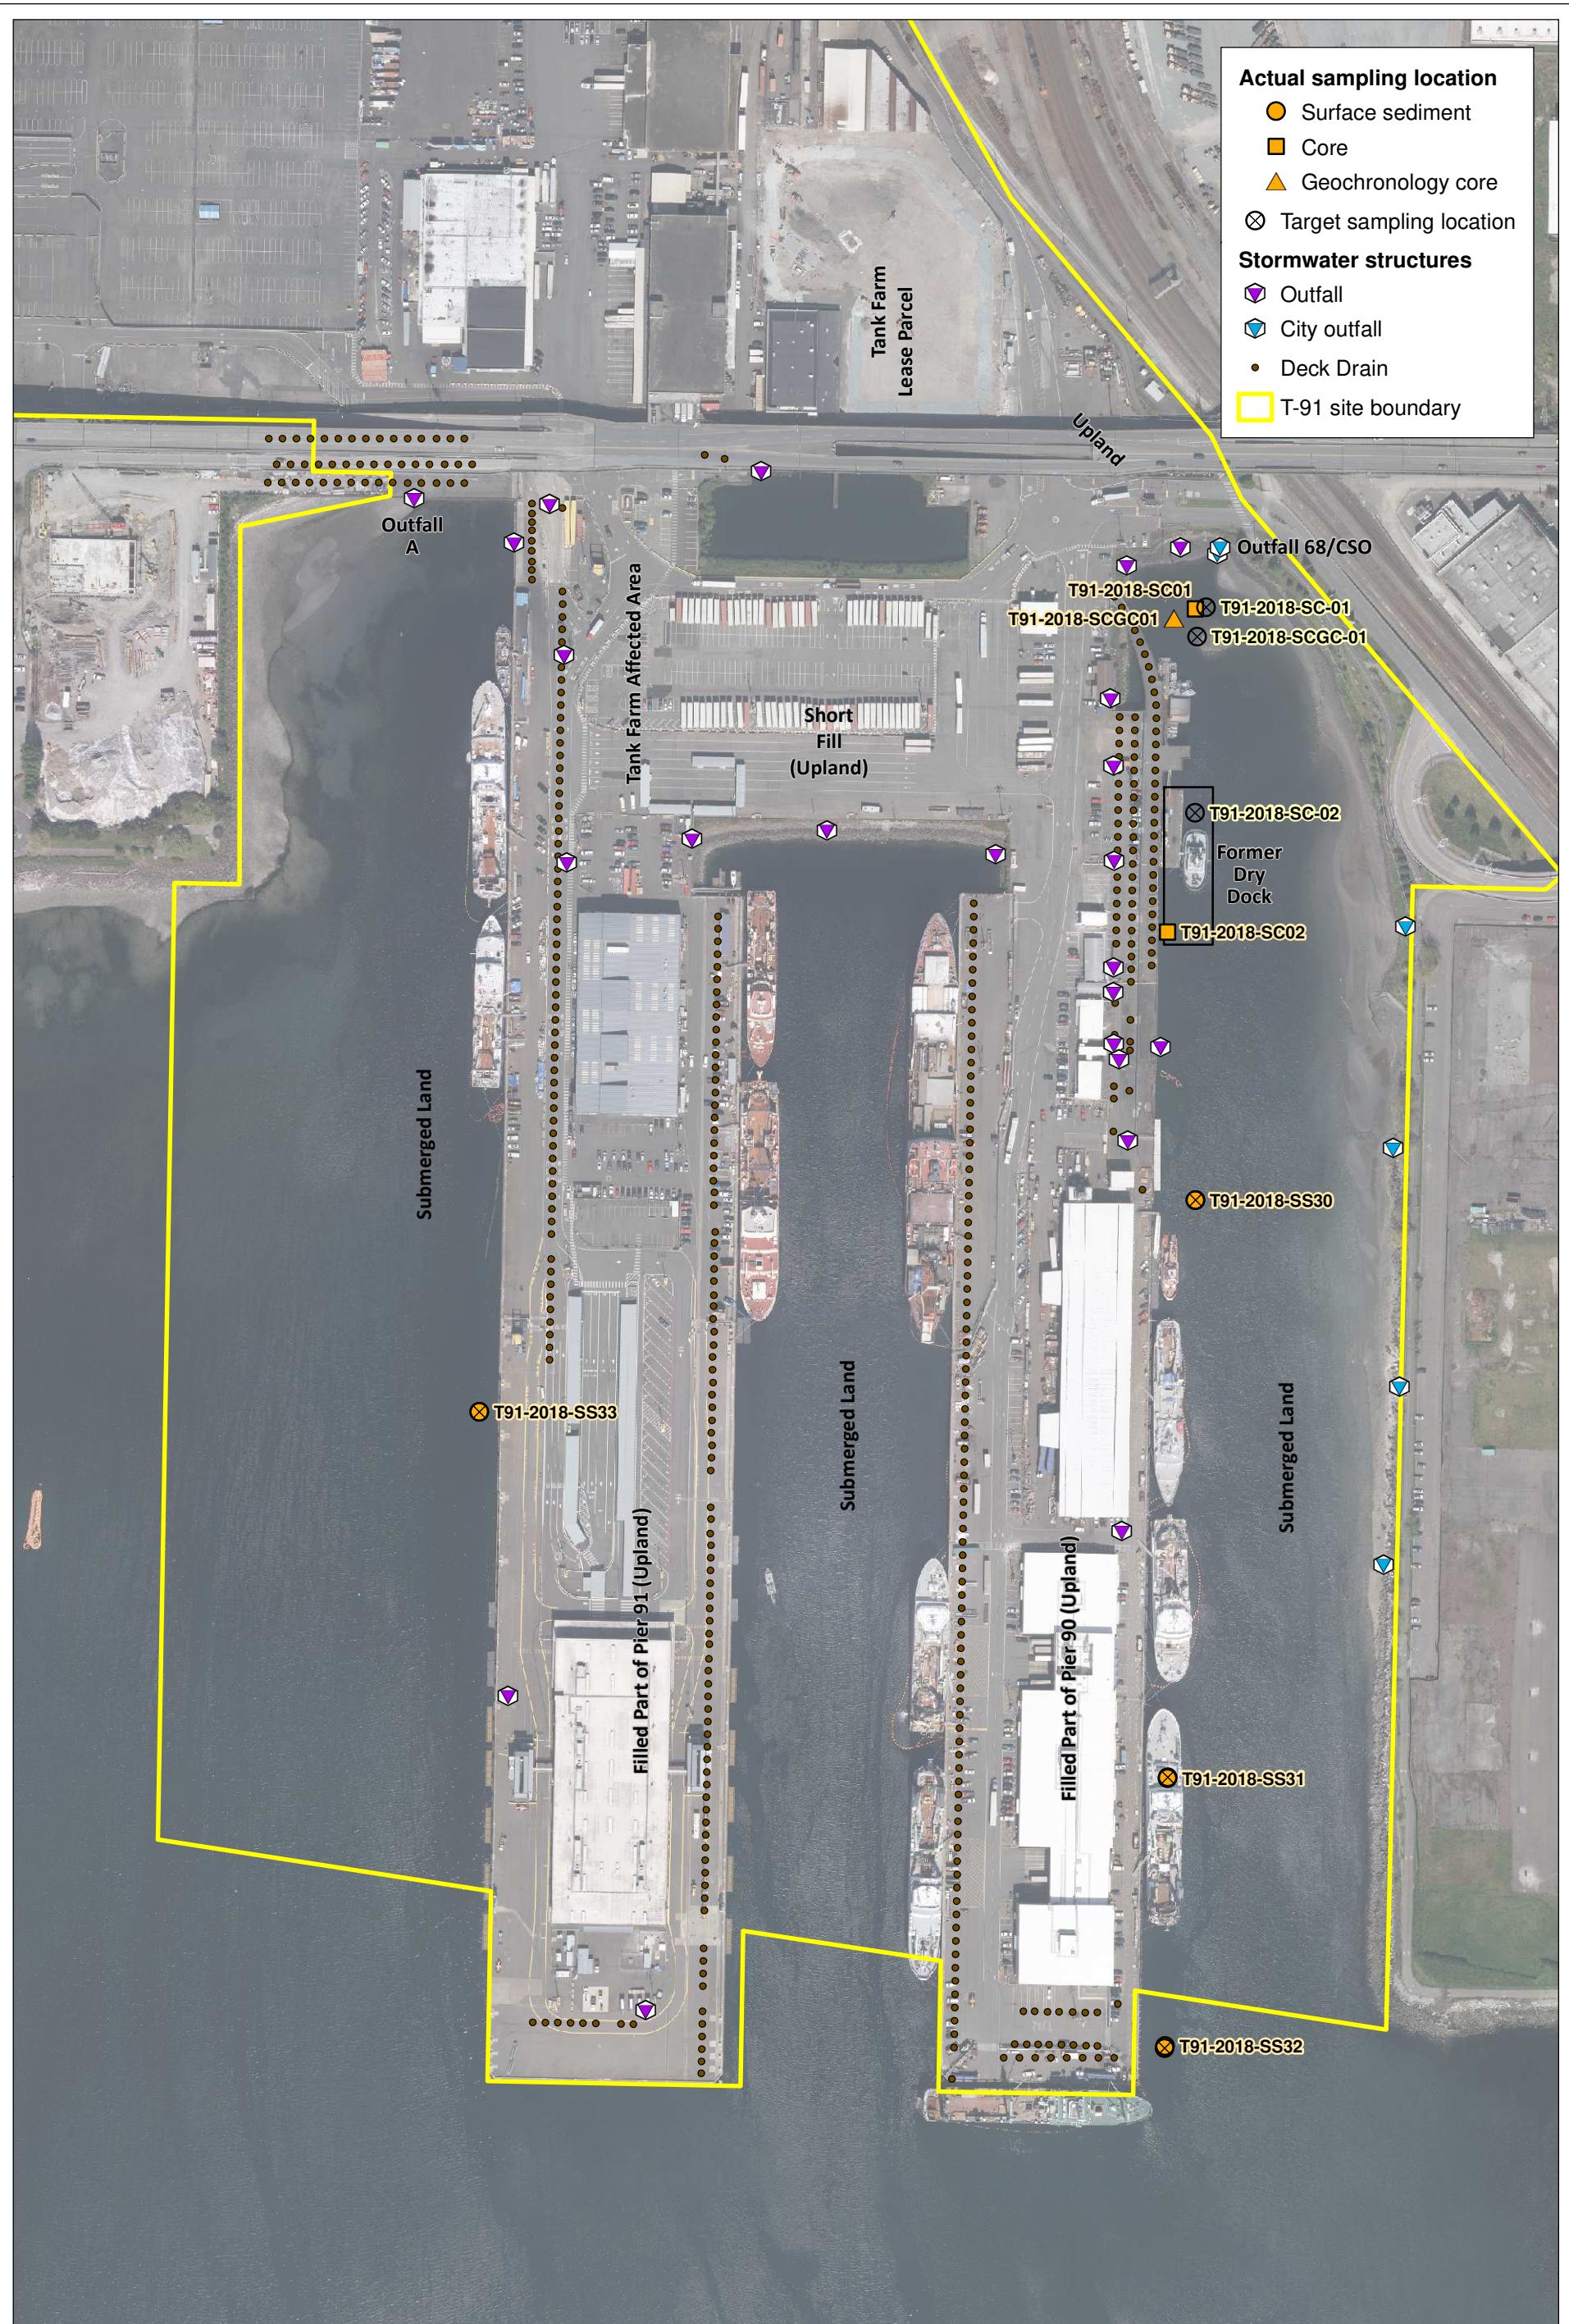
**Surface sediment SMS status**

- > CSL, detect
- > SCO and ≤ CSL, detect

**Subsurface core SMS status**

- > CSL, detect

**Stormwater structures**

- Outfall
- City outfall
- Deck Drain

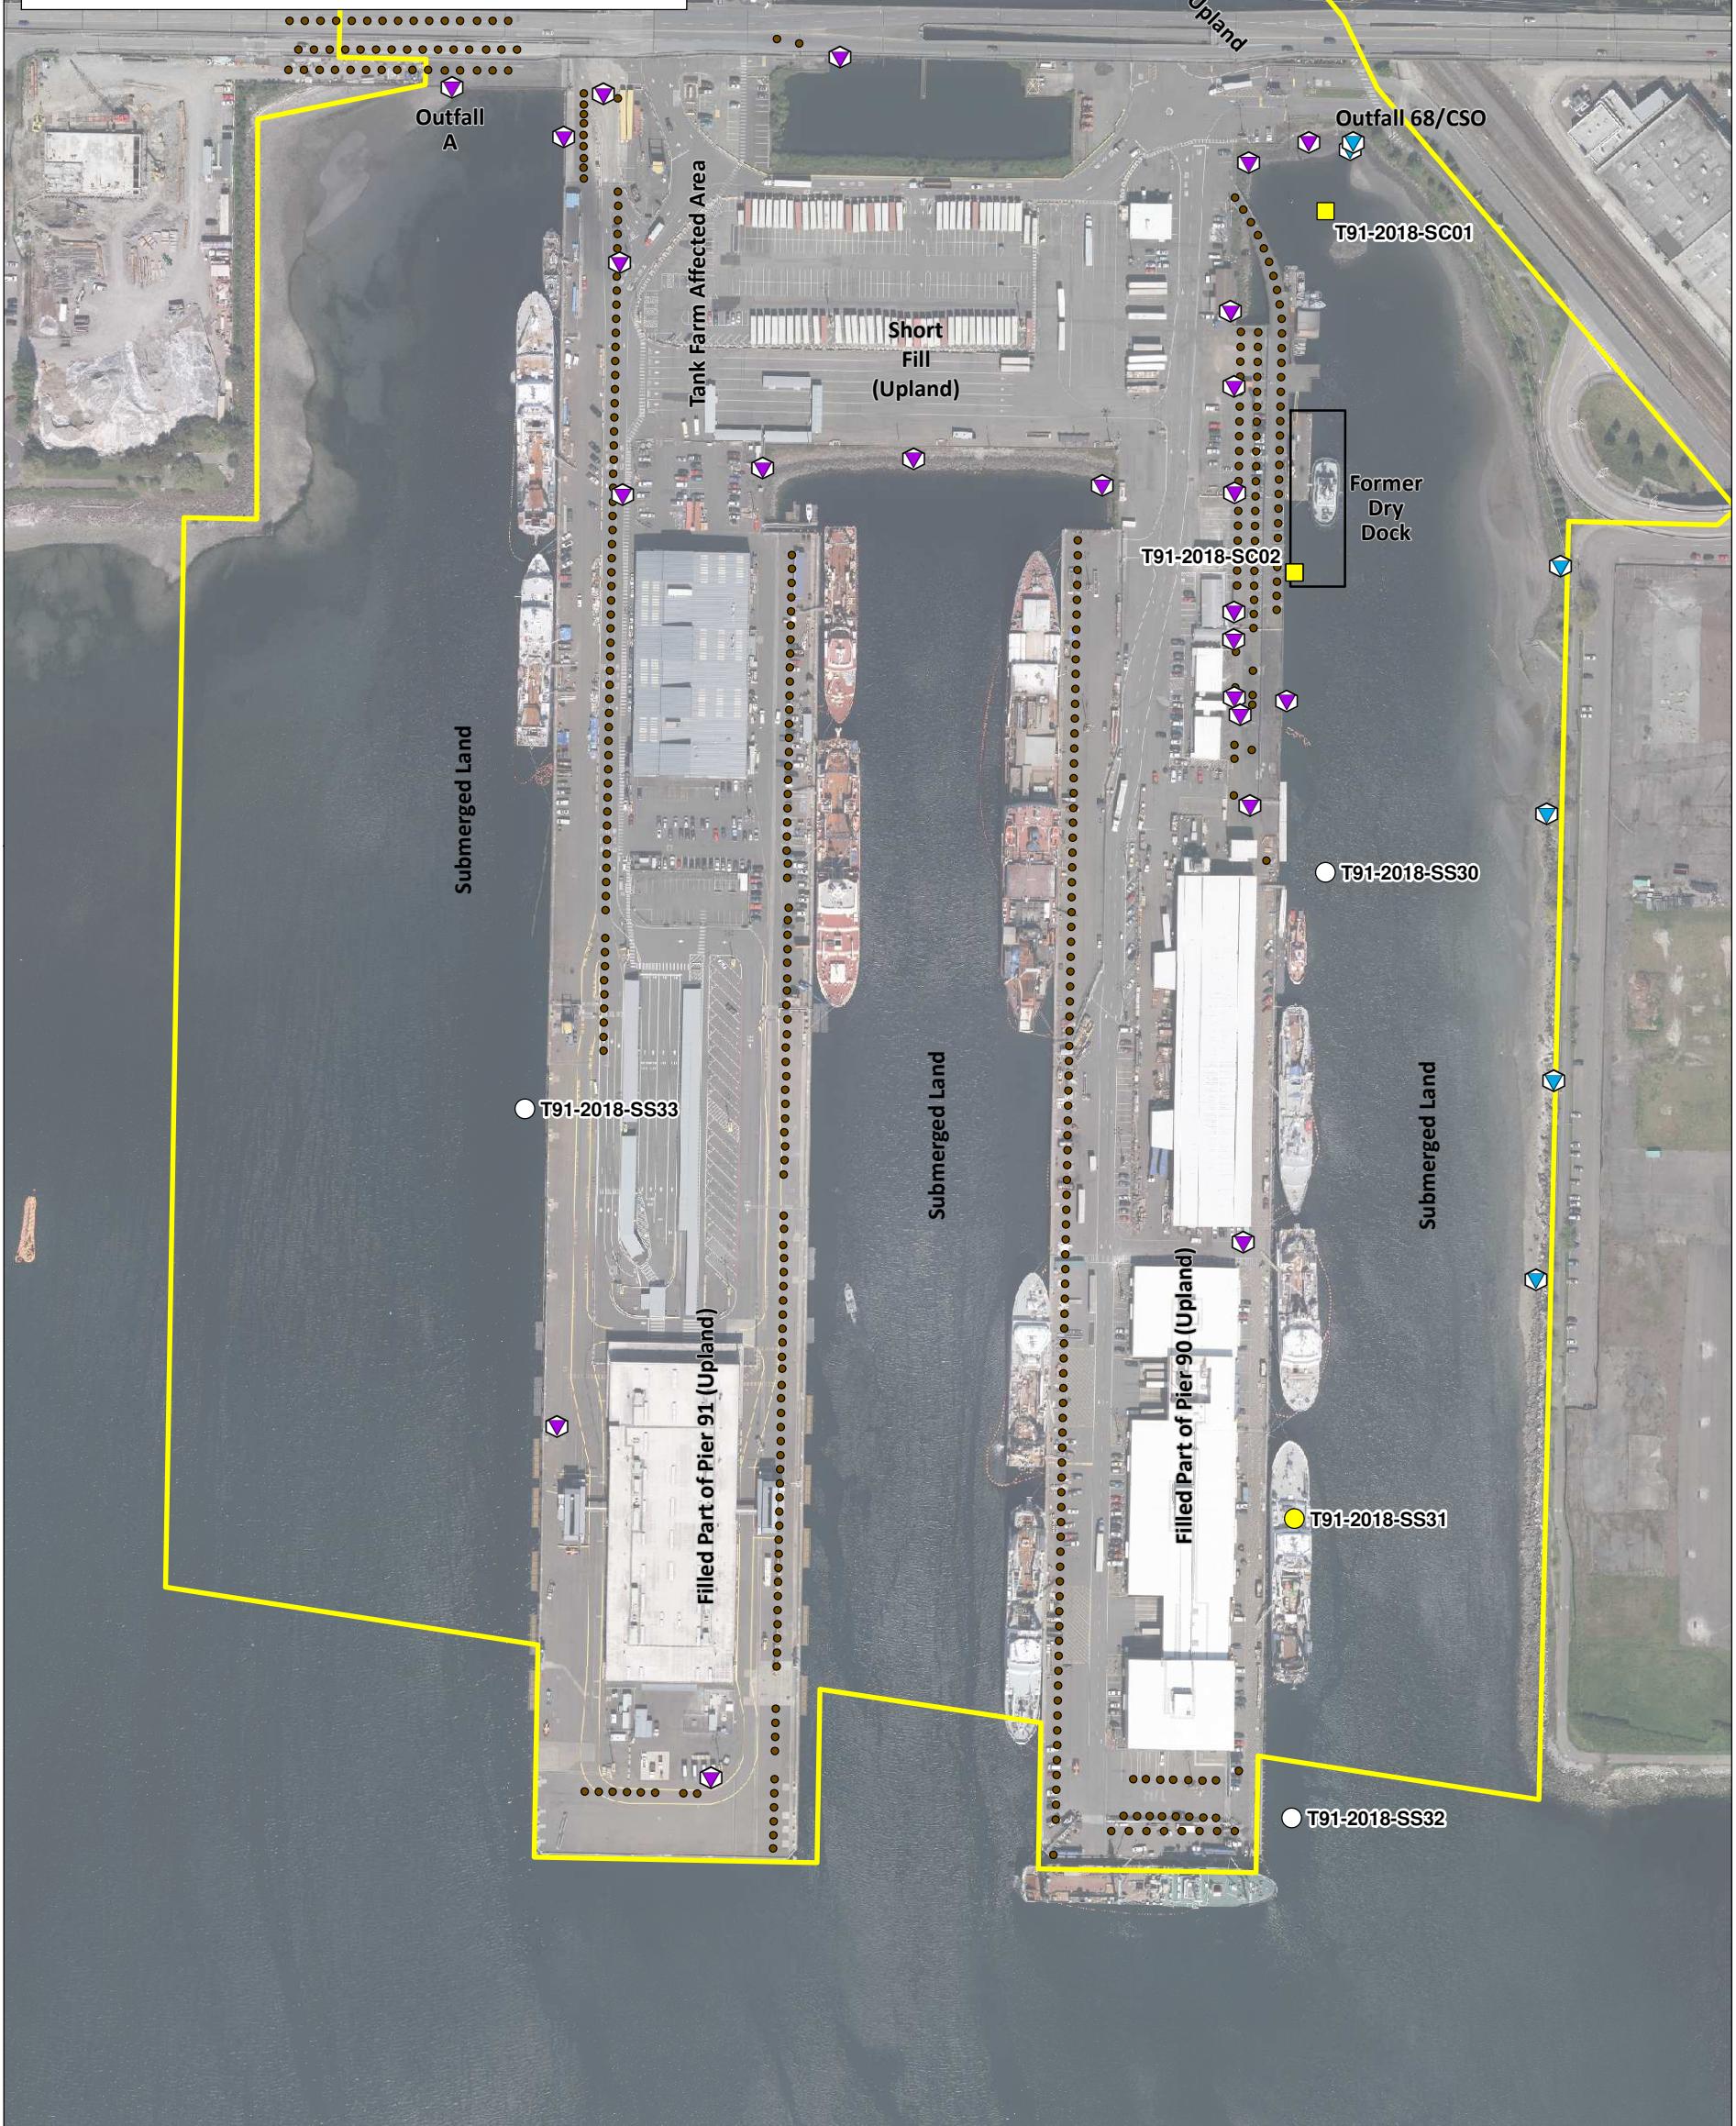
**Total PCB exceedances in surface sediment**

- > SCO and ≤ CSL, detect
- ≤ SCO, detect and non-detect

**Maximum total PCB exceedances in subsurface cores**

- > SCO and ≤ CSL, detect
