**Re: Off-Site Well Decommissioning Report
PACCAR Renton Site
Renton, Washington
1639-73**

Attachment A – Photographs of Field Activities

Photographs of Field Activities

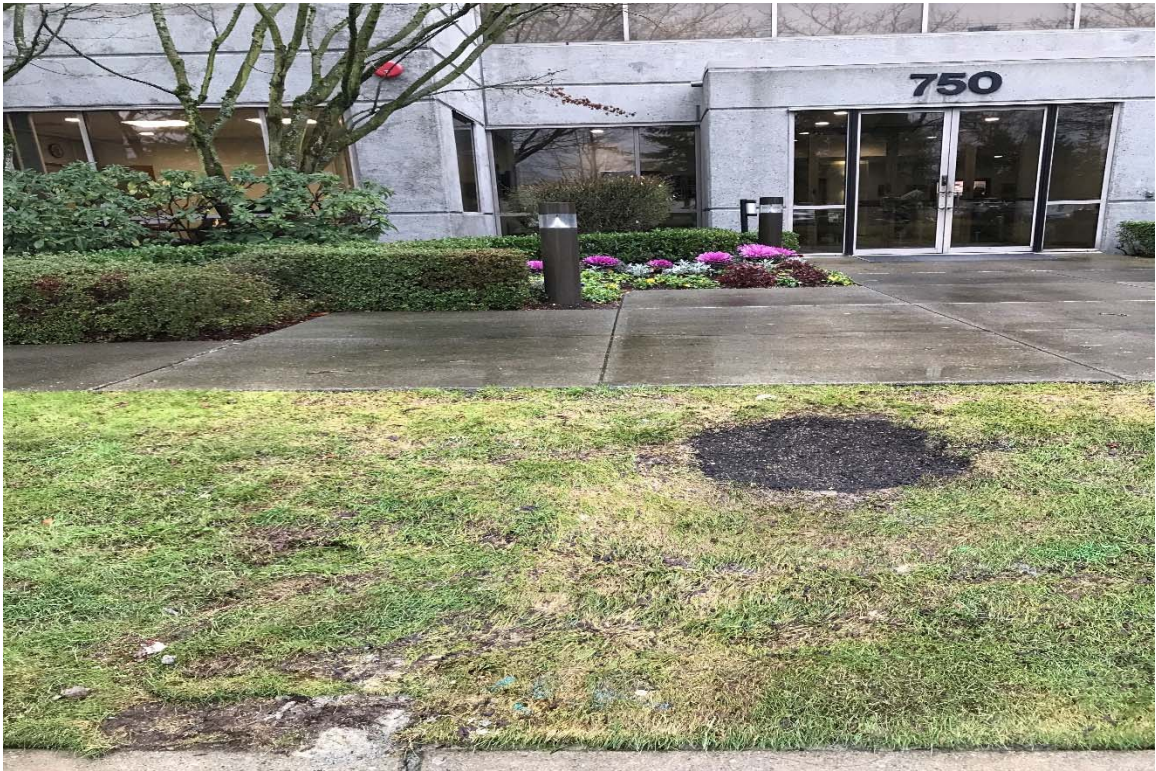
B-15D

- One well (B-15D), located on PACAAR property, should be drilled out because water under artesian pressure is leaking from top of the well. The well is in a landscaped area and was be restored to match surrounding conditions by adding top soil and reseeding with grass.

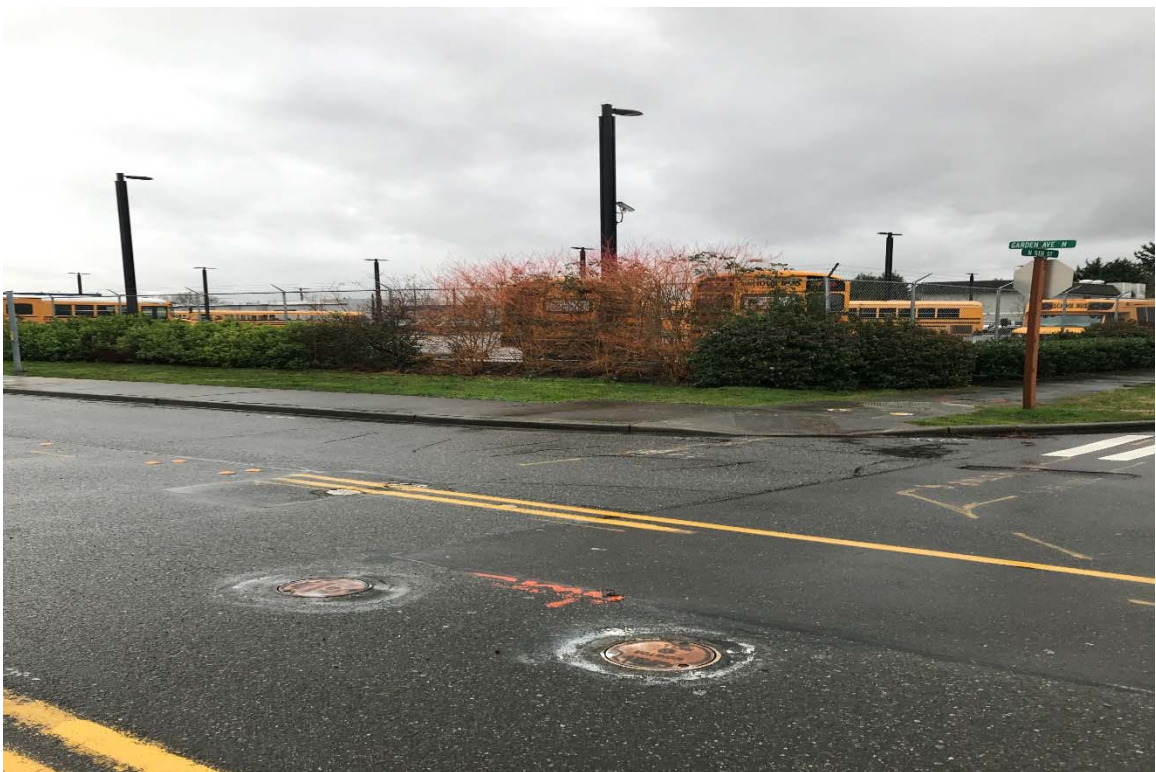
CW-2D and CW-2S

- Three wells (OSP-5D, OSP-5S, and OSP-3D), located on sidewalks within City of Renton right-of-ways, were abandoned in-place. A variance was obtained from Department of Ecology to abandon wells OSP-5D and OSP-5S in-place.
 - Two wells (CW-2D and CW-2S), located on City of Renton right-of-ways, were abandoned in-place. A variance was obtained from Department of Ecology to abandon the wells in-place.
 - Six wells (HC-4I, HC-5I, HC-6I, OSP-6D, OSP-6S and OSP-4D), located on City of Renton street right-of-ways, were decommissioned by drilling out, the monuments removed, and temporary concrete patches applied.
- Hart Crowser obtained appropriate City of Renton street use permits and provided traffic control during decommissioning activities per traffic controls plan following City of Renton standards.

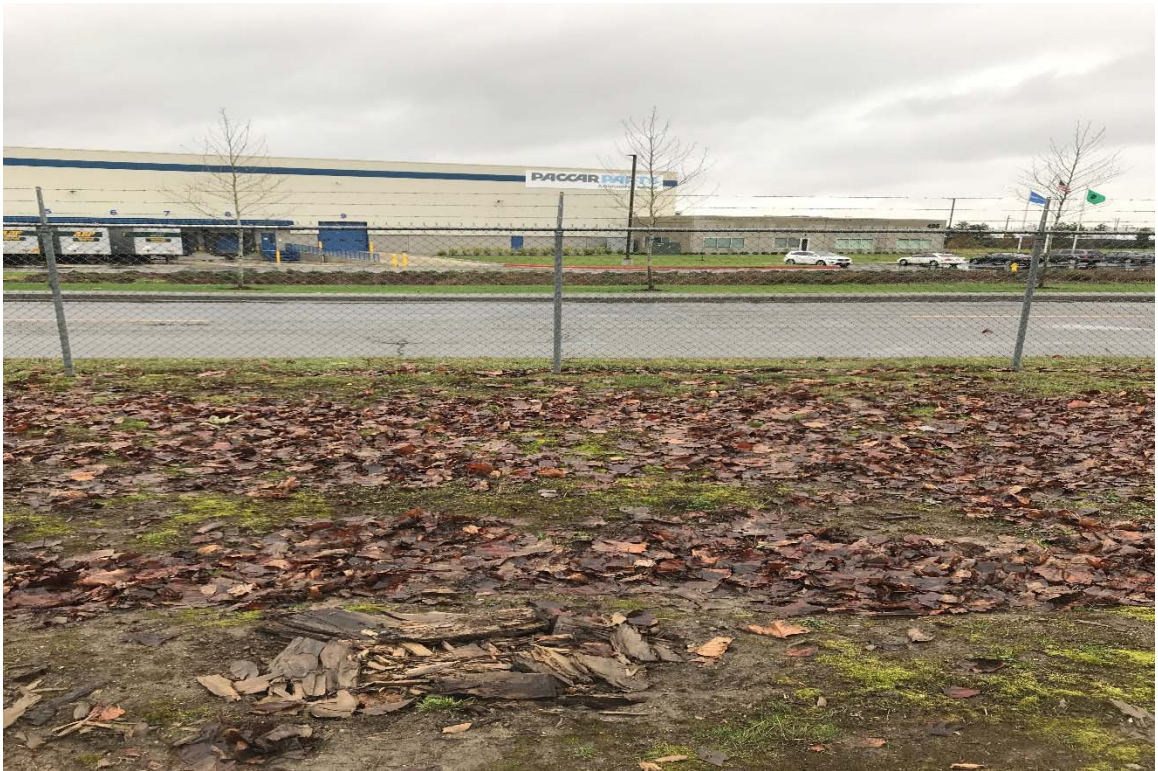
OSP-8D

- Filled the casing with hydrated bentonite.
- The drilling contractor decommissioned 17 wells using the following procedures:
 - Two wells (OSP-9D and OSP-8D) with legal wells logs were abandoned in-place. Borehole (OSP-9D), located in a parking lot, was repaired with a concrete patch. Borehole (OSP-8D) is in a landscaped area which was restored to match surrounding conditions by adding top soil and reseeding with grass.

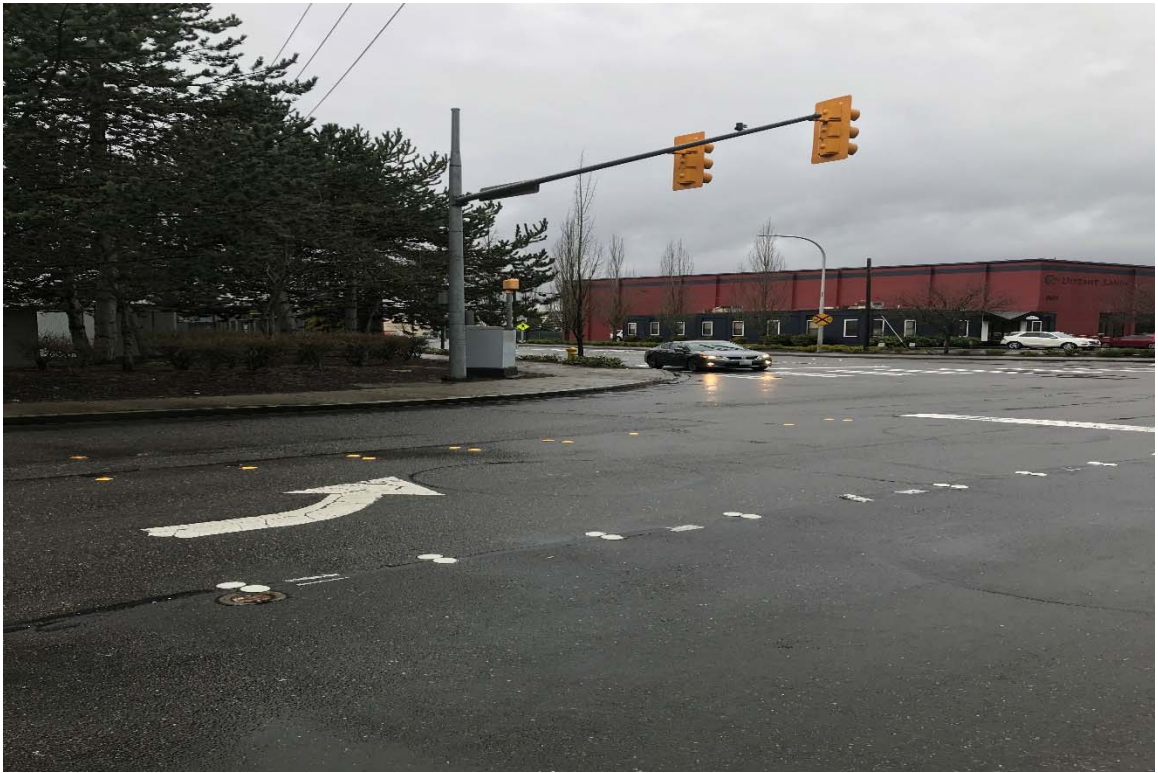
OSP-13D

- One well (OSP-13D), with legal wells log and located in City right-of-way, was abandoned in-place. After filling the casing with bentonite, the monument was left in-place.
