INITIAL INVESTIGATION FIELD REPORT

<u>Site Name (Name over door):</u> Montlake Texaco	<u>Site Address (including City, State and Zip):</u> 2625 E Montlake Place E Seattle, WA 98112	<u>Phone</u> <u>Email</u>
<u>Site Contact, Title, Business:</u> Denise Cieri, SR 520 Program Administrator, Washington State Dept. of Transportation	<u>Site Contact Address (including City, State and Zip):</u> 999 3rd Ave, Suite 2200 Seattle, WA 98104	<u>Phone</u> (206) 770-3591 <u>Email</u> cierid@wsdot.wa.gov
<u>Site Owner, Title, Business:</u> Kemper Development Company	<u>Site Owner Address (including City, State and Zip):</u> 575 Bellevue Square Bellevue, WA 98004	<u>Phone</u> (425) 646-3660 <u>Email</u>
<u>Site Owner Contact, Title, Business:</u> Scott Baker Owner, Montlake Texaco	<u>Site Owner Contact Address (including City, State and Zip):</u> 2625 E Montlake Place E Seattle, WA 98112	<u>Phone</u> (425) 417-3802 <u>Email</u>
<u>Previous Site Owner(s):</u>	<u>Additional Info (for any Site Information Item):</u> ERTS documentation was submitted to Ecology by Washington State Department of Transportation (WSDOT), which is pursuing purchase of this property. WSDOT provided the sampling report to th

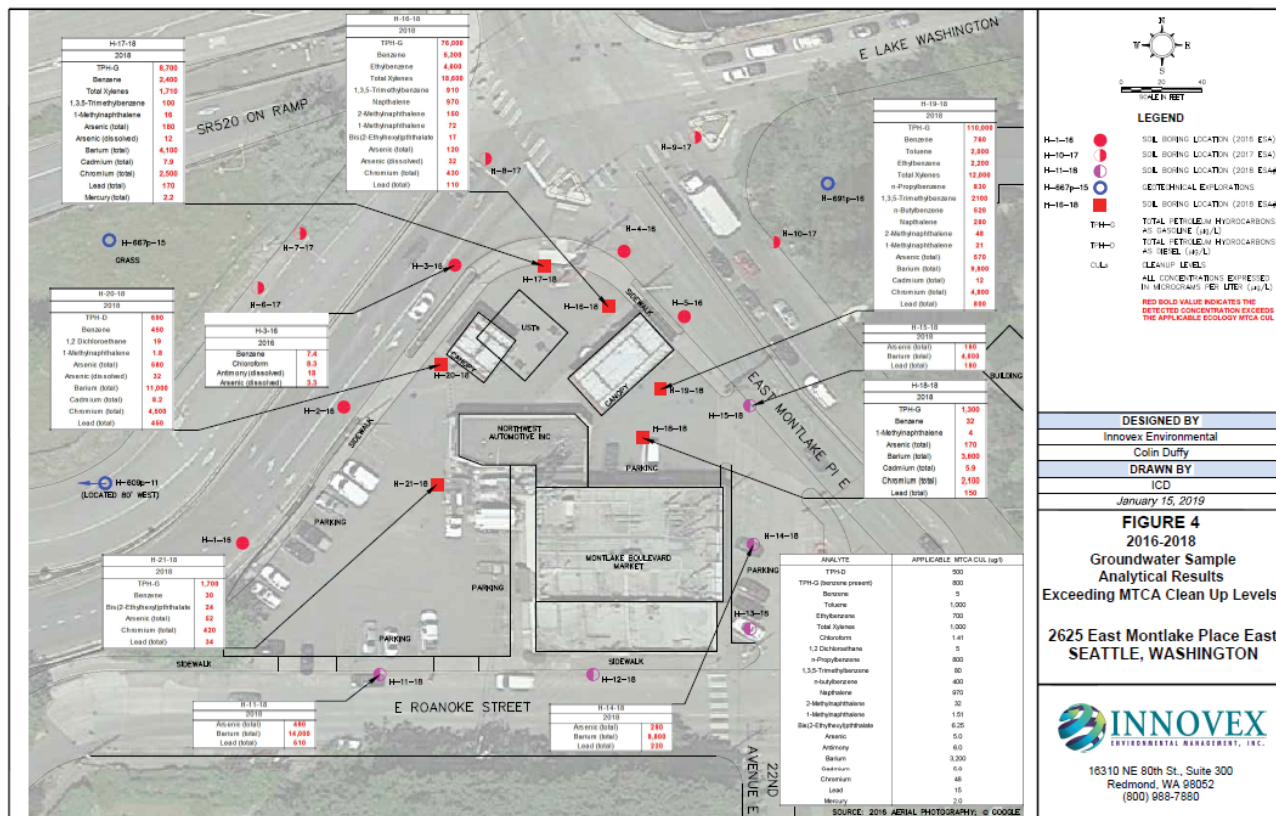
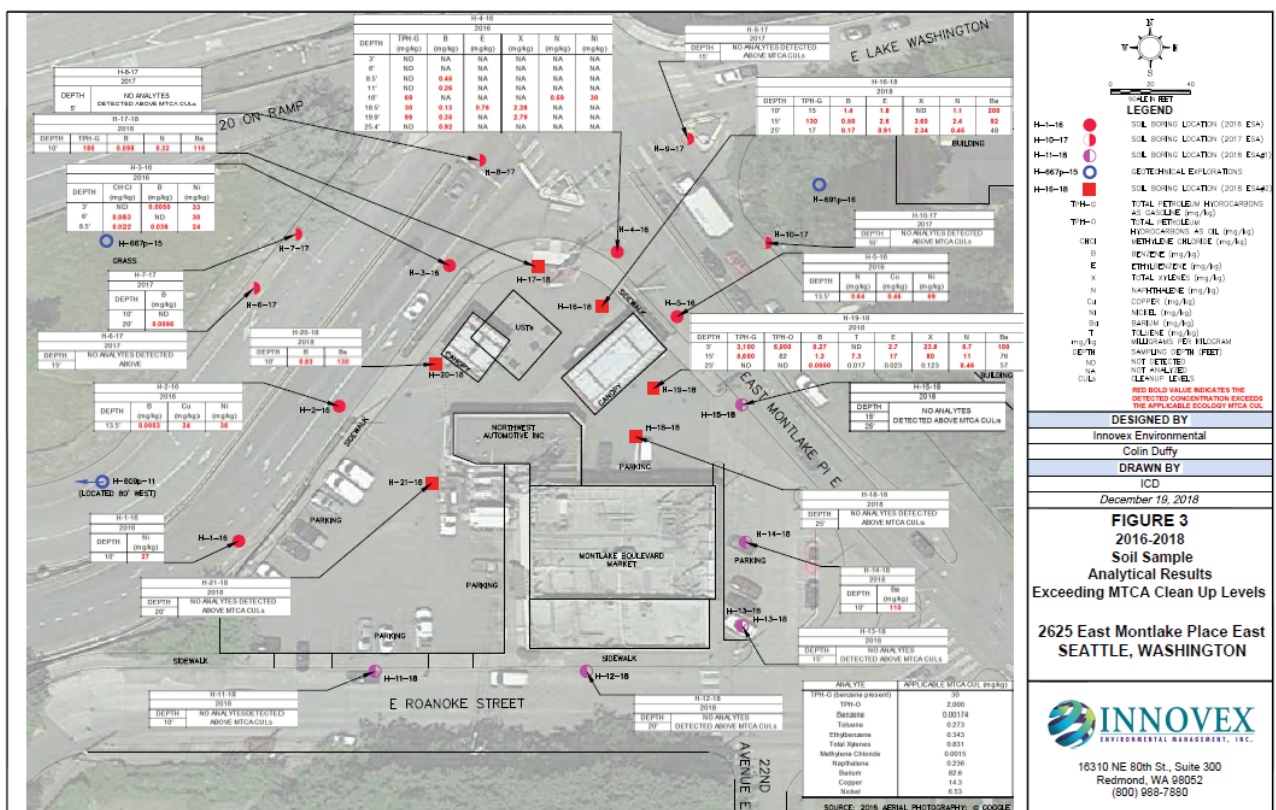
Additional or Supplemental Information from Observations Page

Description (If site visit made, please be sure to include the following: site observations, site features and cover, chronology of events, sources/past practices likely responsible for contamination, presence of water supply wells and other potential exposure pathways, etc.): See Supplemental Page for map of contaminant concentrations in groundwater.

See the Supplemental Page at the end of this report for maps showing sample locations and laboratory results.
