PERIODIC REVIEW REPORT FINAL

**Birds Eye Foods
Facility Site ID#: 1328
Cleanup Site ID#: 5012**

**3303 South 35th Street
Tacoma, Washington 98409**

February 2019

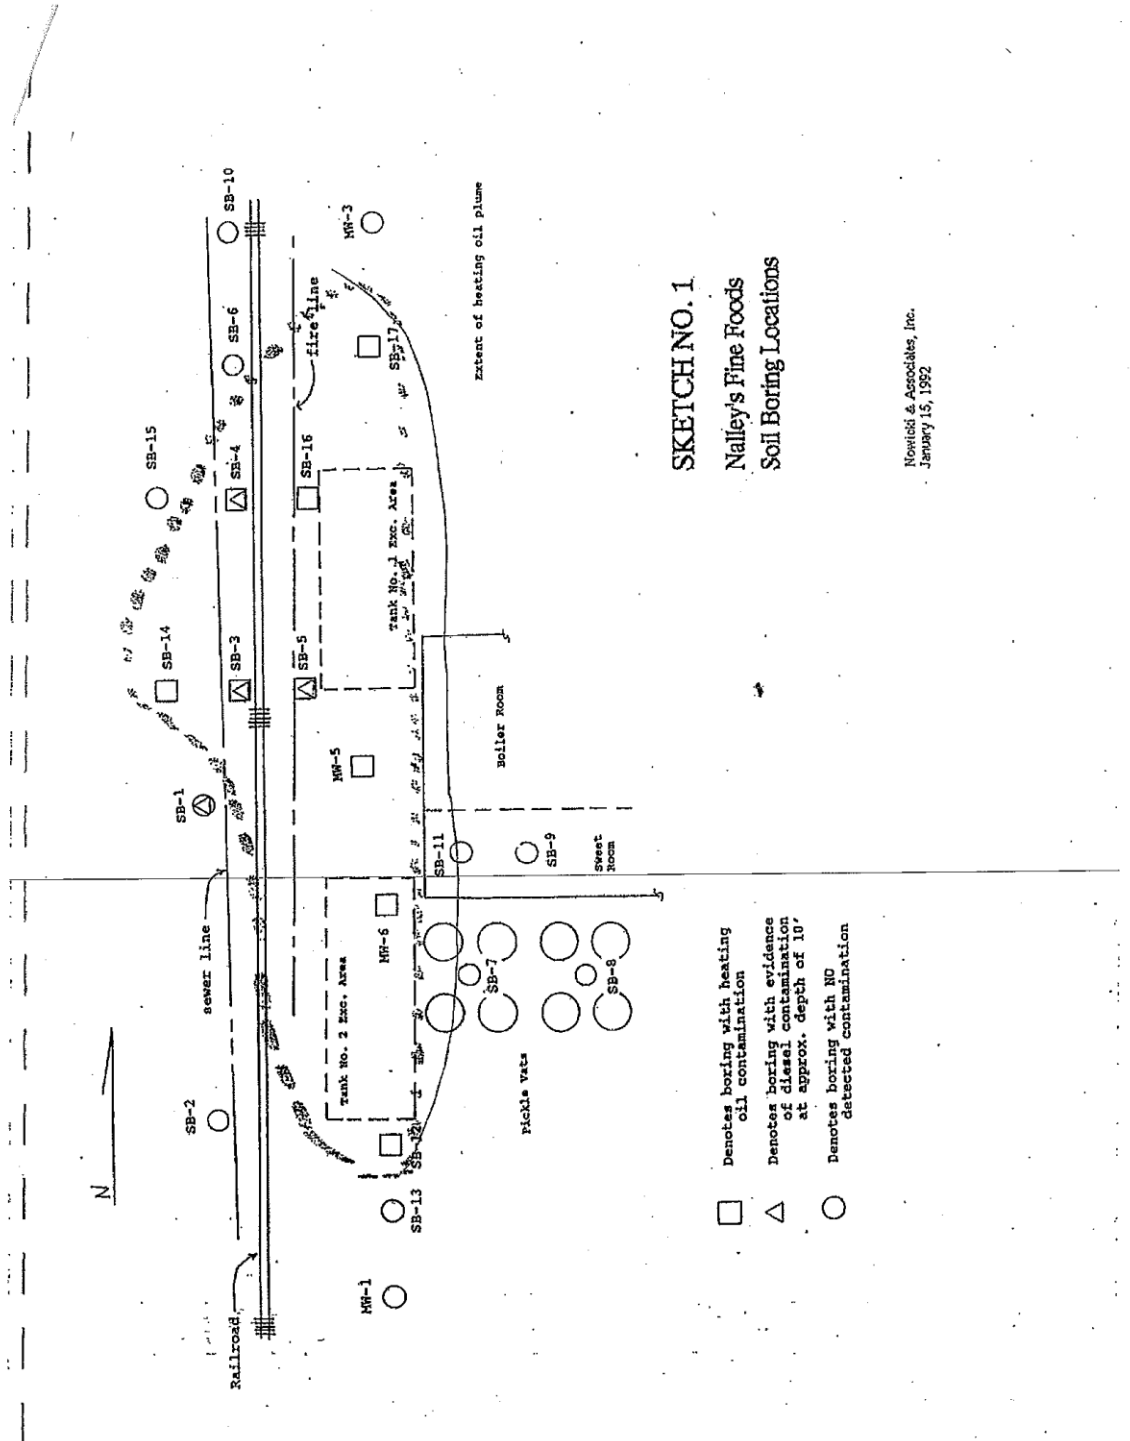
6.5 Nowicki & Associates 1991/1992 Soil Boring Locations and Soil Sample Results

A total of eighteen soil borings was advanced to depths of 25 feet to 31 feet, six new monitoring wells were installed (MW-7 through MW-11, and MW-4D), and six piezometers were installed. Based on field screening selected soil samples were collected from the soil and monitoring well boreholes for laboratory analysis of TPH (EPA 418.1); hydrocarbon scan for gasoline, diesel, and oil (modified EPA Method 8015); BTEX; polycyclic aromatic hydrocarbons (PAHs, Methods 3430/8310); and total lead (EPA Method 6010). The results indicated detections of TPH (10 mg/kg to 15,000 mg/kg), and in concentrations in excess of 2011 MTCA Method A Industrial cleanup levels of diesel (TPH-D: 3,900 mg/kg to 28,000 mg/kg), benzene (0.04 mg/kg to 1.4 mg/kg), ethylbenzene (11 mg/kg), and xylenes (12 mg/kg to 41 mg/kg). These TPH-D, benzene, ethylbenzene, and xylenes concentrations exceeded the 2011 MTCA Method A cleanup levels of 2,000 mg/kg, 0.03 mg/kg, 6 mg/kg, and 9 mg/kg, respectively. Soil boring locations and soil sample results are available as Appendix 6.5.

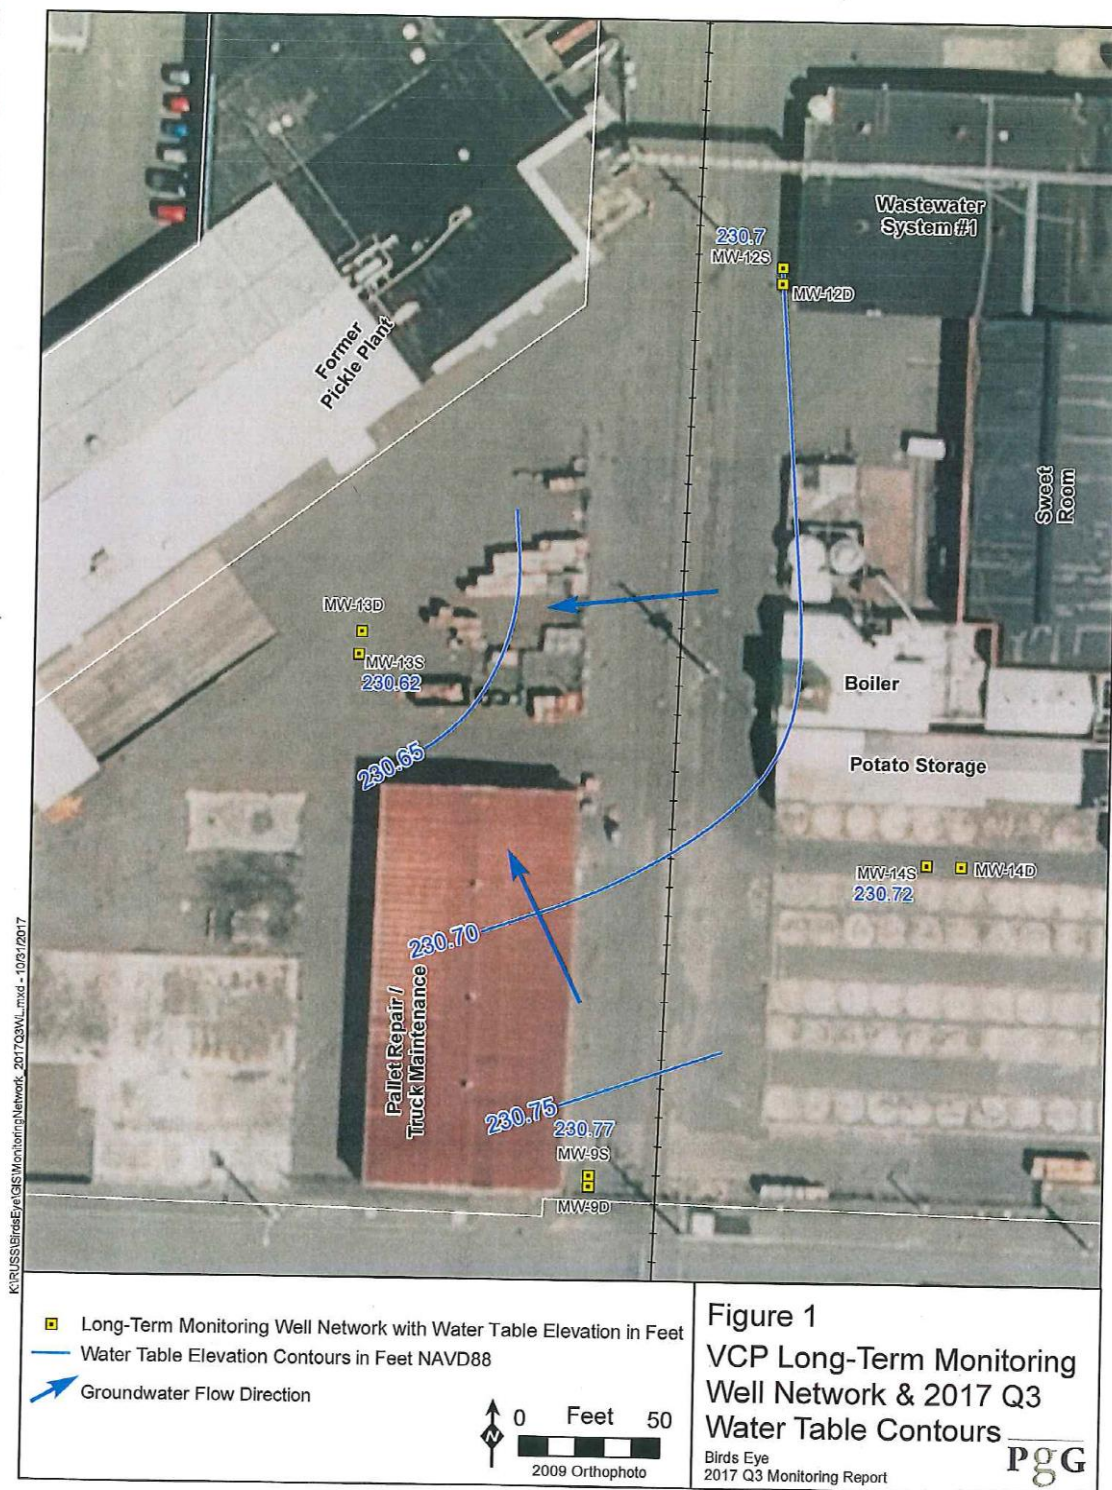
6.8 Long Term Groundwater Monitoring Well Locations and Groundwater Sample Results

Since 2012, a total of seven rounds (four rounds quarterly and three events at an 18-month interval) of groundwater monitoring has been conducted at the Site in accordance with the preferred remedy. The latest groundwater sampling was conducted in September 2017. All the groundwater samples were analyzed for the same parameters as stated above and contaminant concentrations were all below the laboratory detection limits. Since the contaminated soil is left-in-place at the Site, the groundwater monitoring program will be continued at the Site. The groundwater monitoring well locations and the latest sampling results are included as Appendix 6.8.

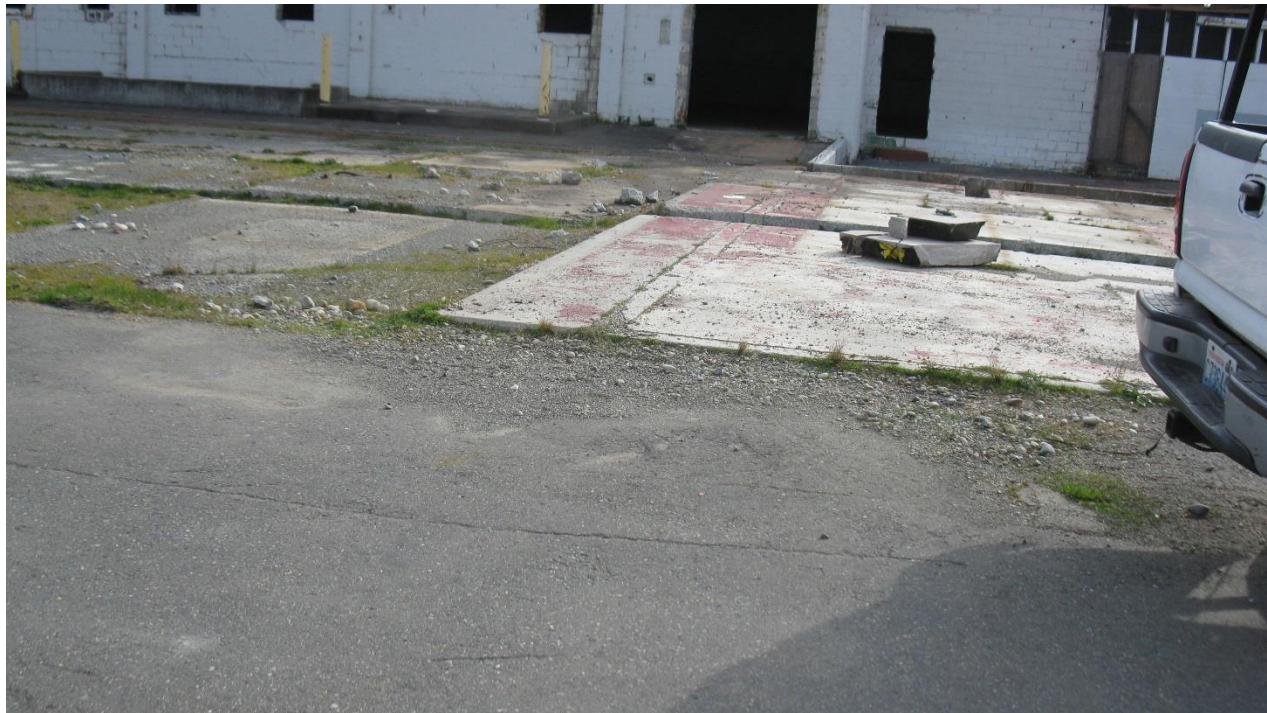
**Photo 1: Pervious Underground Storage Tanks Location and Boiler Building
- from the West**

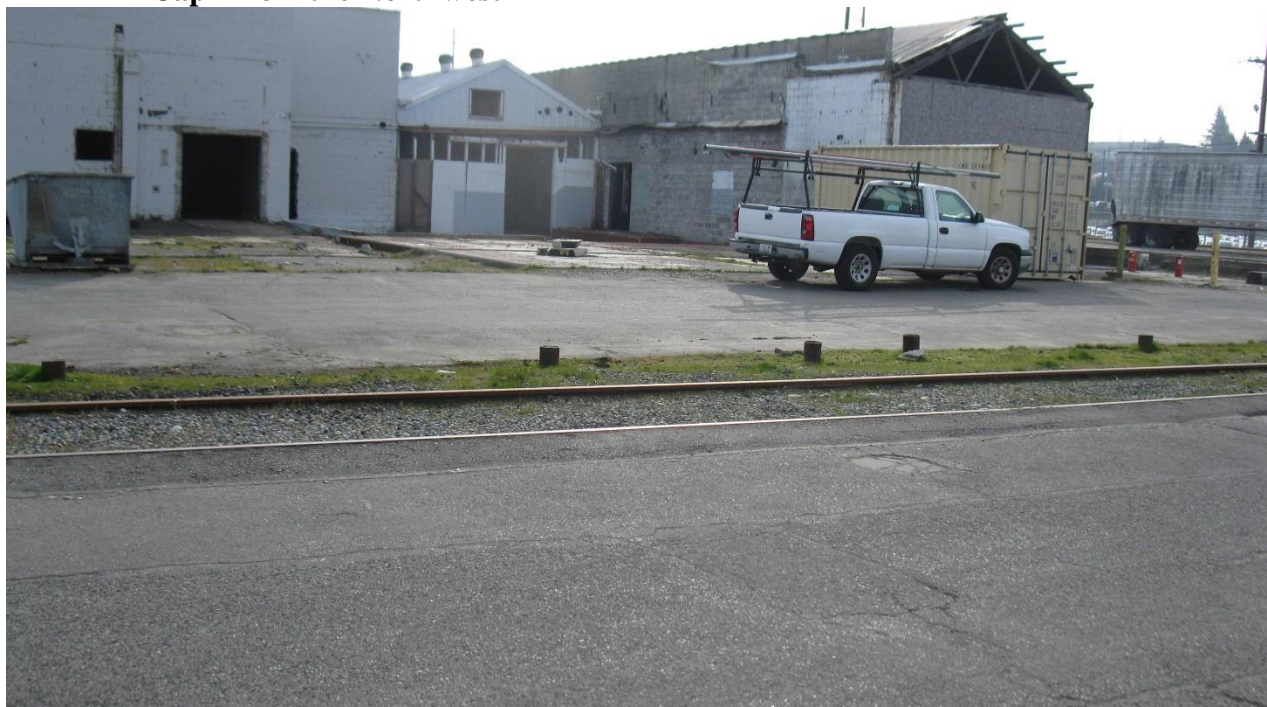
Based upon the Site visit conducted on March 21, 2018, the asphalt pavement continues to provide an adequate barrier to direct exposure pathways (ingestion, direct contact) to the contaminated soils. The asphalt pavement is in satisfactory condition and no repair, maintenance or contingency actions are required at this time. Currently the Site is occupied by empty buildings and open asphalt pavement. A photo log is available as Appendix 6.10.

Photo 2: Boiler and Potato Warehouse Buildings Area of Soil Contamination and Asphalt Cap - from the Northwest

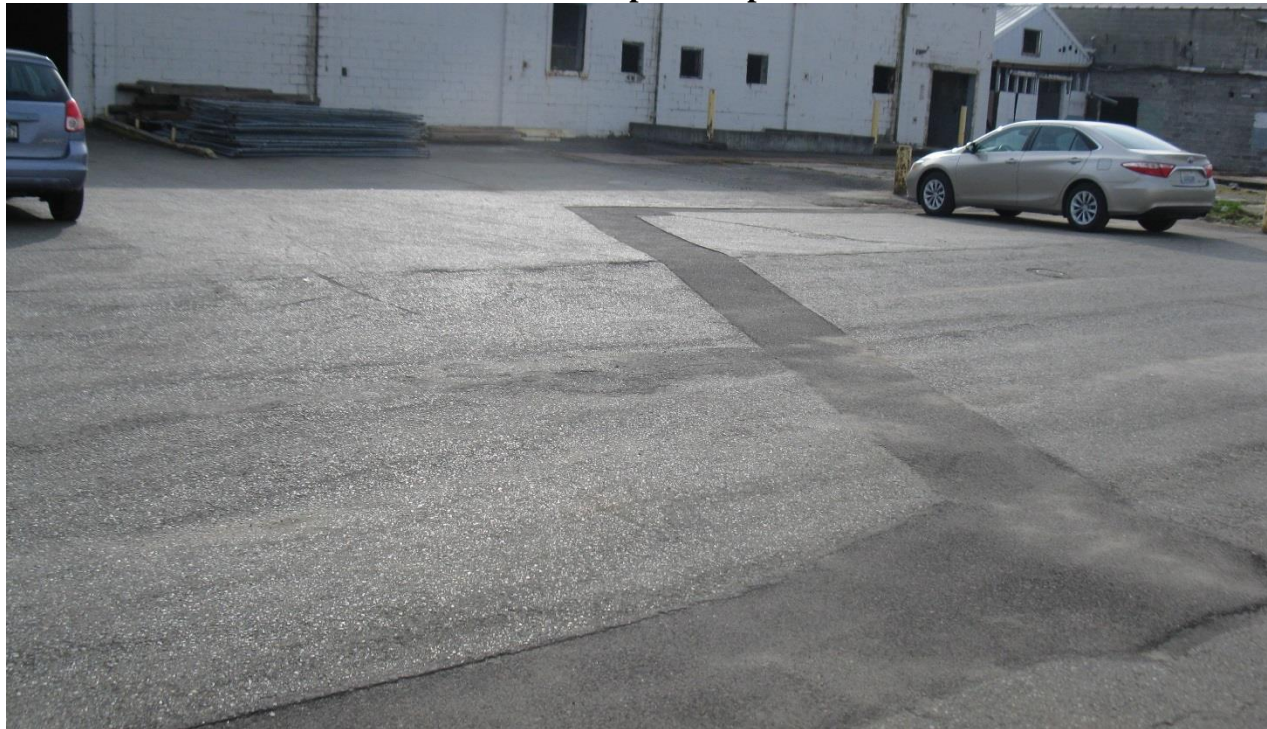
Photo 3: Area of Soil Contamination and Asphalt Cap – from the Northwest

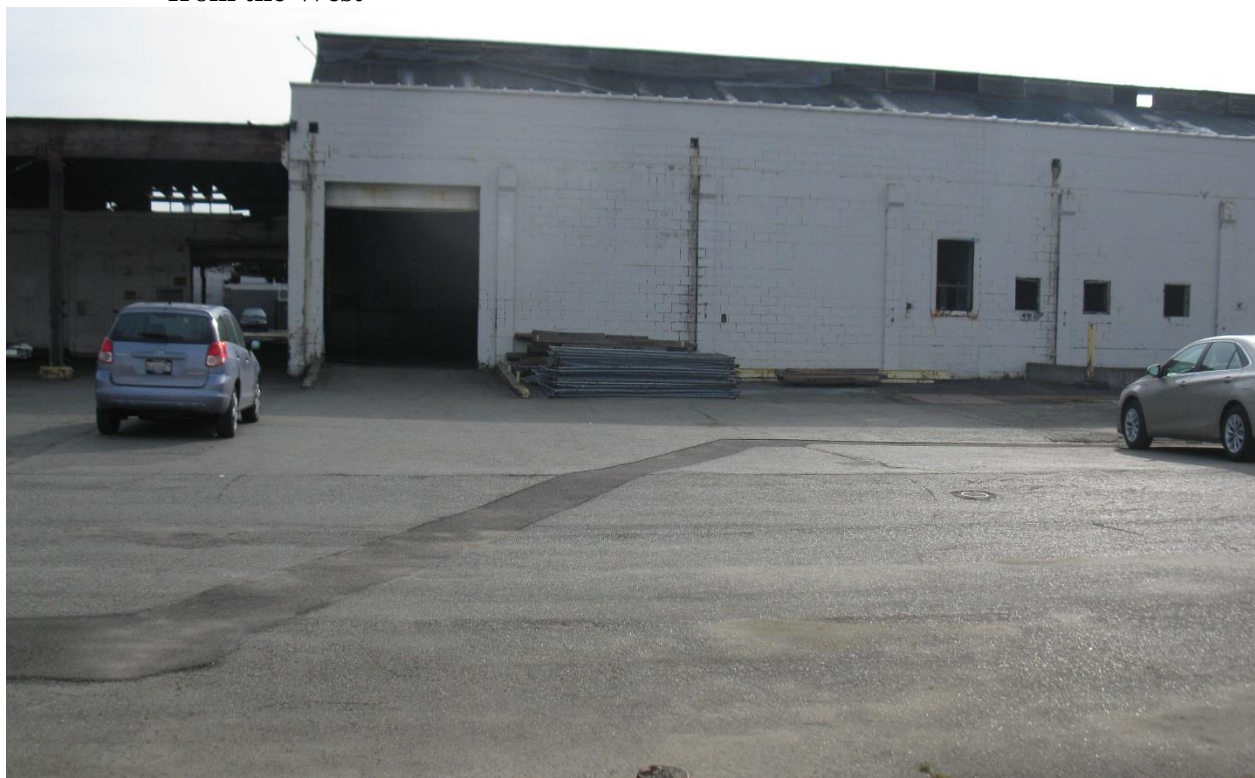
Photo 4: Previous Soil Cleanup/Soil Contamination Area and Asphalt Cap/Boiler Room - from the West

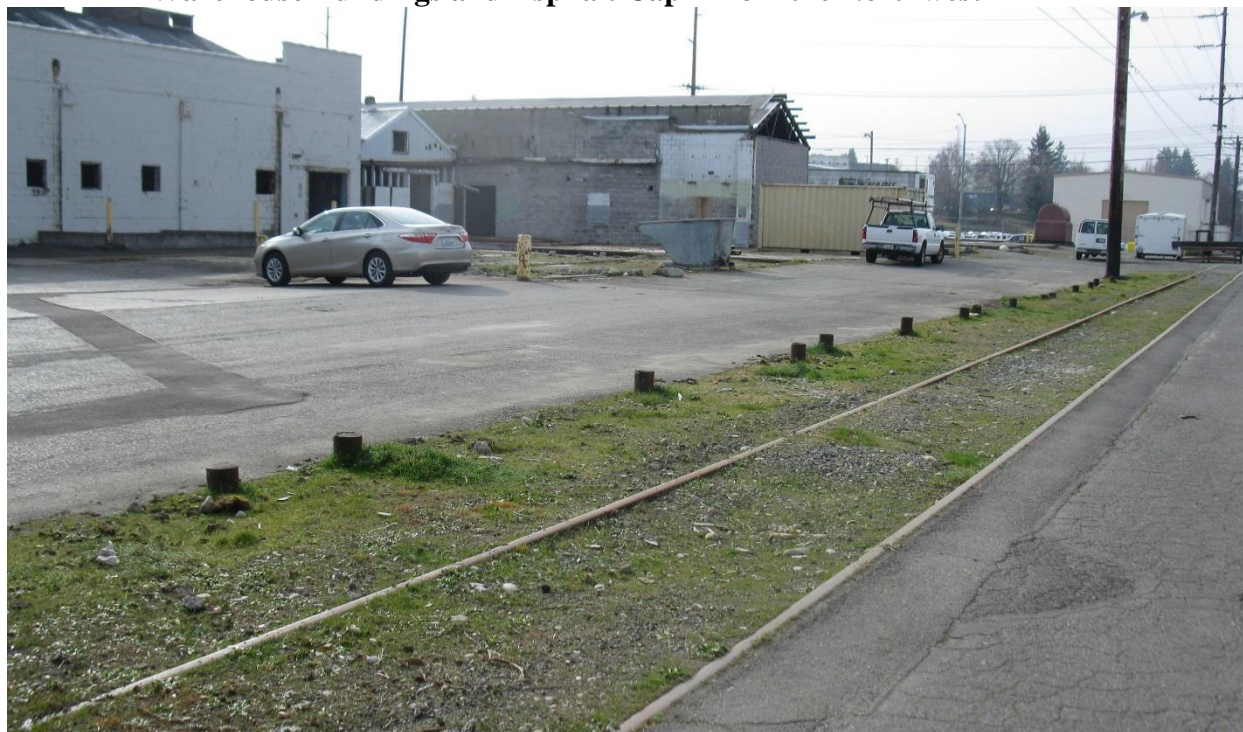
Photo 5: Area of Residual Contaminated Soil, Railroad Tracks, Boiler and Potato Warehouse Buildings and Asphalt Cap – from the Northwest

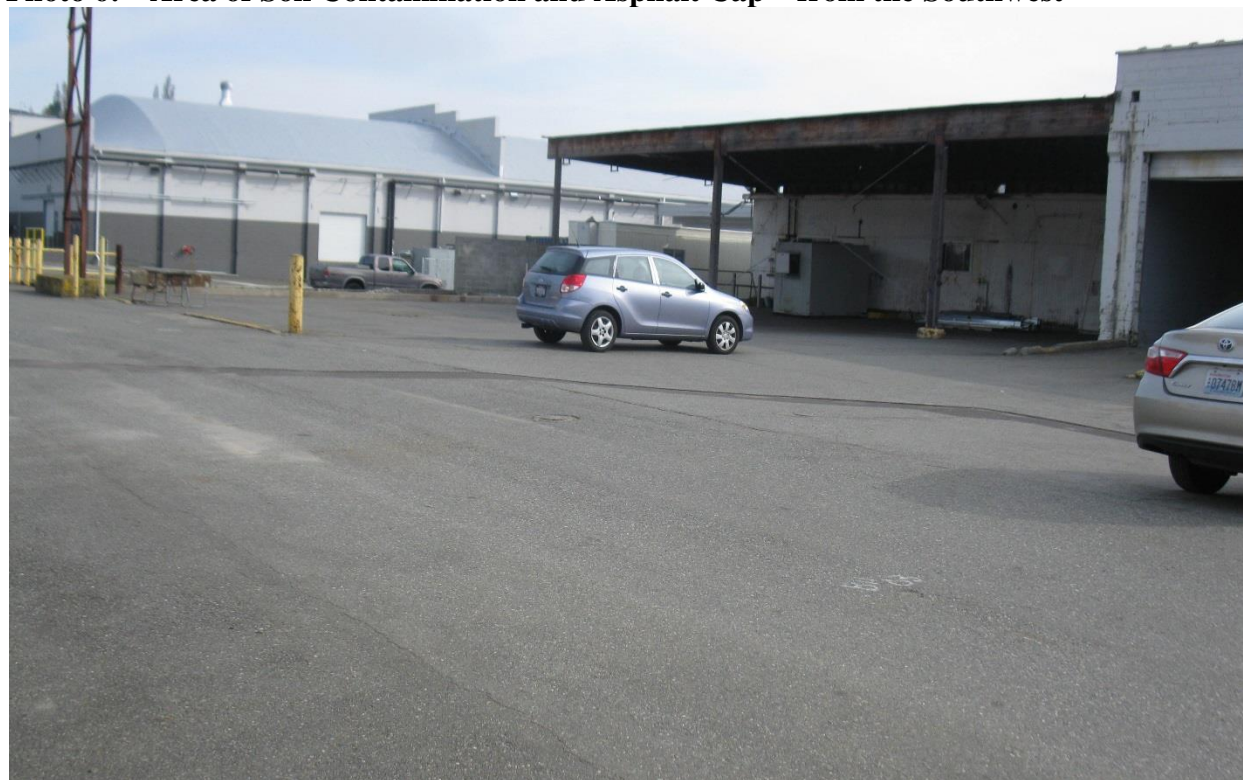
Photo 6: Area of Soil Contamination and Asphalt Cap – from the Southwest

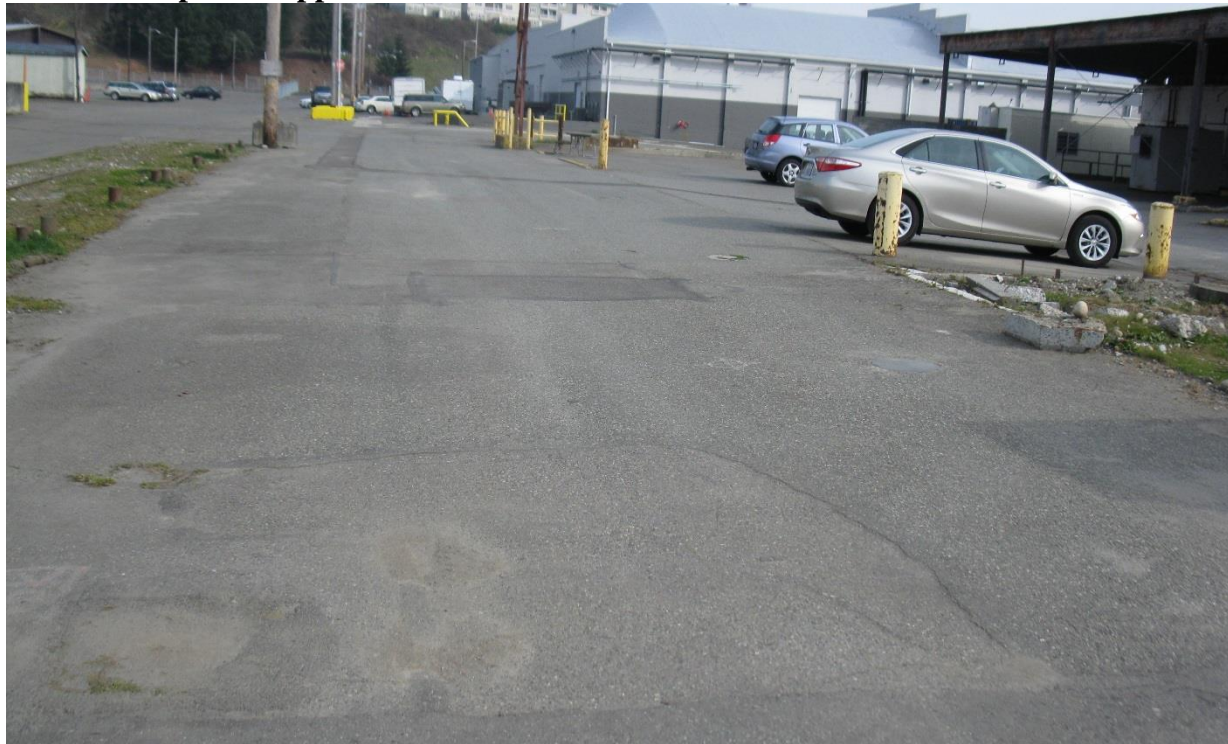
Photo 7: Asphalt Capped Area – from the South

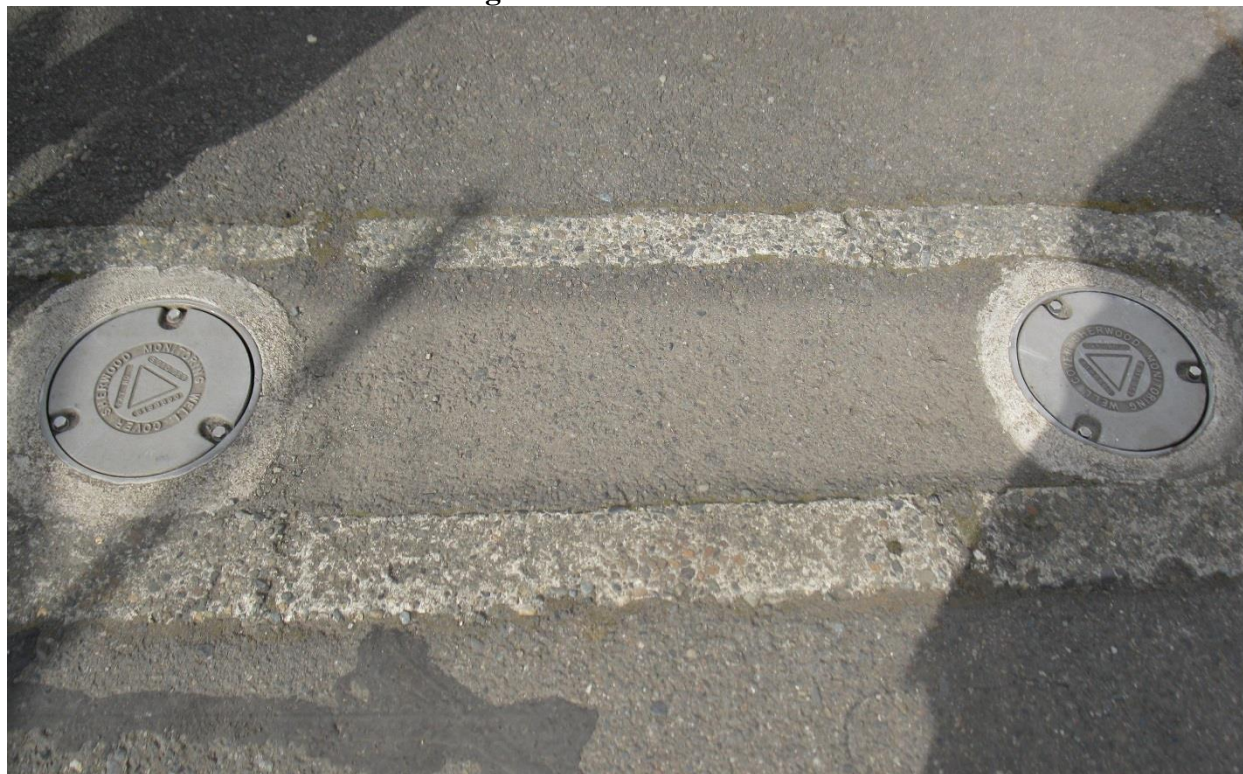
Photo 8: Groundwater Monitoring Well Pair MW-9S and MW-9D
