Appendix C

Seepage Sampler & Weir Installation Photos

King County

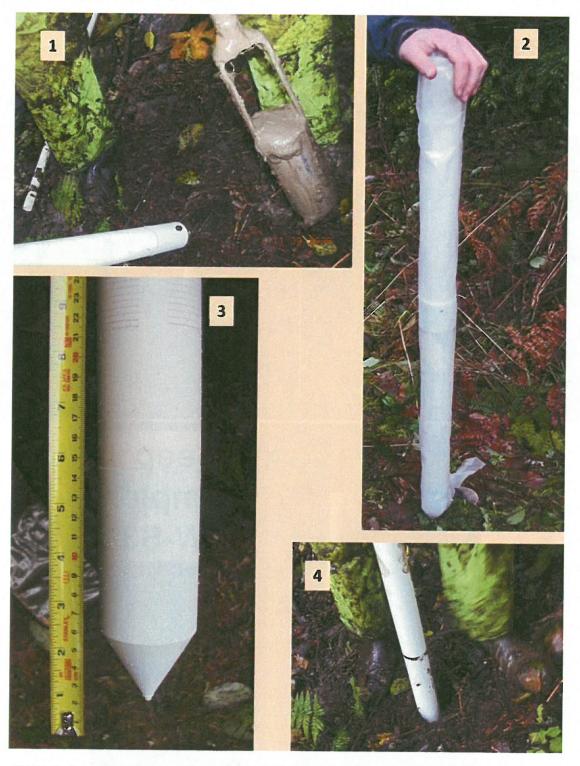
(1) Borehole was hand augered through soil and into underlying sediments (2) Sampler was constructed of clean 2-inch Sch. 40 PVC with 0.010-slot screen (3)Bottom PVC Monopoint; 0.010-inch slots visible at top of picture (4) Inserting seepage sampler into borehole.

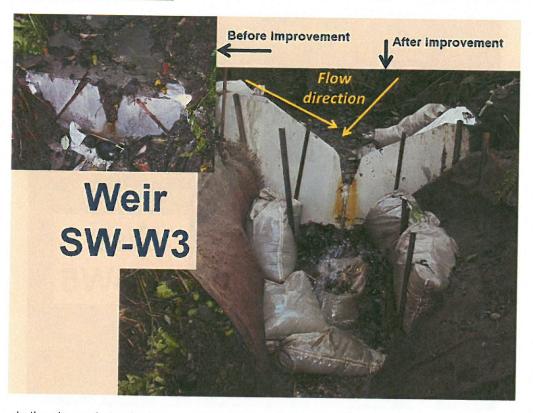
In the above photo, the inset shows how the weir used to fill up with debris and sediment during a high rainfall event. The newer weir has not had the problem.
