Re: CFN Station, 3200 20th Ave E, Fife; APN 0320115006,

ERTS 637532, Petrocard CFN Fuel Station, 3200 20th St E, Fife
Photos taken by S. Bell, 11.27.12

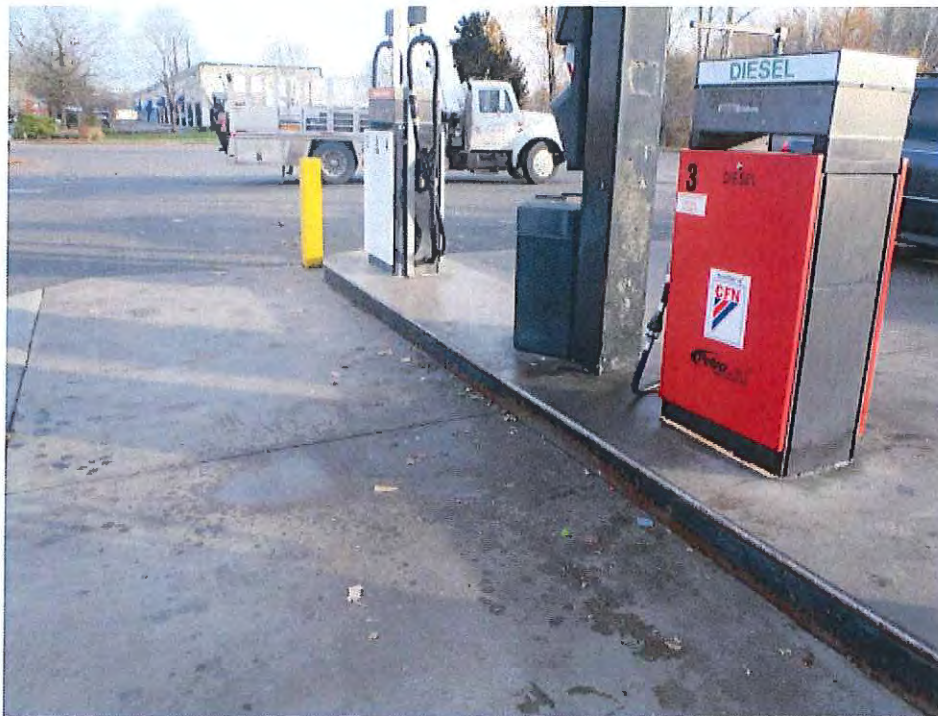
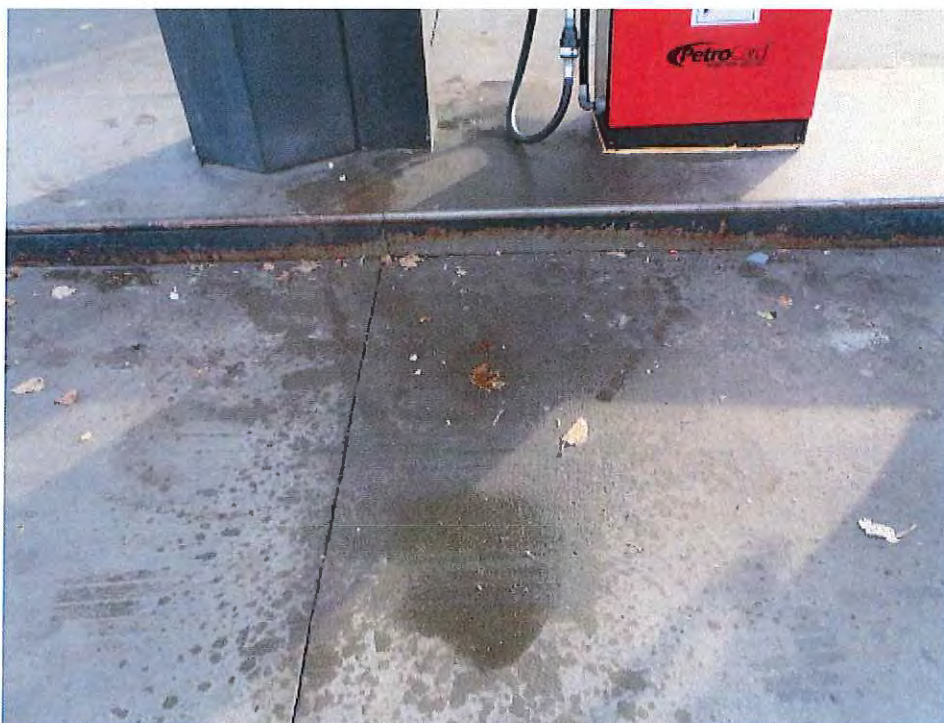
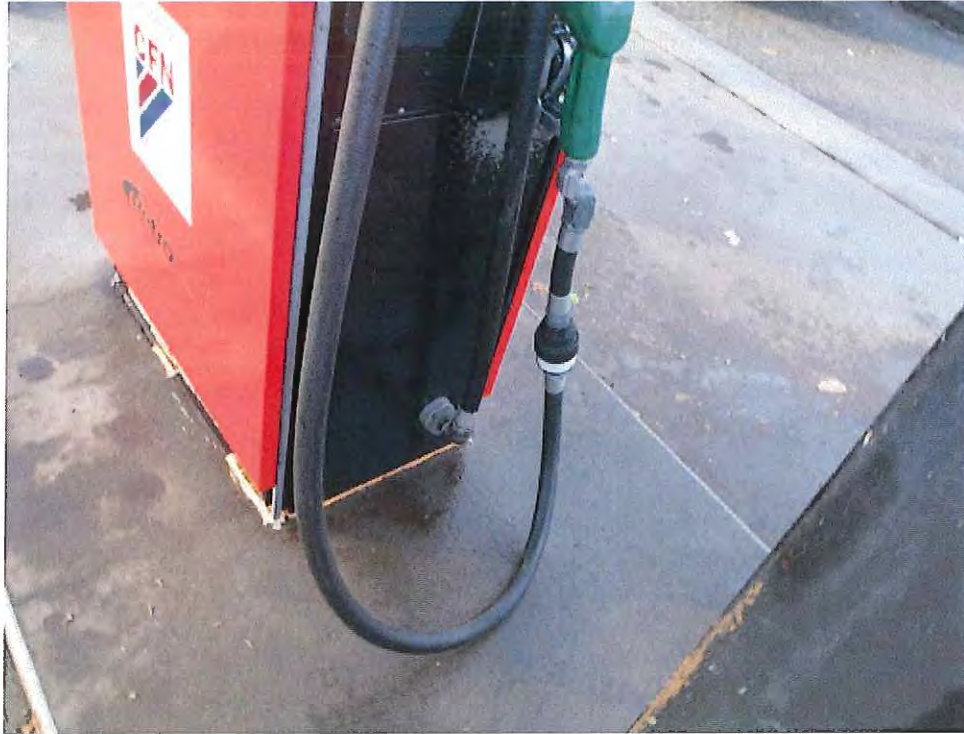
First row of pumps on north side of site, adjacent to 20th Street E, diesel pump 3 leaking:

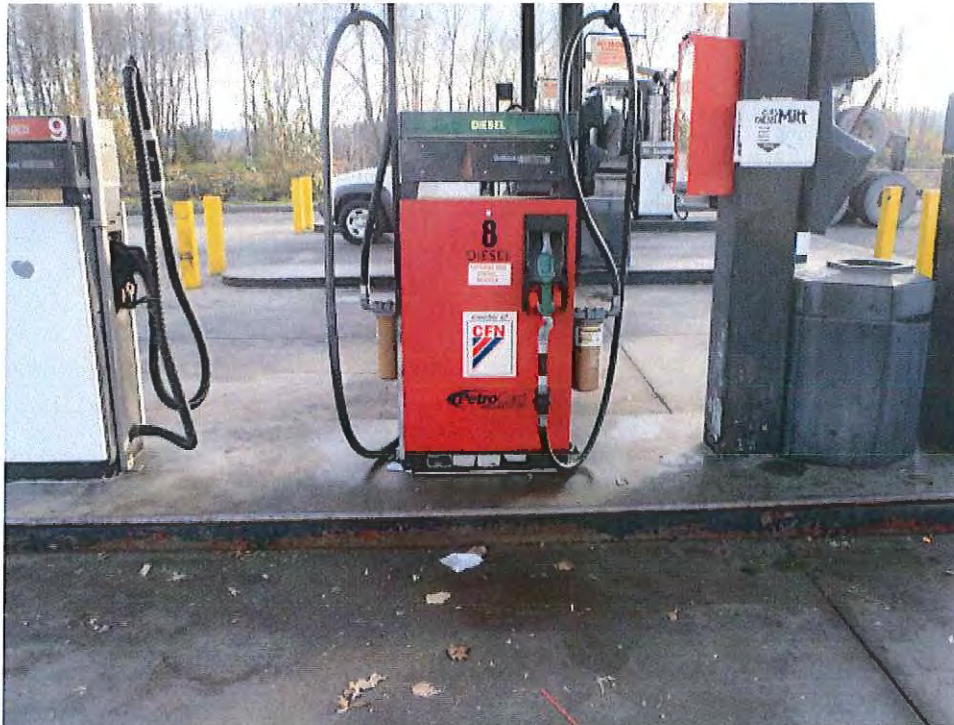
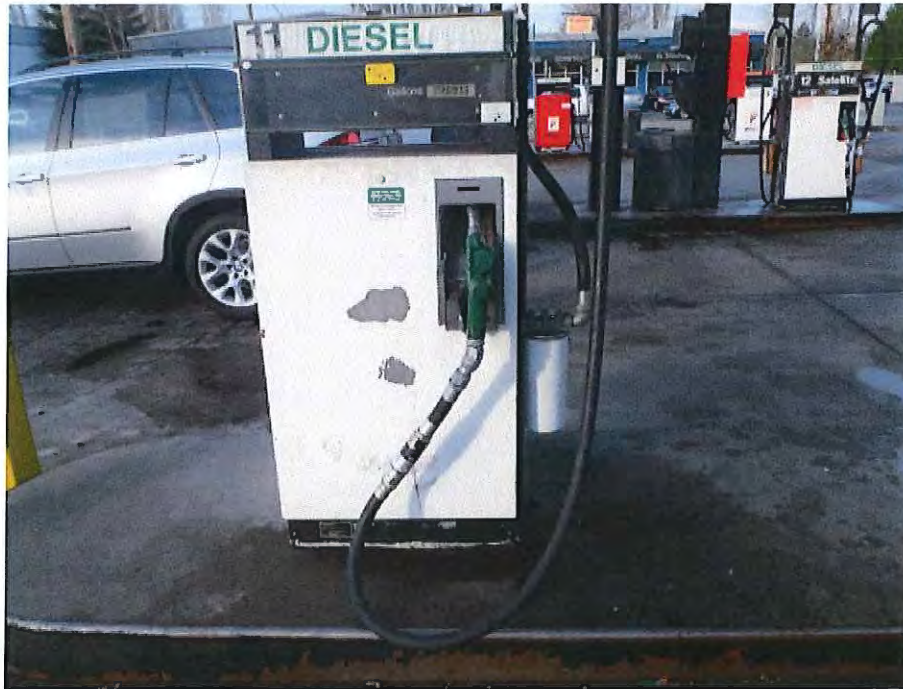
Next row of pumps, Pump #8 and Satellite #12 (back side of #8) leaking:

Note: Pump #12 satellite is in right background of photo.

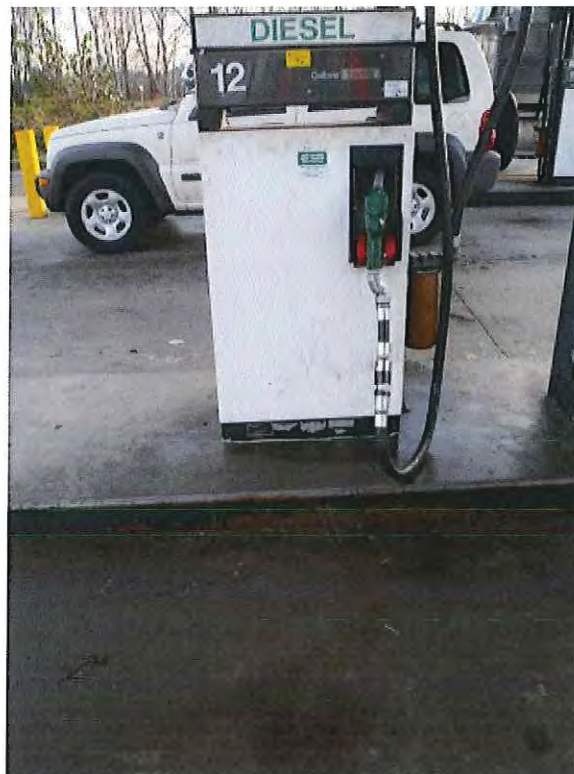
Next row of pumps, #11 (see above) and #12 leaking:

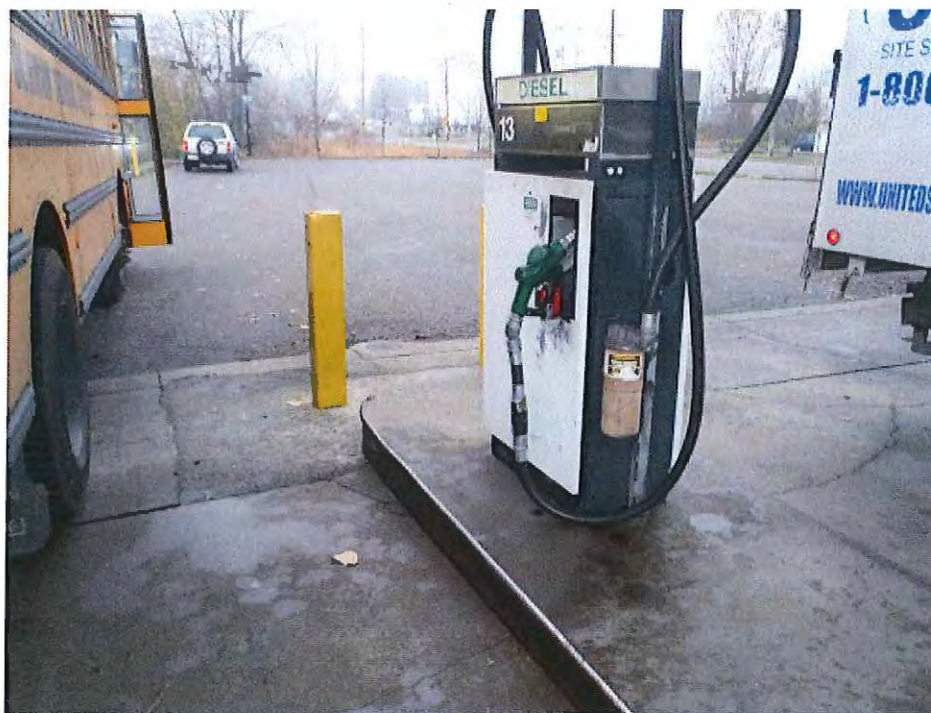
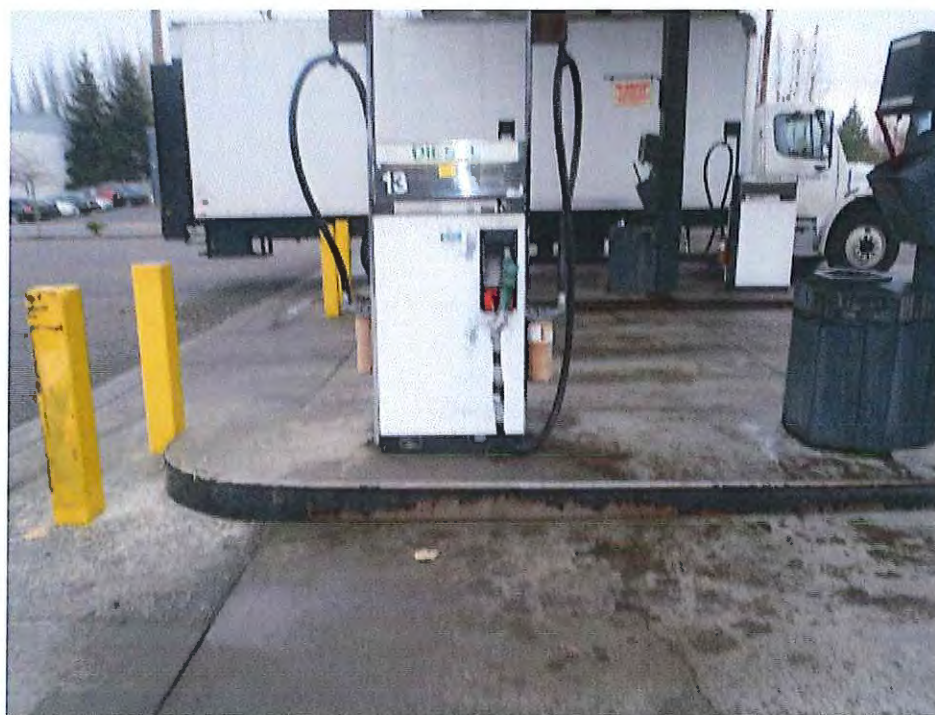
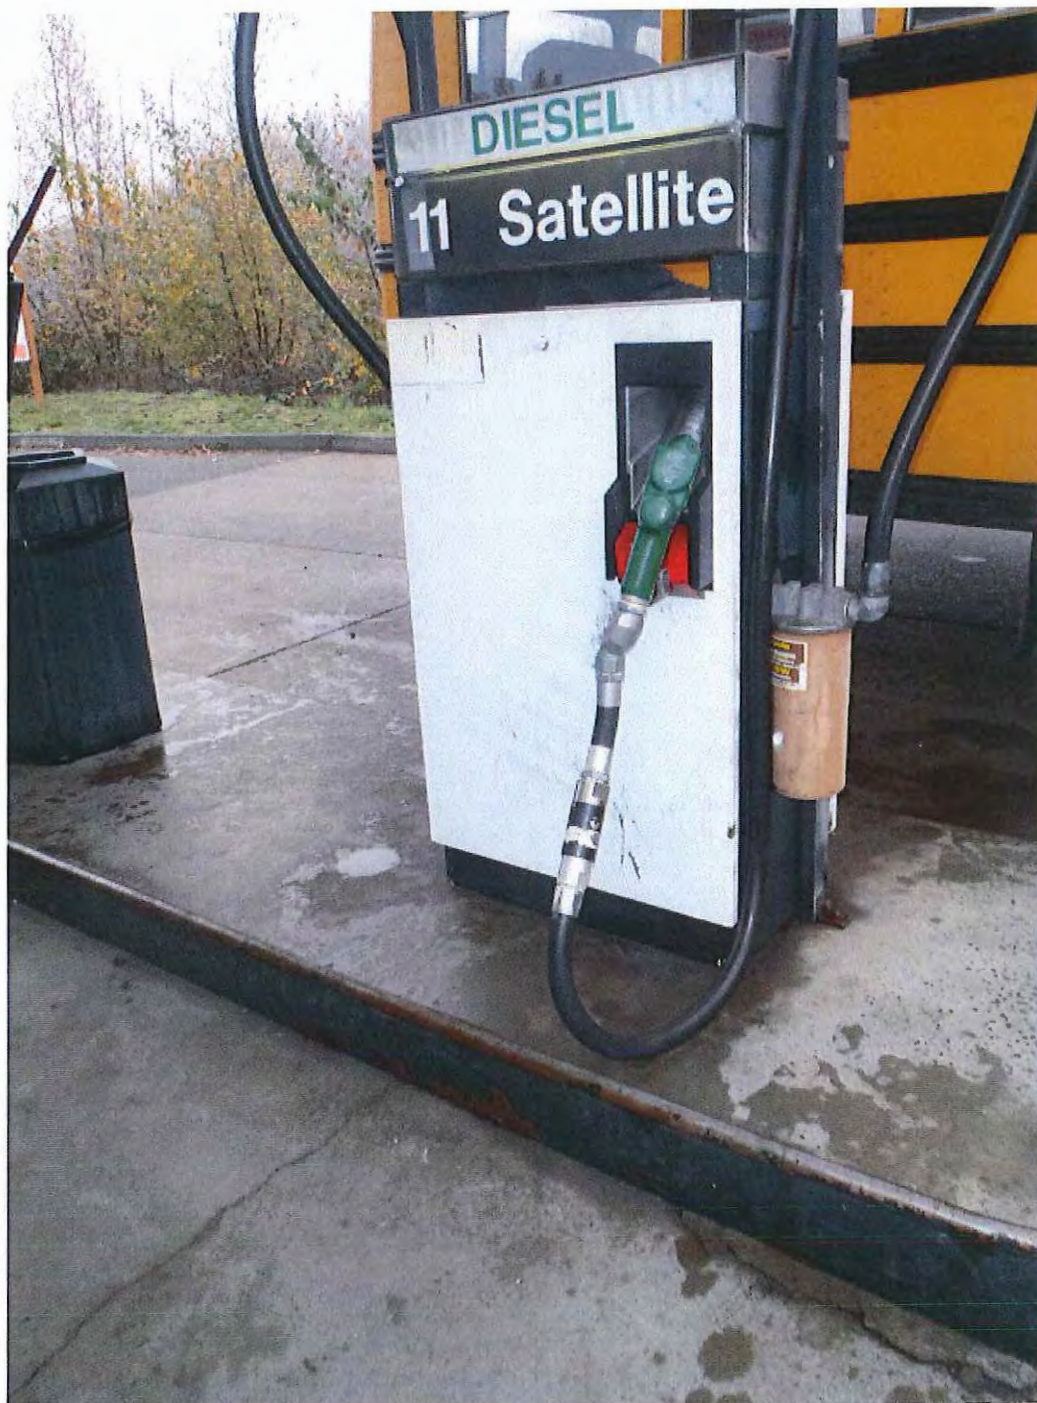
Last pump island, on south side of site, pump #13/11 satellite leaking:

Selim with Petrocard called a short while ago and told me that he would be going out to inspect this station tomorrow. Any leaking/faulty nozzles will be repaired/replaced and he will get back to me about whether he agrees a subsurface investigation is warranted. From my perspective, on-going leaks from nozzles around pump islands are one of the weak points at a fuel station, where seams and cracks in the pavement allow continued accumulation of contamination to occur in the subsurface. There does seem to be a problem at this site over the last month or so, based on the original complaint combined with yesterday and today's observations.

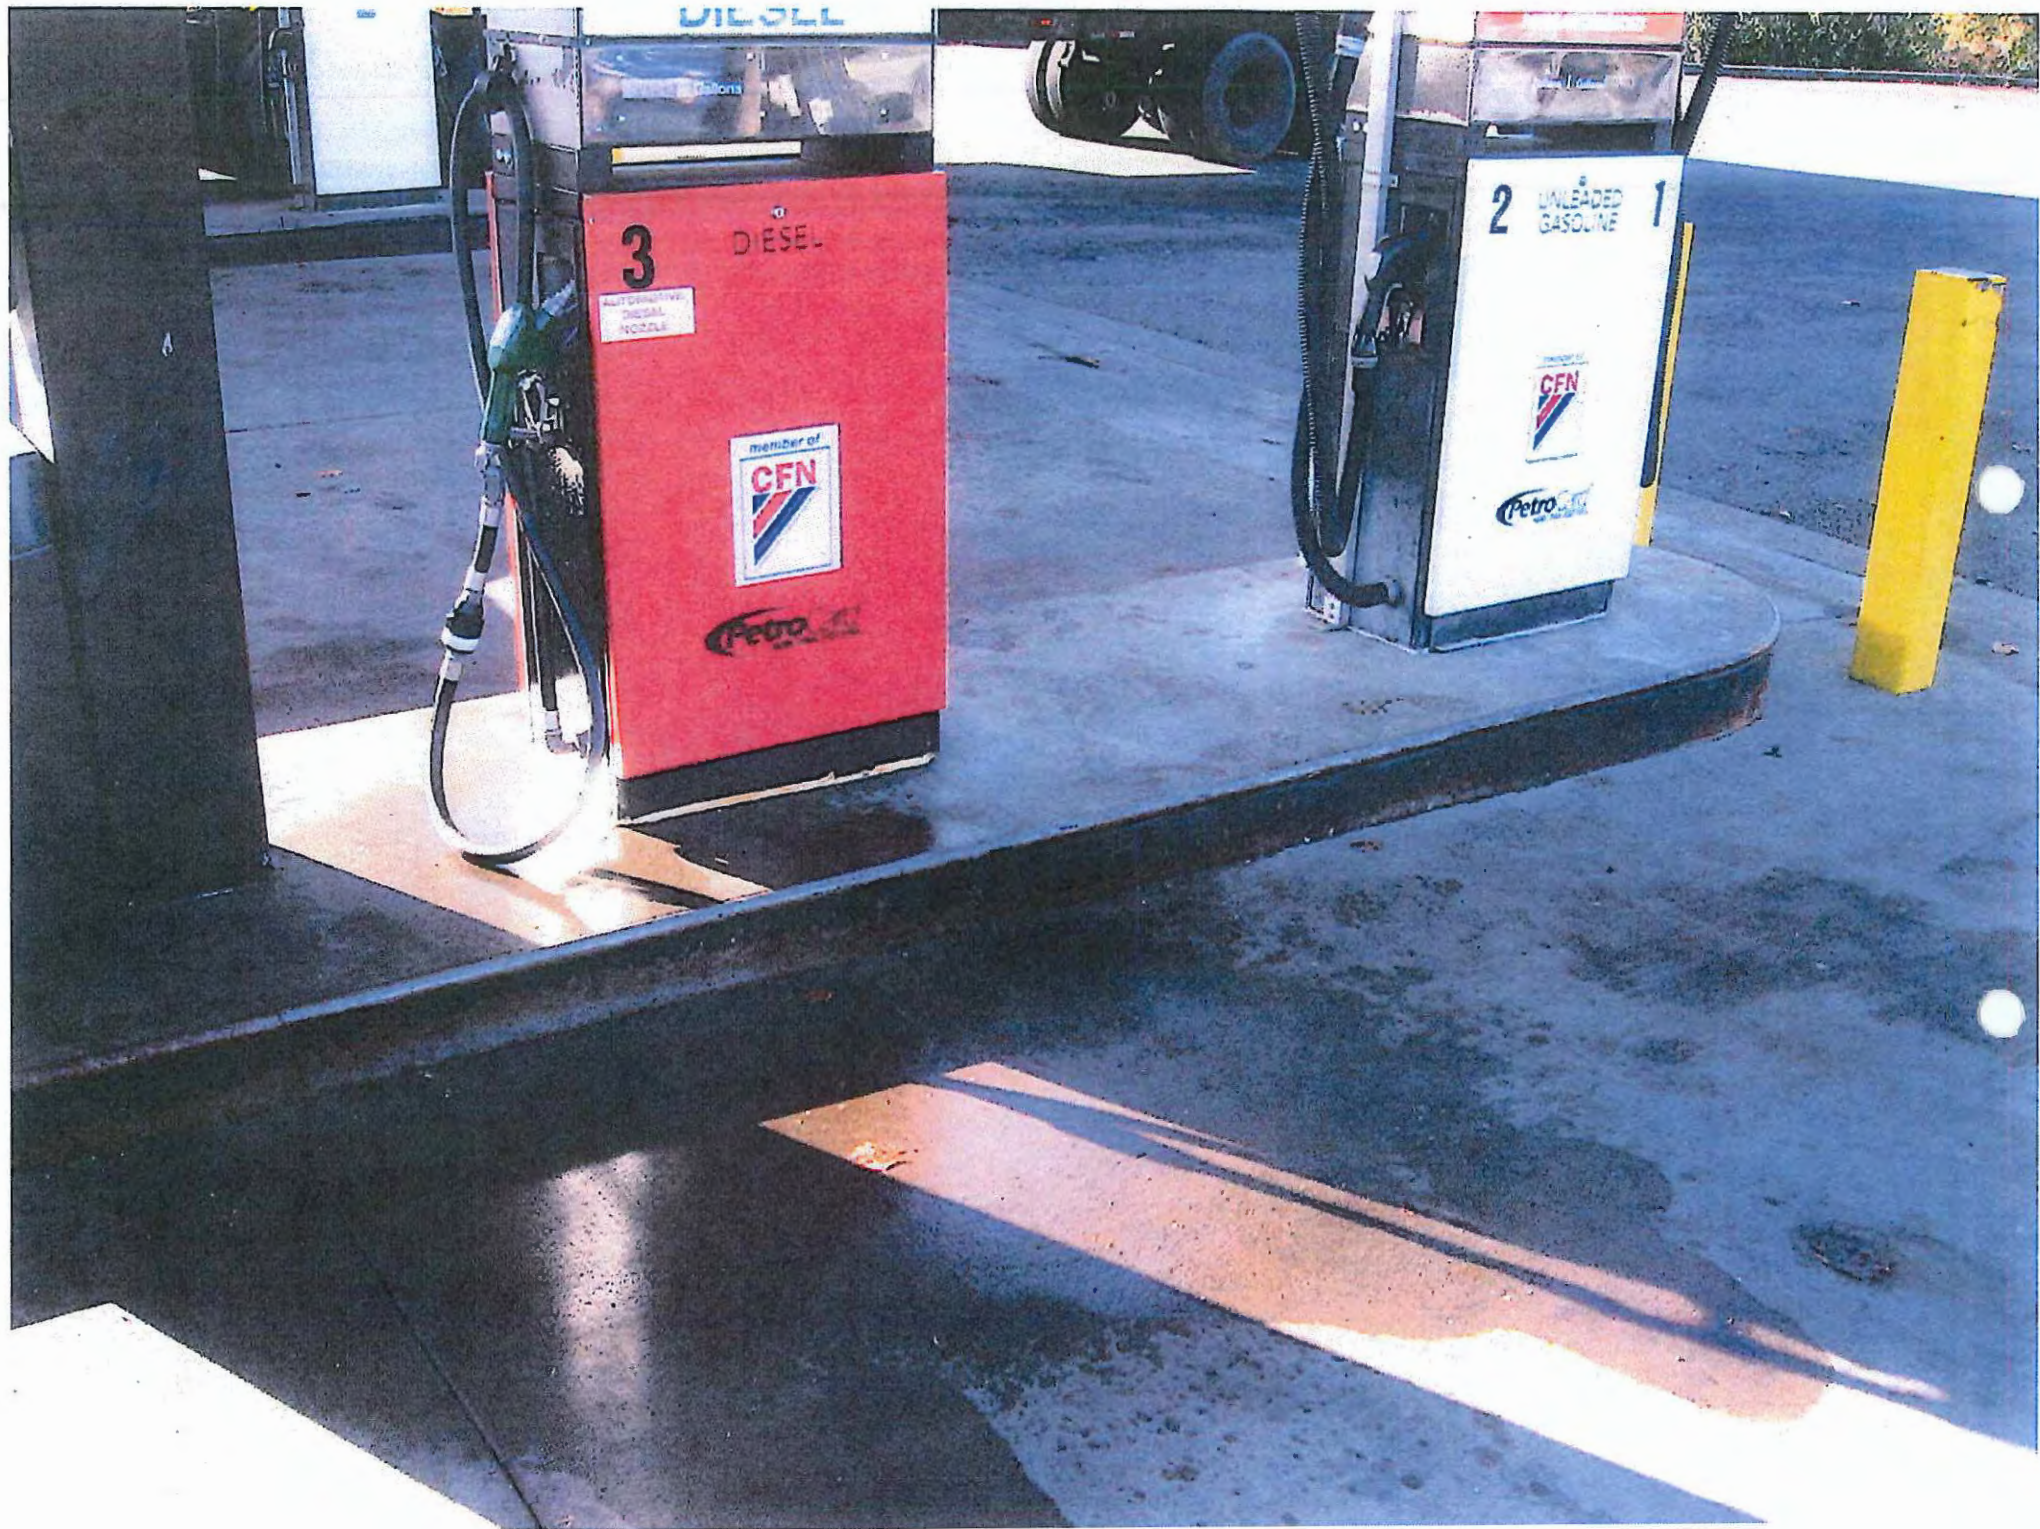
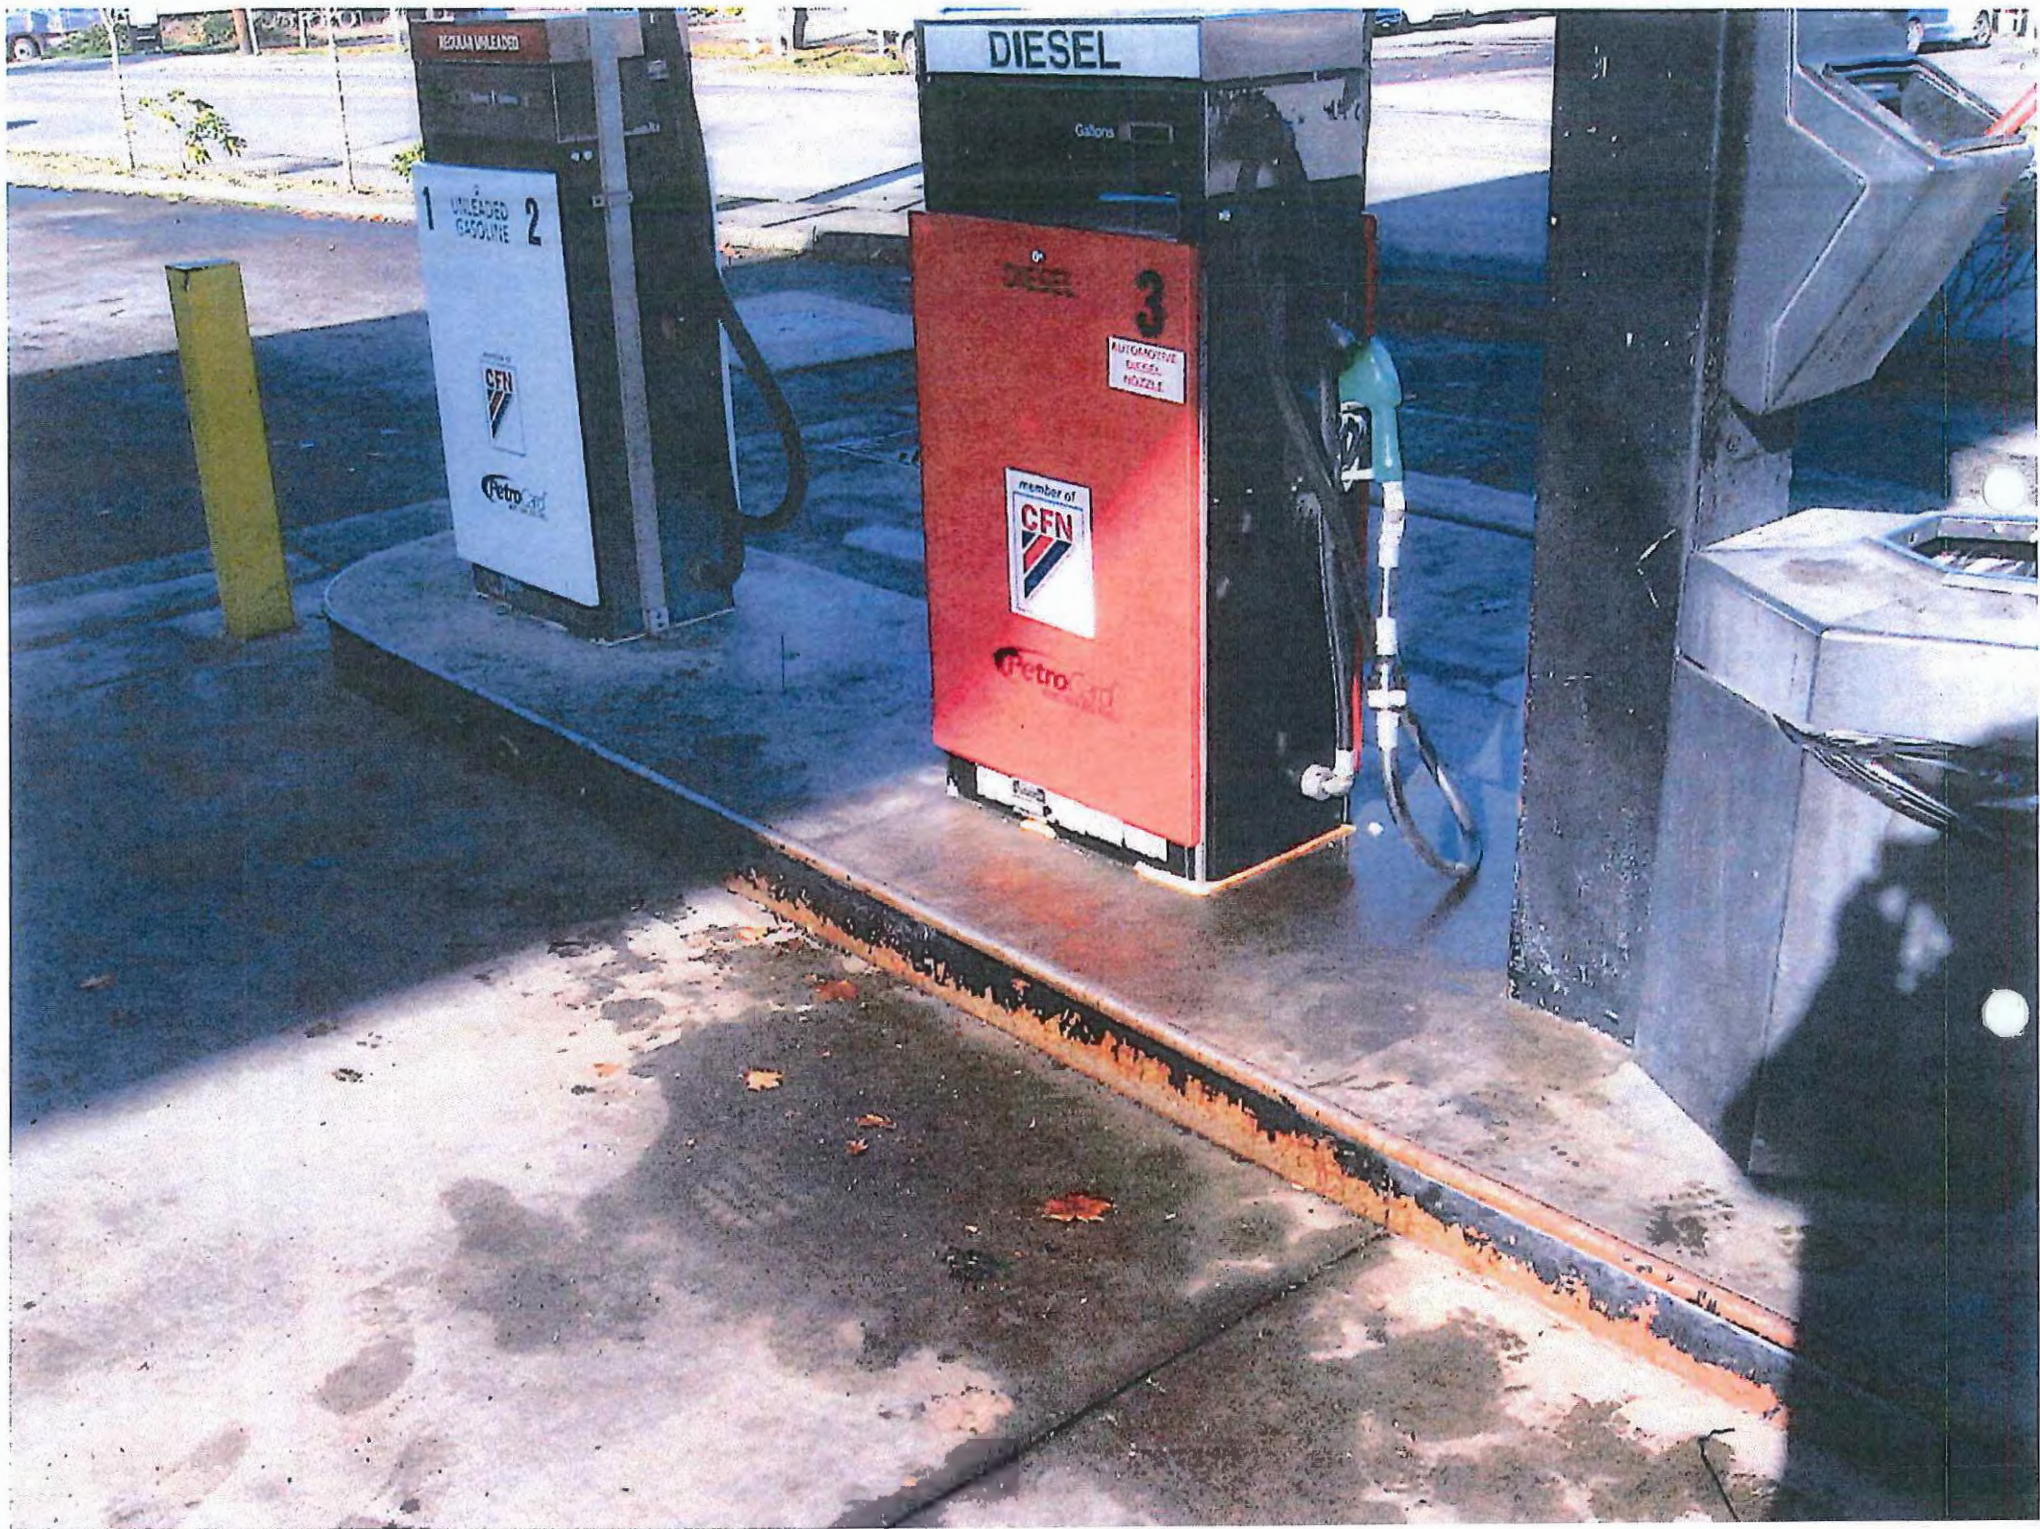
The attached photos were submitted with the original report of diesel pump #3 leaking at this location; that report went to Ecology on 11.09.12. Together with the observations and photos collected today at the site, there is evidence of an on-going issue with poor maintenance and continued release of diesel at this site contributing to potential site contamination.
