INTERIM ACTION WORK PLAN

RGI PROJECT No. 2017-015K

**ROYSTONE REDEVELOPMENT
631 QUEEN ANNE AVENUE NORTH
SEATTLE, WASHINGTON 98109**

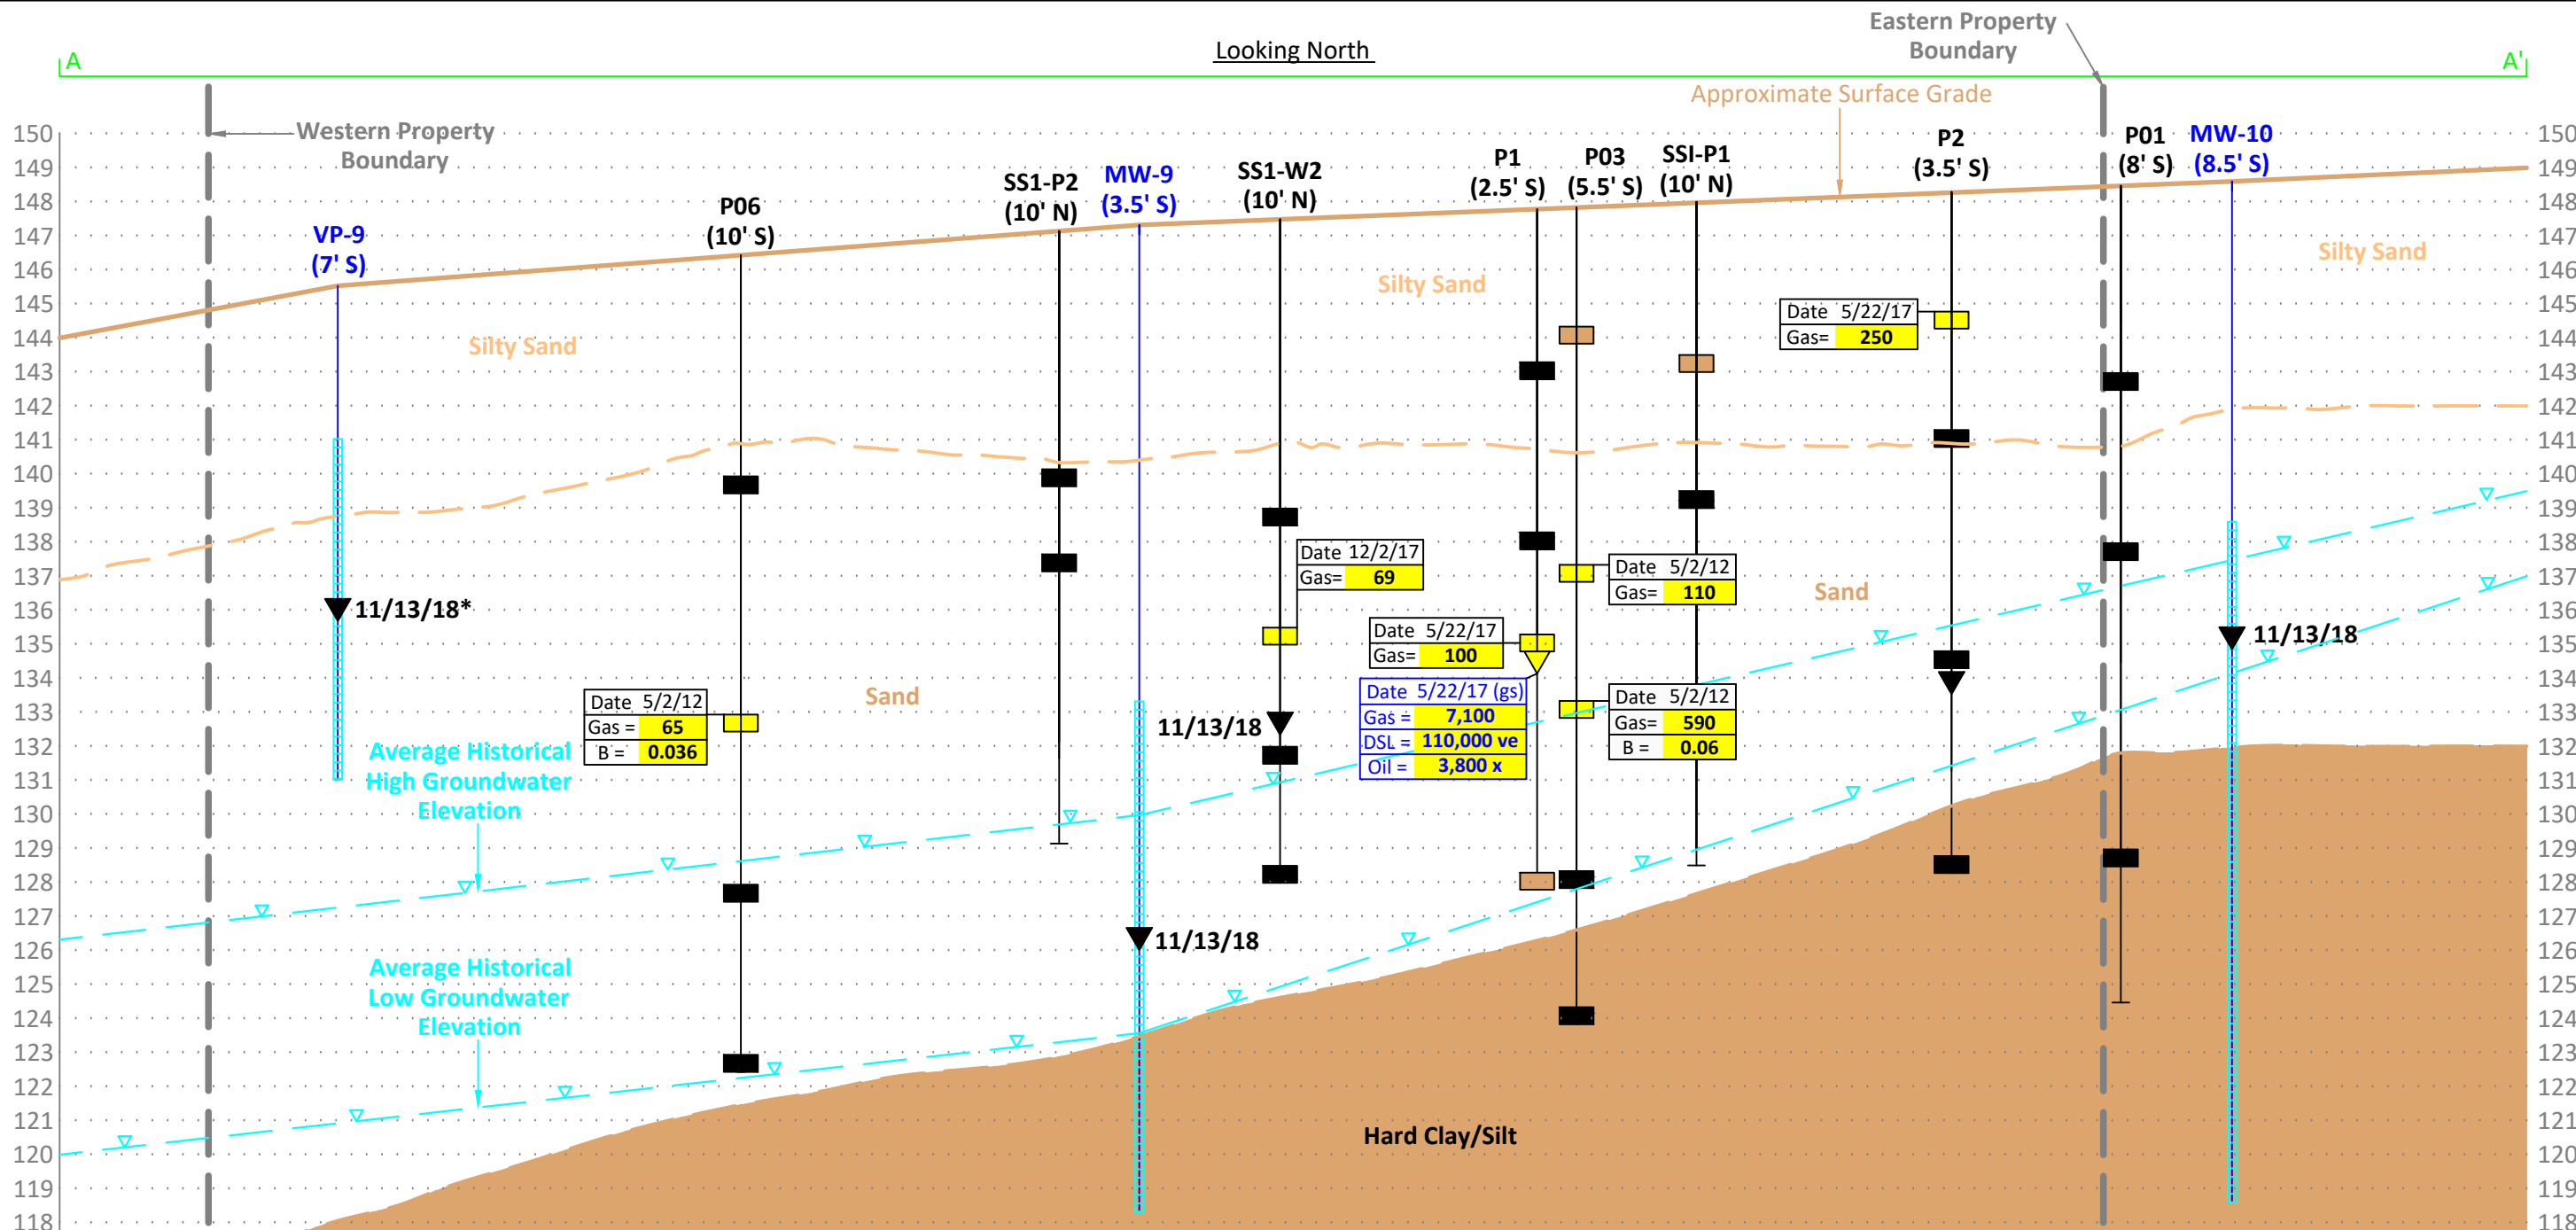
Roystone Redevelopment		Figure 6
RGI Project Number 2017-015K	Cross Section A - A'	Date Drawn: 08/2019
Address: 631 Queen Anne Avenue North, Seattle, Washington 98109

Soil Samples

In general, the soils underlying the Property consist of silty sands to depths of approximately 6 feet to 8 feet bgs, underlain by sand to depths of 17 to 31 feet bgs. The depth to the bottom of the sand horizon is shallower beneath the eastern portion of the Property (approximately 17 feet bgs) and deepens to the west (up to 31 feet bgs beneath the western portion of the Property). Underlying the sand is a hard to very hard, relatively impervious, clayey silt (Lawton Clay). A cross-section depicting subsurface conditions along the northern Property boundary is displayed on Figure 6.

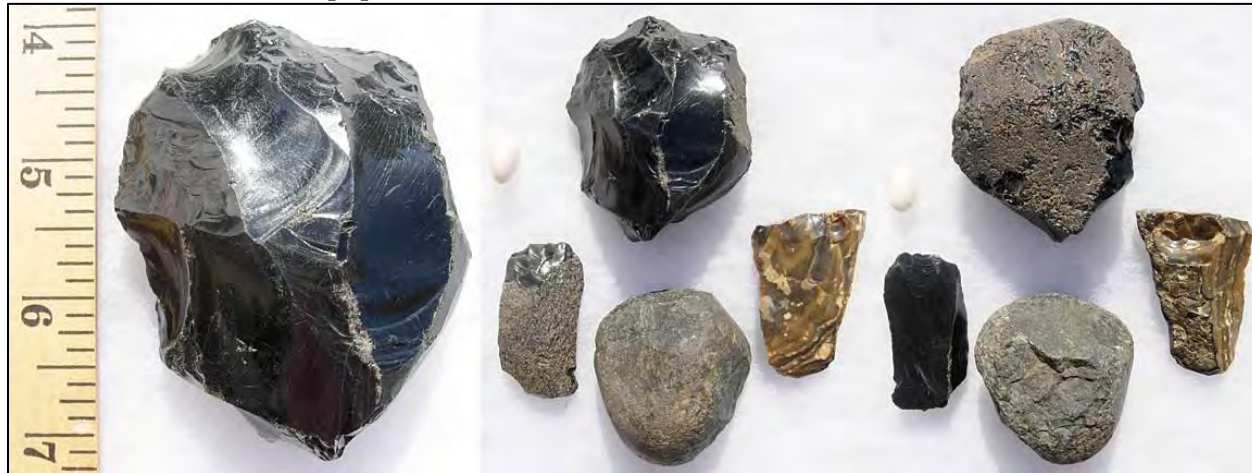
You see chipped stone artifacts.

- Glass-like material
- Angular
- “Unusual” material for area
- “Unusual” shape
- Regularity of flaking
- Variability of size

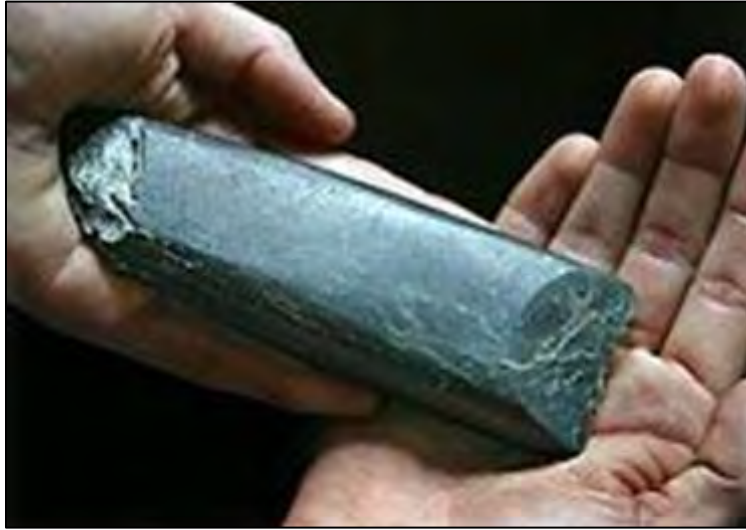
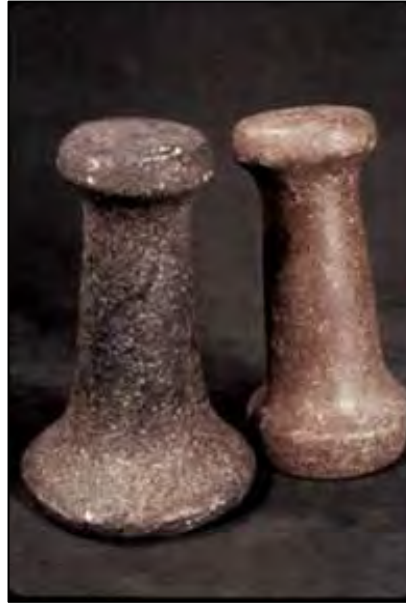
You see ground or pecked stone artifacts.

- Striations or scratching
- Unusual or unnatural shapes
- Unusual stone
- Etching
- Perforations
- Pecking
- Regularity in modifications
- Variability of size, function, and complexity

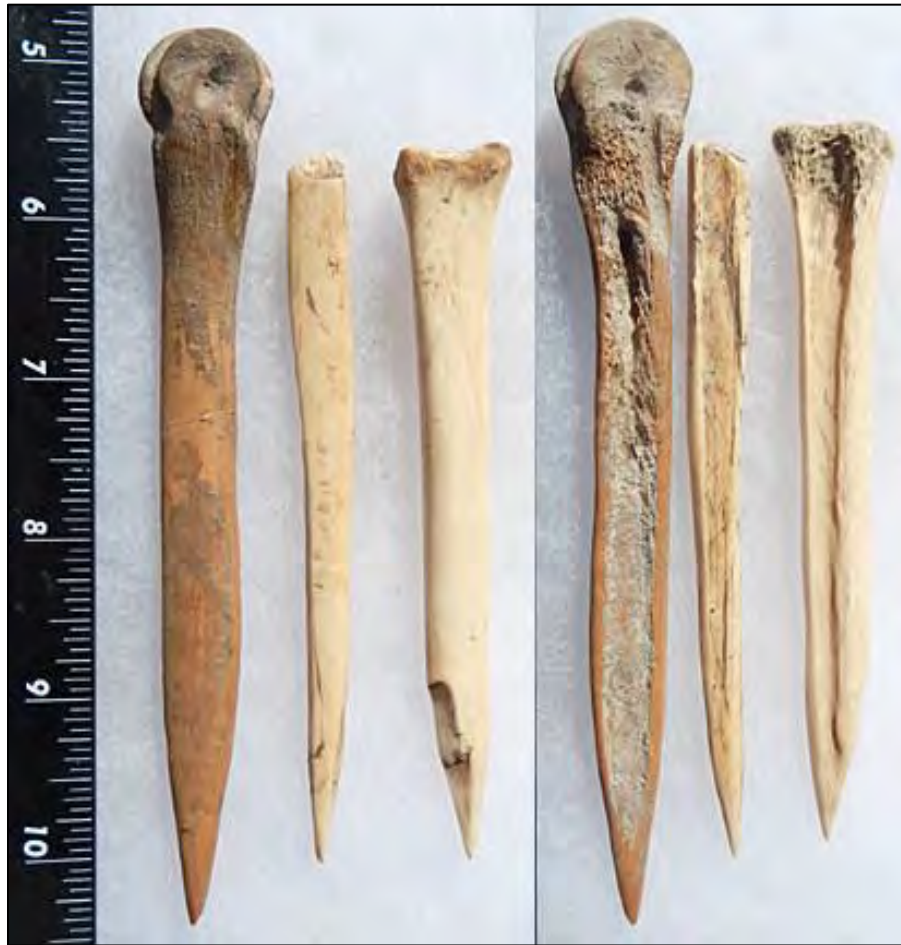
You see bone or shell artifacts.

- Often smooth
- Unusual shape
- Carved
- Often pointed if used as a tool
- Often wedge shaped like a “shoehorn”

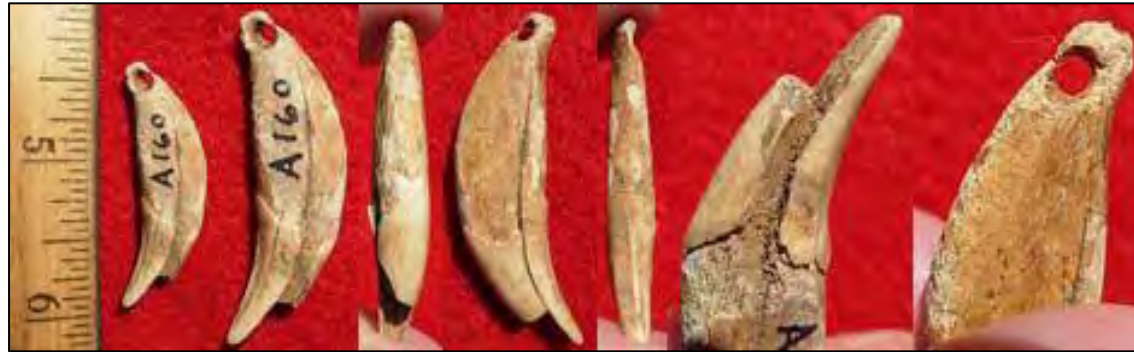
You see bone or shell artifacts.

- Often smooth
- Unusual shape
- Perforated
- Variability of size

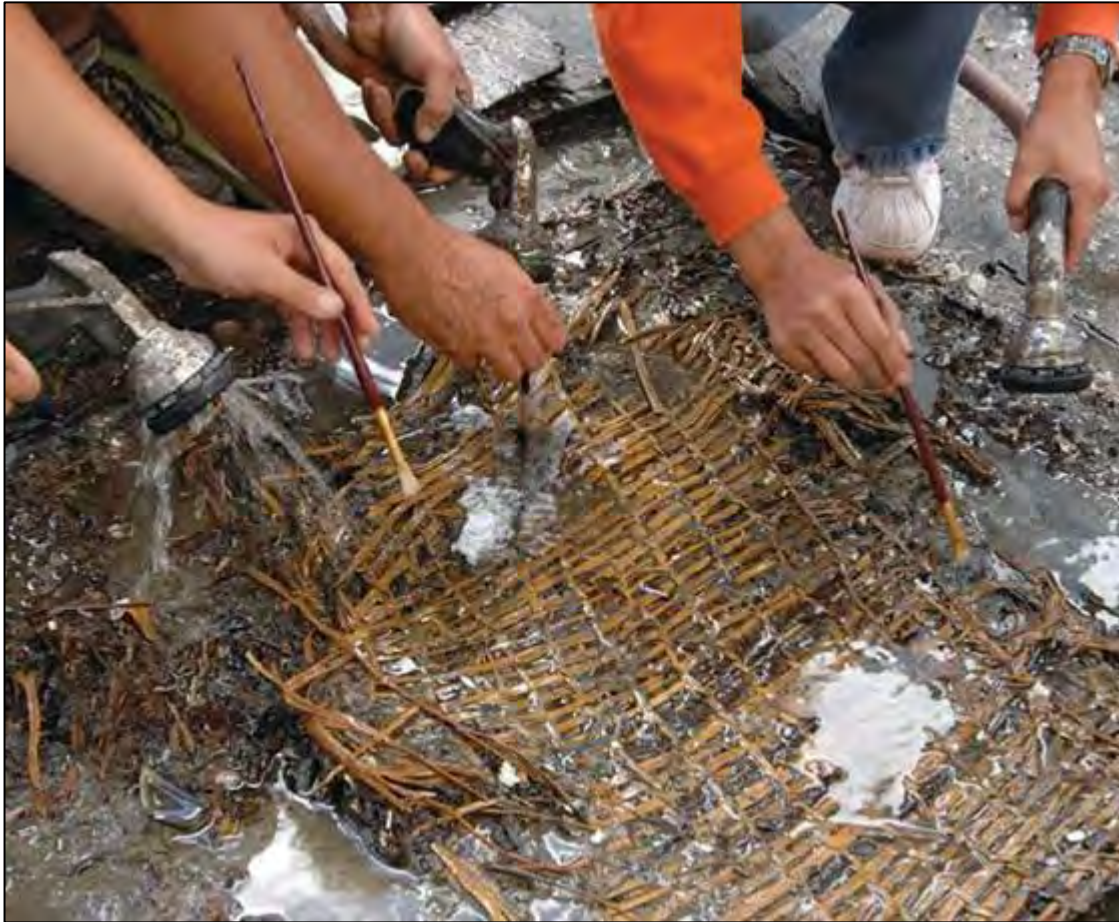
You see fiber or wood artifacts.

- Wet environments needed for preservation
- Variability of size, function, and complexity
- Rare

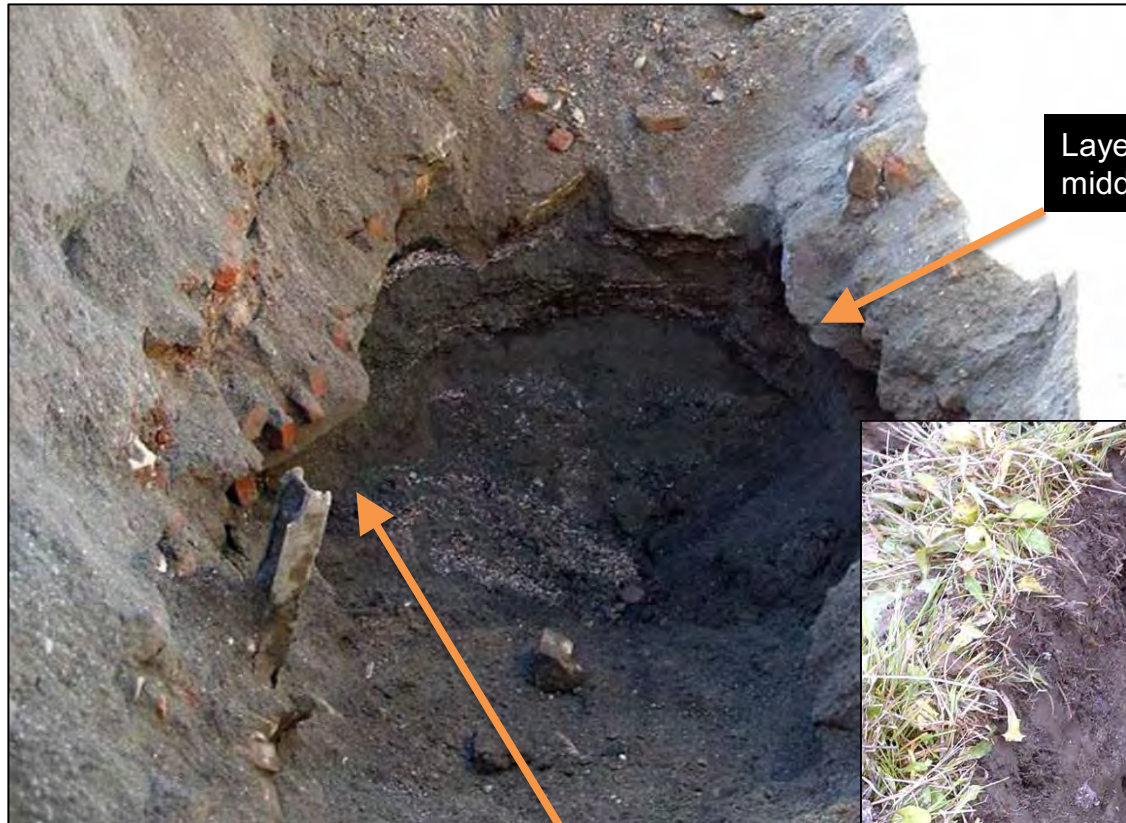
Layers of shell
midden

- Often have a layered or “layer cake” appearance
- Often associated with black or blackish soil
- Often have very crushed and compacted shells

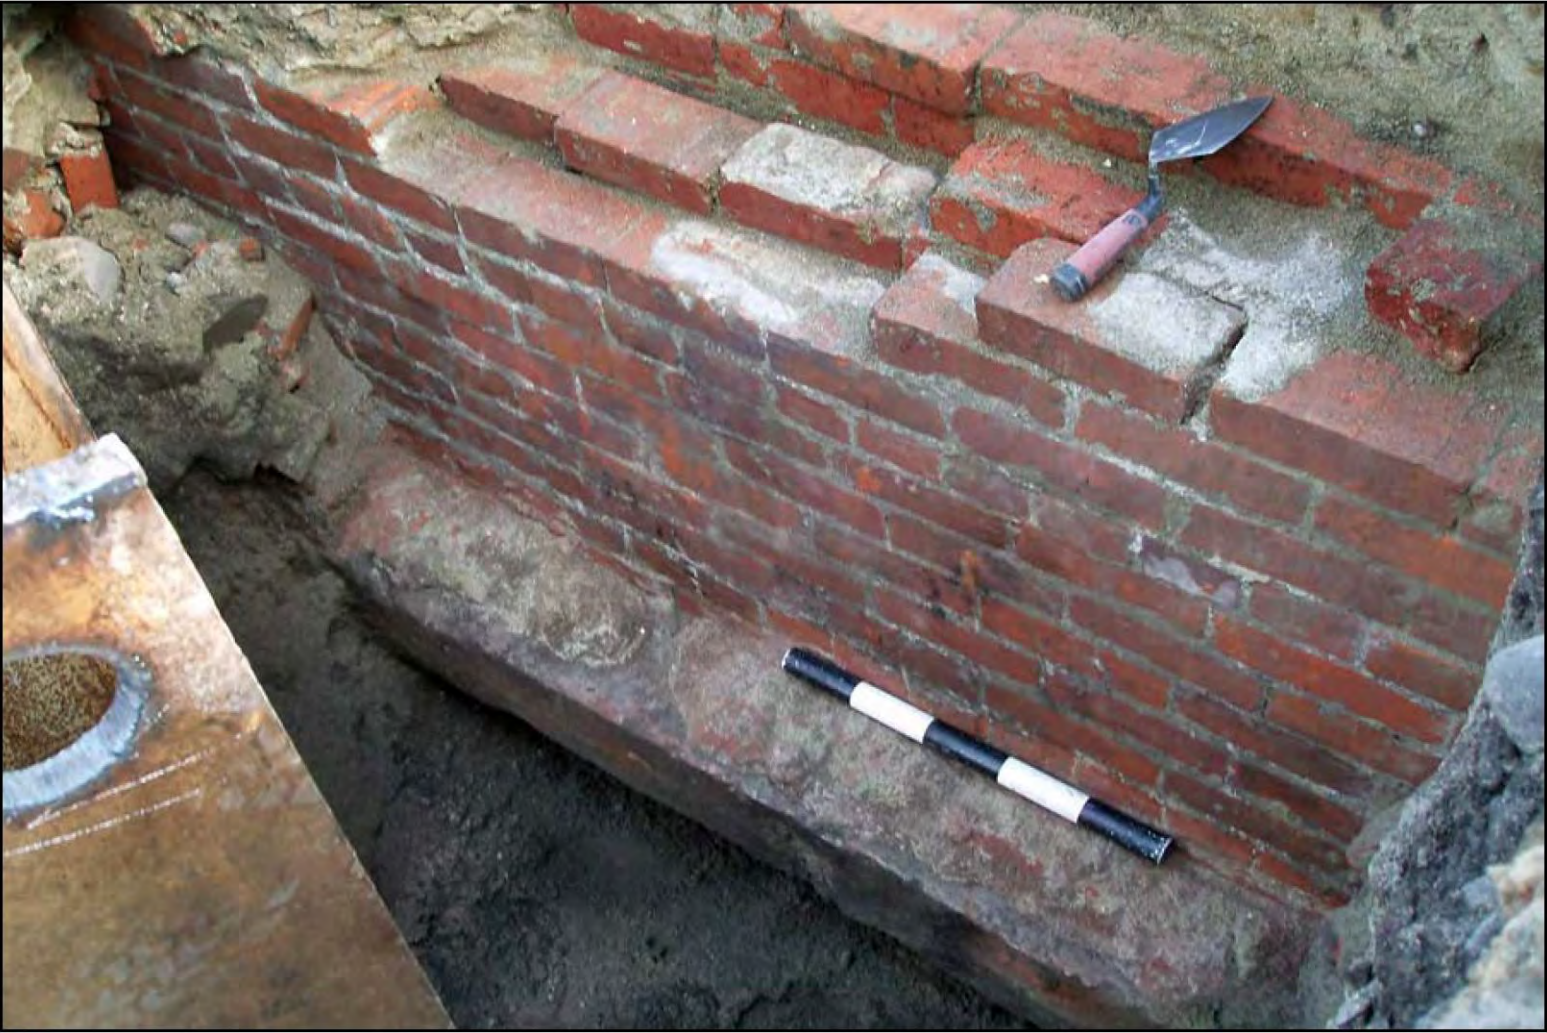
You see historic foundations or buried structures.

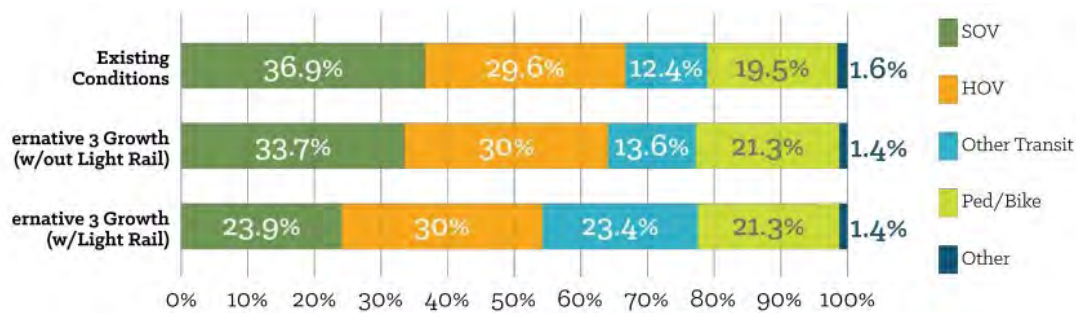
Figure 3 Mode Shift Assumptions

The travel mode split was not adjusted for this forecast. Future mode split projections in the neighborhood show significant shifts toward increased transit and pedestrian and bike use with light rail and a decrease in single-occupant vehicle use. These travel shifts support the relatively low number of net new trips forecasted. Figure 3 includes an excerpt from the Uptown & Seattle Center Strategic Parking Study.
