To: Sandra Treccani and Katie Larimer; Washington State Department of Ecology
From: Bruce D. Williams and Jedediah R. Sugalski, PE *JR* *BOW*
Date: September 10, 2019
File: 0110-148-14
Subject: Riverfront Park Revitalization – North Bank

INTRODUCTION AND OBJECTIVE

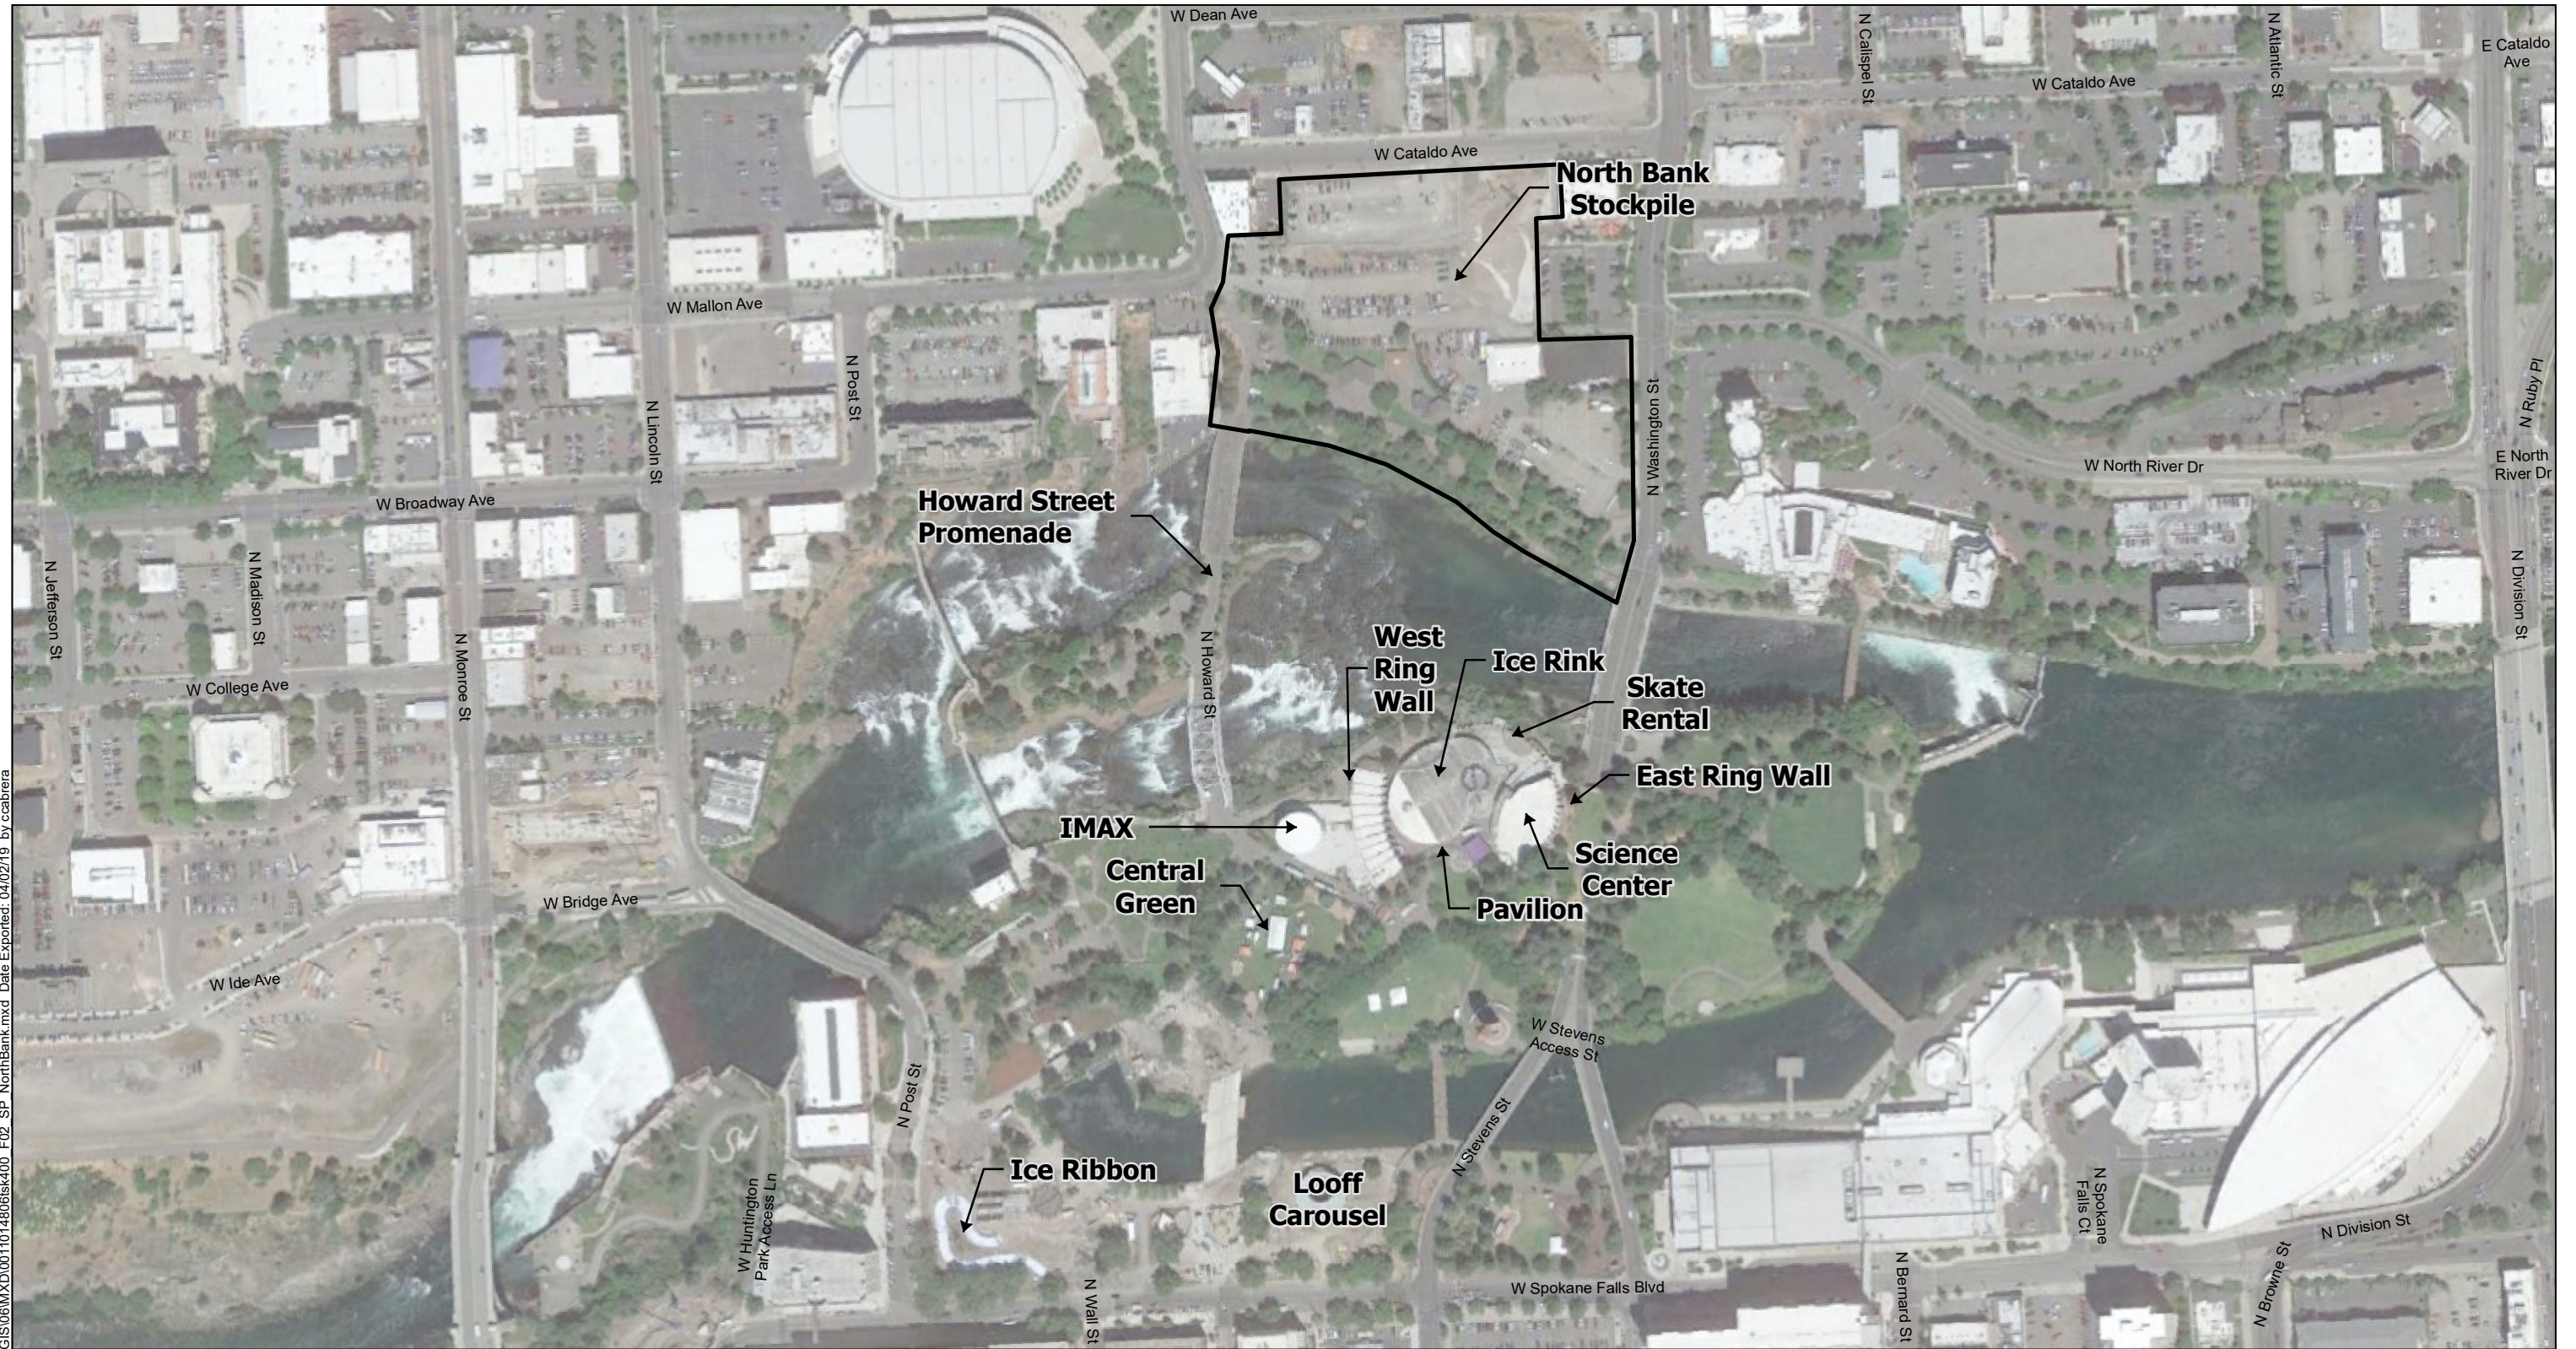
Site Plan	
Riverfront Park Spokane, Washington	
	Figure 2

North Bank Approximate Limits of Improvement

Riverfront Park (the site) is currently undergoing redevelopment as part of a municipal bond approved in 2014. The North Bank project is the third phase of the multi-year, multi-phase redevelopment. This memorandum summarizes anticipated construction activities with respect to managing contaminated soil at the site. Riverfront Park and the North Bank are shown on the Vicinity Map, Figure 1 and Site Plan, Figure 2.

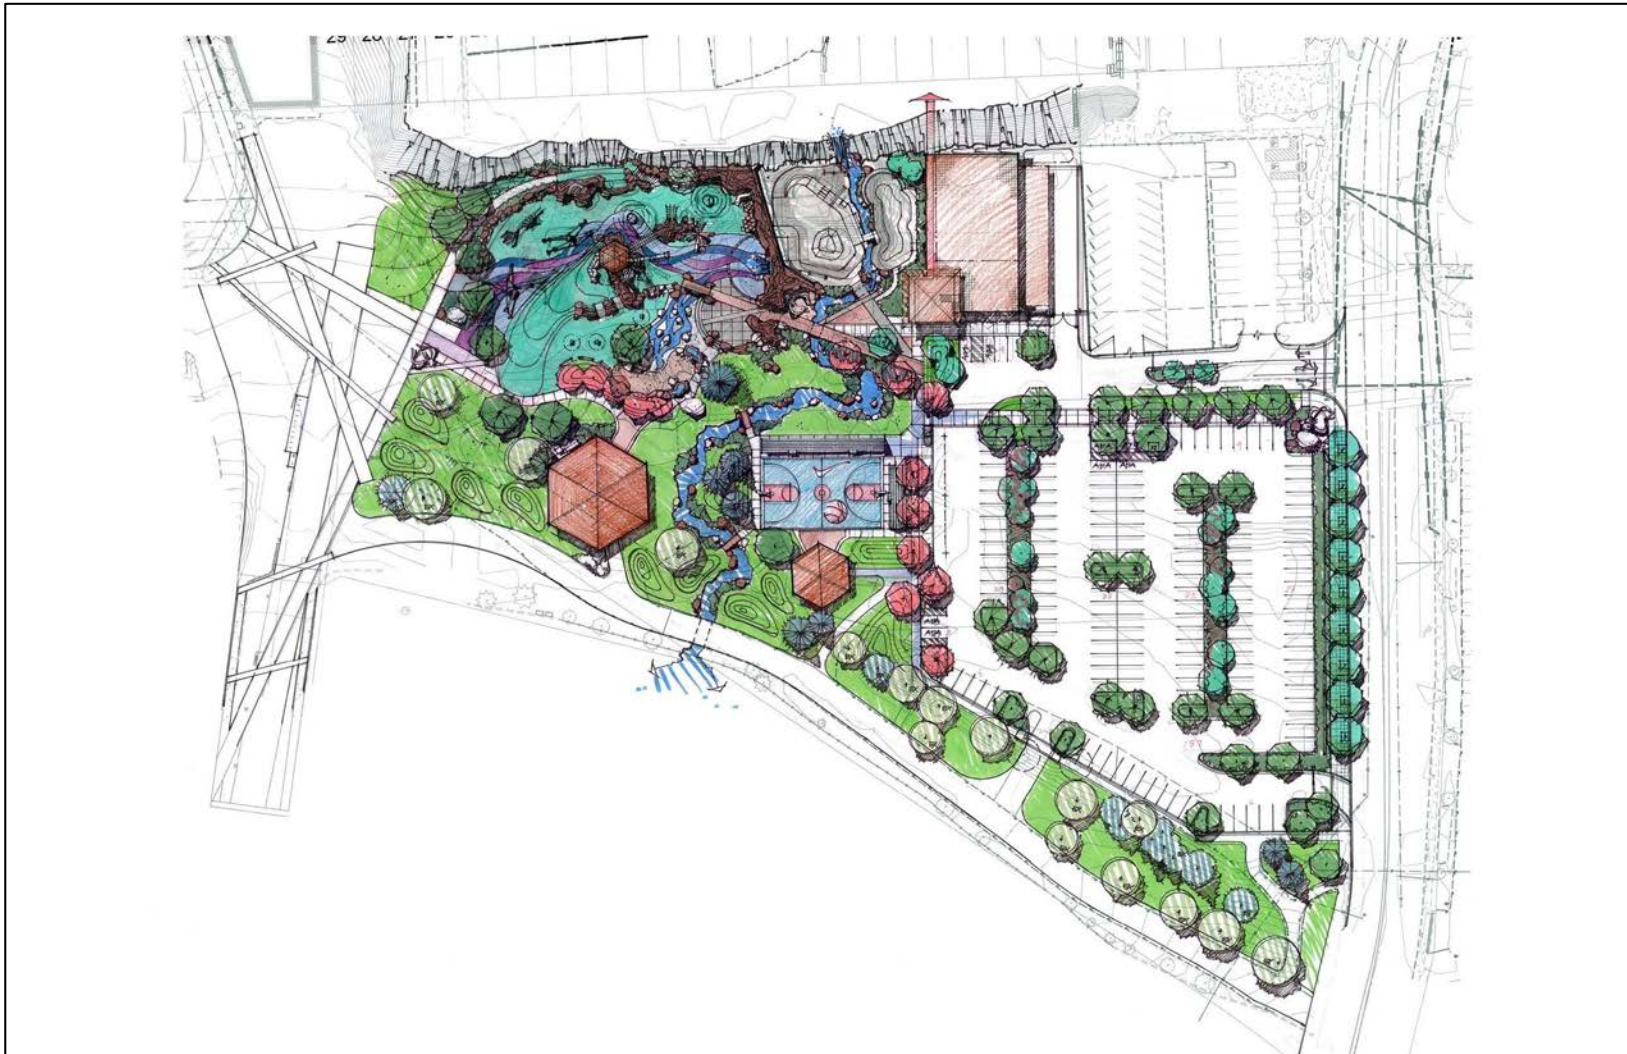
Figure 3

Conceptual Design: North Bank

The North Bank project will redevelop an area previously used as multiple parking lots and where the Central Park Maintenance (CPM) building is located. New project features include a new CPM building, playground and wheel park along the northern boundary and a new parking area along Washington Street as shown on Conceptual Design: North Bank, Figure 3. A new basketball court is also planned near the center of the North Bank and a dry creek bed will run from north to south through the project site.

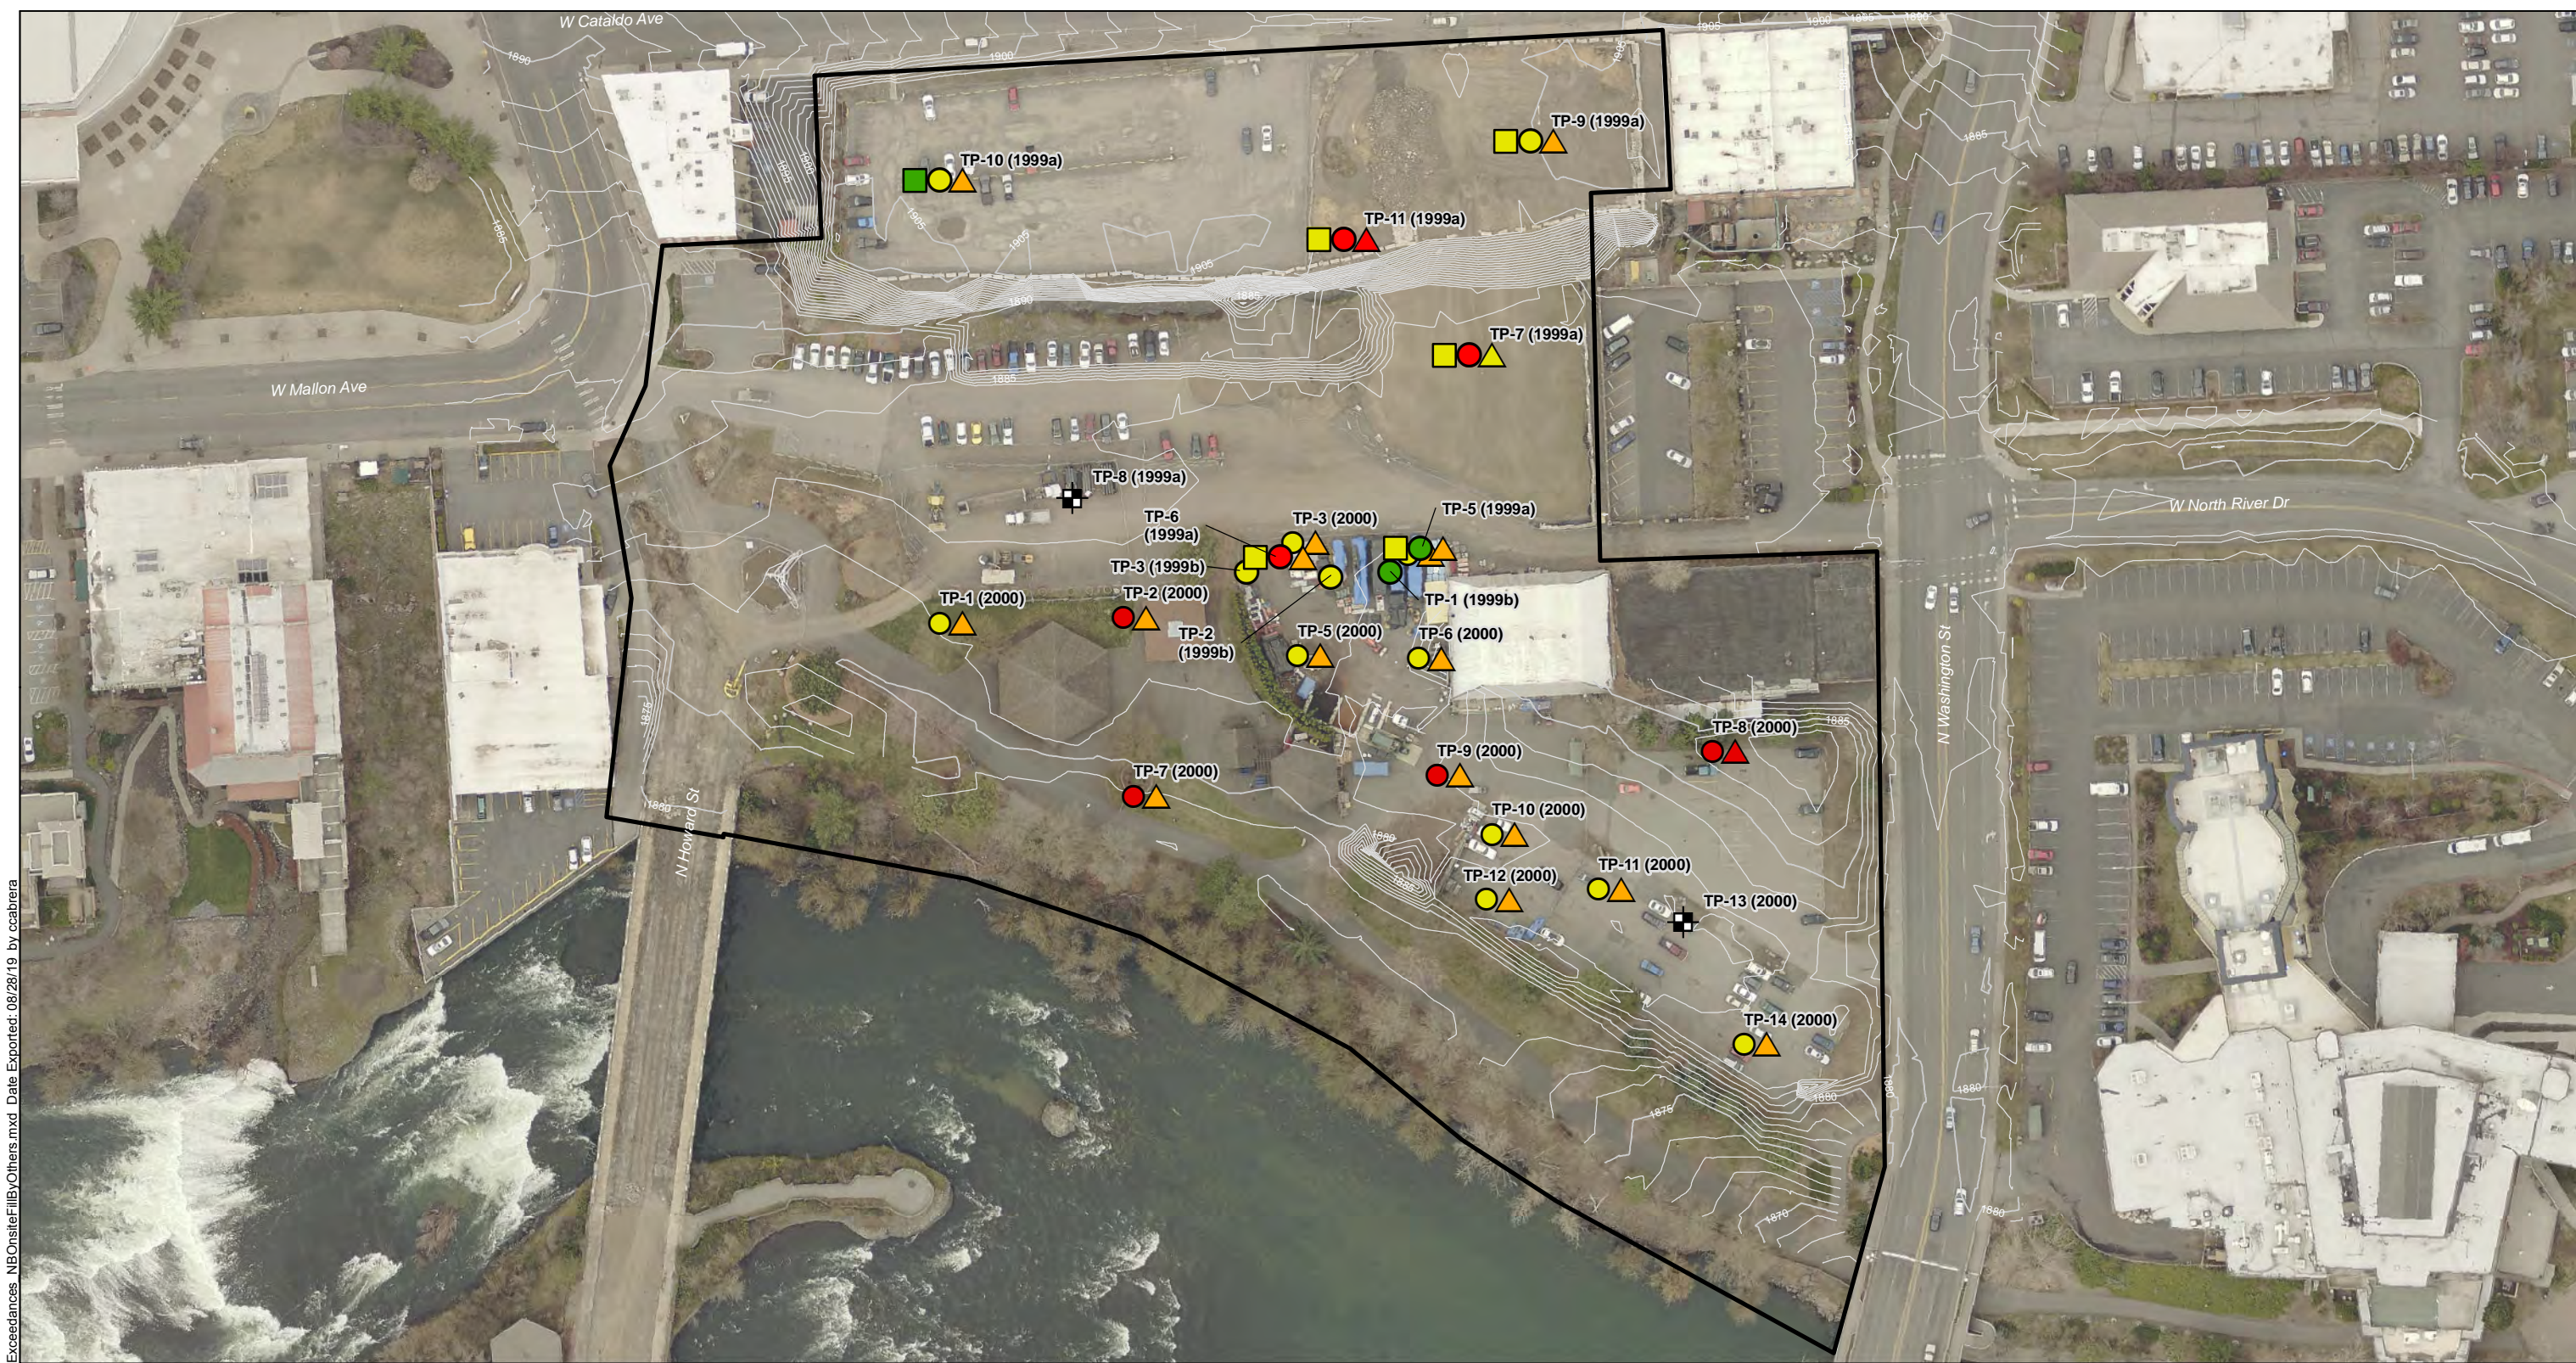
● Contaminated – Concentration greater than MTCA Method A Cleanup Level for one or more COC analyzed	 North Bank Approximate Limits of Improvement
● Contaminated – COCs were not detected, however laboratory reporting limits were greater than the MTCA Method A Cleanup levels	 TPH
● Impacted – Concentration less than MTCA Method A Cleanup Levels and greater than laboratory reporting limits or twice the available background metals concentration for each COC analyzed	 Metals
● Clean – Concentration less than laboratory reporting limits or near available background metals concentrations for each COC analyzed	▲ PAH
■ Test Pit Soil Sample Not Analyzed

**Exploration Locations and Analytical Results:
CH2M Hill 1999 and 2000**

Exploration Locations and chemical analytical results for the 1999 and 2000 are shown on Figure 4 and locations and results for the 2016, 2017 and 2019 sampling efforts are shown on Figure 5. Table I summarizes chemical analytical results greater than MTCA Method A Cleanup Levels for samples collected from the North Bank geotechnical and environmental assessments.
