Figure 7
Solid Wood Incorporated Site
(West Bay Park)
Olympia, Washington
Interim Action Areas

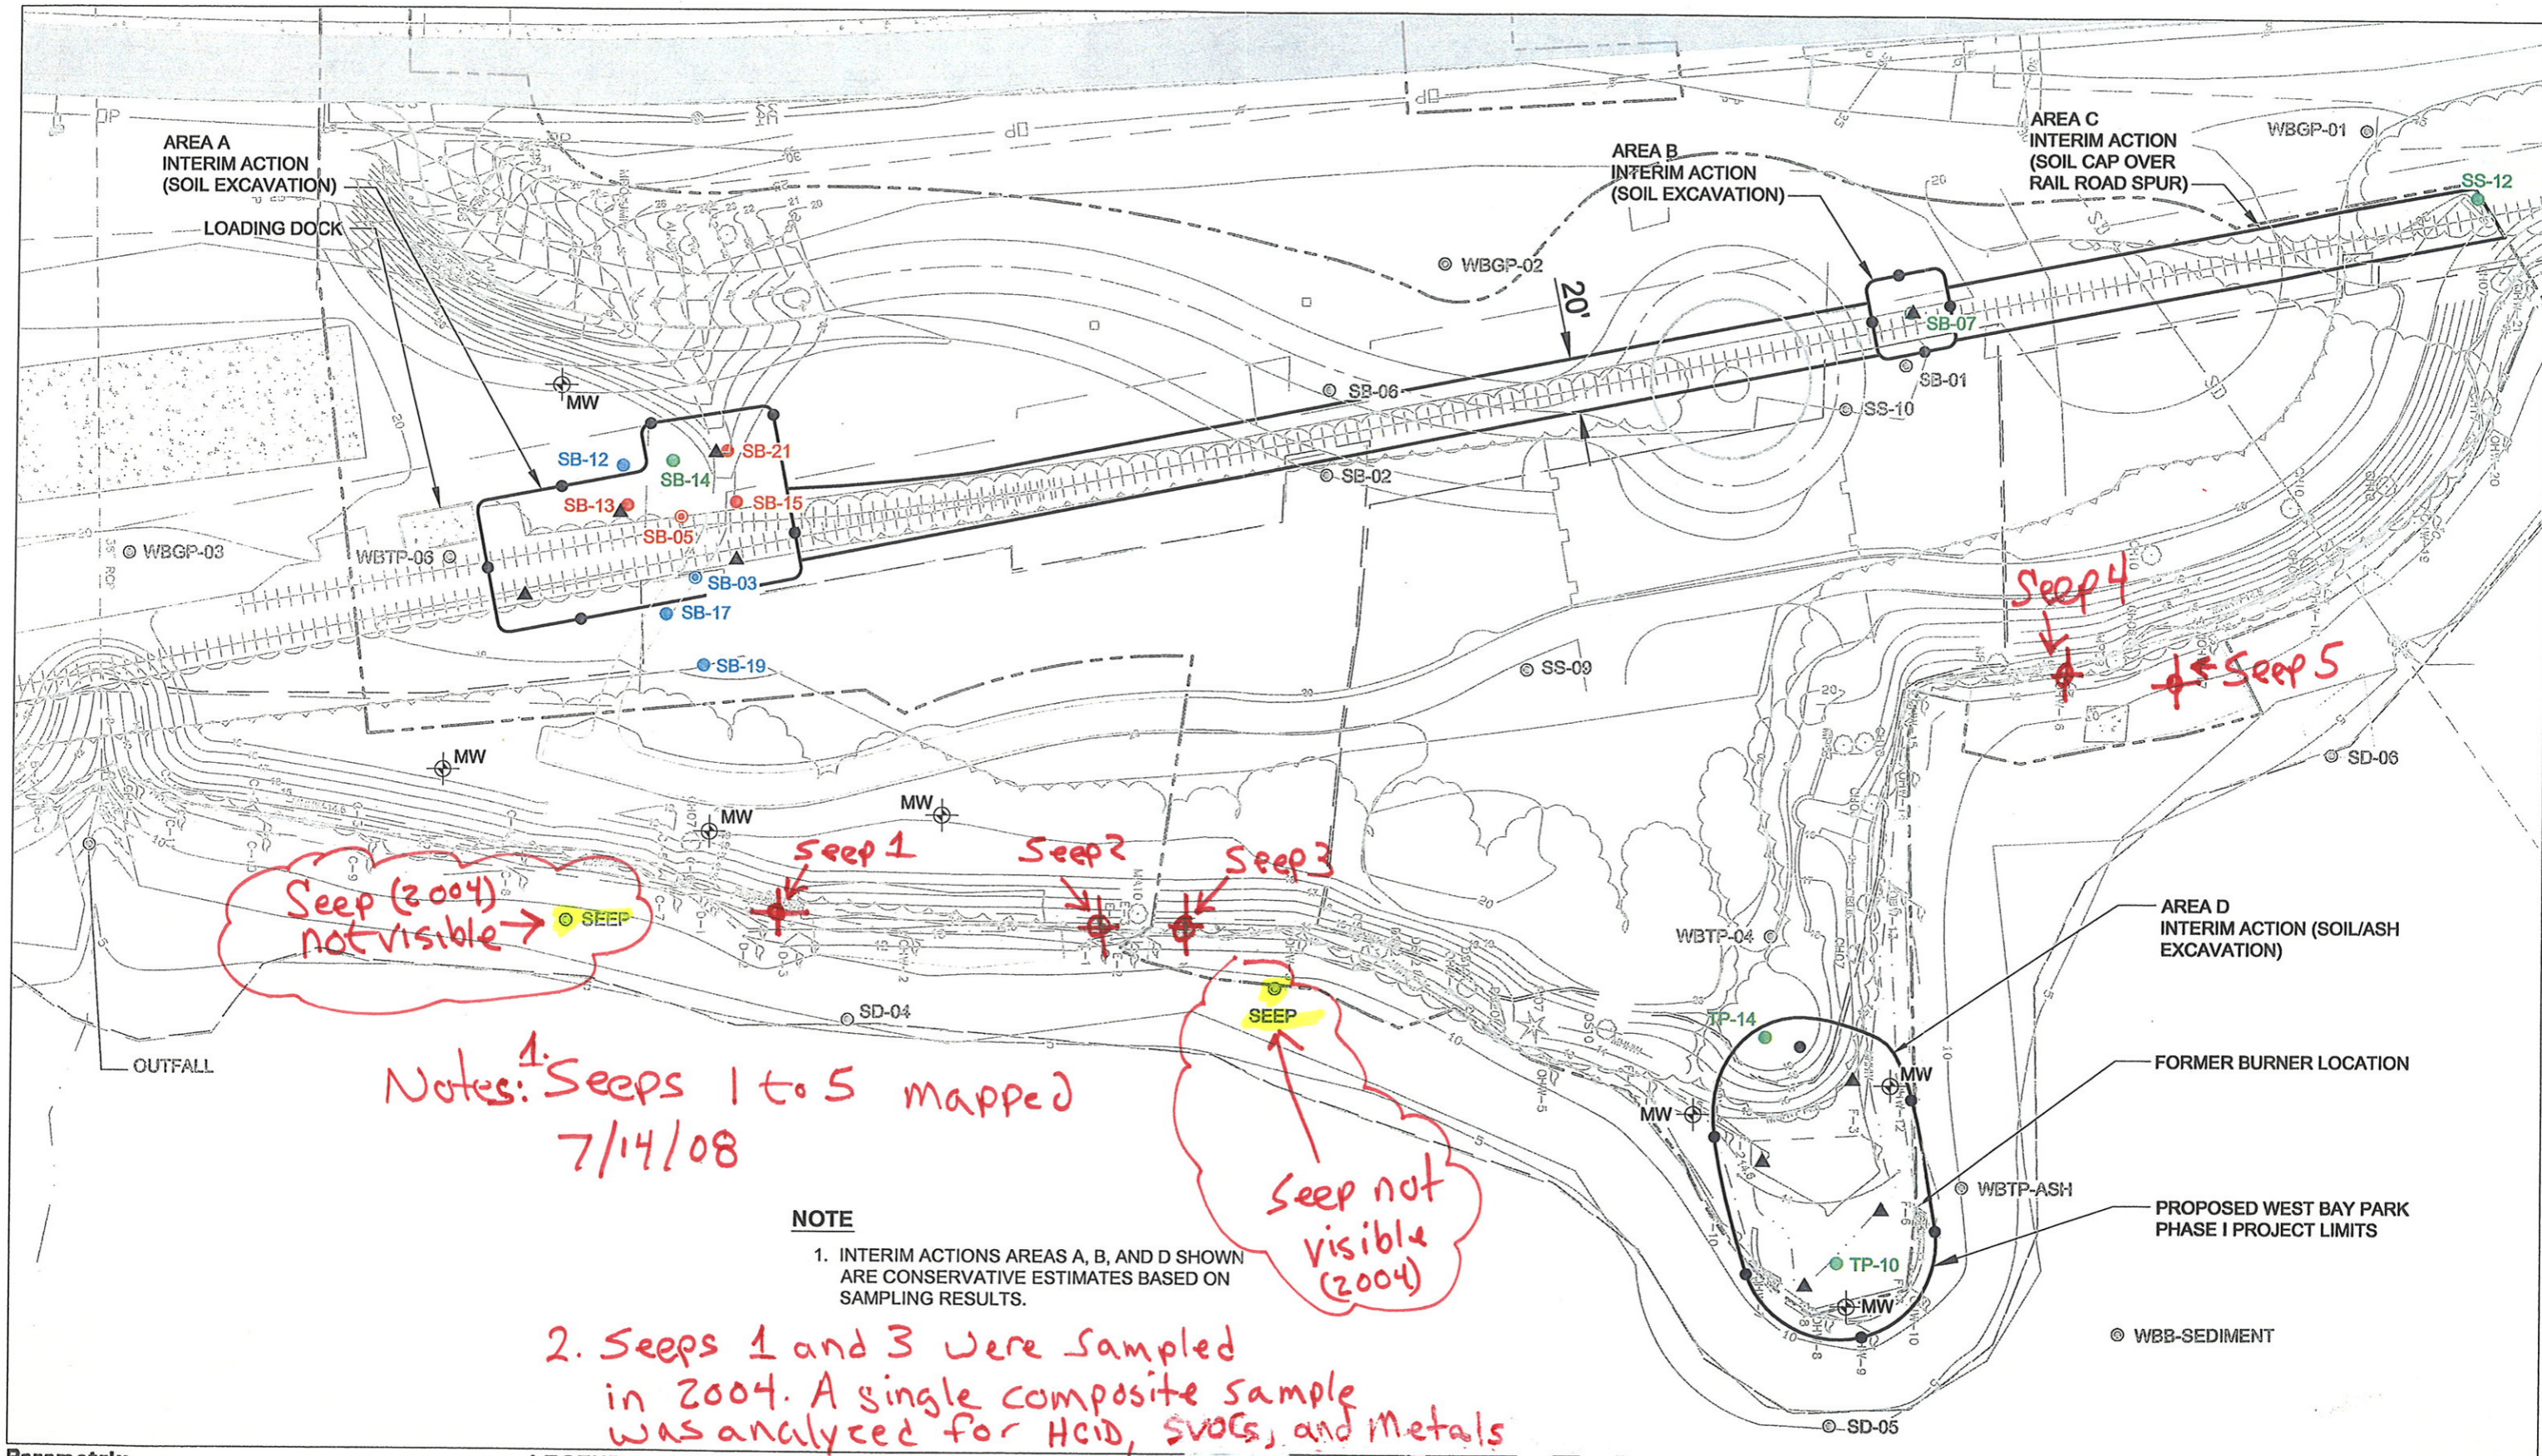
Notes: 1. Seeps 1 to 5 mapped
7/14/08

1. INTERIM ACTIONS AREAS A, B, AND D SHOWN ARE CONSERVATIVE ESTIMATES BASED ON SAMPLING RESULTS.

2. Seeps 1 and 3 were sampled in 2004. A single composite sample was analyzed for HClD, SVOCs, and Metals
