Re: No Further Action at the following Site:

- **Site Name:** L & E Auto Sales
- **Site Address:** 227 Naval Ave & 2101 Burwell Pl, Bremerton, WA 98312
- **Facility/Site No.:** 14170
- **VCP Project No.:** NW2785
- **Cleanup Site No.:** 11943

Enclosure A

Description and Diagrams of the Site

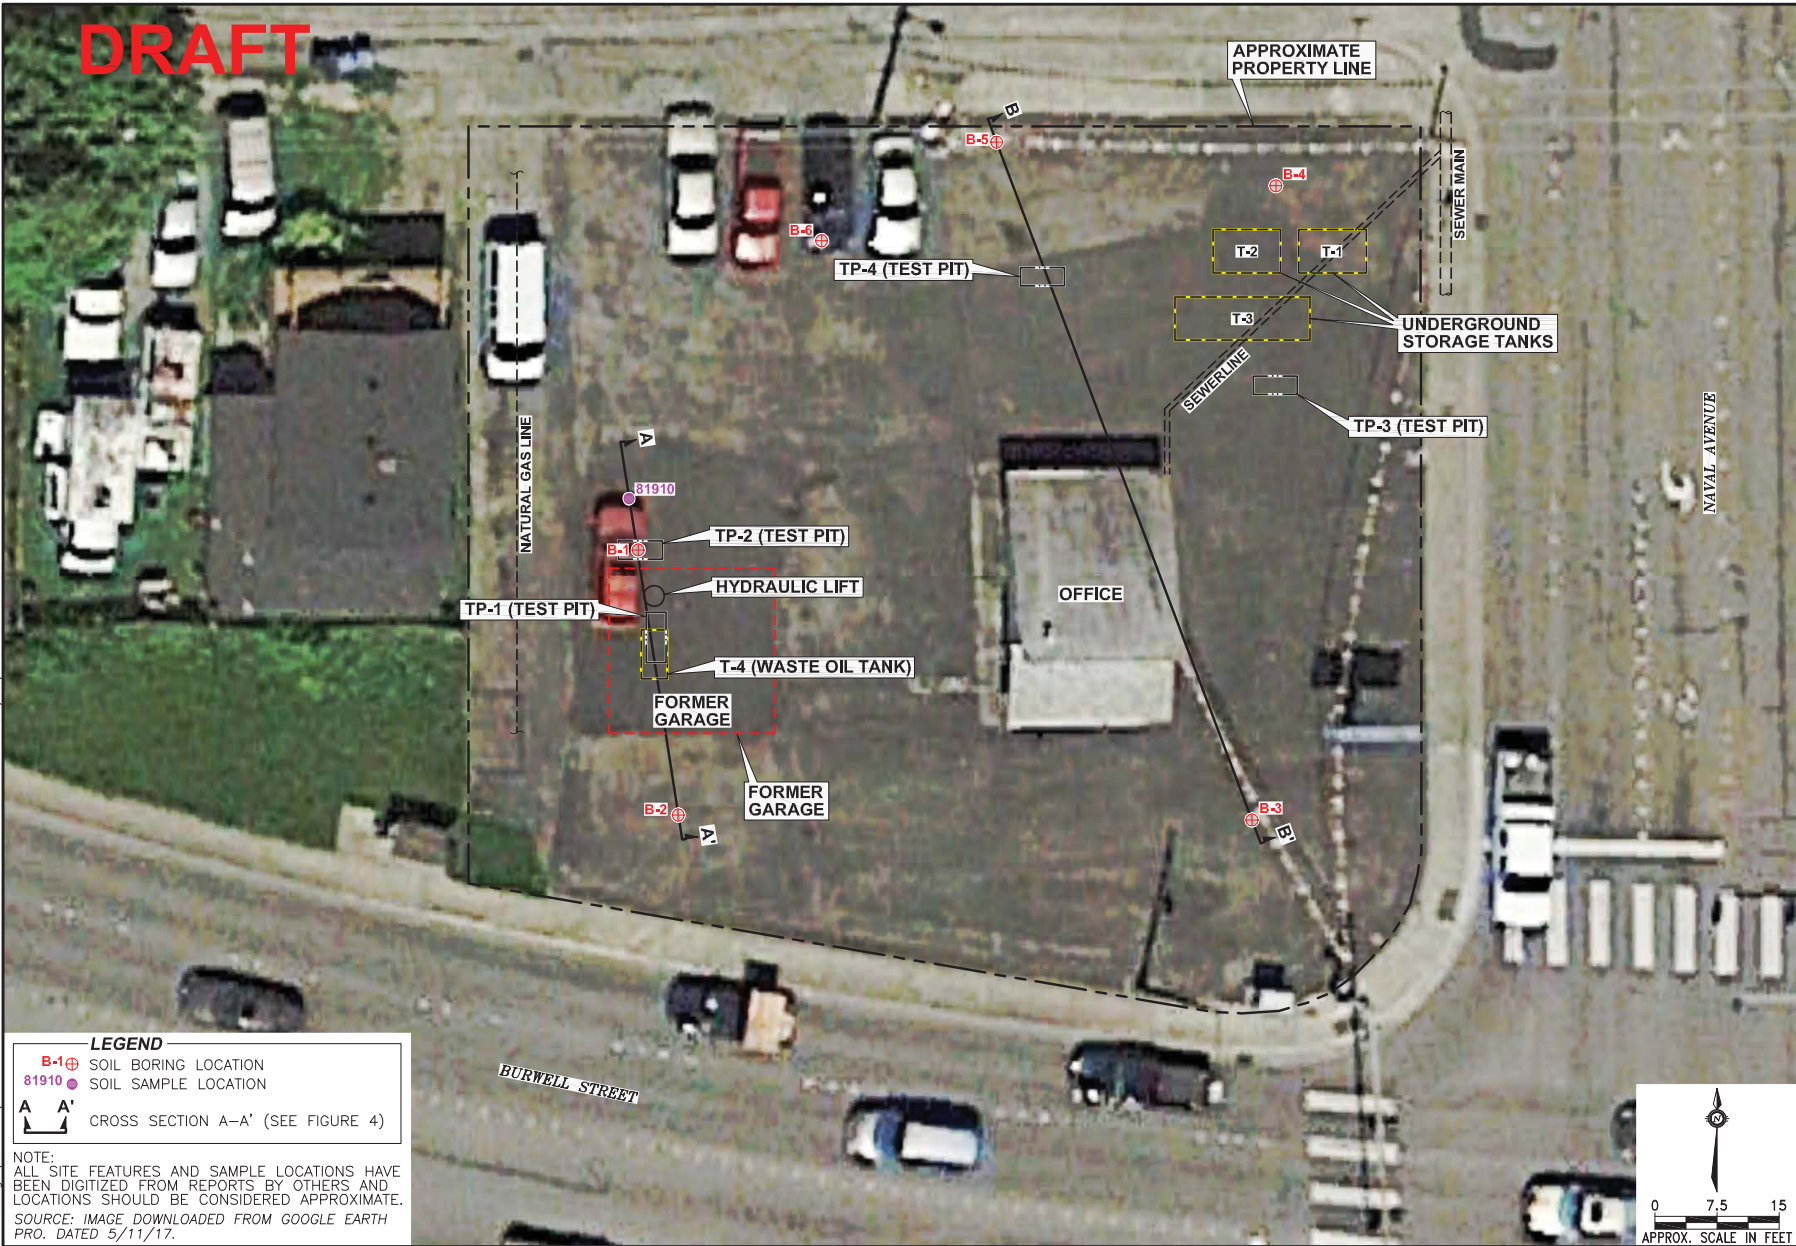
Enclosure A, Figure 2

Site History and Current Use: The Site is noted to have been previously used as a taxi cab stand, but the dates of this use are unknown. Historical aerial photograph review in 2010 indicated the former presence of three pump islands at the northeastern portion of the Property. Concurrent Kitsap County file review indicated that three USTs were present at the Property. Four USTs were removed from the Property in 2010. These included two 1,000-gallon steel tanks and one 2,000-gallon steel tank believed to have been used for gasoline storage, and one 250-gallon steel UST used to store waste oil. One hydraulic lift was also identified near the former waste oil tank. The Property has one building that is reportedly vacant and a gravel parking area. Locations of Site features are shown on **Figure 2**.

Release and Extent of Contamination: In 2010, historical research identified three likely dispenser island locations and the potential presence of three USTs at the Site. Six borings advanced at the Site indicated that TPHo was detected at concentrations greater than MTCA Method A soil cleanup levels at location B-1 (**Figure 2**).

SITE DETAIL AND SAMPLING LOCATIONS

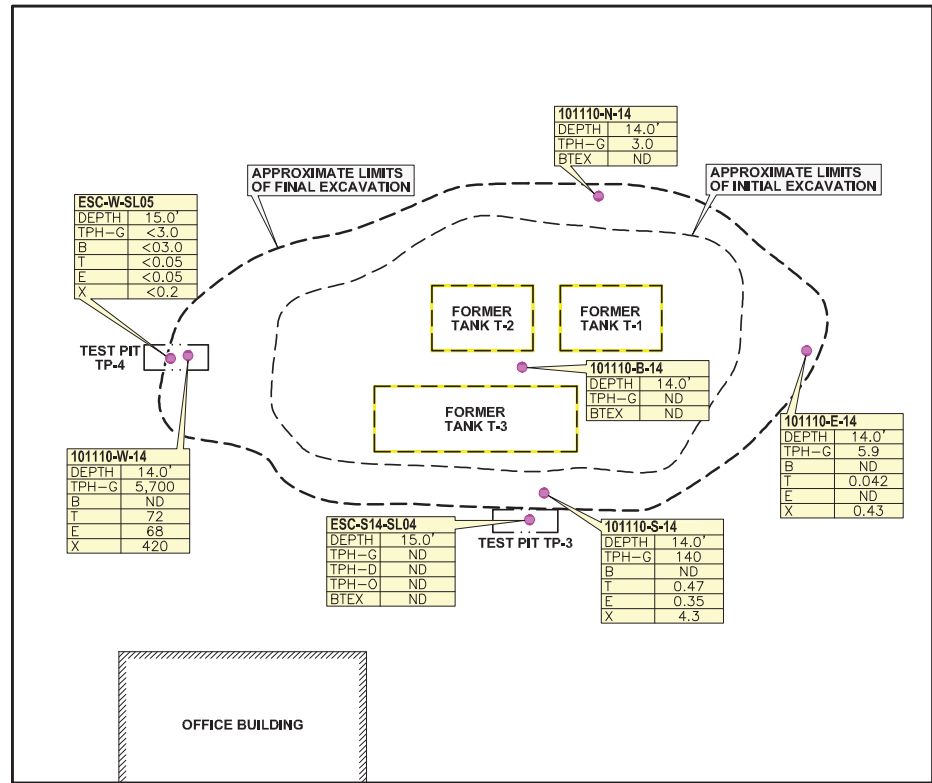
Enclosure A, Figure 4

Soil samples collected from below each of the former gasoline tanks at depths of approximately 8 to 12 feet bgs contained TPHg and one or more of the BTEX compounds at concentrations greater than MTCA Method A soil cleanup levels. One base sample was collected from the gasoline UST excavation at 14 feet bgs, but it was not located directly beneath any of the previous samples collected under the USTs that showed TPHg concentrations up to 20,000 mg/kg. Therefore, the base sample did not confirm that the over excavation removed contamination above Method A cleanup levels.

Soil samples collected beneath and in the vicinity of the former waste oil UST showed concentrations of TPHd and TPHo above MTCA Method A soil cleanup levels. Site reports do not specify if contaminated soil was totally removed from the area below and around the waste oil UST.

ANALYTICAL RESULTS IN mg/kg

FUEL TANK EXCAVATION, SAMPLING, AND RESULTS

Additional soil samples were collected from test pits in 2013, to further assess the extent of soil impacts (see **Figures 3 and 4**). These samples provided information to bound the horizontal extent of soil impacts in the vicinity of the former gasoline and waste oil USTs.
