**RE: CONFIRMATIONAL GROUNDWATER MONITORING AND SAMPLING
STATUS REPORT – 2019
FORMER EVERGREEN FUEL FACILITY
661 EAST PINE STREET, SHELTON, WASHINGTON
FARALLON PN: 863-001**

CONFIRMATIONAL GROUNDWATER MONITORING AND SAMPLING STATUS REPORT – 2019

**Former Evergreen Fuel Facility
661 East Pine Street
Shelton, Washington**

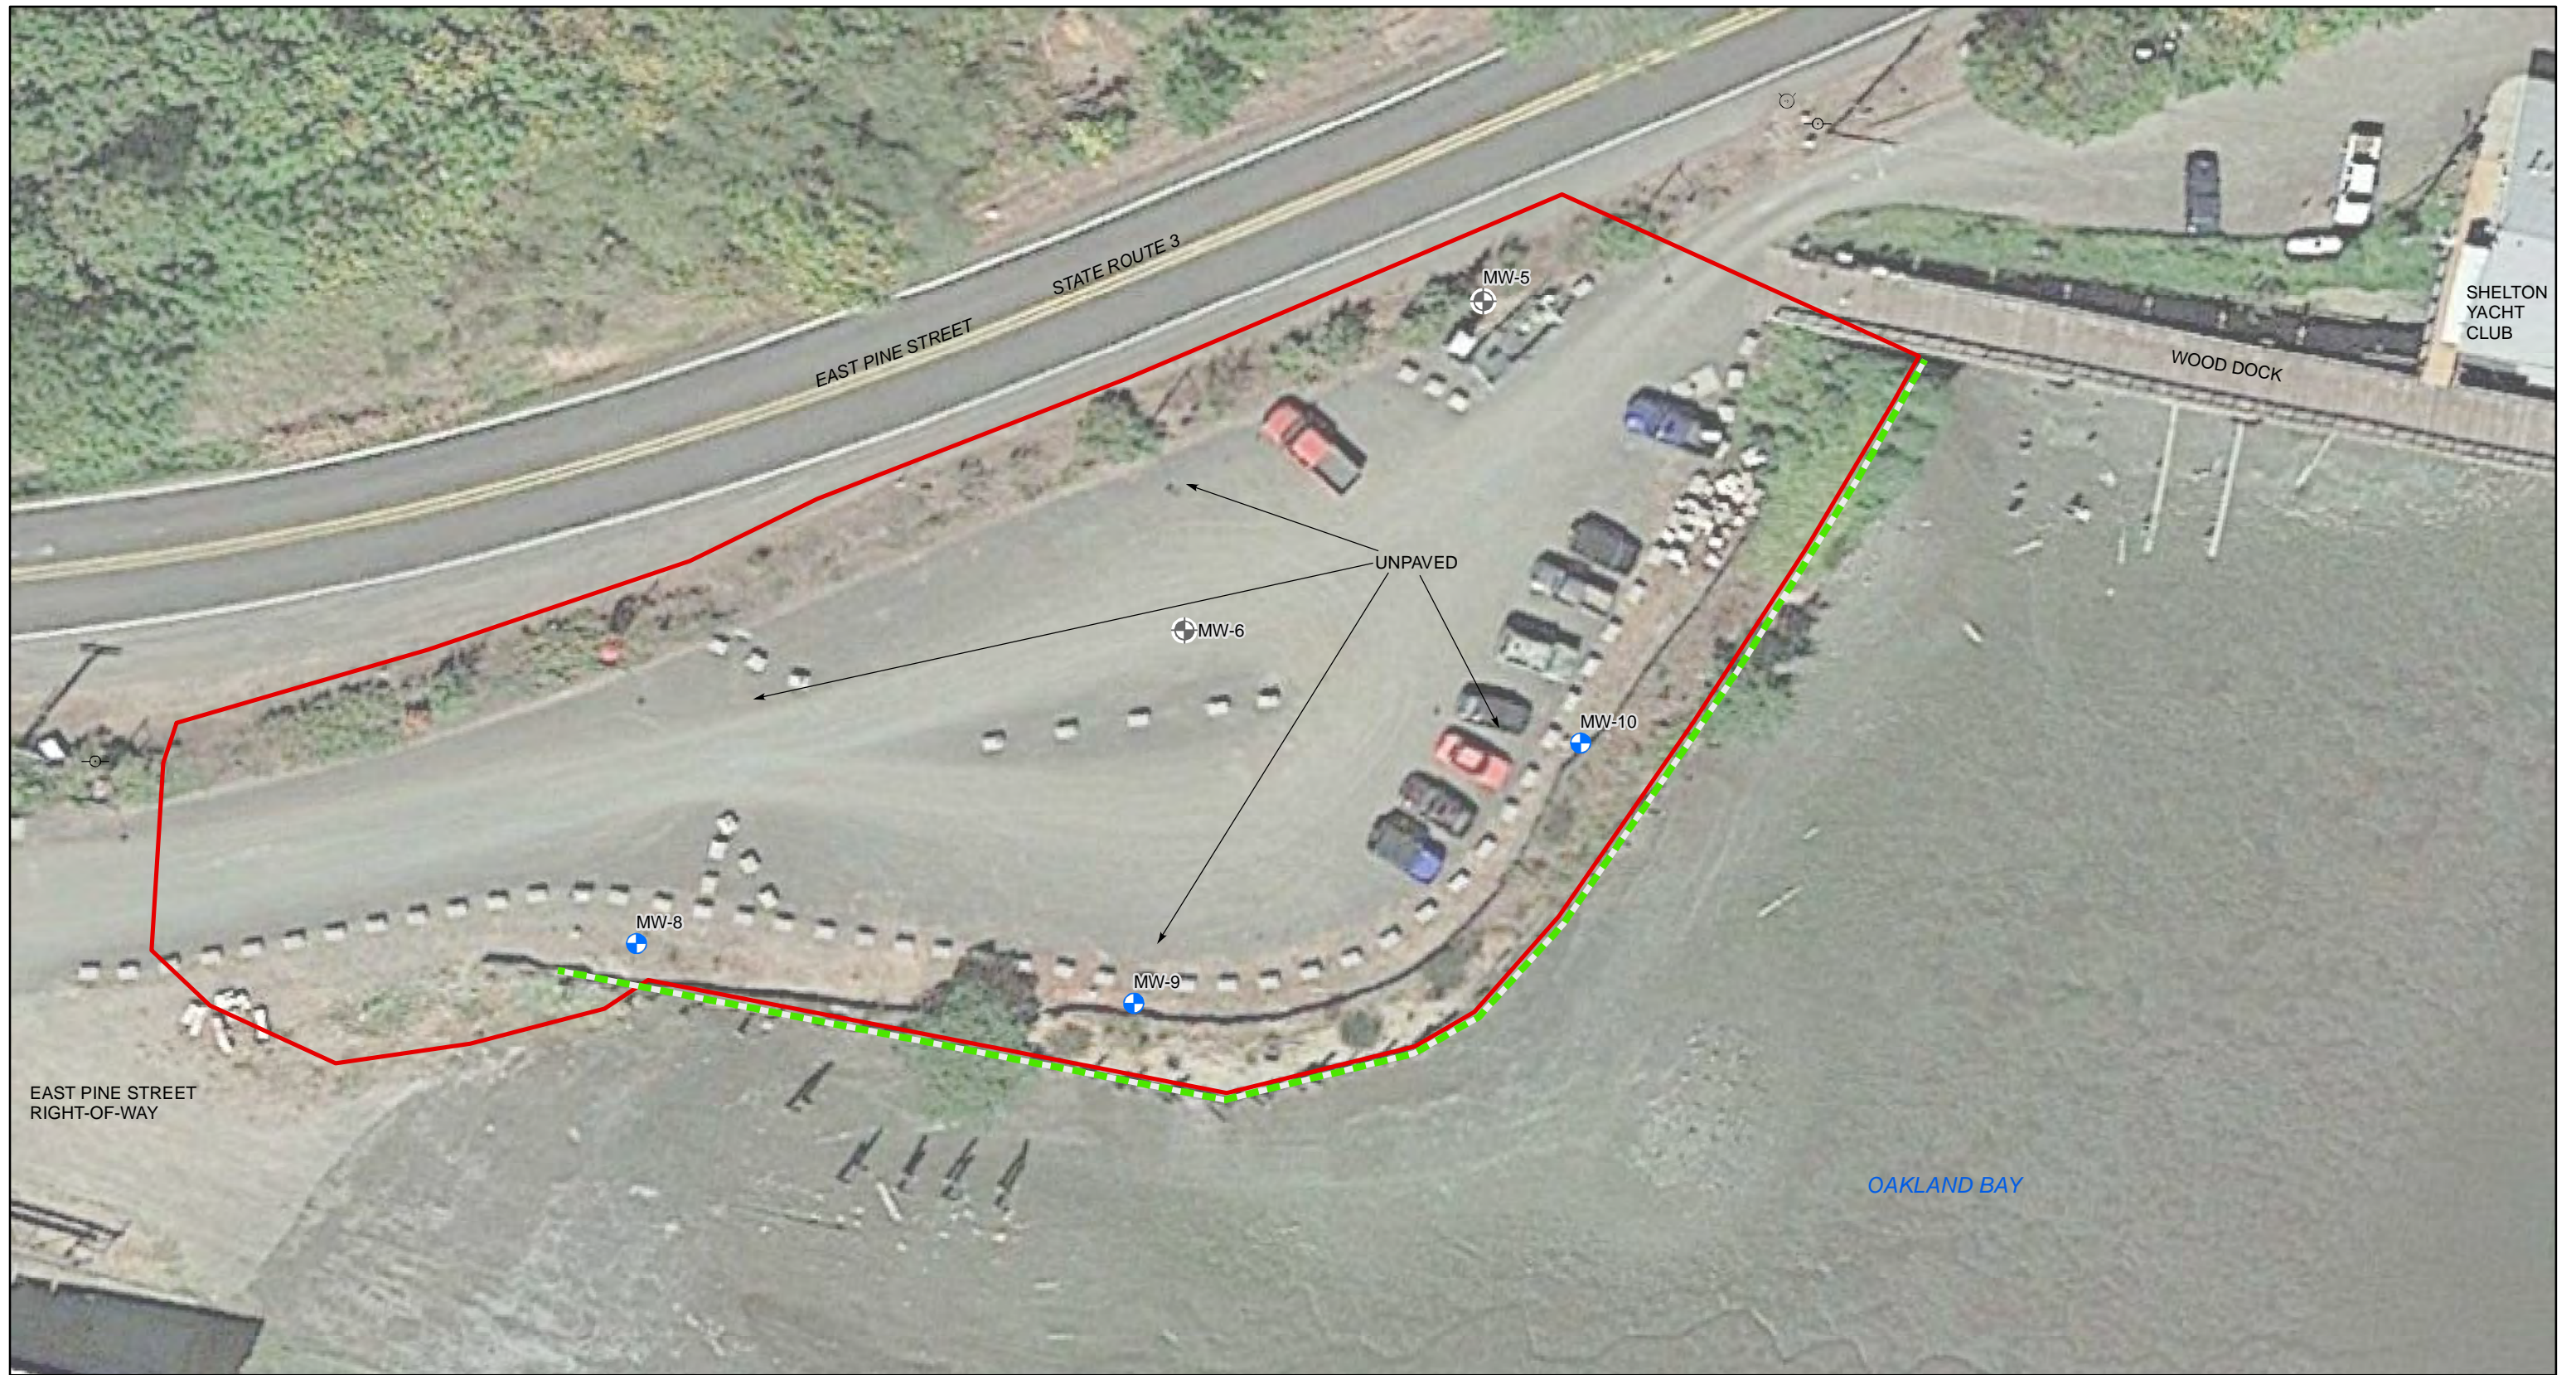
FIGURE 2
SITE PLAN
FORMER EVERGREEN FUEL FACILITY
661 EAST PINE STREET
SHELTON, WASHINGTON

Confirmational groundwater monitoring and sampling events were conducted on June 27 and December 5, 2019 at monitoring wells MW-8 through MW-10 (Figure 2). The confirmational groundwater monitoring included measuring the depth to groundwater at all accessible monitoring wells and collecting groundwater samples for laboratory analysis from monitoring wells MW-8 through MW-10. Upon Farallon's arrival at the Site, monitoring wells MW-8 through MW-10 were opened, and the water level was permitted to equilibrate with atmospheric pressure for a minimum of 15 minutes before groundwater levels in the wells were measured. Groundwater levels were measured to an accuracy of 0.01 foot using a water-level meter.

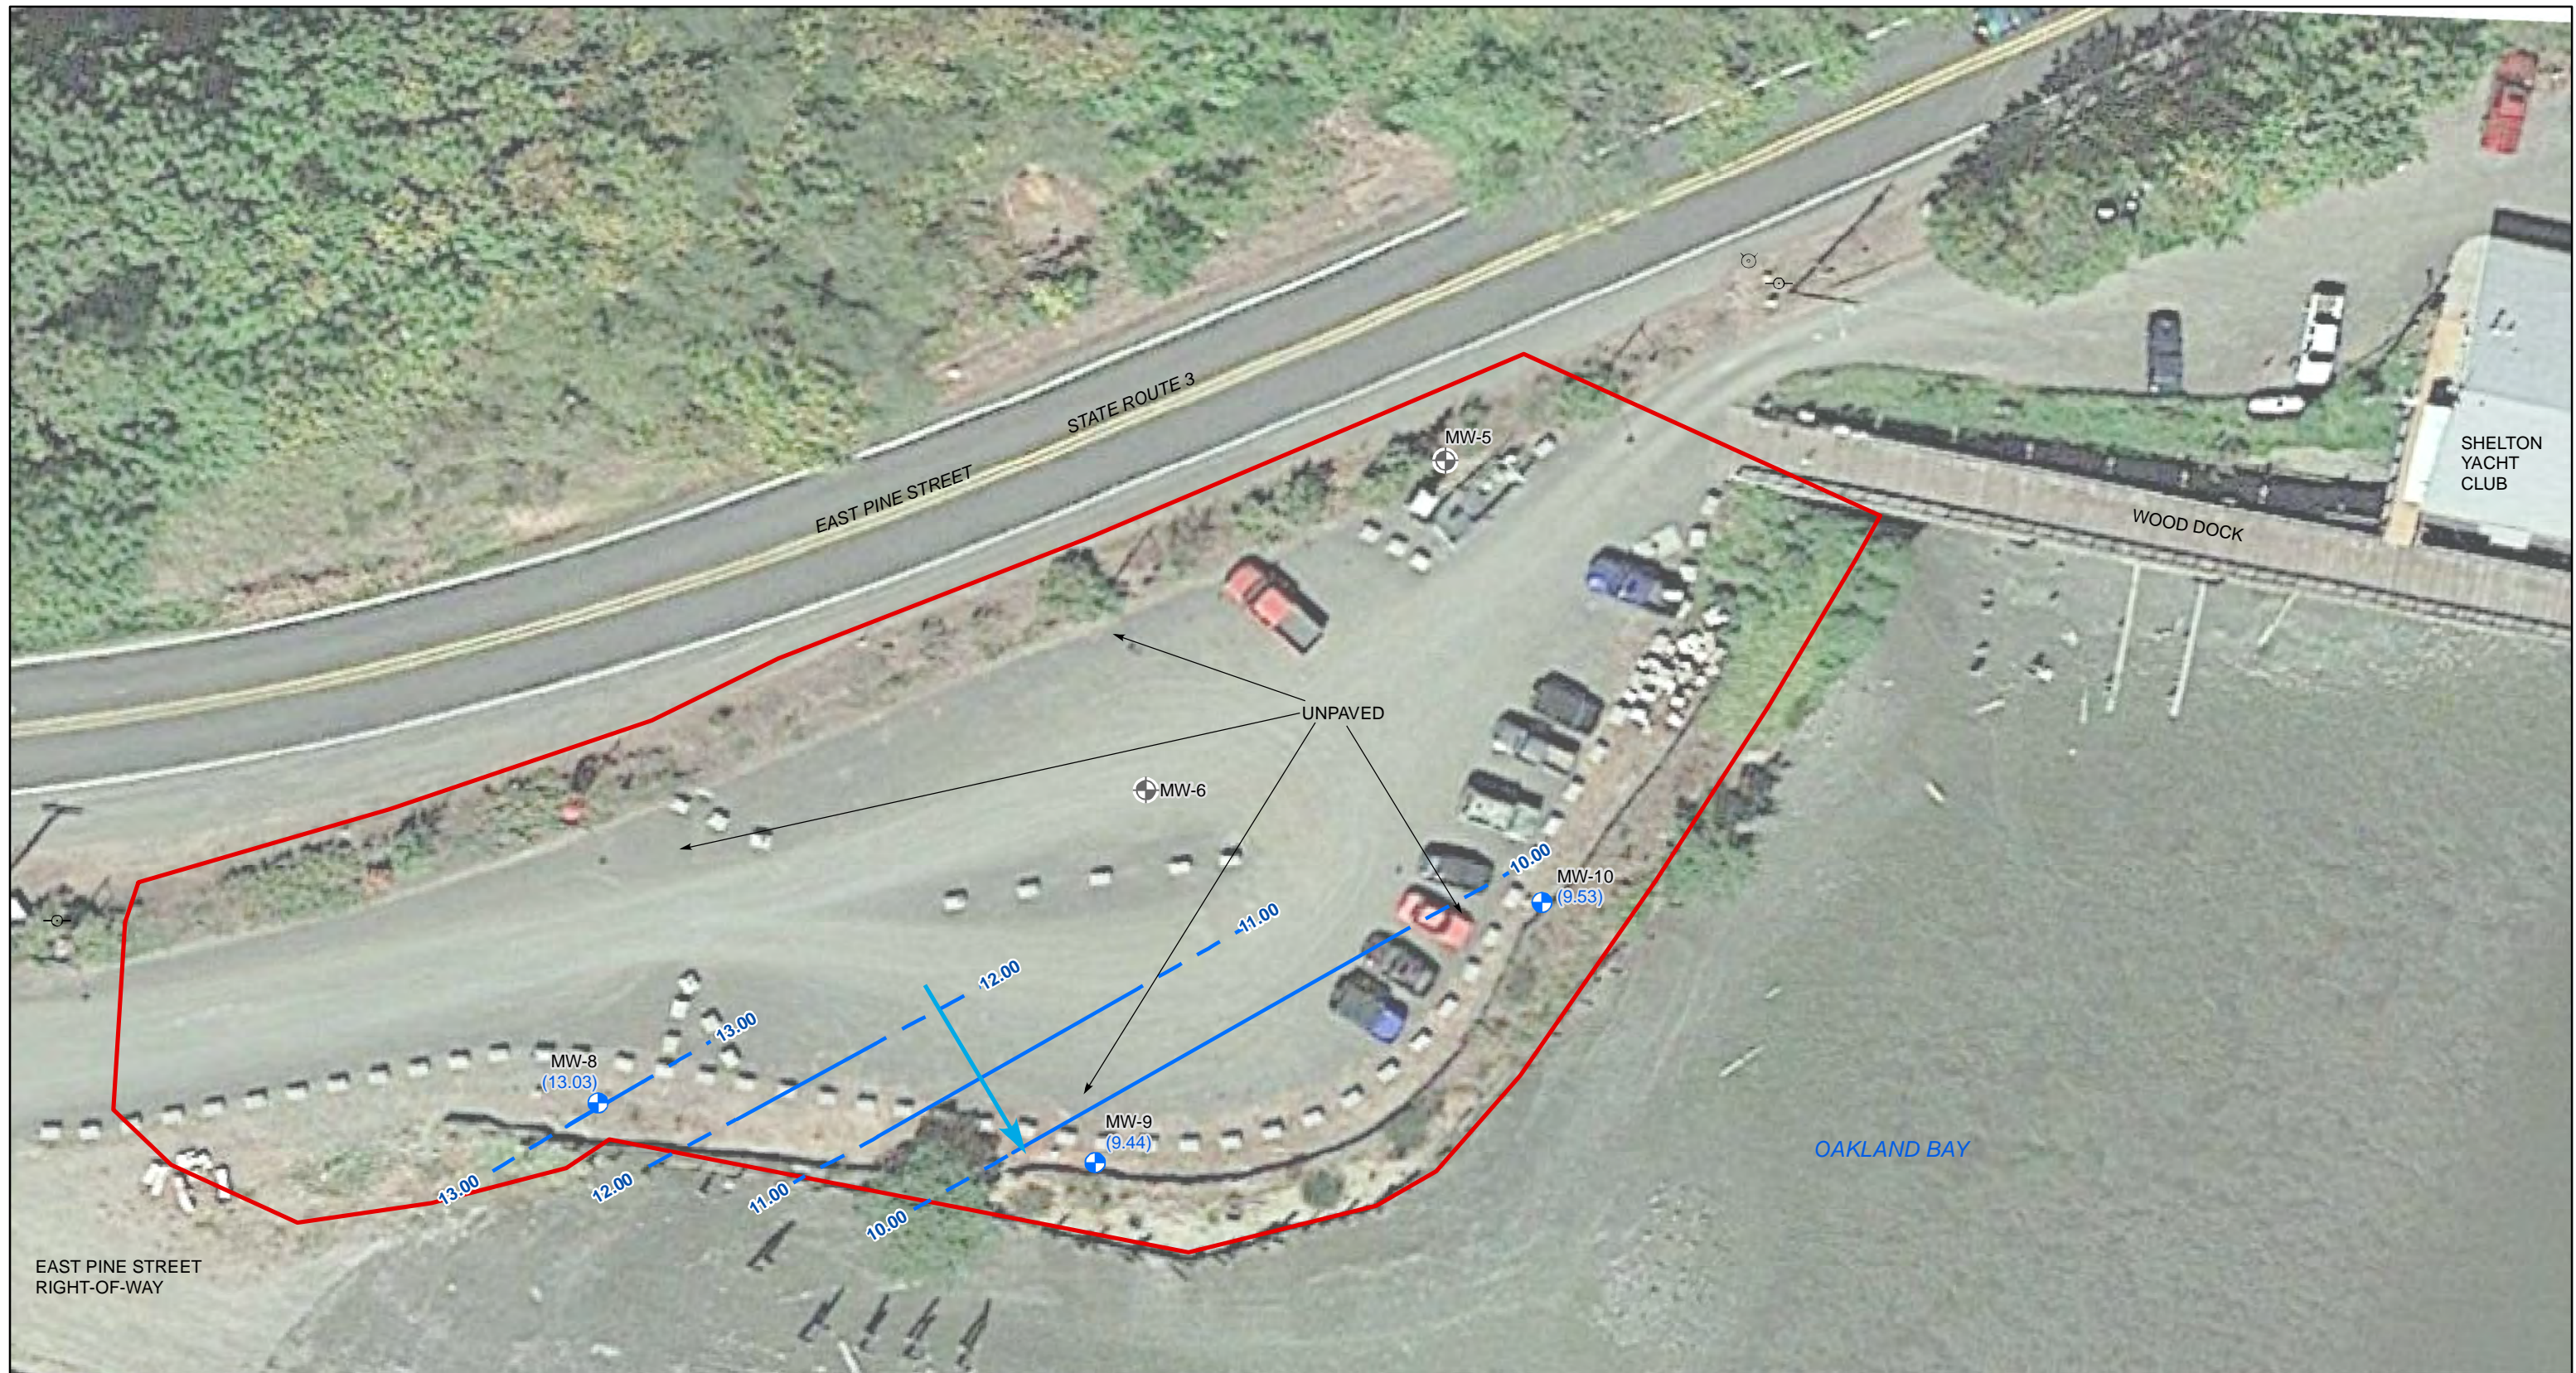
FIGURE 3
 GROUNDWATER ELEVATION CONTOURS AND FLOW DIRECTION
 JUNE 27, 2019
 FORMER EVERGREEN FUEL FACILITY
 661 EAST PINE STREET
 SHELTON, WASHINGTON
 FARALLON PN: 863-001

June 27 and December 5, 2019 groundwater elevation data indicate a southeastern groundwater flow direction toward Oakland Bay (Figures 3 and 4). During the June 27, 2019 confirmational groundwater monitoring event, groundwater levels were measured during a low tide cycle, which had a minimum height of 2.02 feet above mean sea level at 10:05 a.m. according to National Ocean Service tidal prediction data accessed on January 17, 2020¹. During the December 5, 2019 confirmational groundwater monitoring event, groundwater levels were measured during a high tide cycle, which had a maximum height of 14.30 feet above mean sea level at 1:27 p.m. according to the National Ocean Service tidal prediction data accessed on January 17, 2020².
