THIRD AMENDMENT
TO AGREED ORDER

No. DE 3441

January 2020
Central Waterfront Site
Bellingham, Washington

Final Cleanup Action Plan

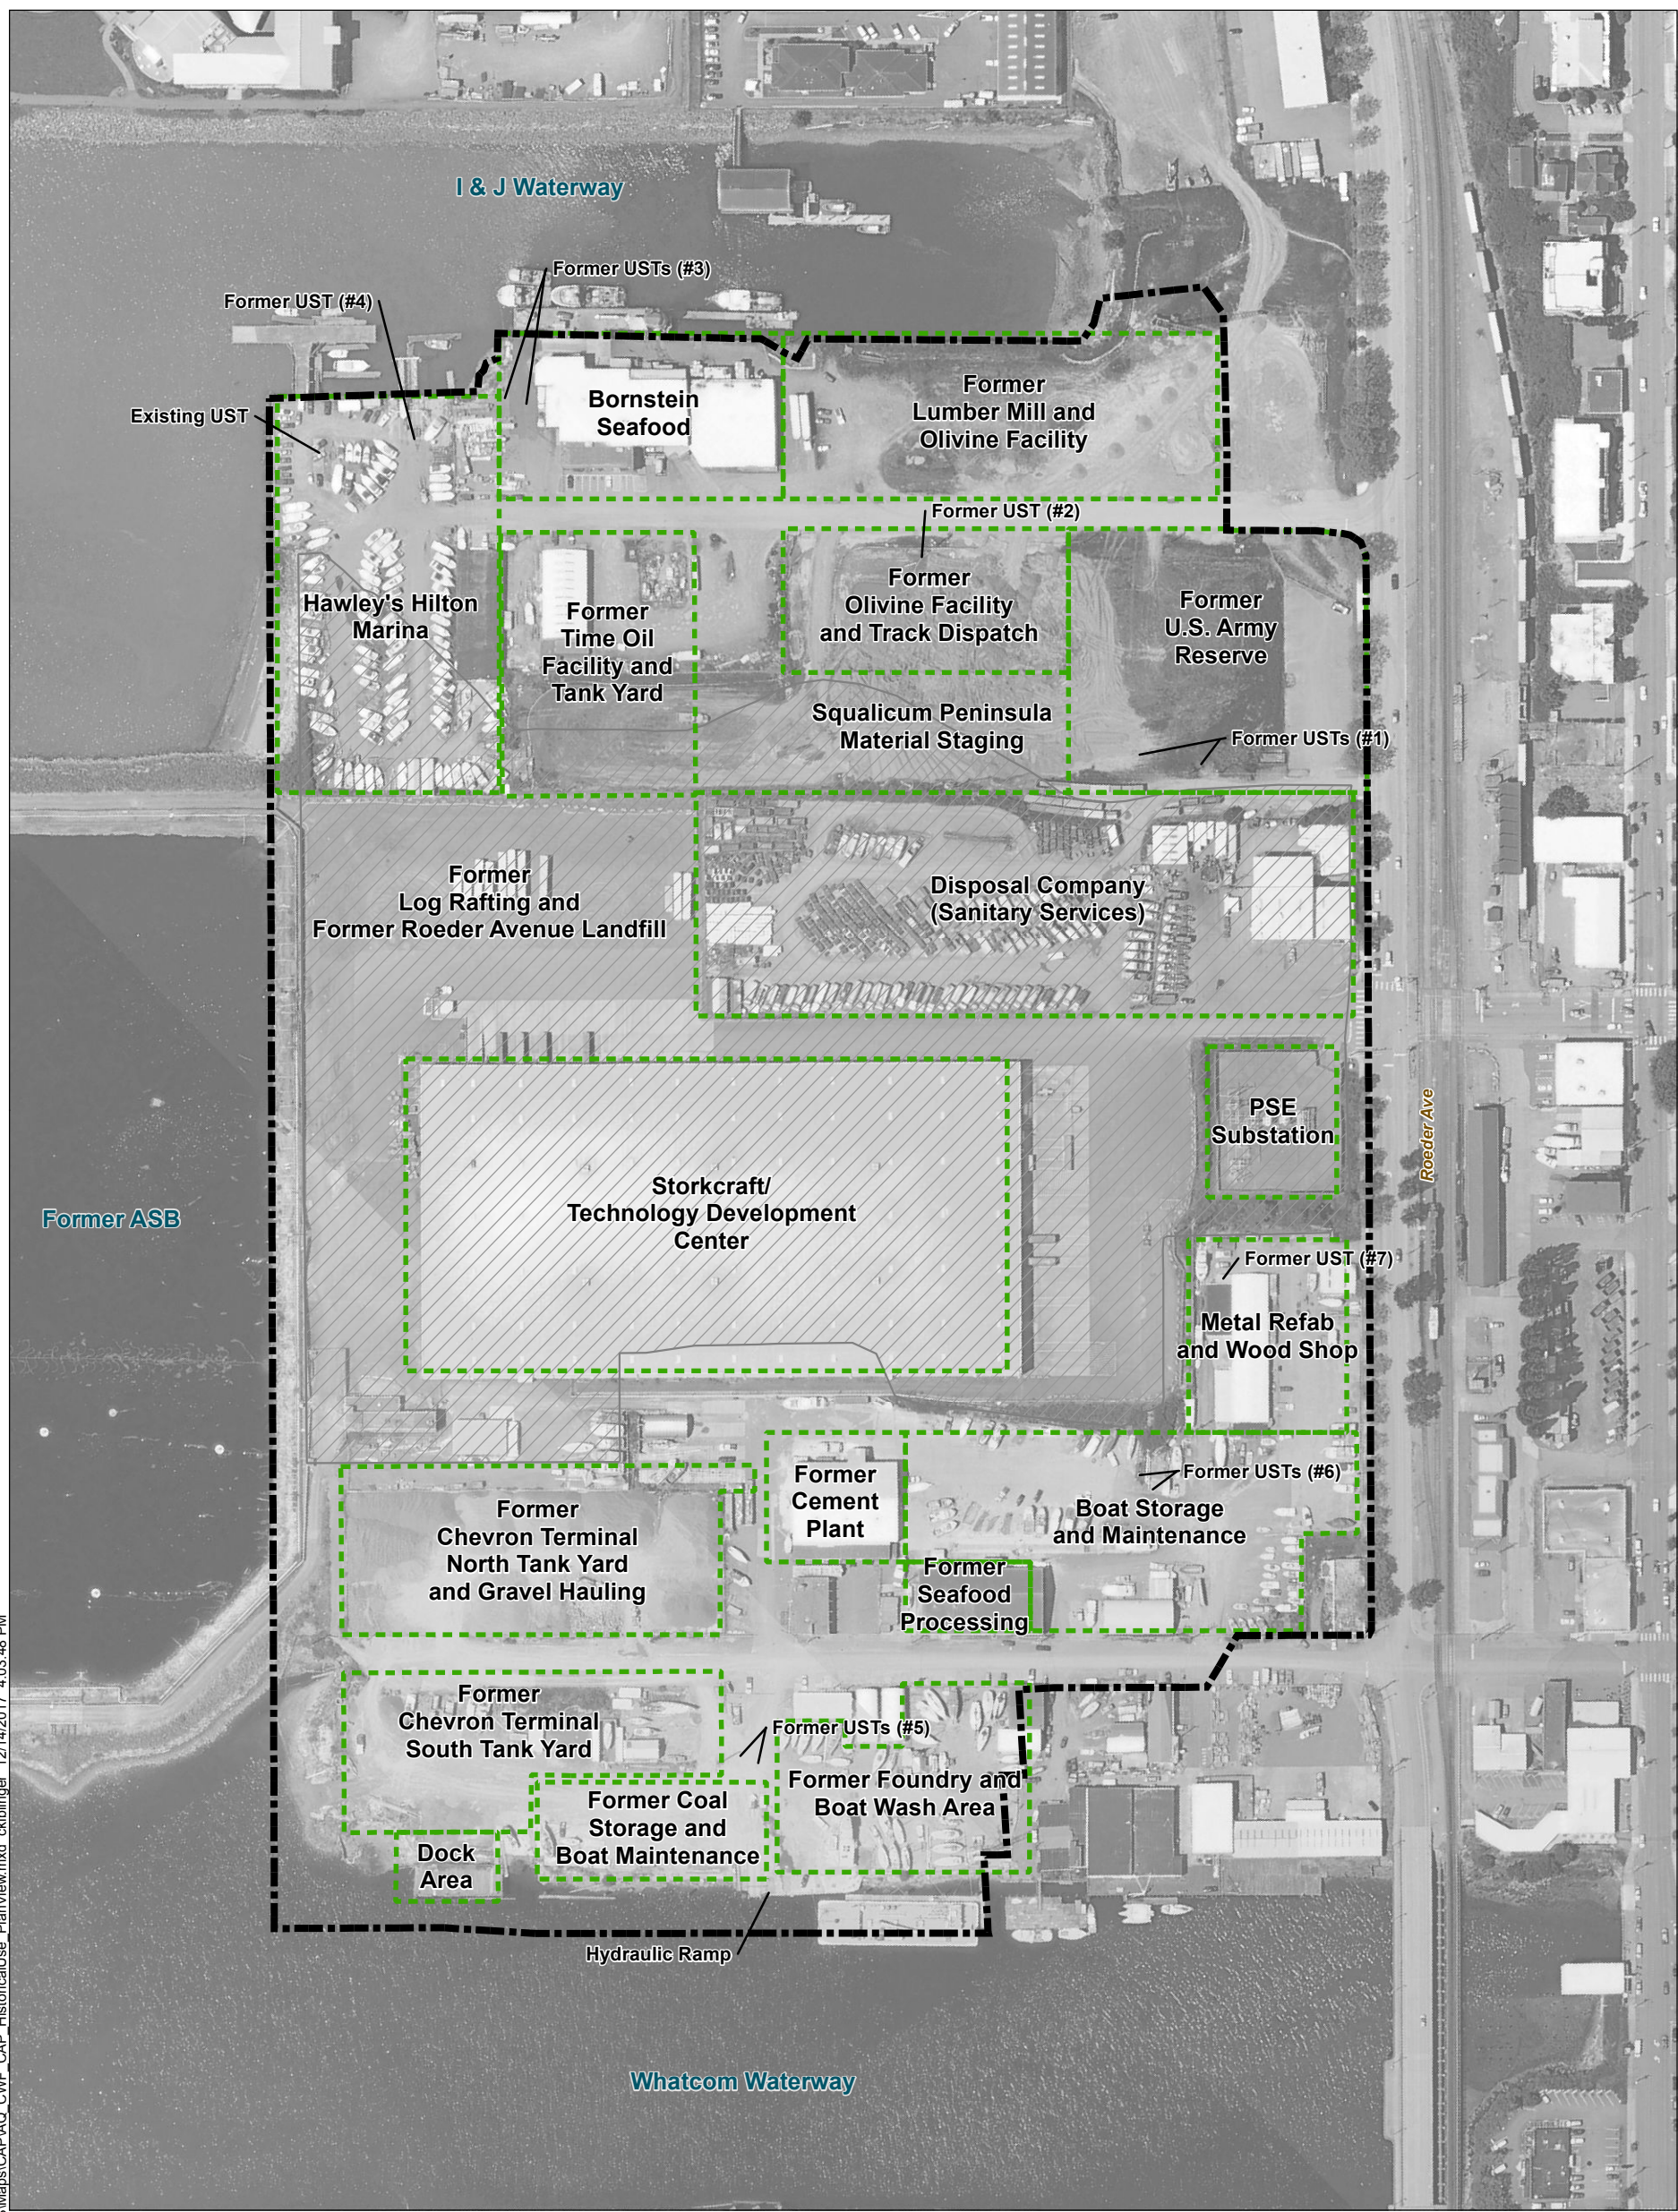
- Central Waterfront Site Boundary
- Former Roeder Avenue Landfill and Log Rafting
- Historical Operations Areas

Figure 2-1
 Historical Site Operations and Land Use
 Cleanup Action Plan
 Central Waterfront Site
 Bellingham, WA

- Decommissioning of eleven USTs at seven locations between 1987 and 2003 (see Figure 2-1)
- Completion of remedial actions at the former Chevron Terminal to address petroleum-related contamination to prevent the migration to Bellingham Bay, including 1) soil bioremediation efforts between 1993 and 1994; 2) removal of contaminated soil and product accumulation in the southern corner of the site during 2001; and 3) an interim action in 2013 along the southwest shoreline to remove impacted soil and sediments, in the area where sheens had been observed, and creosote-treated pilings

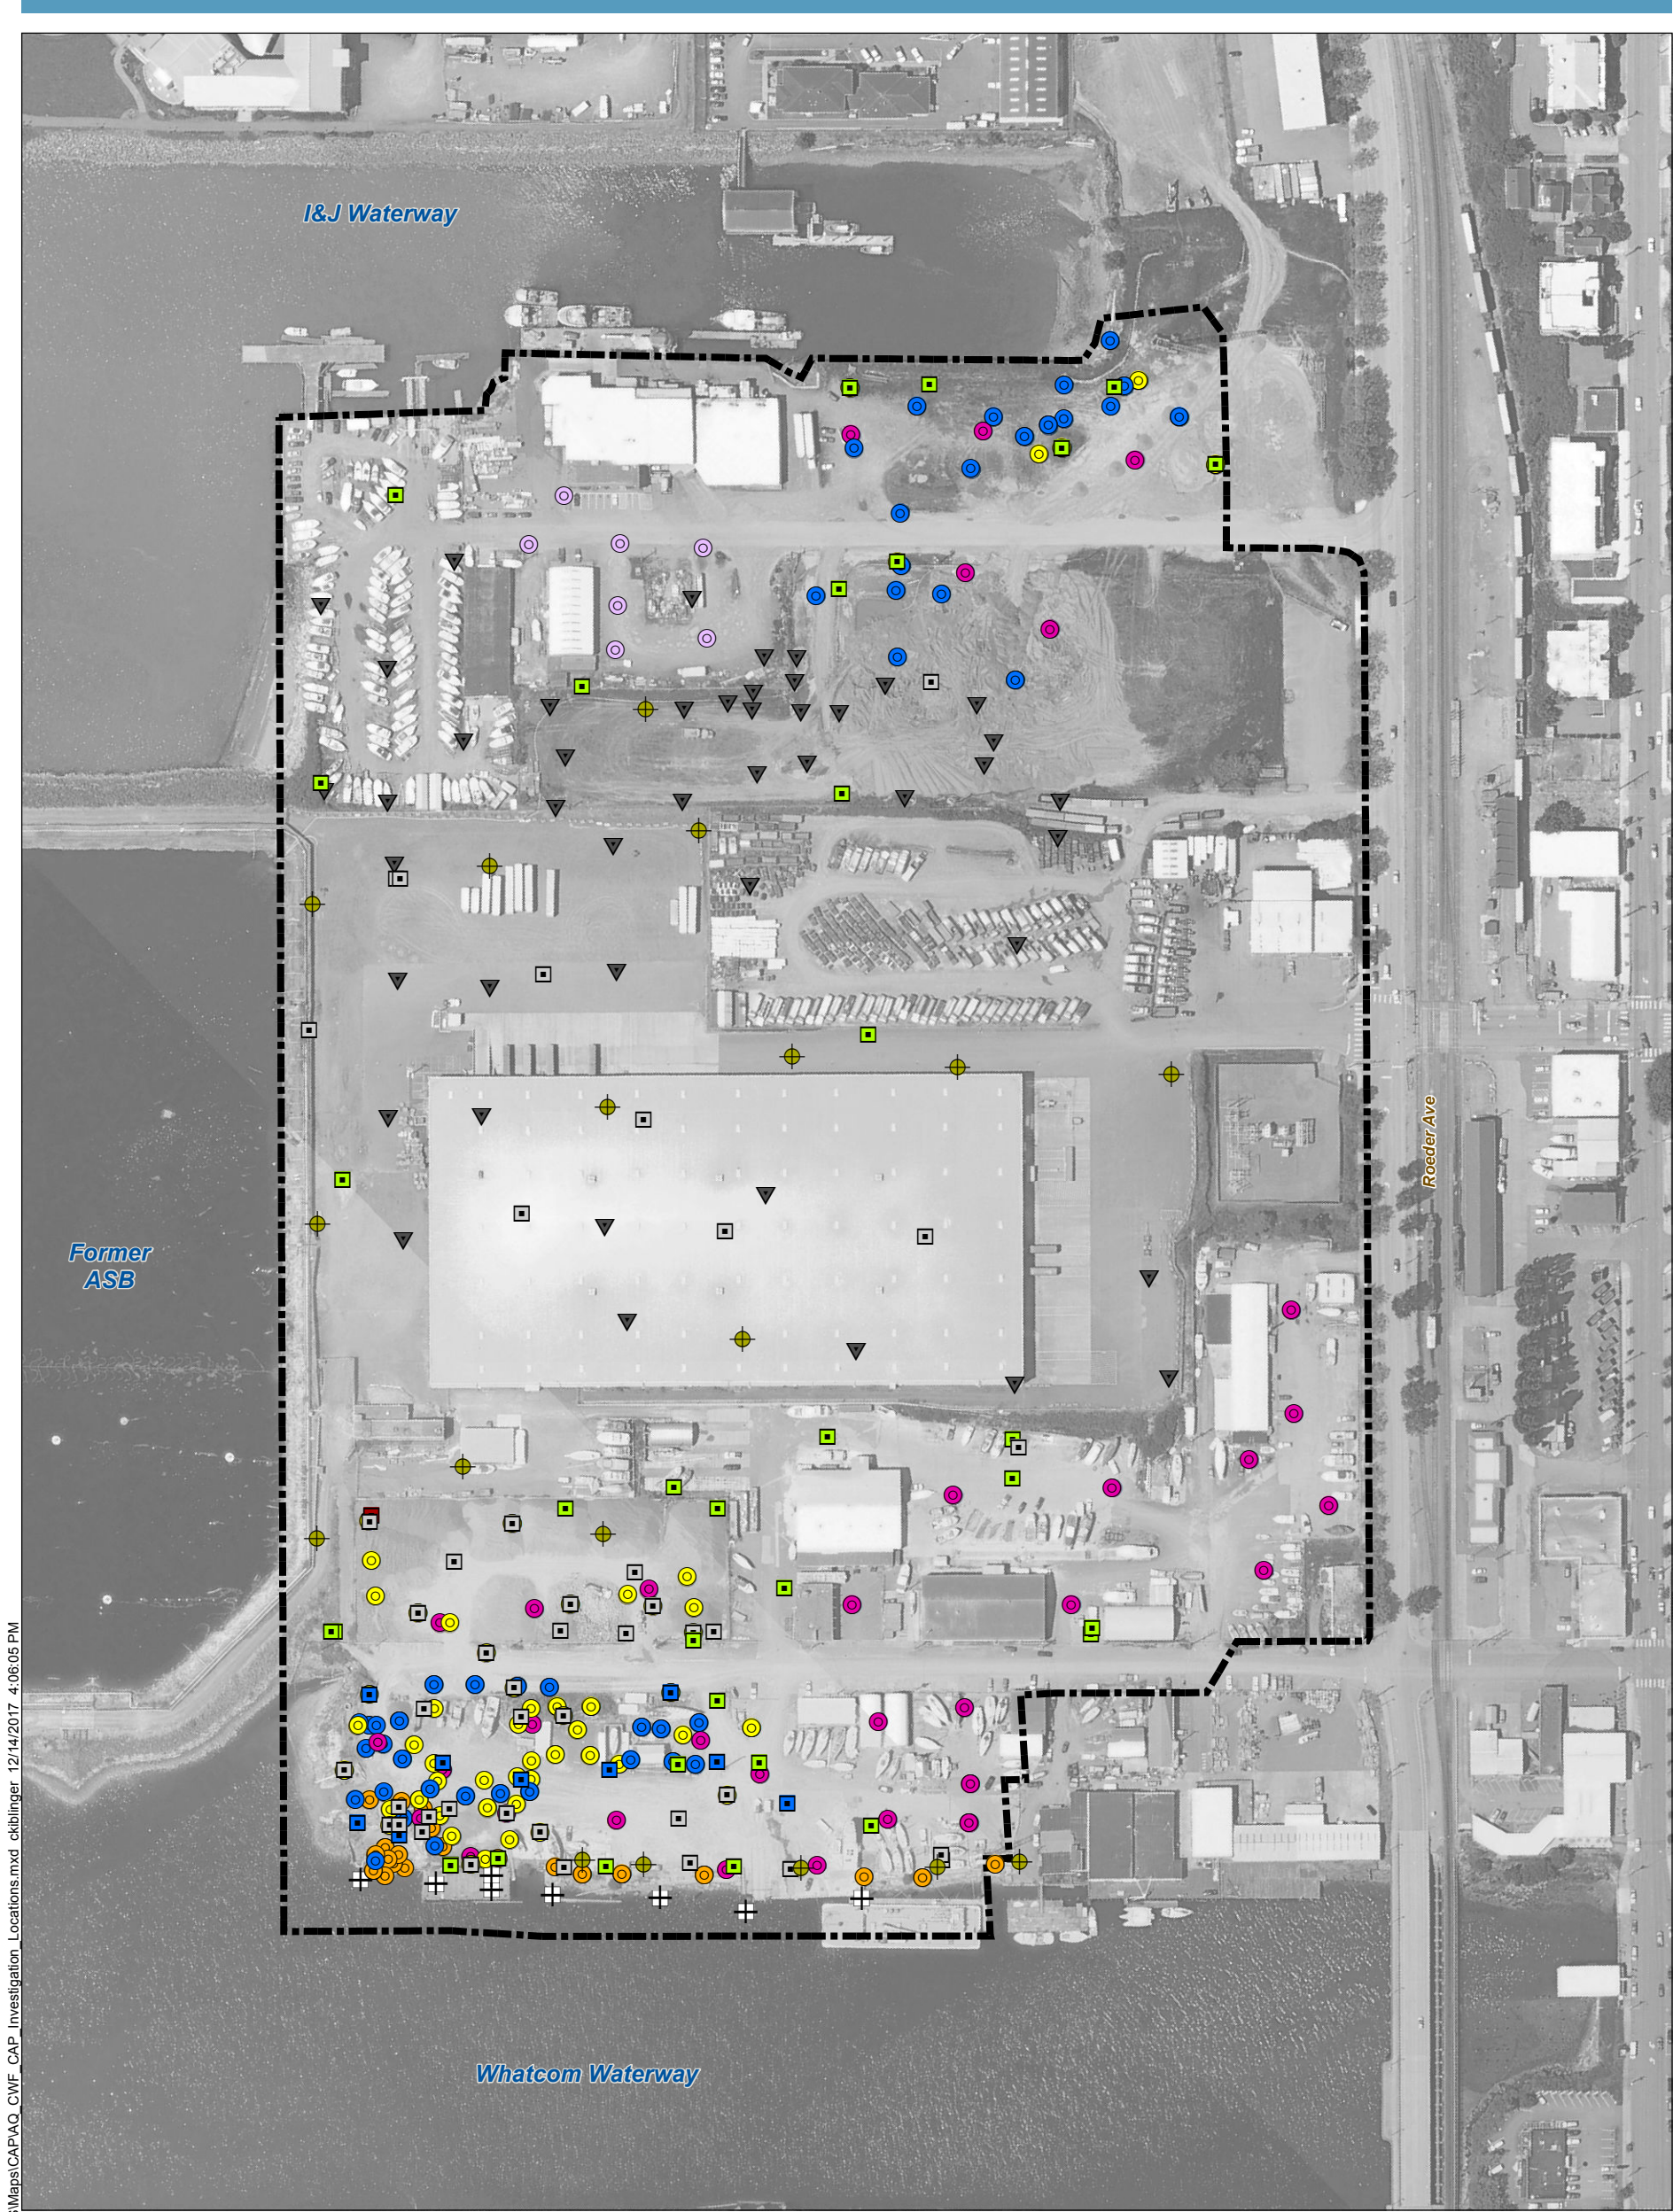
Historical Soil Sample Location		Monitoring Well Status (RI Survey)

Figure 2-2
 Central Waterfront Site Investigation Locations
 Cleanup Action Plan
 Central Waterfront Site
 Bellingham, WA

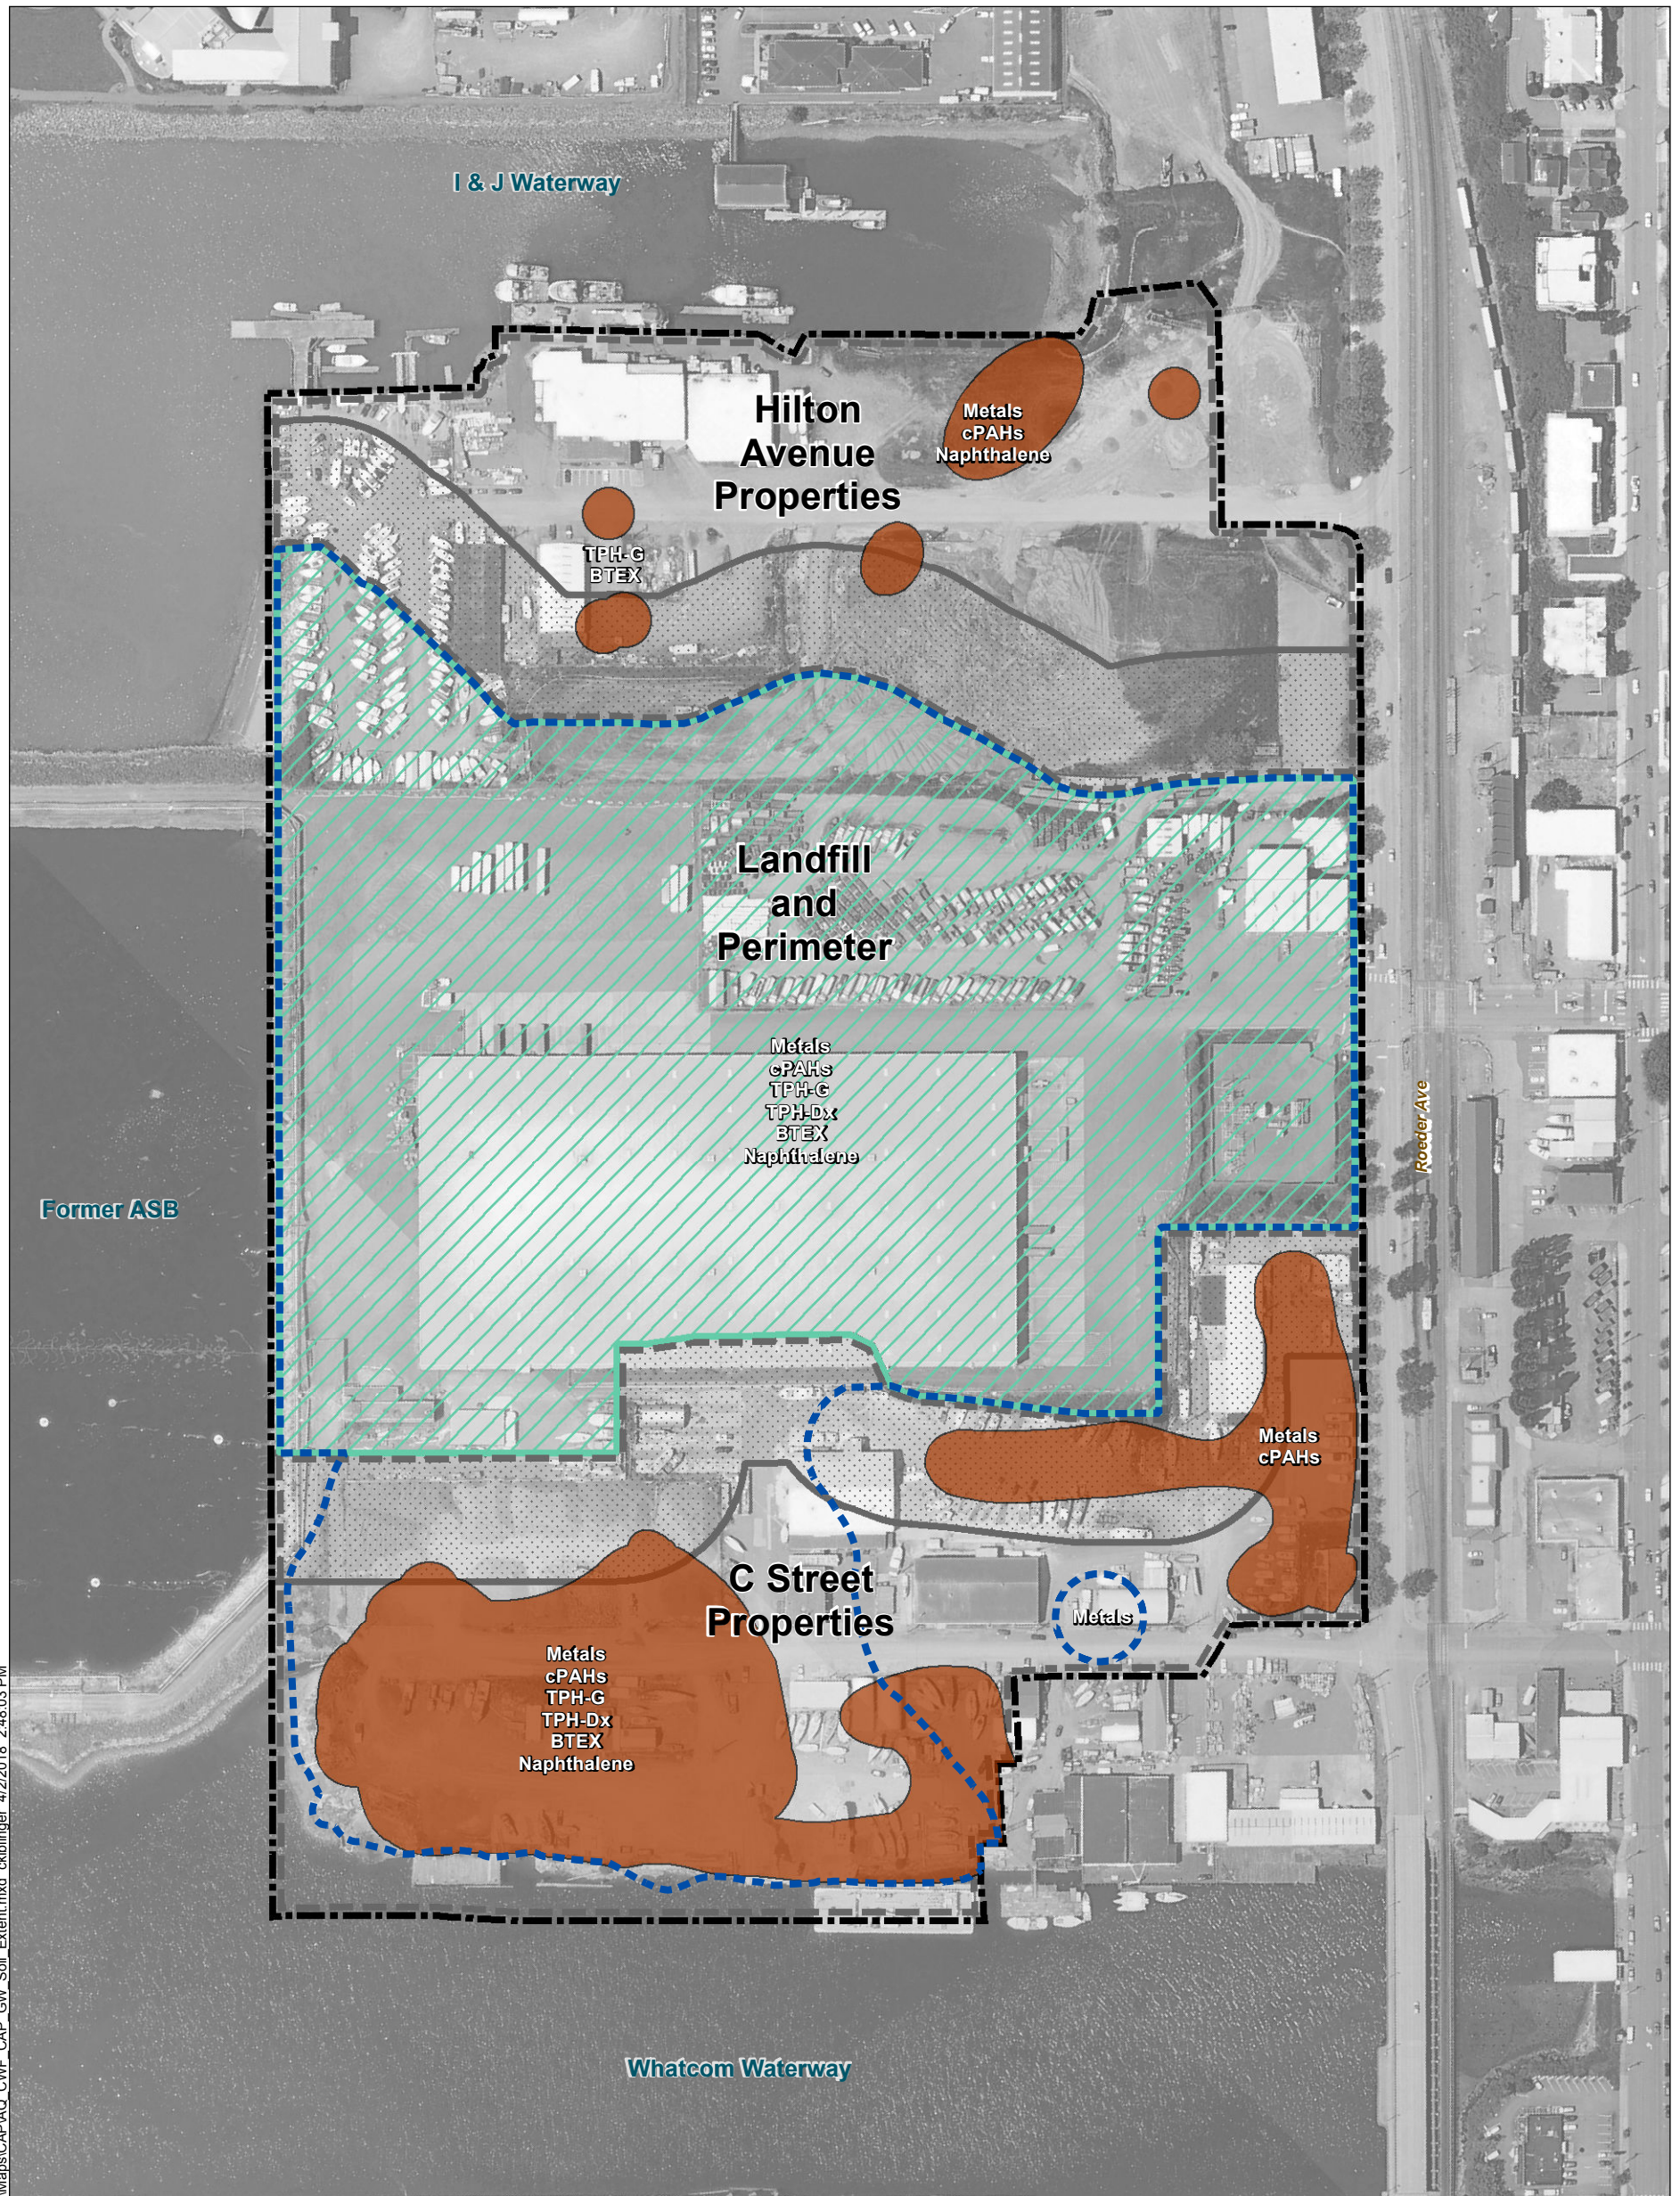
- Extent of Groundwater and Porewater Concentrations Above Screening Levels
- Extent of Soil Concentrations Above Screening Levels

NOTES:
 1. Areas within the landfill boundary are assumed to pose a threat to human health or the environment through direct contact or release to the environment
 2. Landfill gas is limited to areas within the landfill perimeter and soil gas is limited to areas of soil and/or groundwater petroleum impacts in the C Street Properties subarea.
 3. Areas addressed in the RI/FS are based on screening levels and the RI/FS evaluated a range of cleanup levels applicable to the Site.
 4. Aerial by U.S. Geological Survey; July 2009.

Figure 2-4
 Extent of Groundwater and Soil Contamination
 Cleanup Action Plan
 Central Waterfront Site
 Bellingham, WA

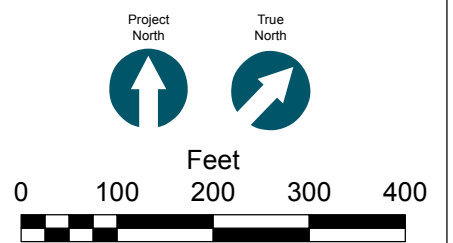
- Central Waterfront Site Boundary
- Extent of Landfill Refuse
- Landfill Perimeter
- Subarea Boundary

During the RI/FS, the Site was divided into three subareas that have been identified as having soil, groundwater, sediment, and/or landfill gas and soil vapor contamination, based on evaluation of data obtained during the past 30 years of environmental investigations and cleanups. The three Site subareas are: Landfill and Perimeter subarea (including the former Roeder Avenue landfill and adjacent perimeter areas), C Street Properties subarea (including properties along the southern shoreline of the Site that previously included the former Chevron Terminal and Colony Wharf areas), and Hilton Avenue Properties subarea (including properties along the northern shoreline of the Site that previously included the former Olivine Uplands and former Time Oil fuel facility). Figure 2-4 shows the subarea boundaries.

Table 2-2 provides a detailed summary of the principle RI/FS findings, including the nature and extent of contaminants, fate and transport, and current and future pathways and receptors for each subarea. Figure 2-4 depicts the extent of soil and groundwater contamination developed as part of the RI/FS.

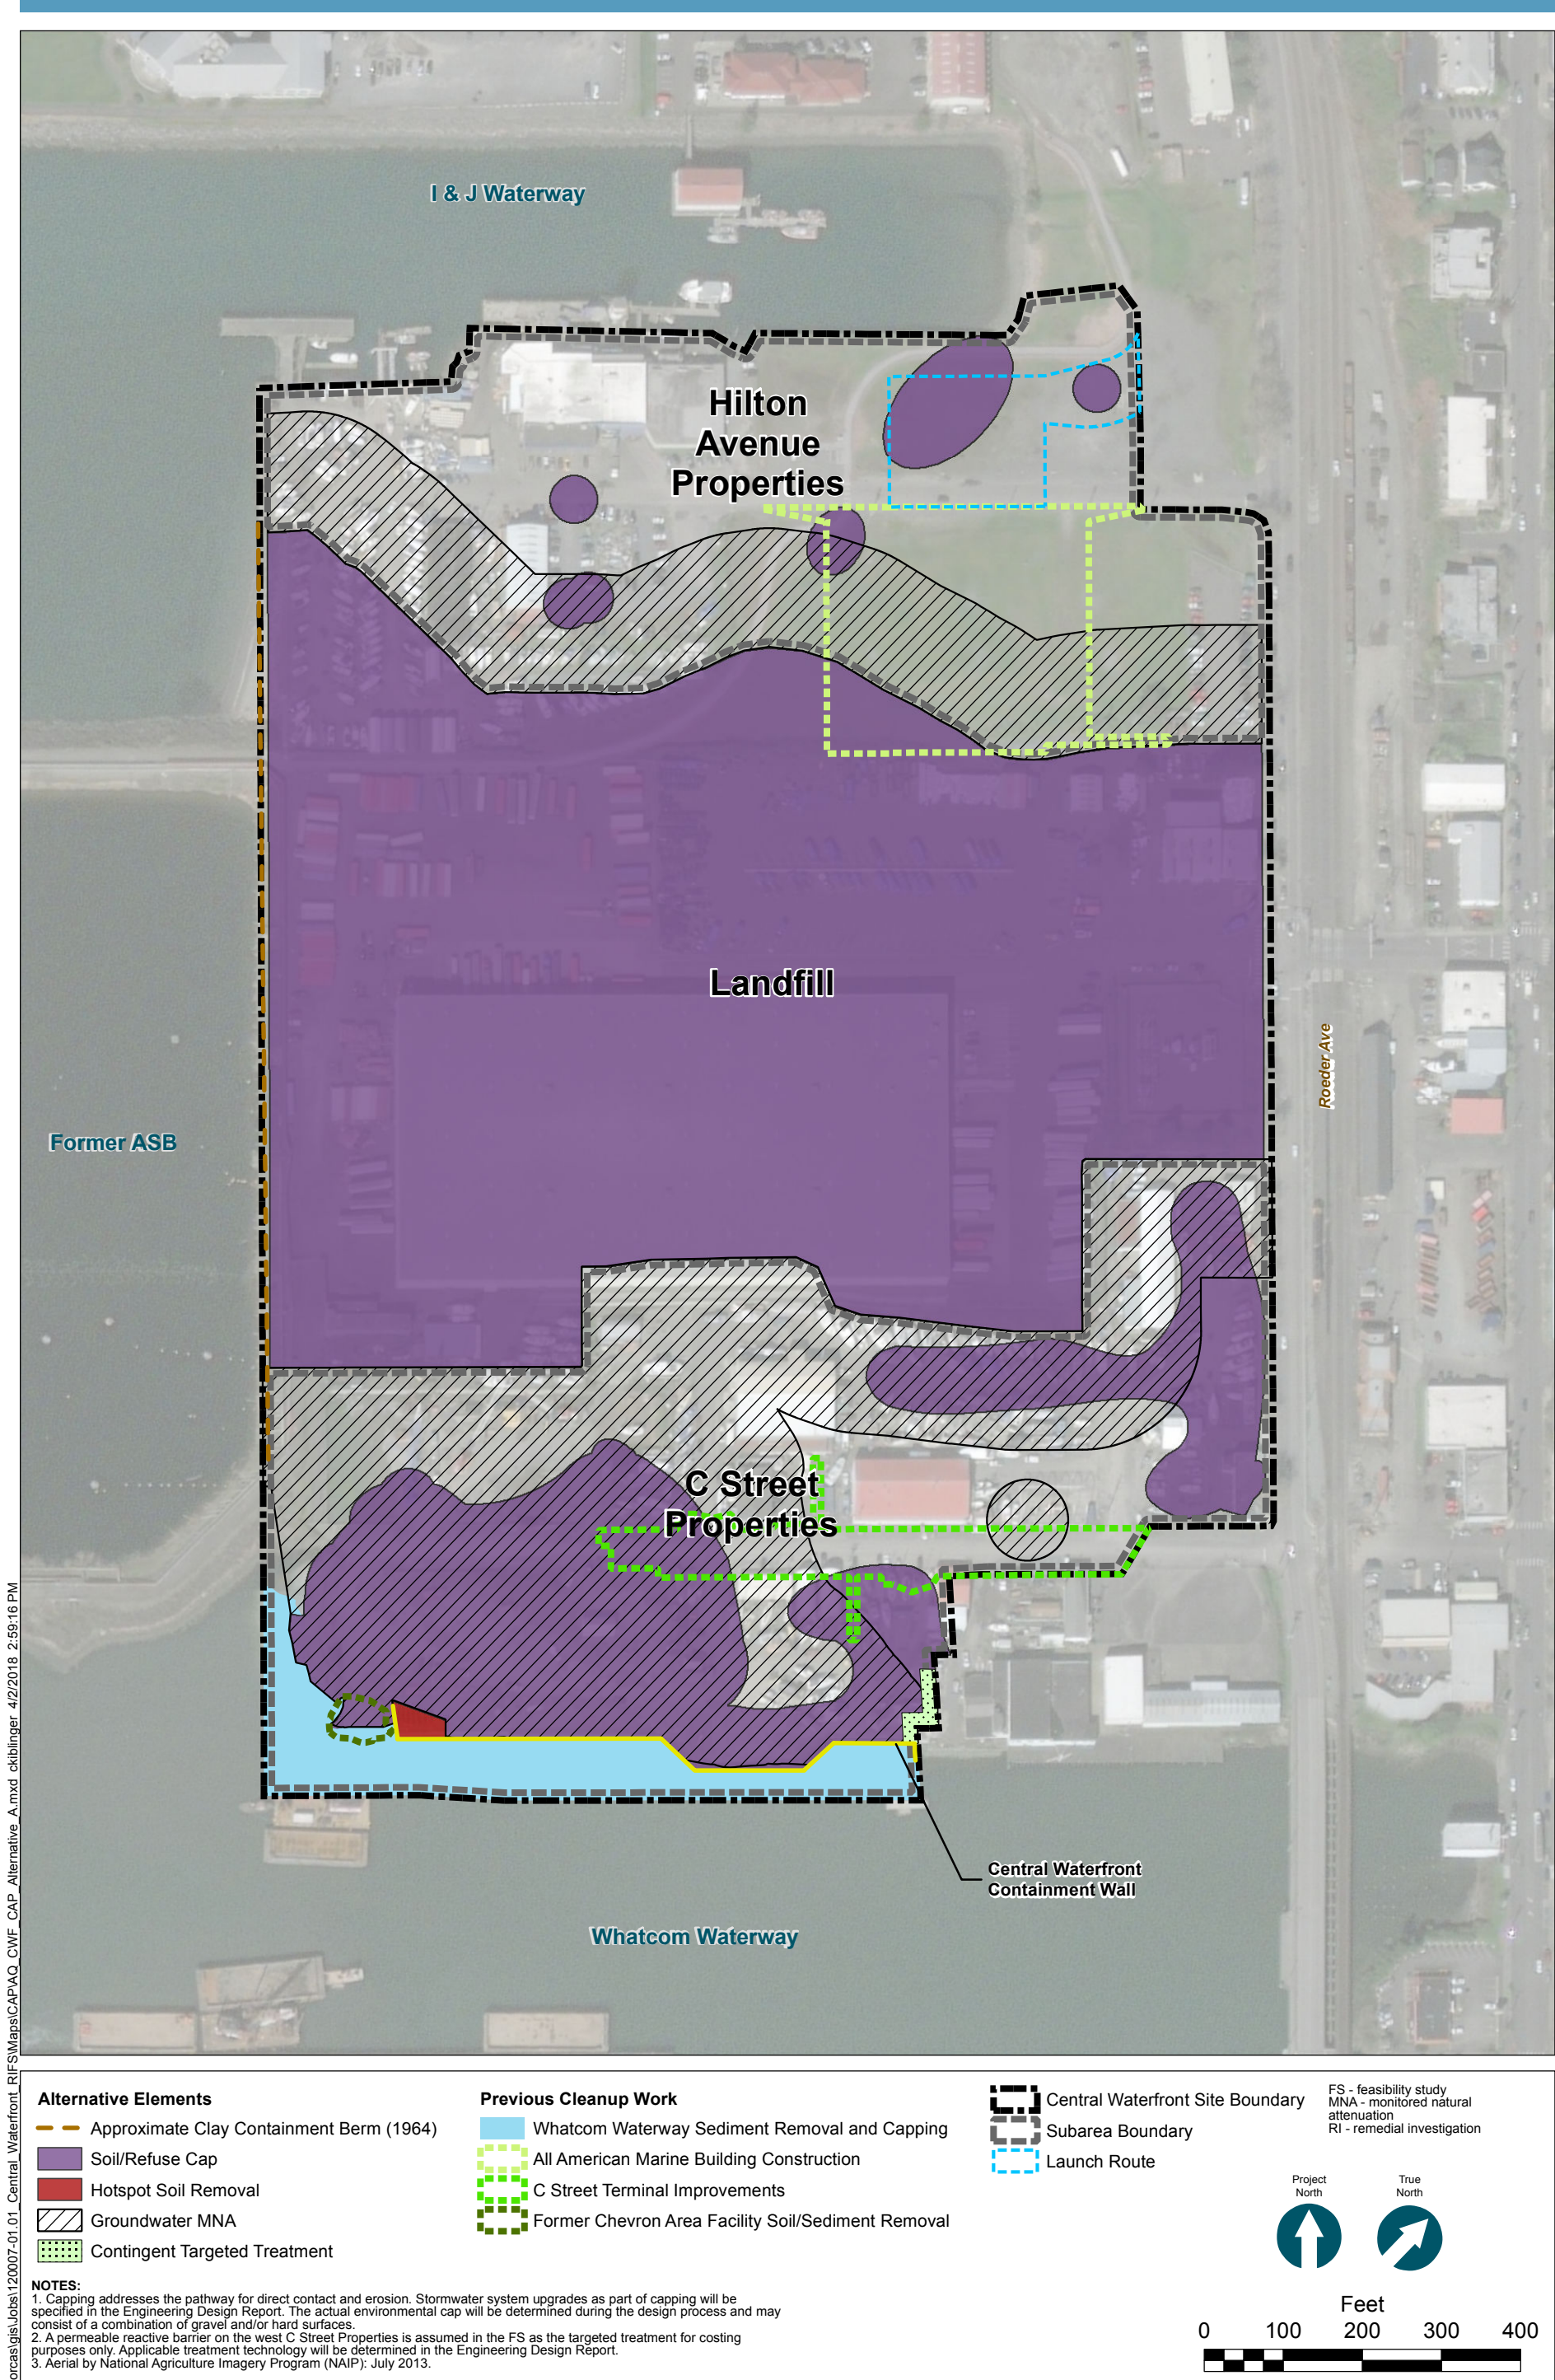
Figure 4-1
 Alternative A
 Cleanup Action Plan
 Central Waterfront Site
 Bellingham, WA

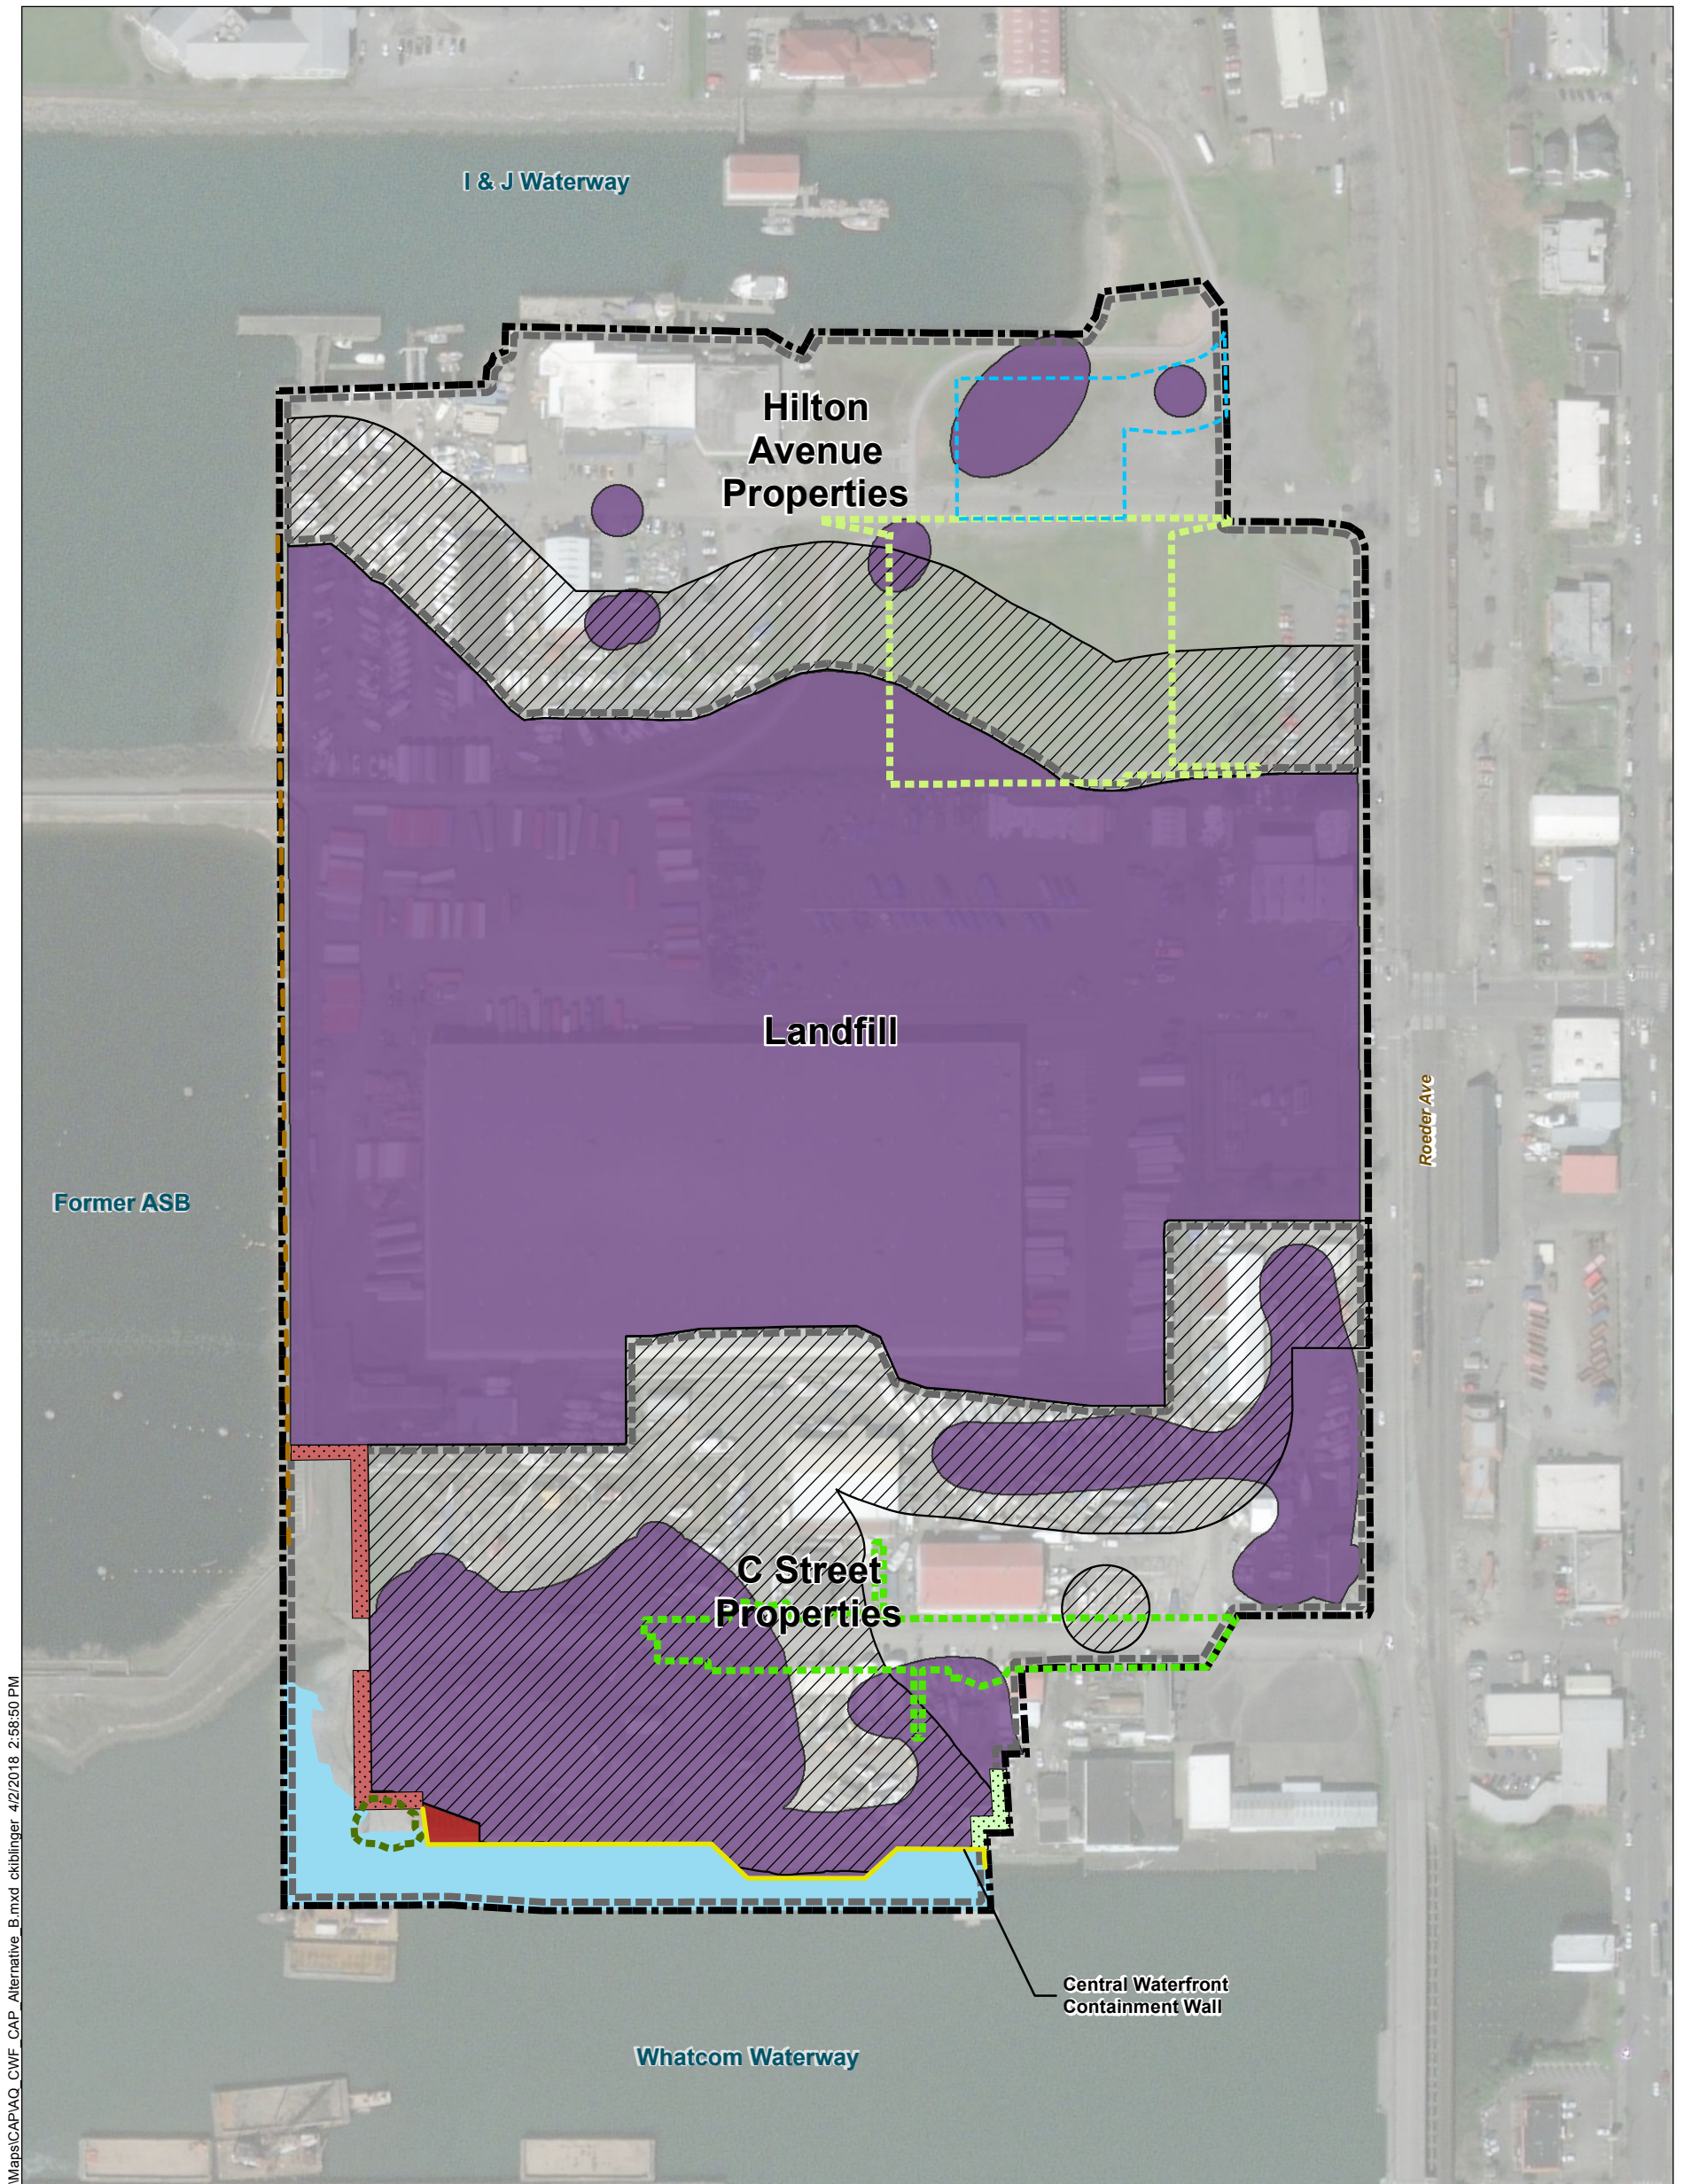
Figure 4-2
 Alternative B
 Cleanup Action Plan
 Central Waterfront Site
 Bellingham, WA
