THIRD AMENDMENT
TO AGREED ORDER

No. DE 3441

January 2020
Central Waterfront Site
Bellingham, Washington

Final Cleanup Action Plan

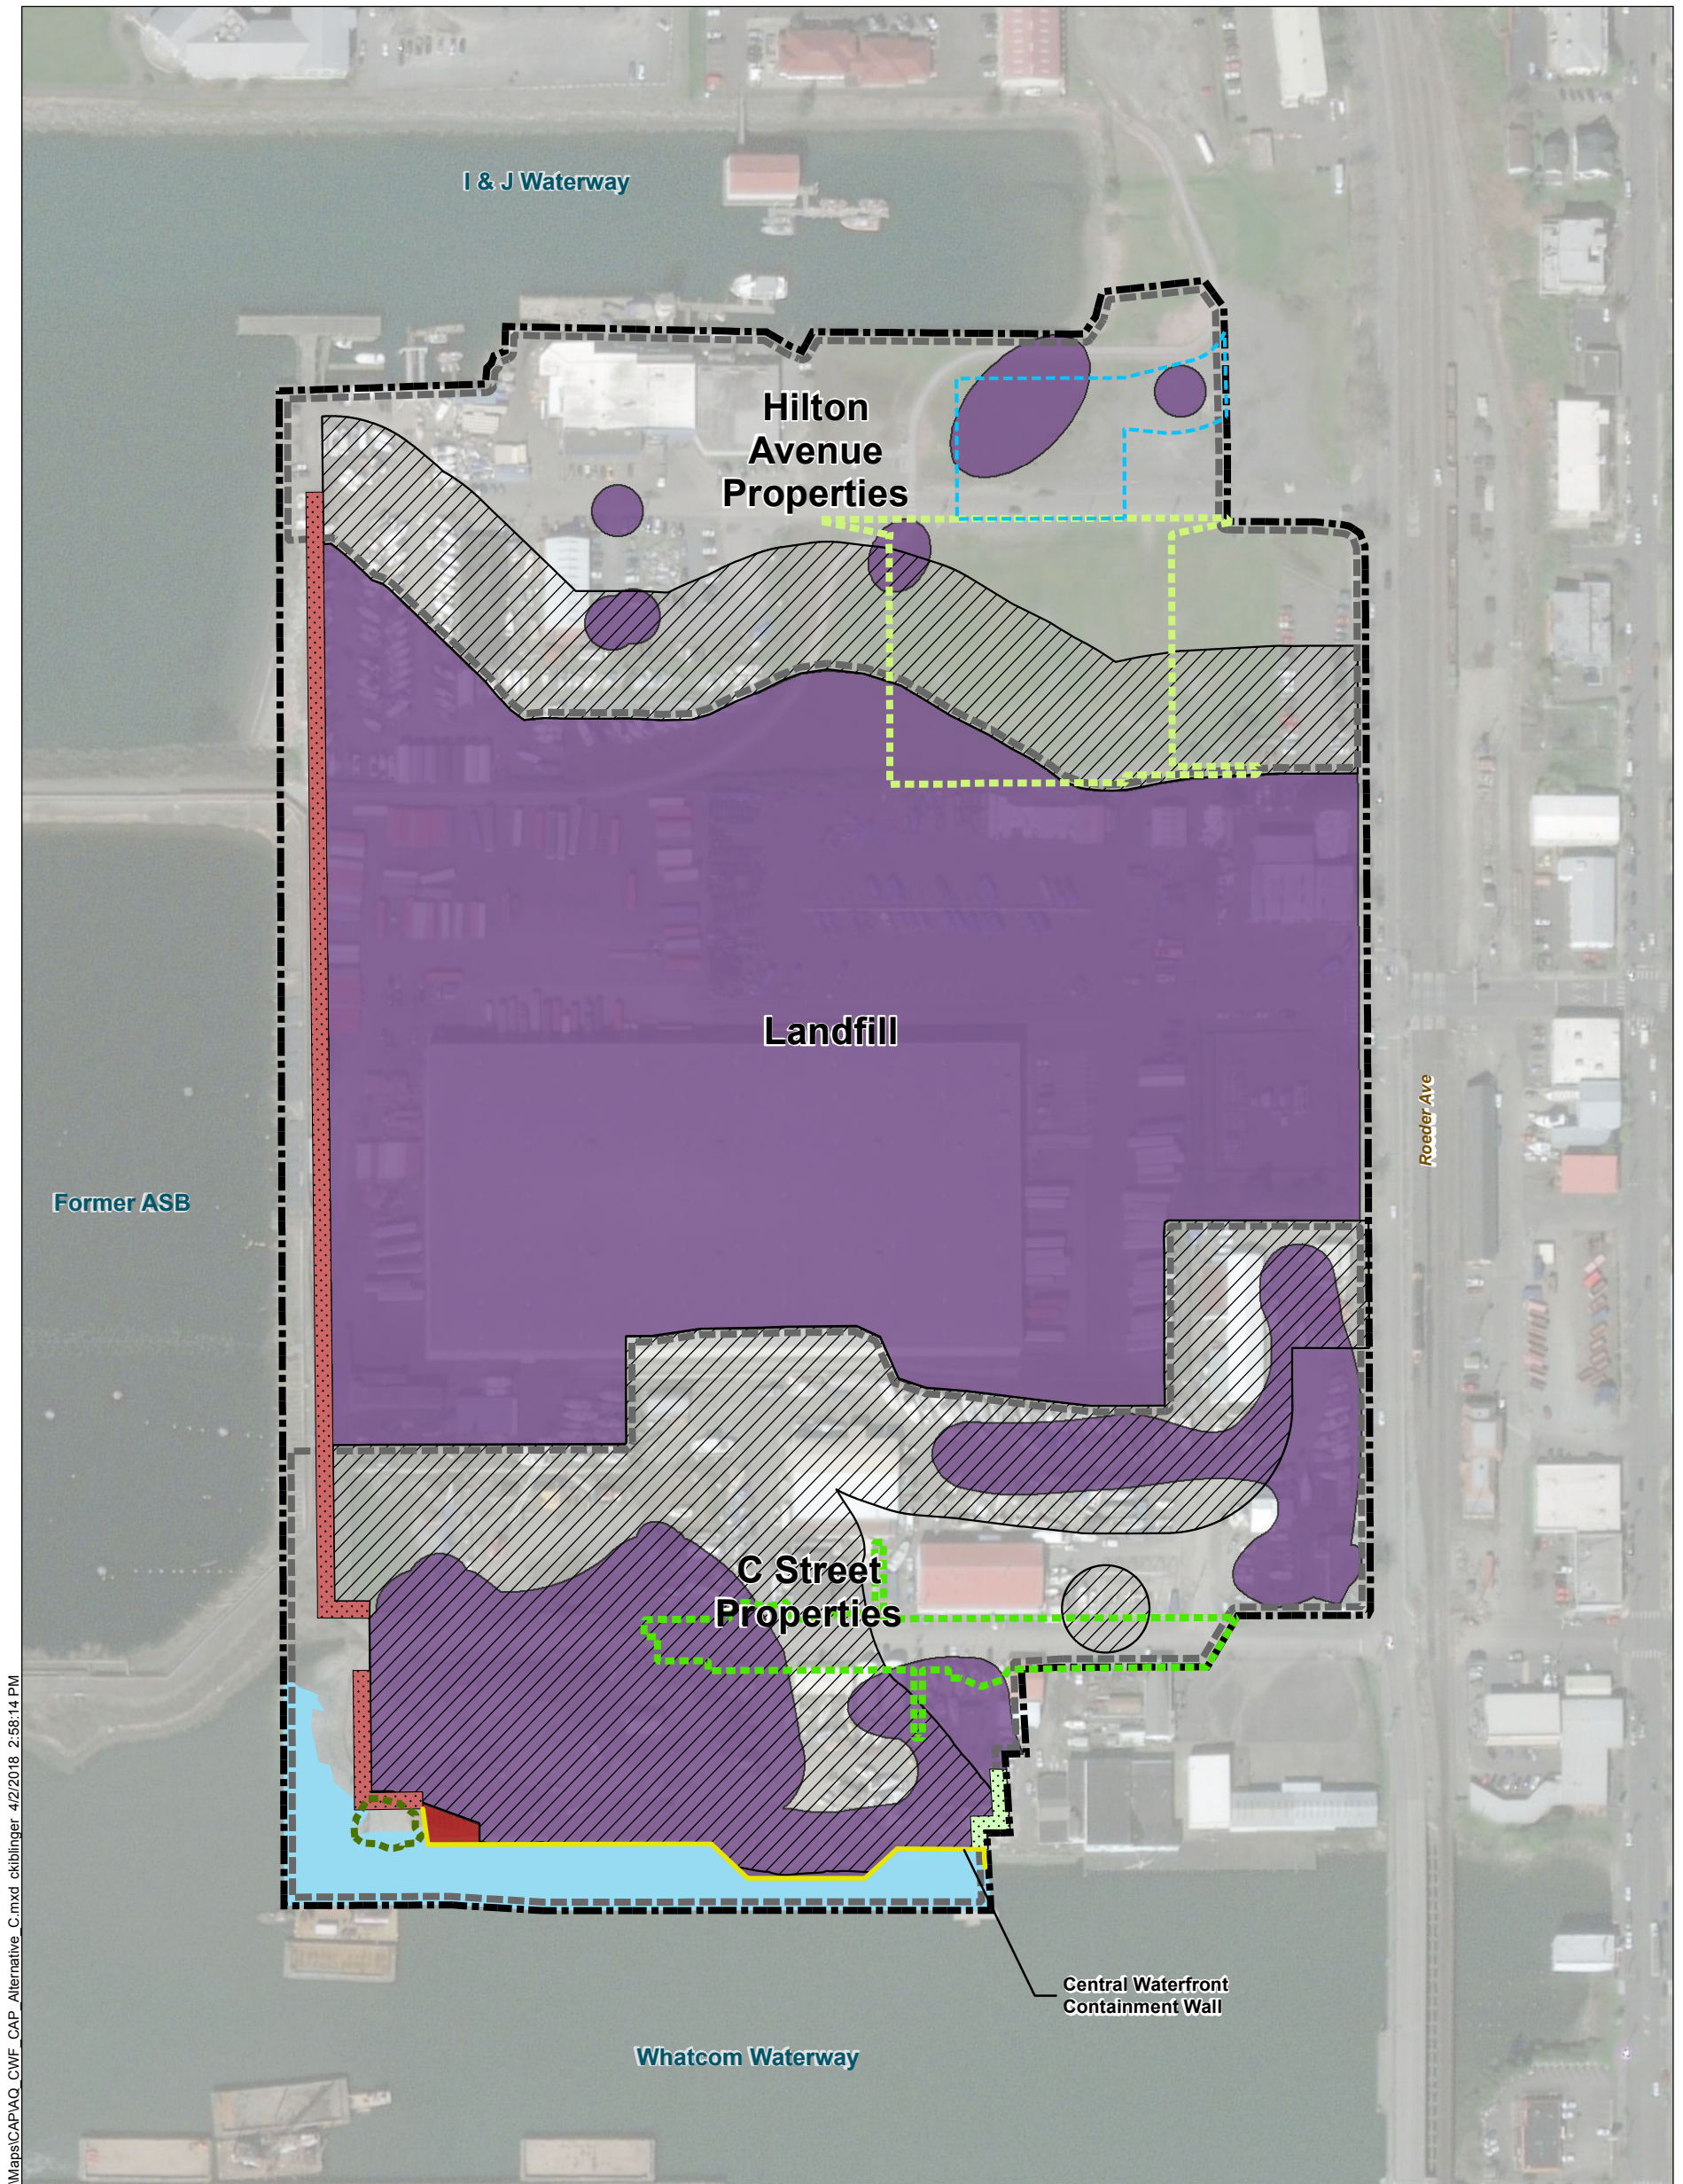
Alternative Elements Soil/Refuse Cap Hotspot Soil Removal Groundwater MNA Targeted Treatment Contingent Targeted Treatment		Previous Cleanup Work Whatcom Waterway Sediment Removal and Capping All American Marine Building Construction C Street Terminal Improvements Former Chevron Area Facility Soil/Sediment Removal		Central Waterfront Site Boundary Subarea Boundary Launch Route		FS - feasibility study MNA - monitored natural attenuation RI - remedial investigation
NOTES: 1. Capping addresses the pathway for direct contact and erosion. Stormwater system upgrades as part of capping will be specified in the Engineering Design Report. The actual environmental cap will be determined during the design process and may consist of a combination of gravel and/or hard surfaces. 2. A permeable reactive barrier in C Street Properties and Landfill areas is assumed in the FS as the targeted treatment for costing purposes only. Applicable treatment technology will be determined in the Engineering Design Report. 3. The opening in the permeable reactive barrier represents the presence of a significant box culvert outfall located along C Street. The shoreline treatment system (if selected) would be designed to accommodate this structure, while performing the anticipated remedial function. 4. Aerial by National Agriculture Imagery Program (NAIP); July 2013.		Project North True North		Feet 0 100 200 300 400

Figure 4-3
 Alternative C
 Cleanup Action Plan
 Central Waterfront Site
 Bellingham, WA

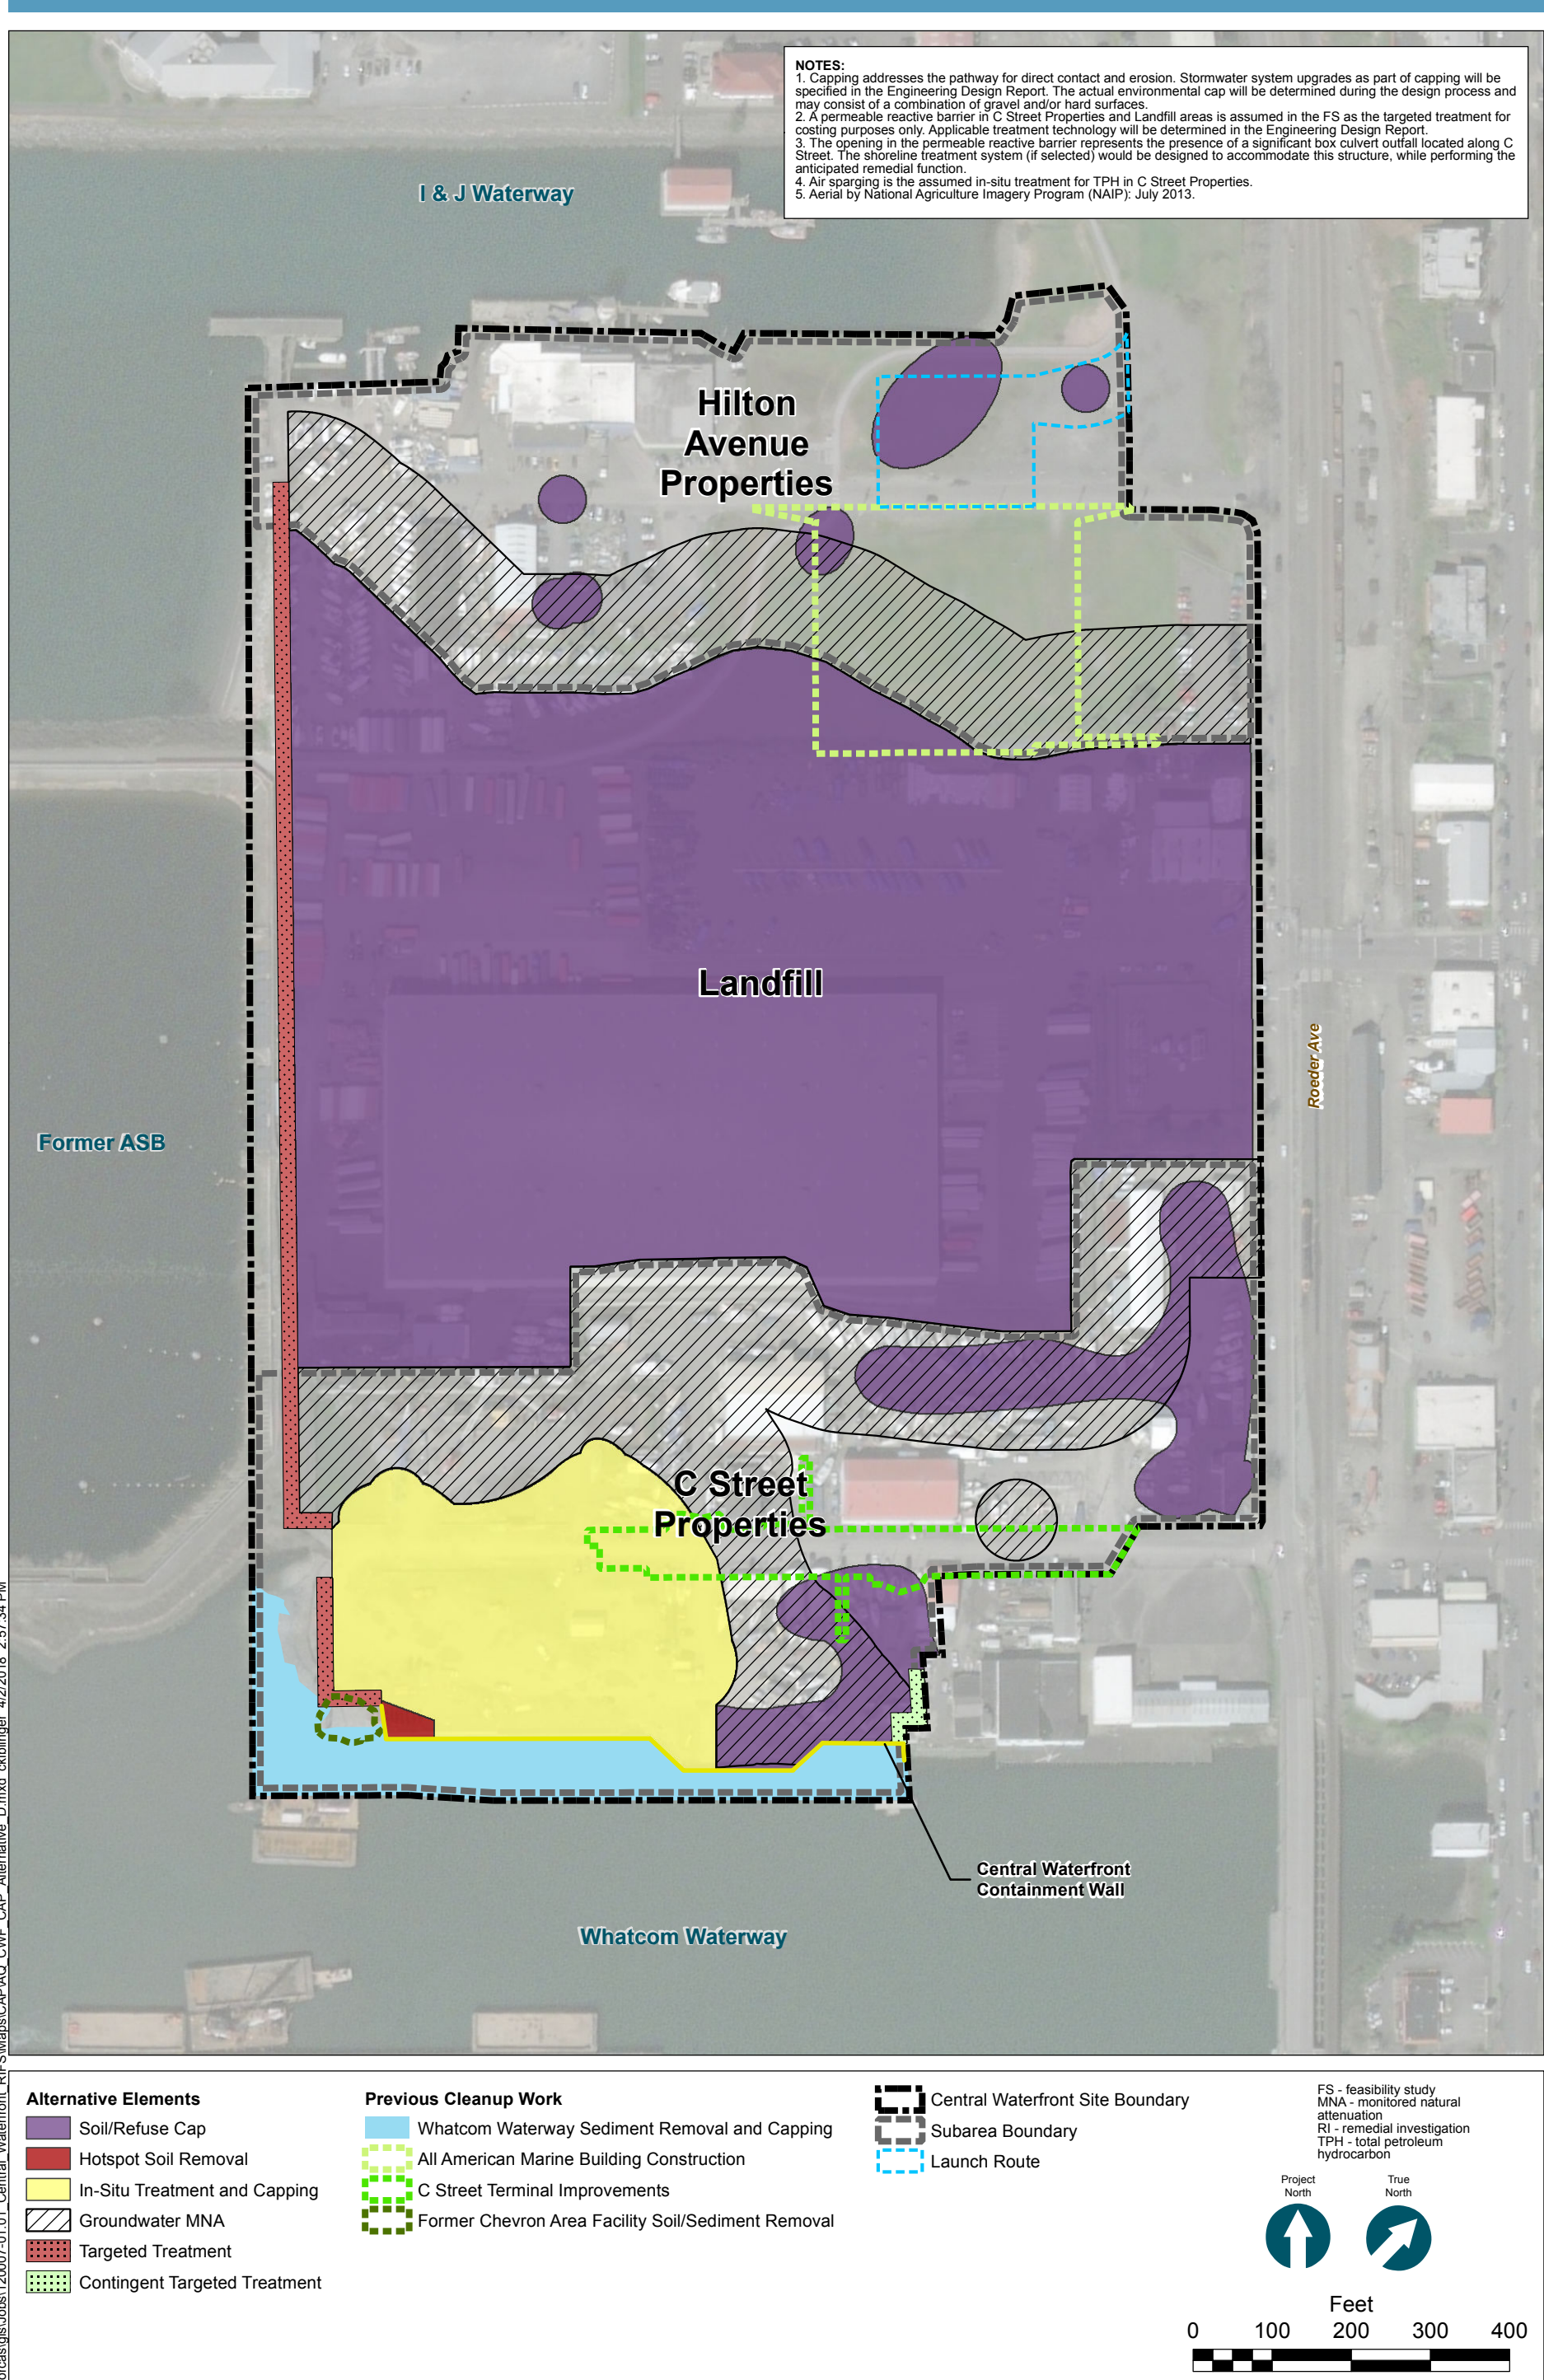
Figure 4-4
Alternative D
Cleanup Action Plan
Central Waterfront Site
Bellingham, WA

4. Air sparging is the assumed in-situ treatment for TPH in C Street Properties.
5. Barrier wall along the Landfill footprint may be a slurry wall or sheetpile wall to be determined in the Engineering Design Report.

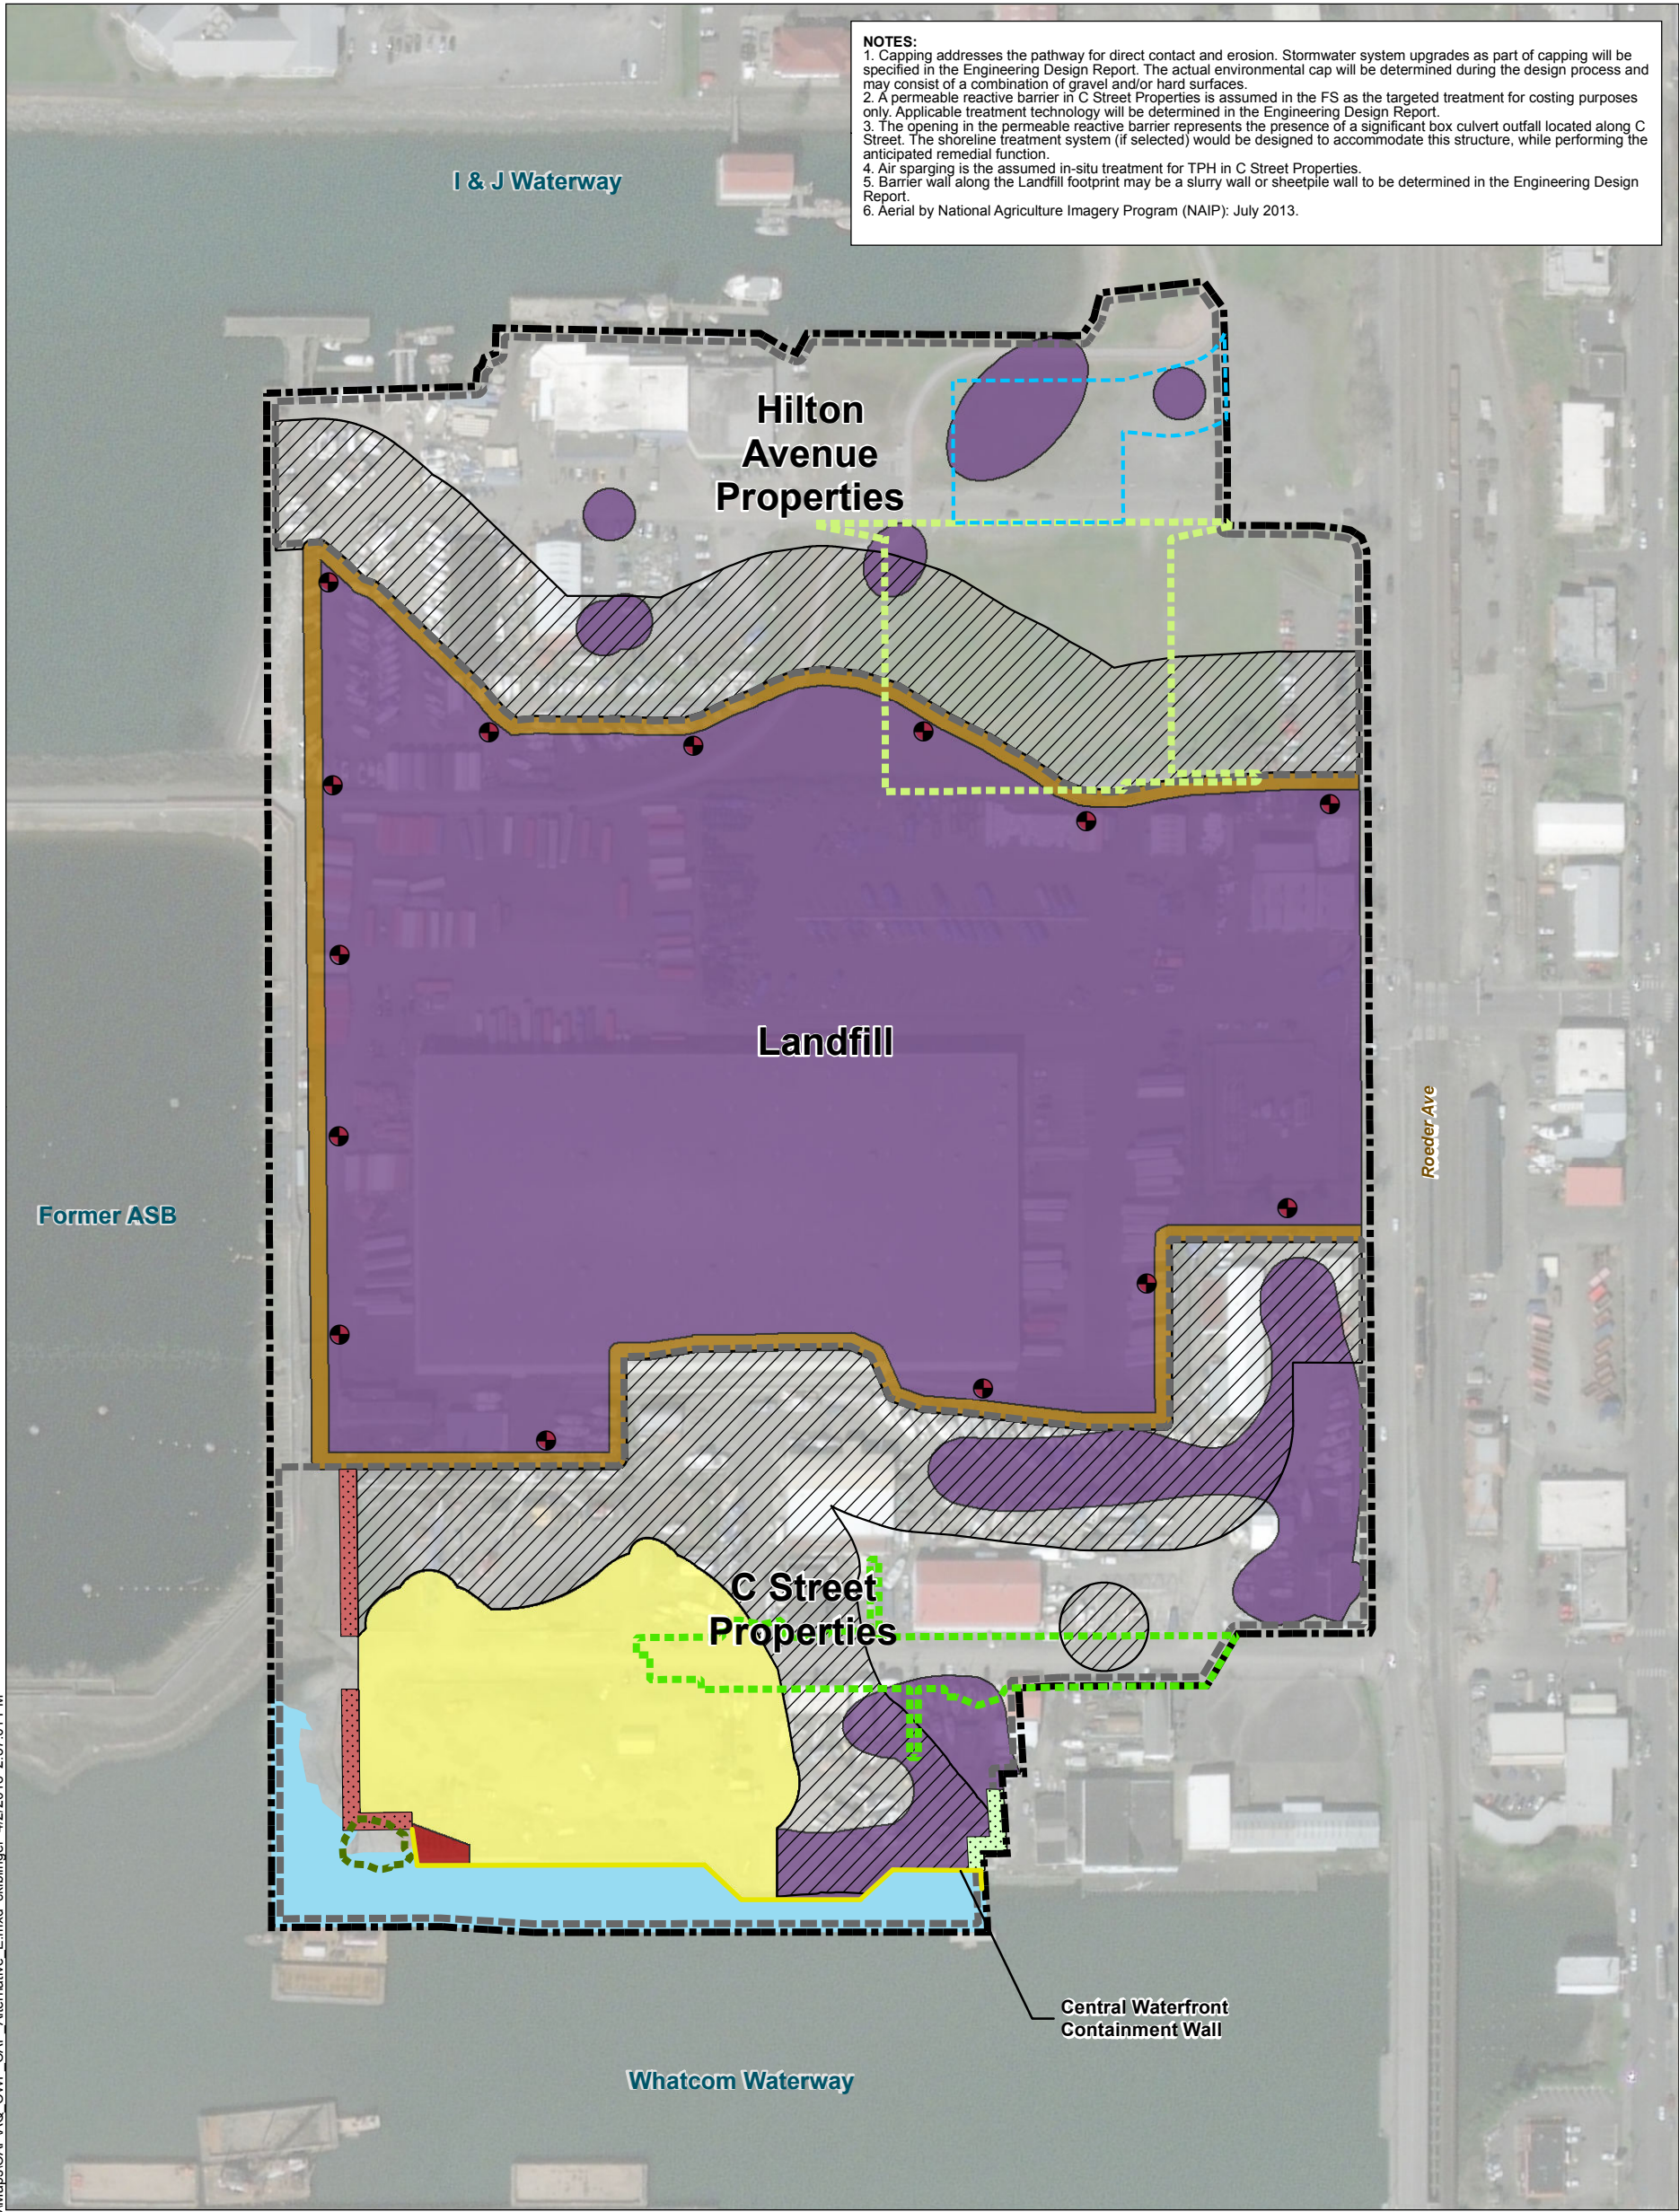
<p>Alternative Elements</p> <ul style="list-style-type: none"> Soil/Refuse Cap Hotspot Soil Removal In-Situ Treatment and Capping Barrier Wall Groundwater MNA Targeted Treatment Contingent Targeted Treatment ● Groundwater Extraction Well with Discharge to POTW 		<p>Previous Cleanup Work</p> <ul style="list-style-type: none"> Whatcom Waterway Sediment Removal and Capping All American Marine Building Construction C Street Terminal Improvements Former Chevron Area Facility Soil/Sediment Removal 		<p>Site Boundaries and Features</p> <ul style="list-style-type: none"> Central Waterfront Site Boundary Subarea Boundary Launch Route 		<p>Legend and Scale</p> <ul style="list-style-type: none"> FS - feasibility study MNA - monitored natural attenuation POTW - Publicly Owned Treatment Works RI - remedial investigation TPH - total petroleum hydrocarbon <p>Project North ↑ True North ↗ </p> <p style="text-align: center;">Feet</p> <p style="text-align: center;">0 100 200 300 400</p>

Figure 4-5
Alternative E
Cleanup Action Plan
Central Waterfront Site
Bellingham, WA

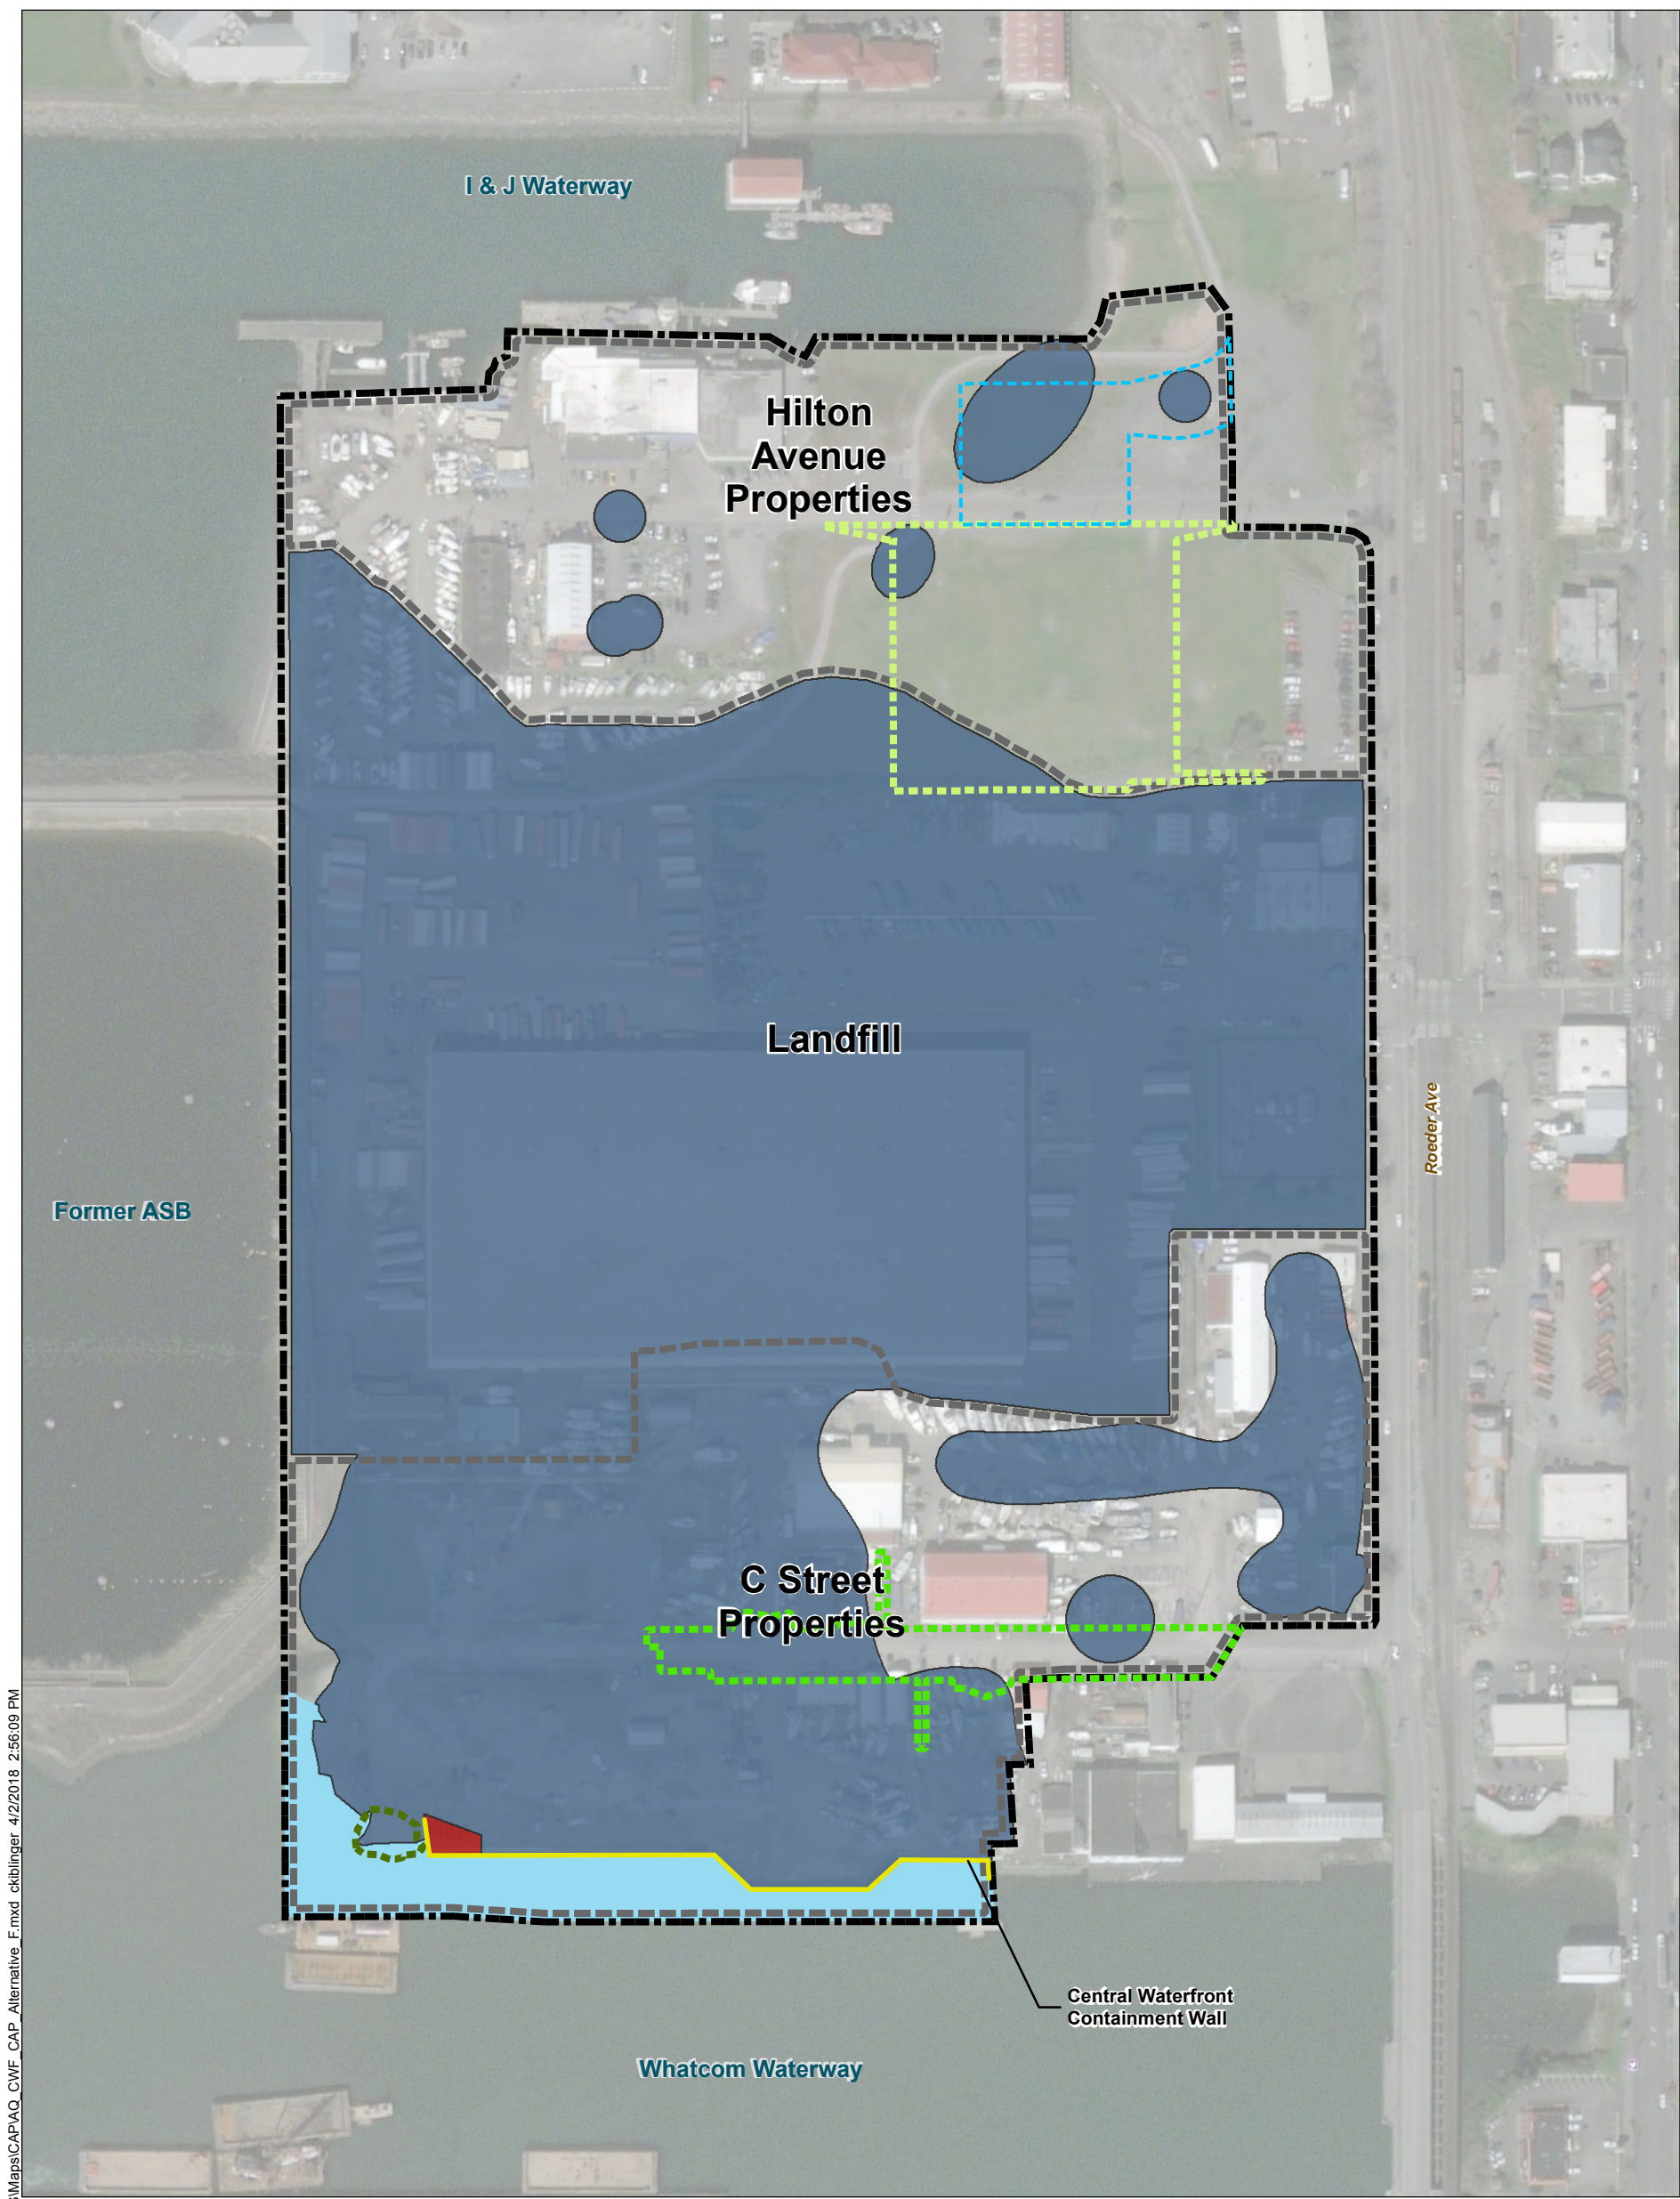
Alternative Elements Removal and Off-site Disposal Hotspot Soil Removal		Previous Cleanup Work Whatcom Waterway Sediment Removal and Capping All American Marine Building Construction C Street Terminal Improvements Former Chevron Area Facility Soil/Sediment Removal		Central Waterfront Site Boundary Subarea Boundary Launch Route		FS - feasibility study RI - remedial investigation
NOTES: 1. Aerial by National Agriculture Imagery Program (NAIP): July 2013.				Project North True North		
				Feet 0 100 200 300 400

Figure 4-6
 Alternative F
 Cleanup Action Plan
 Central Waterfront Site
 Bellingham, WA

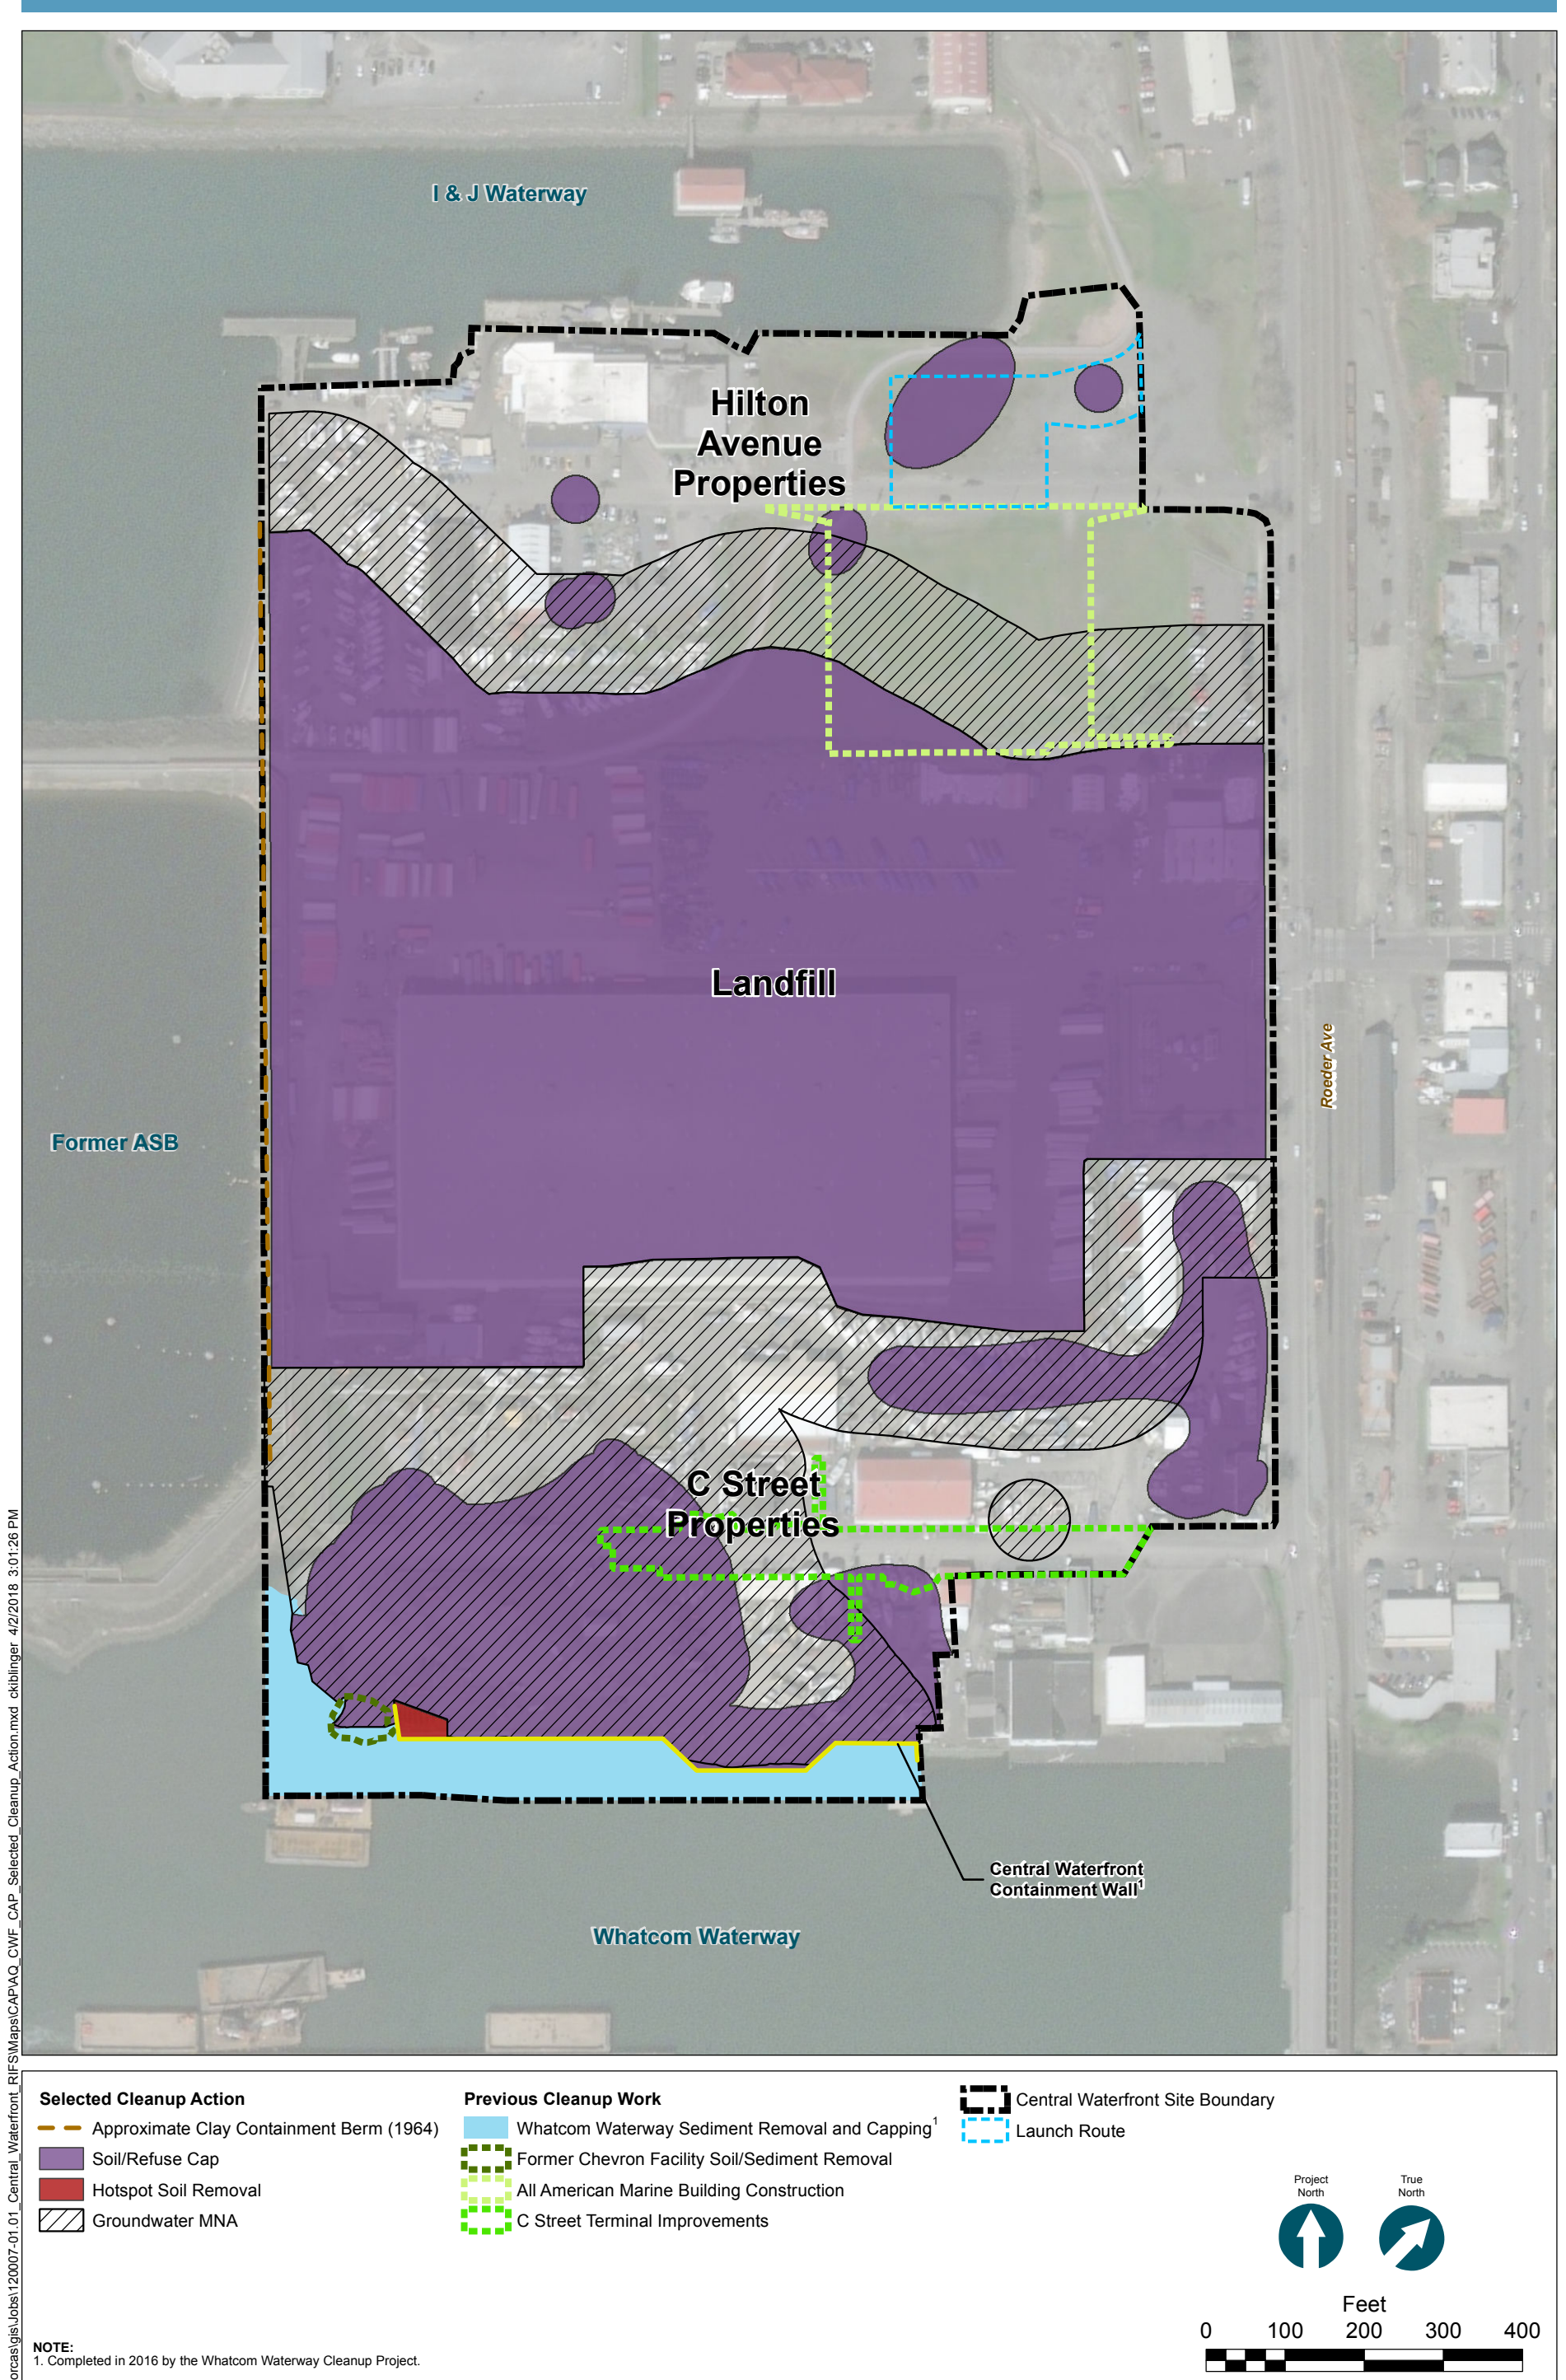
Figure 5-1
 Selected Cleanup Action
 Cleanup Action Plan
 Central Waterfront Site
 Bellingham, WA

- **Reduced-permeability caps in the Landfill footprint and in the C Street Properties subareas.** Reduced-permeability caps will limit infiltration of surface water and mobility of contaminants into groundwater and will prevent direct contact and erosion in these subareas. Capping will consist of a combination of existing asphalt pavement, concrete building foundations, new buildings and pavement, and/or new soil covers. Existing surface conditions in the Landfill footprint subarea and the southwestern portion of the C Street Properties subarea are expected to limit infiltration sufficiently to meet the requirements of a reduced-permeability cap (RI/FS Section 9.3). Under the Selected Cleanup Action, a physical barrier (e.g. soil/gravel and/or hard surface) is needed to supplement existing graveled areas to address the soil pathway for direct contact and erosion of soils.

- **Physical barrier cap in the Hilton Avenue Properties subarea.** A physical barrier cap in this subarea will address the soil pathway for direct contact and erosion of surface and subsurface contaminated soils, because infiltration reduction is not required. Under the Selected Cleanup Action, the physical barrier will be evaluated during remedial design and may consist of a hard surface (e.g., asphalt paving) or soil/gravel cap. New hard surfaces will be composed of a minimum 3 inches of concrete/asphalt or building foundations, and their design will need to incorporate applicable stormwater collection and control systems. A soil/gravel cap will consist of a 2-foot soil/gravel cap (consisting of a minimum 24 inches of uncontaminated soil and/or gravel with a marker/separation layer). The physical barrier will be placed on the contaminated areas that currently have a soil/gravel surface. The actual environmental cap will be determined during the design process and may consist of a combination of soil/gravel and/or hard surfaces.

- **Clay berm/ASB groundwater diversion wall on the western boundary of the Landfill footprint subarea.** As described in RI/FS Section 8.4, the clay berm is currently performing as an effective “hanging” low-permeability physical diversion wall down to the native layer, not only containing groundwater within the Landfill subarea, but also diverting it and increasing its flow path and travel time prior to discharging to adjacent surface water. Also, under current conditions, the ASB water level is about a half-foot higher than the adjacent groundwater elevation of the landfill and creates a relatively flat groundwater gradient and area of stagnation.

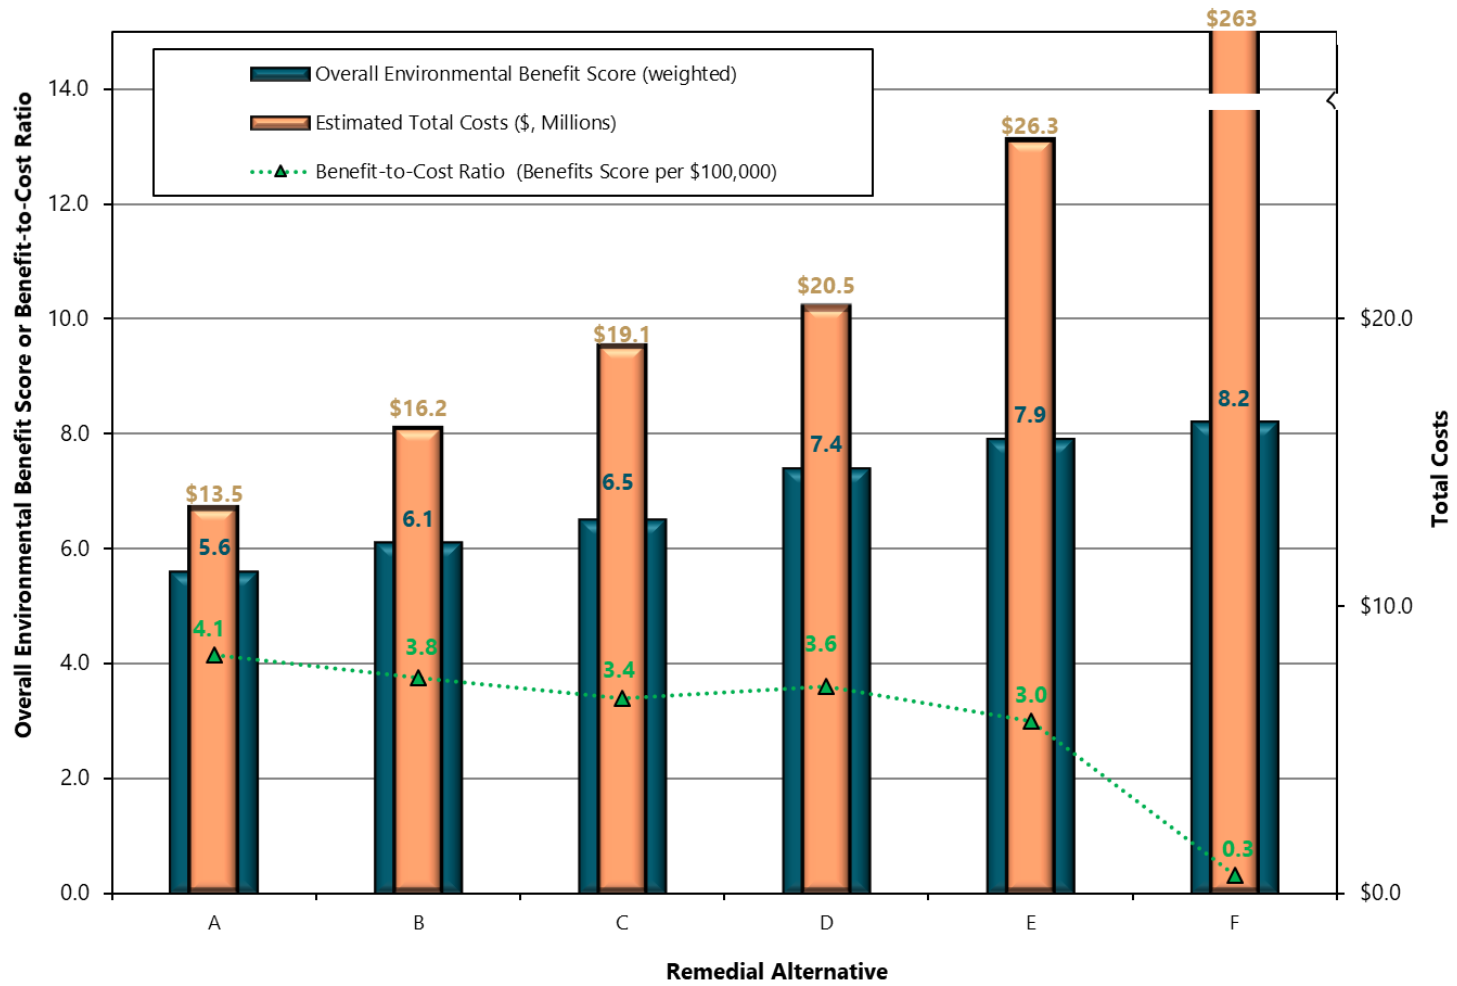
Figure 5-2
Relationship Between Benefits and Costs
Cleanup Action Plan
Central Waterfront Site, Bellingham, WA
