**COMPREHENSIVE CLEANUP ACTION REPORT:
EMPIRICAL DEMONSTRATION, GROUNDWATER MODELING, AND
SITE-WIDE NO FURTHER ACTION DETERMINATION REQUEST**

**FORMER CLEANING CENTER OF REDMOND
15796 REDMOND WAY
REDMOND, WASHINGTON**

RE: **REQUEST FOR SITE-WIDE NO FURTHER ACTION DETERMINATION
FORMER CLEANING CENTER OF REDMOND
15796 REDMOND WAY
REDMOND, WASHINGTON
FACILITY/SITE IDENTIFICATION NO. 26296554
VCP IDENTIFICATION NO. NW3166
FARALLON PN: 650-001**

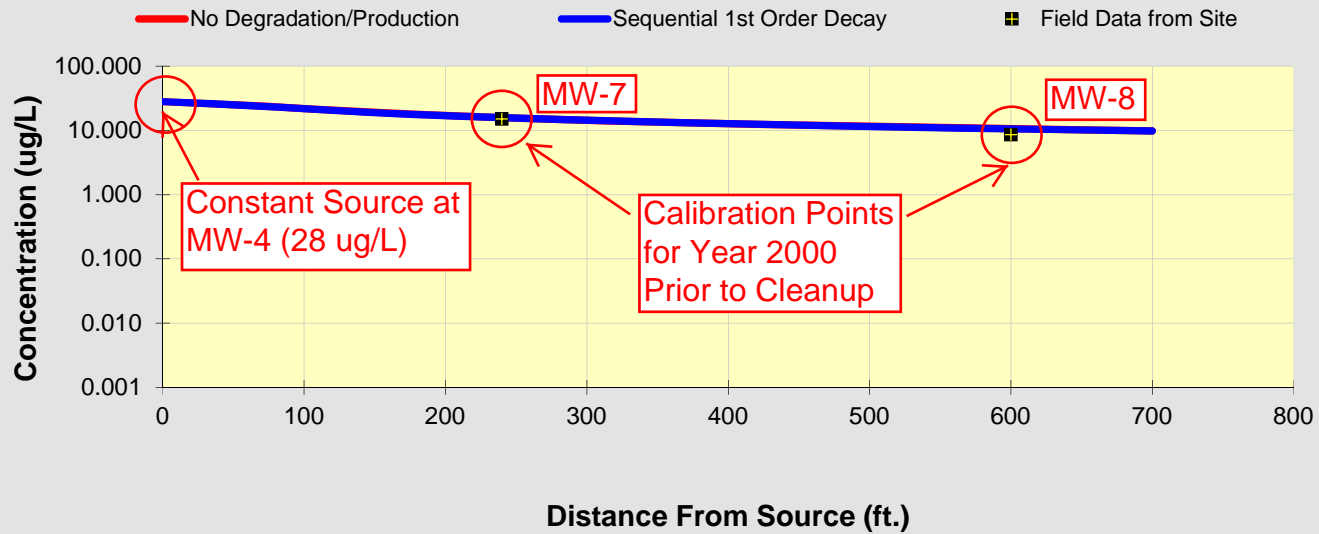
Figure 4A
 BIOCHLOR Model Inputs - Decaying Source at MW-4
 Former Cleaning Center of Redmond
 Redmond, Washington
 Farallon PN: 650-001

Figure 4A, *BIOCHLOR Model Inputs – Decaying Source at MW-4*

A decaying source was then specified in the model (Figure 4A) to simulate PCE attenuation in groundwater after source removal. Model results (Figure 4B) indicated an acceptable match between simulated and measured PCE concentrations at these locations at an elapsed time of 4 years (representing 2004 conditions). These model results represent the time required, with gradual source removal, for PCE concentrations at the source area and down-gradient of the source area to attenuate to observed conditions.

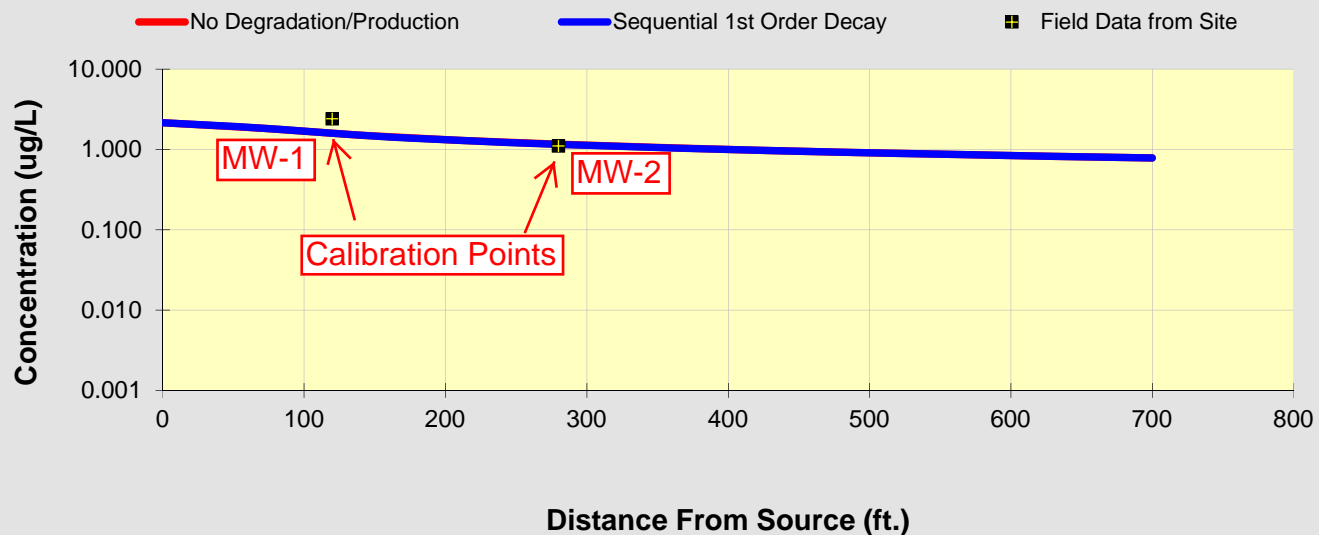
Figure 8B
 Simulated PCE Concentration Downgradient of MW-5 at 4 Years with Decaying Source
 Former Cleaning Center of Redmond
 Redmond, Washington
 Farallon PN: 650-001

PCE	Distance from Source (ft)											
	0	70	140	210	280	350	420	490	560	630	700	
No Degradation	2.157	1.841	1.503	1.296	1.157	1.056	0.978	0.916	0.865	0.822	0.786	
Biotransformation	2.1568	1.841	1.503	1.296	1.157	1.056	0.978	0.916	0.865	0.822	0.786

Figure 8B, *Simulated PCE Concentration Downgradient of MW-5 at 4 Years with Decaying Source*
