Scott Paper Mill
Anacortes, Washington

Port Uplands Area Preliminary Soil Cleanup Level Exceedance Locations (0-2 ft BGS)

Figure 26
Plan View Marine Alternative M-1
Former Scott Paper Mill

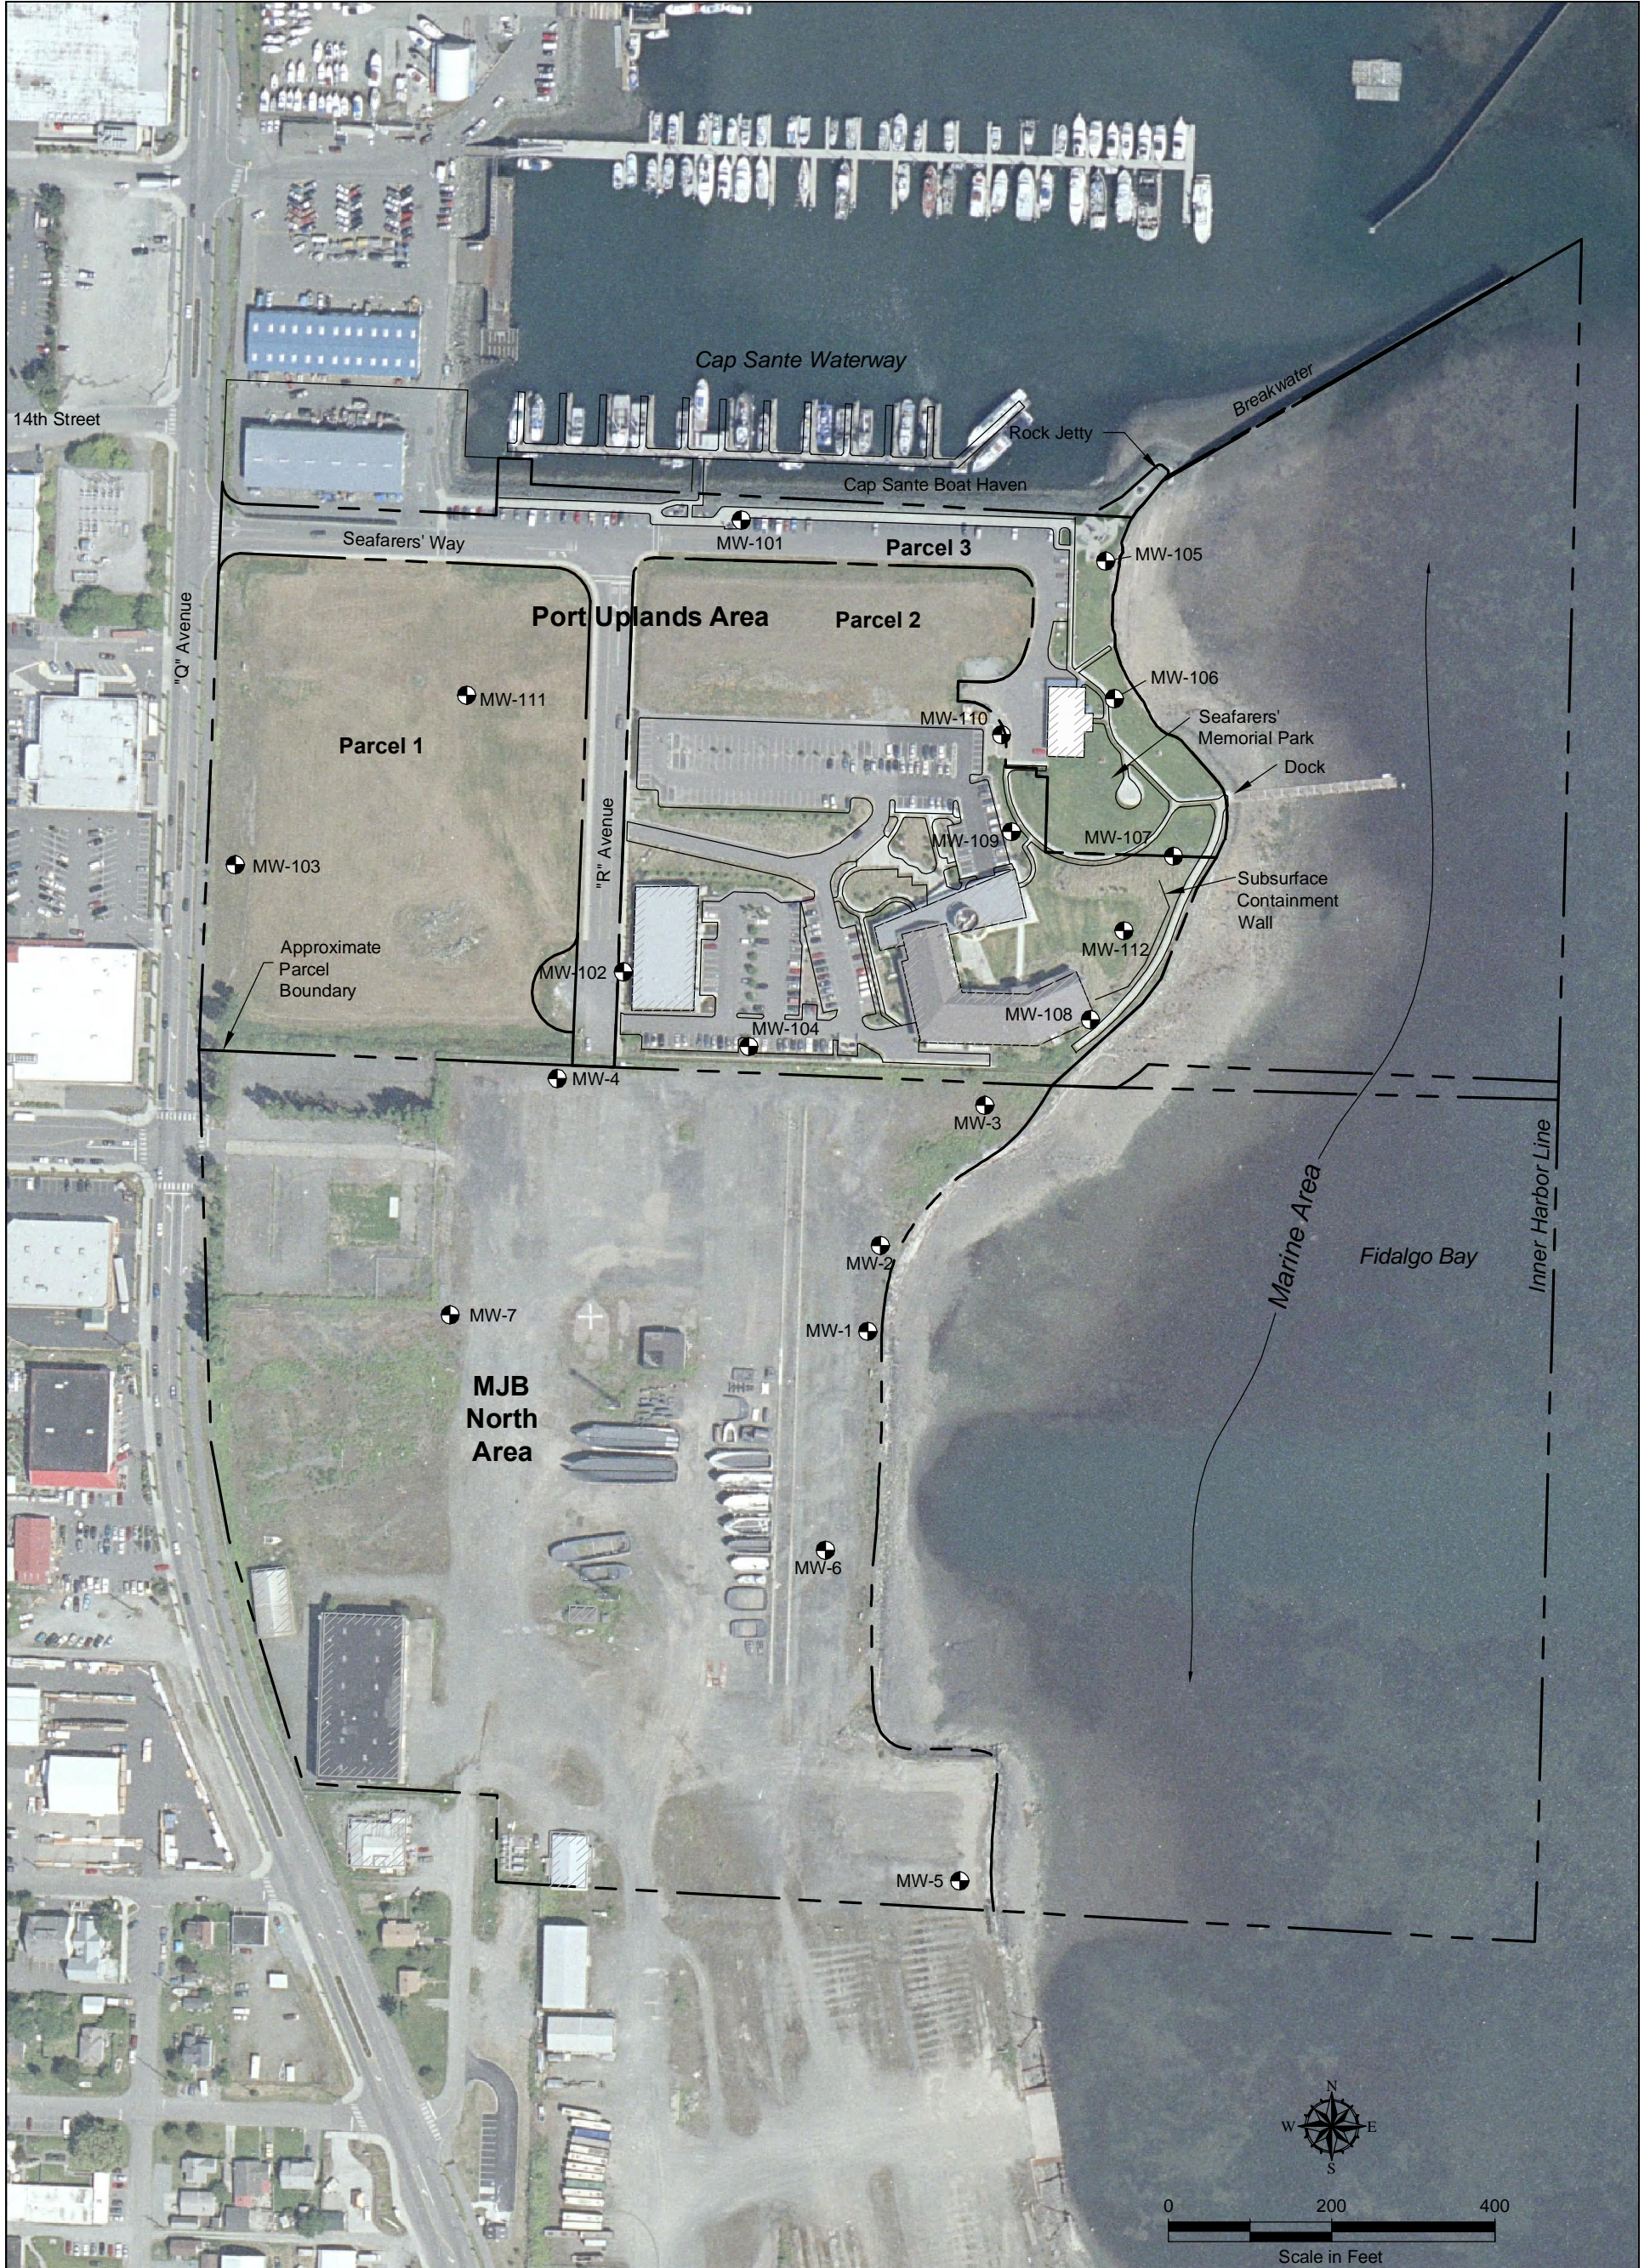
Figure 2

Site Plan

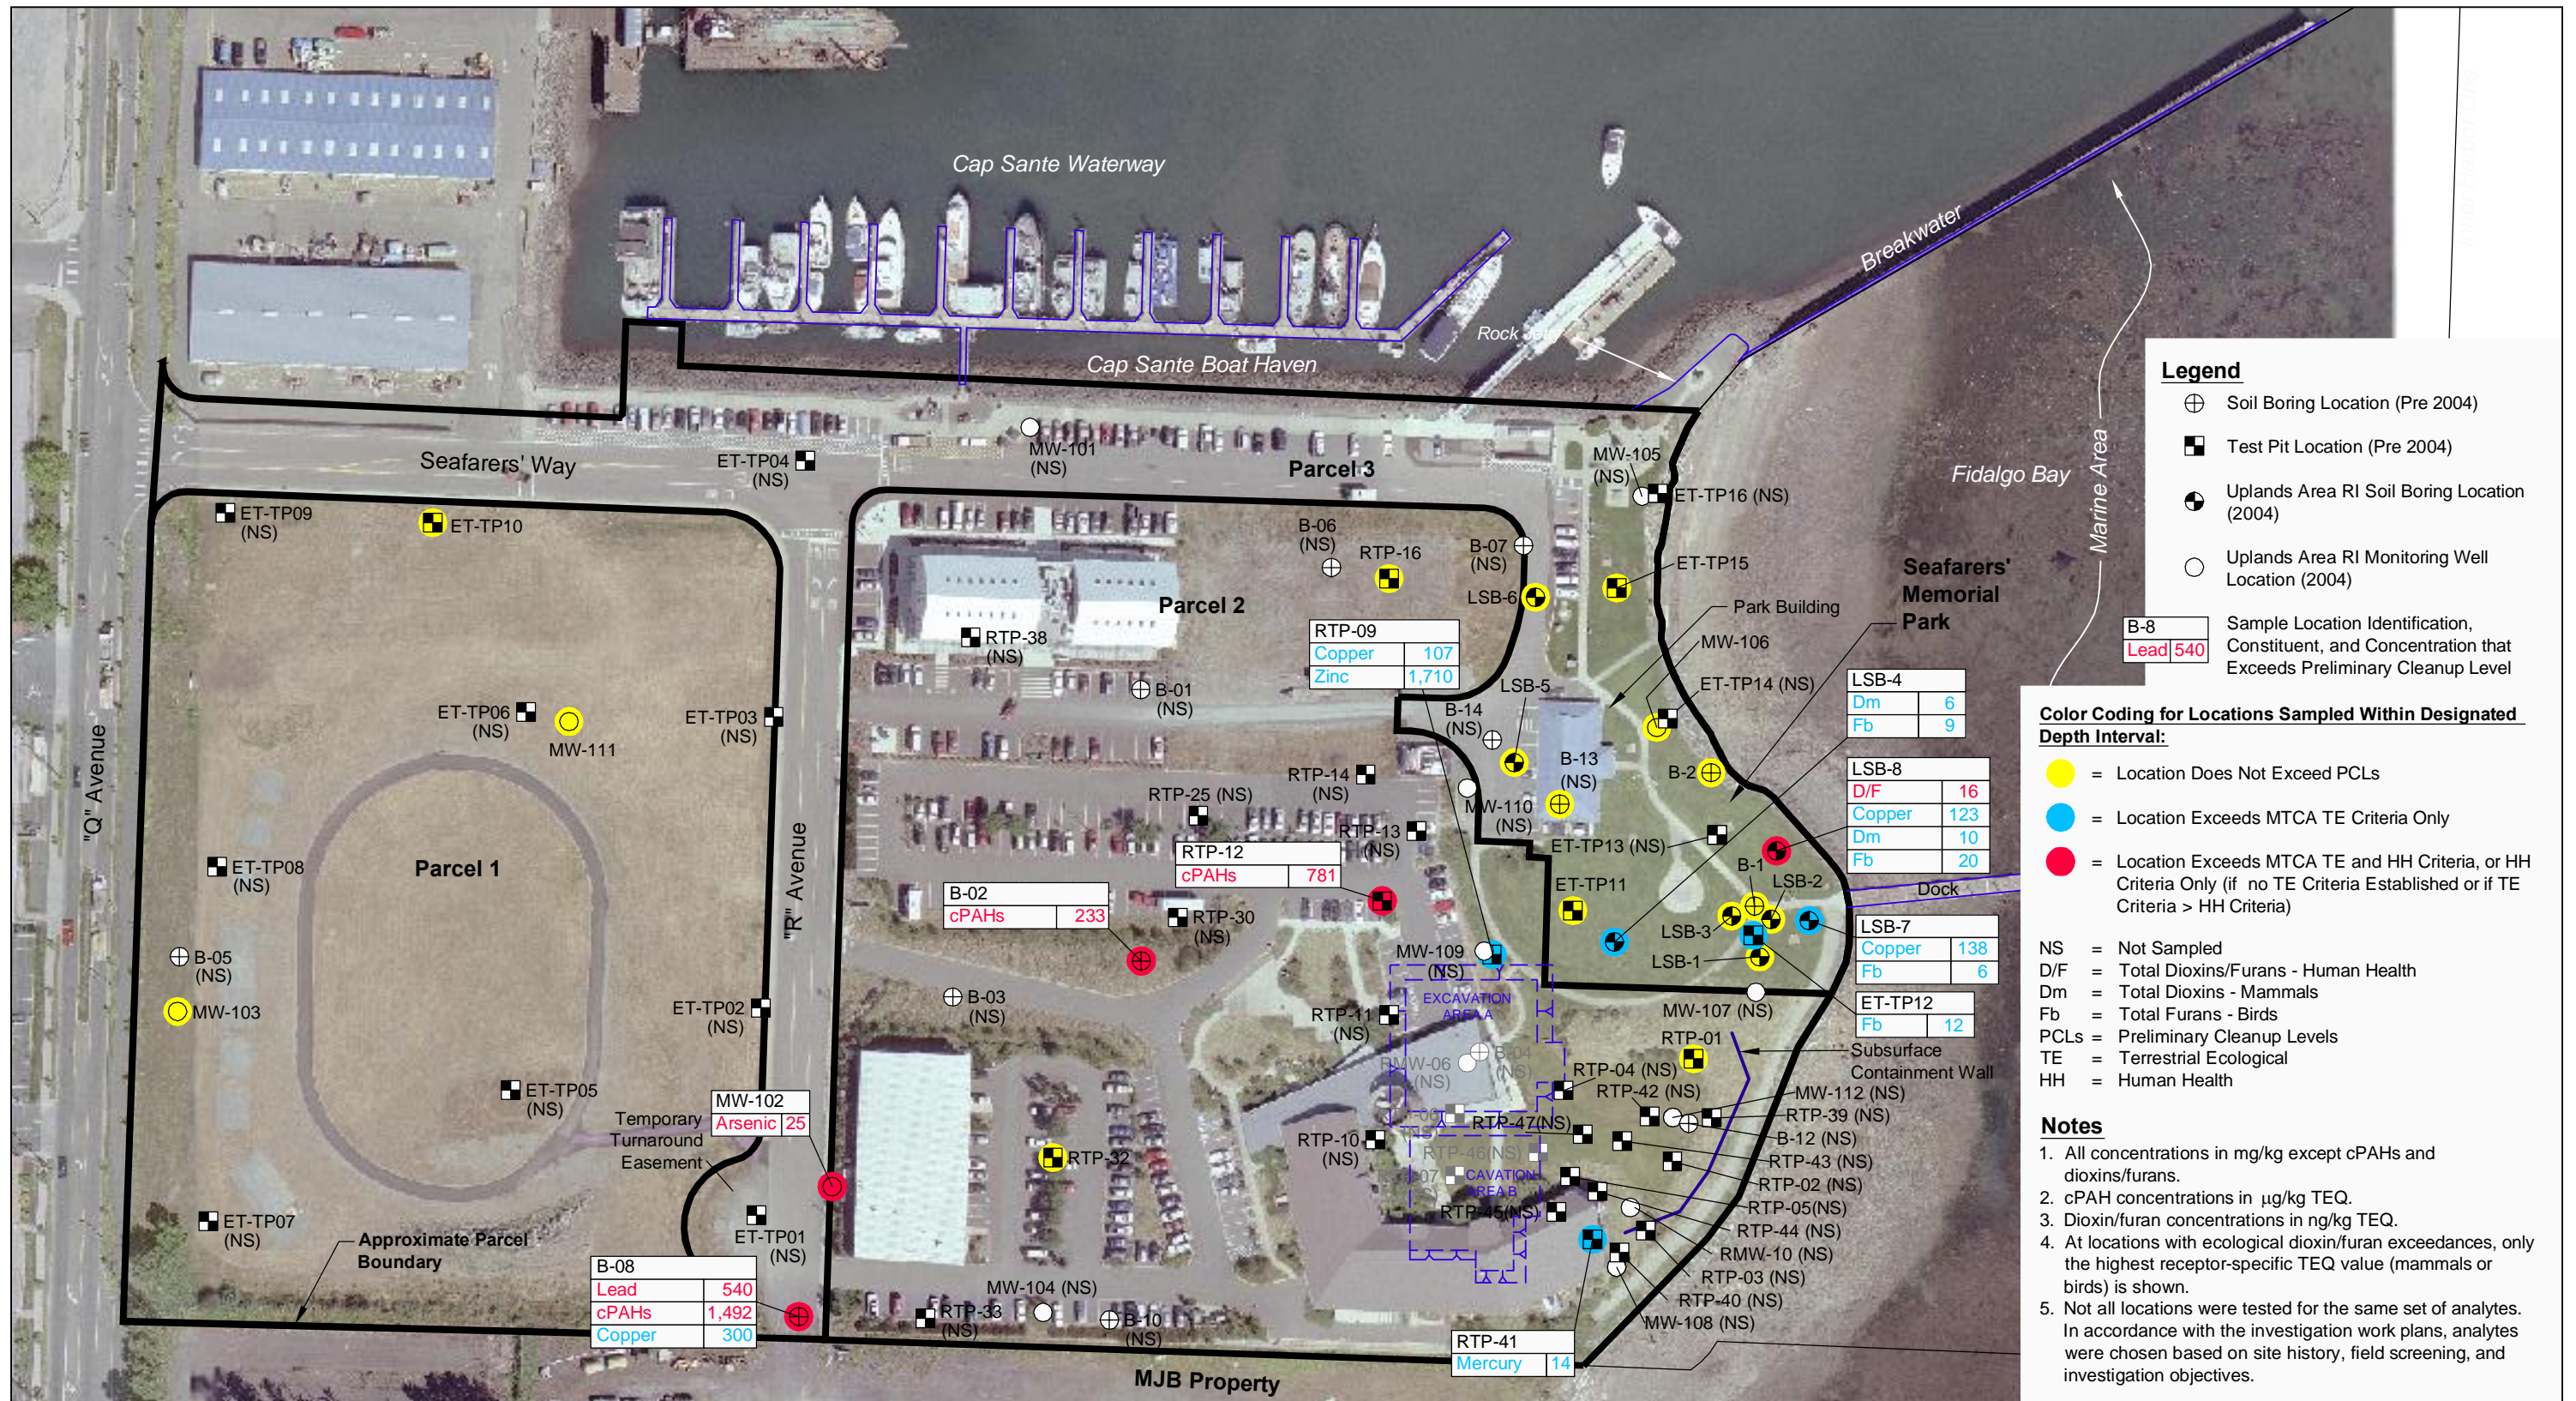
Figure 4

Port Uplands Area Preliminary Soil Cleanup Level Exceedance Locations (2-6 ft BGS)

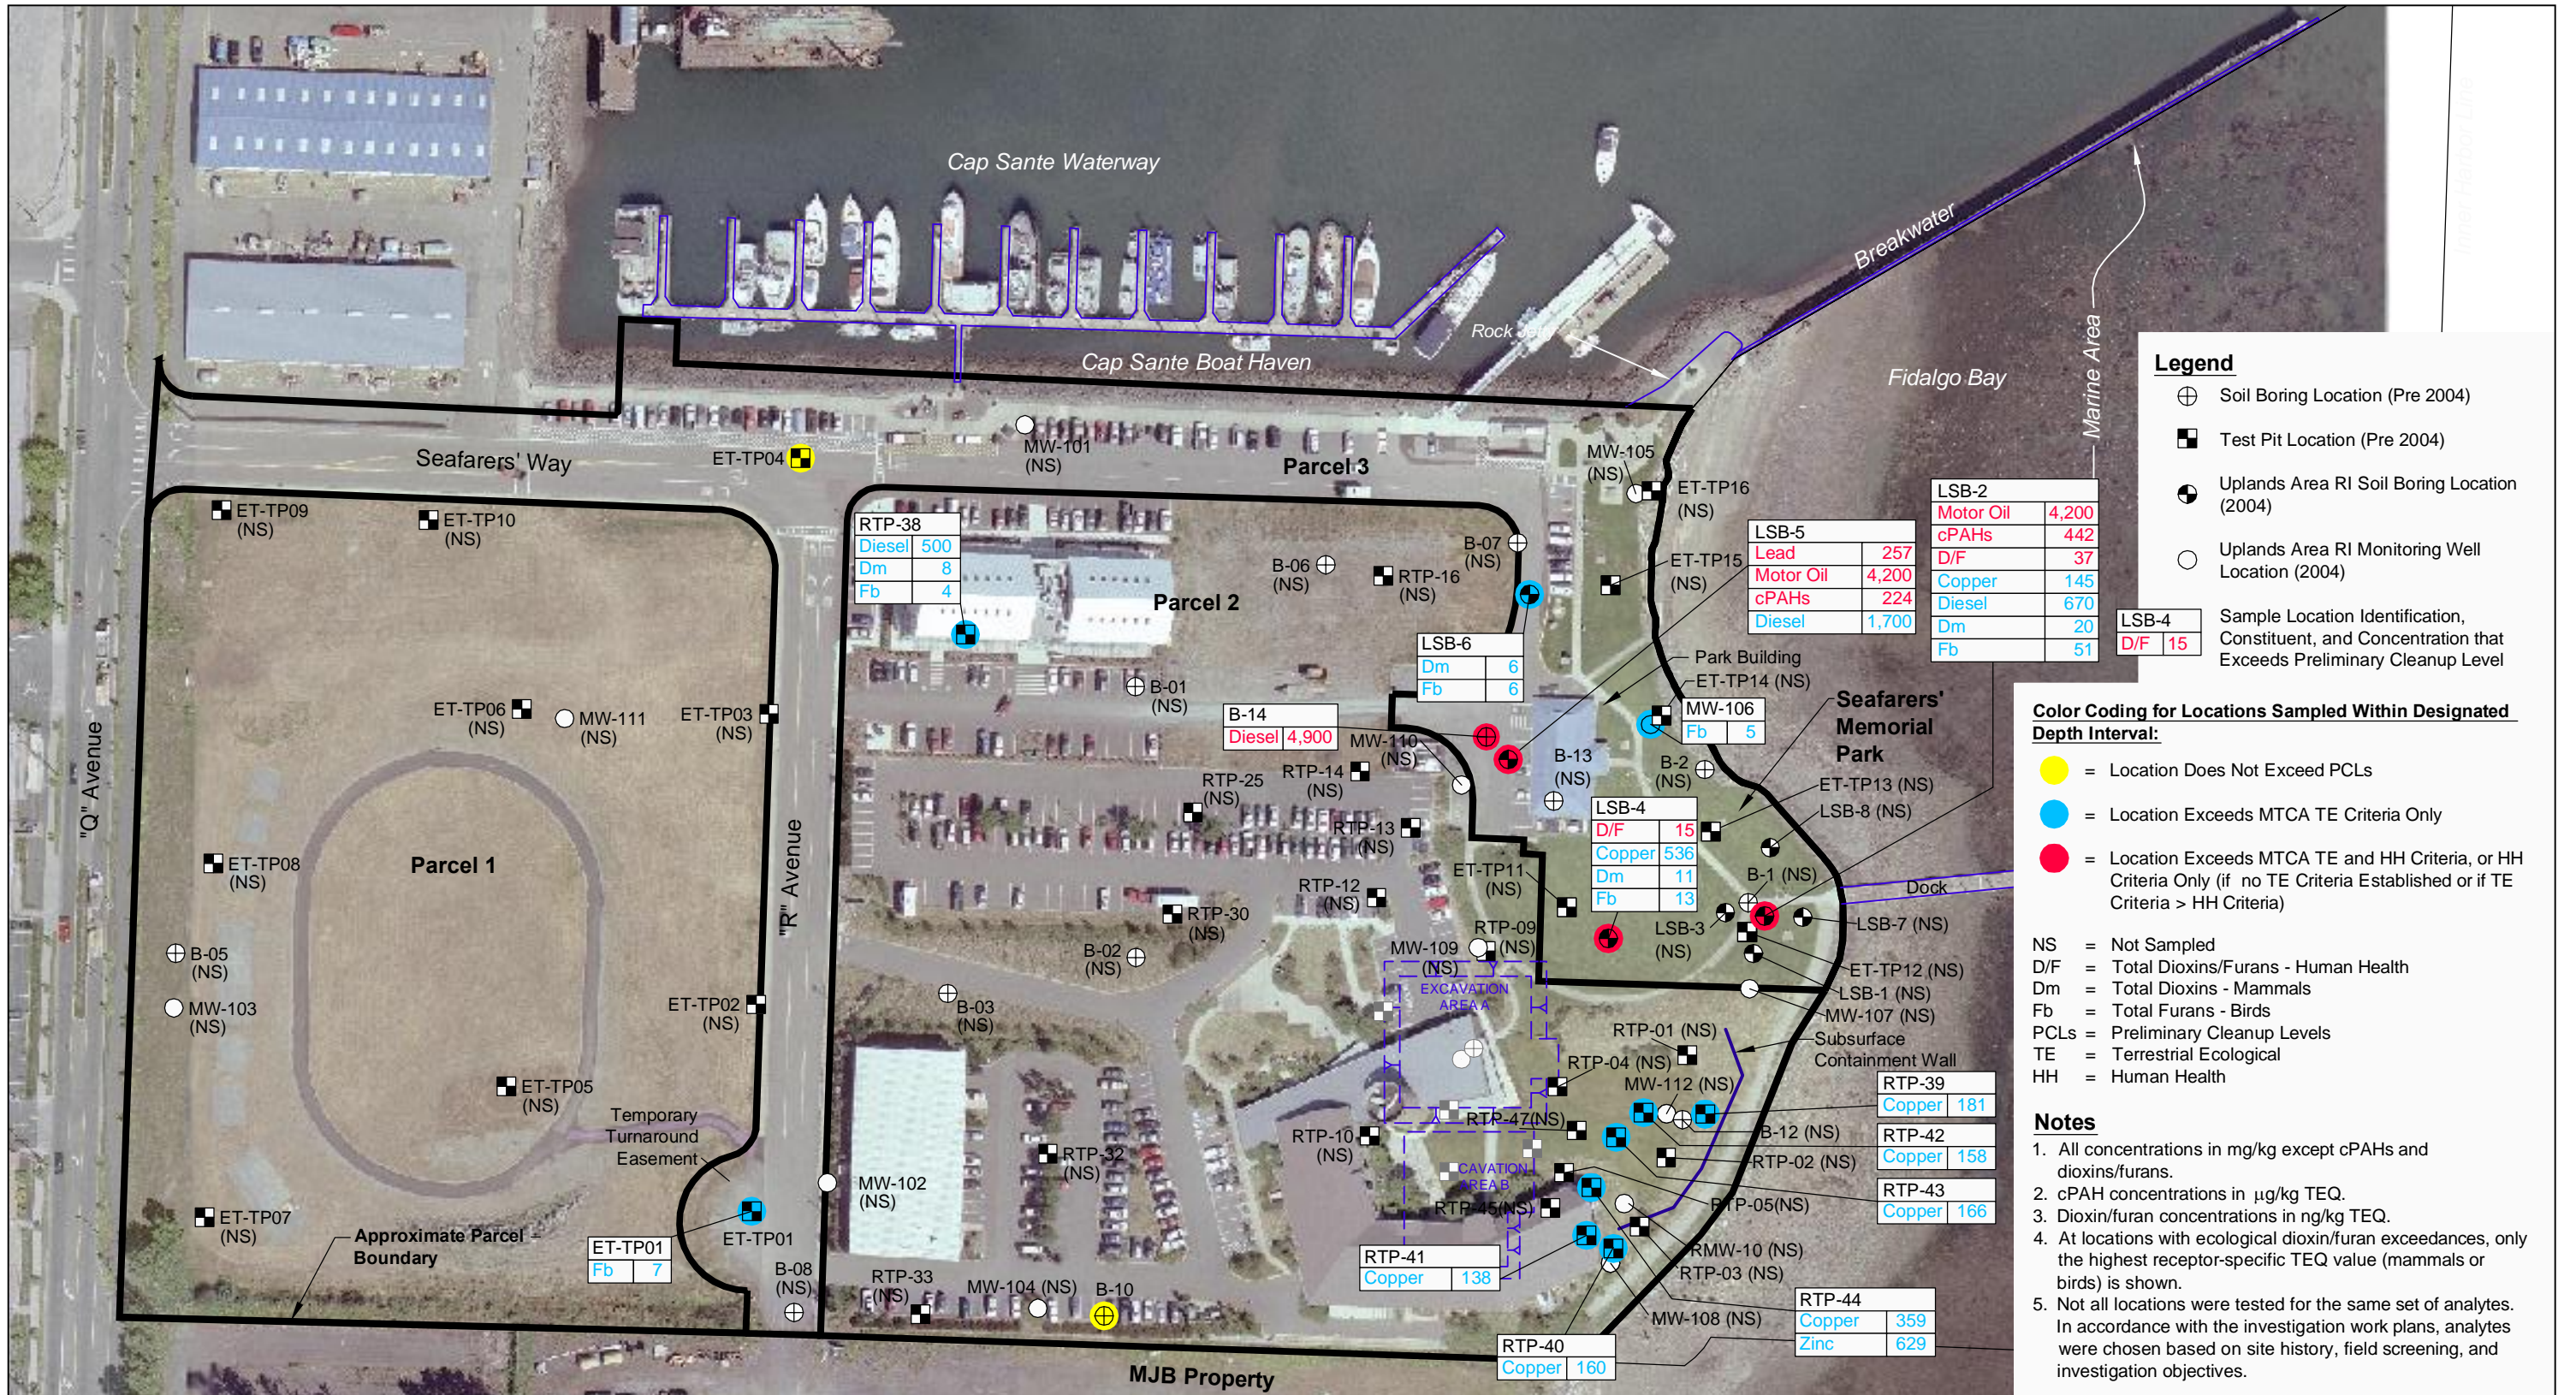
Figure 6

Port Uplands Area Preliminary Soil Cleanup Level Exceedance Locations (10-15 ft BGS)

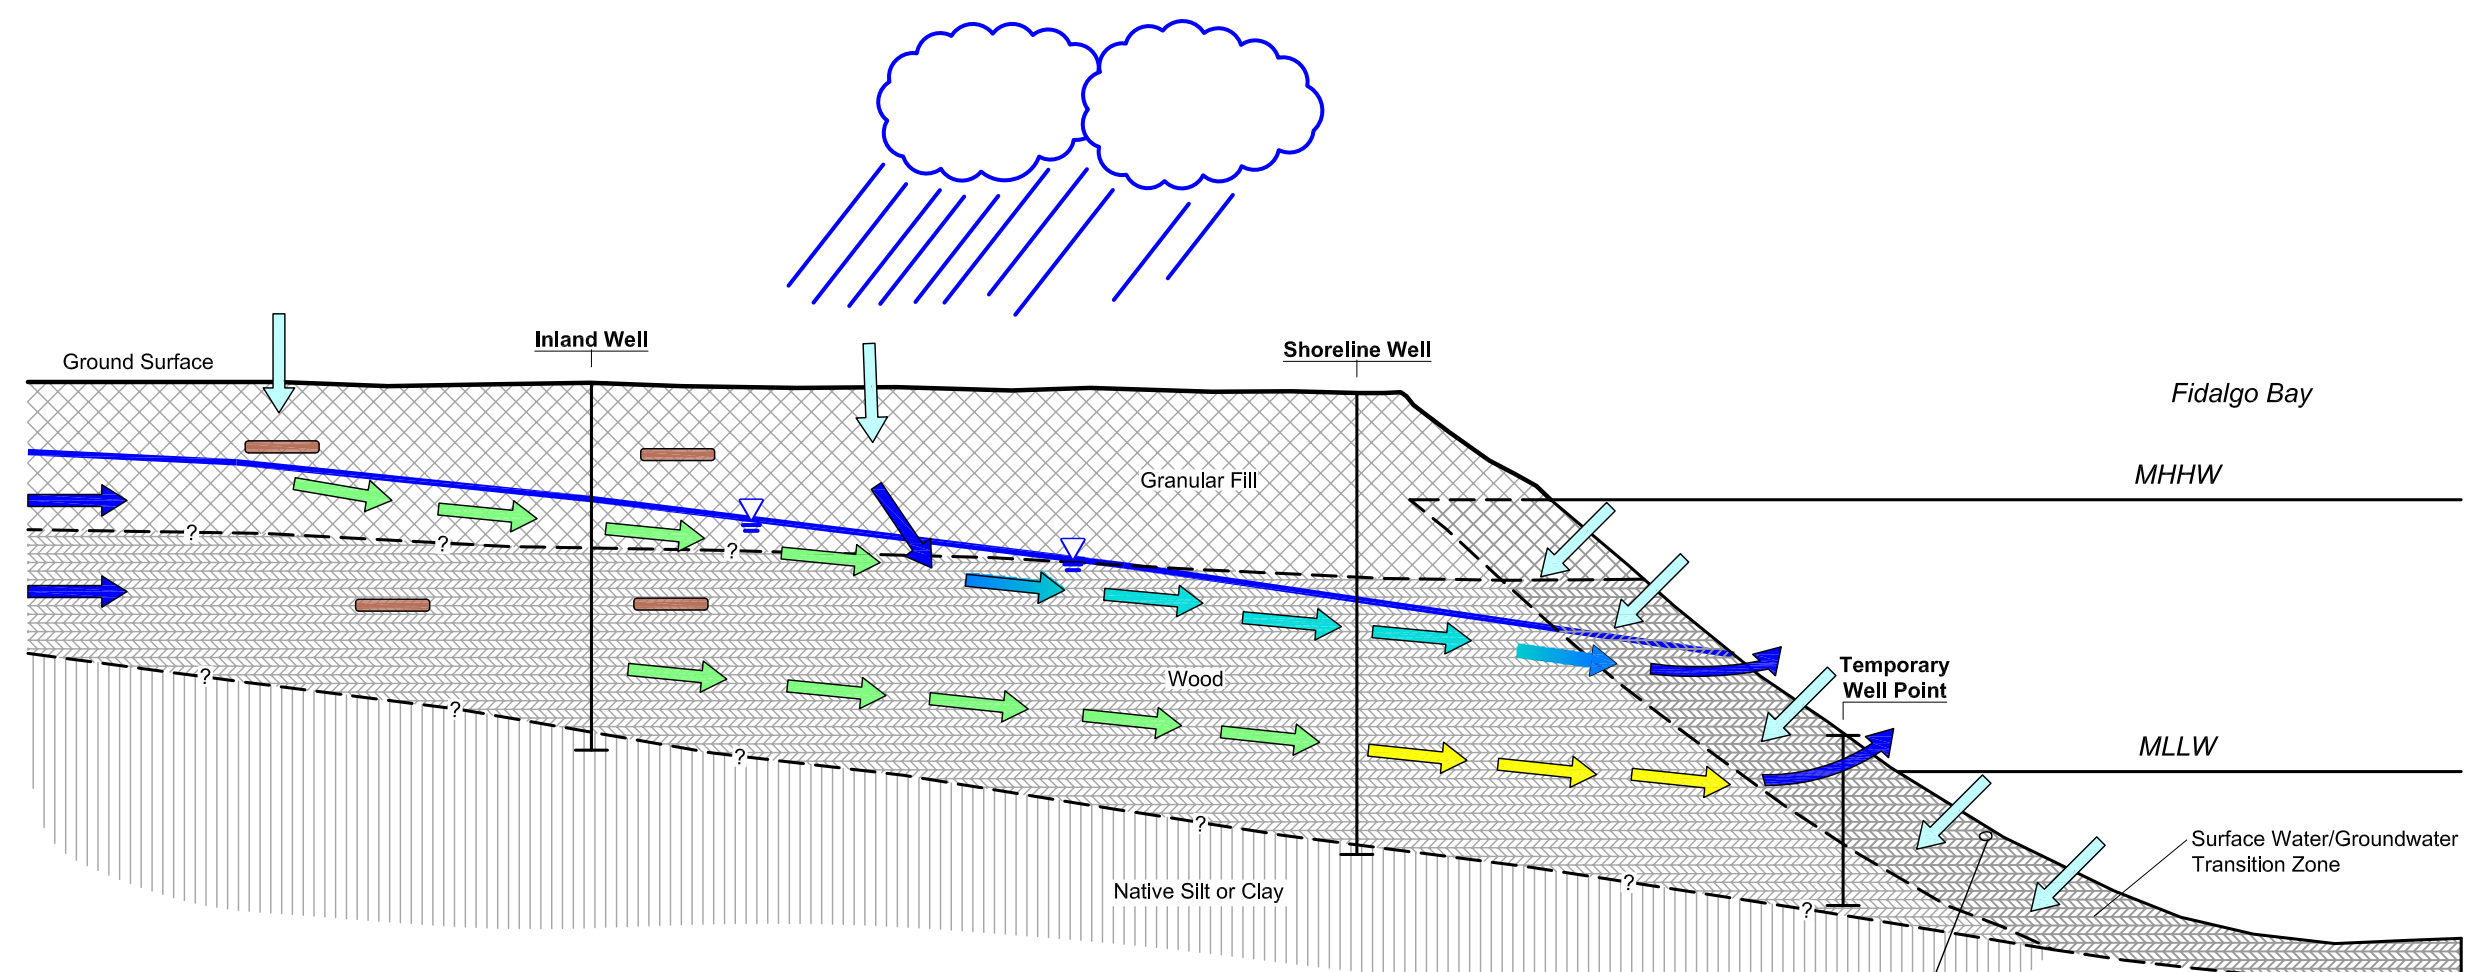
- Groundwater Flow Direction not Adversely Impacted by Site Conditions
- Groundwater Impacted by Site Conditions Due to Leaching of Contaminants from Soil (Concentrations Exceed Preliminary Screening Levels)
- Groundwater Impacted by Site Conditions but at Concentrations Below the Preliminary Cleanup Levels
- Groundwater Affected by Sulfide as a Result of Decaying Wood Debris
- Surface Water Infiltration
- Localized Soil Interval with Contaminant (Arsenic, Lead, cPAHs, TPH, Dioxin/Furan) Concentrations Exceeding Preliminary Screening Levels
- Groundwater Table

Conceptual Site Model	
Scott Paper Mill Anacortes, Washington	
	Figure 10

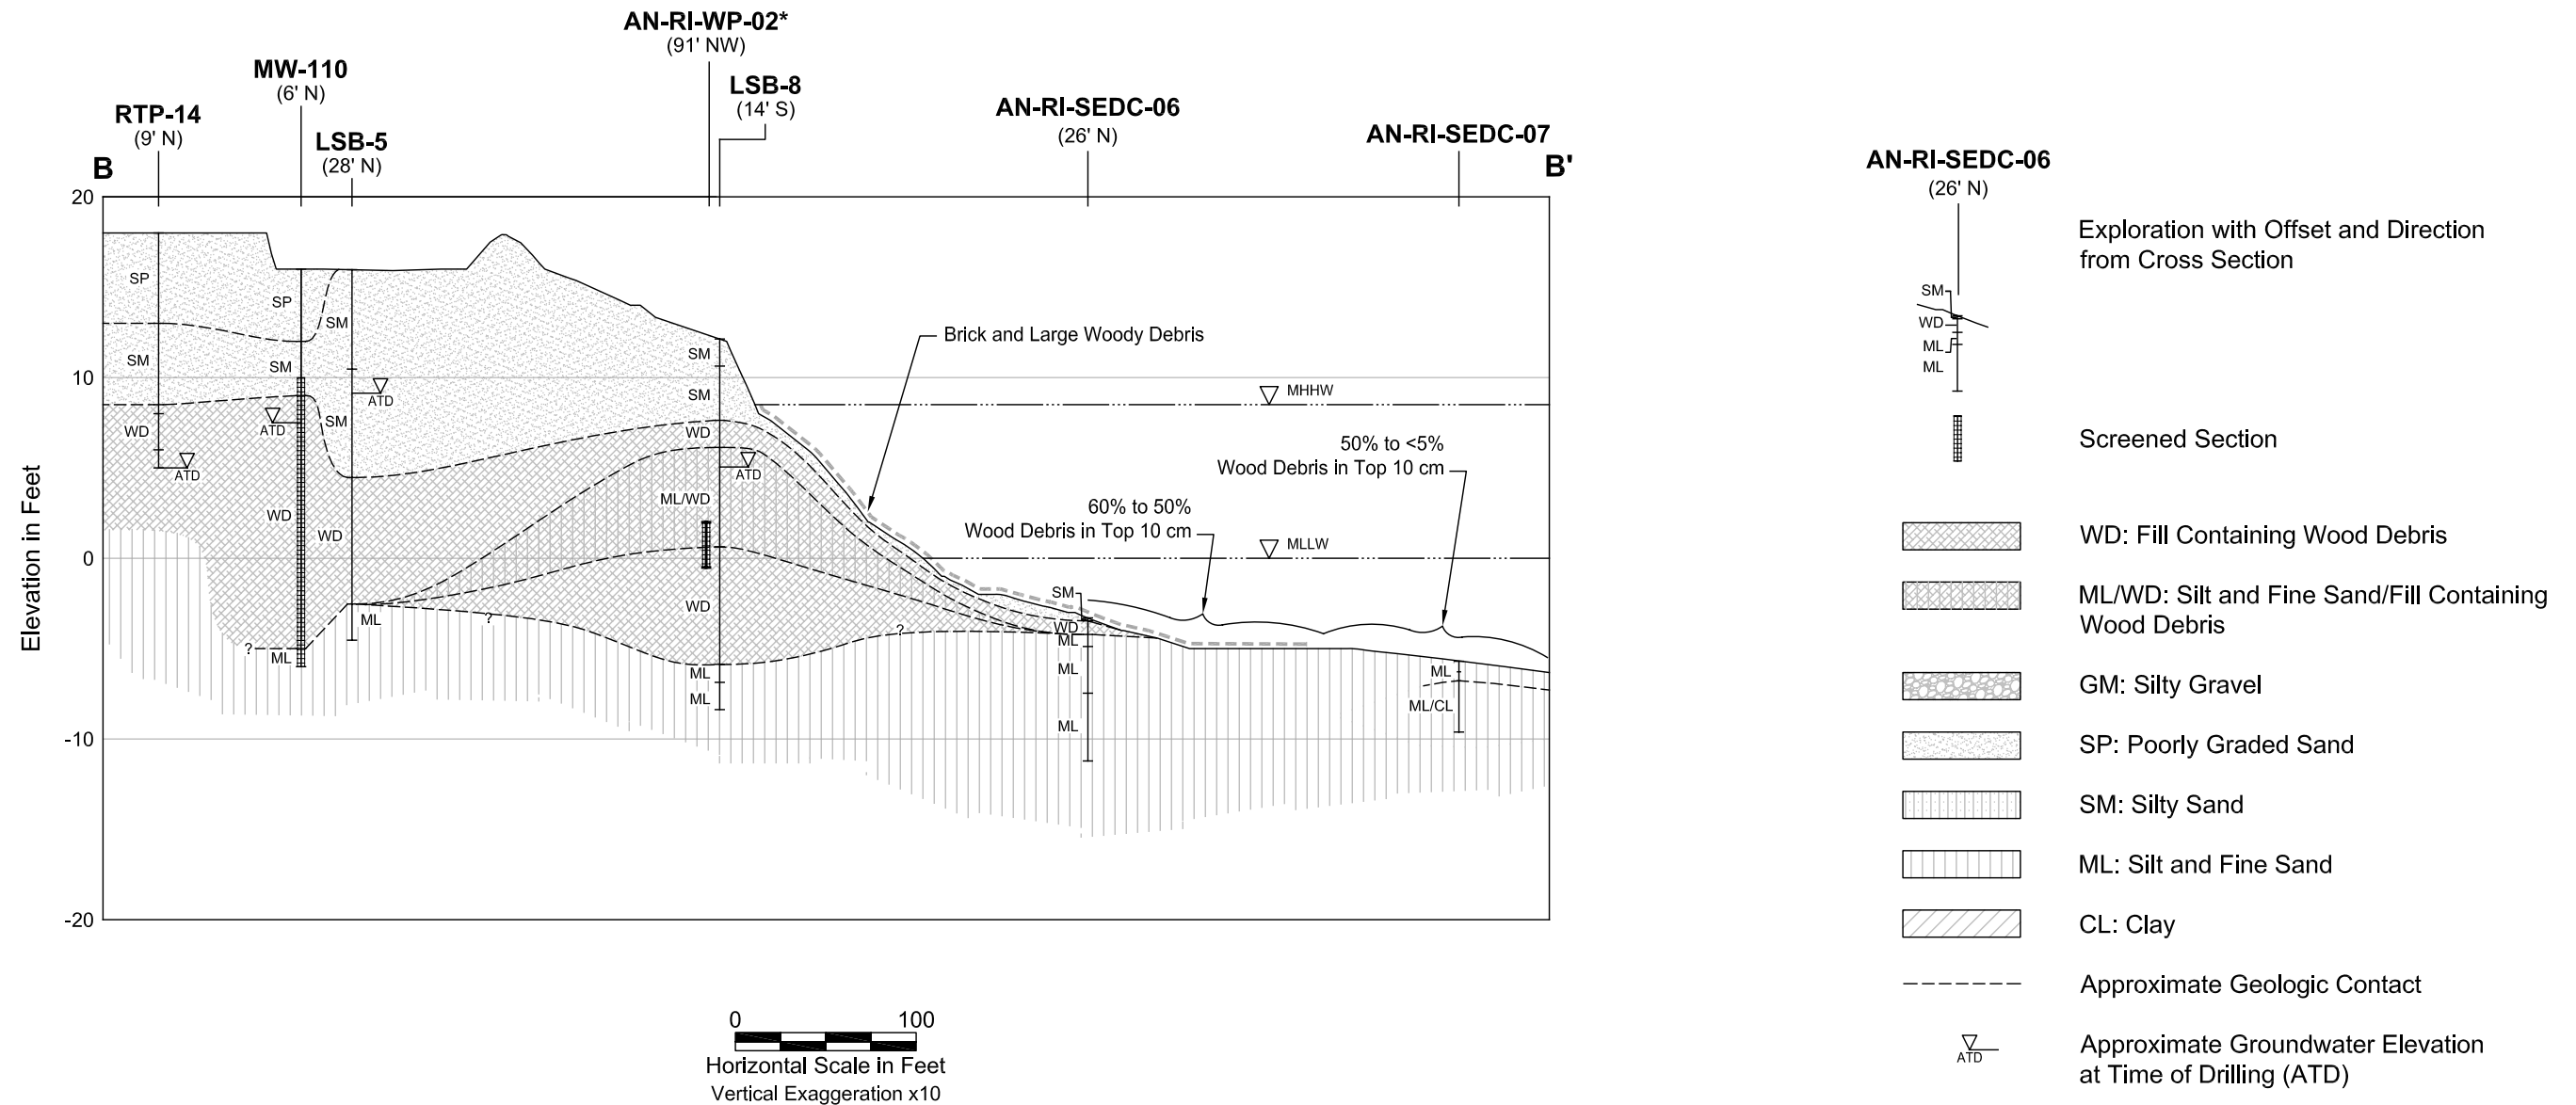
Figure 15
Cross Sections B-B'
Former Scott Paper Mill

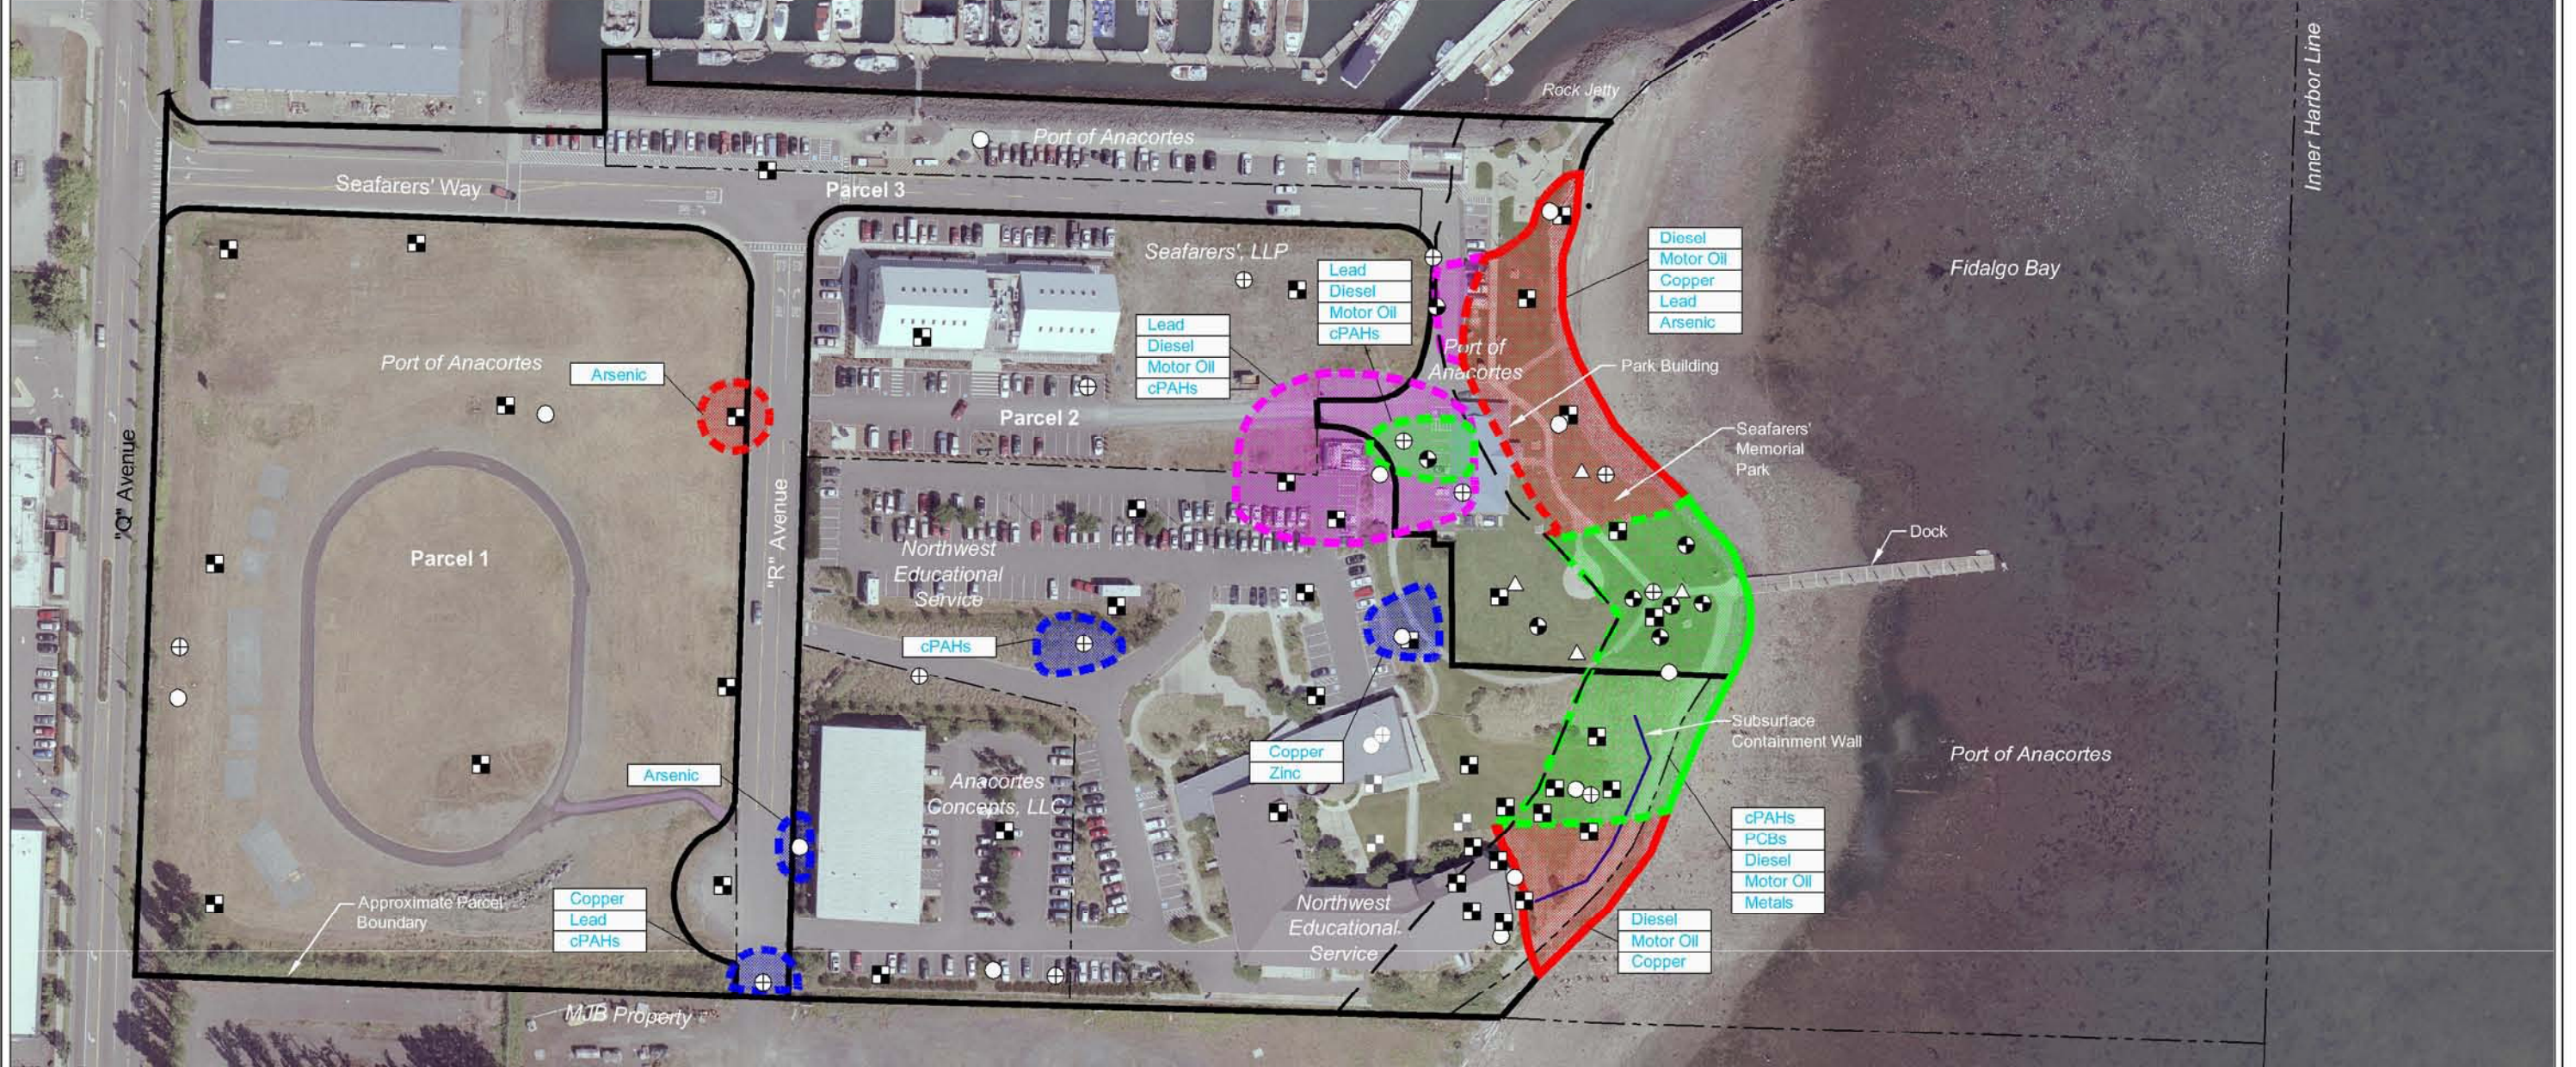
Alternative PUA-2	
Scott Paper Mill Anacortes, Washington	
GEOENGINEERS	Figure 19

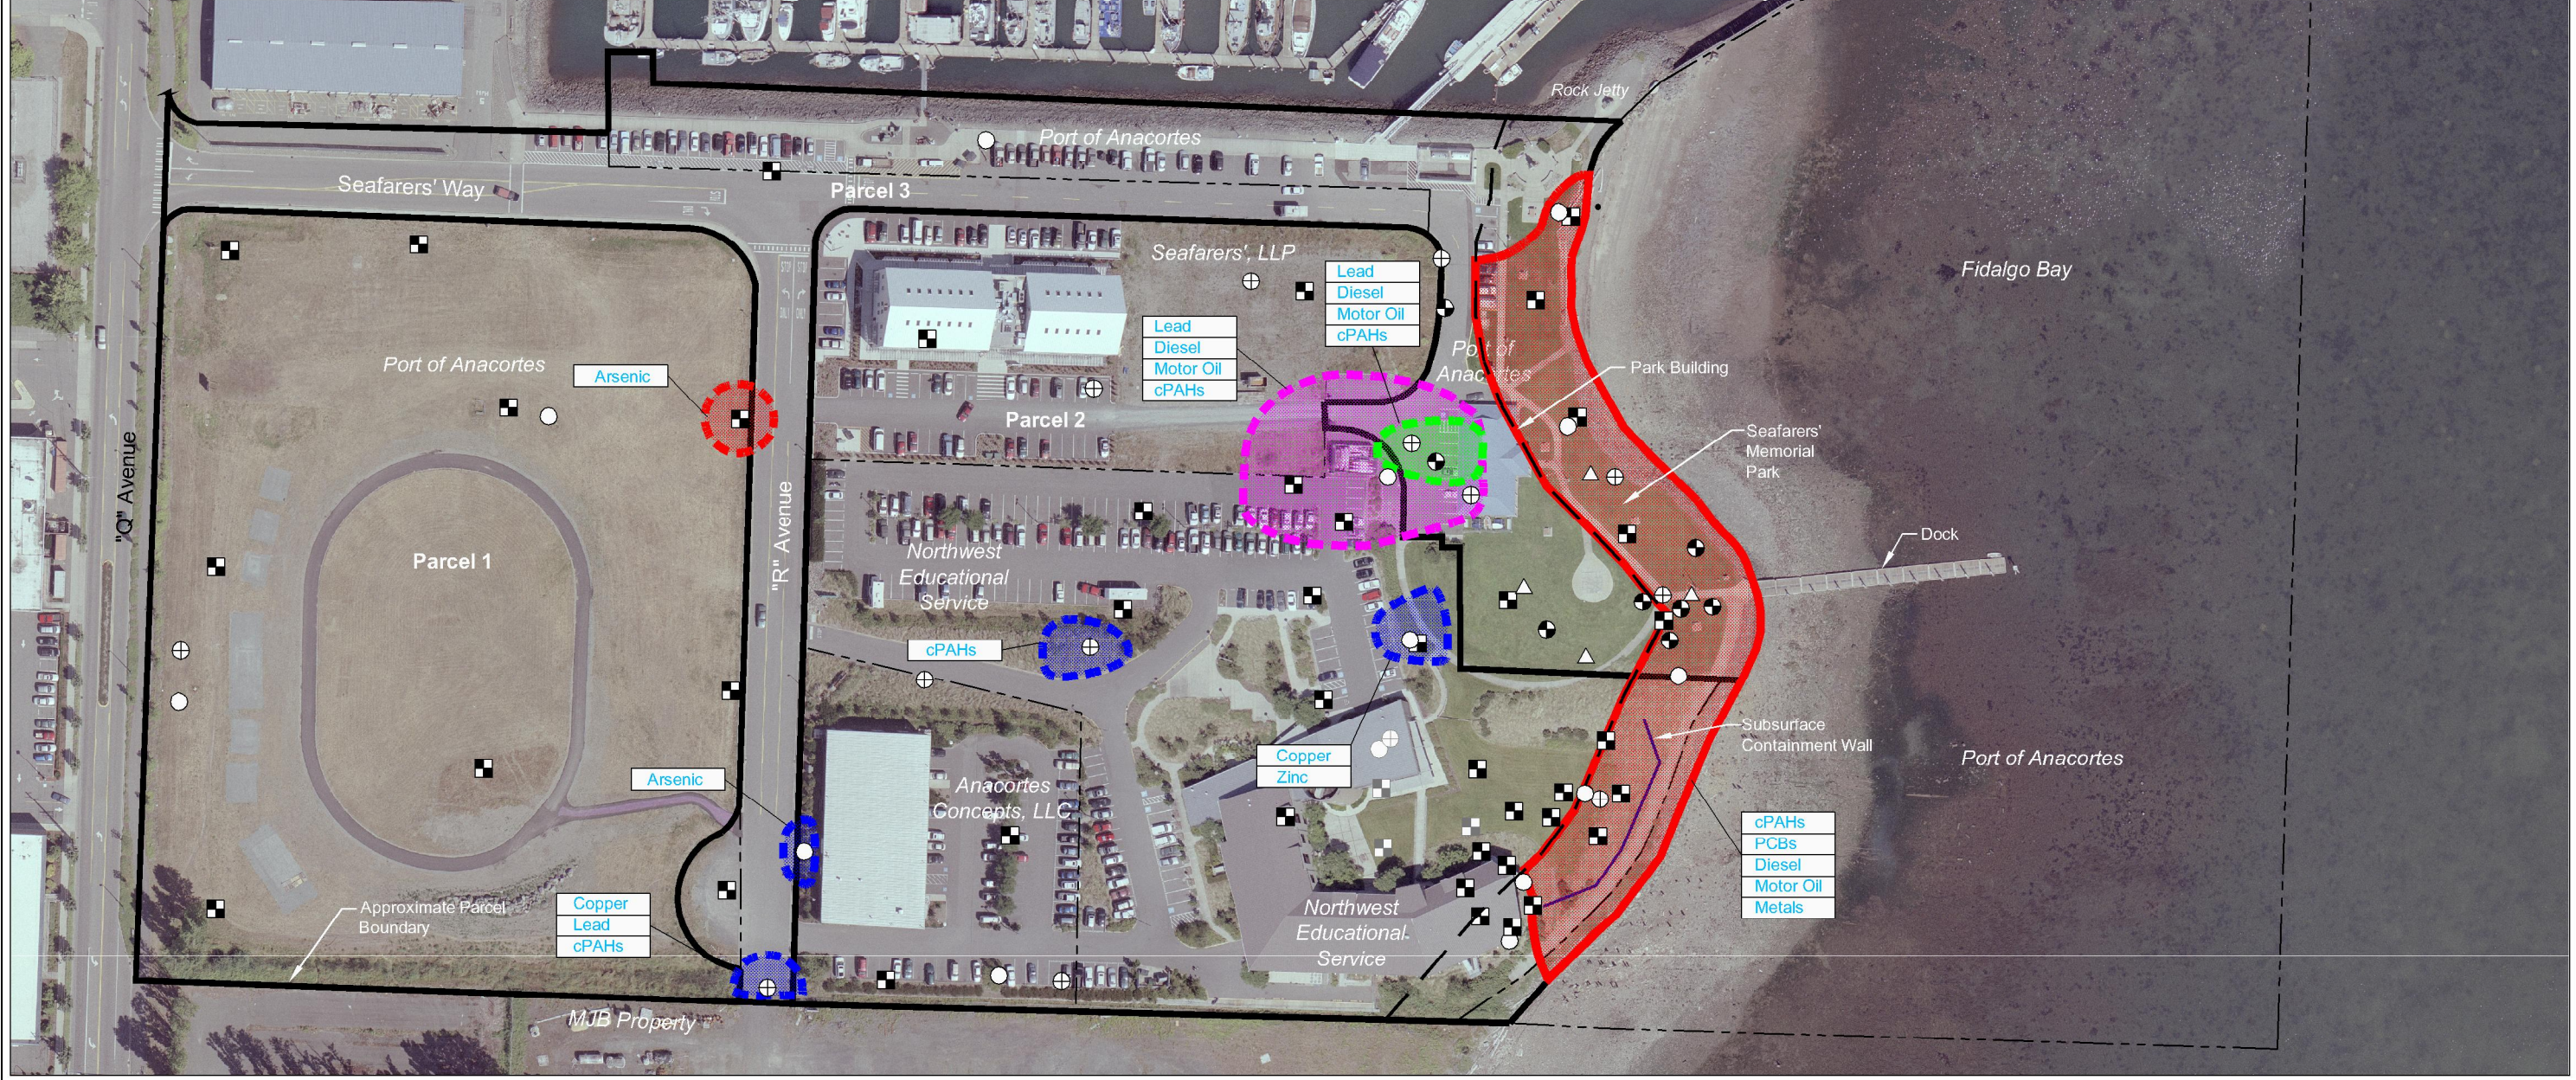
Alternative PUA-4	
Scott Paper Mill Anacortes, Washington	
GEOENGINEERS	Figure 21
