Scott Paper Mill
Anacortes, Washington

Port Uplands Area Preliminary Soil Cleanup Level Exceedance Locations (0-2 ft BGS)

Figure 26
Plan View Marine Alternative M-1
Former Scott Paper Mill

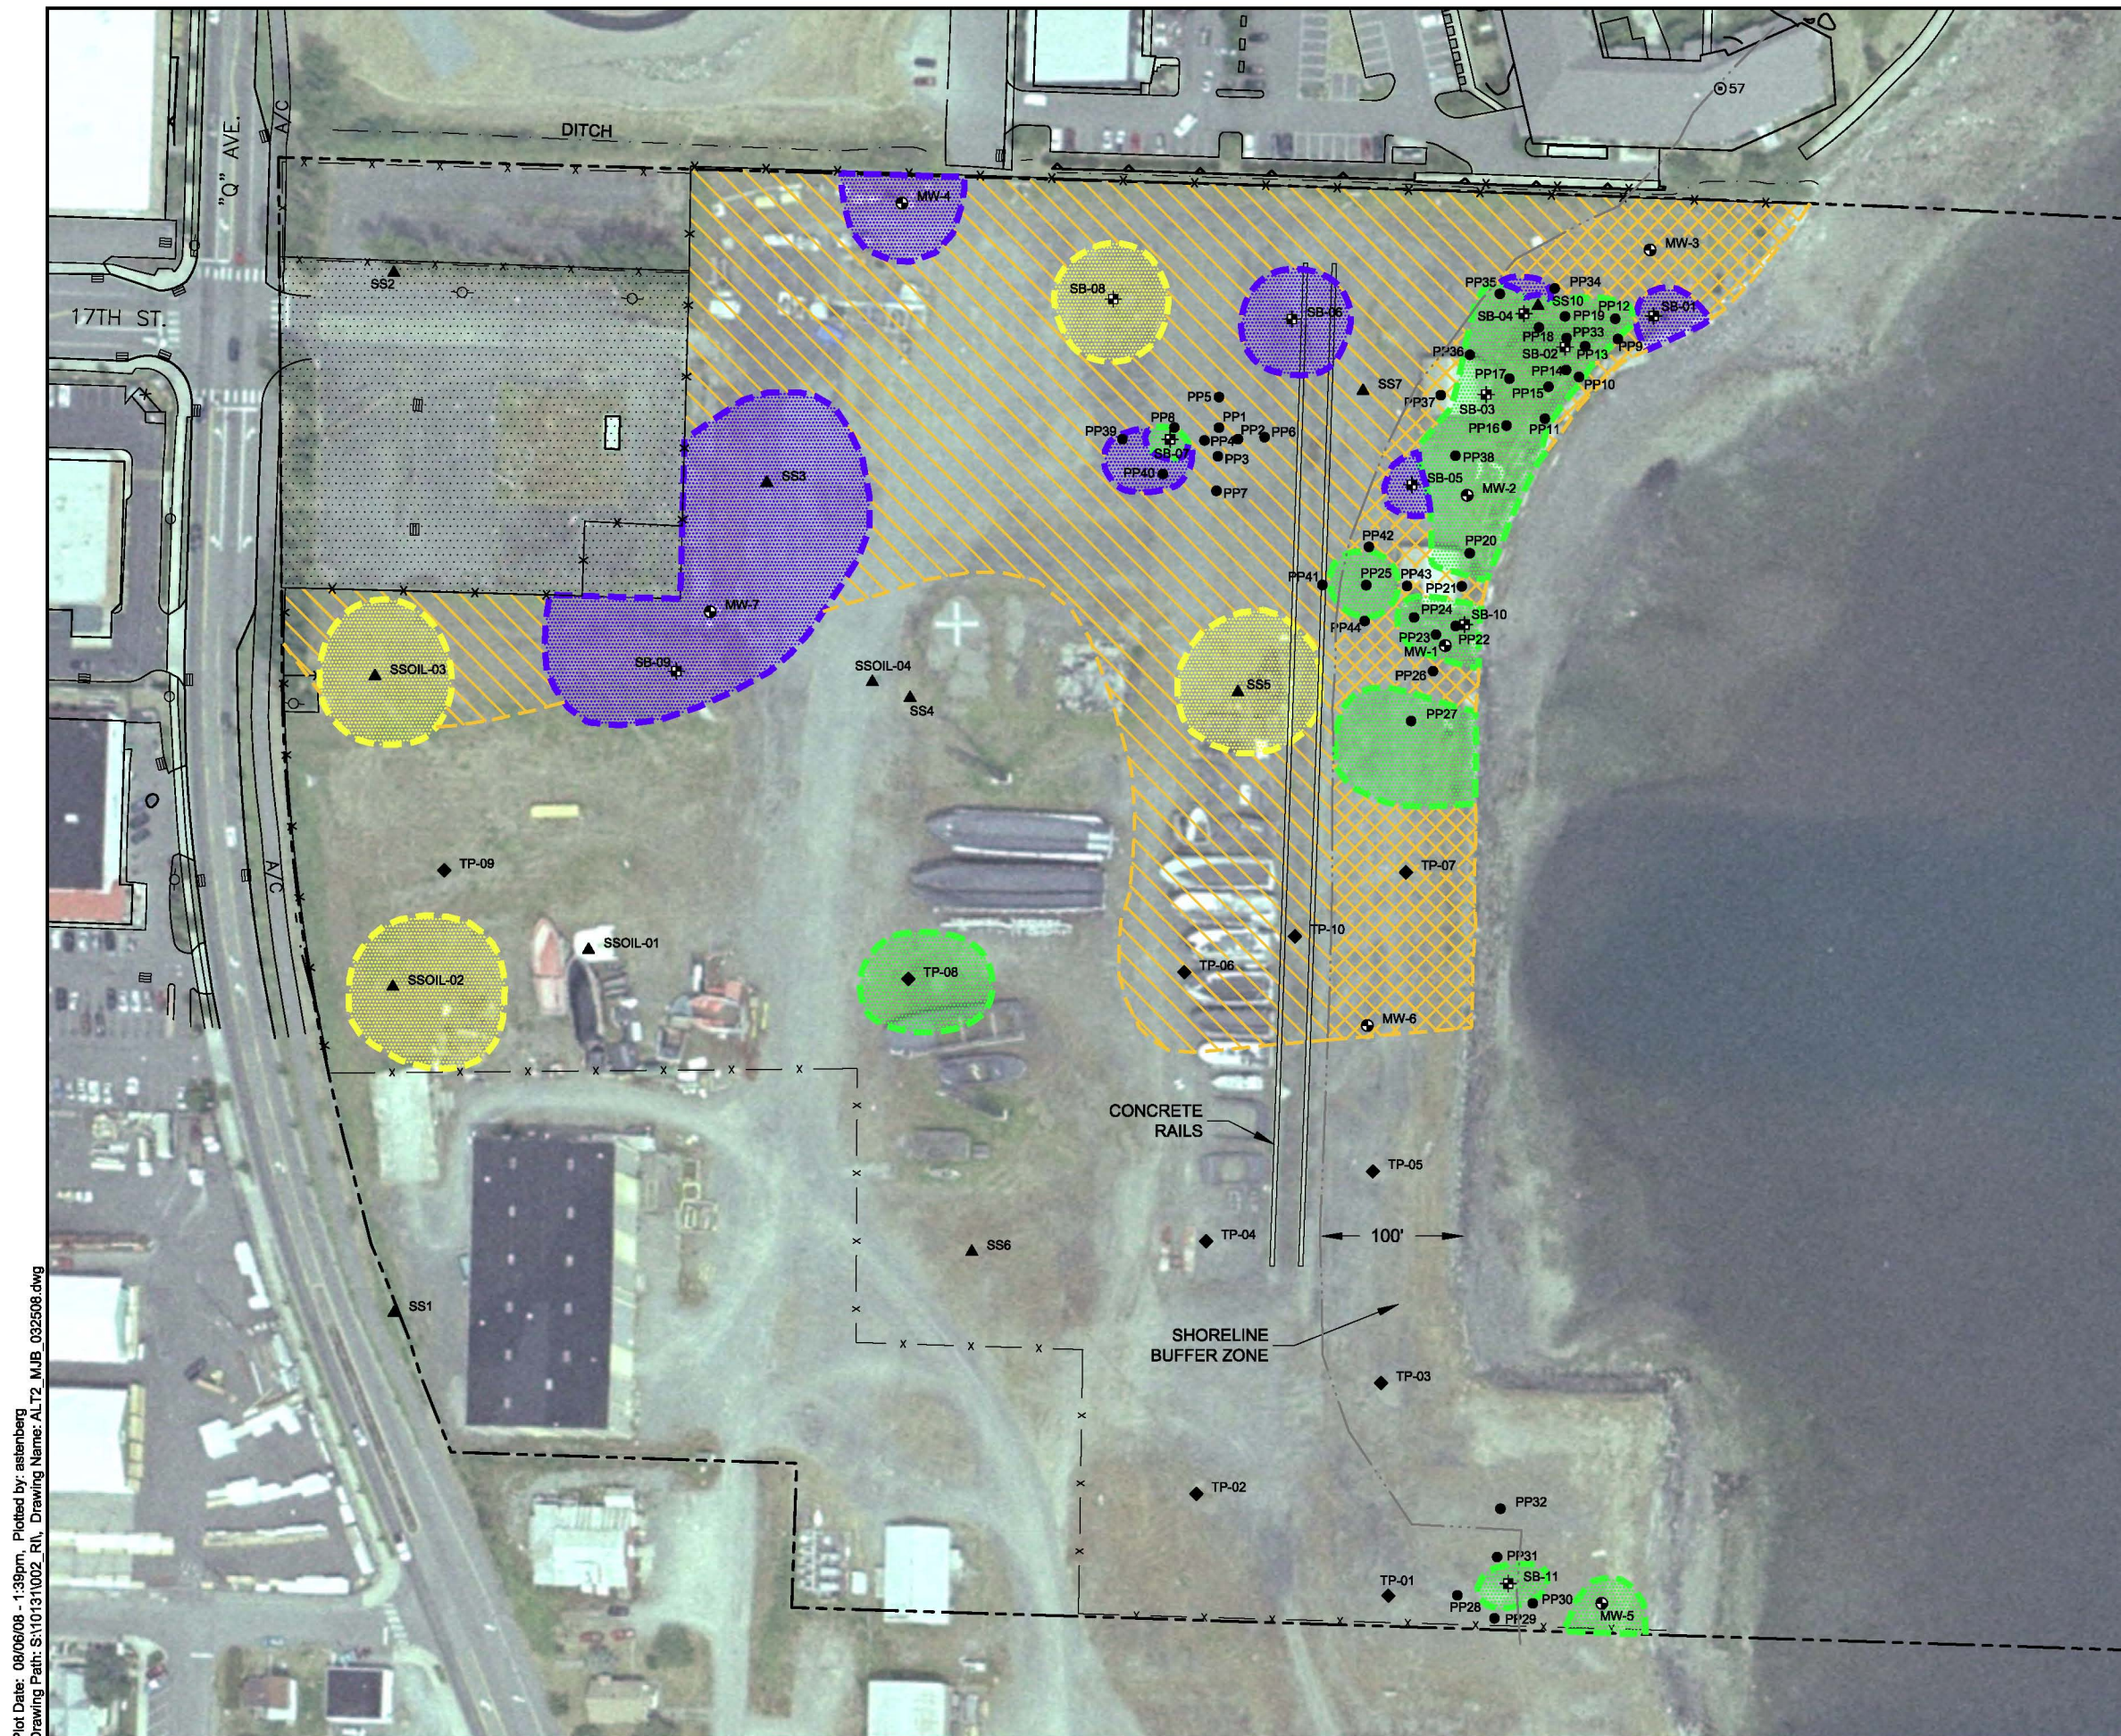
- ▨ Anticipated Limit of Excavation from 0 to 2' BGS
- ▨ Anticipated Limit of Excavation from 0 to 6' BGS
- ▨ Anticipated Limit of Homogenization from 0 to 4' BGS
- ▨ Potential Upper Limit of Homogenization from 0 to 4' BGS
- ▨ Potential Upper Limit of Excavation from 0 to 2' BGS

ALTERNATIVE MJB-2
MJB North Area
Anacortes, Washington

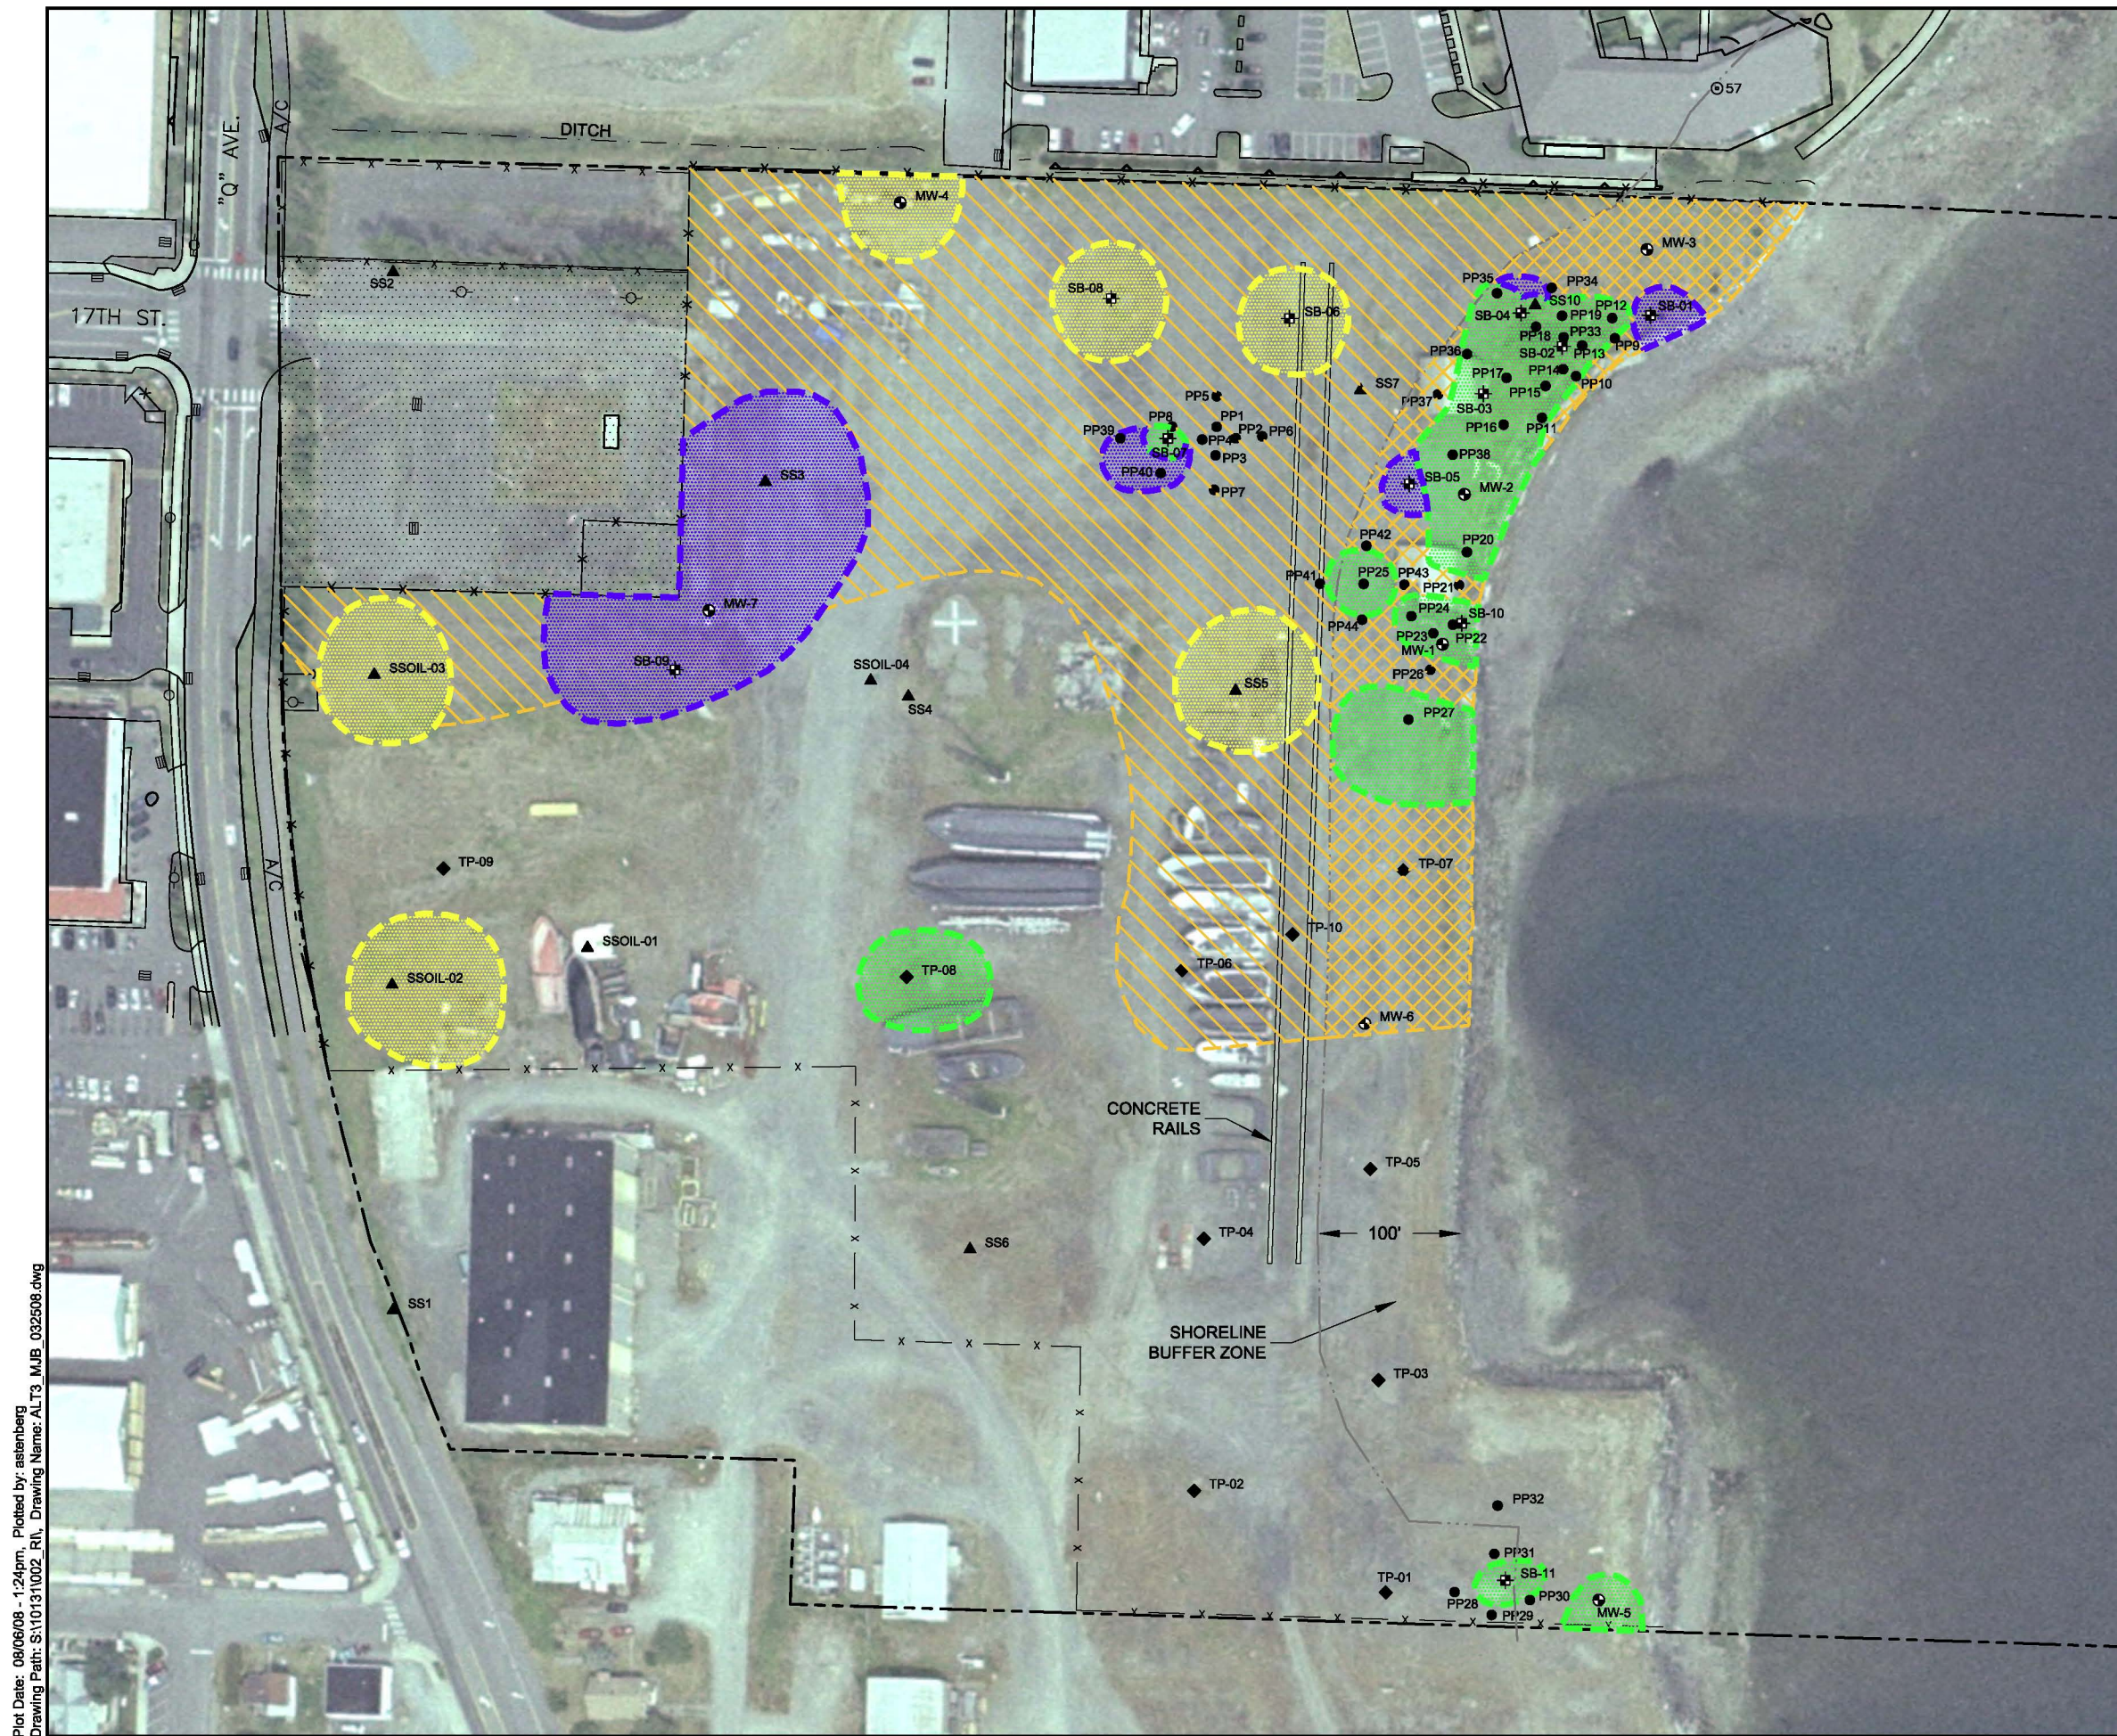
- ▨ Anticipated Limit of Excavation from 0 to 2' BGS
- ▨ Anticipated Limit of Excavation from 0 to 6' BGS
- ▨ Anticipated Limit of Asphalt Cover
- ▨ Potential Upper Limit of Asphalt Cover
- ▨ Potential Upper Limit of Excavation from 0 to 2' BGS

**ALTERNATIVE MJB-3
MJB North Area
Anacortes, Washington**

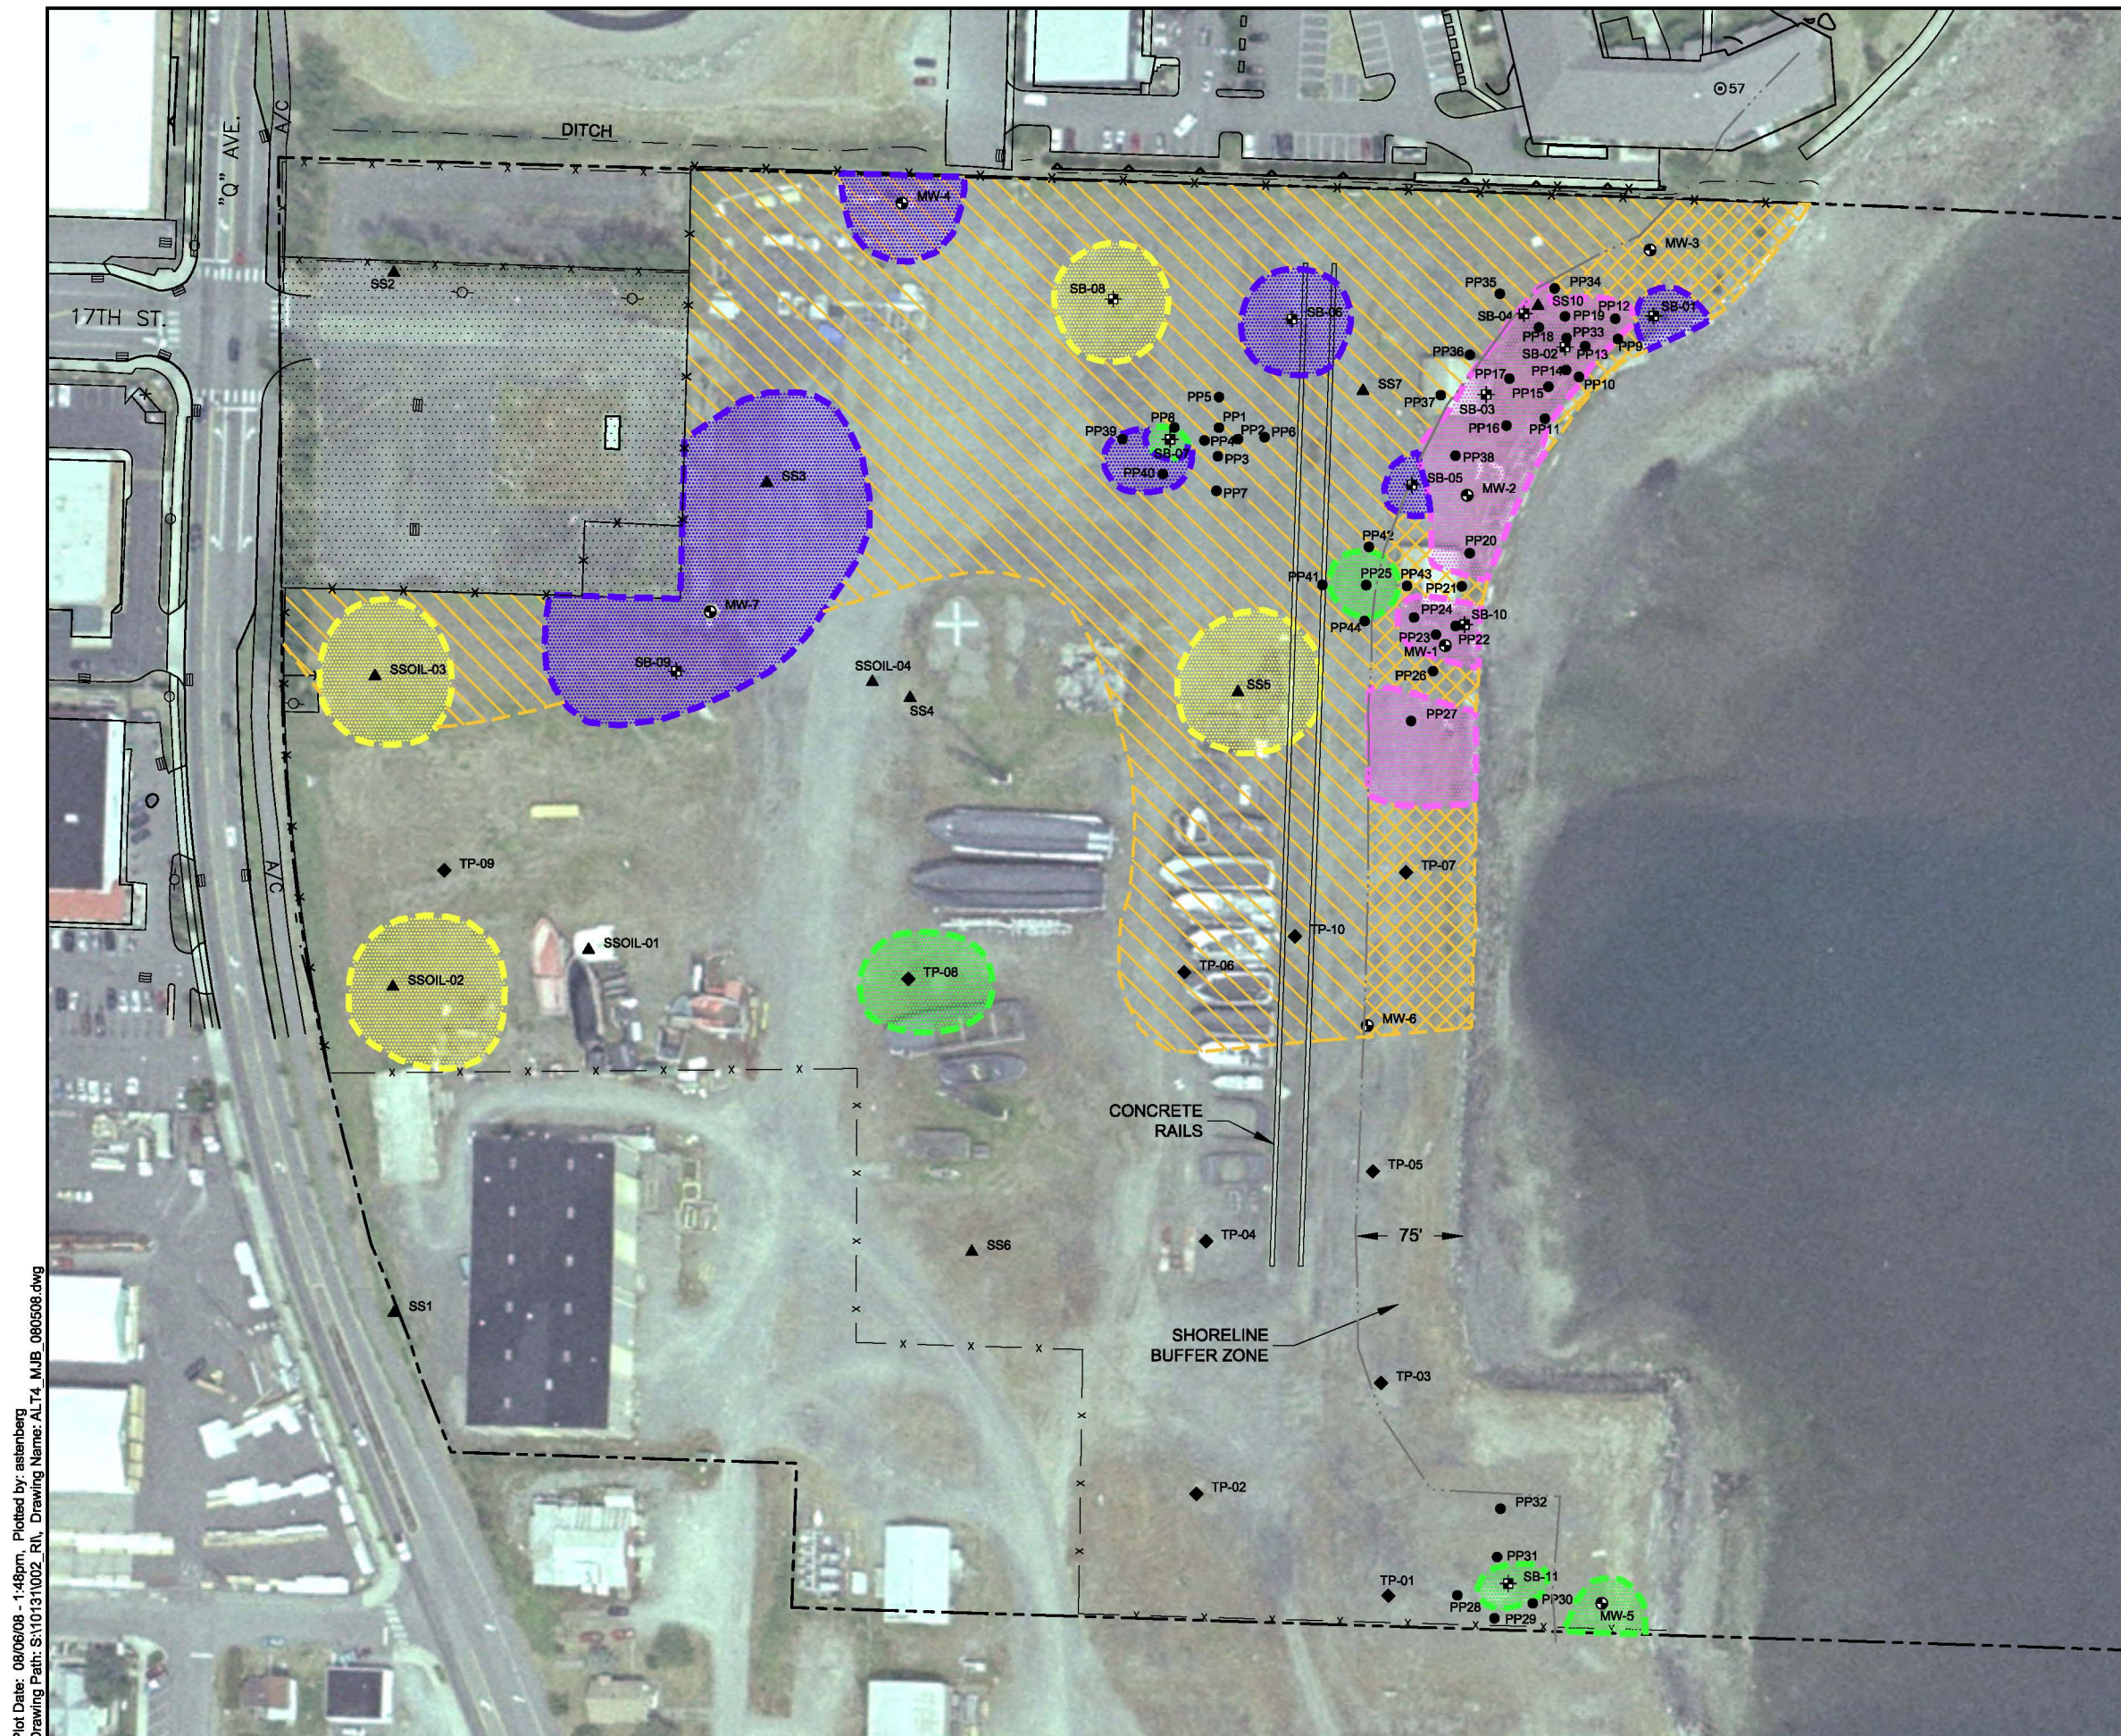
- ▨ Anticipated Limit of Excavation from 0 to 2' BGS
- ▨ Anticipated Limit of Excavation from 0 to 6' BGS
- ▨ Anticipated Limit of Excavation from 0 to 10' BGS
- ▨ Anticipated Limit of Homogenization from 0 to 4' BGS
- ▨ Potential Upper Limit of Homogenization from 0 to 4' BGS
- ▨ Potential Upper Limit of Excavation from 0 to 2' BGS

**ALTERNATIVE MJB-4
MJB North Area
Anacortes, Washington**

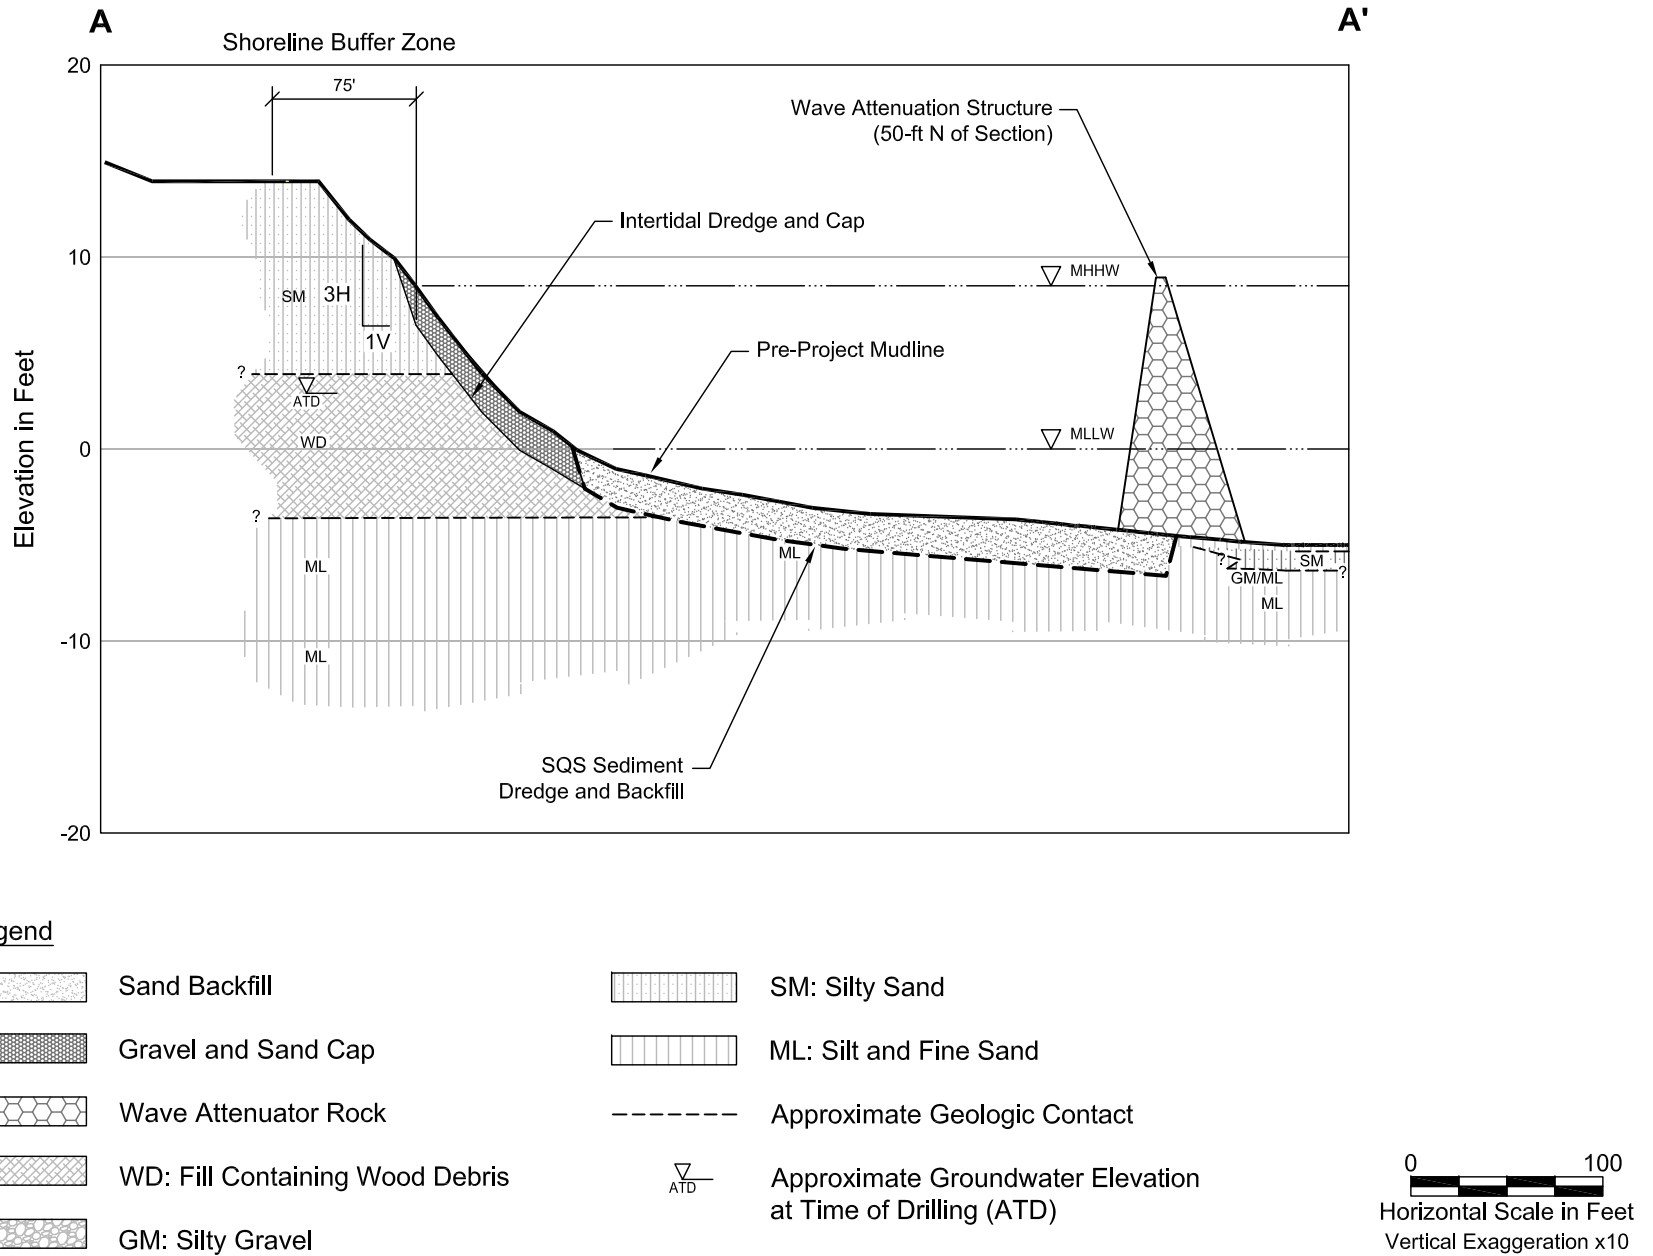
Figure 28
Cross-Section A-A': Marine Alternative M-1
Former Scott Paper Mill

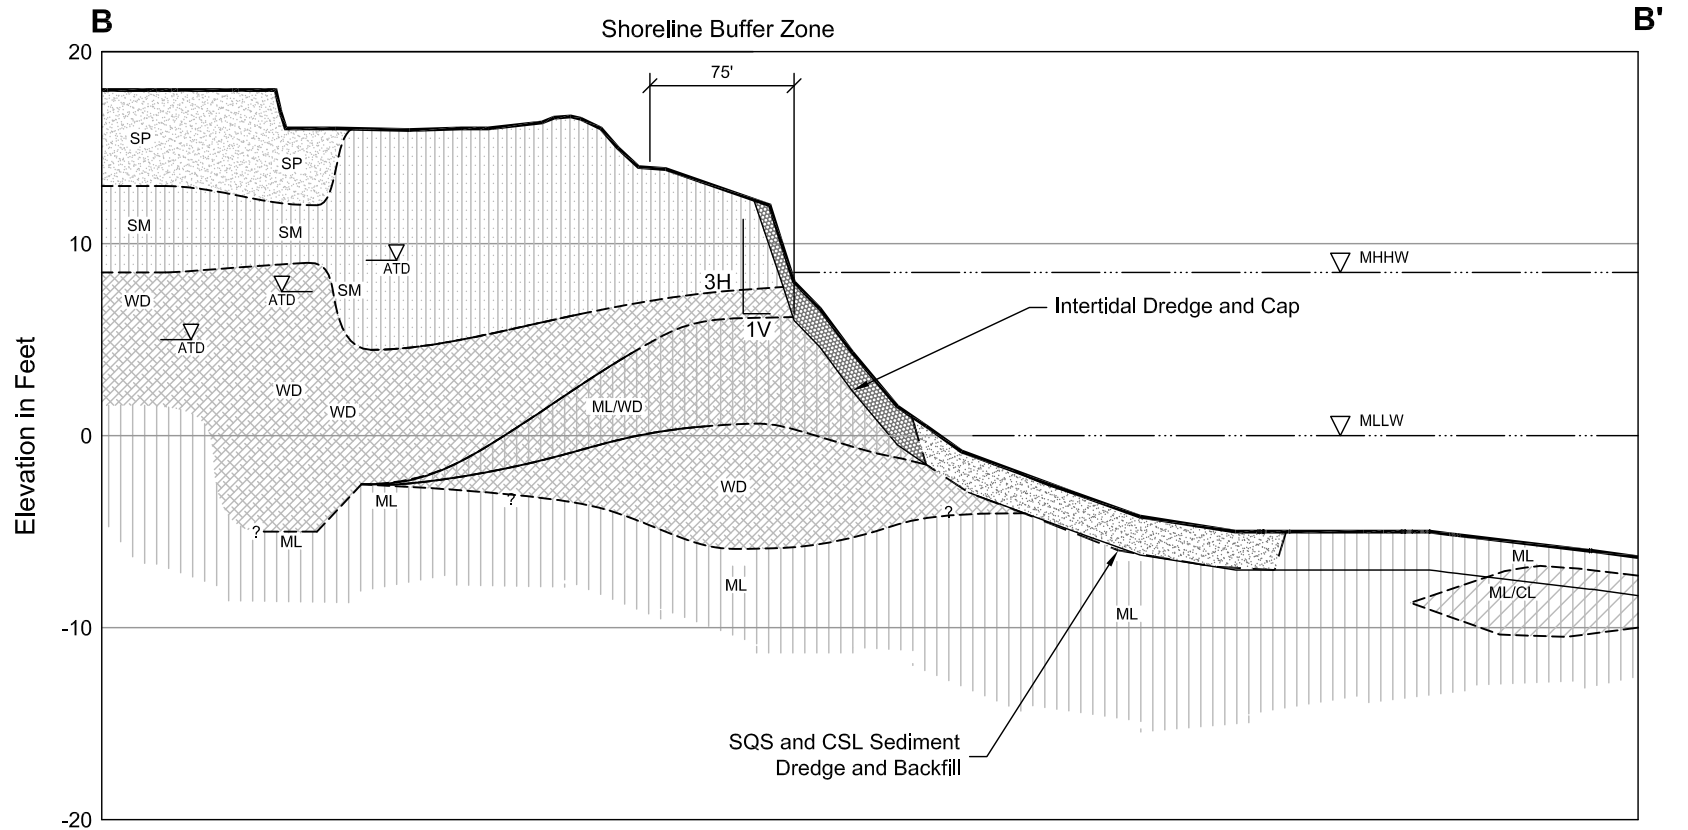
Figure 29
Cross-Section B-B': Marine Alternatives M-1 and M-2
Former Scott Paper Mill

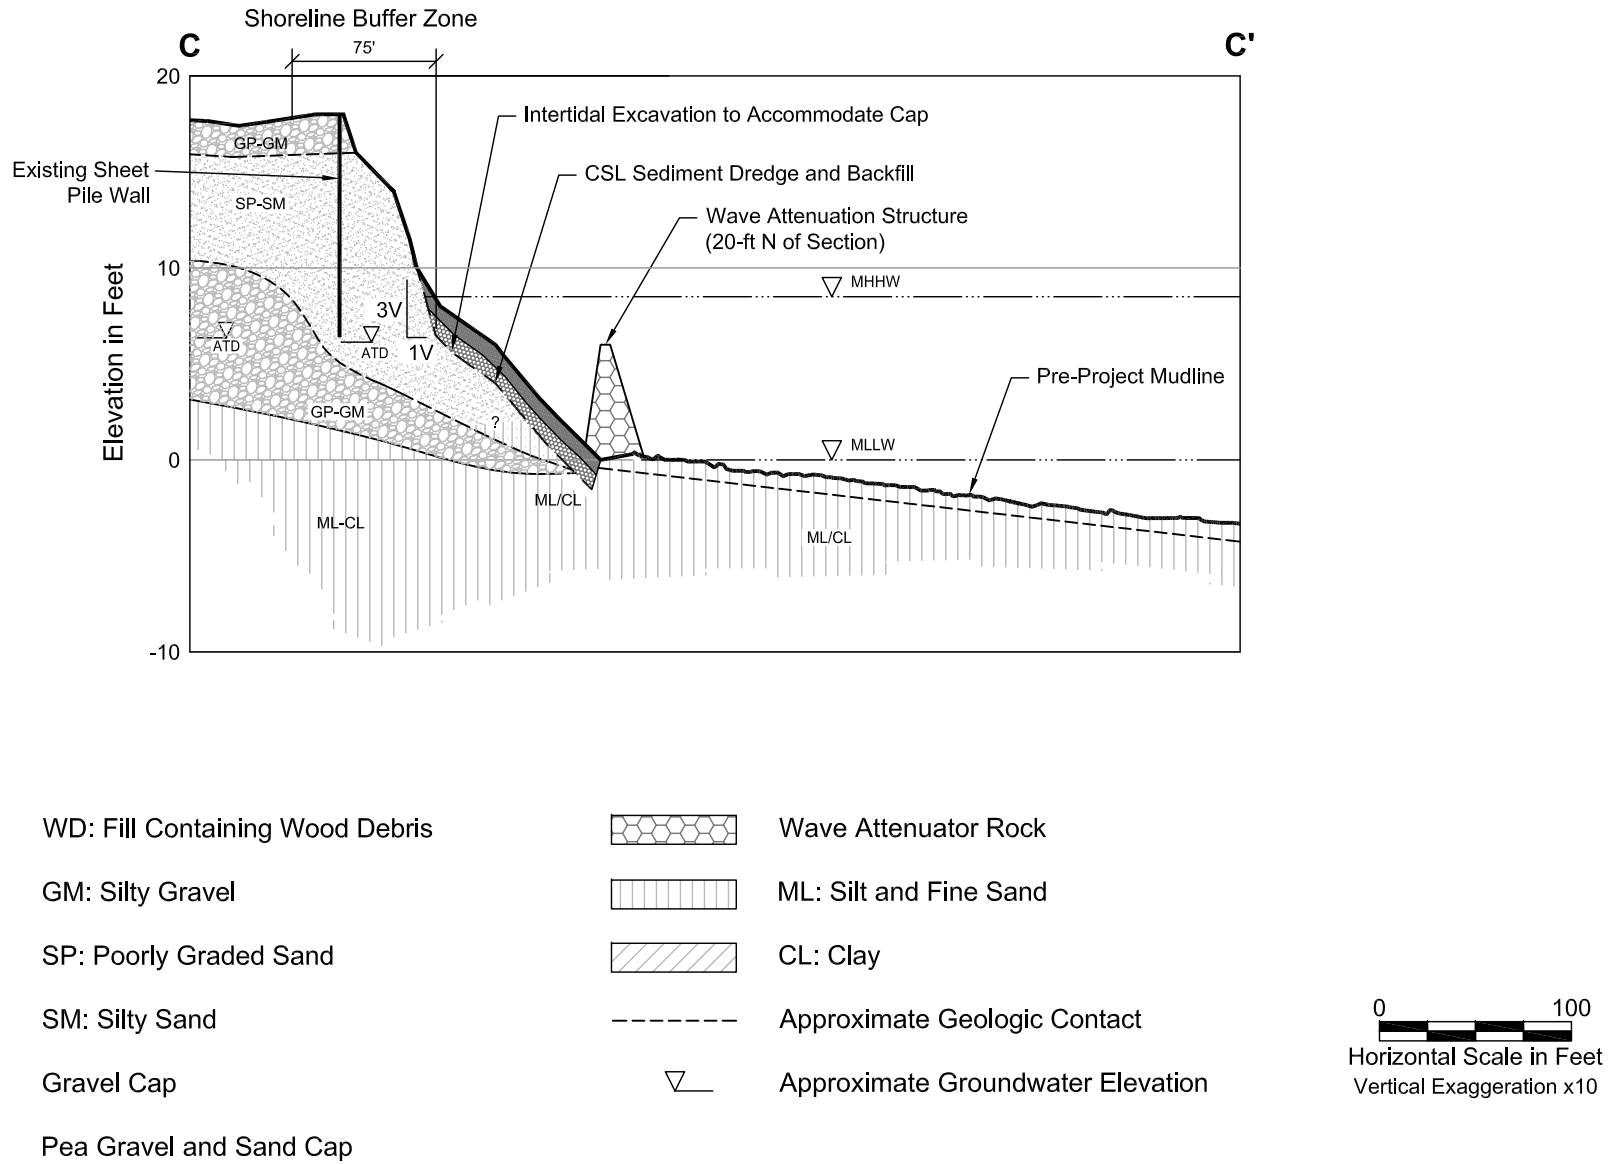
Figure 33
Cross-Section C-C': Marine Alternative M-2
Former Scott Paper Mill
