Scott Paper Mill  
Anacortes, Washington

**Soil Explorations - Port Parcel 3 Uplands Area RI and Previous Investigations**

<b>Cross Section A-A'</b>	
Scott Paper Mill Anacortes, Washington	
<b>GEOENGINEERS</b>	<b>Figure 9</b>

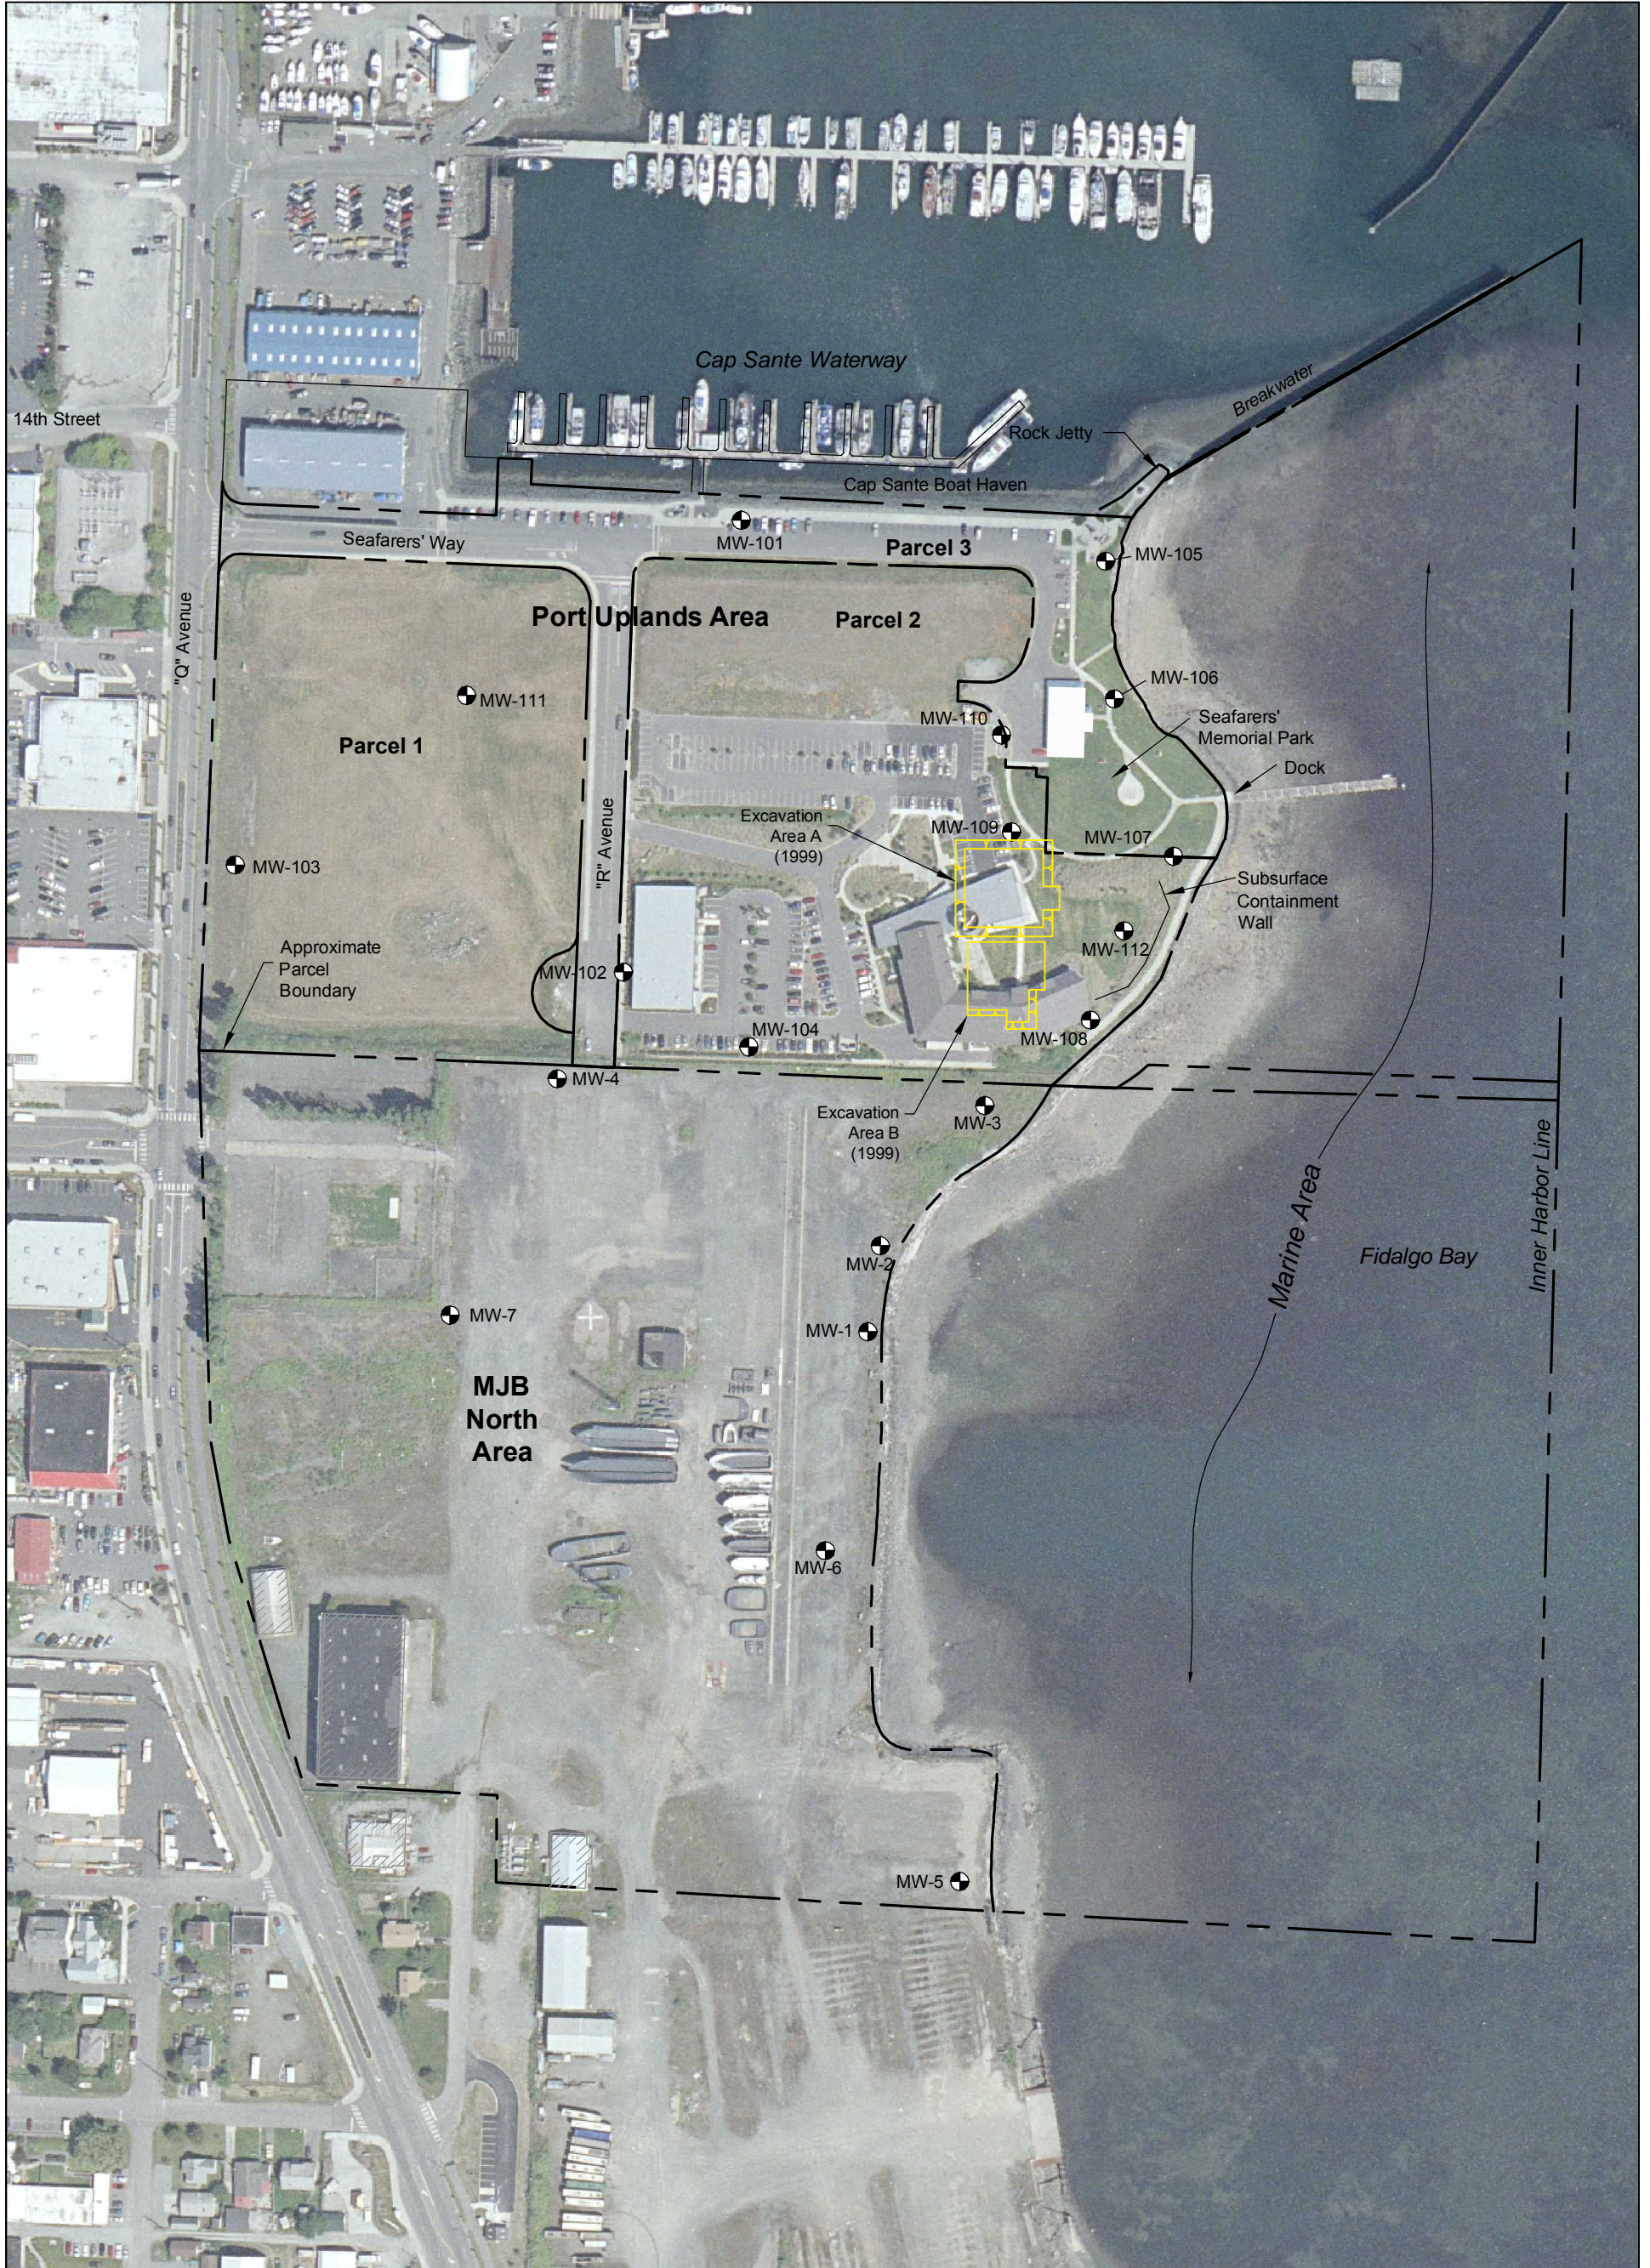
Figure 2

**Site Plan**

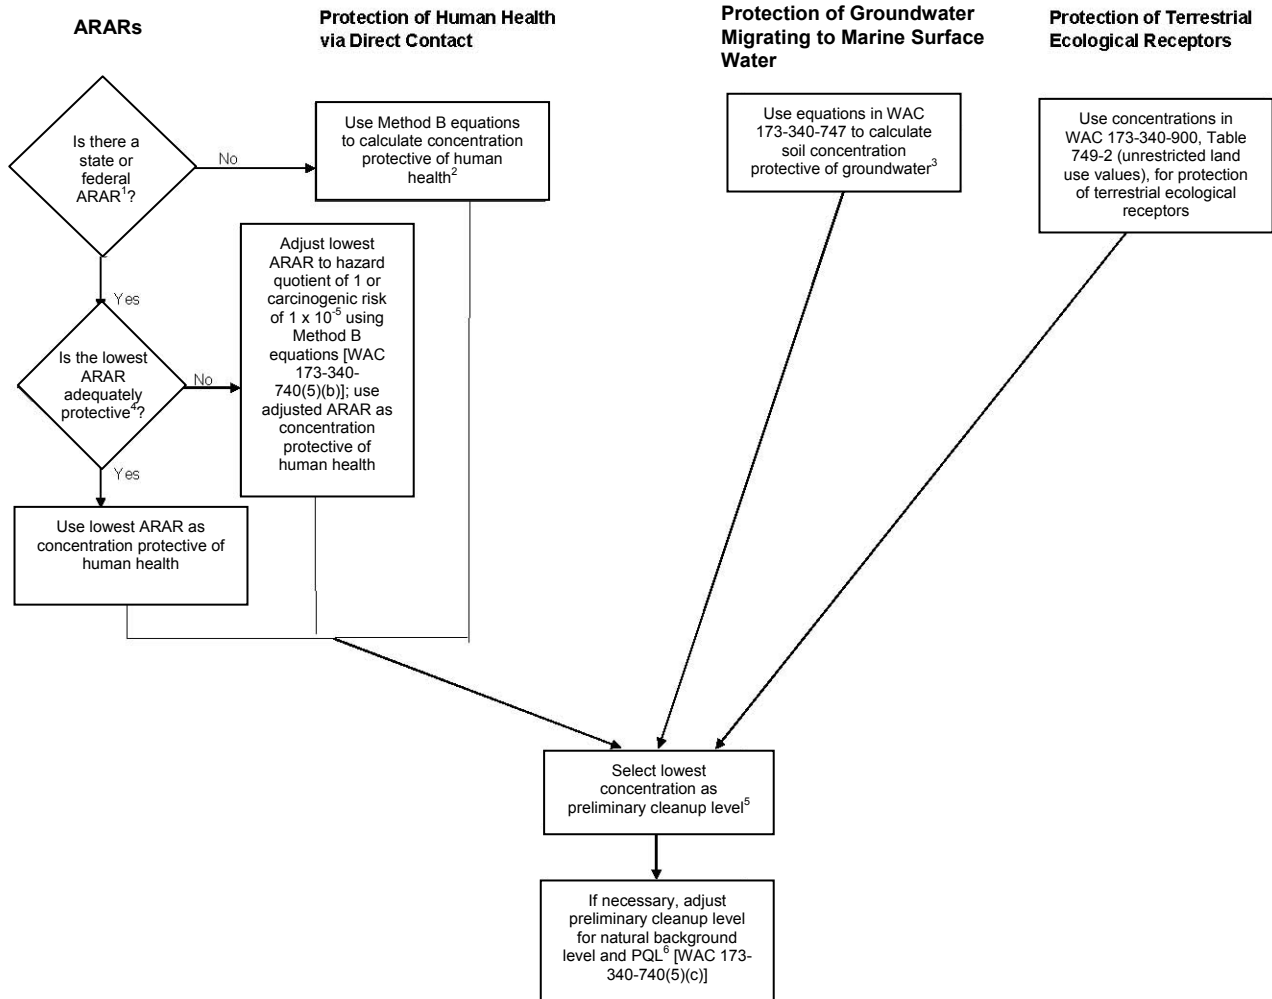
**FIGURE 4**

Site Soil Preliminary Cleanup Level Development Under  
MTCA

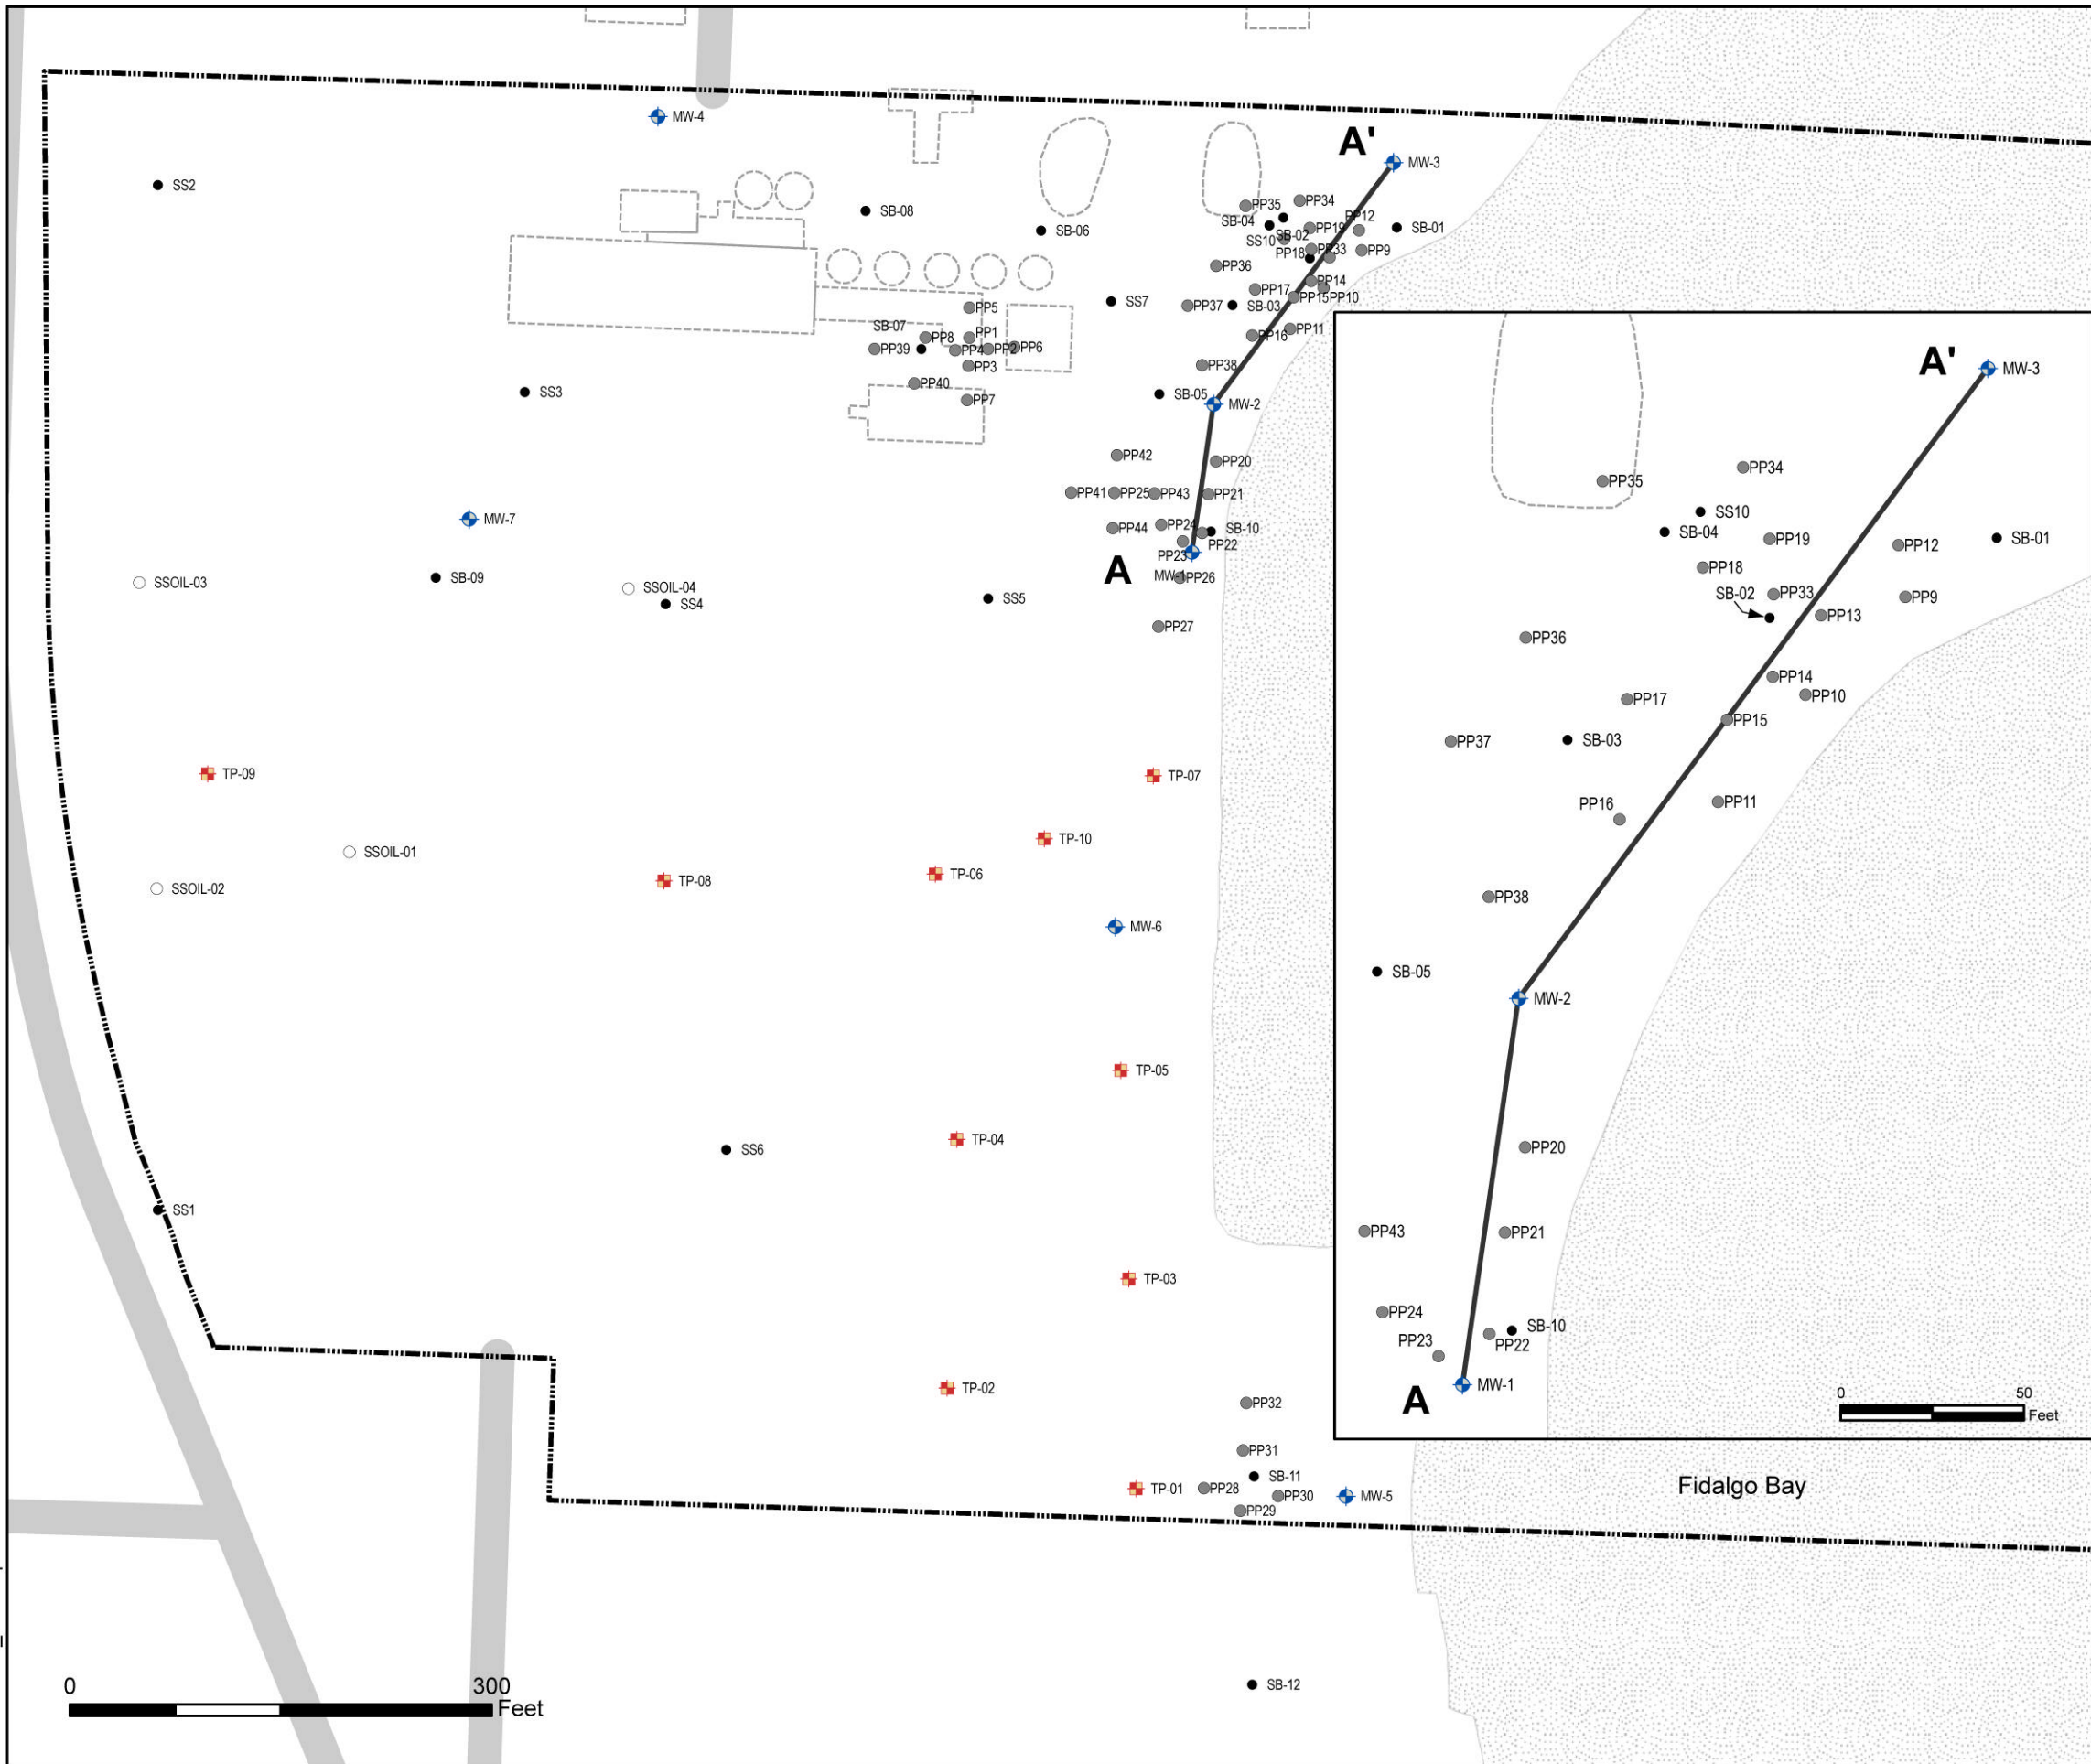
**SAMPLE AND CROSS SECTION LOCATIONS**  
 Upland Remedial Investigation  
 MJB Property, Anacortes, Washington

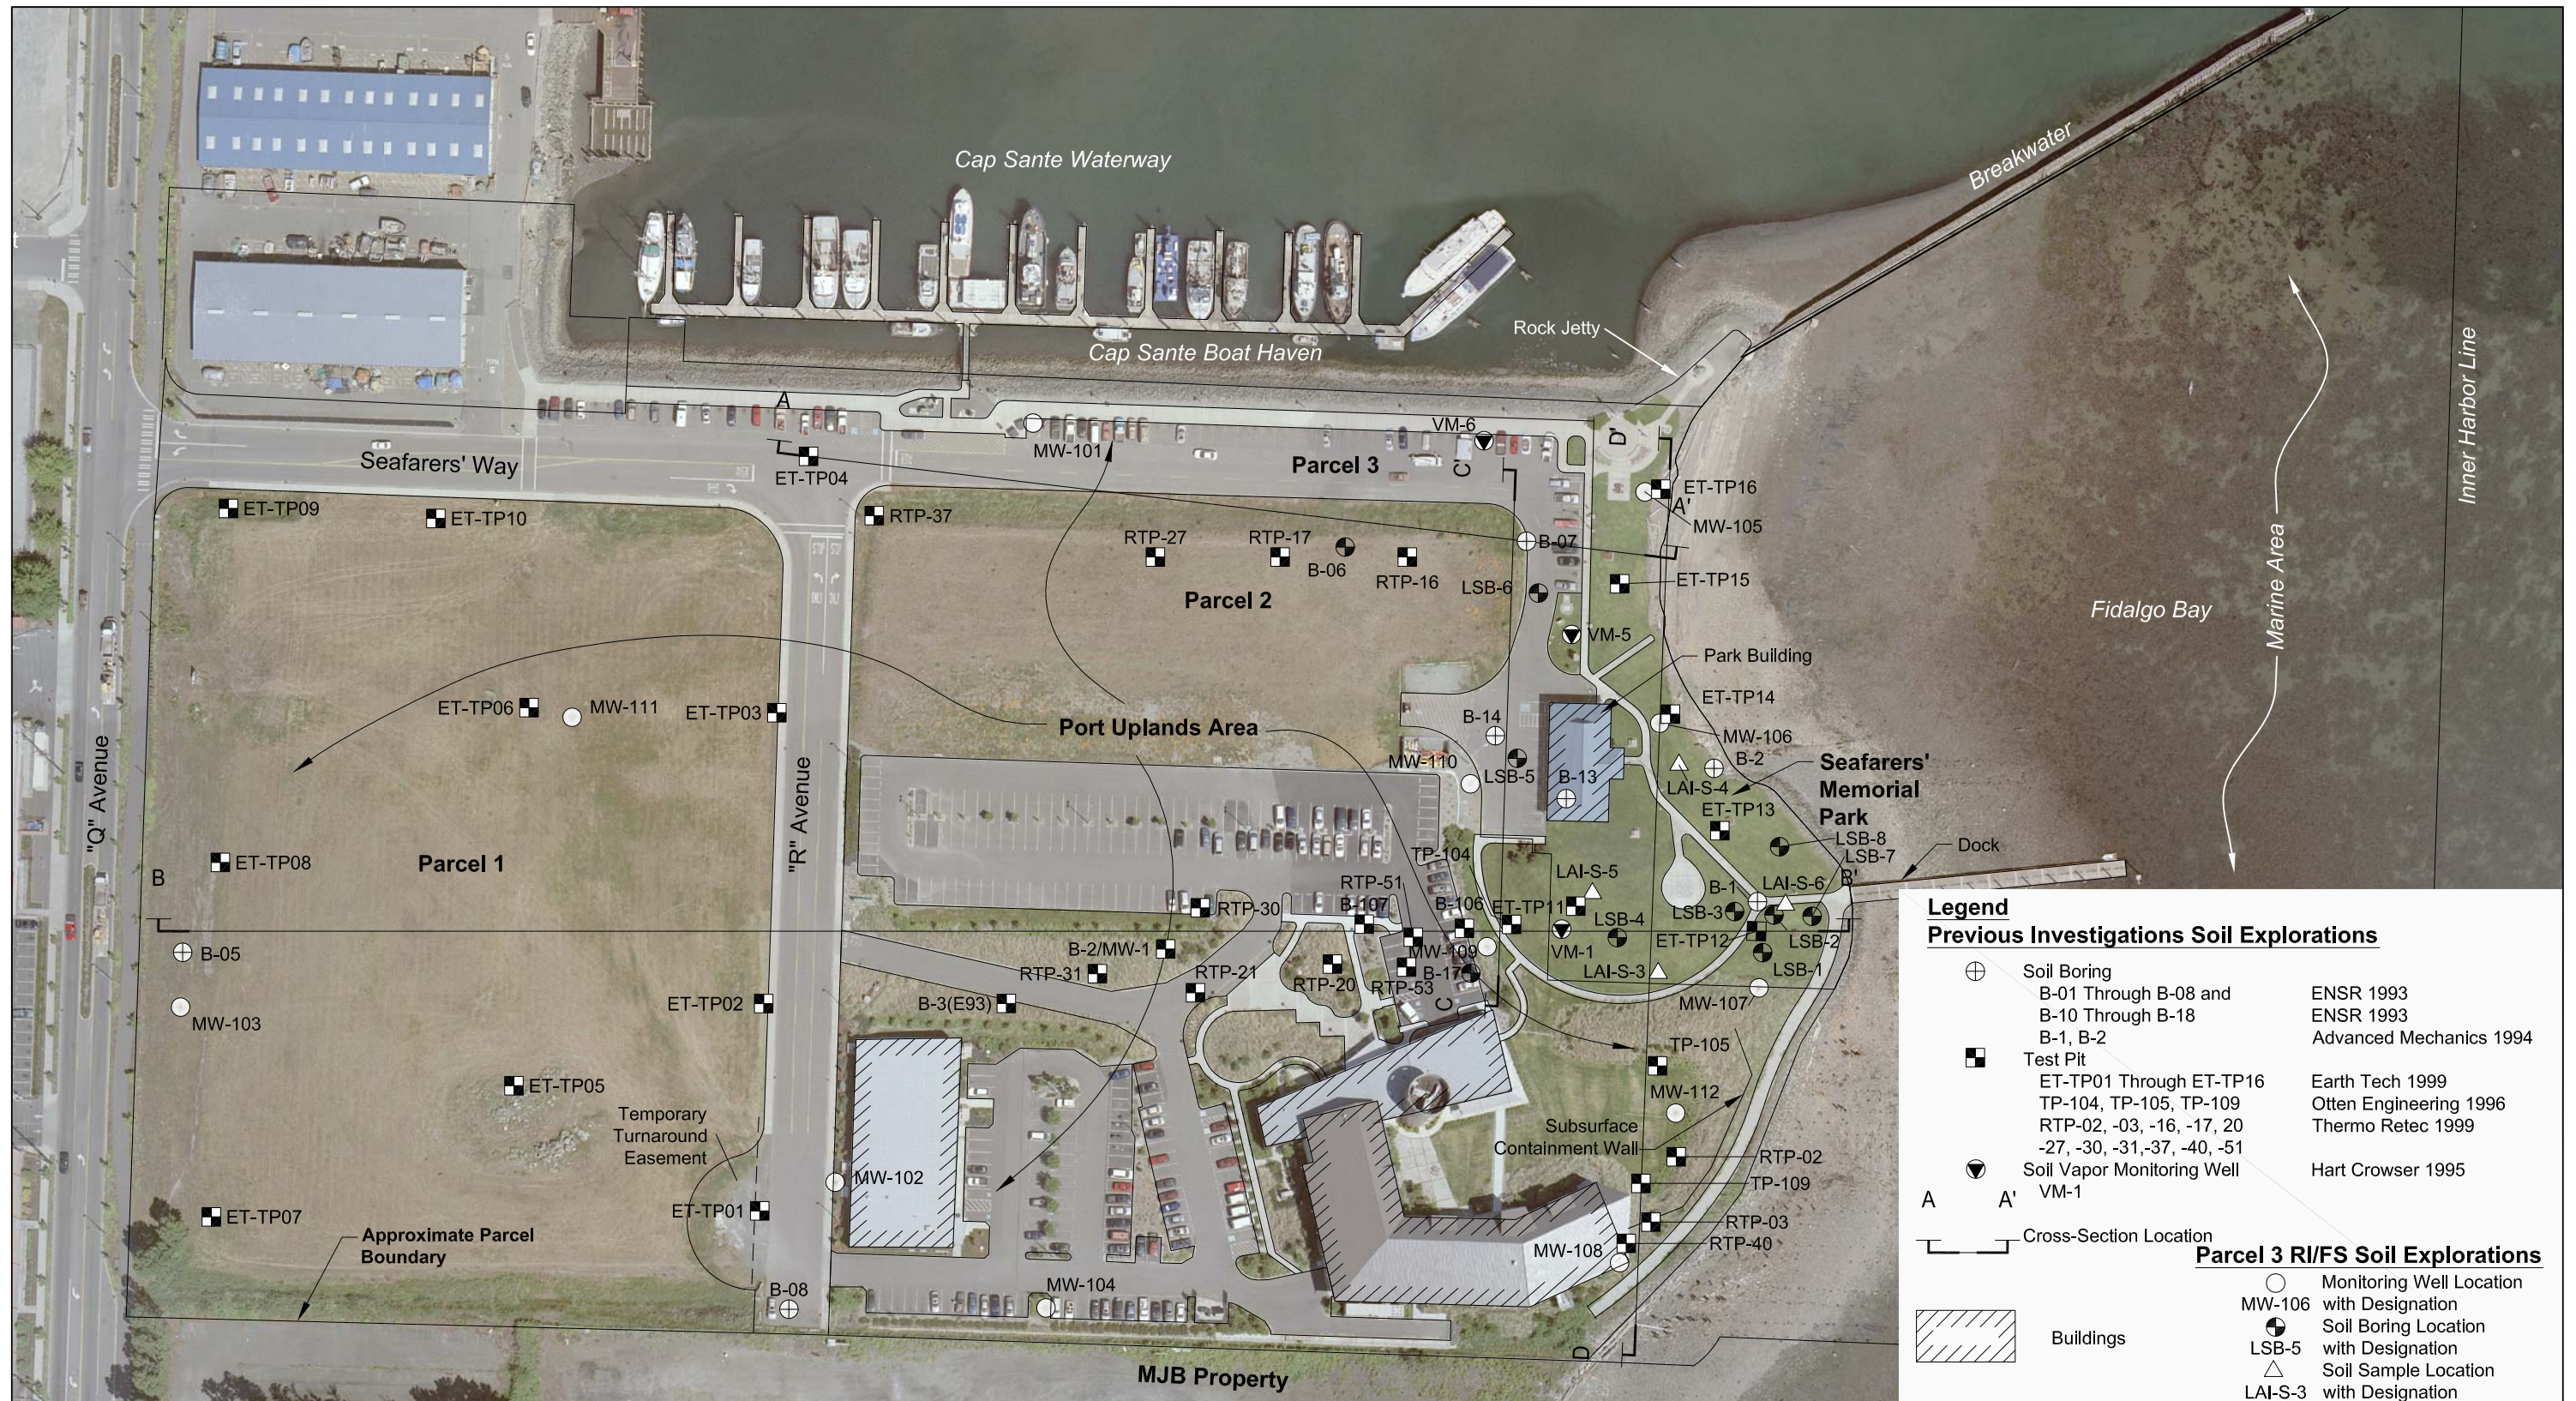
**Figure 8**

**Cross Section Locations**

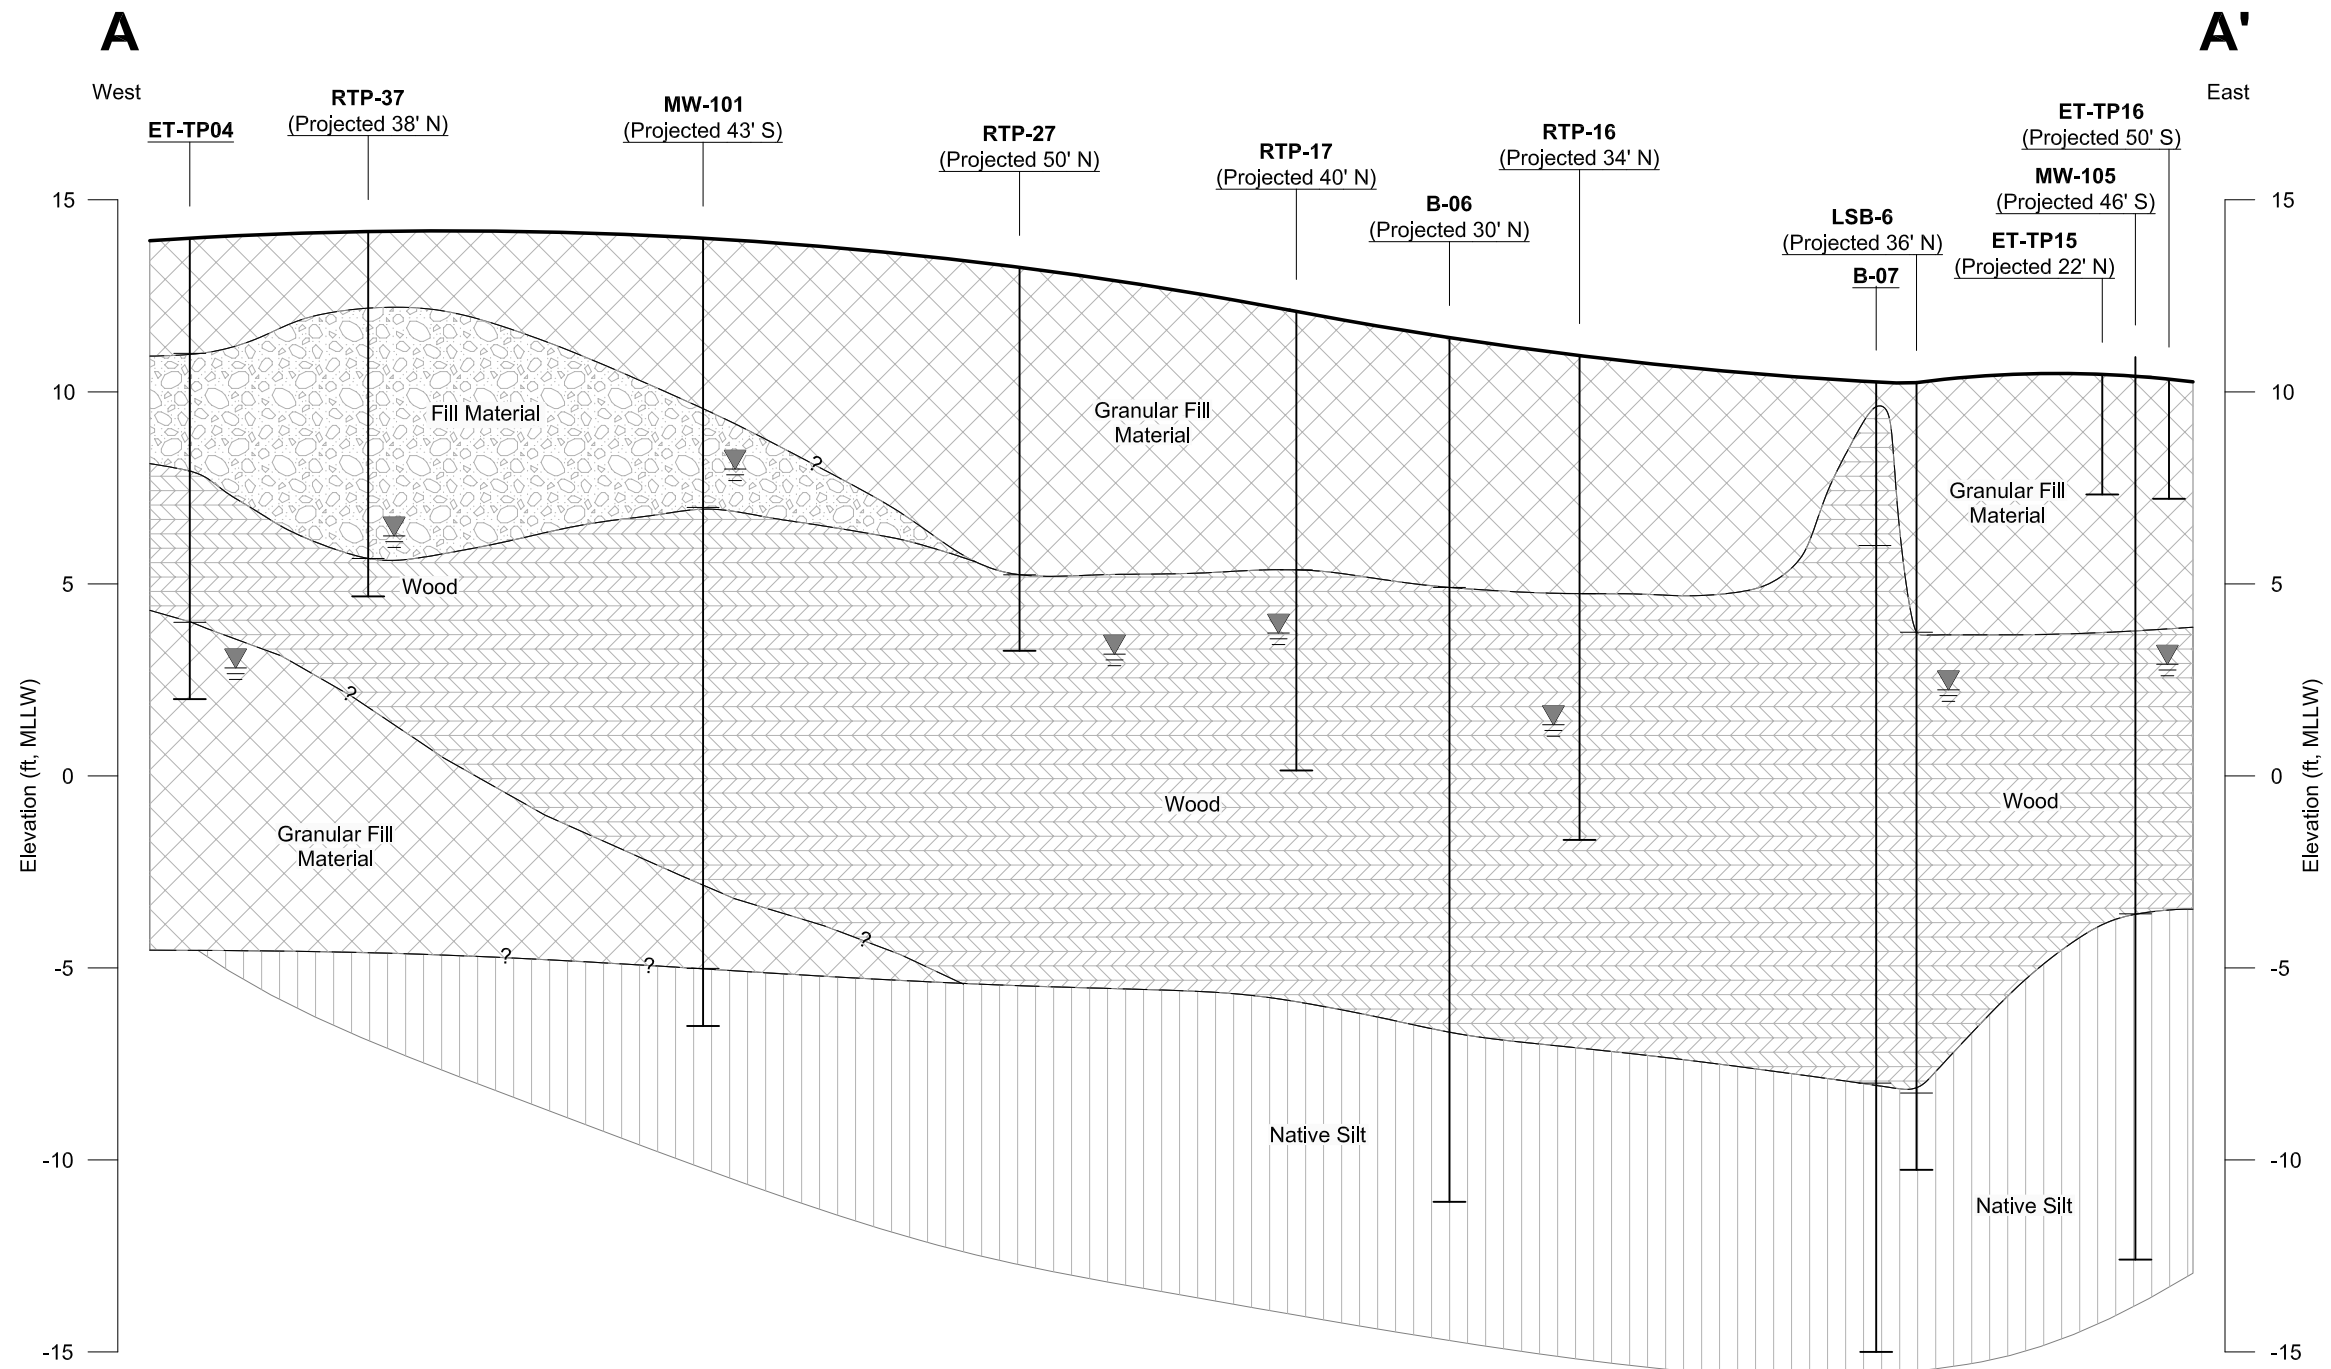
- Groundwater Level at Time of Drilling or Excavation
- Granular Fill Material (Silty, Gravelly, Sand) (SP)
- Fill Material (Sandy Silt, Silty Sand, Varying Amounts of Wood Debris) (SM/SP)
- Wood (Lumber, Wood Debris) (WD)
- Native Silt (ML)

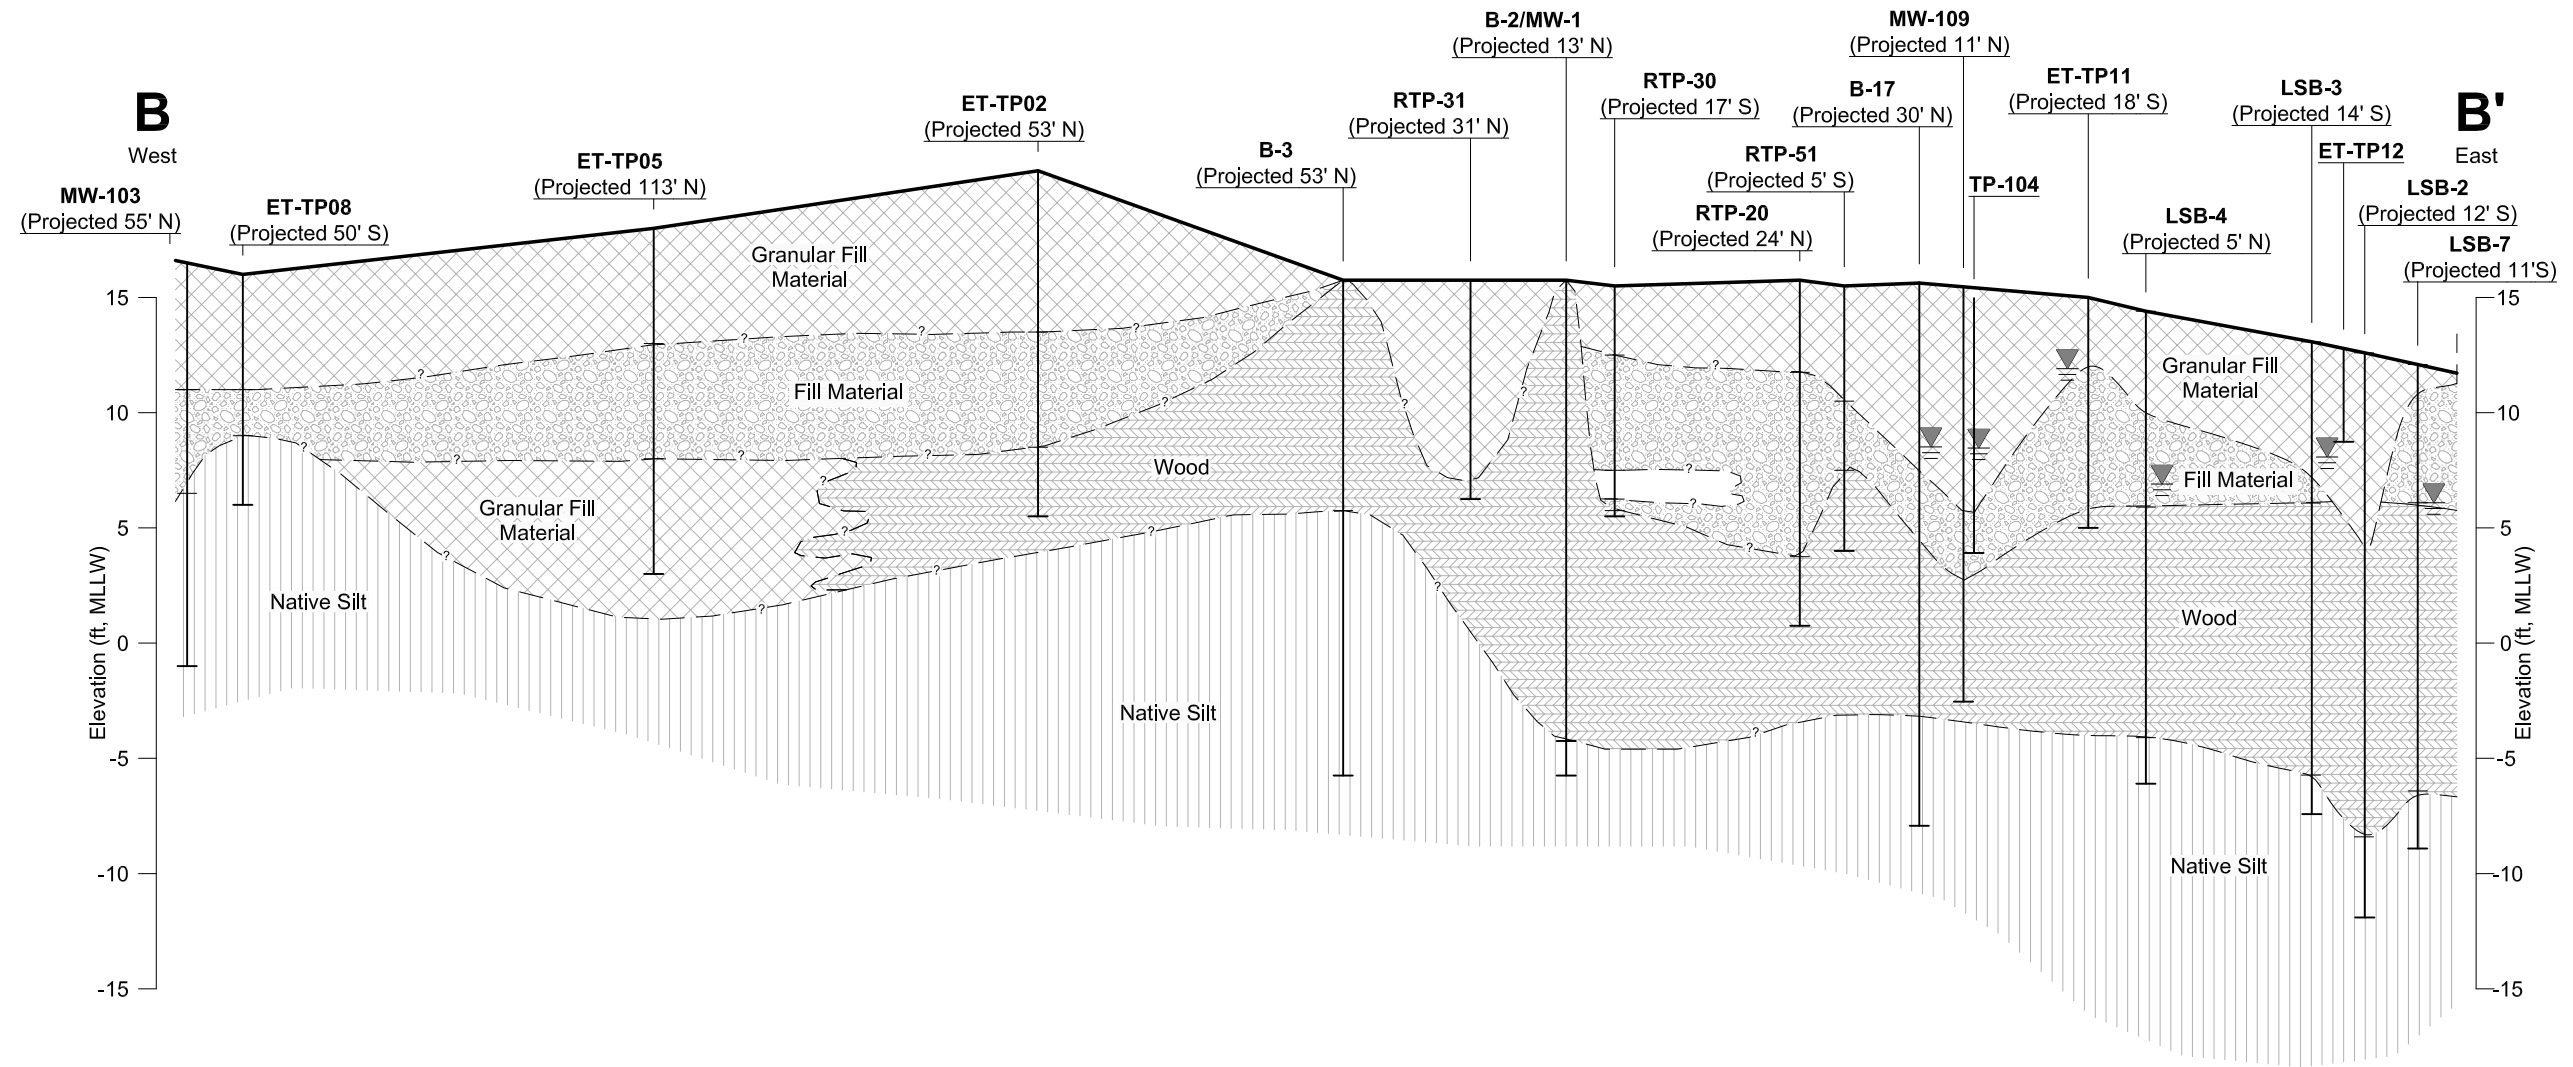
<b>Figure 10</b>

<b>Cross Section B-B'</b>	
Scott Paper Mill Anacortes, Washington	
<b>GEOENGINEERS</b>

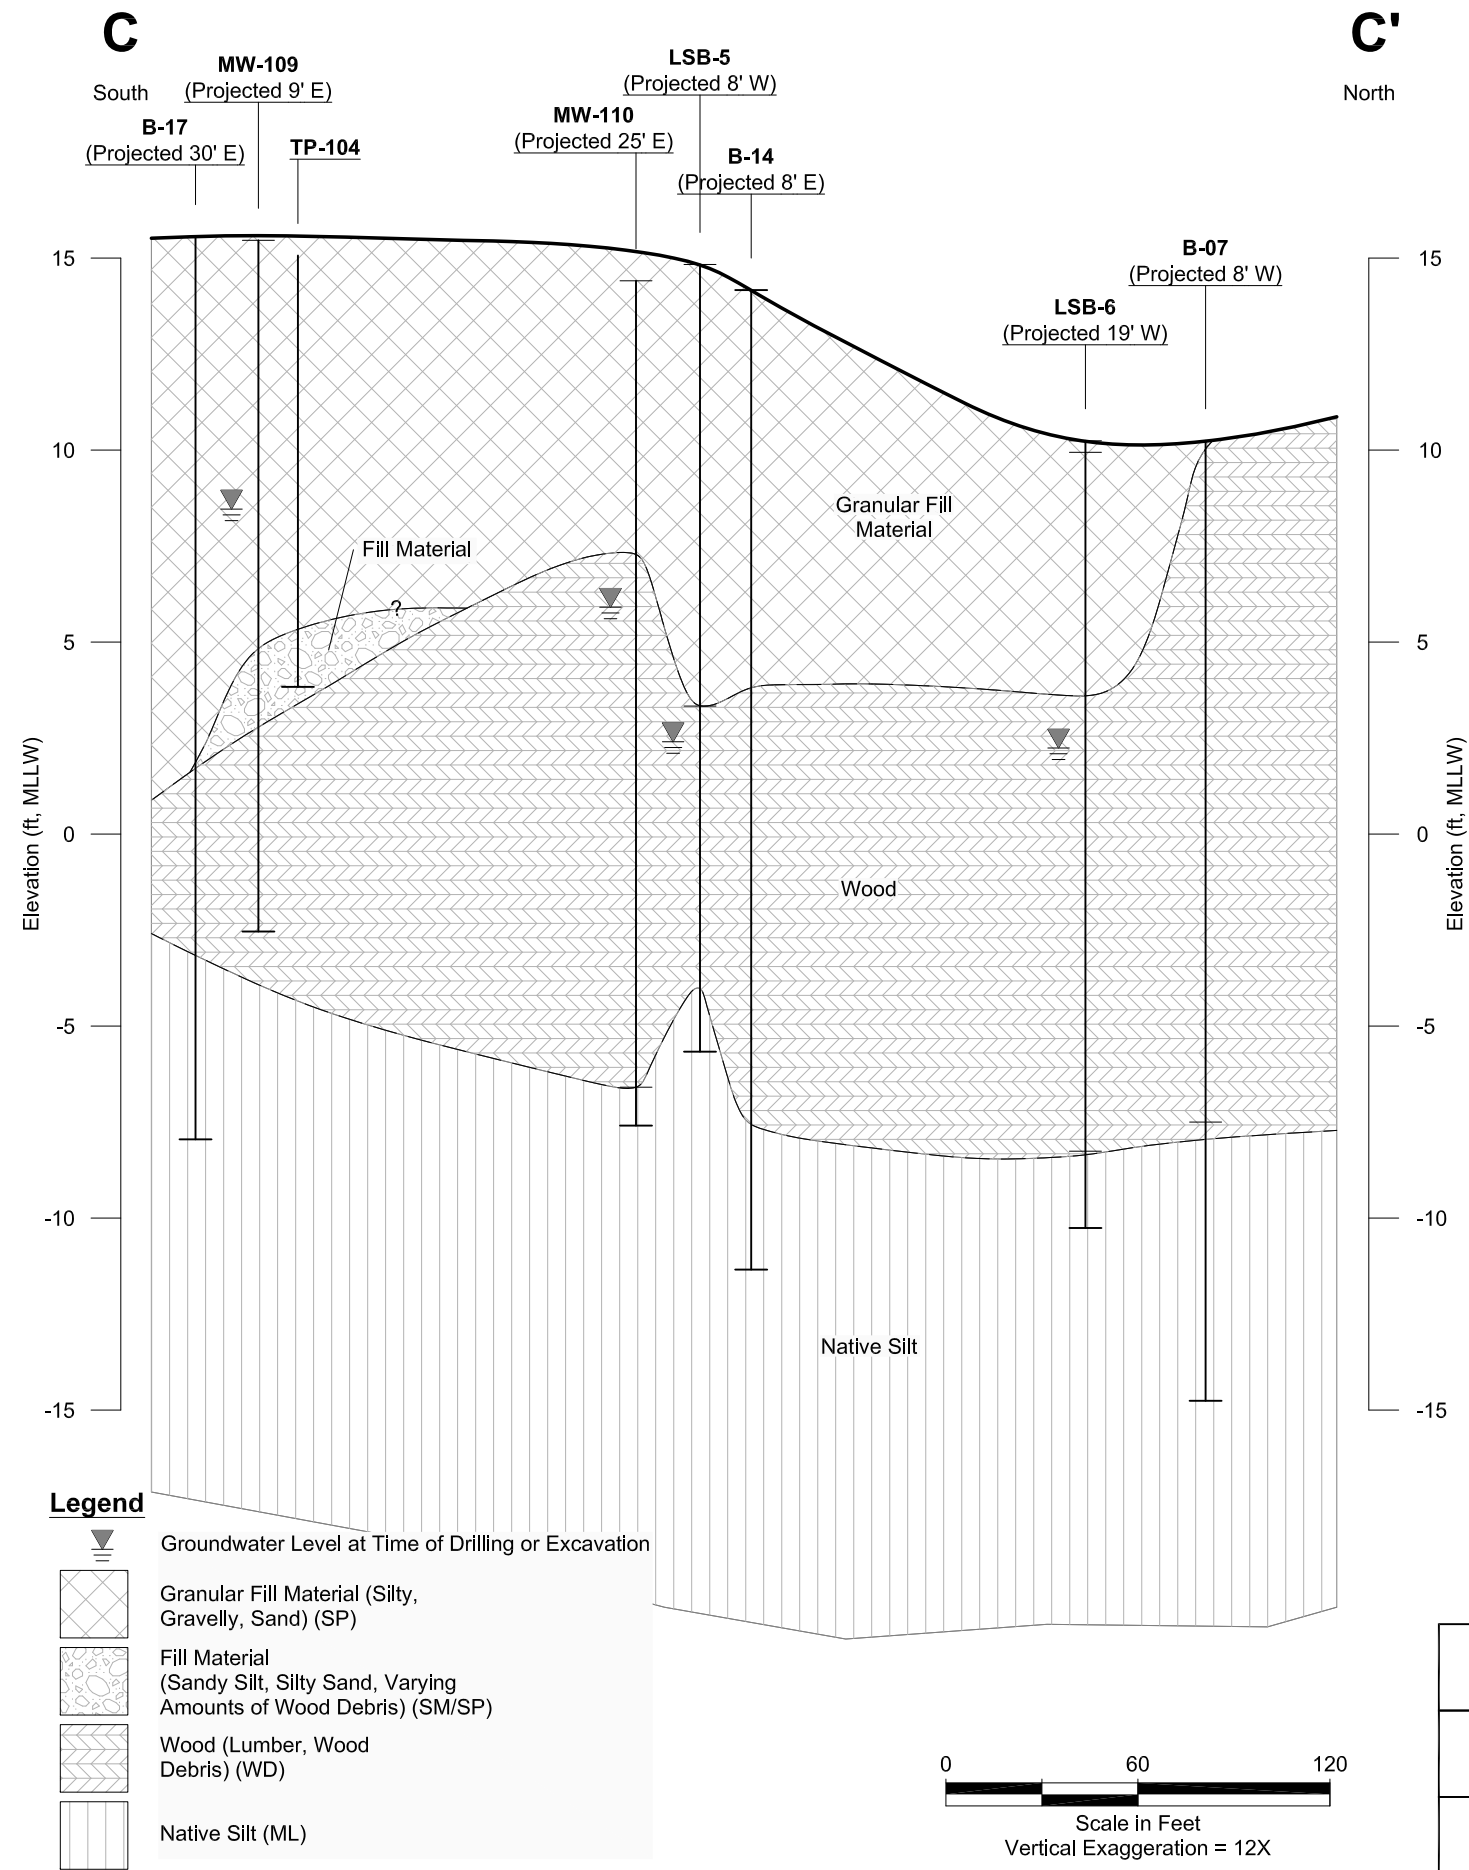
<b>Figure 11</b>

<b>Cross Section C-C'</b>	
Scott Paper Mill Anacortes, Washington	
<b>GEOENGINEERS</b>
