Scott Paper Mill  
Anacortes, Washington

**Soil Explorations - Port Parcel 3 Uplands Area RI and Previous Investigations**

<b>Cross Section A-A'</b>	
Scott Paper Mill Anacortes, Washington	
<b>GEOENGINEERS</b>	<b>Figure 9</b>

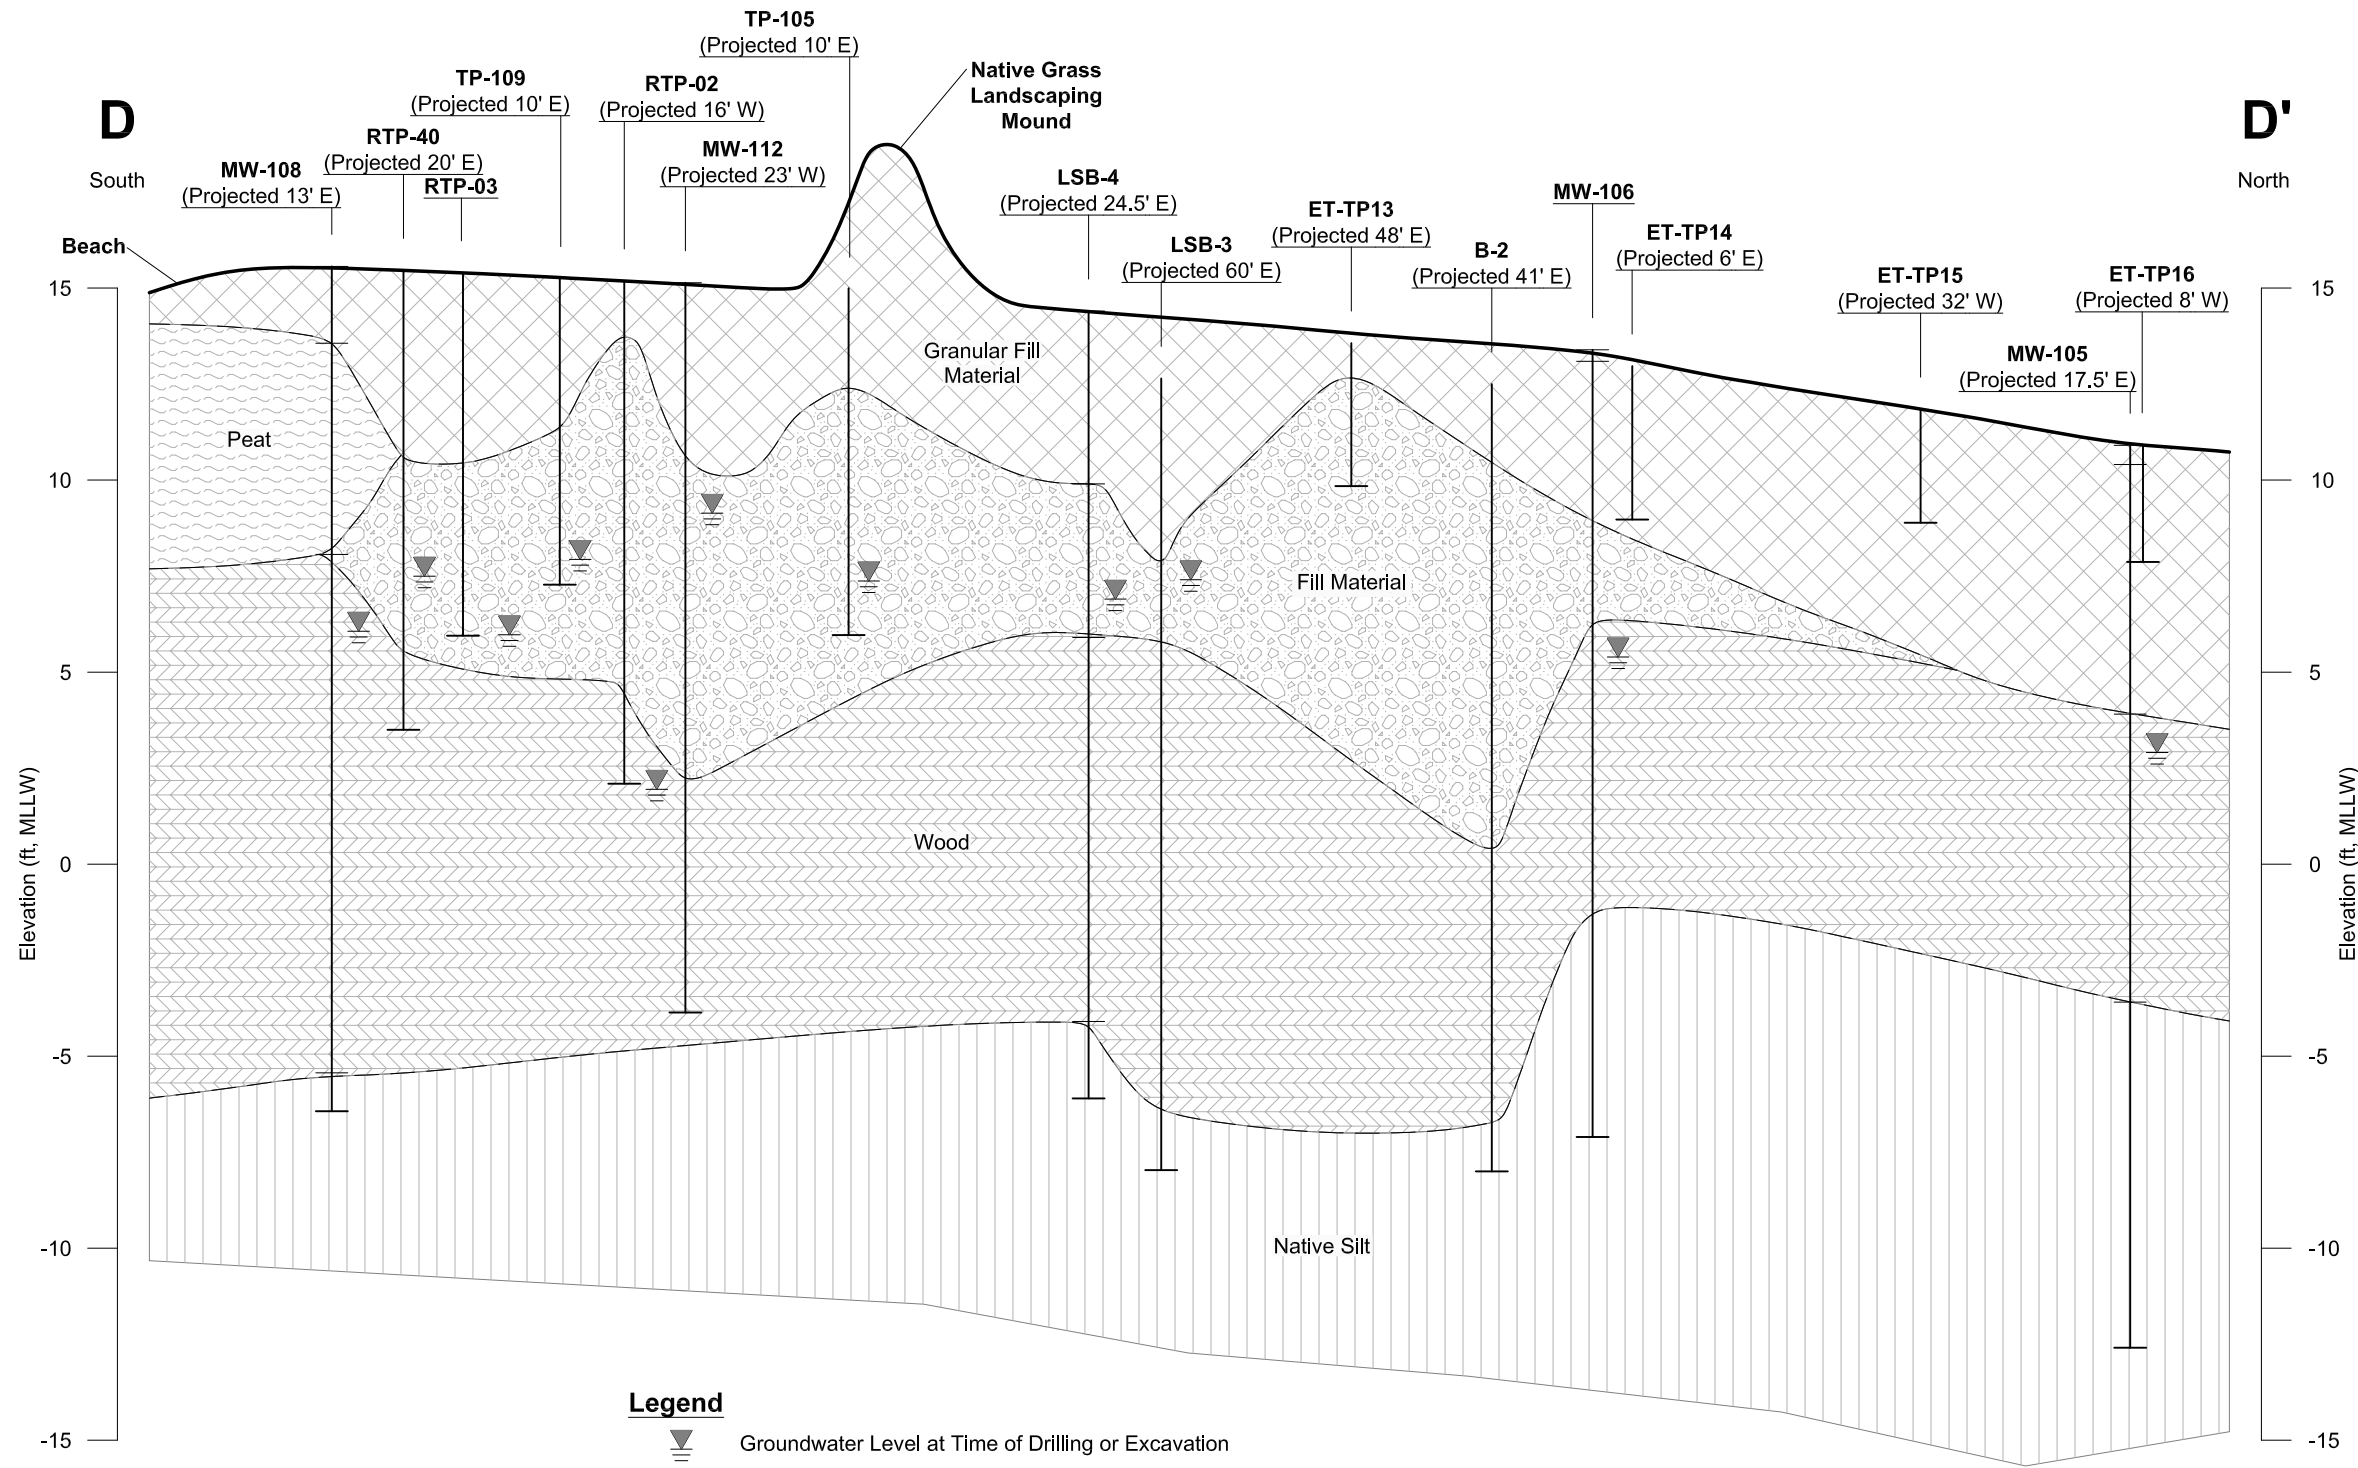
<b>Cross Section D-D'</b>	
Scott Paper Mill Anacortes, Washington	
	<b>Figure 12</b>

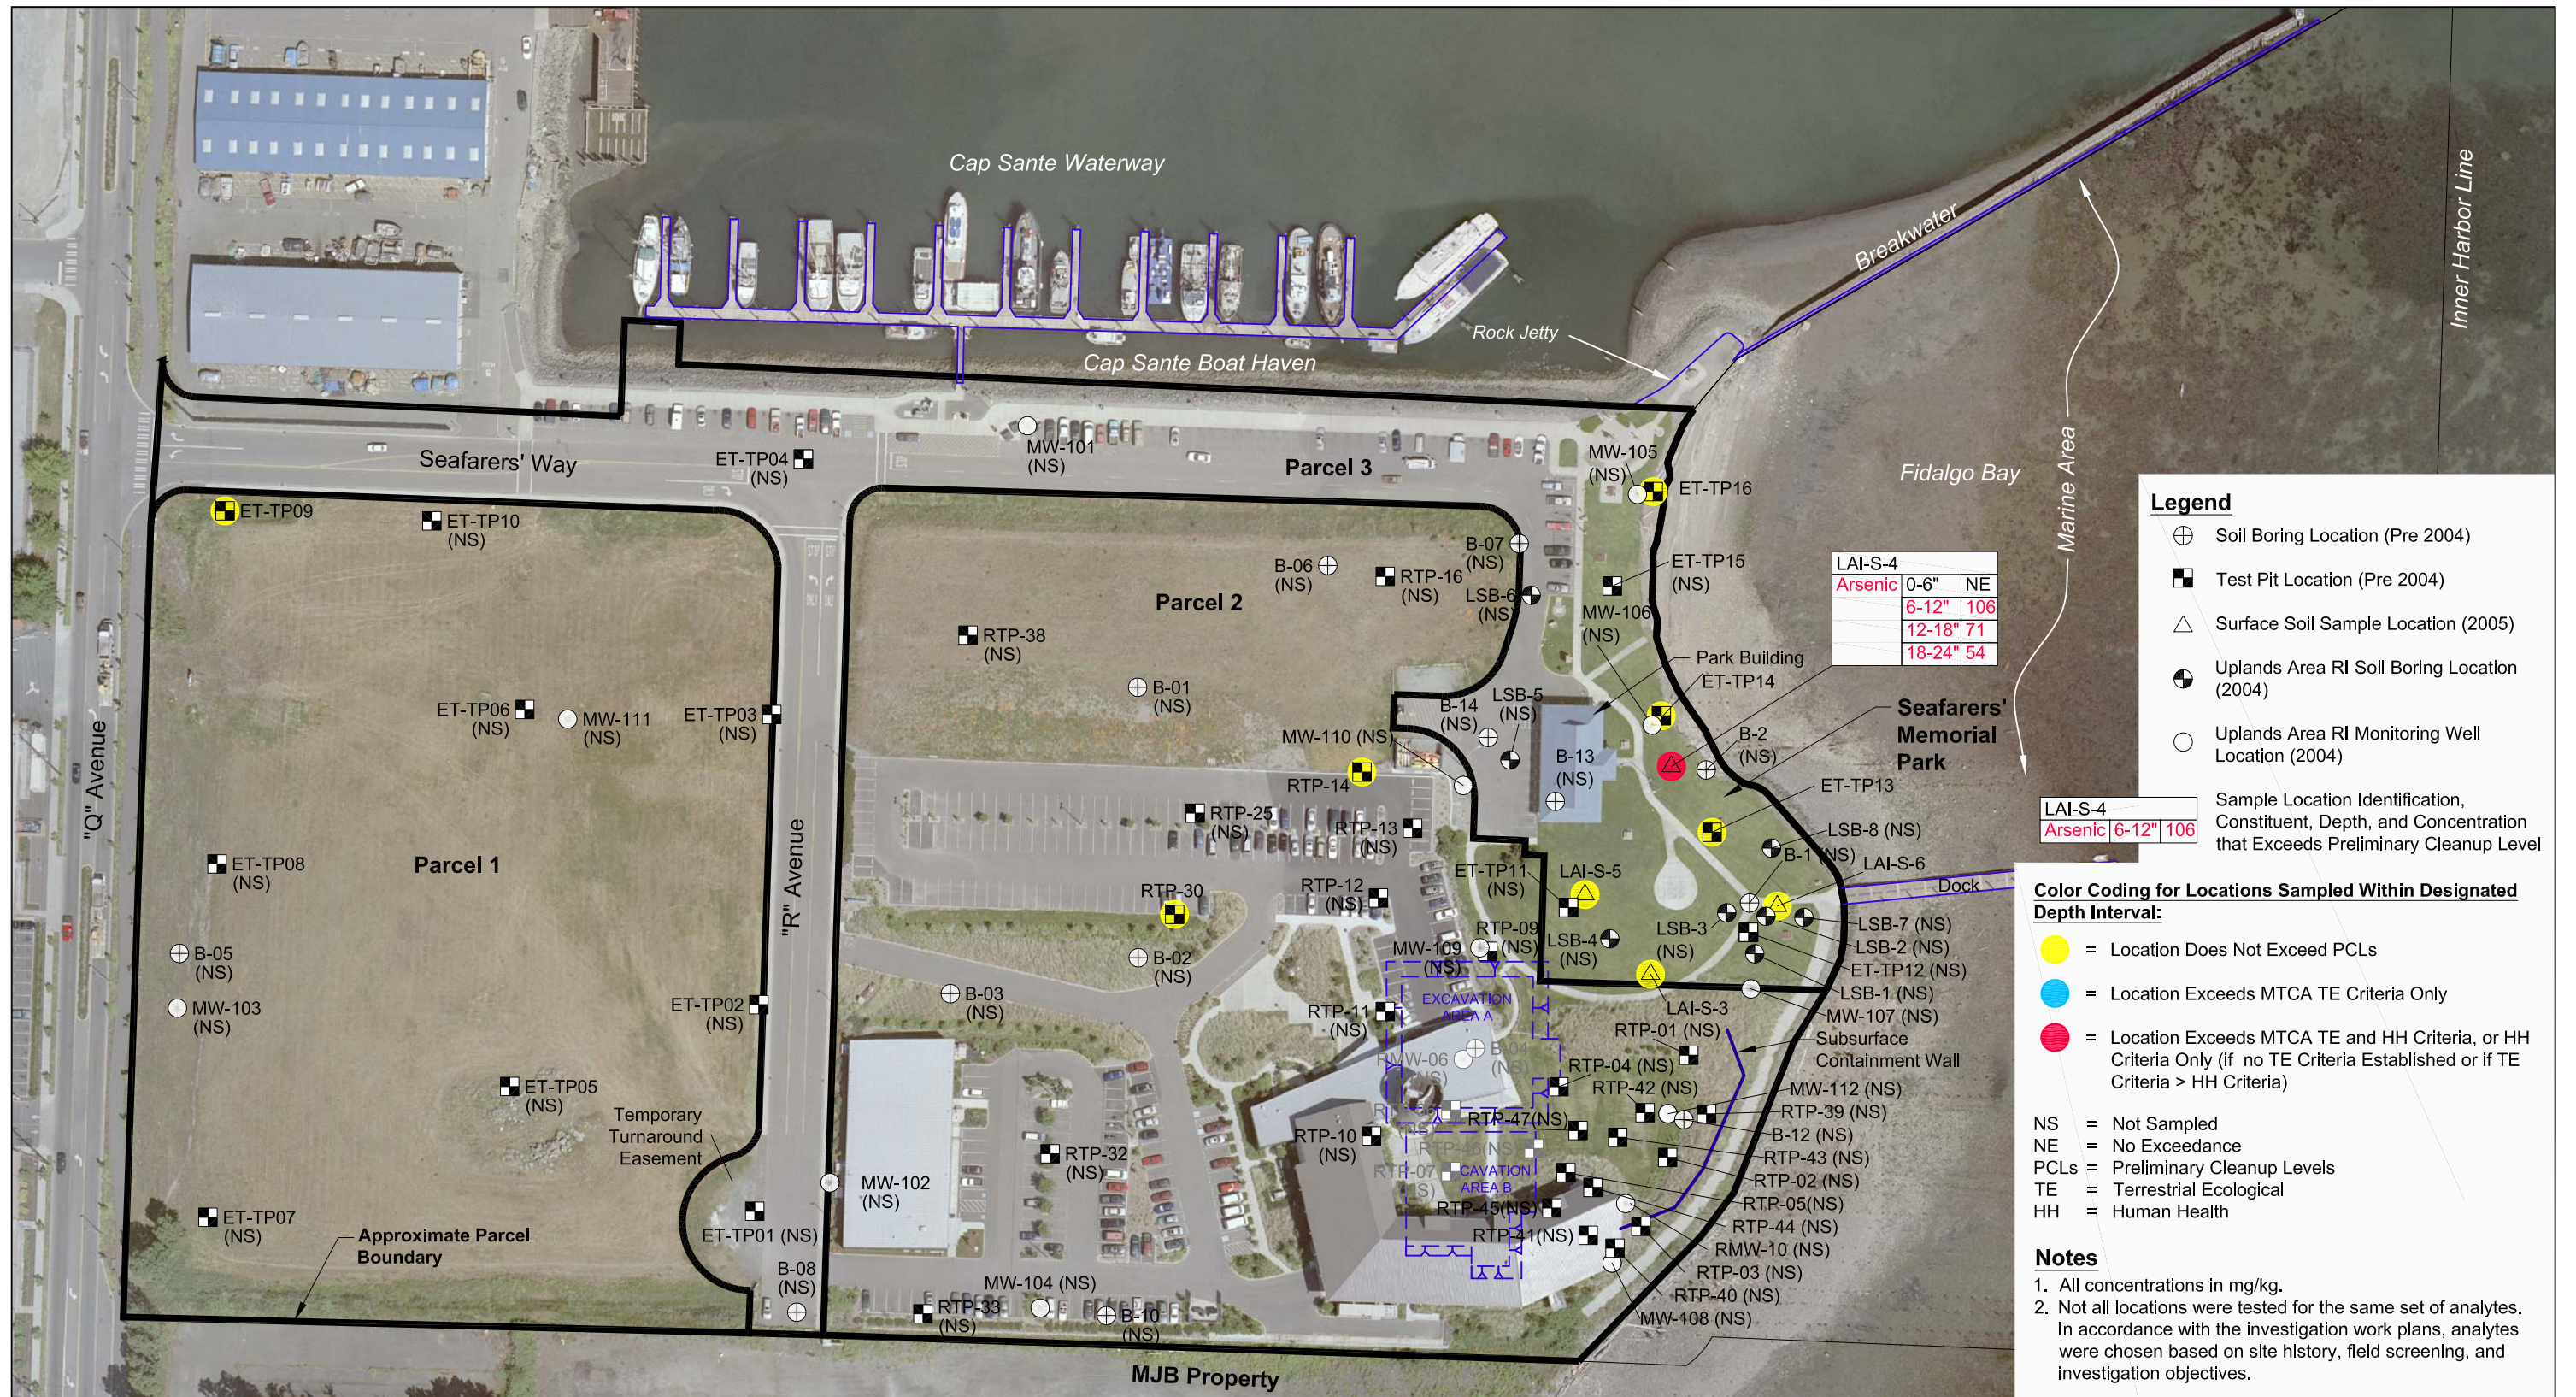
**Figure 13**

**Port Uplands Area Preliminary Soil Cleanup Level Exceedance Locations (0-2 ft BGS)**

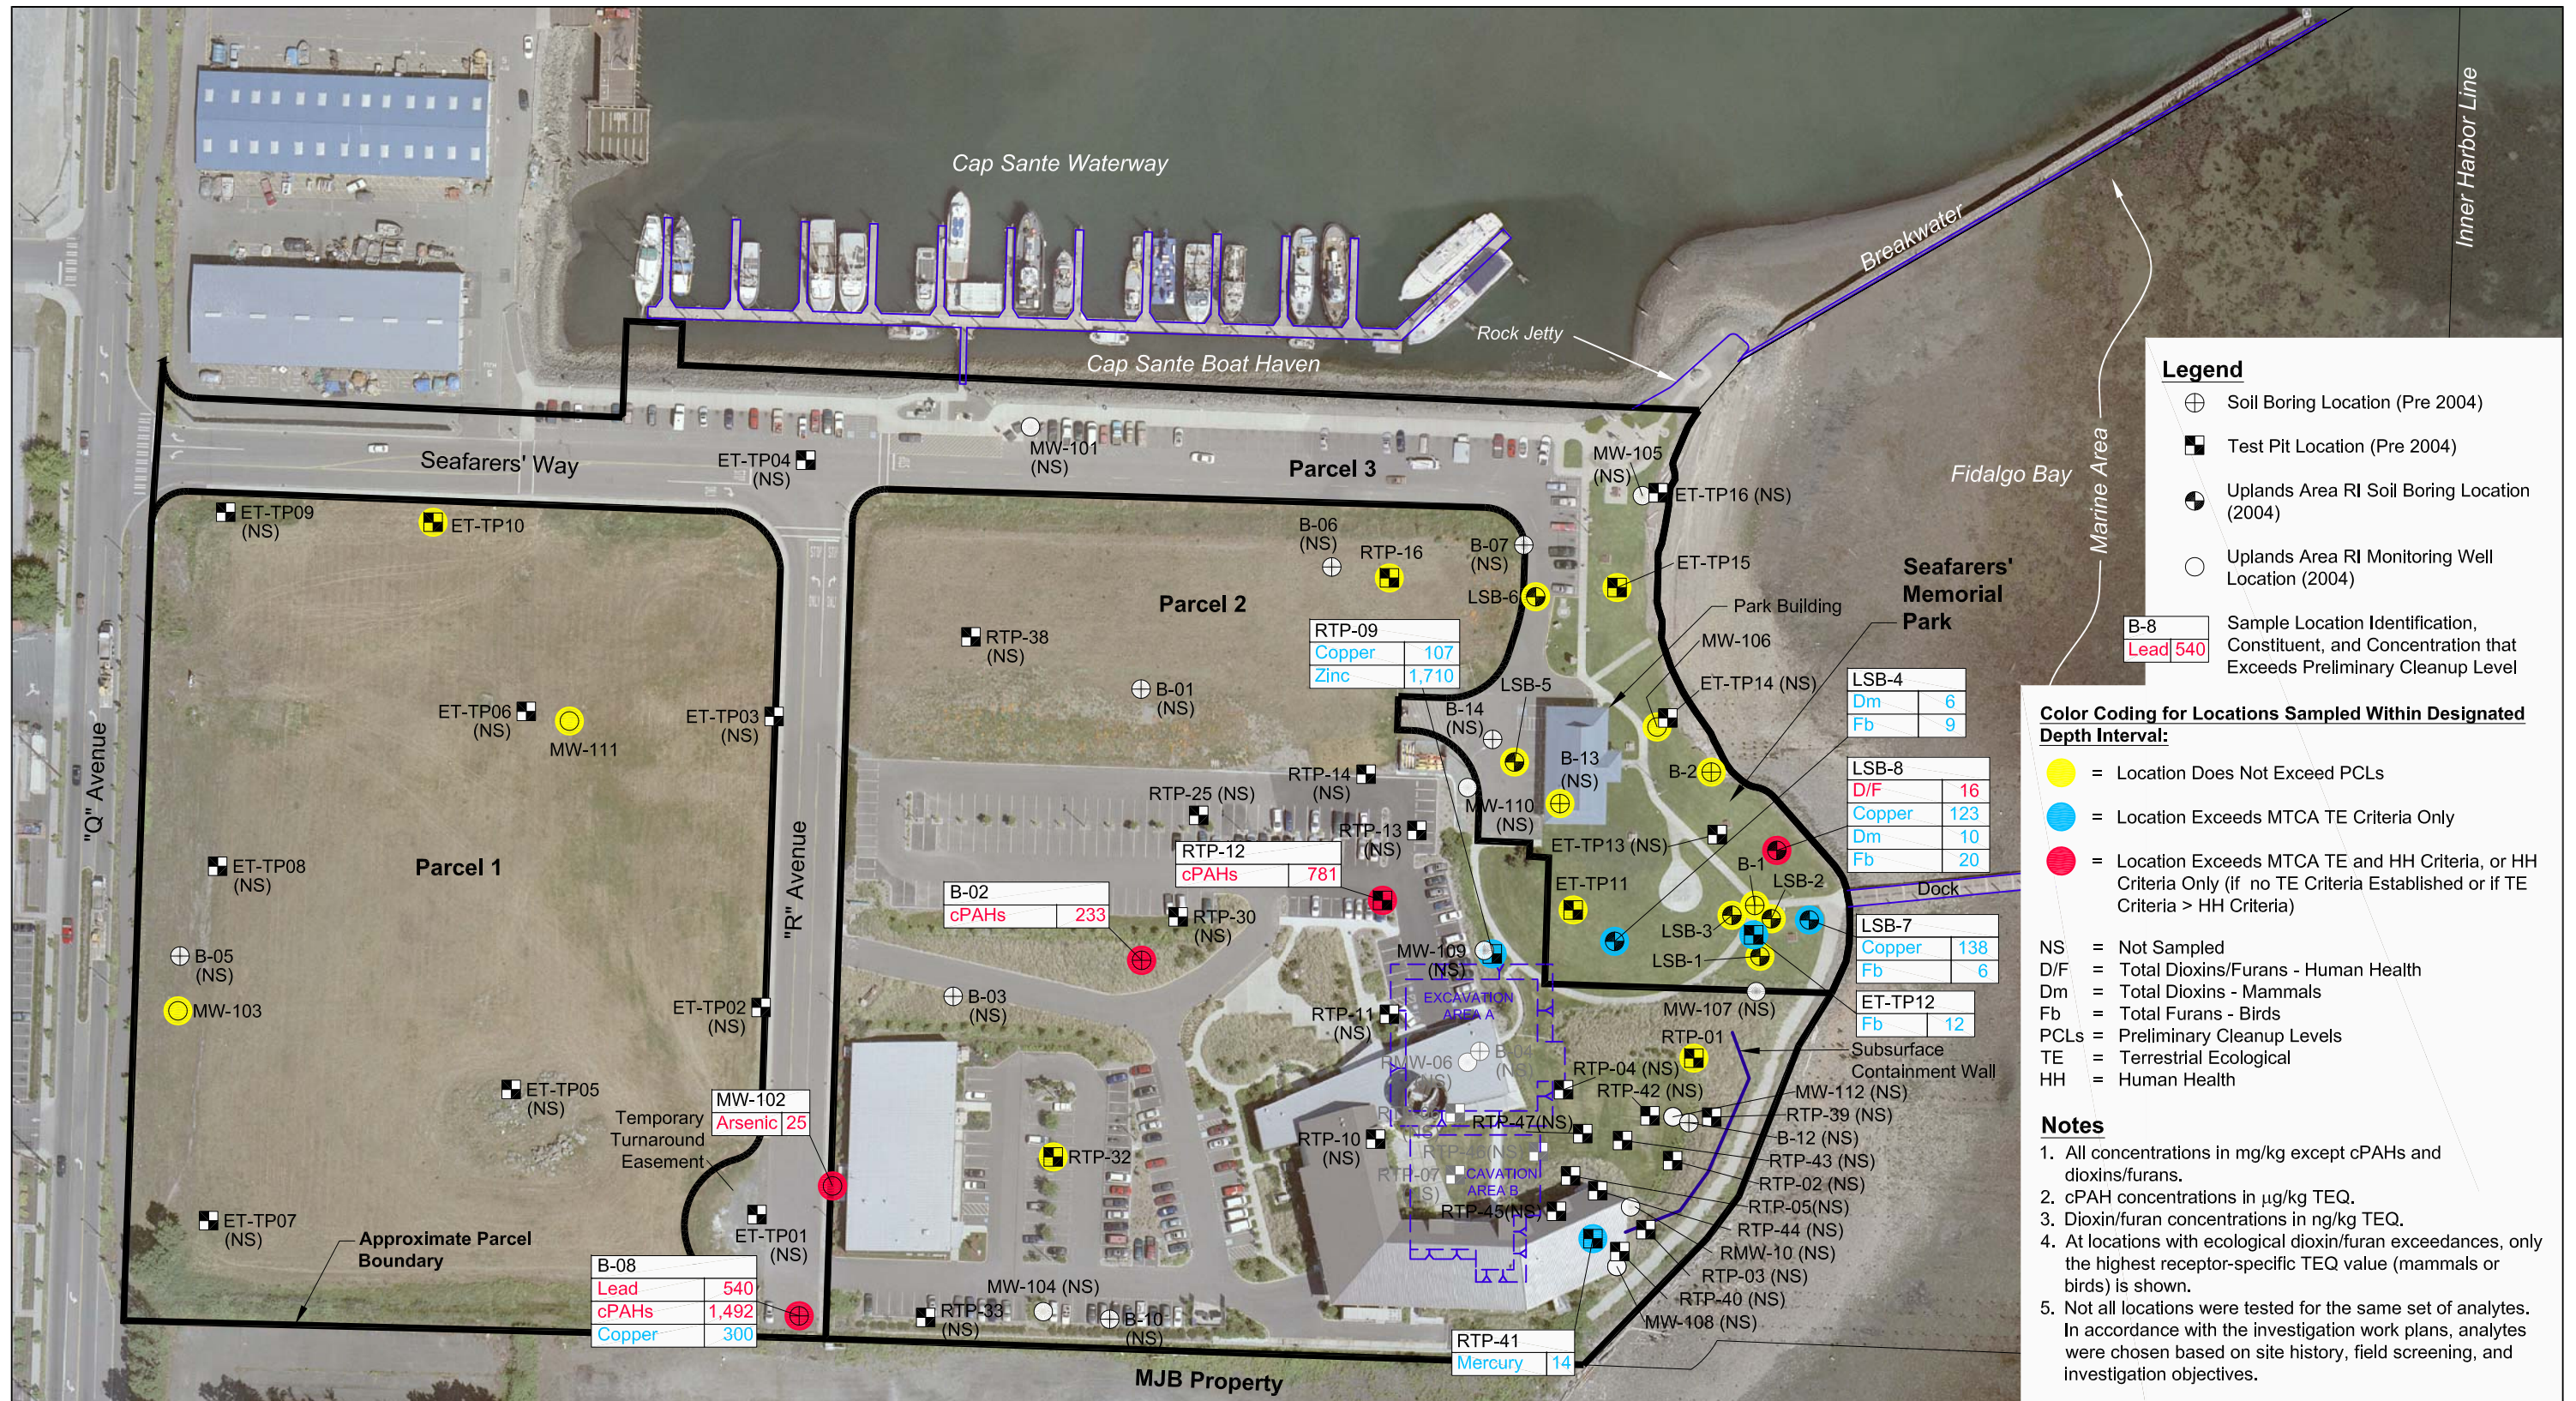
**Figure 14**

**Port Uplands Area Preliminary Soil Cleanup Level Exceedance Locations (2-6 ft BGS)**

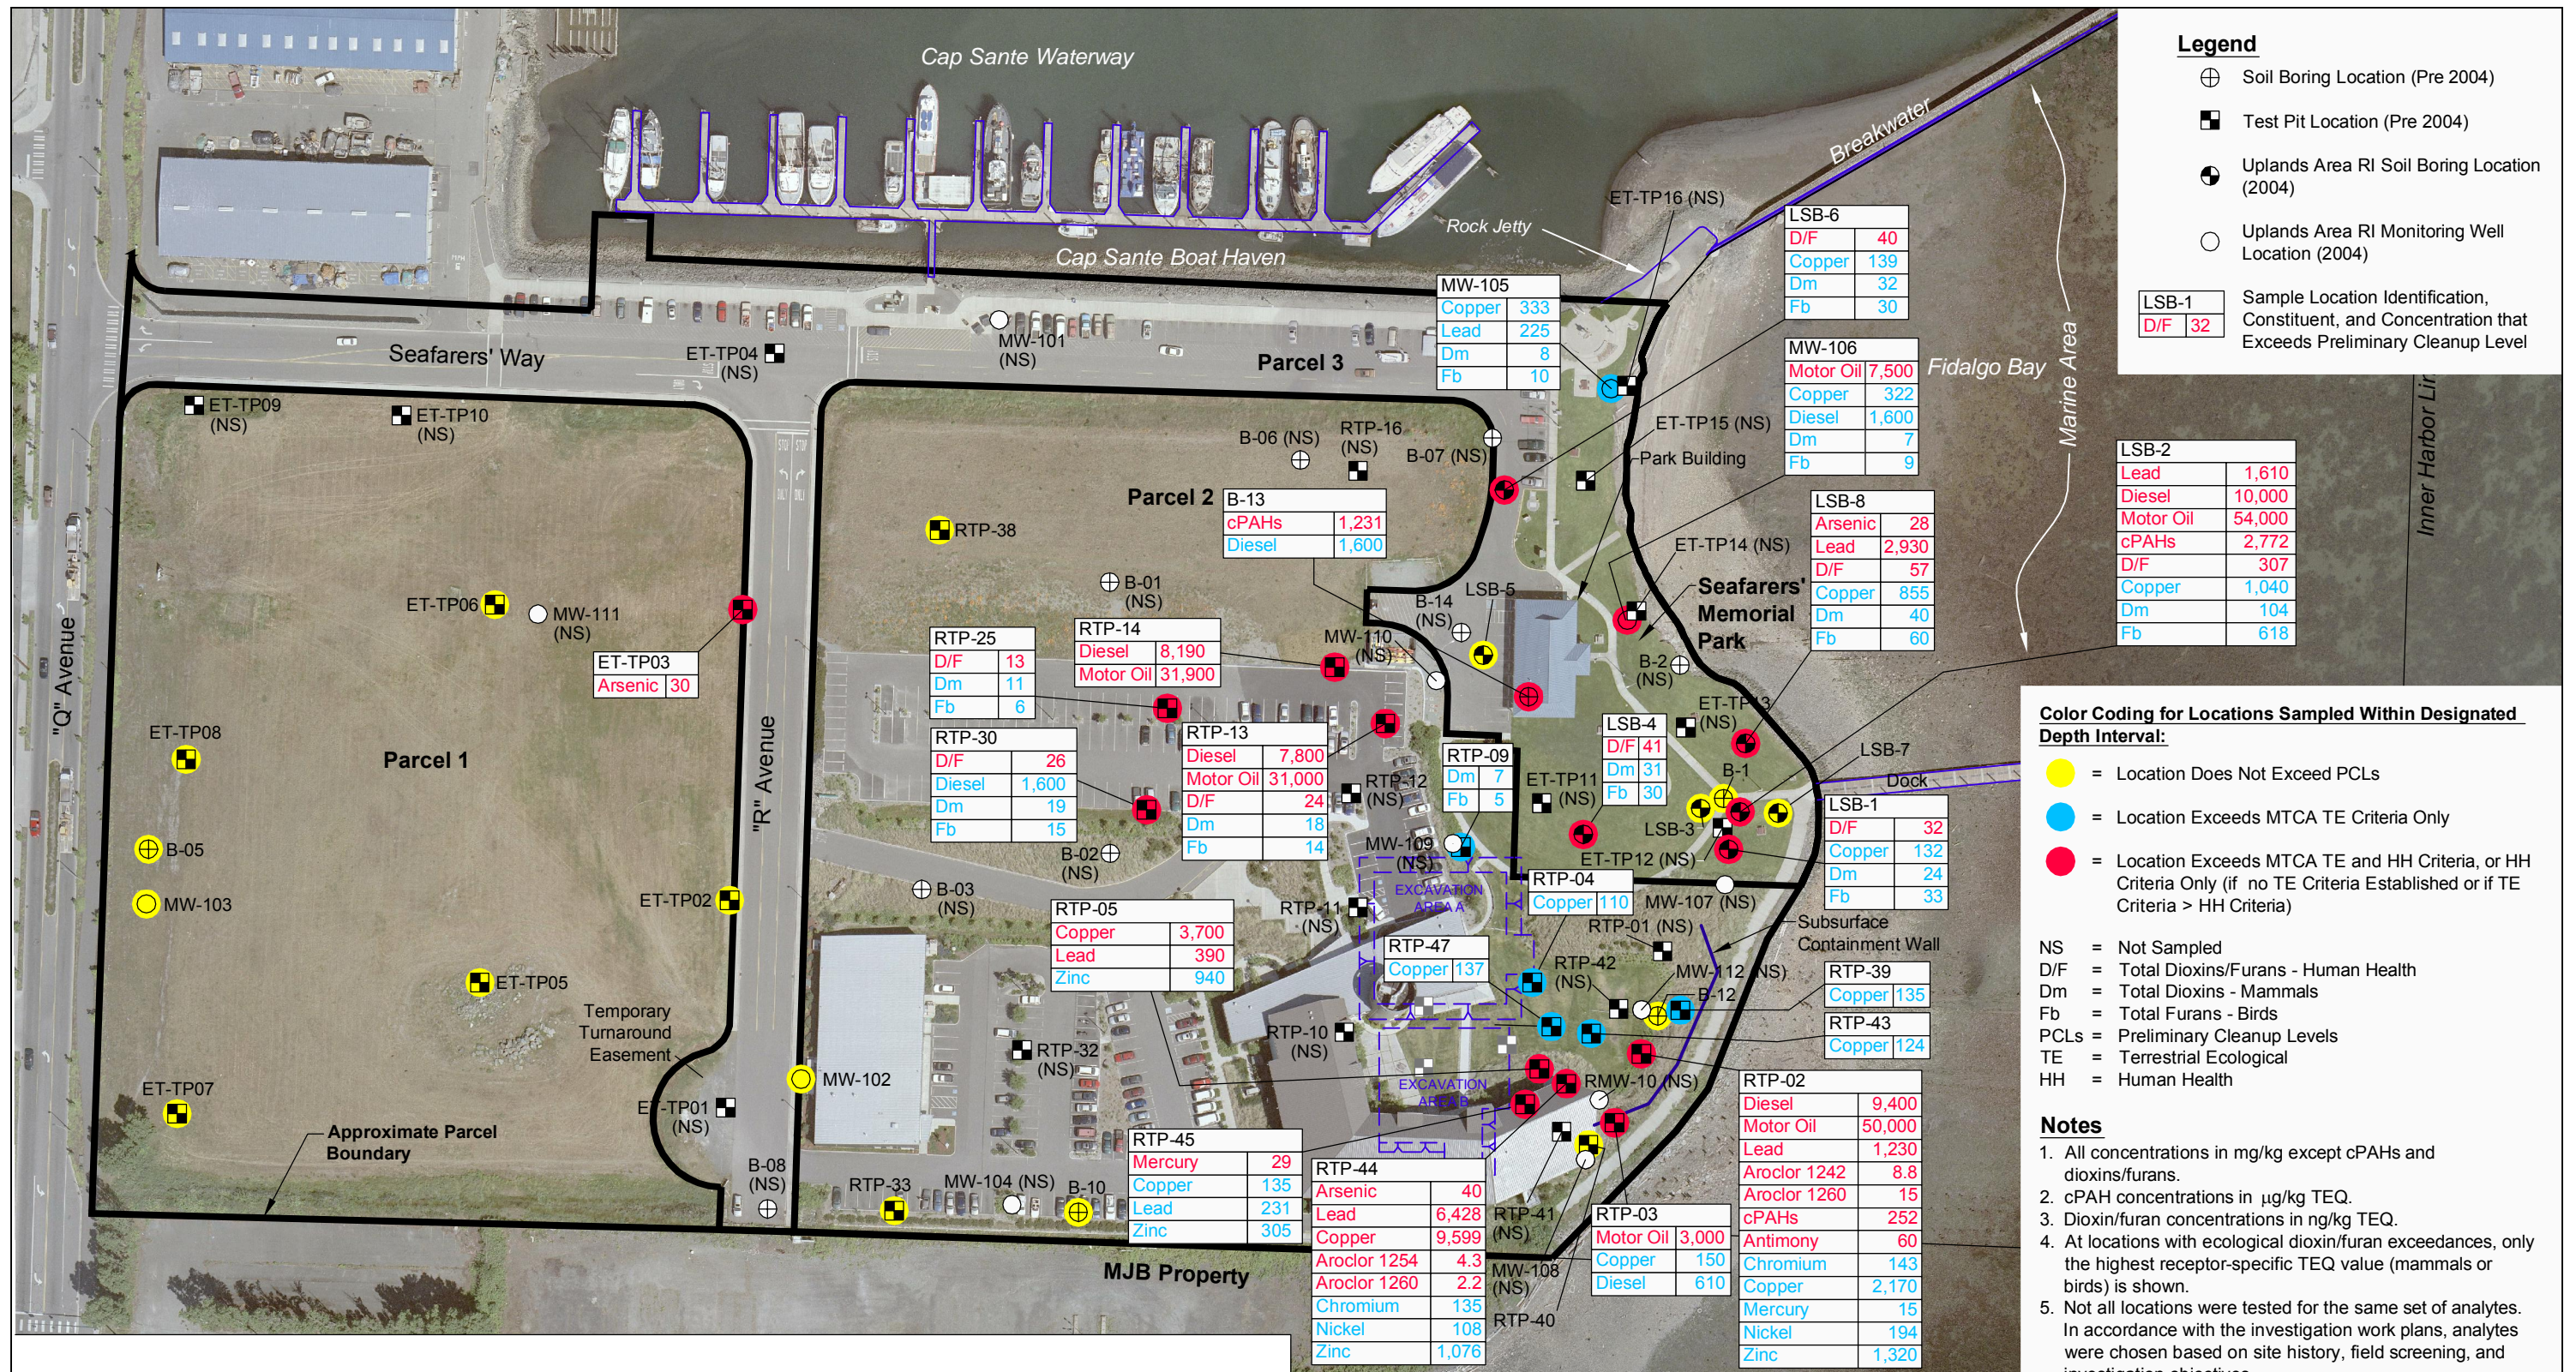
Figure 15

**Port Uplands Area Preliminary Soil Cleanup Level Exceedance Locations (6-10 ft BGS)**

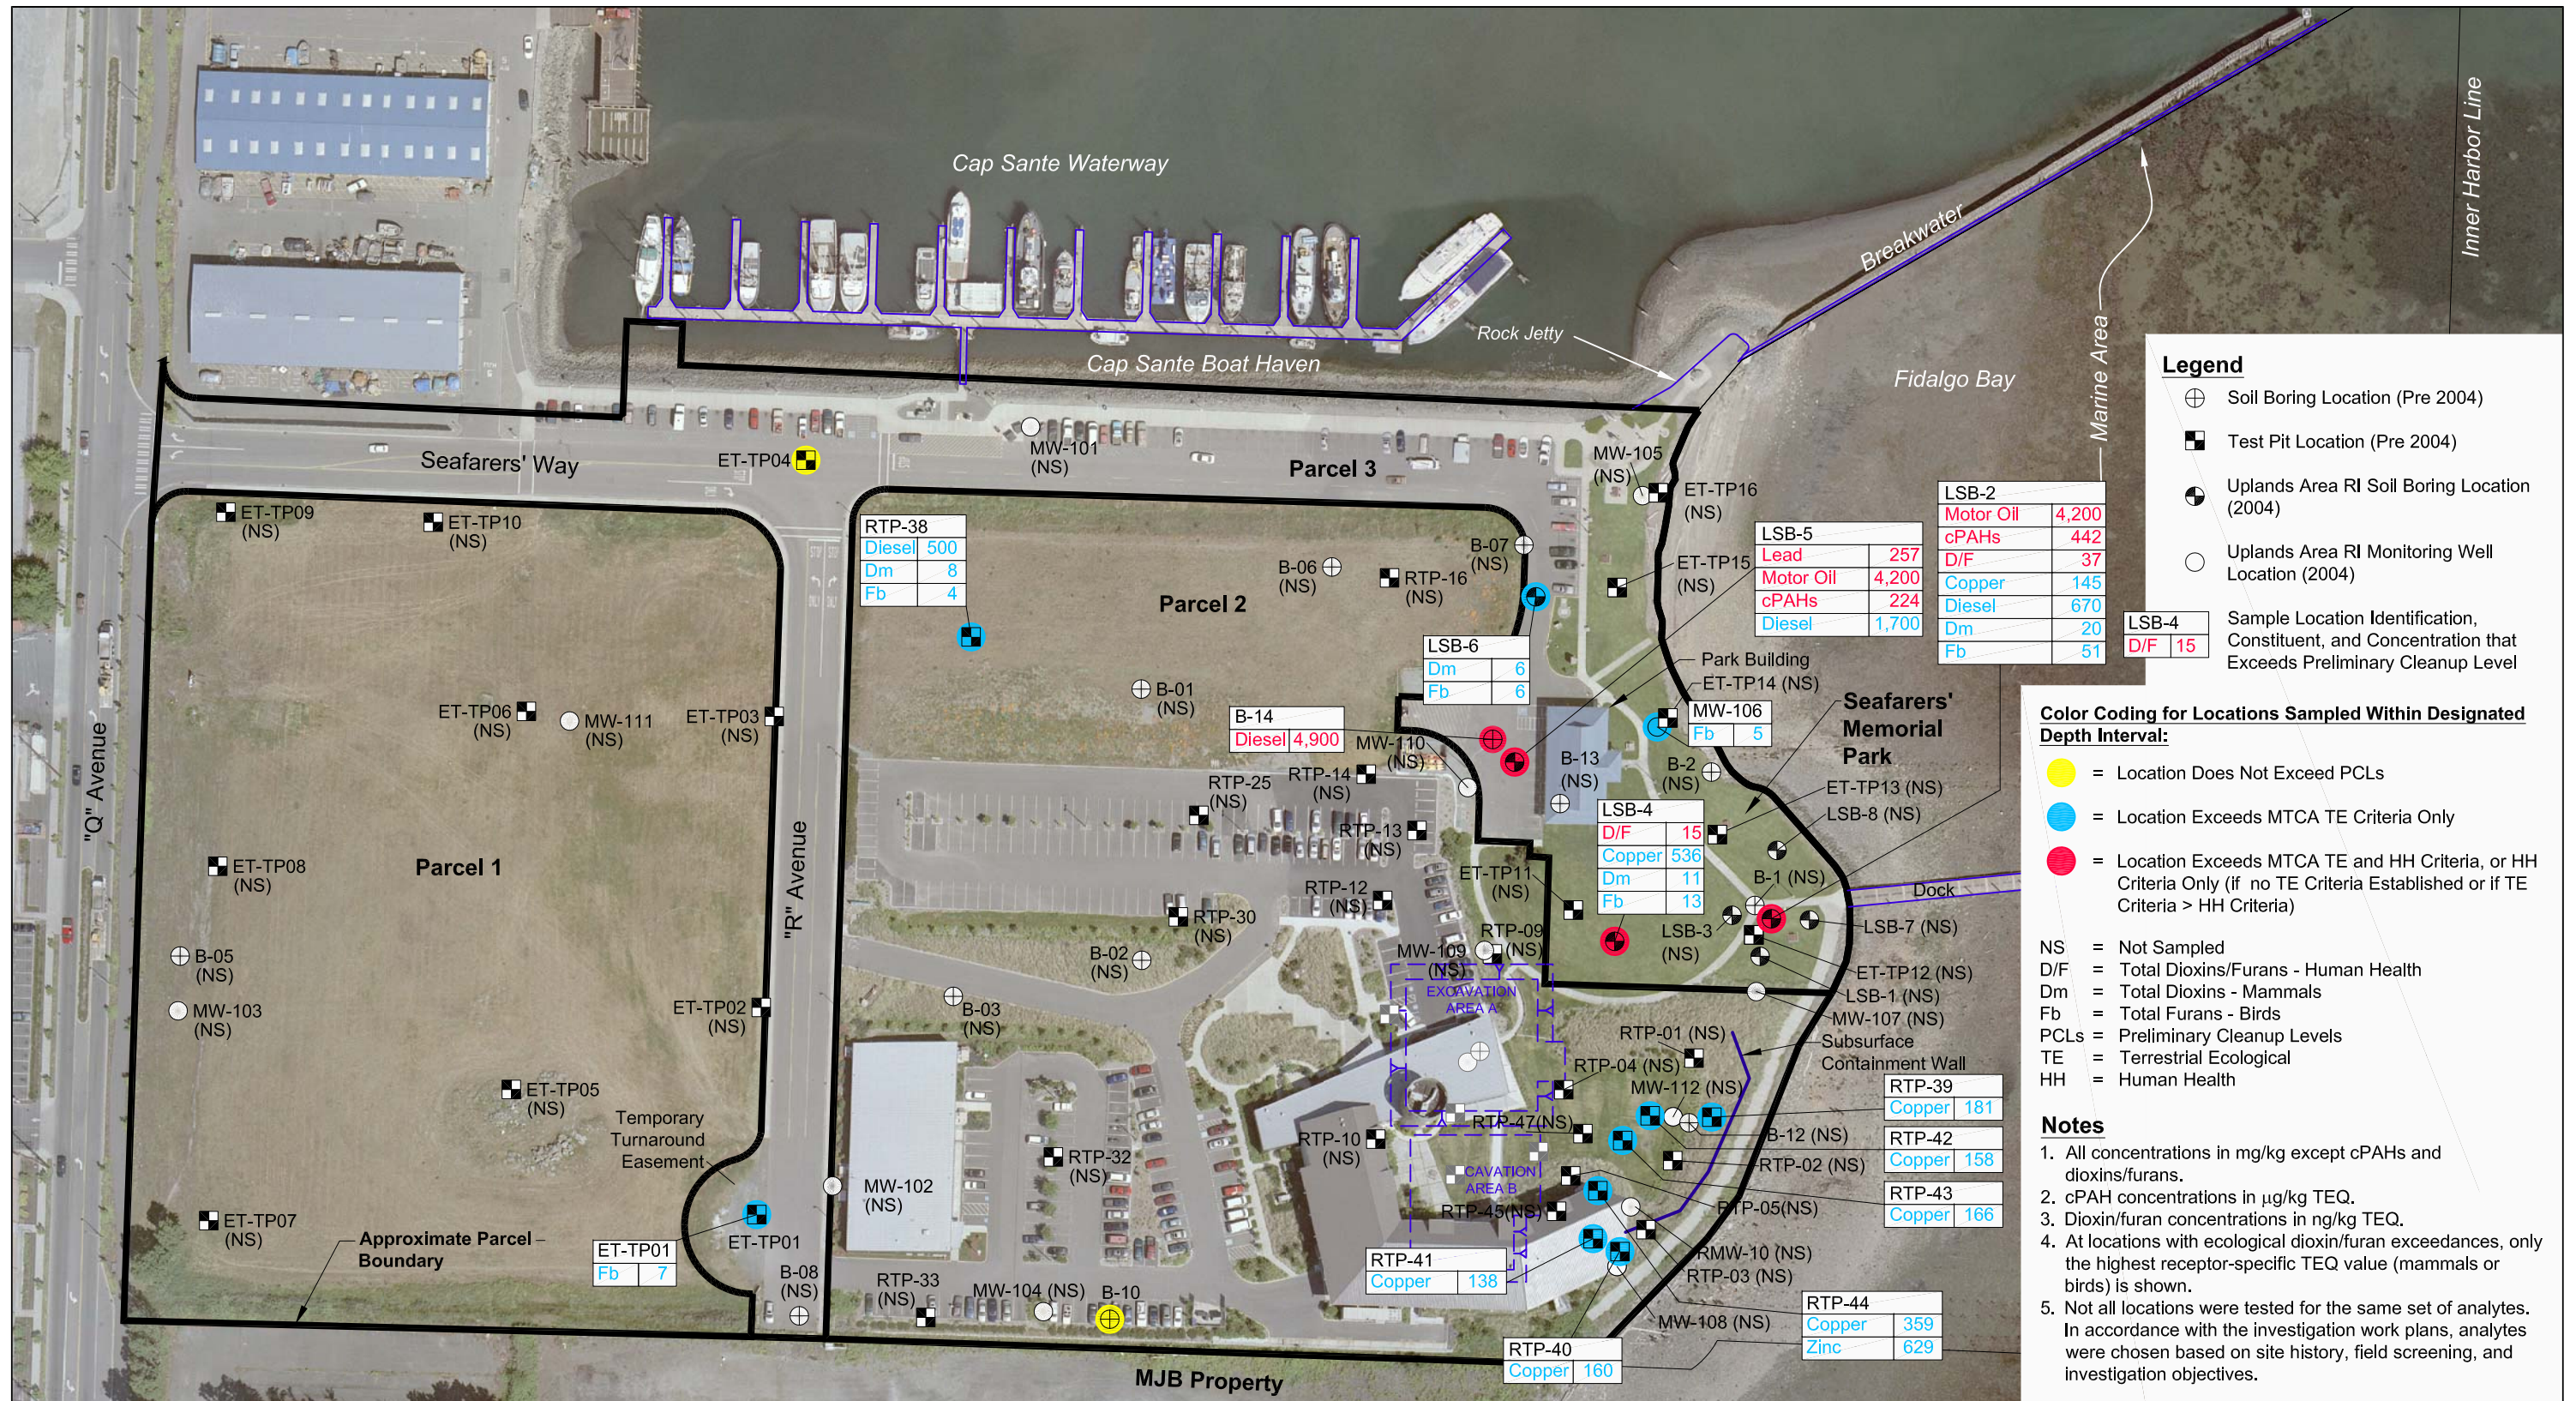
**Figure 16**

**Port Uplands Area Preliminary Soil Cleanup Level Exceedance Locations (10-15 ft BGS)**

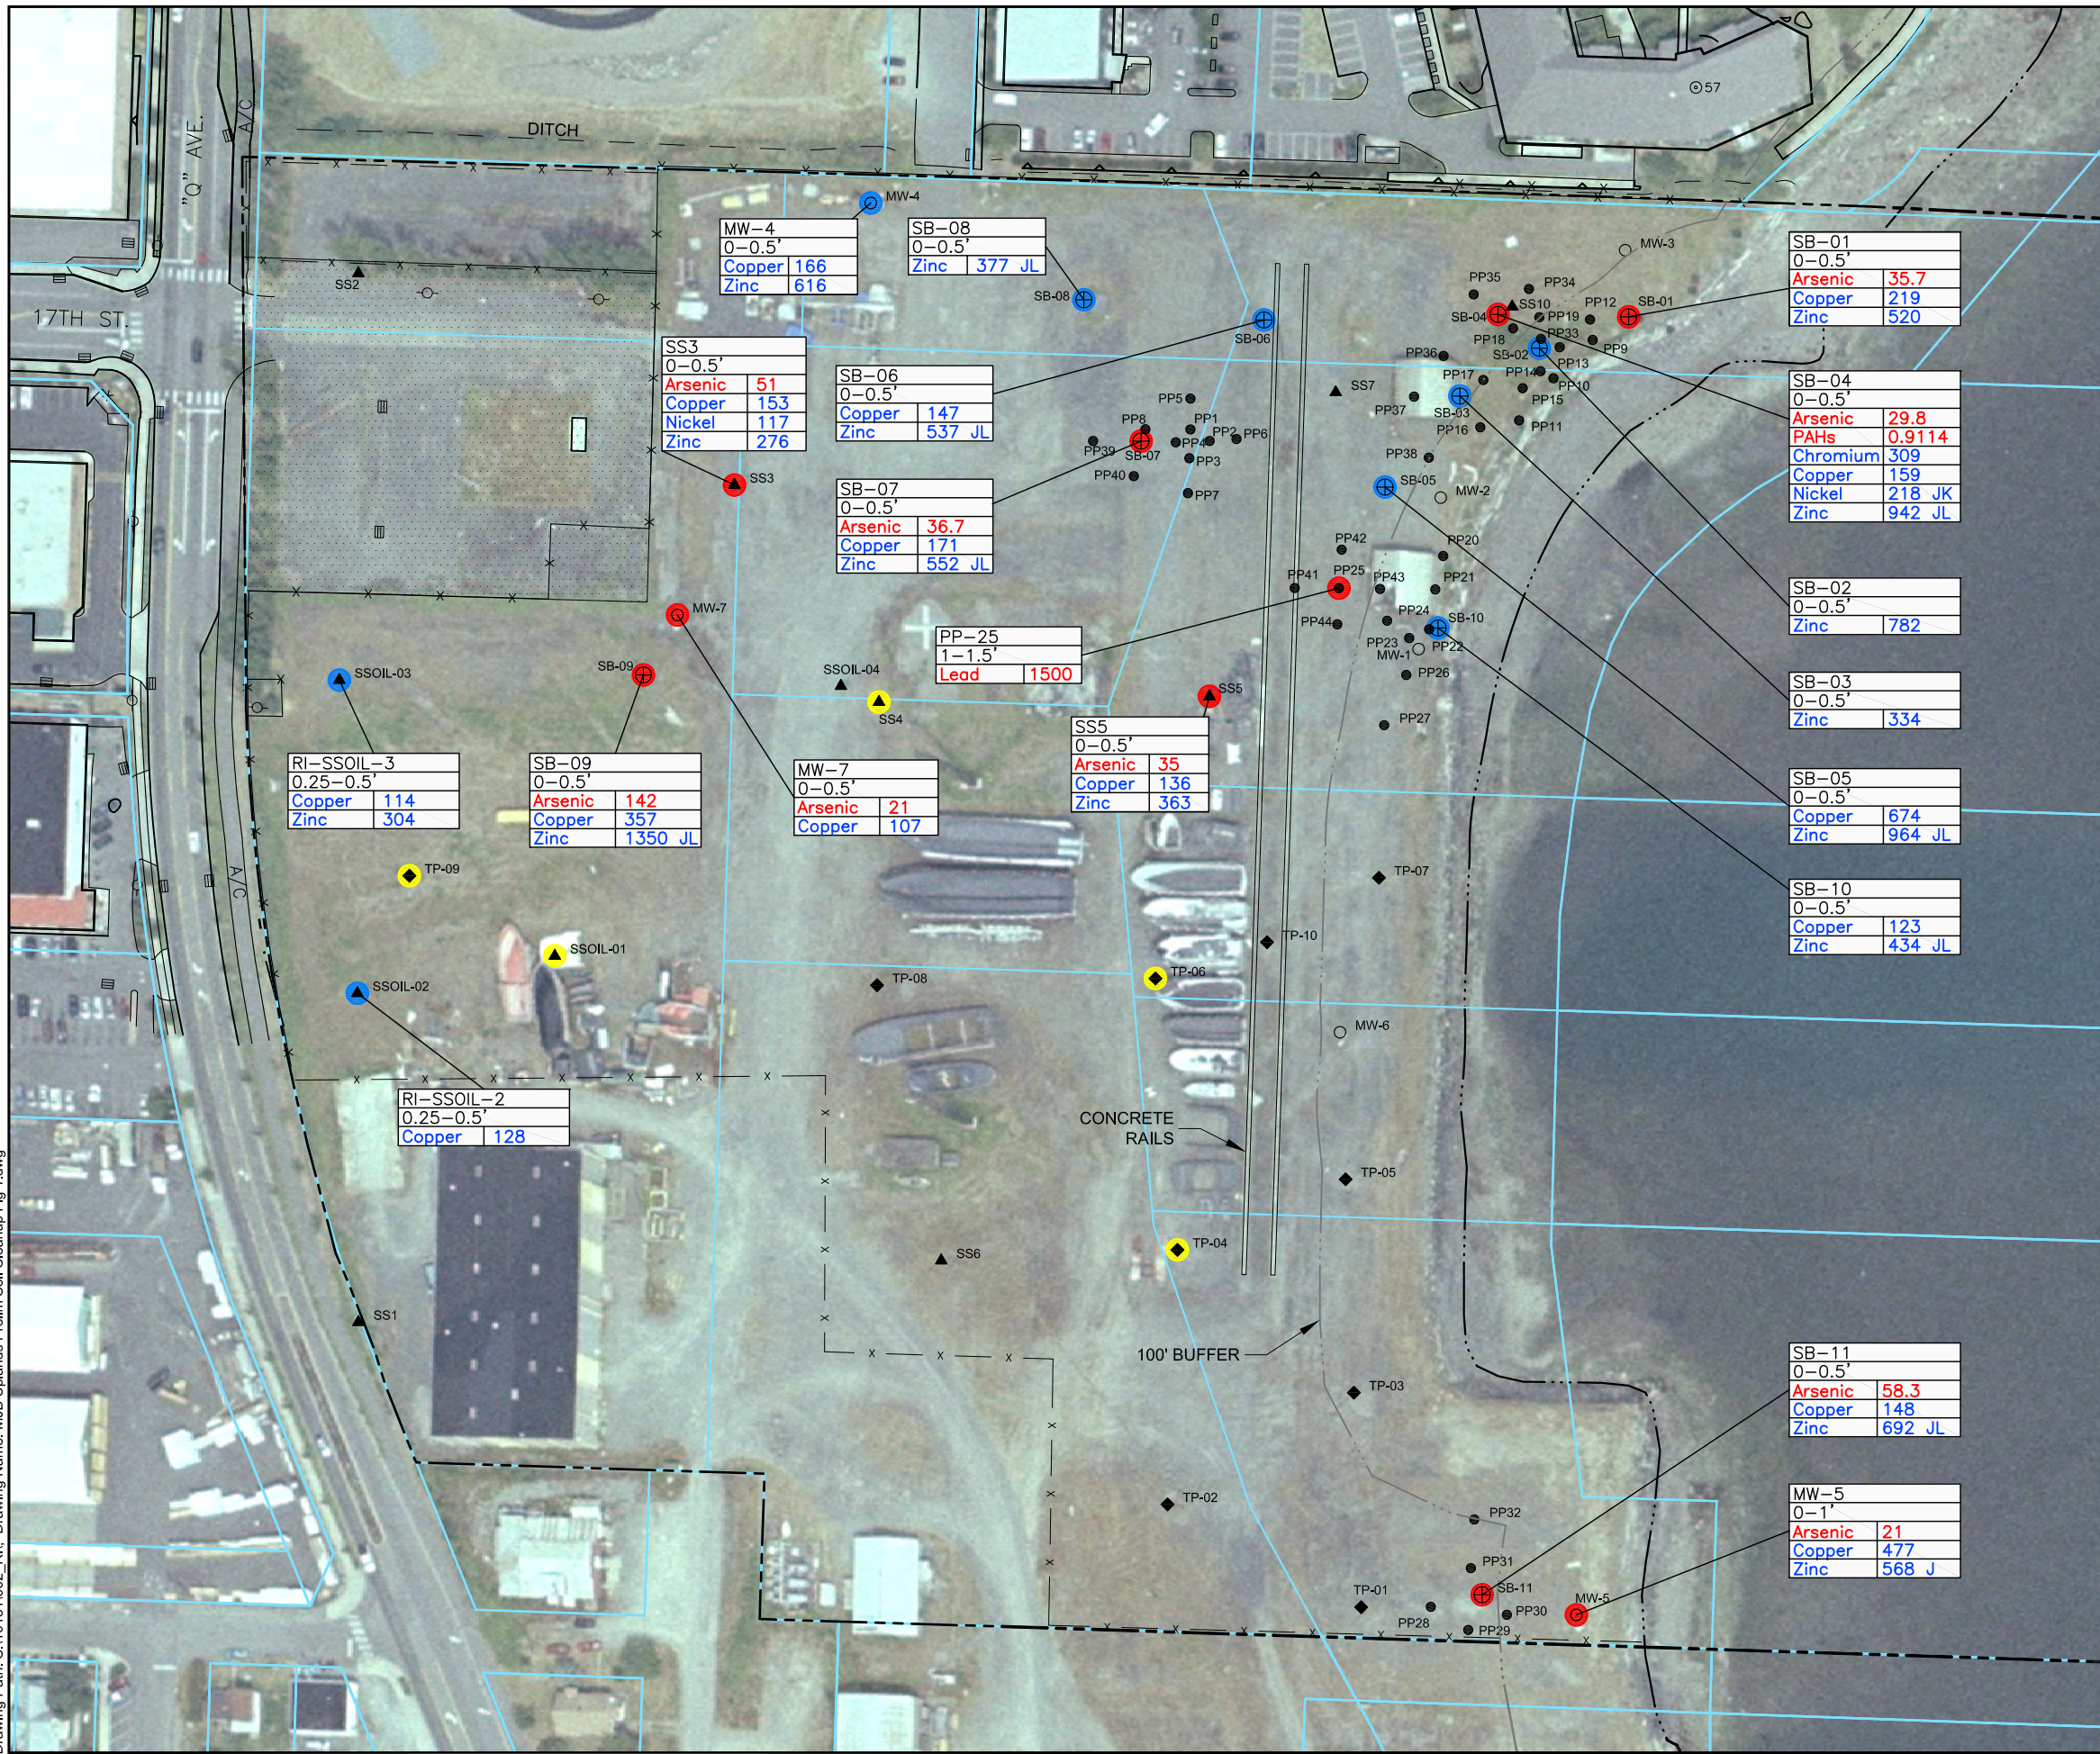
**PRELIMINARY SOIL CLEANUP LEVEL  
 EXCEEDANCE LOCATIONS  
 (0-2 ft BGS)  
 MJB North Area  
 Anacortes, Washington**
