Scott Paper Mill  
Anacortes, Washington

**Soil Explorations - Port Parcel 3 Uplands Area RI and Previous Investigations**

<b>Cross Section A-A'</b>	
Scott Paper Mill Anacortes, Washington	
<b>GEOENGINEERS</b>	<b>Figure 9</b>

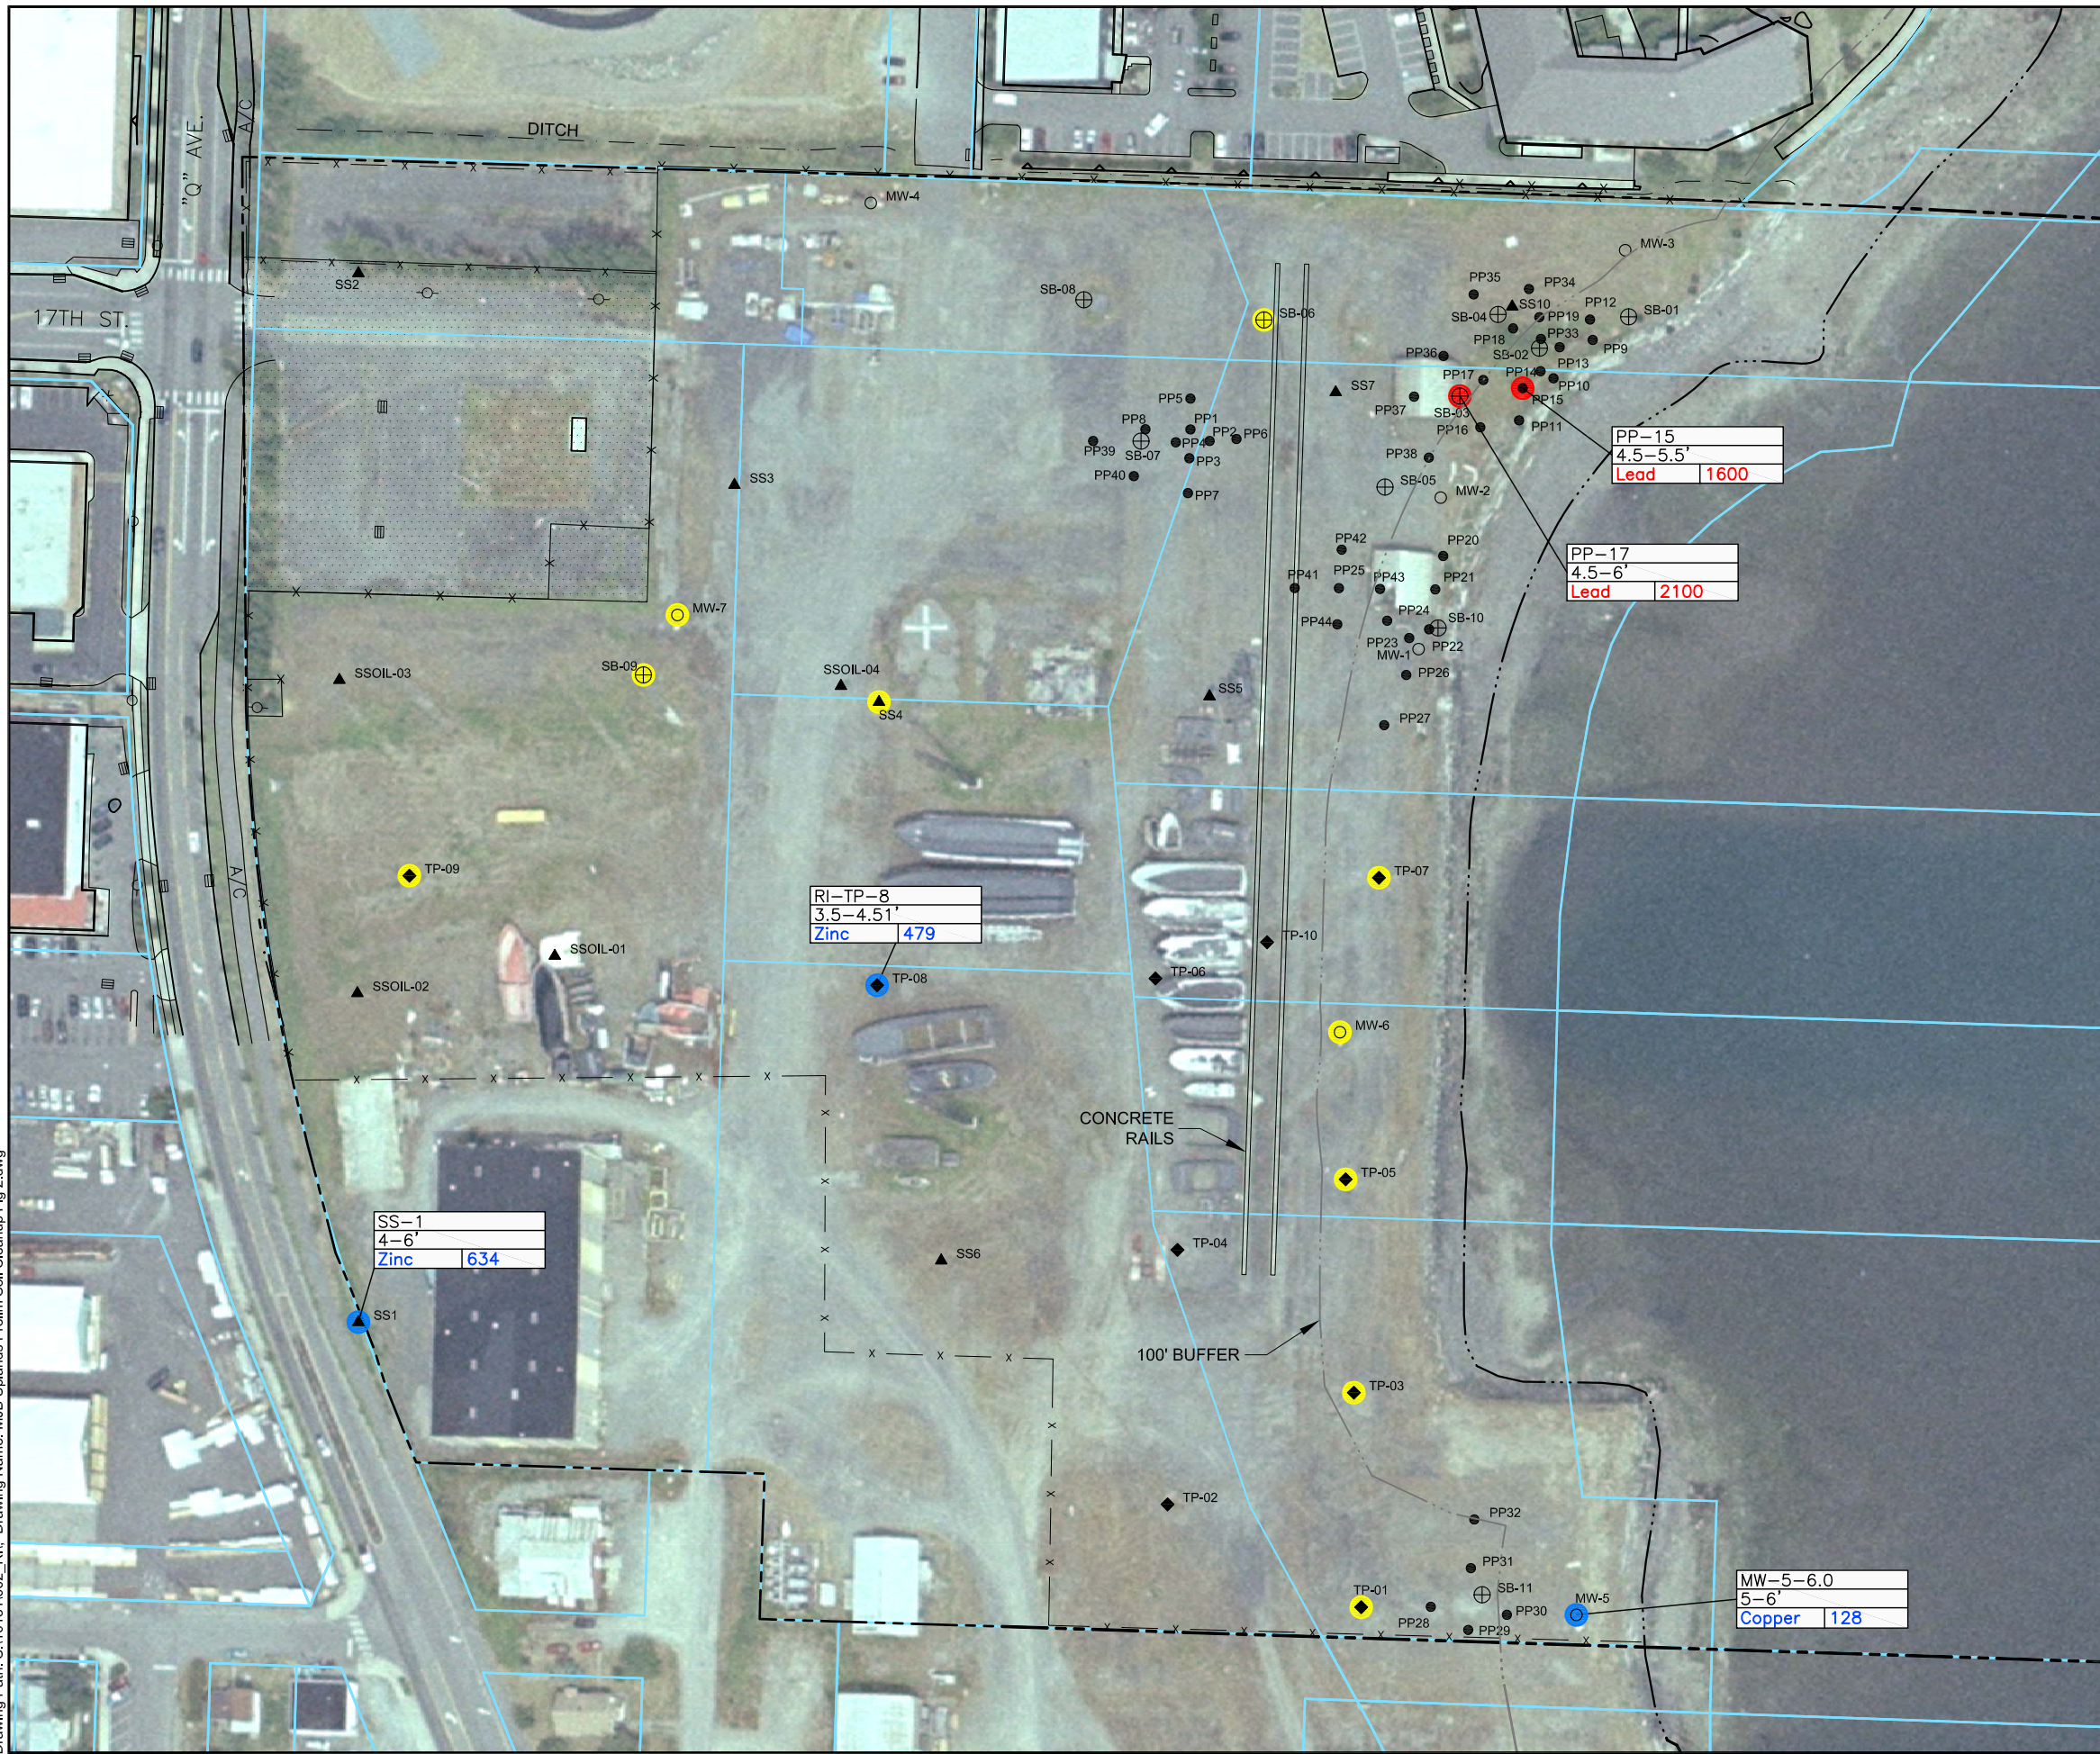
**PRELIMINARY SOIL CLEANUP LEVEL EXCEEDANCE LOCATIONS (2-6 ft BGS)  
 MJB North Area  
 Anacortes, Washington**

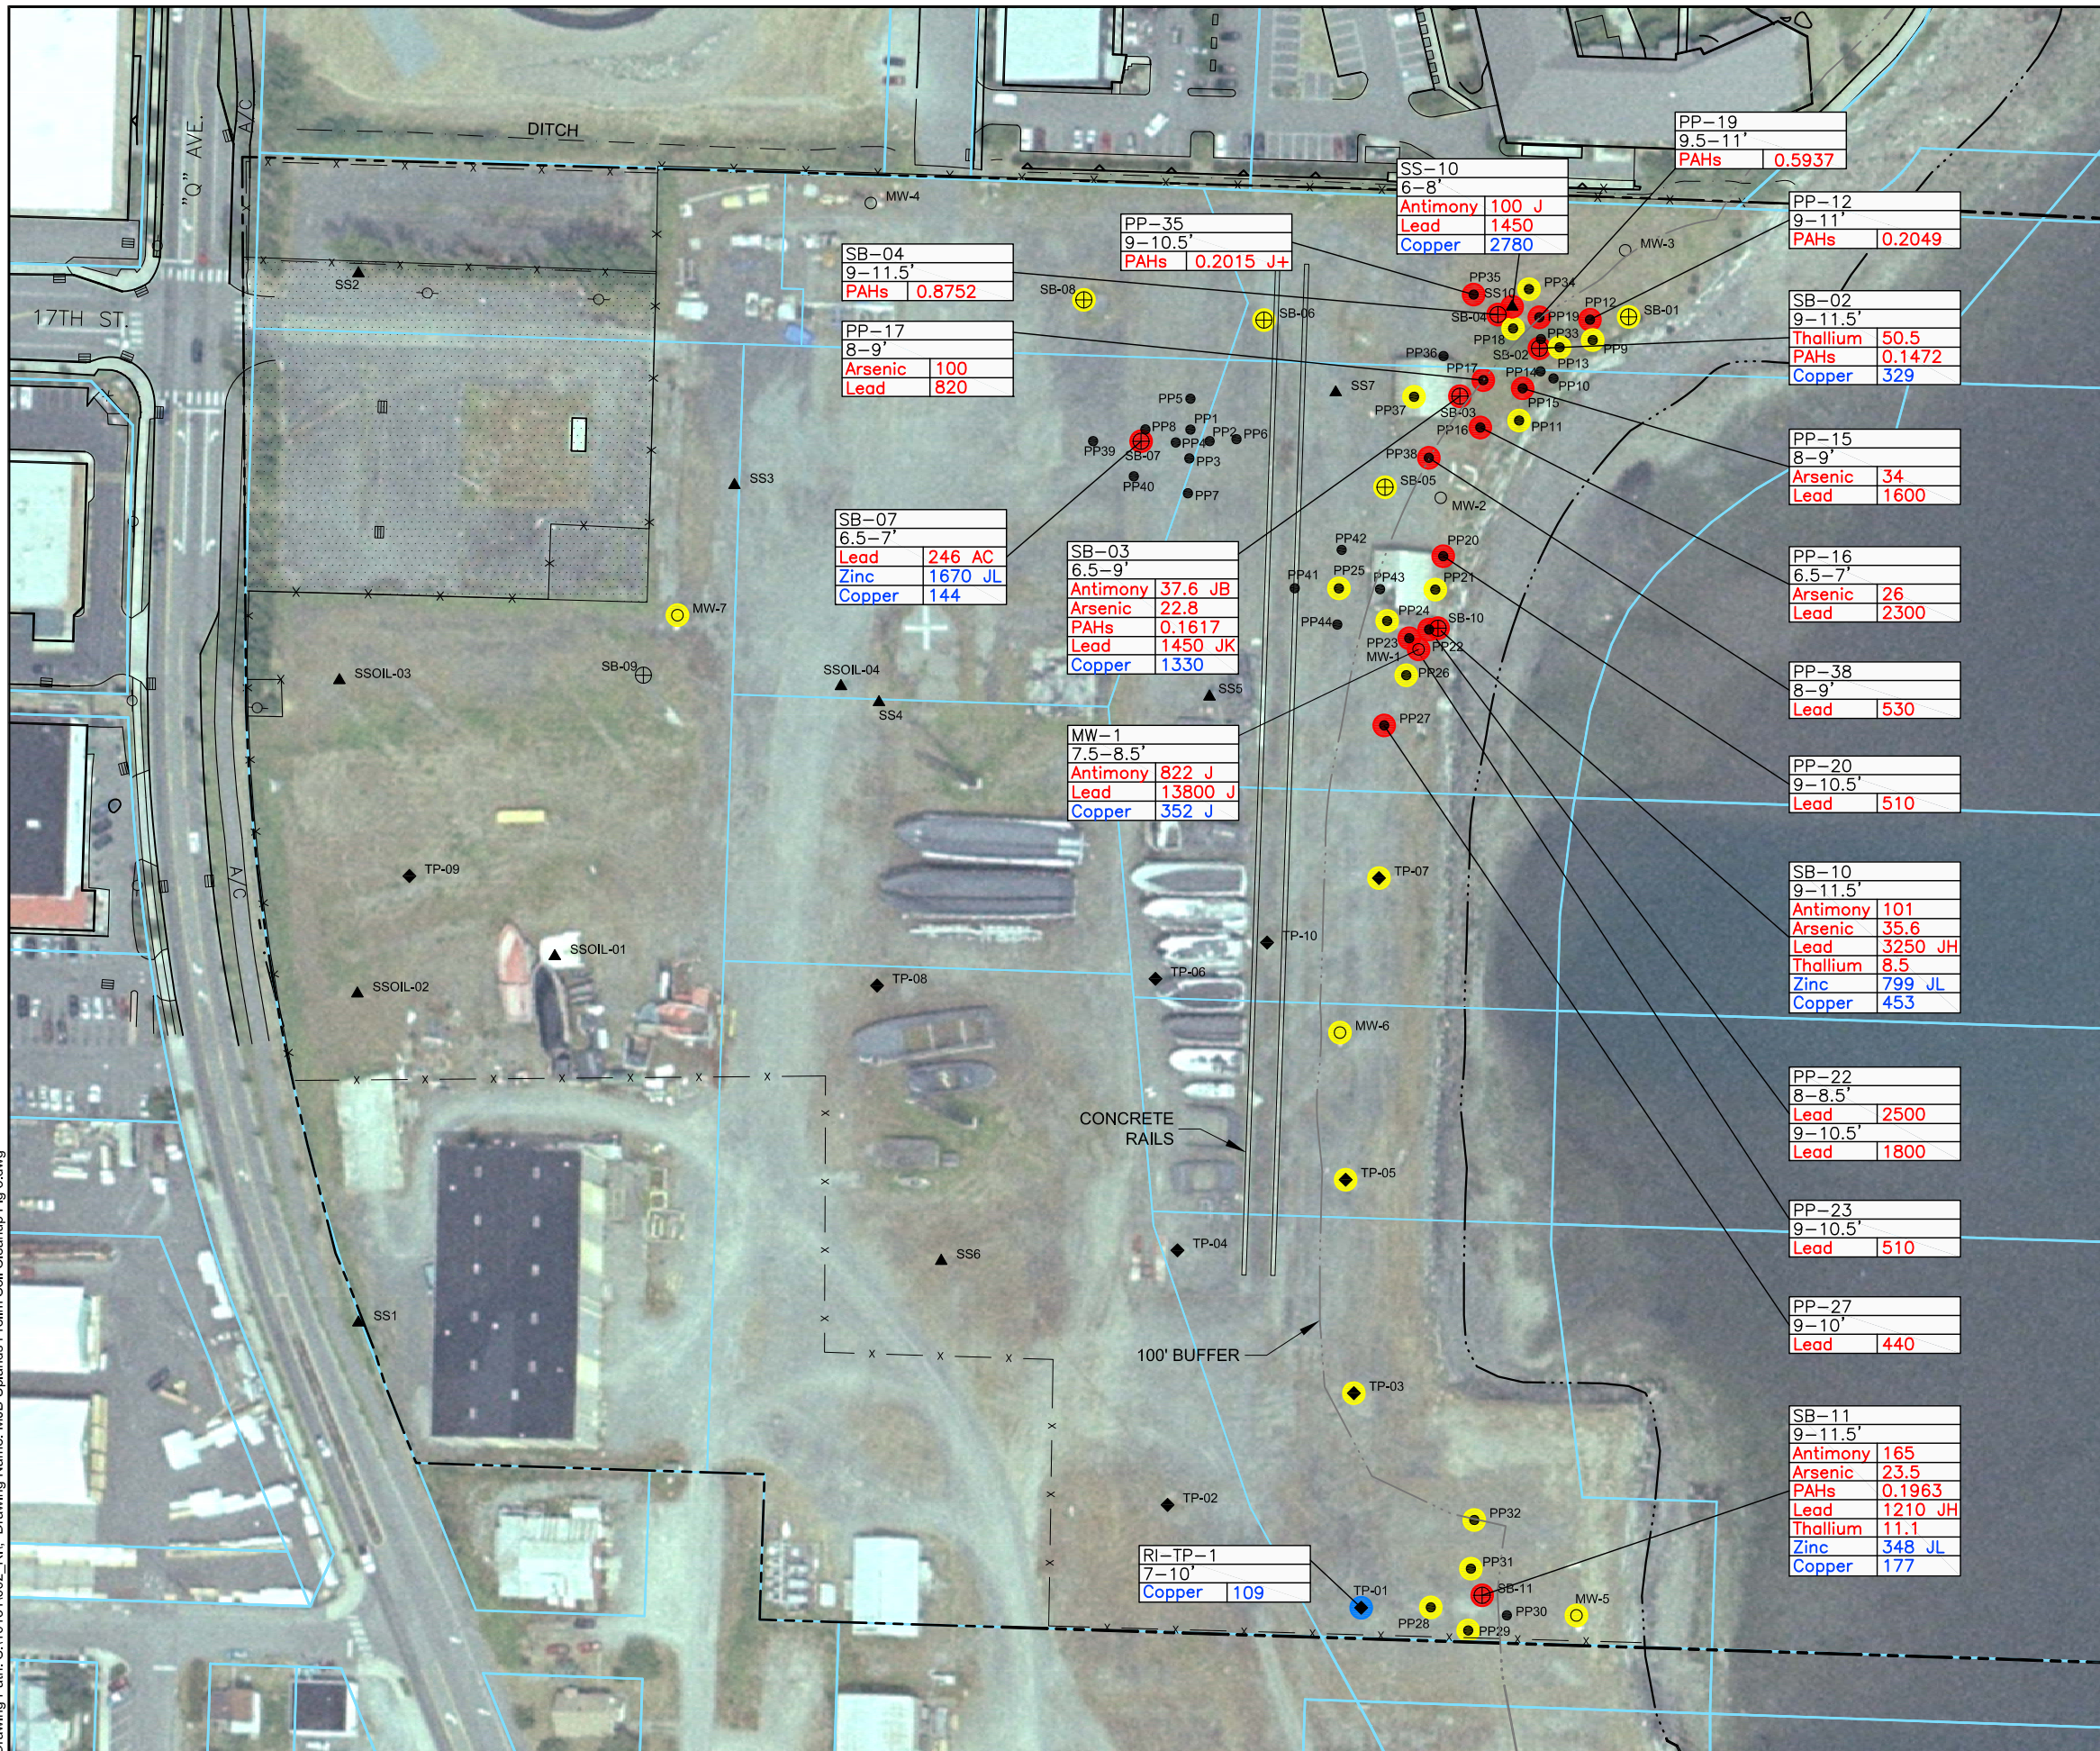
**PRELIMINARY SOIL CLEANUP LEVEL EXCEEDANCE LOCATIONS (6-15 ft BGS)**  
**MJB North Area**  
**Anacortes, Washington**

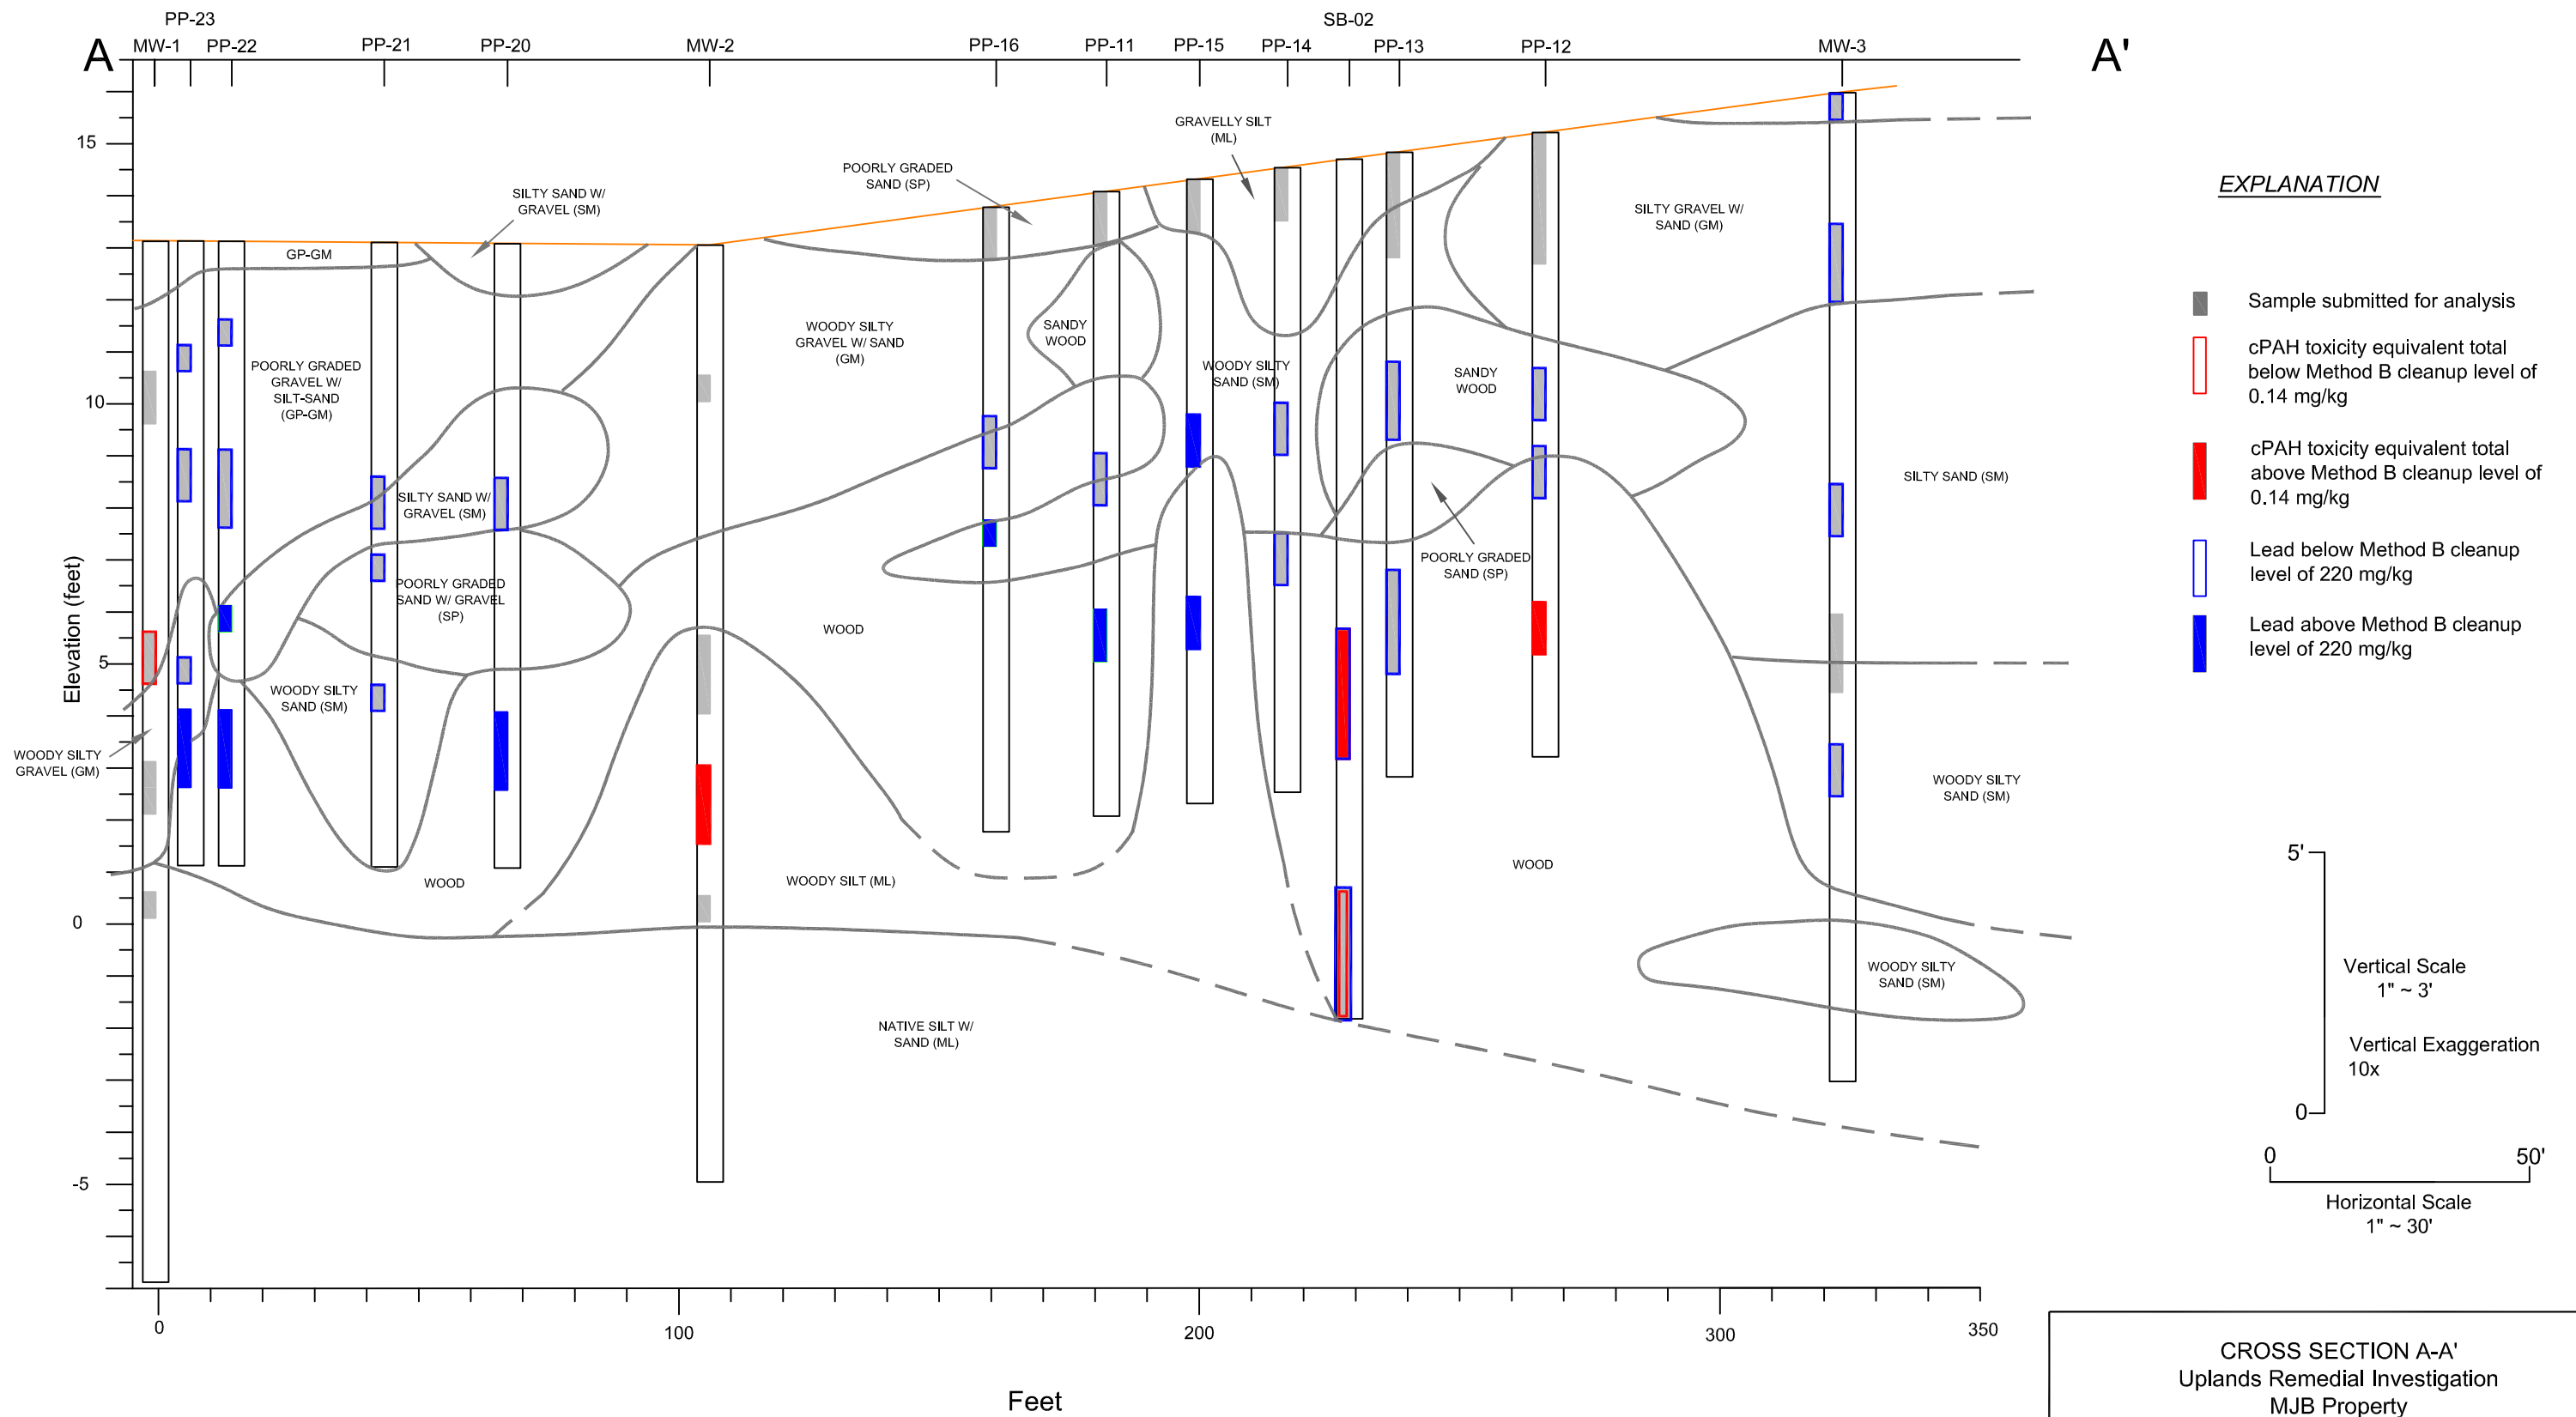
**CROSS SECTION A-A'**  
Uplands Remedial Investigation  
MJB Property  
Anacortes, Washington

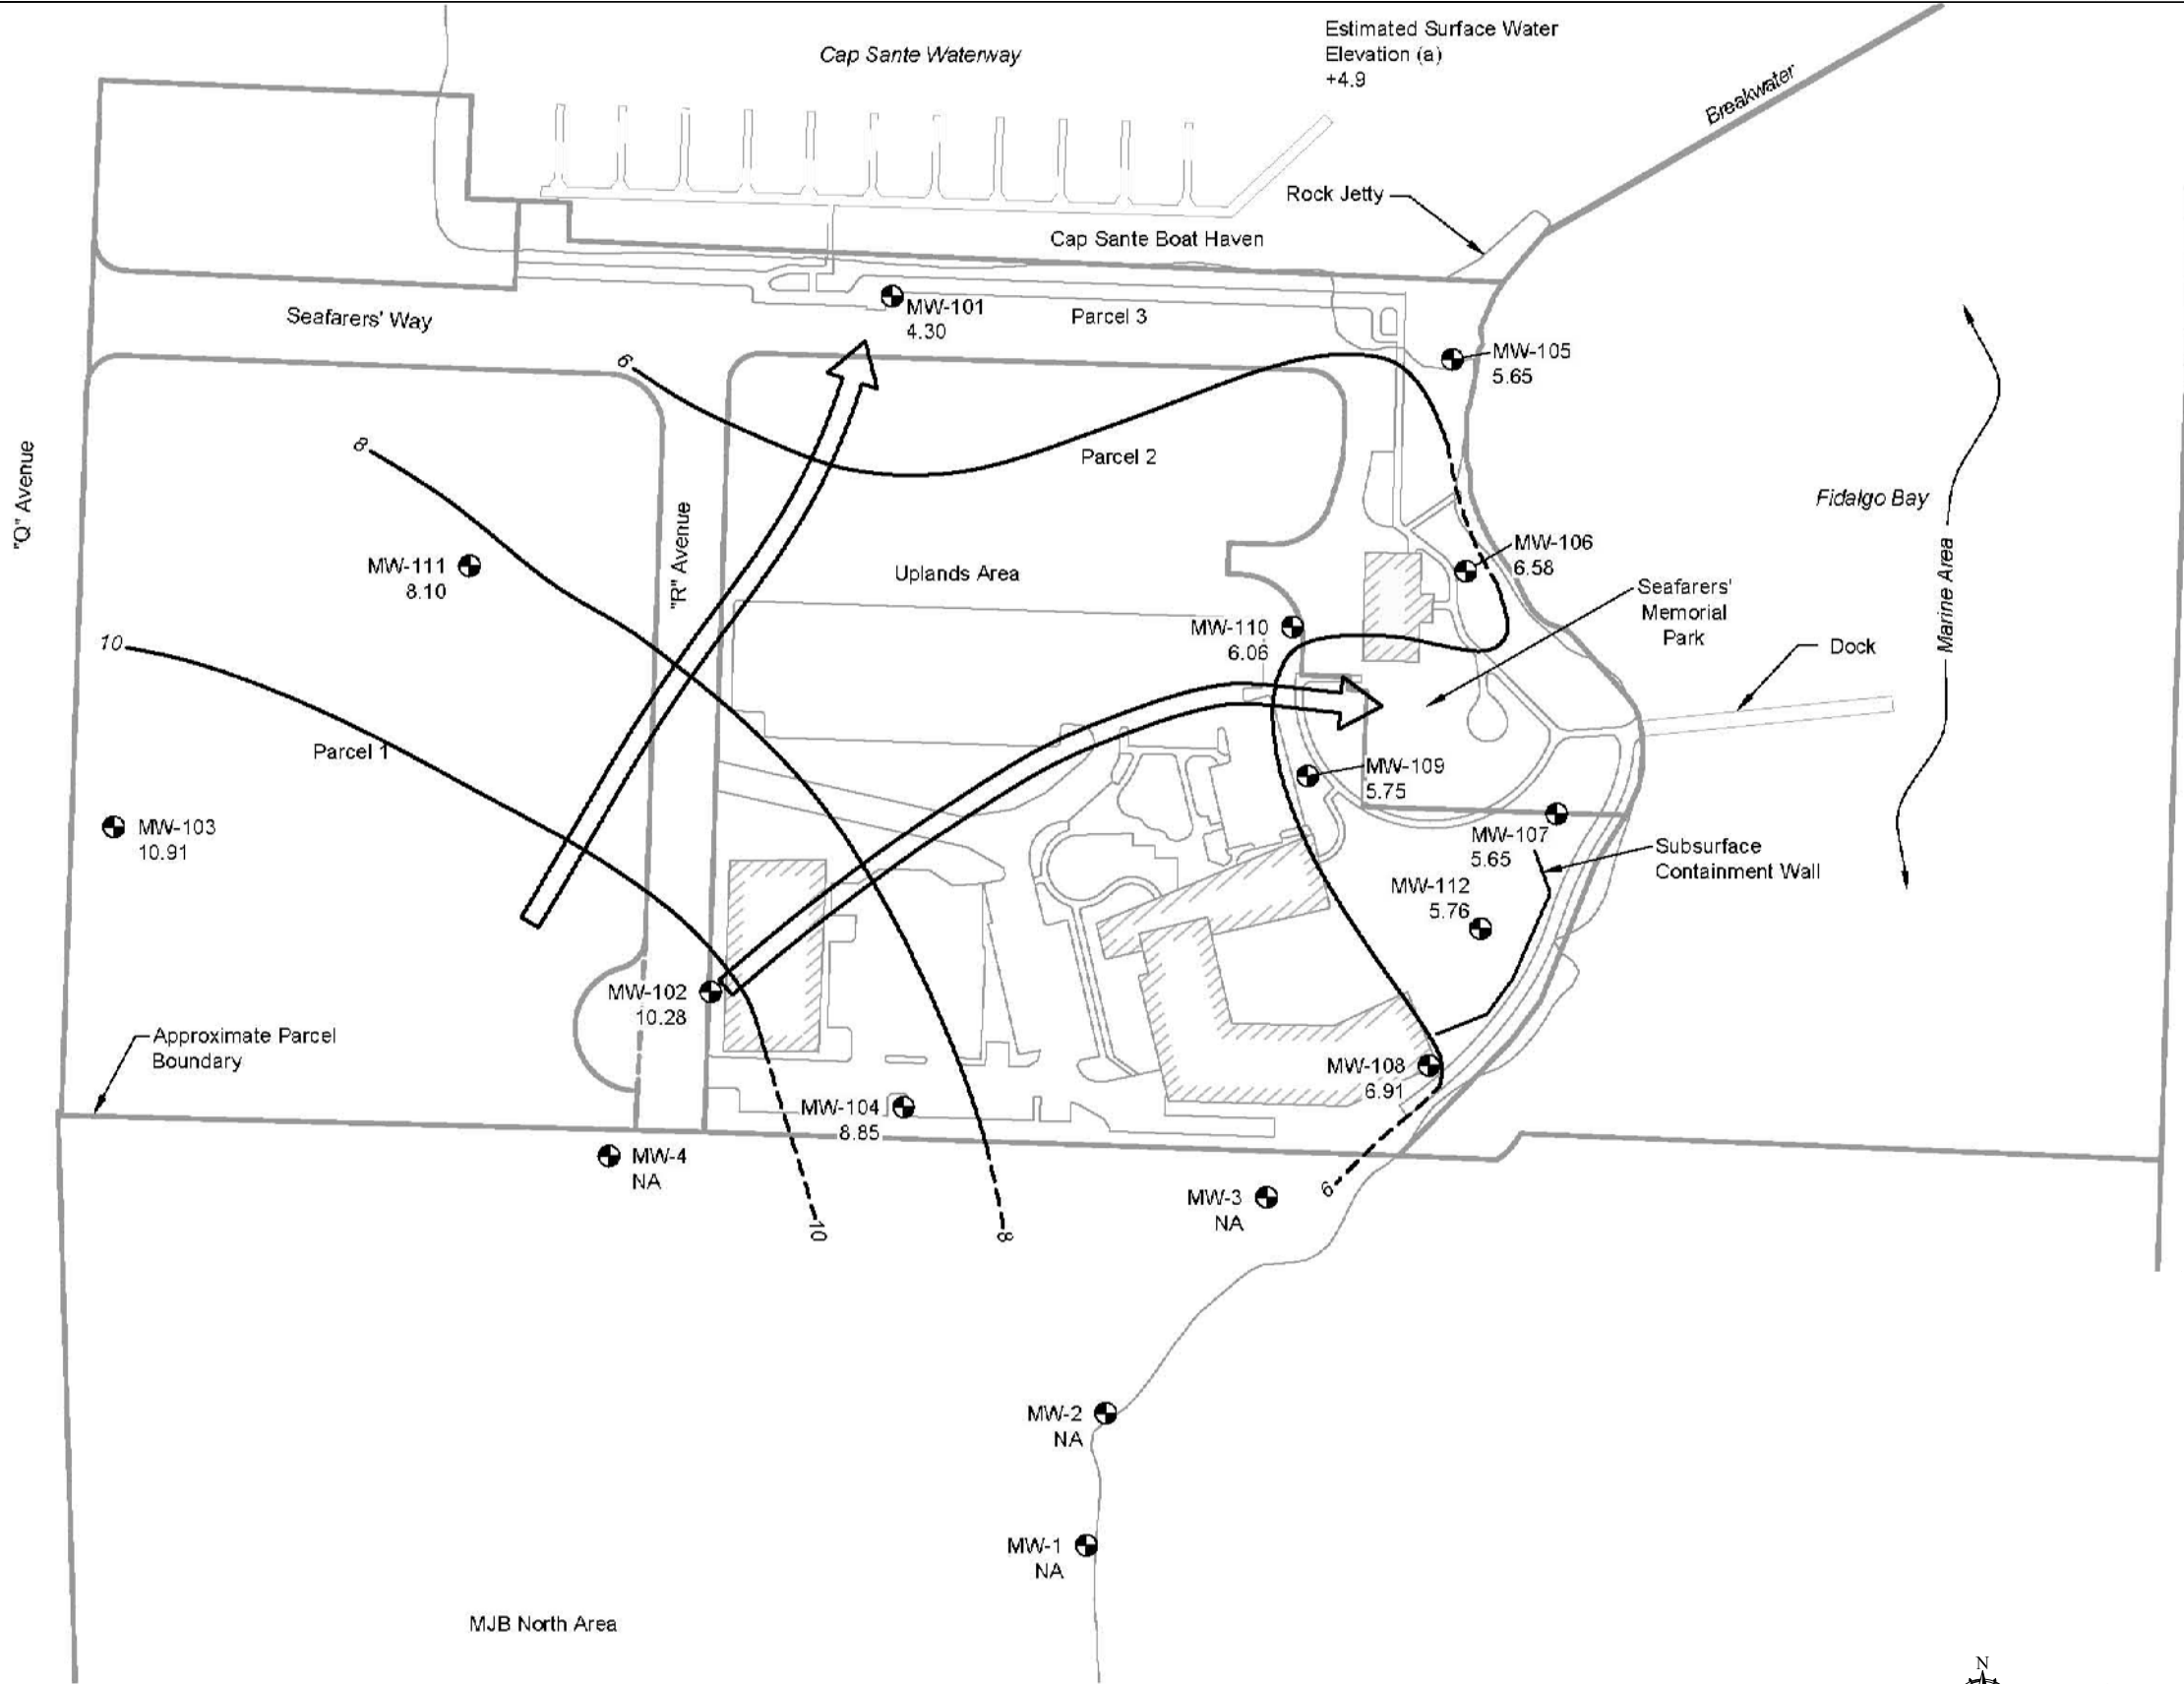
**Figure 21**

**Groundwater Elevation Contours  
May 2004**

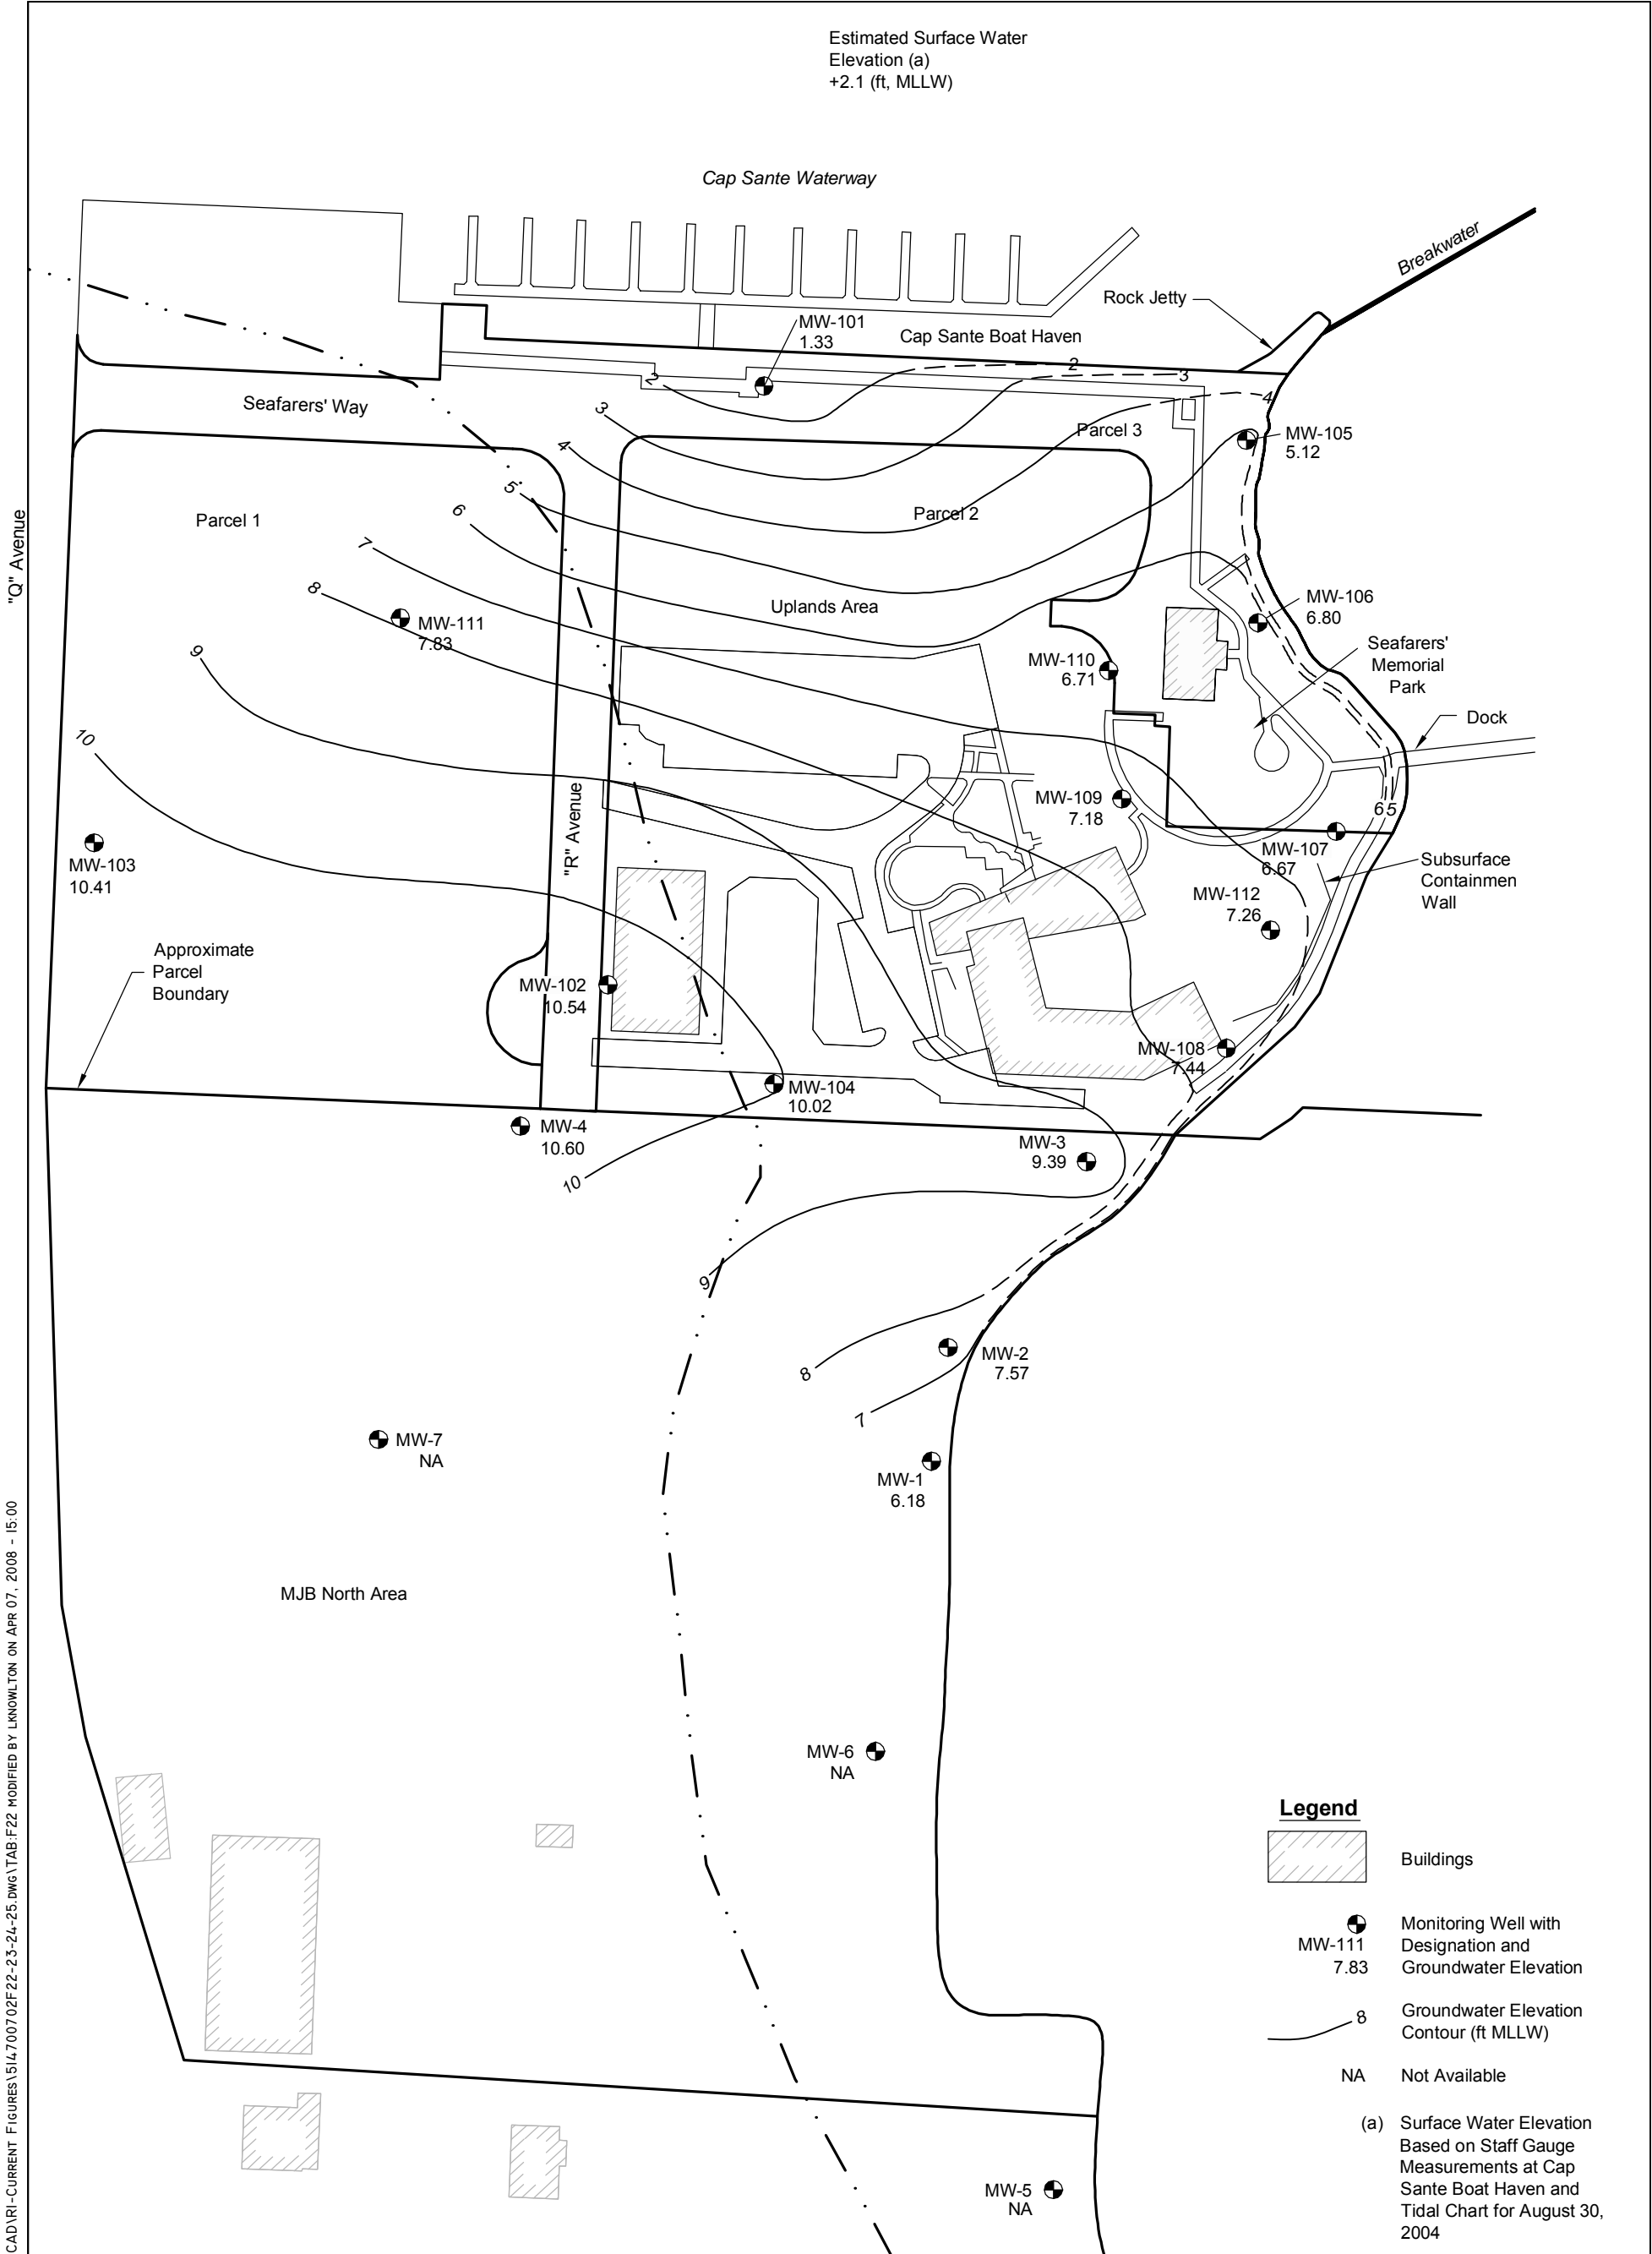
<b>Groundwater Elevation Contours August 2004</b>	
Scott Paper Mill Anacortes, Washington	
<b>GEOENGINEERS</b>	<b>Figure 22</b>

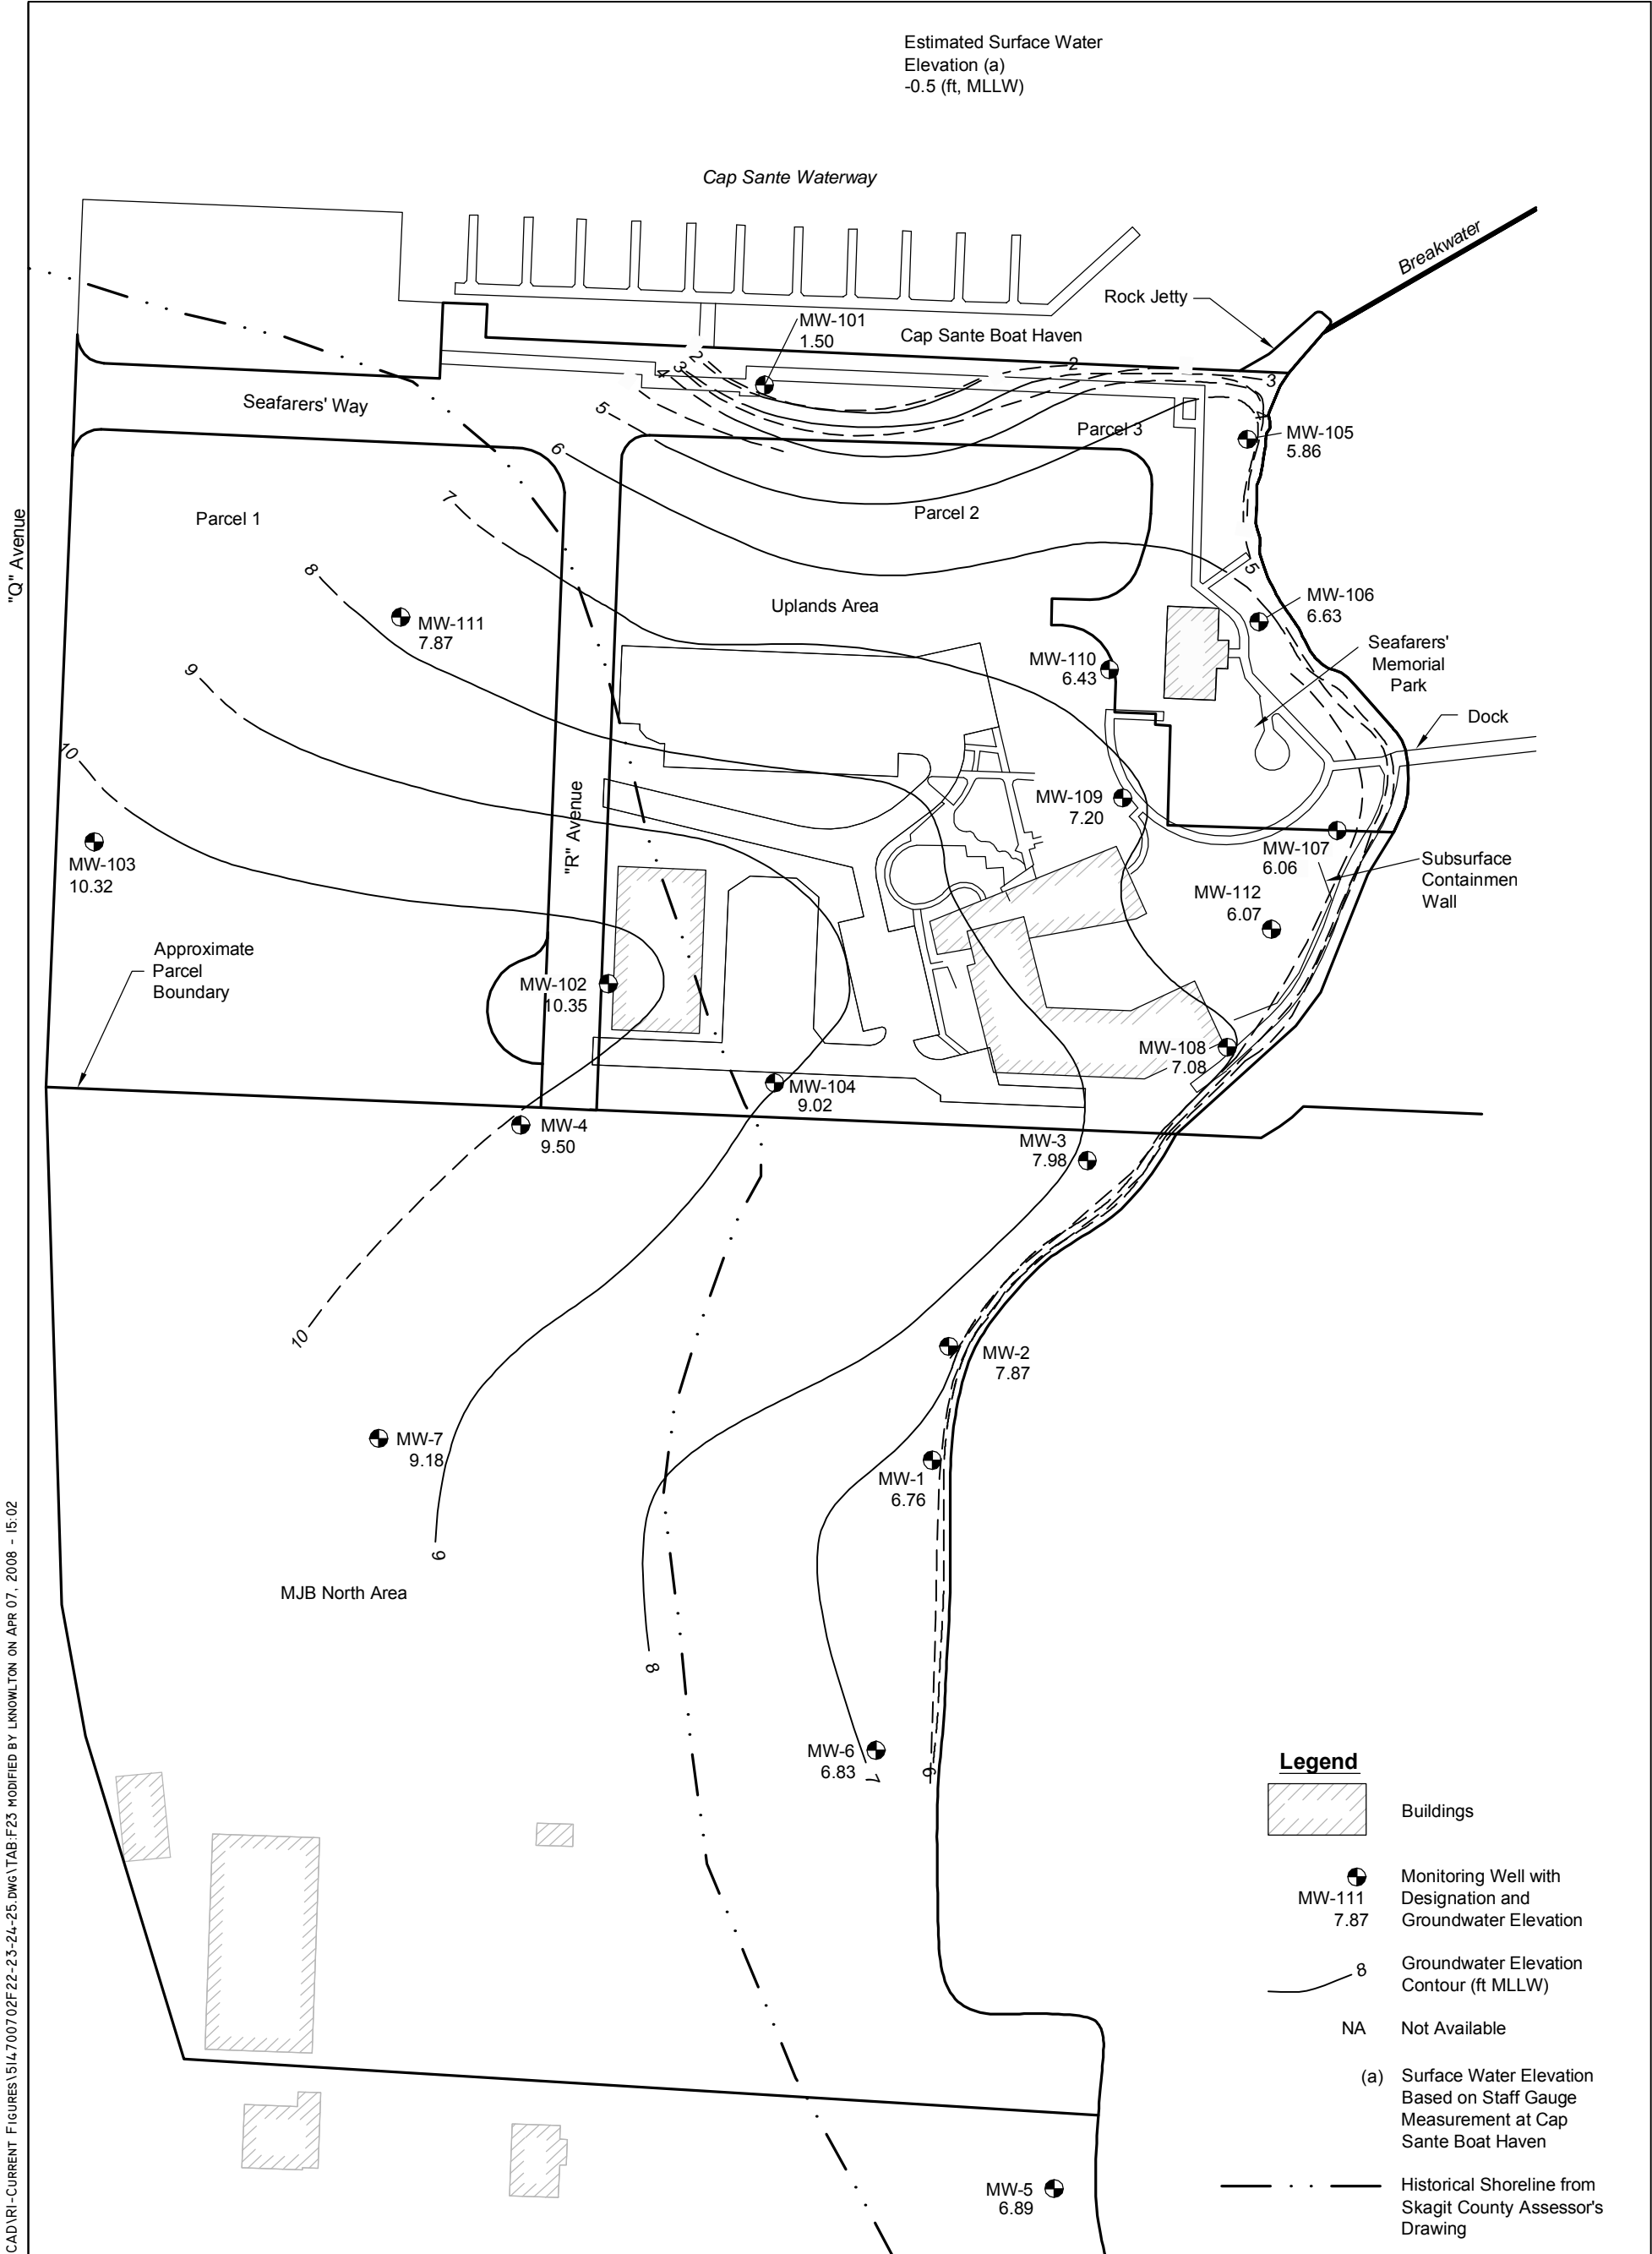
<b>Figure 23</b>

<b>Groundwater Elevation Contours July 2005</b>	
Scott Paper Mill Anacortes, Washington	
<b>GEOENGINEERS</b>
