Scott Paper Mill  
Anacortes, Washington

**Soil Explorations - Port Parcel 3 Uplands Area RI and Previous Investigations**

<b>Cross Section A-A'</b>	
Scott Paper Mill Anacortes, Washington	
<b>GEOENGINEERS</b>	<b>Figure 9</b>

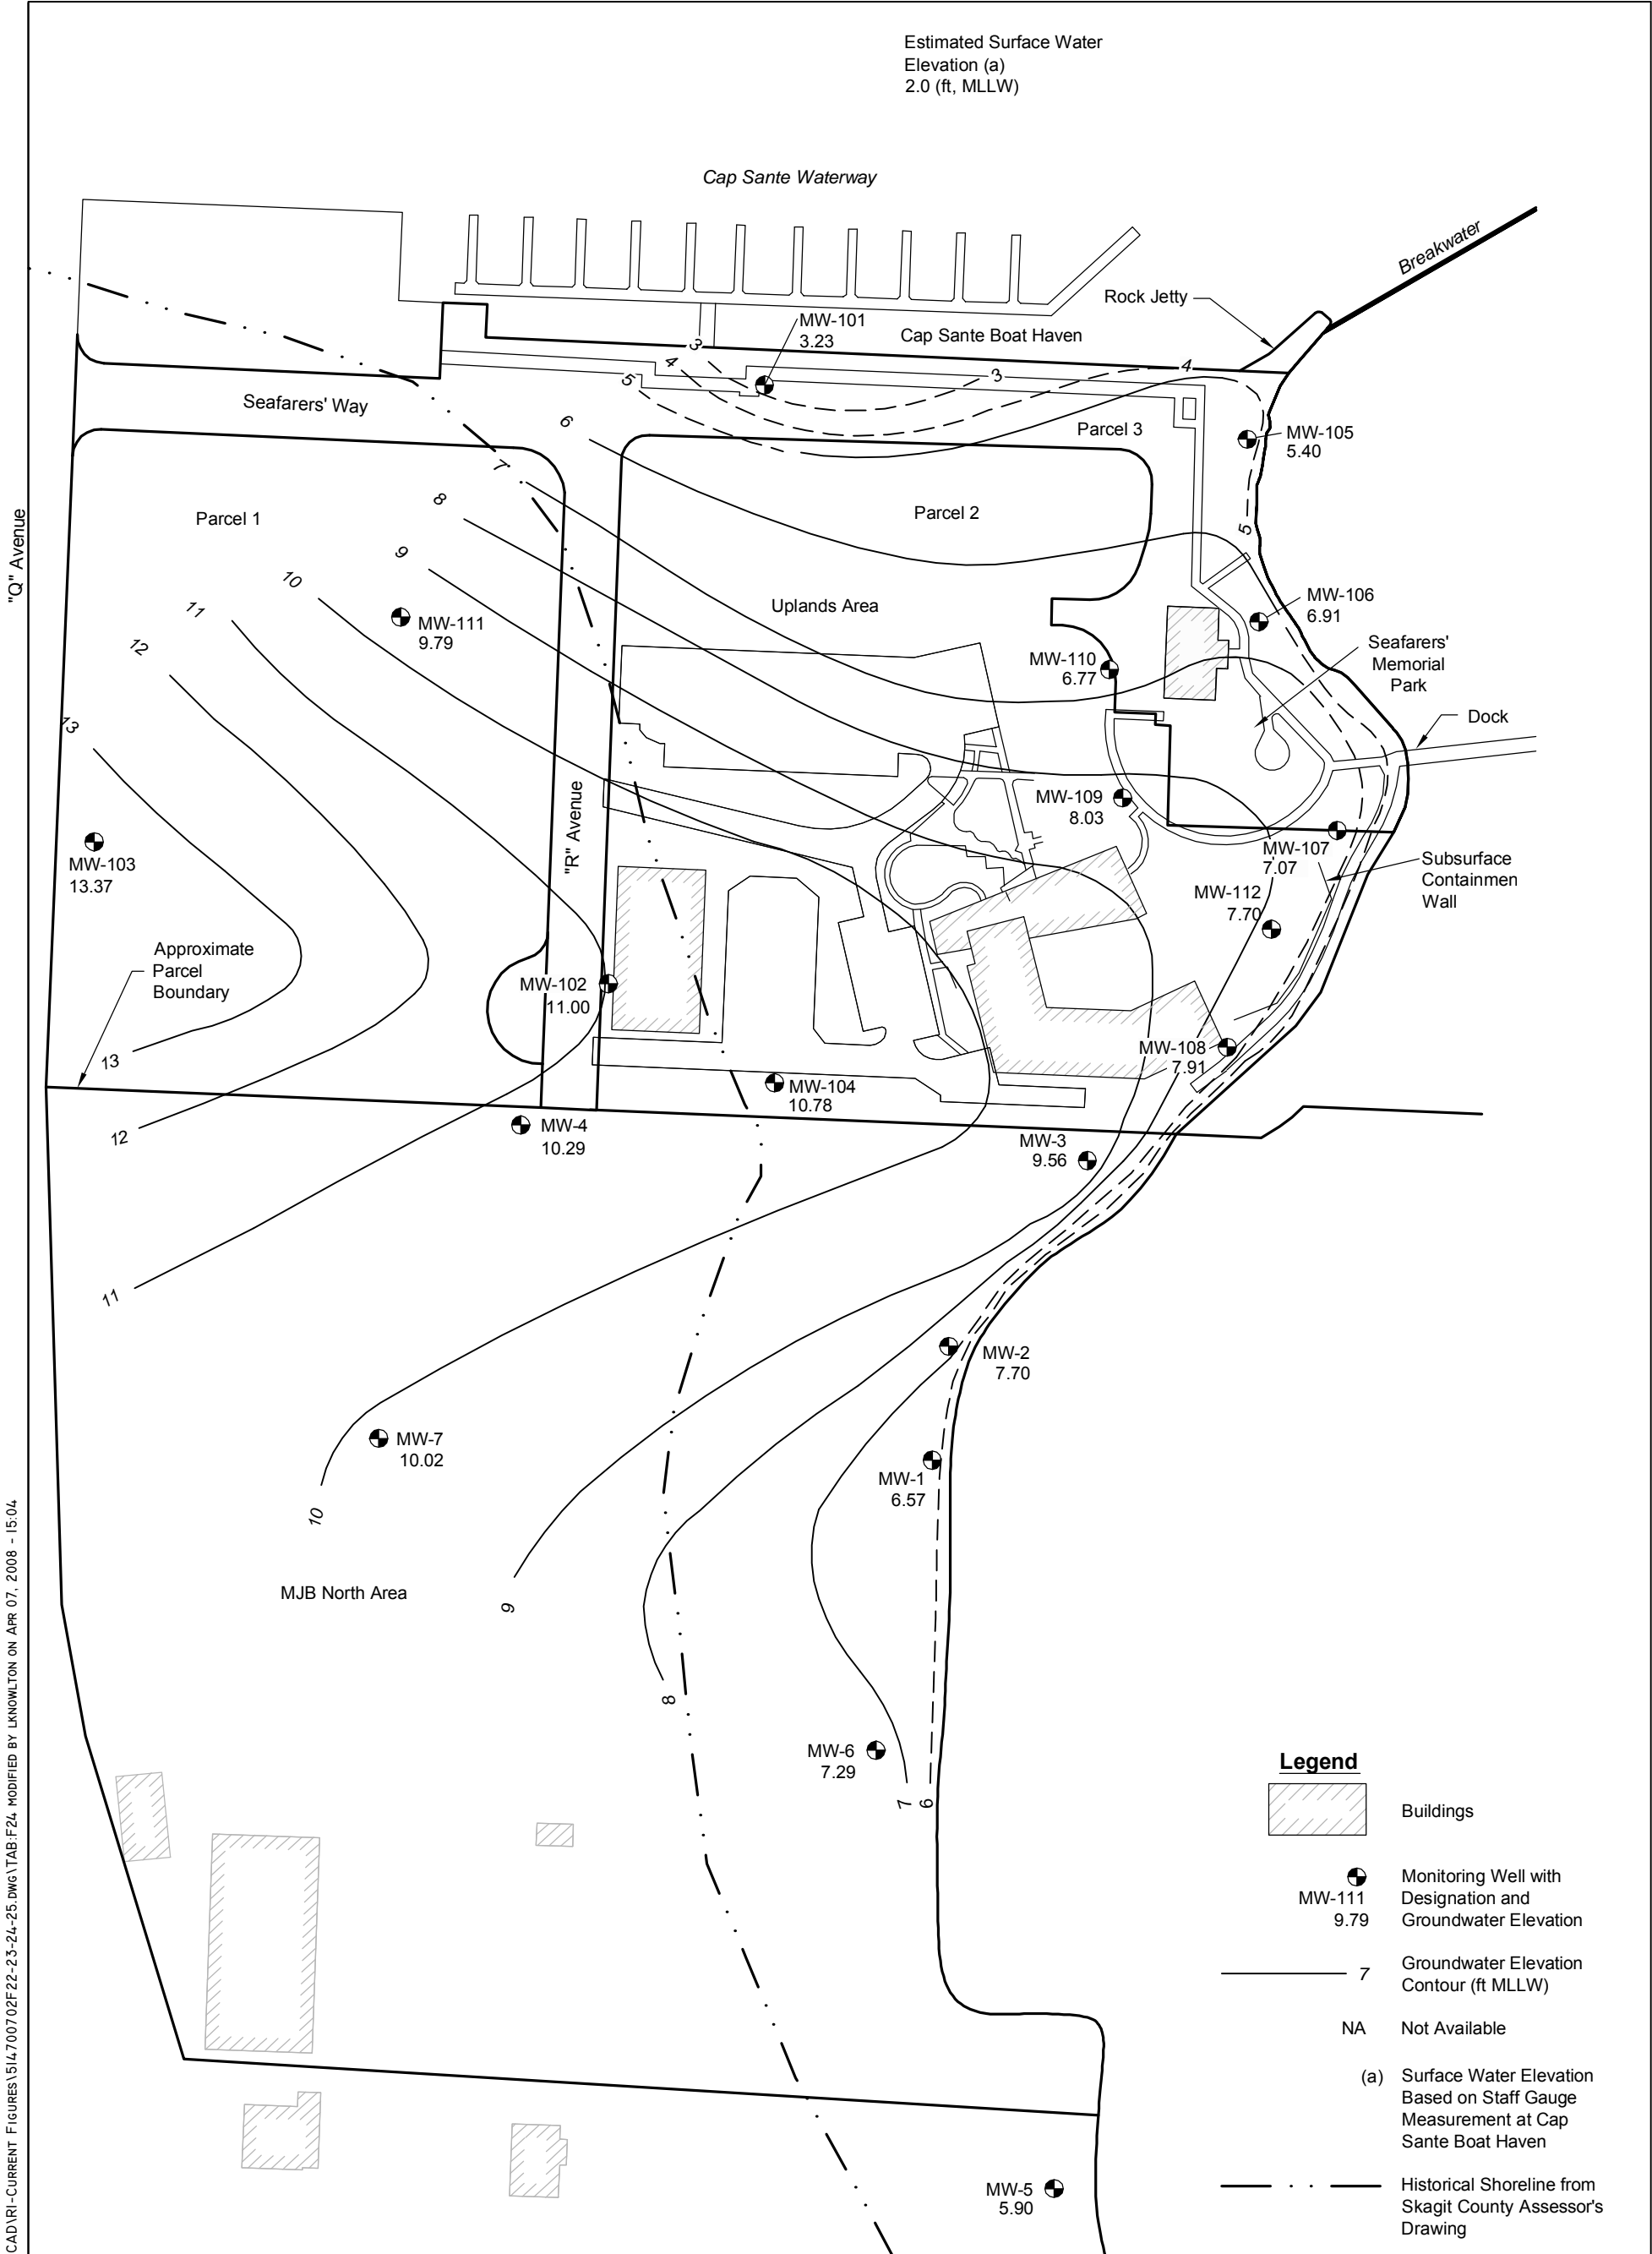
<b>Figure 24</b>

<b>Groundwater Elevation Contours January 2006</b>	
Scott Paper Mill Anacortes, Washington	
<b>GEOENGINEERS</b>

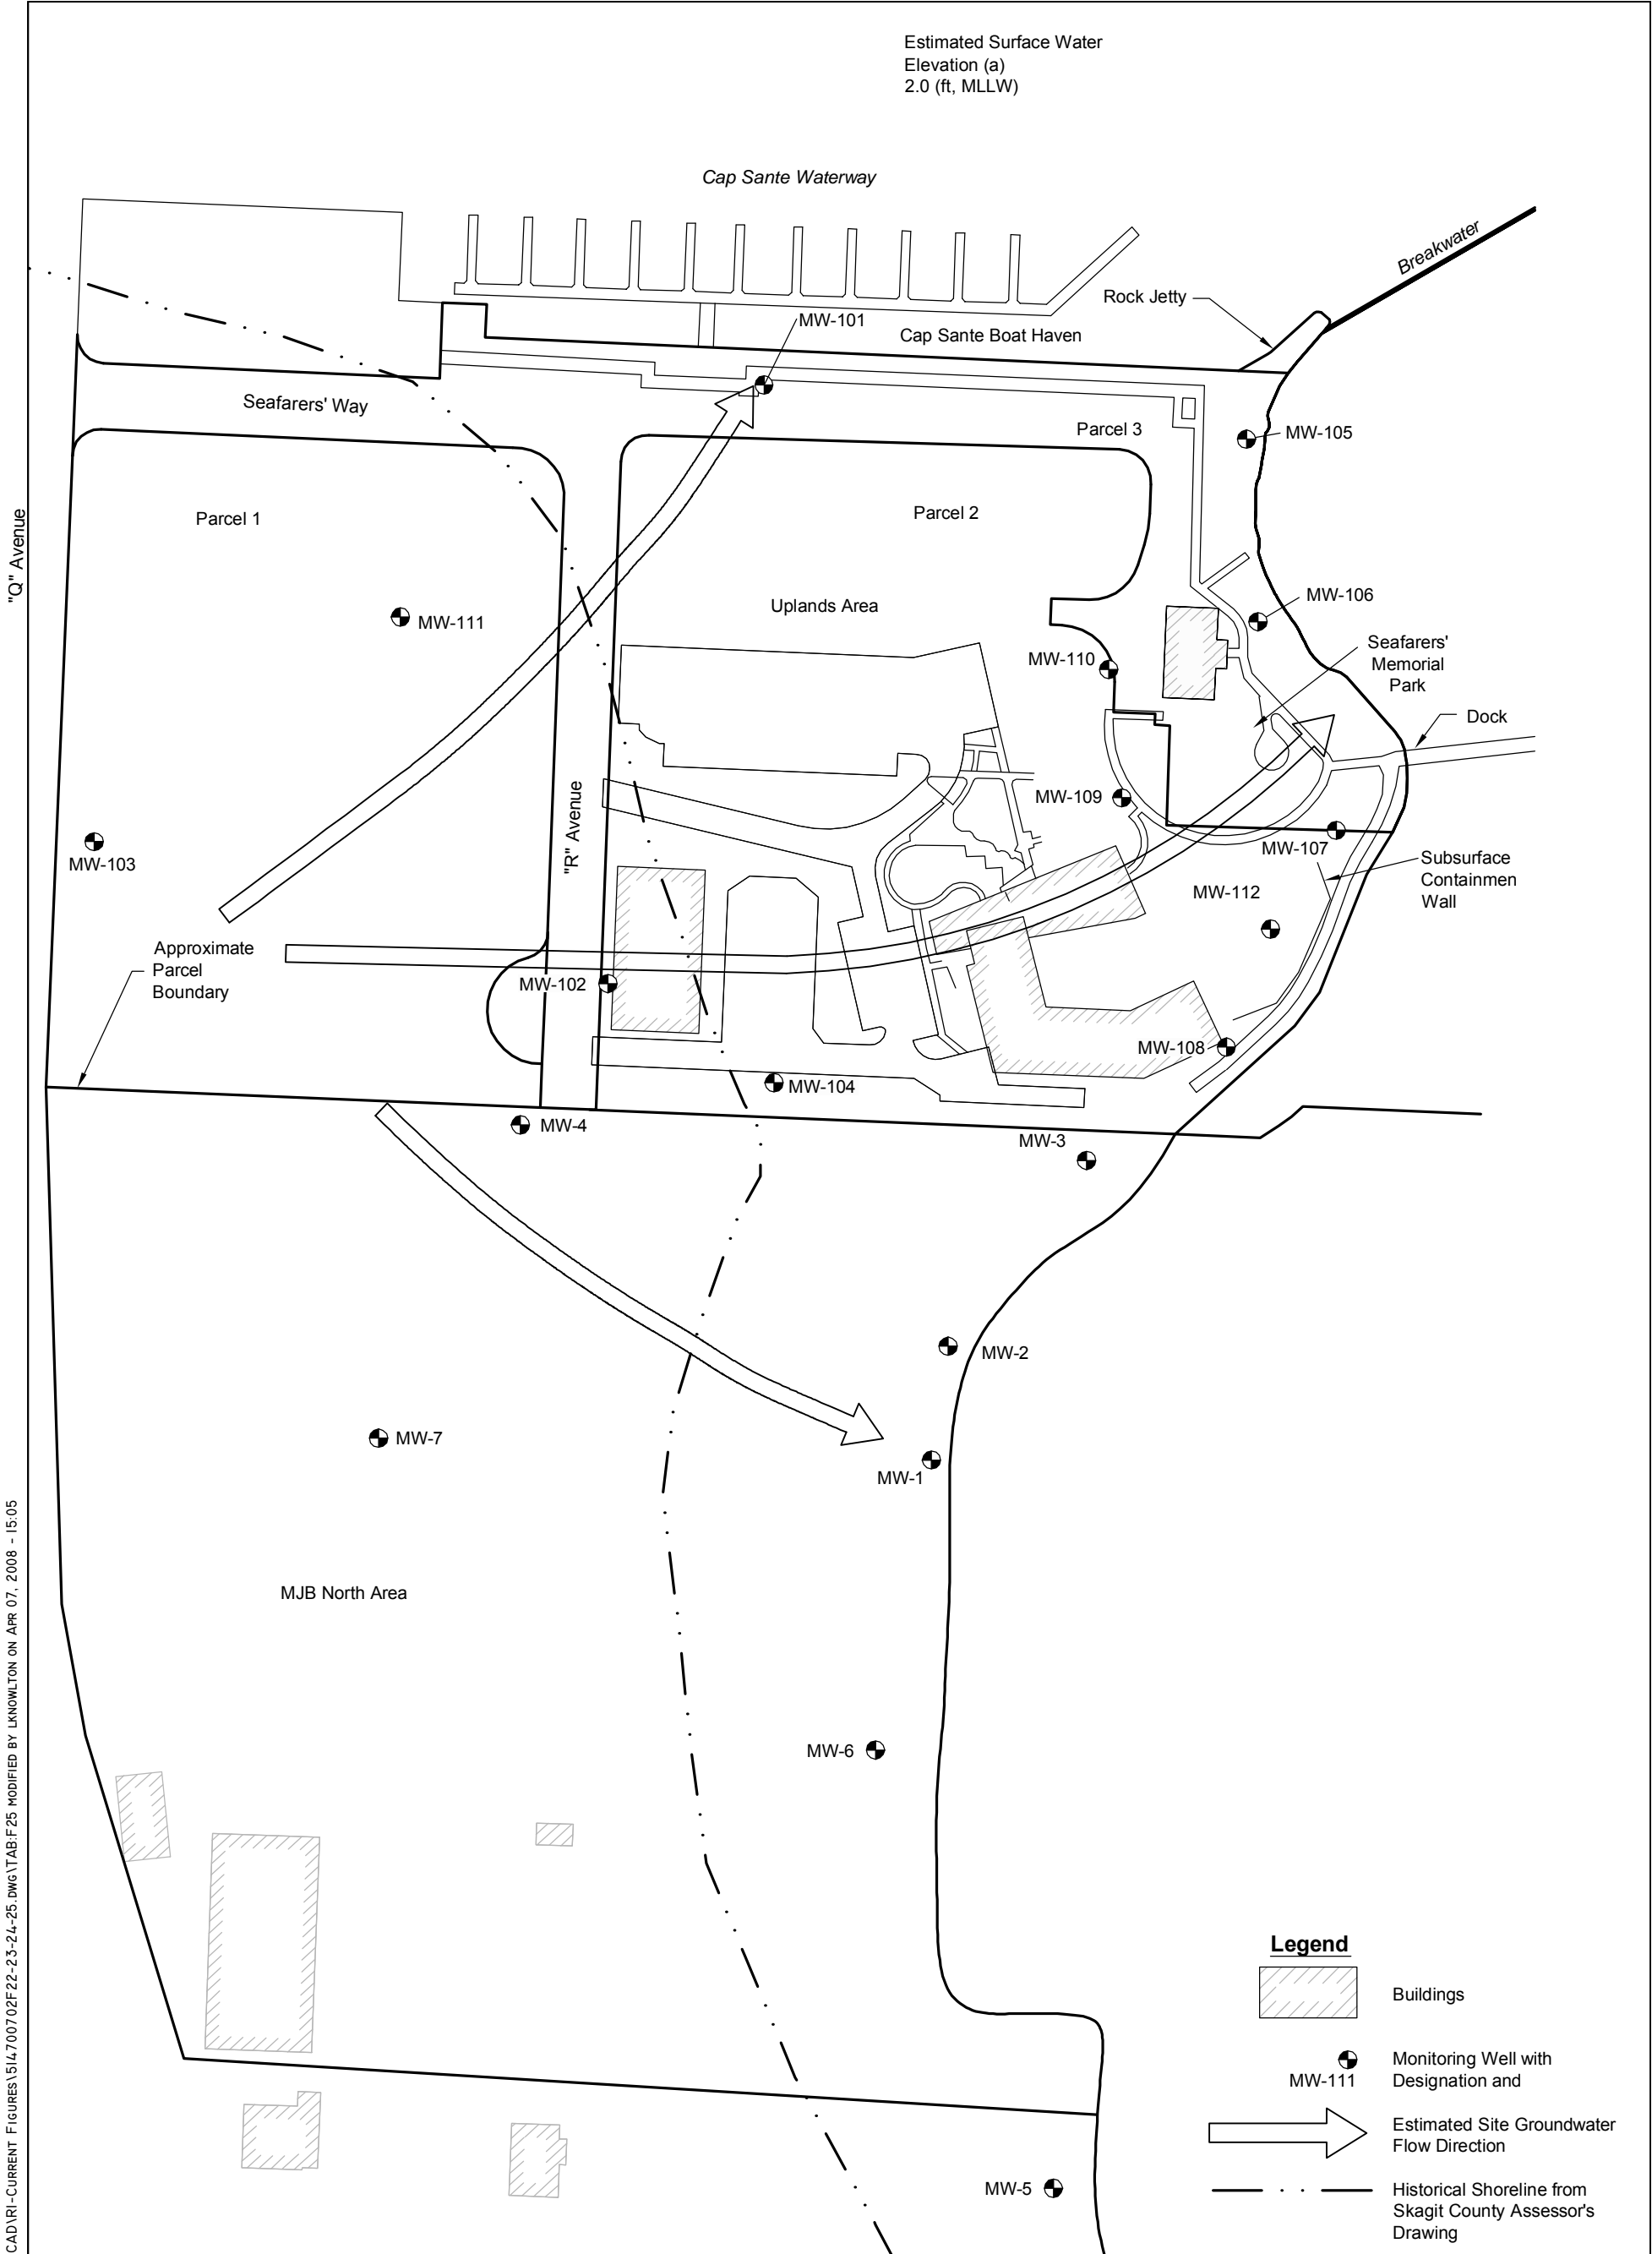
<b>Estimated Groundwater Flow Direction</b>	
Scott Paper Mill Anacortes, Washington	
<b>GEOENGINEERS</b>	<b>Figure 25</b>

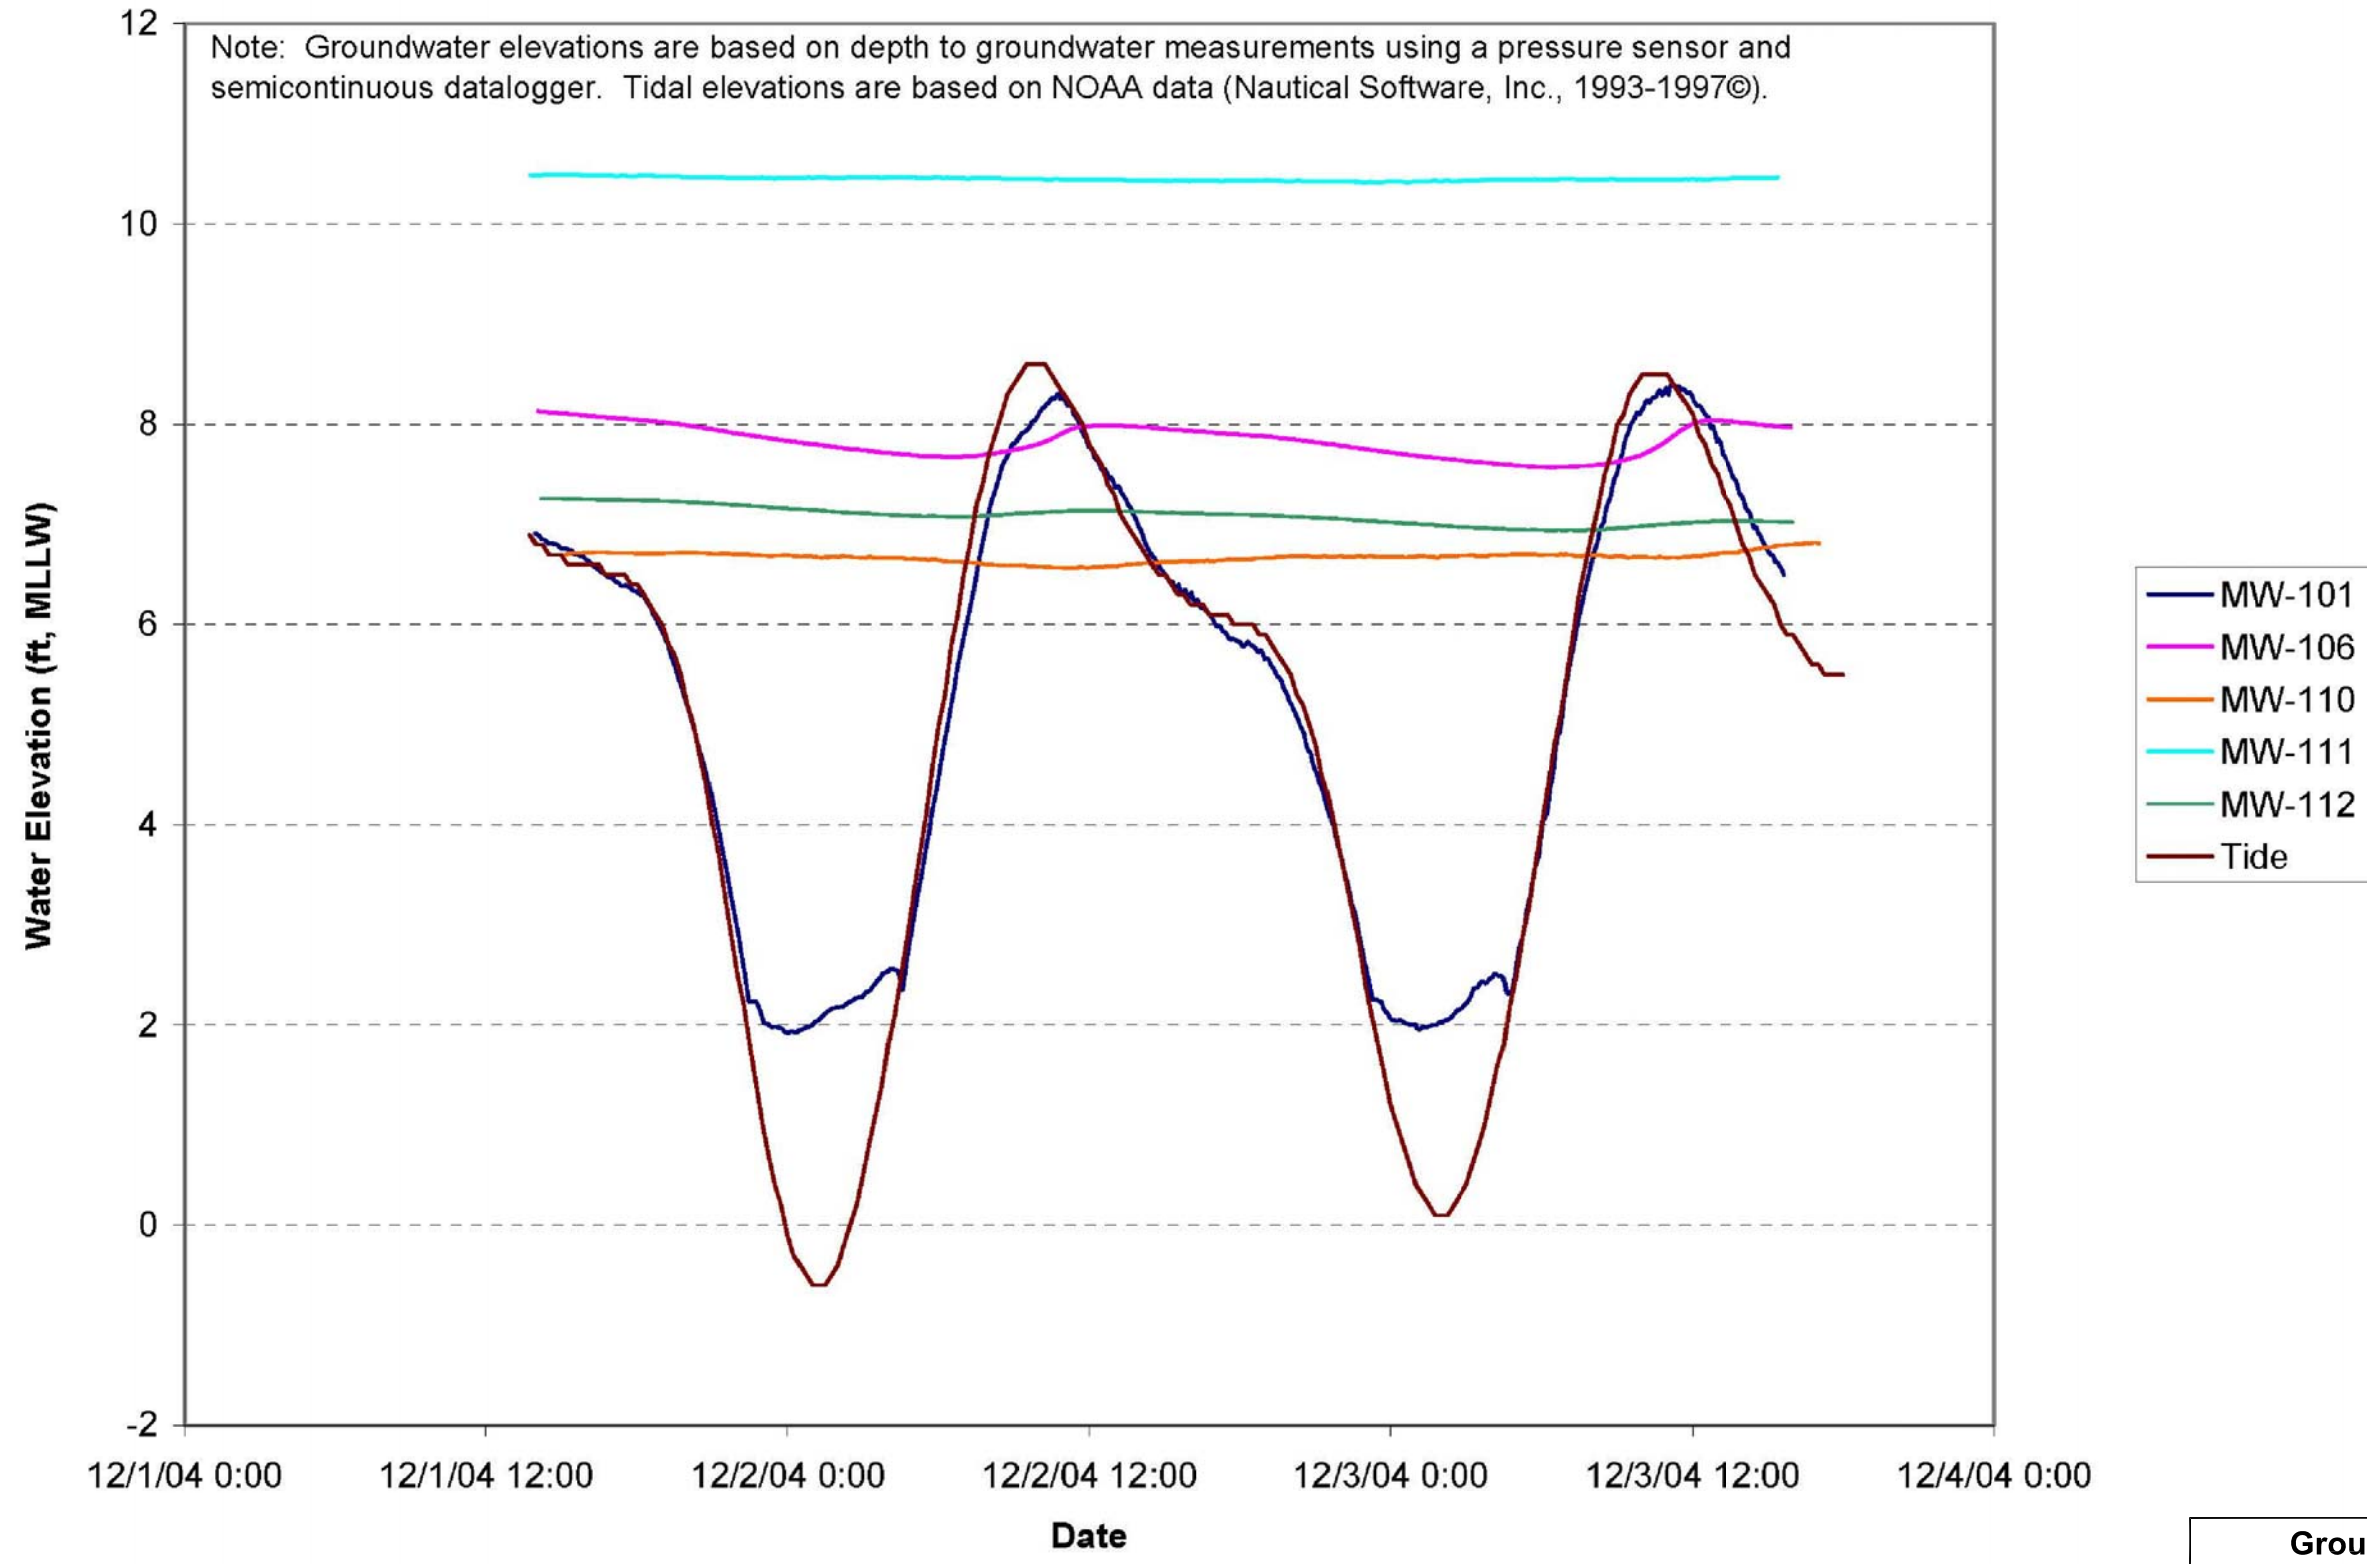
**Groundwater and Surface Water Elevations vs. Time**  
Scott Paper Mill  
Anacortes, Washington  
**GEOENGINEERS**  
Figure 27

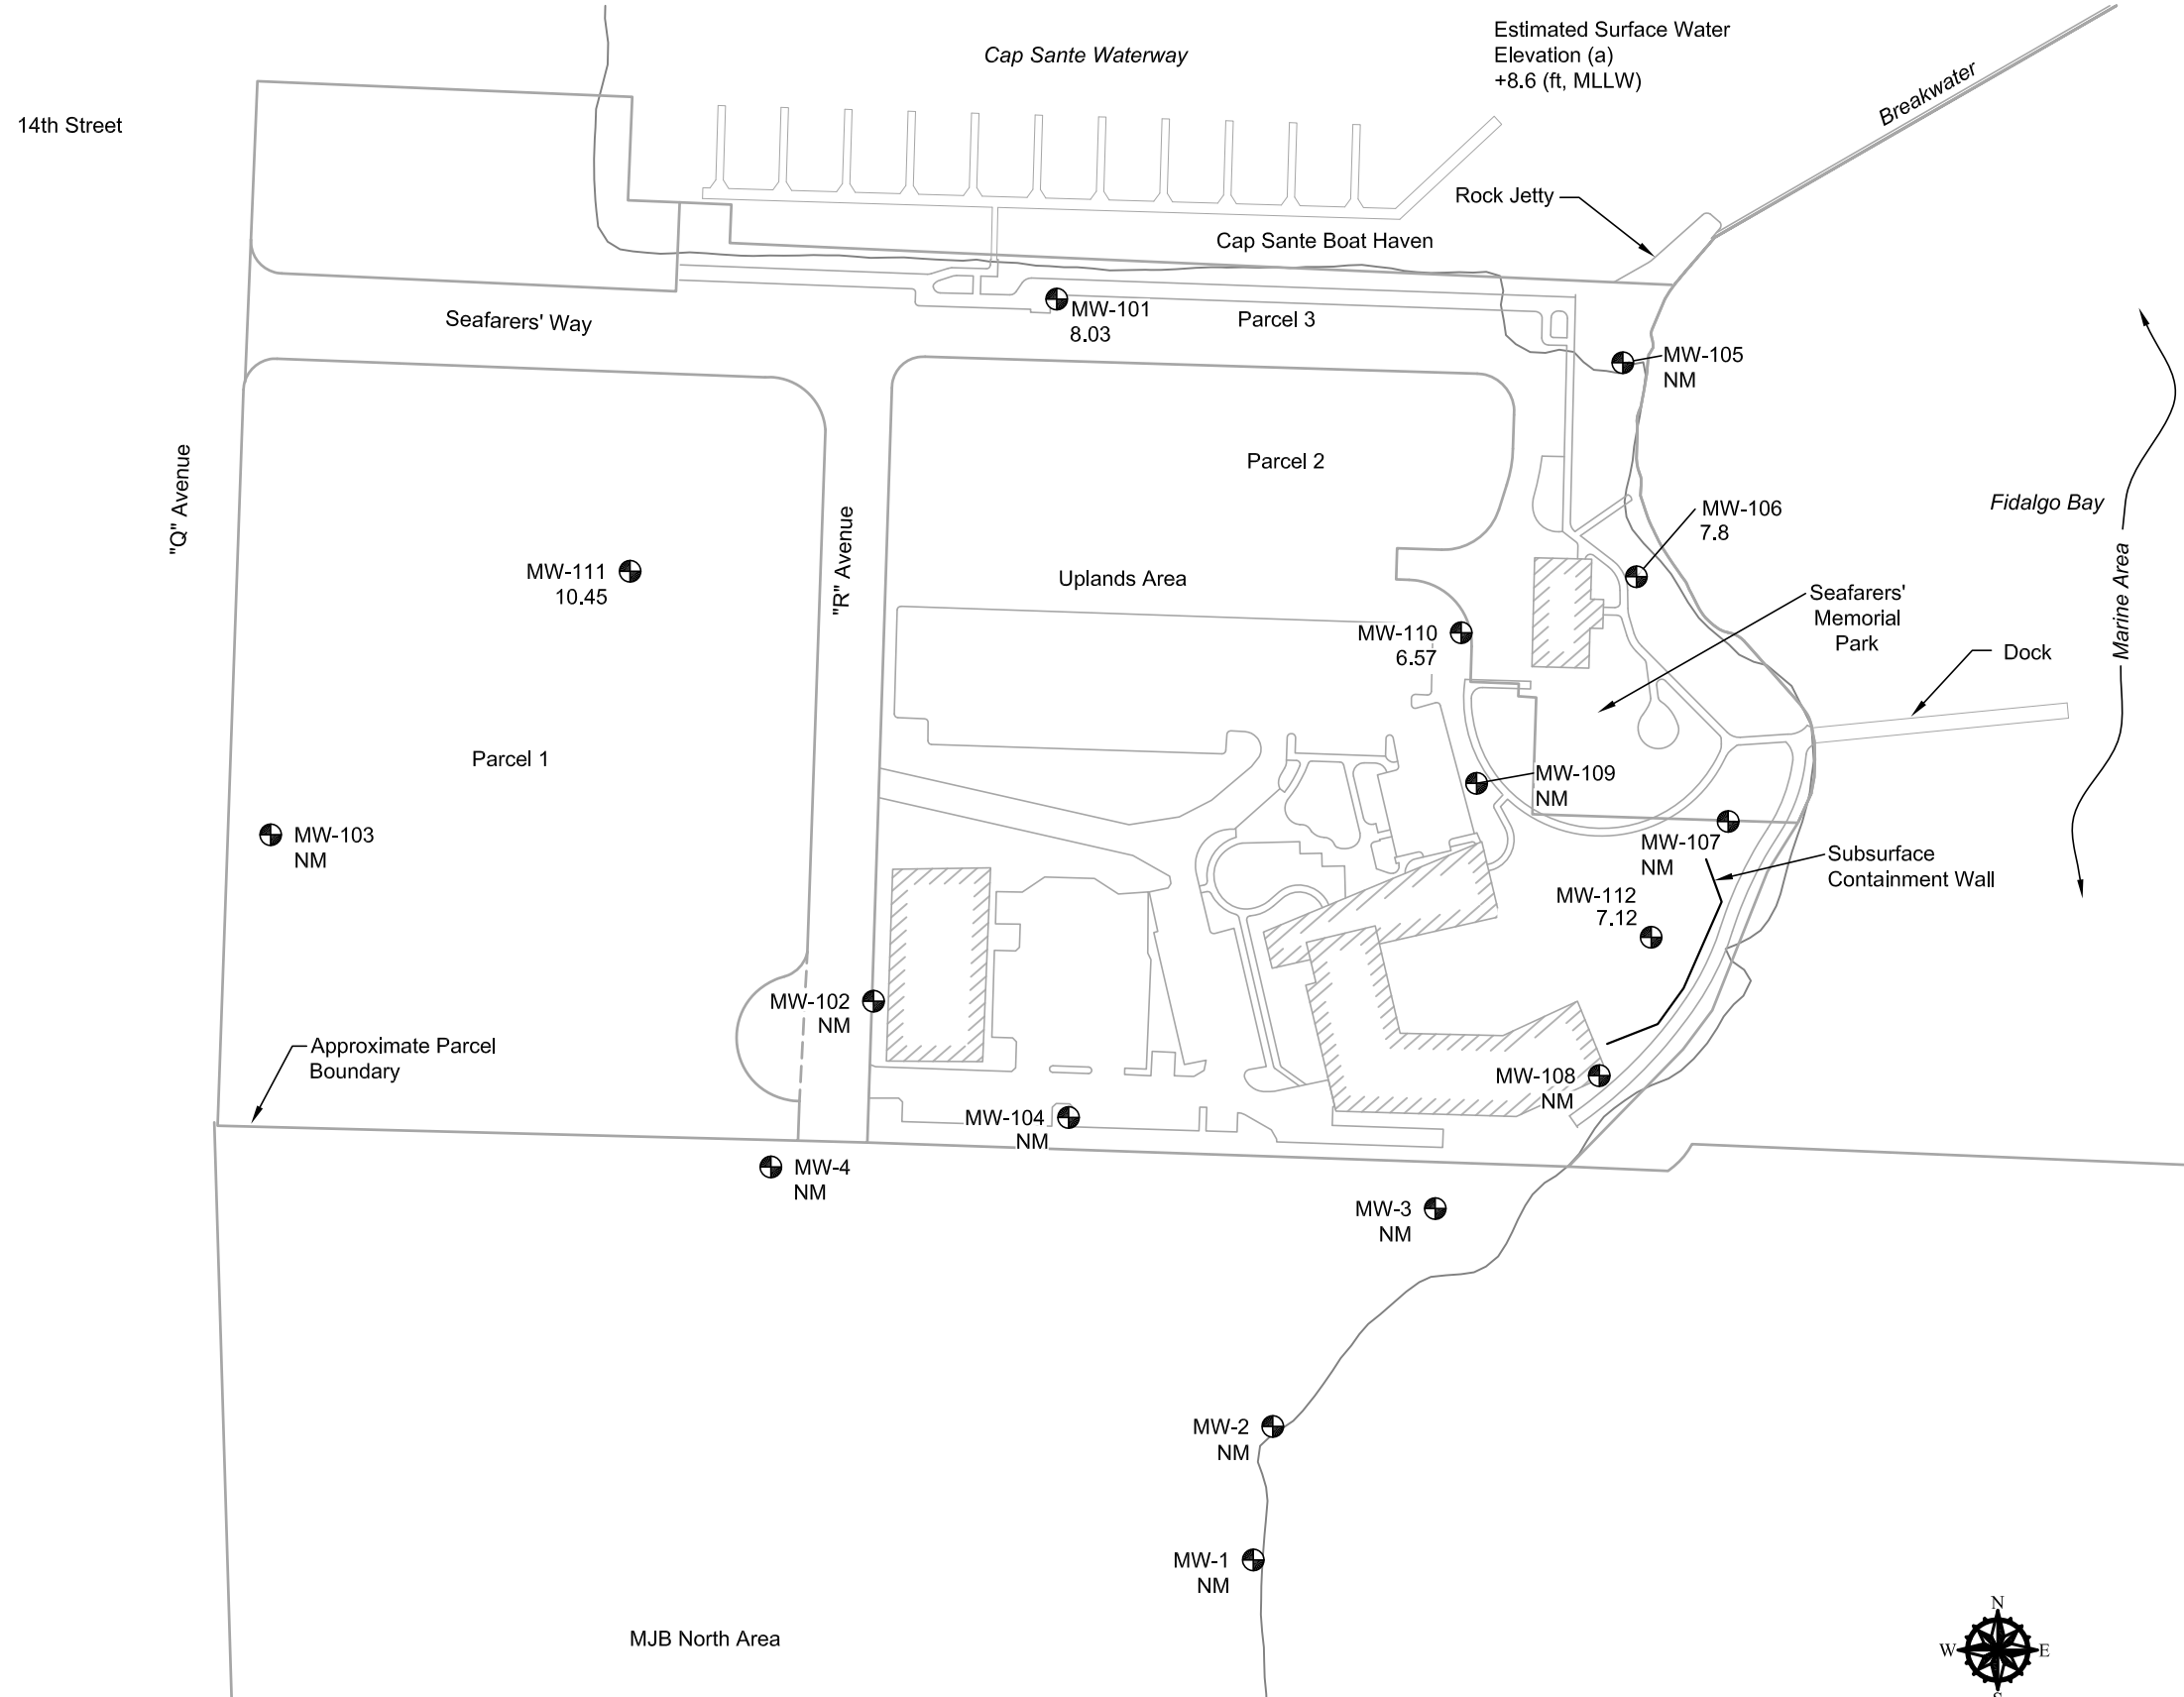
<b>Figure 30</b>

<b>Groundwater Elevations at High Tide December 2, 2004</b>	
Scott Paper Mill Anacortes, Washington	
<b>GEOENGINEERS</b>

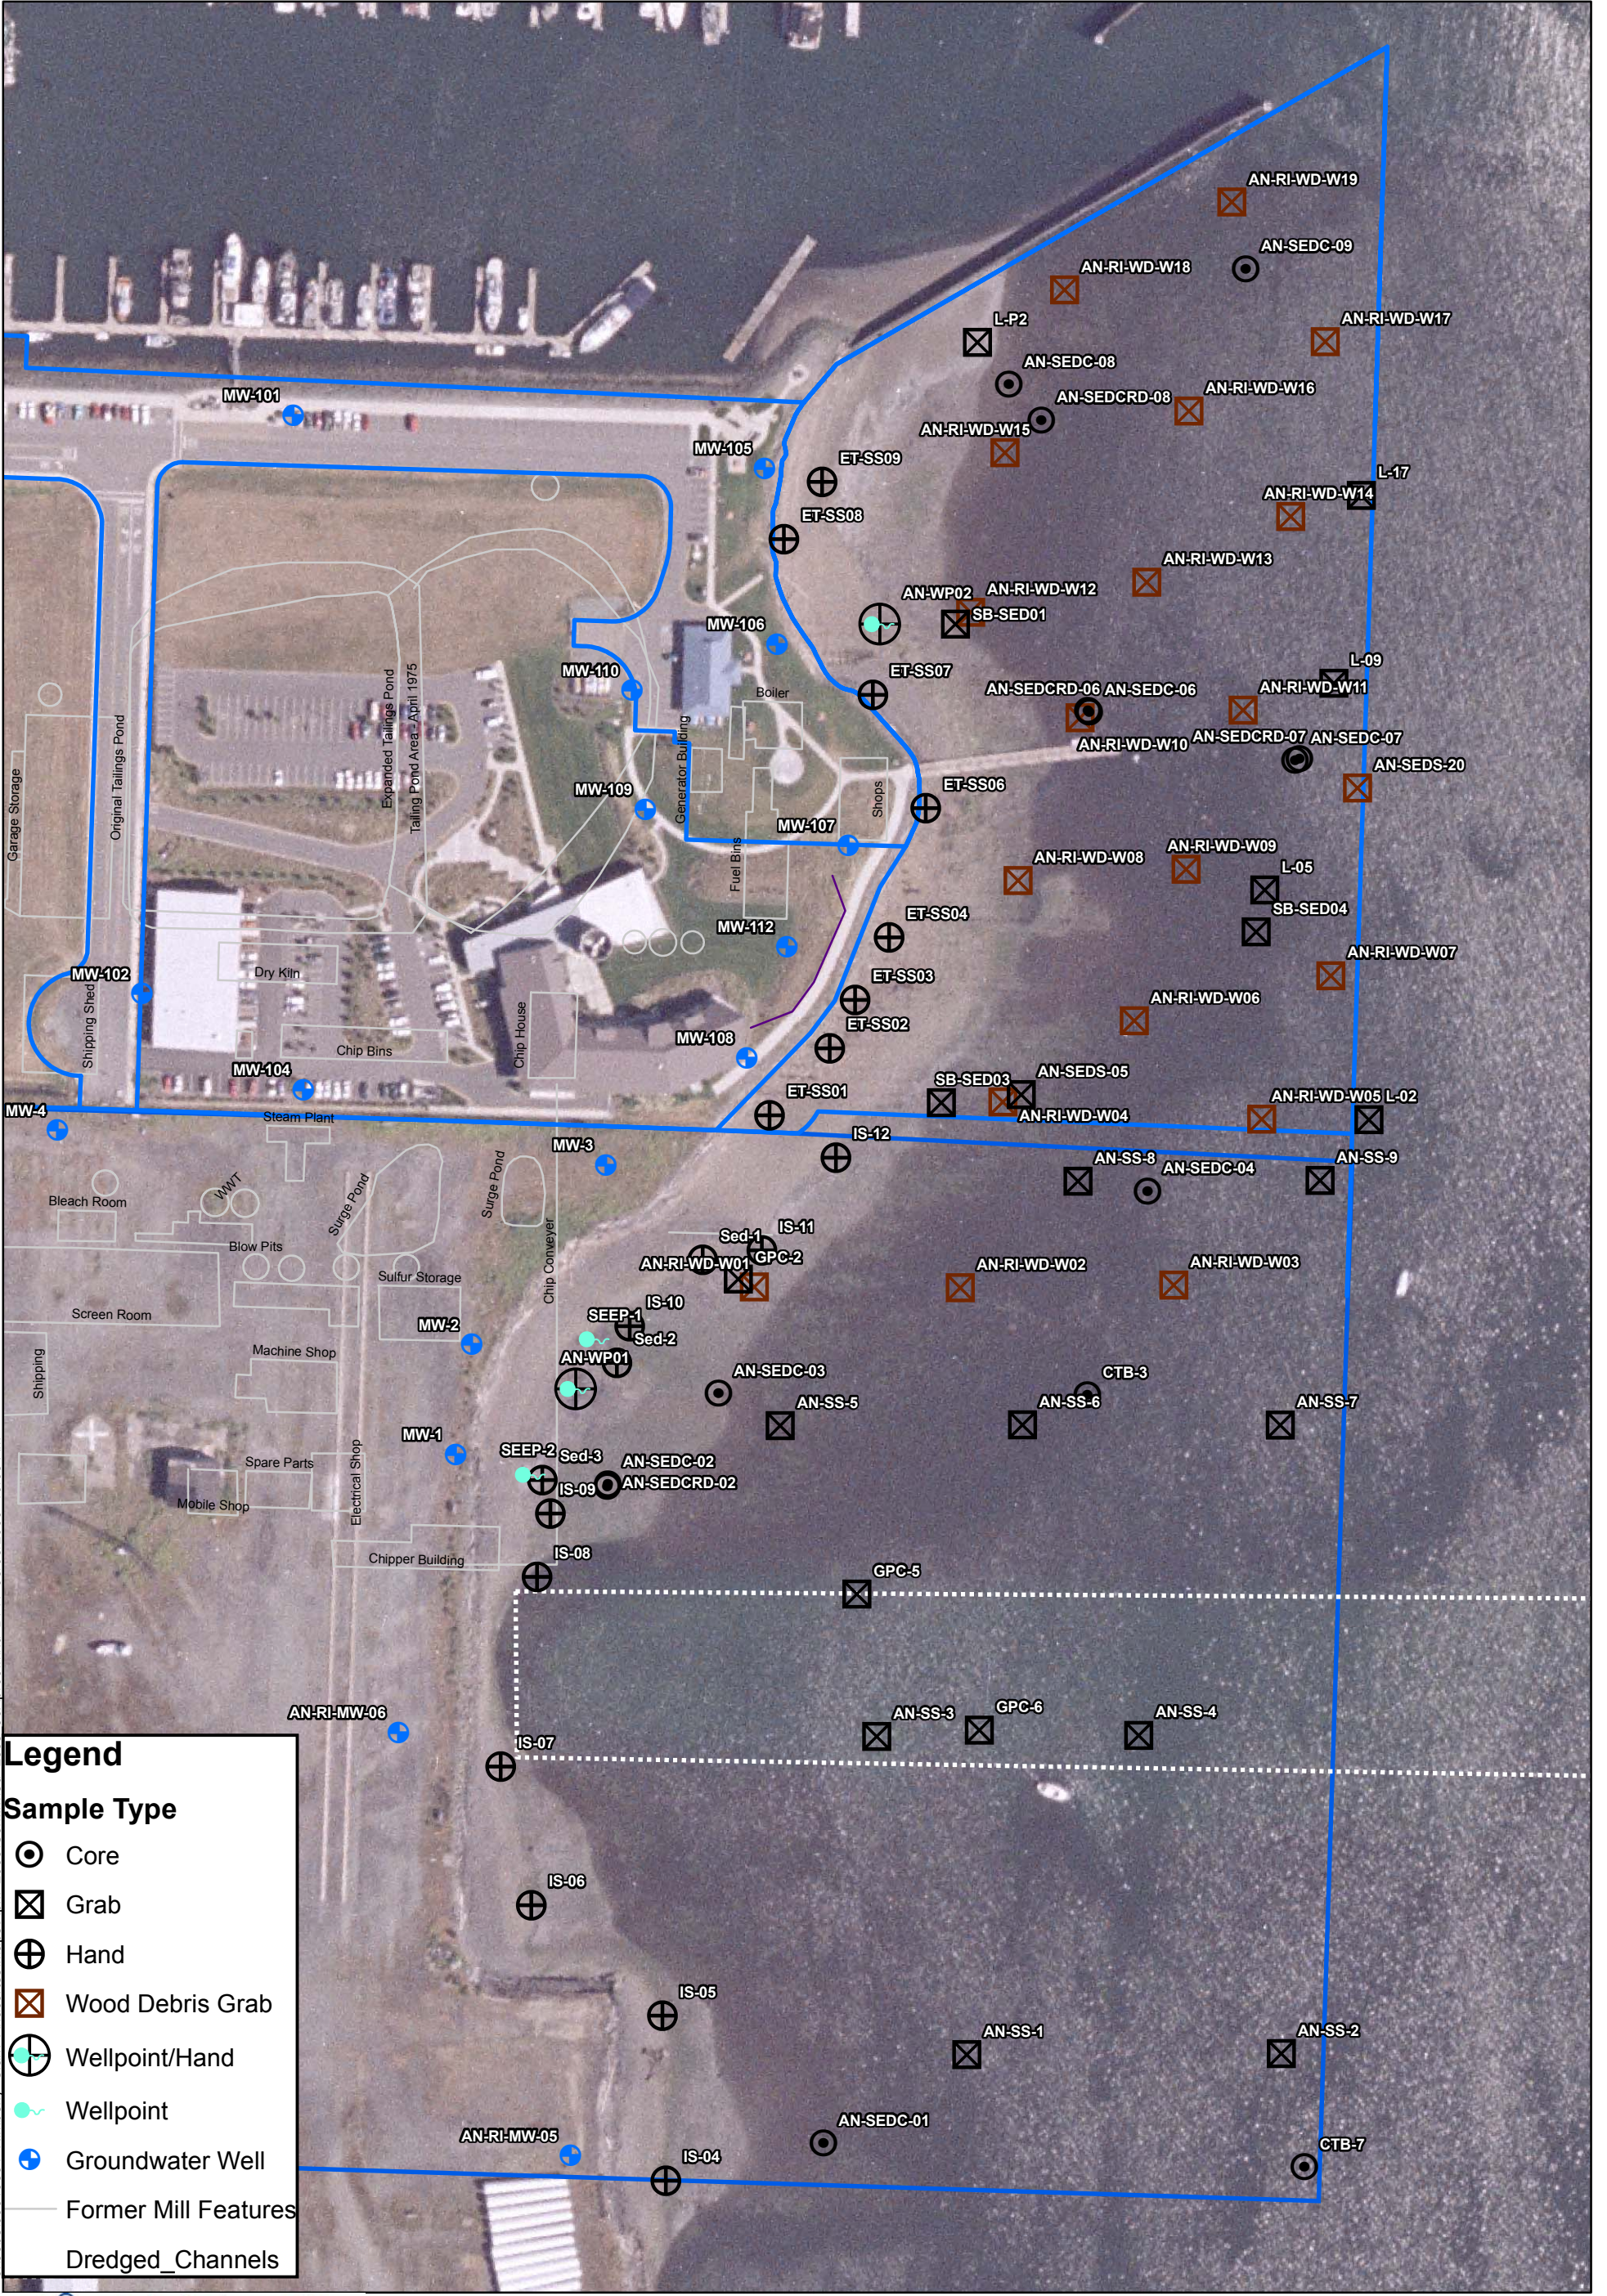
**Figure 31**  
 Historical and RI/FS Sediment and Nearshore Groundwater Samples  
 Site-Wide Marine Area  
 Former Sott Paper Mill

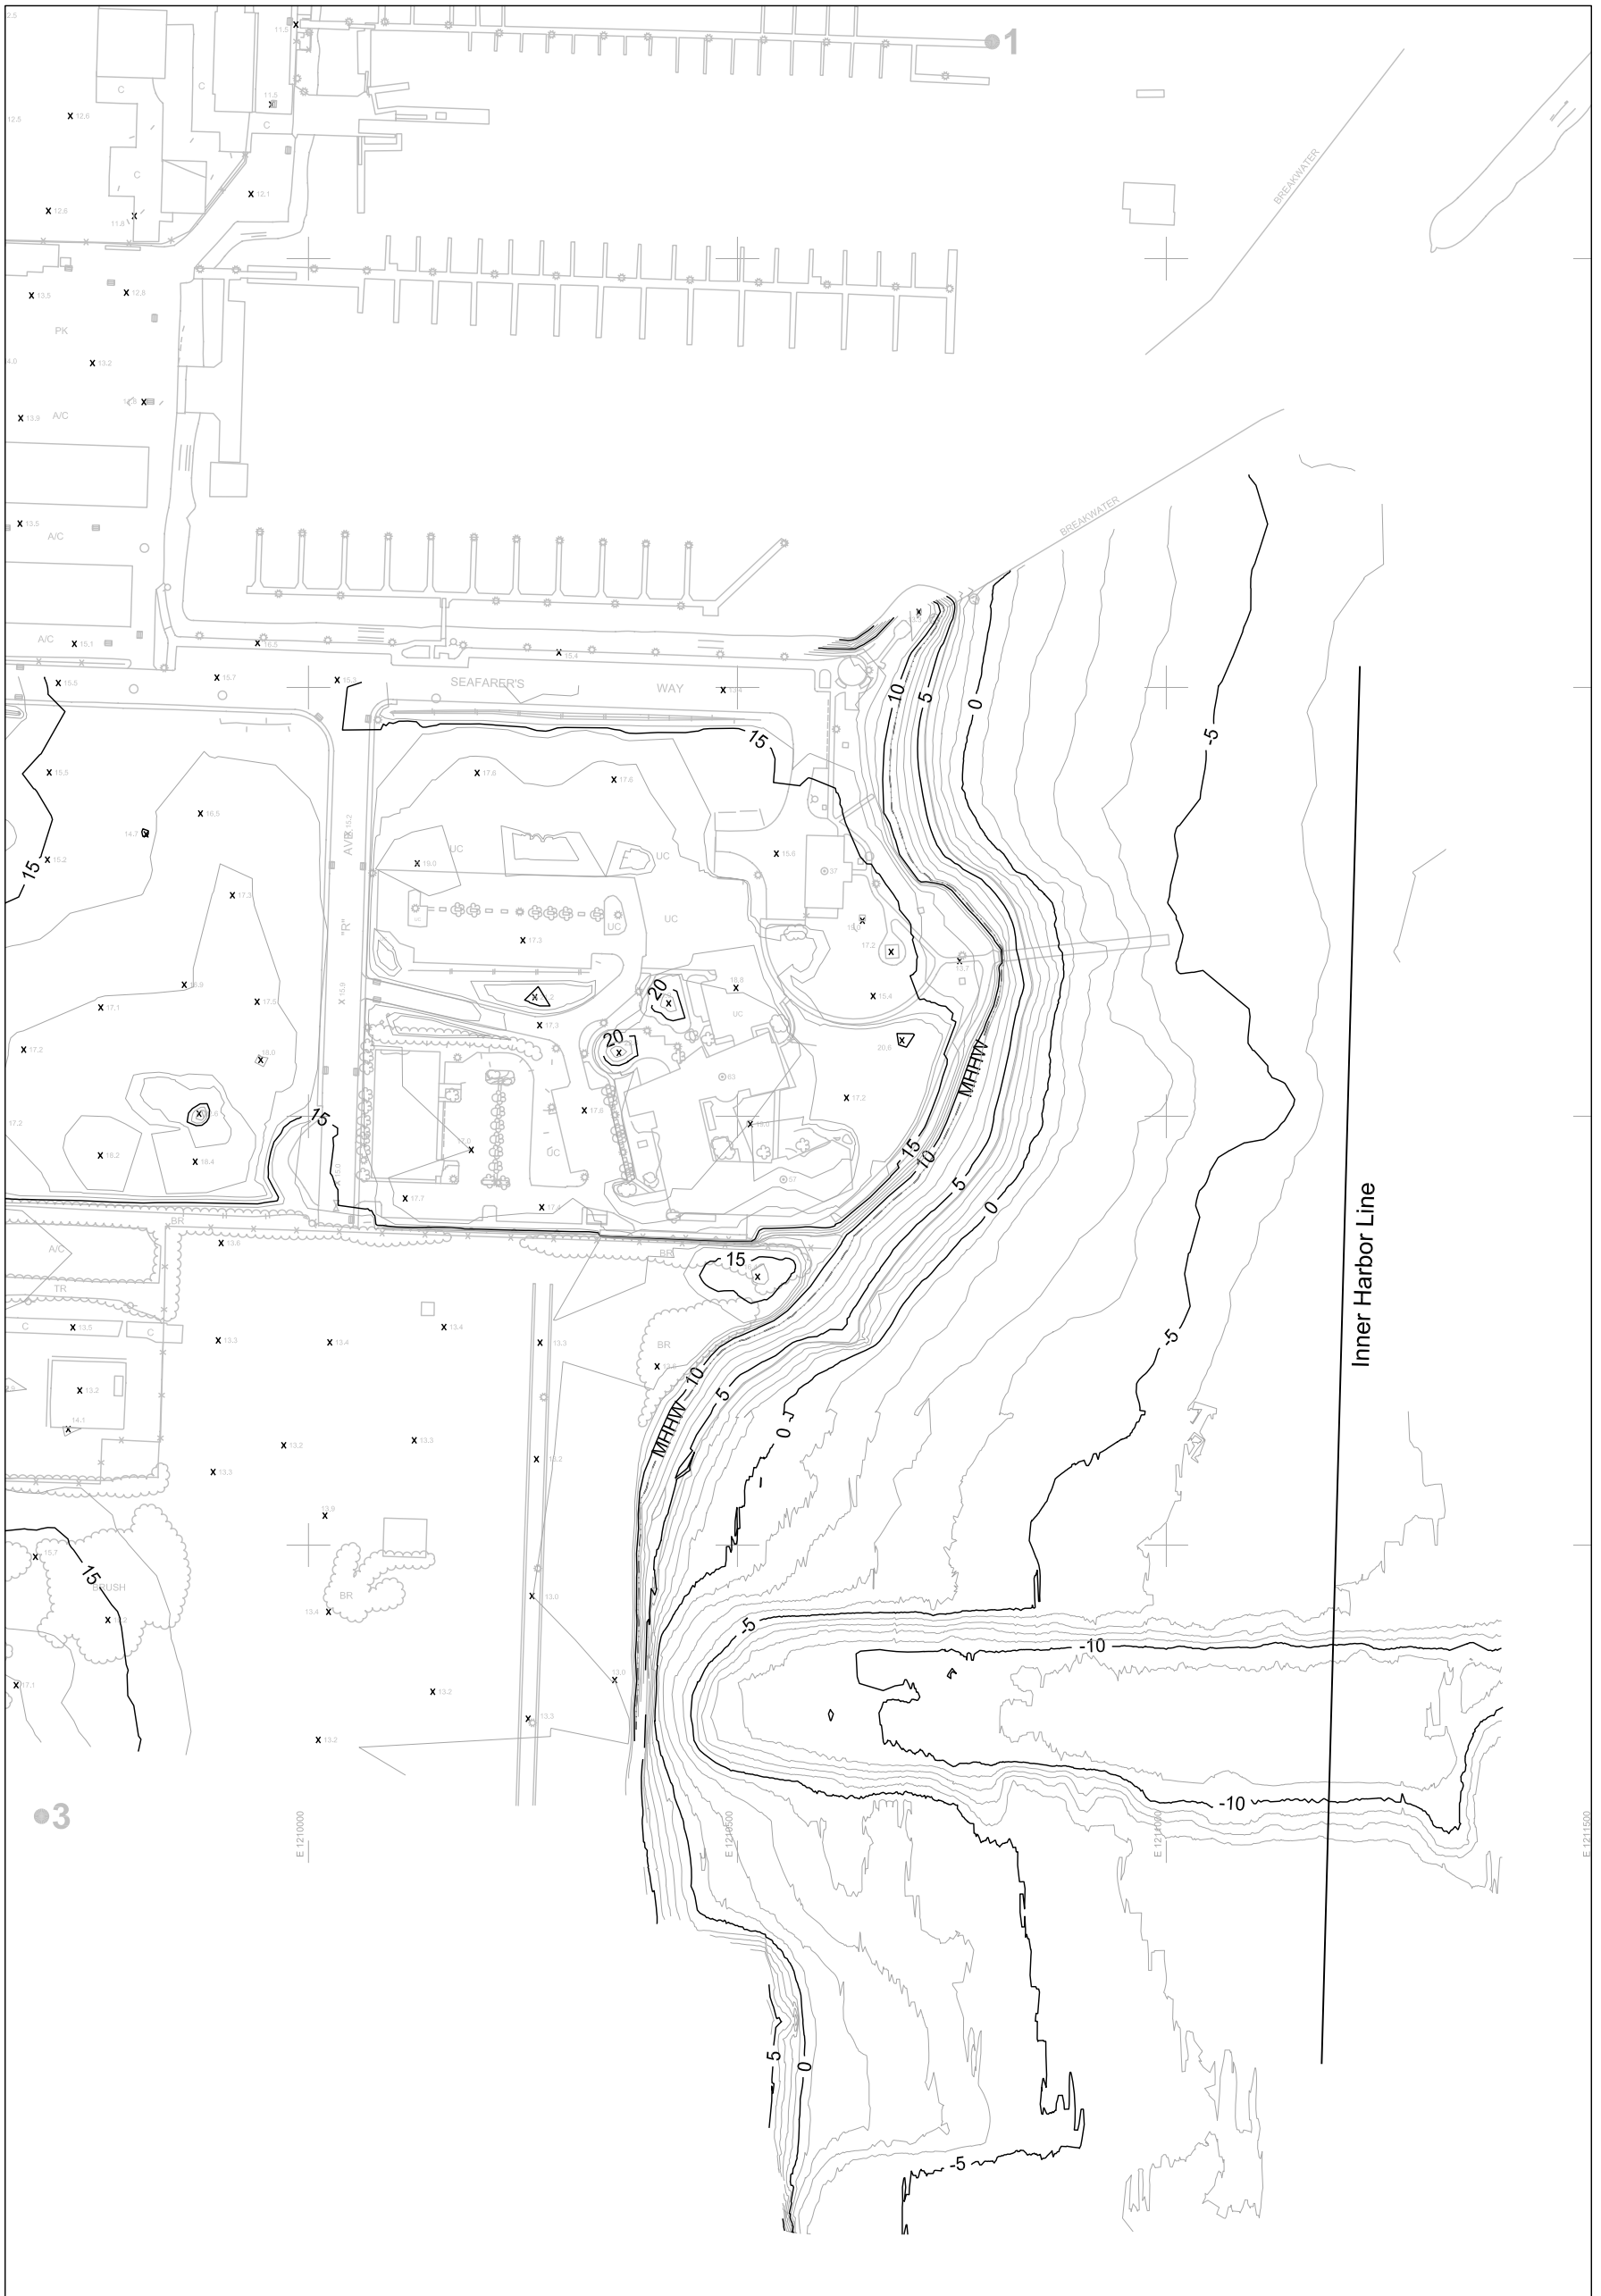
**Figure 32**  
Bathymetric Contours - Marine Area  
Former Scott Paper Mill
