Scott Paper Mill  
Anacortes, Washington

**Soil Explorations - Port Parcel 3 Uplands Area RI and Previous Investigations**

<b>Cross Section A-A'</b>	
Scott Paper Mill Anacortes, Washington	
<b>GEOENGINEERS</b>	<b>Figure 9</b>

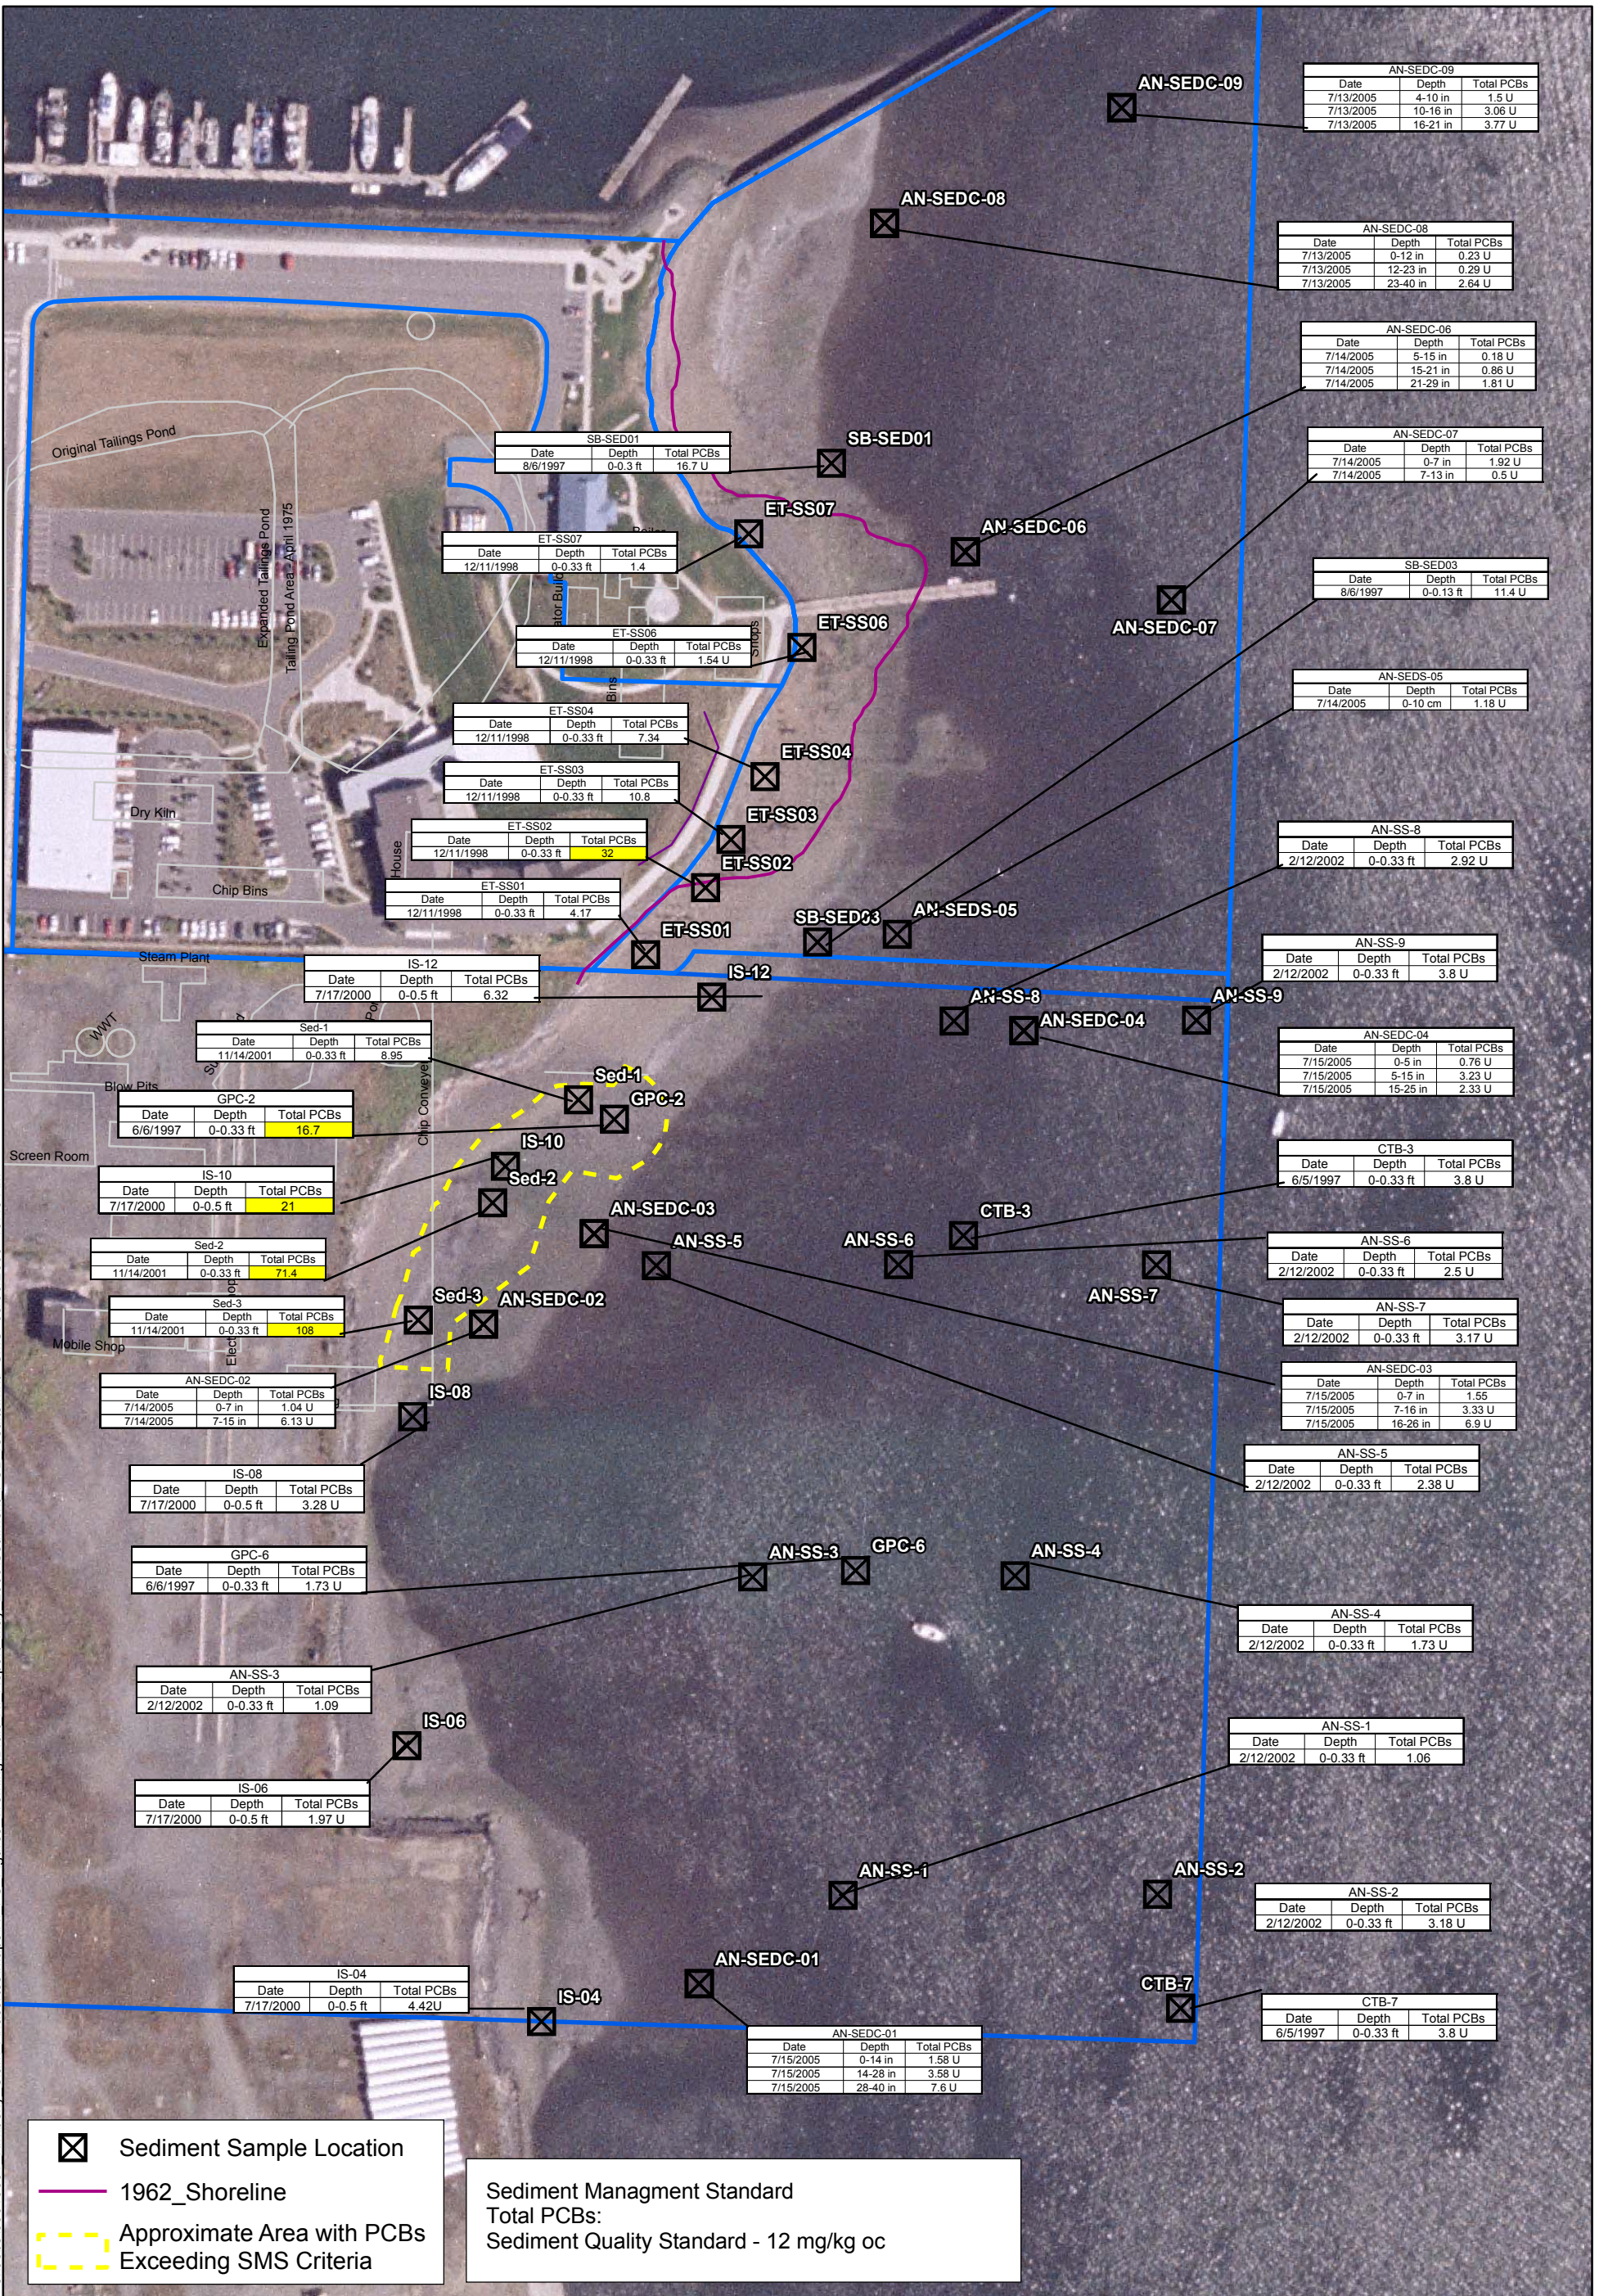
**Figure 35**  
Summary of Total PCB Concentrations in Sediment  
Marine Area  
Former Scott Paper Mill

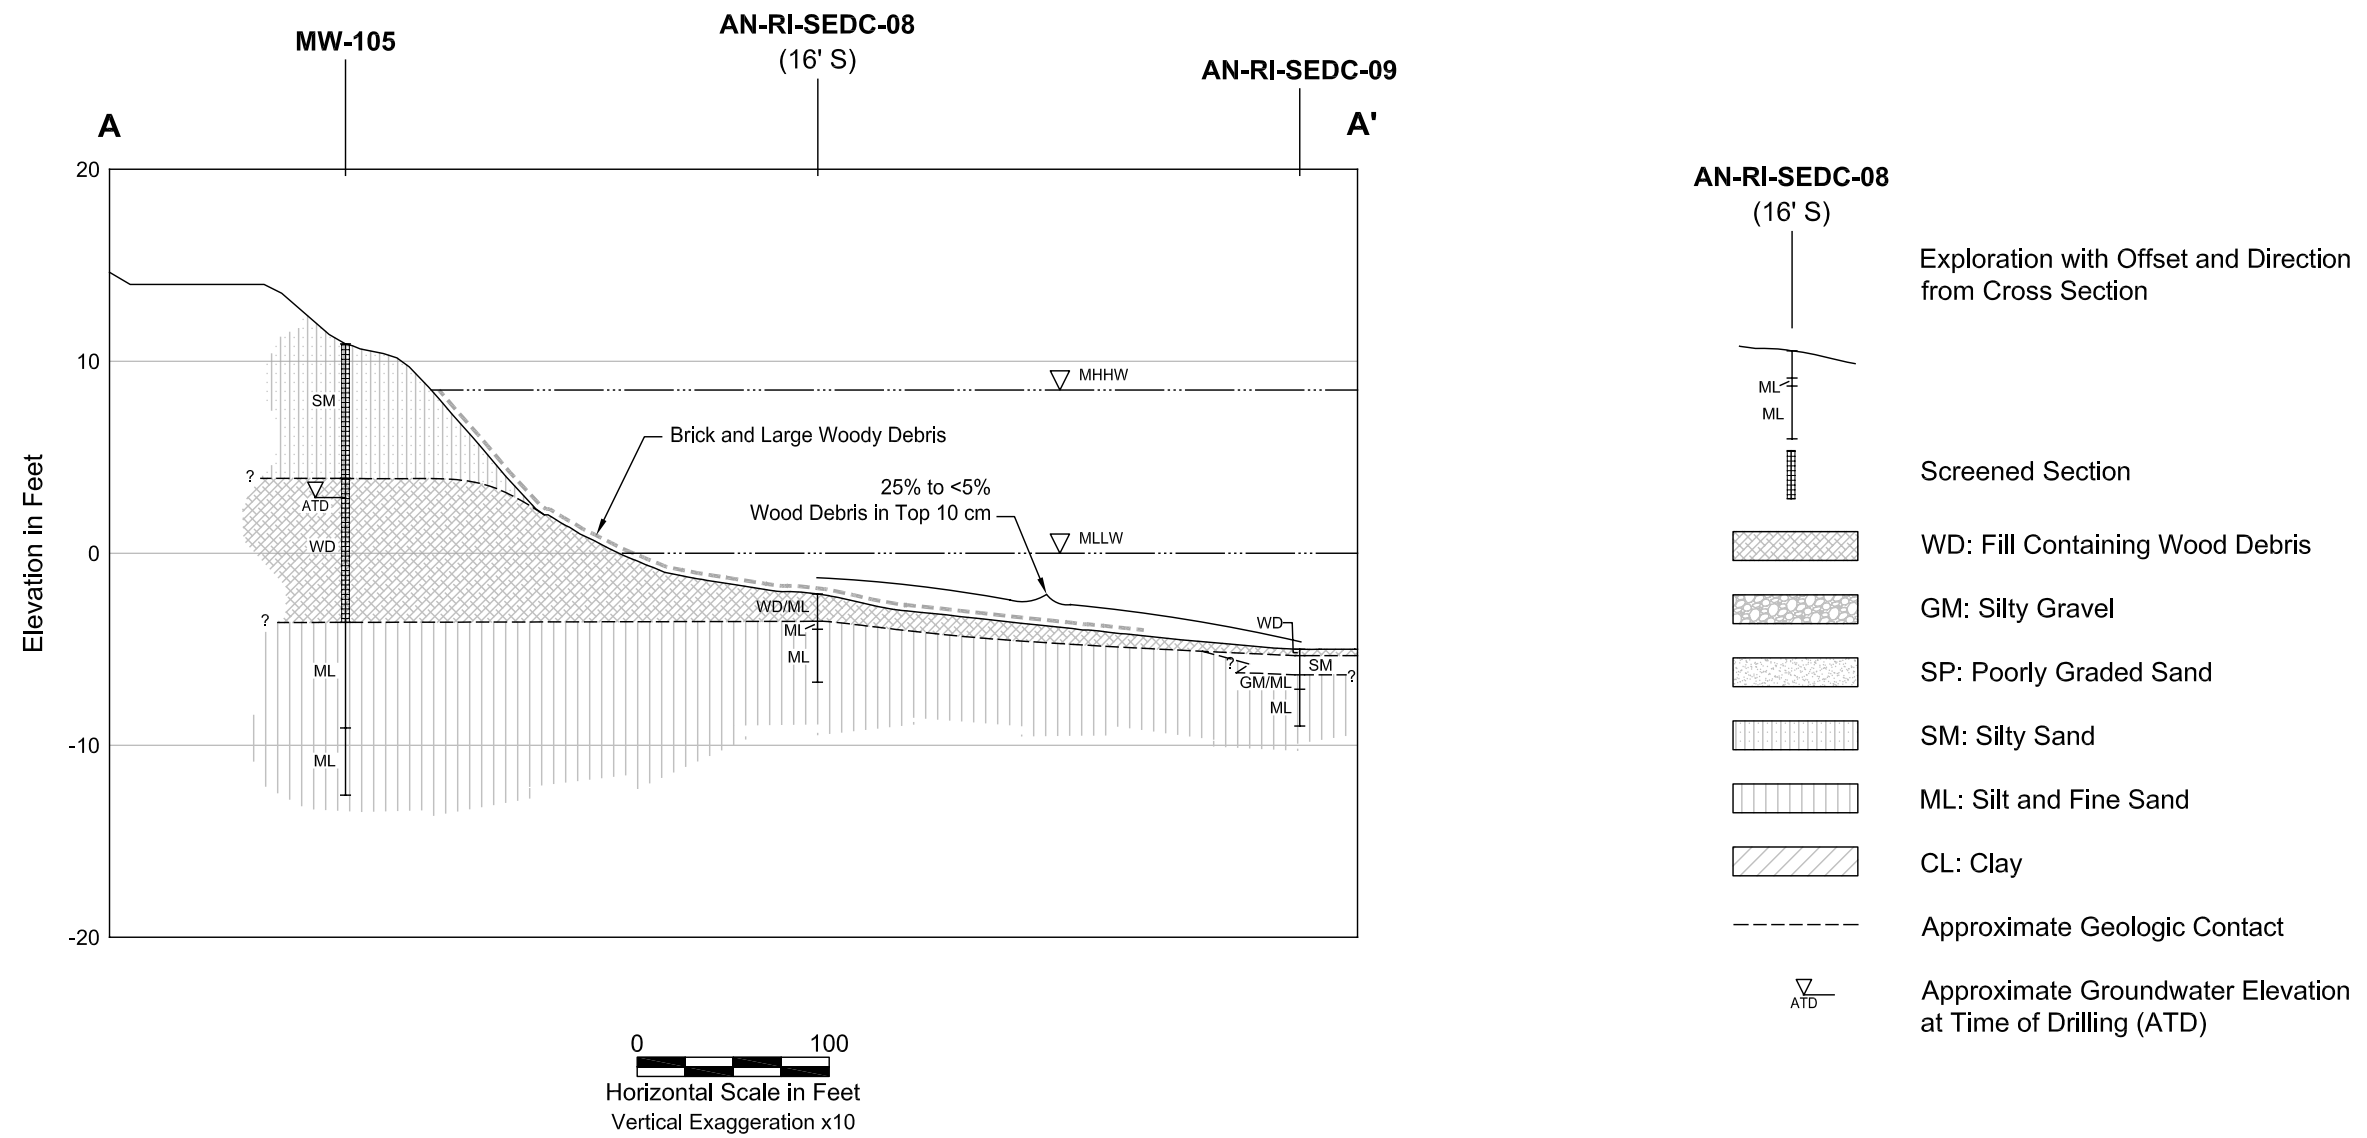
**Figure 38**  
Cross Sections A-A'  
Former Scott Paper Mill
